PROPERTY CONDITION REPORT

195 S Main Street

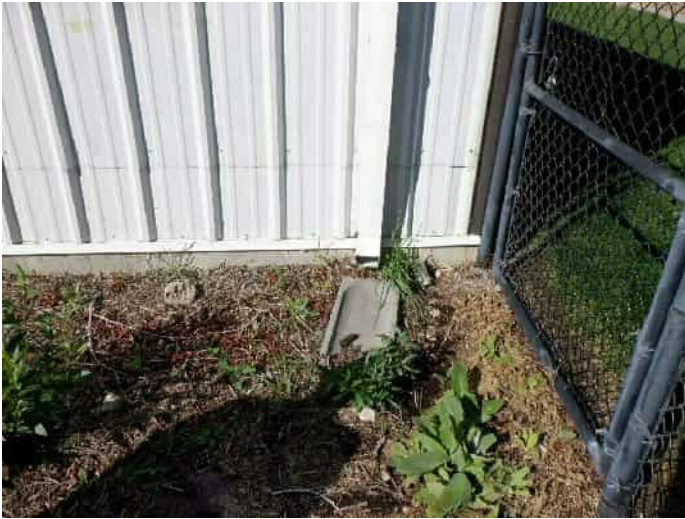
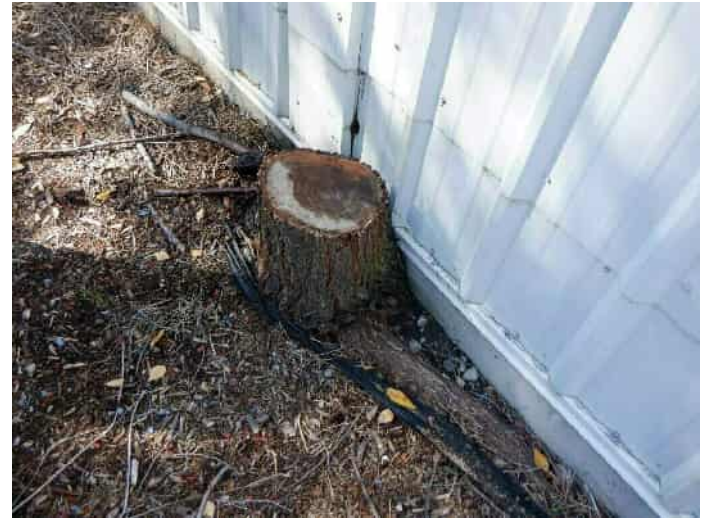
13. Roof, drainage, splash block at northeast corner of bldg

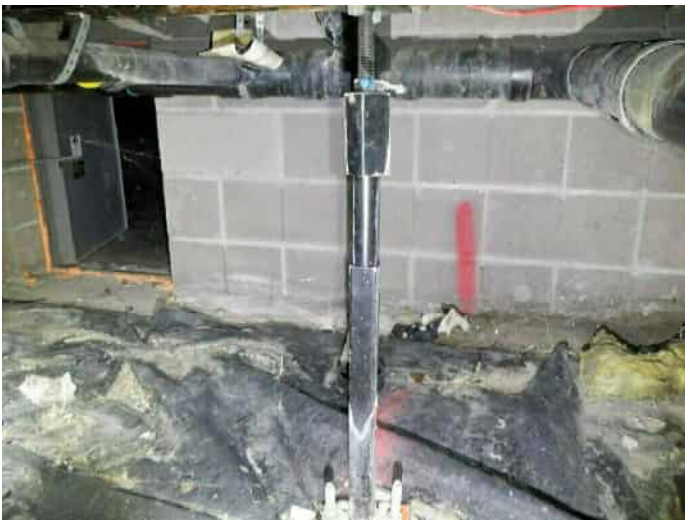
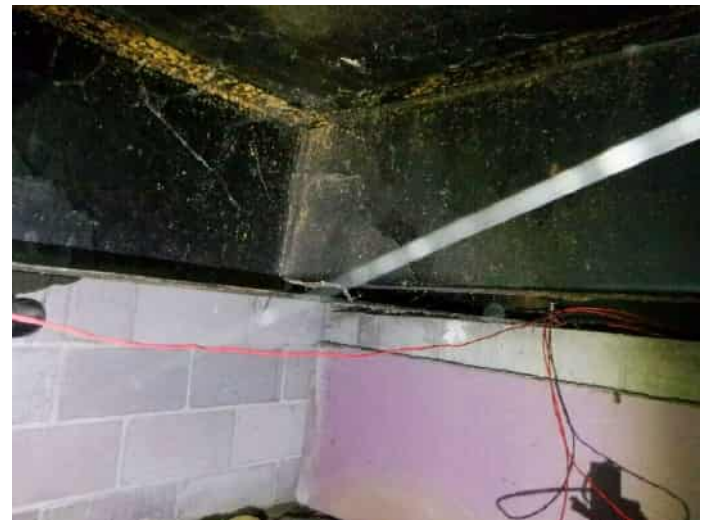
15. Crawlspace, firewall in crawlspace

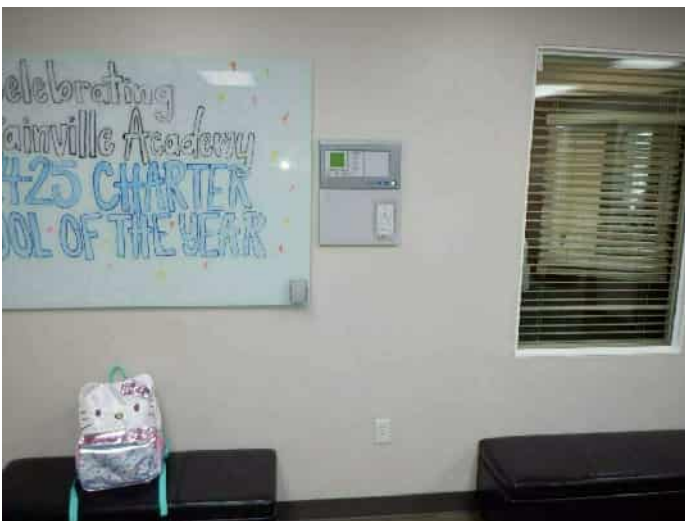
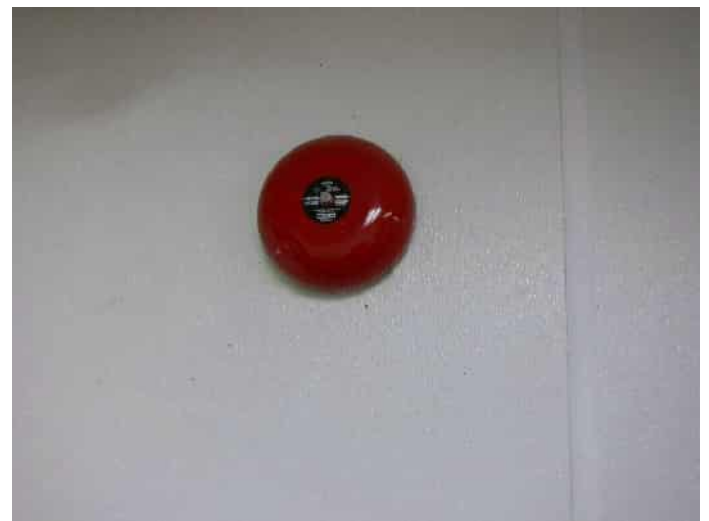
17. FLS, fire alarm, main FACP

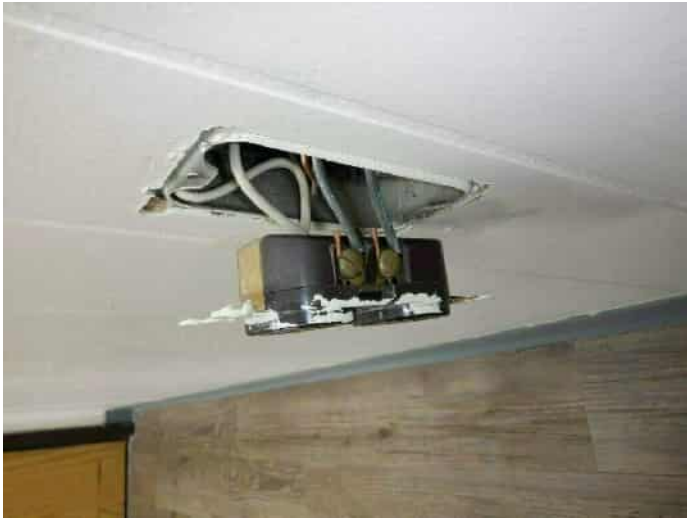
25. MEP, electrical, copper wiring, observed

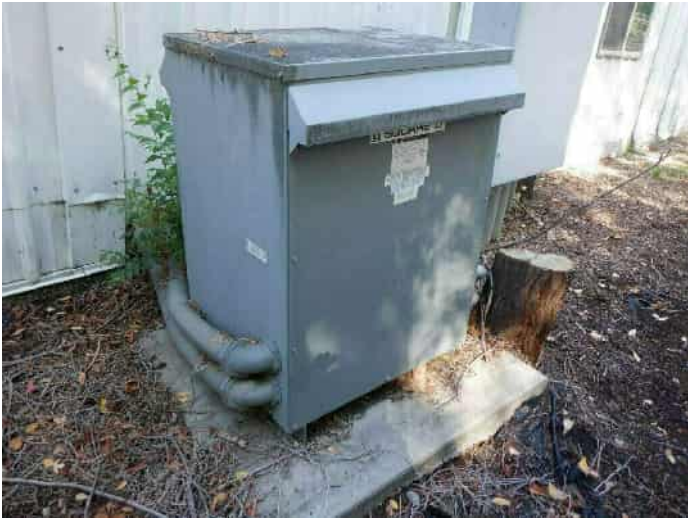
26. MEP, utility, 225 KVA transformer on pad at rear of building

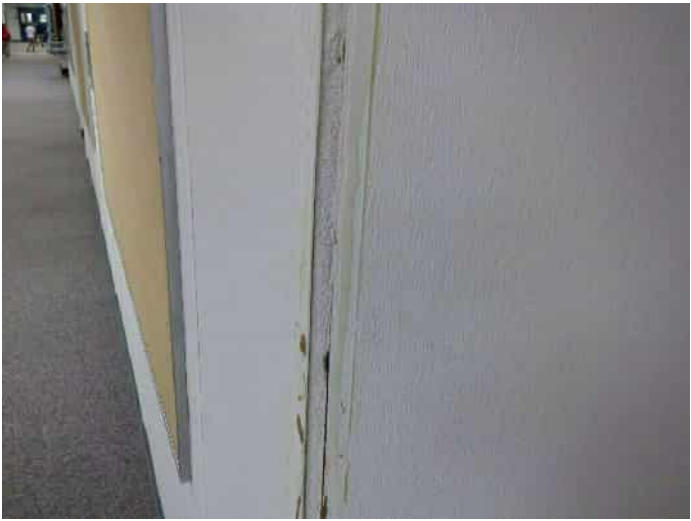
58. Damaged corner molding

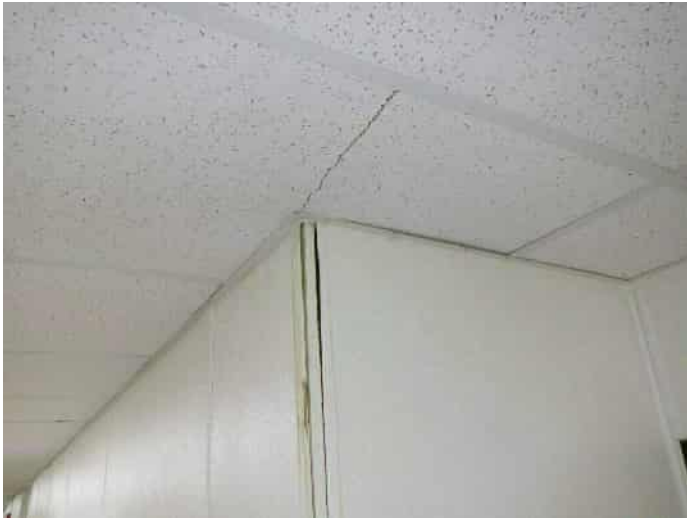
59. Damaged ceiling tiles

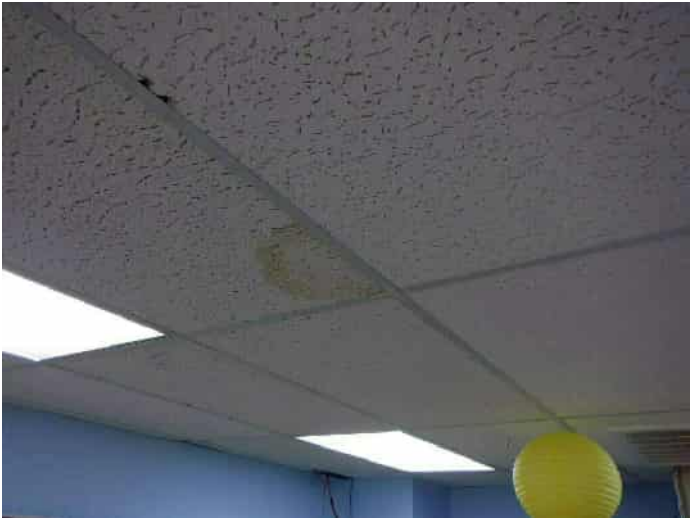
60. Stained ceiling tile

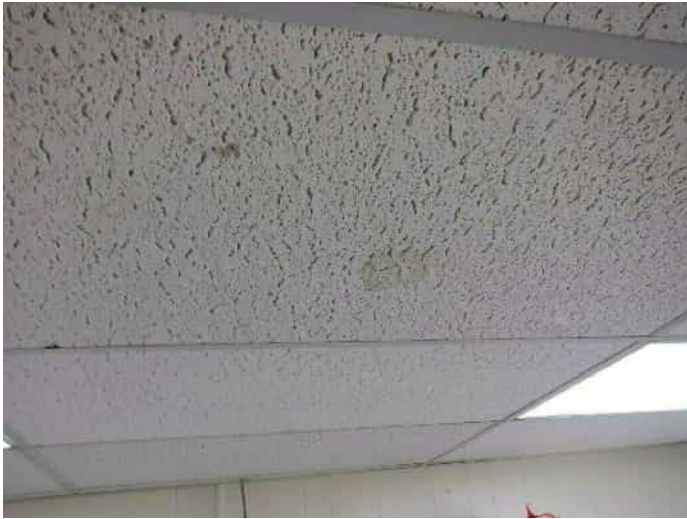
61. Stained ceiling tile

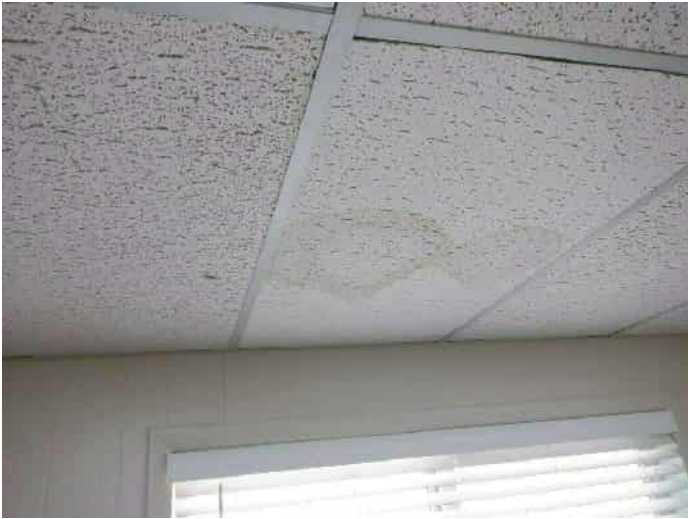
62. Stained ceiling tile

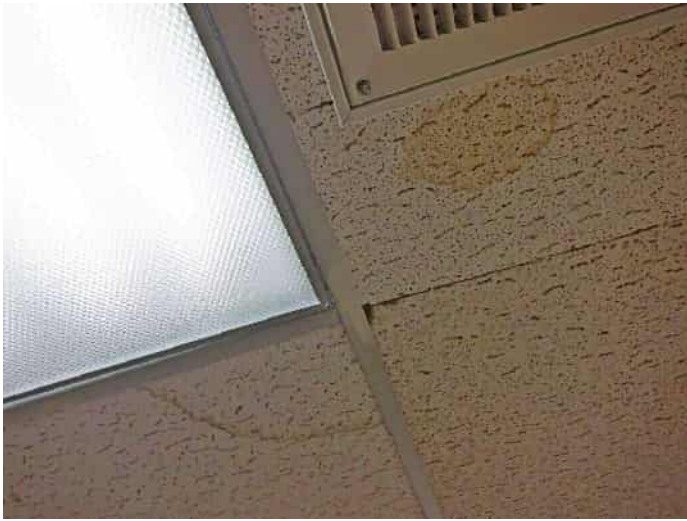
63. Stained ceiling tile

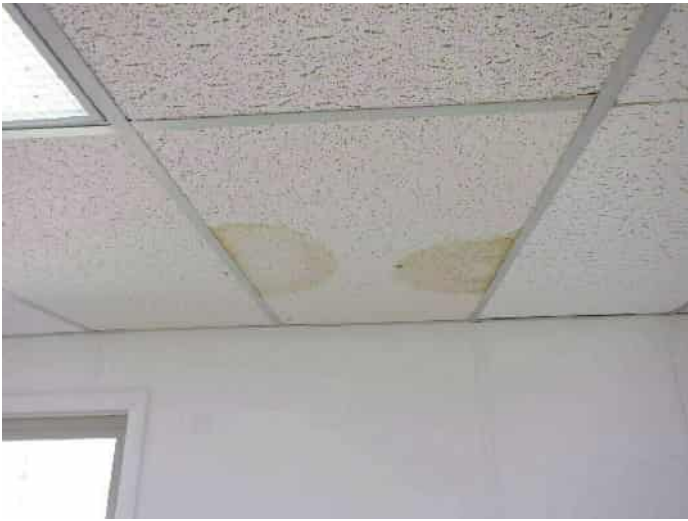
64. Stained ceiling tile

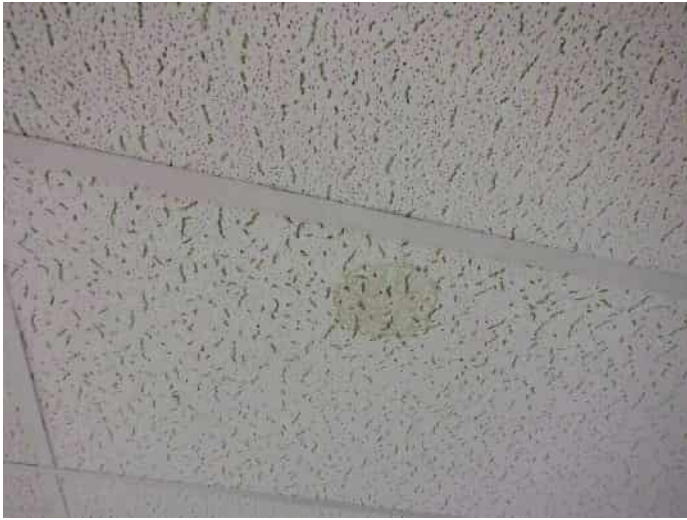
65. Stained ceiling tile

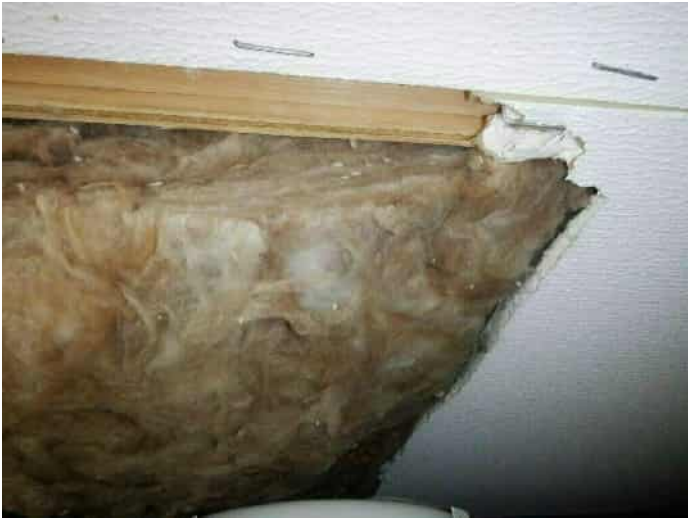
66. Damaged ceiling tile showing ceiling structure

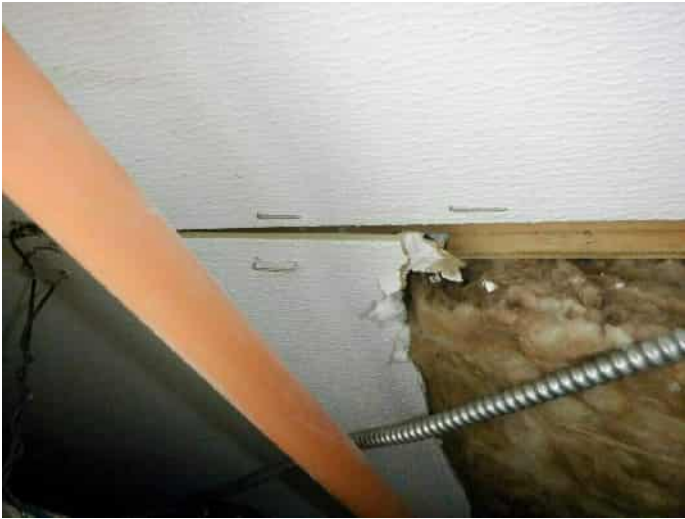
67. Damaged ceiling tile showing ceiling structure

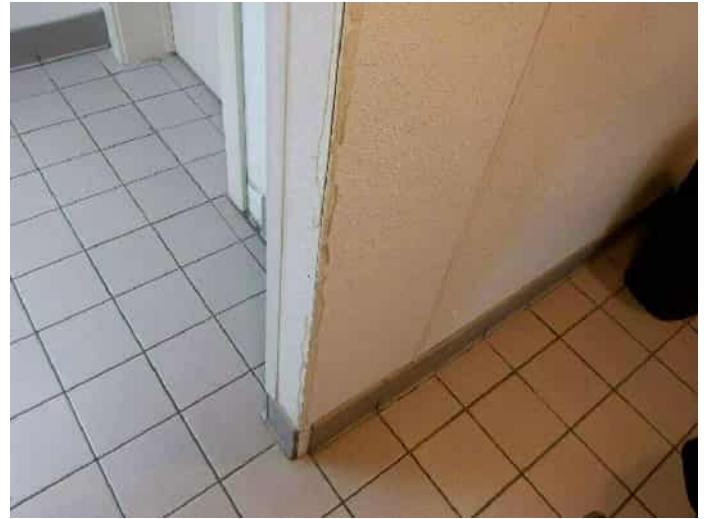
68. Damaged corner molding in old shower room

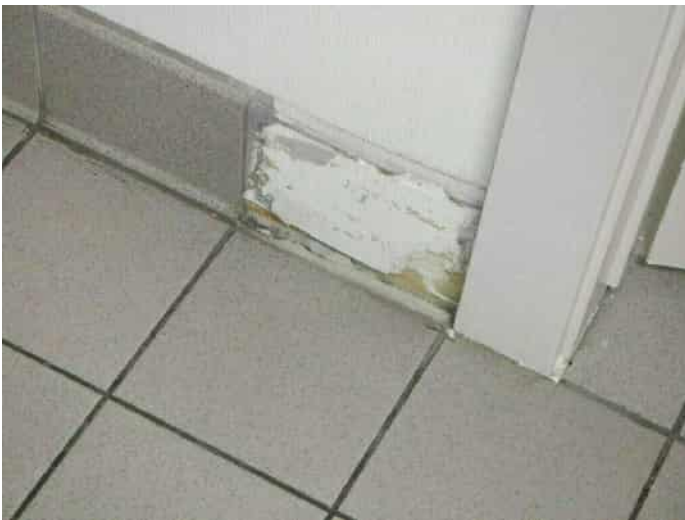
69. Damaged ceramic tile mop board in restroom

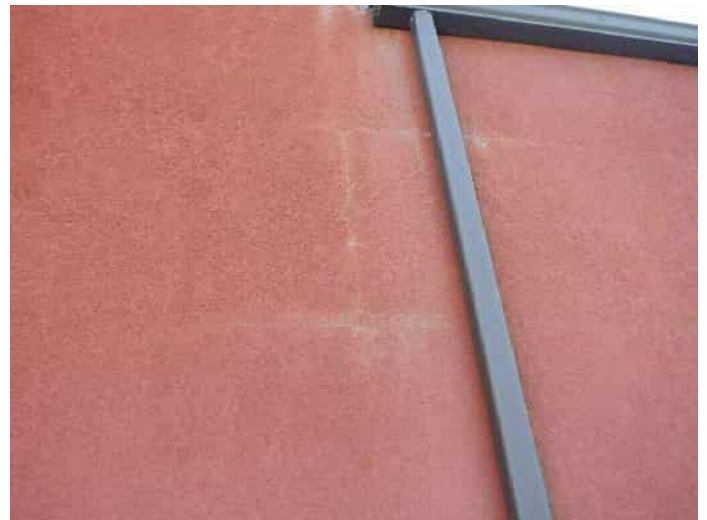
70. Ext, cladding, damaged EIFS

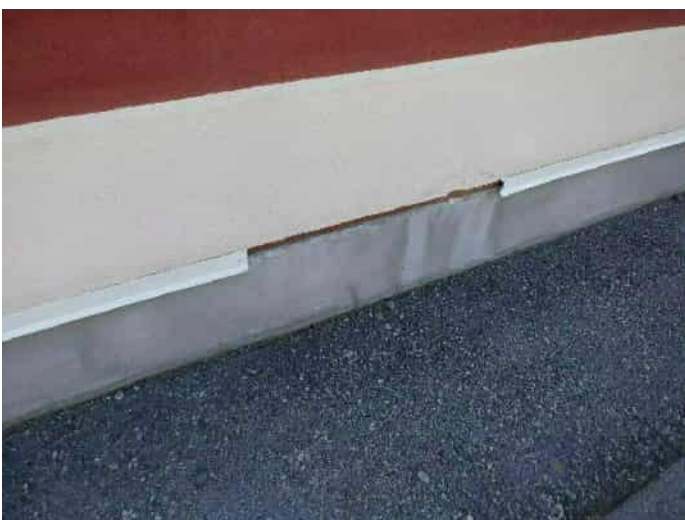
71. Ext, cladding, drip edge missing along sill plate

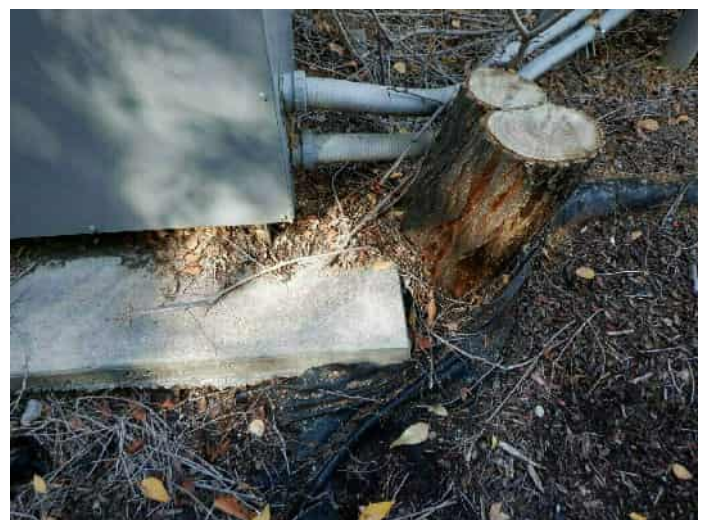
72. MEP, utility, stumps from trees having heaved pad that transformer sits on
