IT PIPE REPORTS

STATE ST

FROM 2100 TO GARDEN

Defect Listing Plot

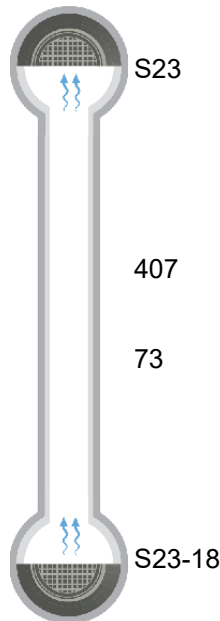
0 ft Miscellaneous Water Level

0 ft Access Point Manhole

120.9 ft Access Point Manhole

120.9 ft Miscellaneous Water Level

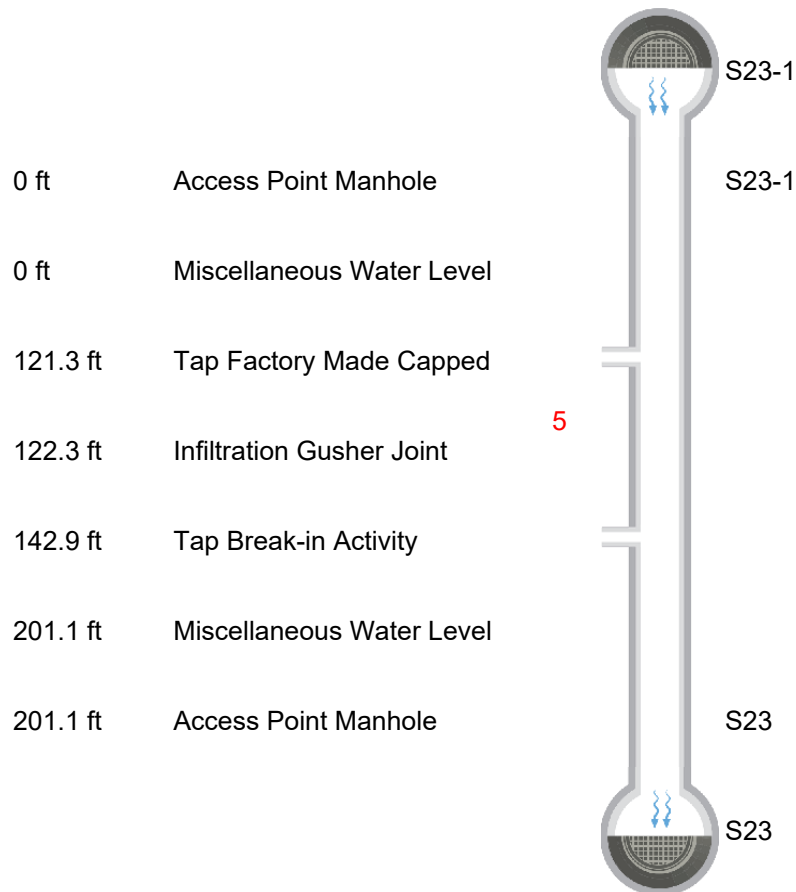
Pipe Segment Reference WWMAIN-378	Street* STATE ST		Material* Vitrified Clay Pipe	Location Code	
Upstream MH* S23-1	Total Length	Year Constructed	Location Details		
Downstream MH* S23	Length surveyed 201.1	Year Renewed	Height* 10	Width*	Pipe Joint
SPR 0	MPR 5	PO Number		Customer	
SPRI 0	MPRI 5	Work Order Number		Purpose	
QSR 0000	QMR 5100				
OPR 5	Surveyed By* JHegvik	Direction* Downstream	Date* 10/13/2025 12:49:19 PM	Media label	
OPRI 5	Certificate Number* 123	Pre-Cleaning Light Cleaning	Time 10/13/2025 12:49:52 PM	Weather	
Date Cleaned			End Time 10/13/2025 1:00:31 PM	Additional Info

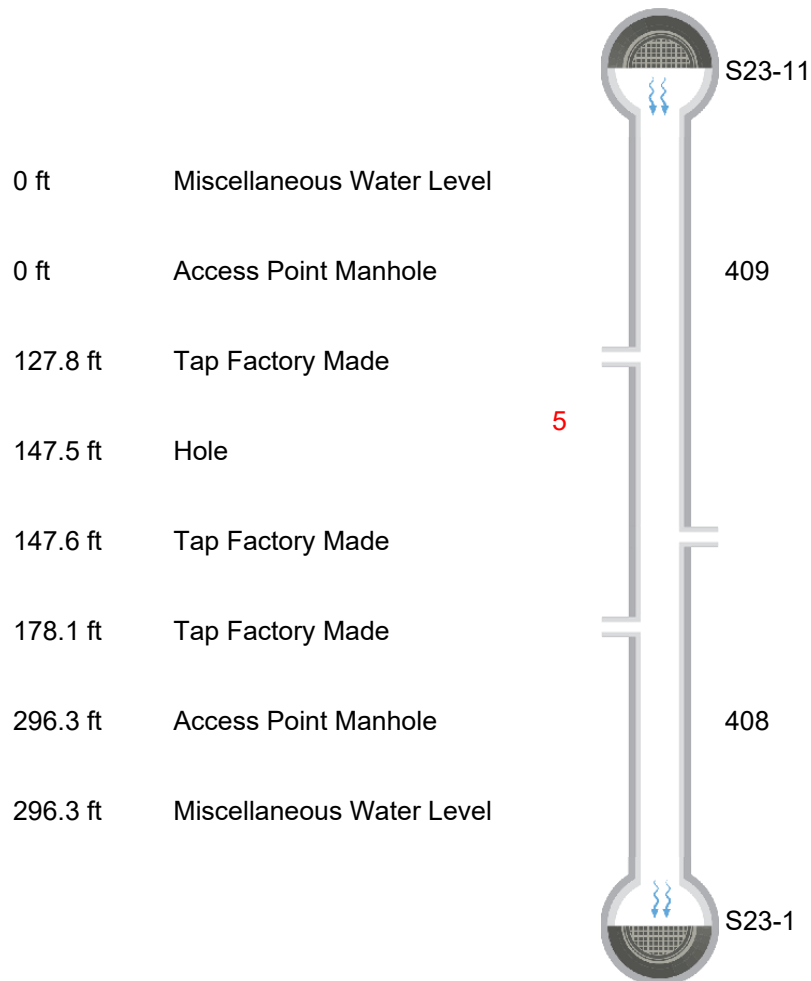
Pipe Segment Reference WWMAN-377	Street* state street UTOPIA AVE		Material* Vitrified Clay Pipe	Location Code	
Upstream MH* S23-11	Total Length	Year Constructed	Location Details		
Downstream MH* S23-1	Length surveyed 296.3	Year Renewed	Height* 10	Width*	Pipe Joint
SPR 5	MPR 0	PO Number		Customer	
SPRI 5	MPRI 0	Work Order Number		Purpose	
QSR 5100	QMR 0000				
OPR 5	Surveyed By* JGILLESPIE	Direction* Downstream	Date* 10/14/2024 2:00:00 AM	Media label	
OPRI 5	Certificate Number* 123	Pre-Cleaning Light Cleaning	Time 10/14/2024 2:00:00 AM	Weather	
Date Cleaned			End Time 10/14/2024 2:11:33 AM	Additional Info

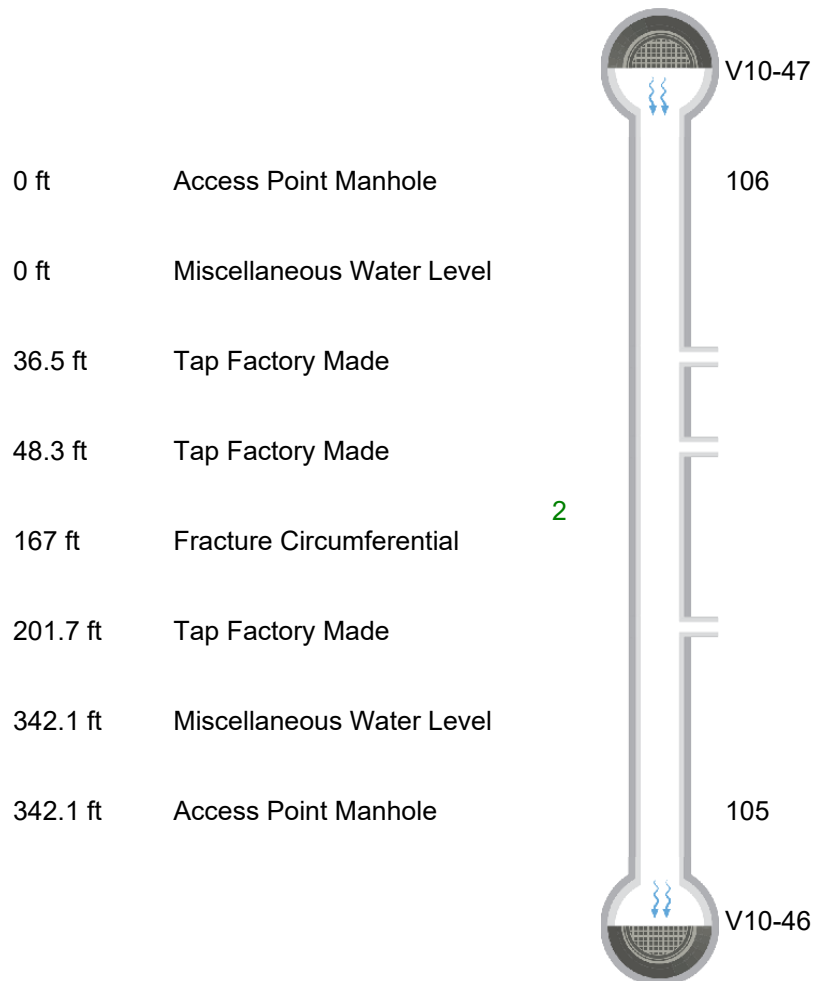
Pipe Segment Reference WWMAIN-123	Street* state street haven ave		Material* Vitrified Clay Pipe	Location Code	
Upstream MH* V10-47	Total Length 391.025	Year Constructed	Location Details		
Downstream MH* V10-46	Length surveyed 342.1	Year Renewed	Height* 8	Width*	Pipe Joint
SPR 2	MPR 0	PO Number		Customer	
SPRI 2	MPRI 0	Work Order Number		Purpose	
QSR 2100	QMR 0000				
OPR 2	Surveyed By* jgillespie	Direction* Downstream	Date* 11/20/2024 7:43:40 PM	Media label	
OPRI 2	Certificate Number* 123	Pre-Cleaning Light Cleaning	Time 11/20/2024 7:44:11 PM	Weather	
Date Cleaned			End Time 11/20/2024 7:58:16 PM	Additional Info

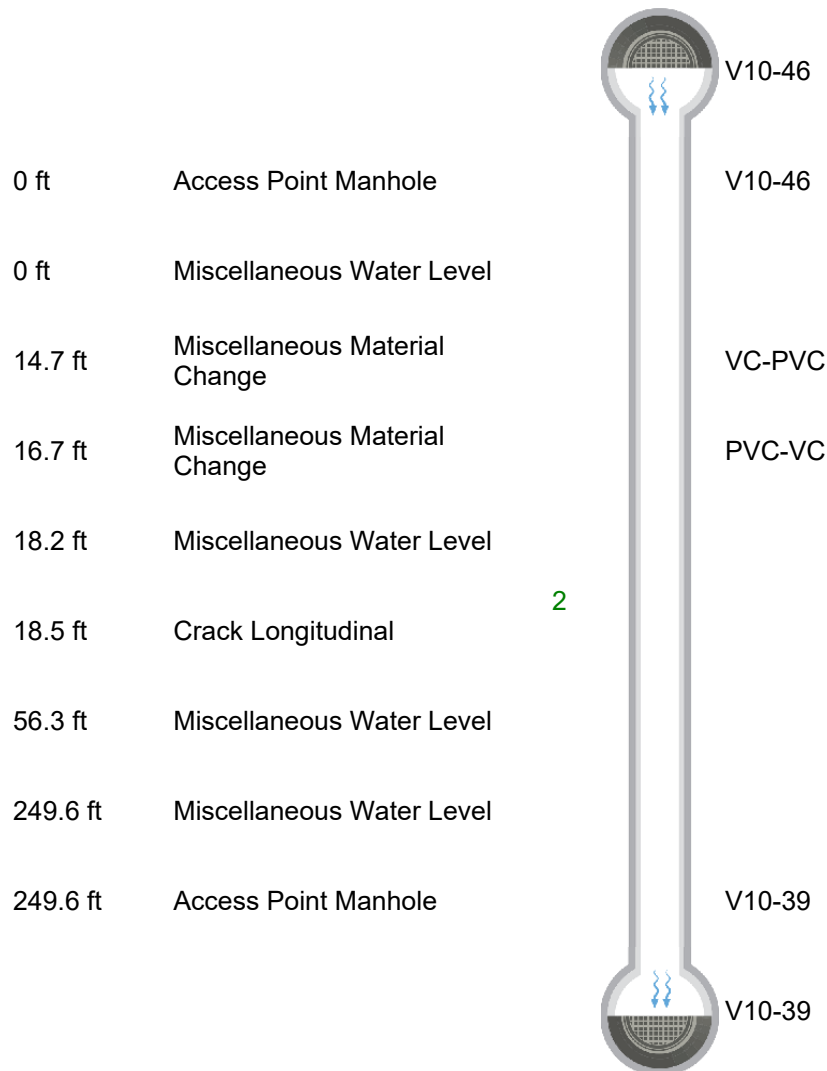
Pipe Segment Reference WWMAIN-124	Street* state street		Material* Vitrified Clay Pipe	Location Code	
Upstream MH* V10-46	Total Length	Year Constructed	Location Details		
Downstream MH* V10-39	Length surveyed 249.6	Year Renewed	Height* 8	Width*	Pipe Joint
SPR 2	MPR 0	PO Number		Customer	
SPRI 2	MPRI 0	Work Order Number		Purpose	
QSR 2100	QMR 0000				
OPR 2	Surveyed By* JHegvik	Direction* Downstream	Date* 7/8/2025 1:19:22 PM	Media label	
OPRI 2	Certificate Number* 123	Pre-Cleaning Light Cleaning	Time 7/8/2025 1:20:06 PM	Weather	
Date Cleaned			End Time 7/8/2025 1:28:25 PM	Additional Info

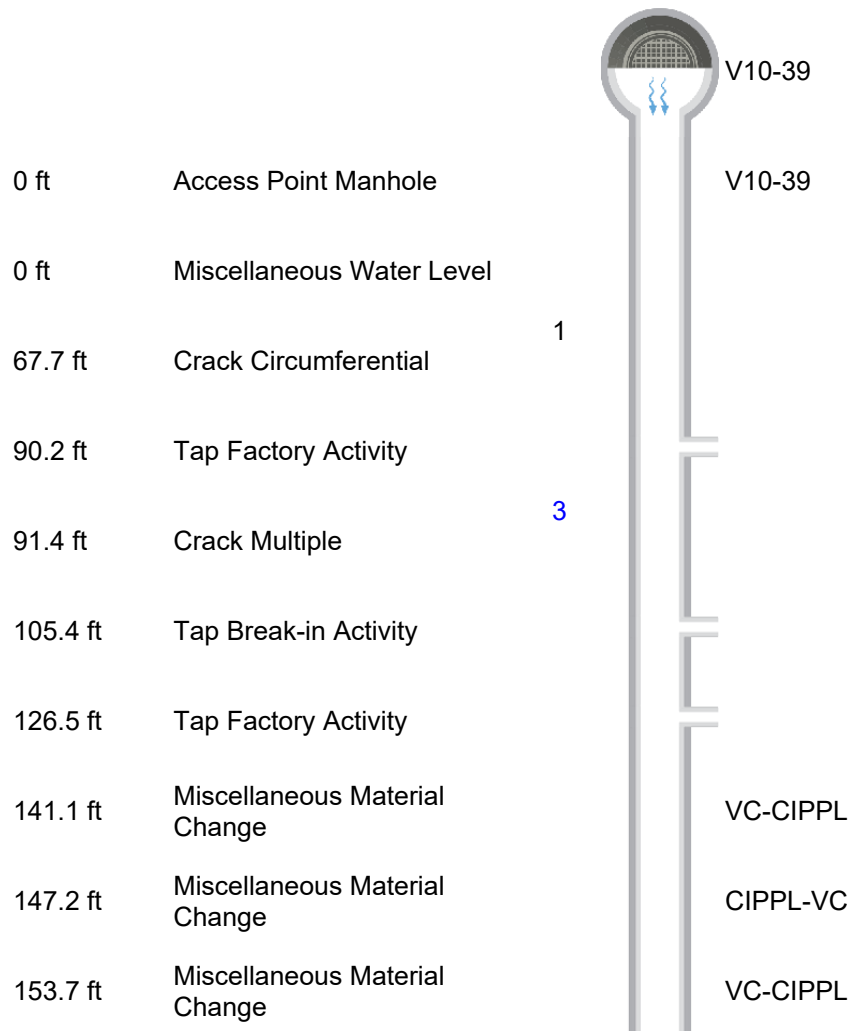
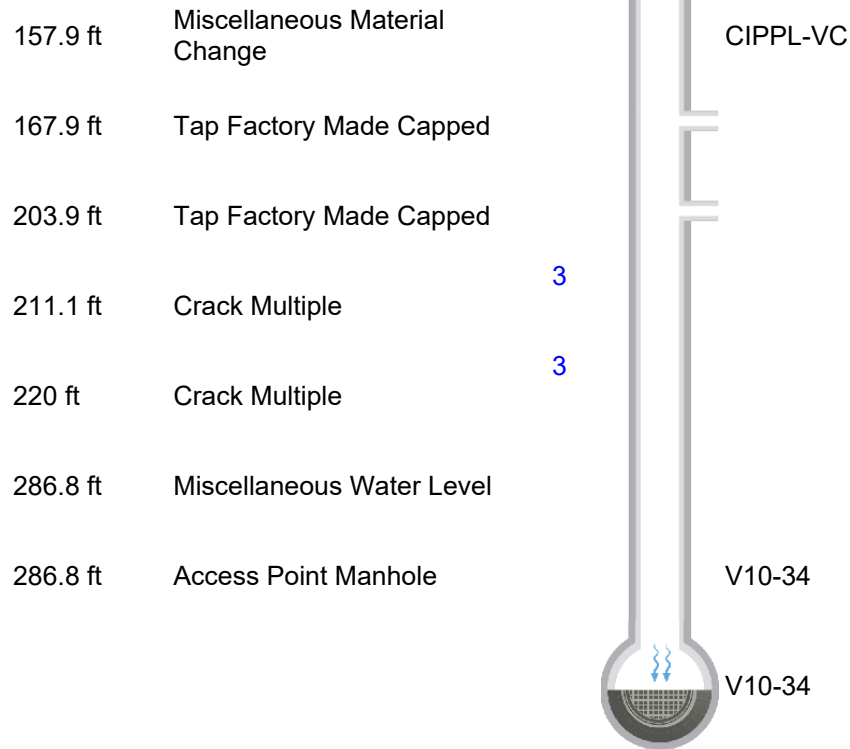
Pipe Segment Reference WWMAIN-125	Street* state st		Material* Vitrified Clay Pipe	Location Code	
Upstream MH* V10-39	Total Length	Year Constructed 0	Location Details		
Downstream MH* V10-34	Length surveyed 286.8	Year Renewed	Height* 8	Width*	Pipe Joint
SPR 10	MPR 0	PO Number		Customer	
SPRI 2.5	MPRI 0	Work Order Number		Purpose	
QSR 3311	QMR 0000				
OPR 10	Surveyed By* JHegvik	Direction* Downstream	Date* 10/7/2025 3:11:23 PM	Media label	
OPRI 2.5	Certificate Number* 123	Pre-Cleaning Light Cleaning	Time 10/7/2025 3:11:52 PM	Weather	
Date Cleaned			End Time 10/7/2025 3:22:40 PM	Additional Info

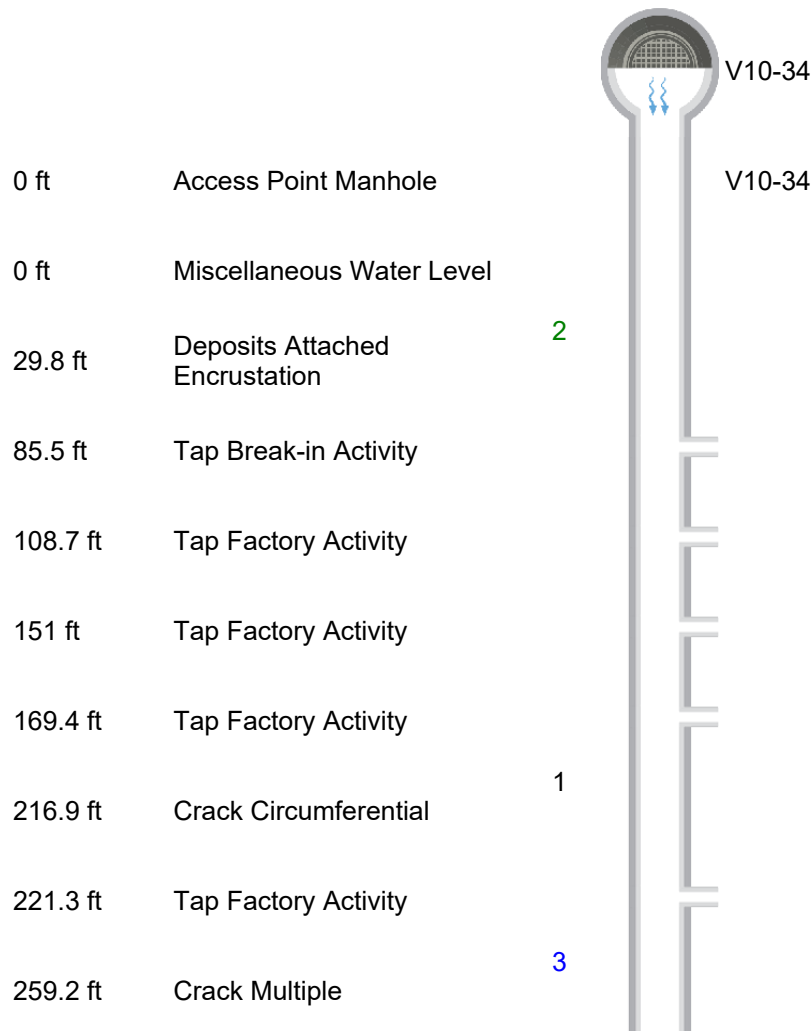
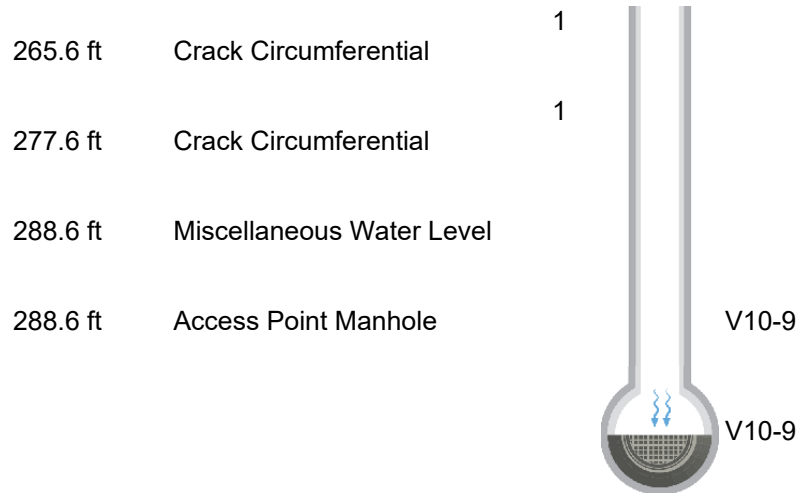
Pipe Segment Reference WWMAIN-121	Street* S State St		Material* Vitrified Clay Pipe	Location Code	
Upstream MH* V10-34	Total Length 288.246	Year Constructed	Location Details		
Downstream MH* V10-9	Length surveyed 288.6	Year Renewed	Height* 8	Width*	Pipe Joint
SPR 6	MPR 2	PO Number		Customer	
SPRI 1.5	MPRI 2	Work Order Number		Purpose	
QSR 3113	QMR 2100				
OPR 8	Surveyed By* JHegvik	Direction* Downstream	Date* 10/7/2025 1:42:57 PM	Media label	
OPRI 1.6	Certificate Number* 123	Pre-Cleaning Light Cleaning	Time 10/7/2025 1:43:19 PM	Weather	
Date Cleaned			End Time 10/7/2025 2:08:54 PM	Additional Info

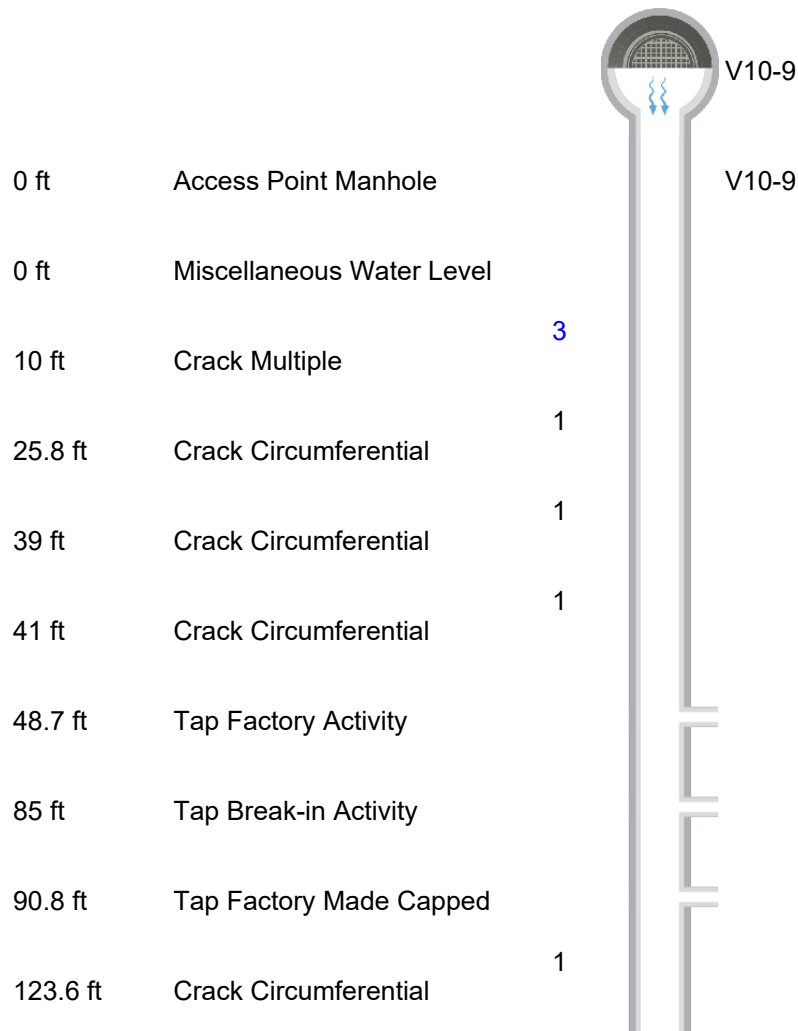
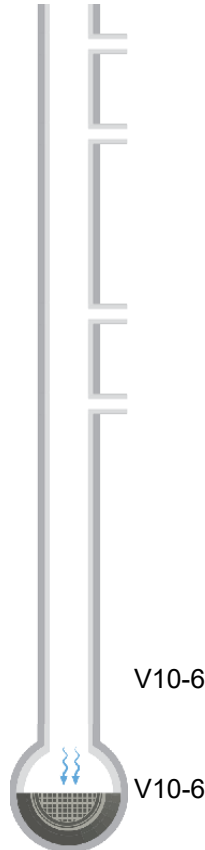
133.1 ft Tap Break-in Activity

145.1 ft Tap Factory Made Capped

146.3 ft Crack Multiple

147.9 ft Tap Factory Made Capped

202.8 ft Tap Factory Activity

265.8 ft Crack Longitudinal

286.9 ft Miscellaneous Water Level

286.9 ft Access Point Manhole

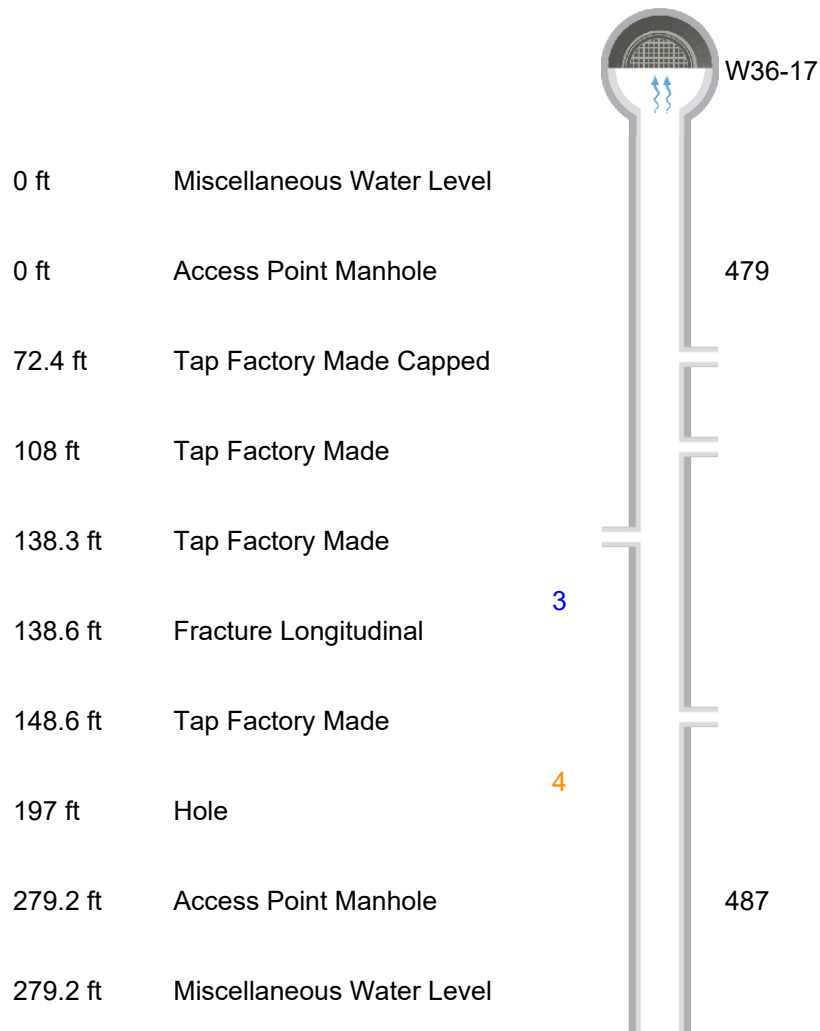
Pipe Segment Reference WWMAIN-463	Street* state street whitlock ave		Material* Vitrified Clay Pipe	Location Code	
Upstream MH* W36-24	Total Length	Year Constructed	Location Details		
Downstream MH* W36-17	Length surveyed 279.2	Year Renewed	Height* 10	Width*	Pipe Joint
SPR 7	MPR 0	PO Number		Customer	
SPRI 3.5	MPRI 0	Work Order Number		Purpose	
QSR 4131	QMR 0000				
OPR 7	Surveyed By* jgillespie	Direction* Upstream	Date* 10/15/2024 2:01:51 AM	Media label	
OPRI 3.5	Certificate Number* 123	Pre-Cleaning Light Cleaning	Time 10/15/2024 2:01:51 AM	Weather	
Date Cleaned			End Time 10/15/2024 2:13:49 AM	Additional Info

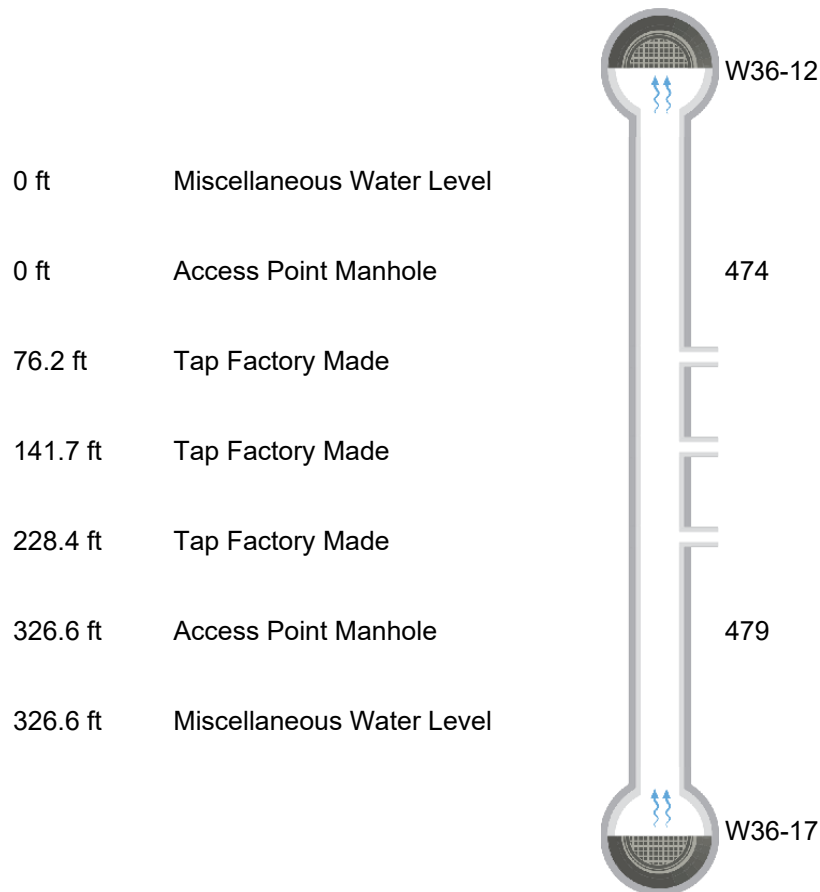
Pipe Segment Reference WWMAIN-464	Street* state street beryl ave		Material* PolyVinyl Chloride	Location Code	
Upstream MH* W36-17	Total Length	Year Constructed	Location Details		
Downstream MH* W36-12	Length surveyed 326.6	Year Renewed	Height* 10	Width*	Pipe Joint
SPR 0	MPR 0	PO Number		Customer	
SPRI 0	MPRI 0	Work Order Number		Purpose	
QSR 0000	QMR 0000				
OPR 0	Surveyed By* jgillespie	Direction* Upstream	Date* 10/15/2024 1:26:53 AM	Media label	
OPRI 0	Certificate Number* 123	Pre-Cleaning Light Cleaning	Time 10/15/2024 1:26:53 AM	Weather	
Date Cleaned			End Time 10/15/2024 2:00:22 AM	Additional Info

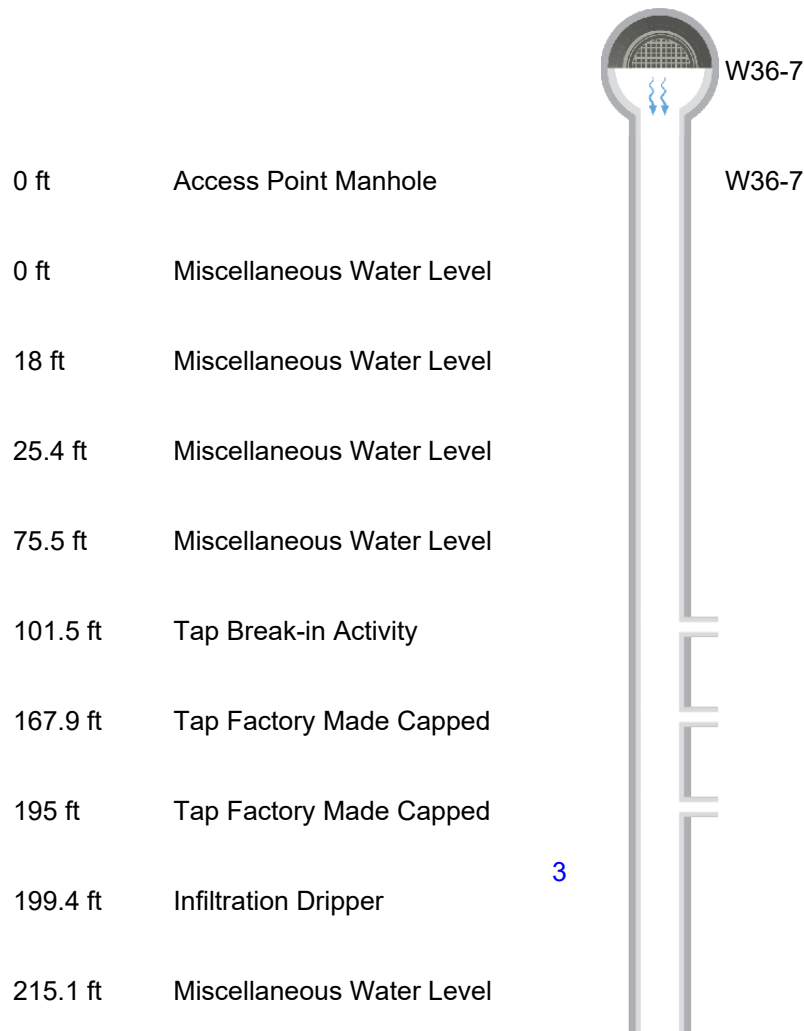
228.2 ft Tap Break-in Activity

233.3 ft Infiltration Dripper

234.1 ft Tap Factory Activity

242.7 ft Miscellaneous Water Level

252.8 ft Infiltration Dripper Joint

265.3 ft Miscellaneous Material Change

304.1 ft Miscellaneous Water Level

330.6 ft Miscellaneous Water Level

330.6 ft Access Point Manhole

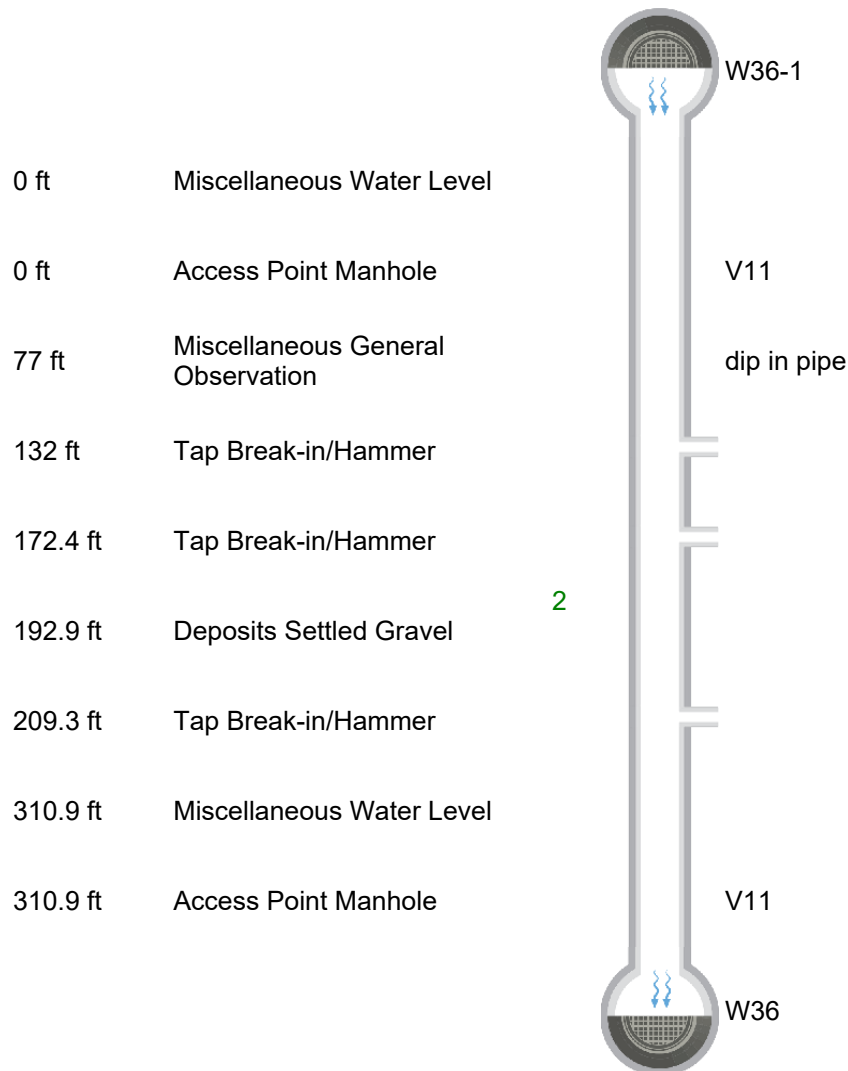
Pipe Segment Reference WWMAIN-467	Street* state st leslie ave to 2700 s		Material* PolyVinyl Chloride	Location Code	
Upstream MH* W36-1	Total Length	Year Constructed	Location Details		
Downstream MH* W36	Length surveyed 310.9	Year Renewed	Height* 10	Width* 0	Pipe Joint
SPR 0	MPR 2	PO Number		Customer	
SPRI 0	MPRI 2	Work Order Number		Purpose	
QSR 0000	QMR 2100				
OPR 2	Surveyed By* jhegvik	Direction* Downstream	Date* 9/4/2024 12:17:28 PM	Media label	
OPRI 2	Certificate Number* 123	Pre-Cleaning No Pre-Cleaning	Time 9/4/2024 12:17:28 PM	Weather	
Date Cleaned			End Time 9/4/2024 12:17:28 PM	Additional Info

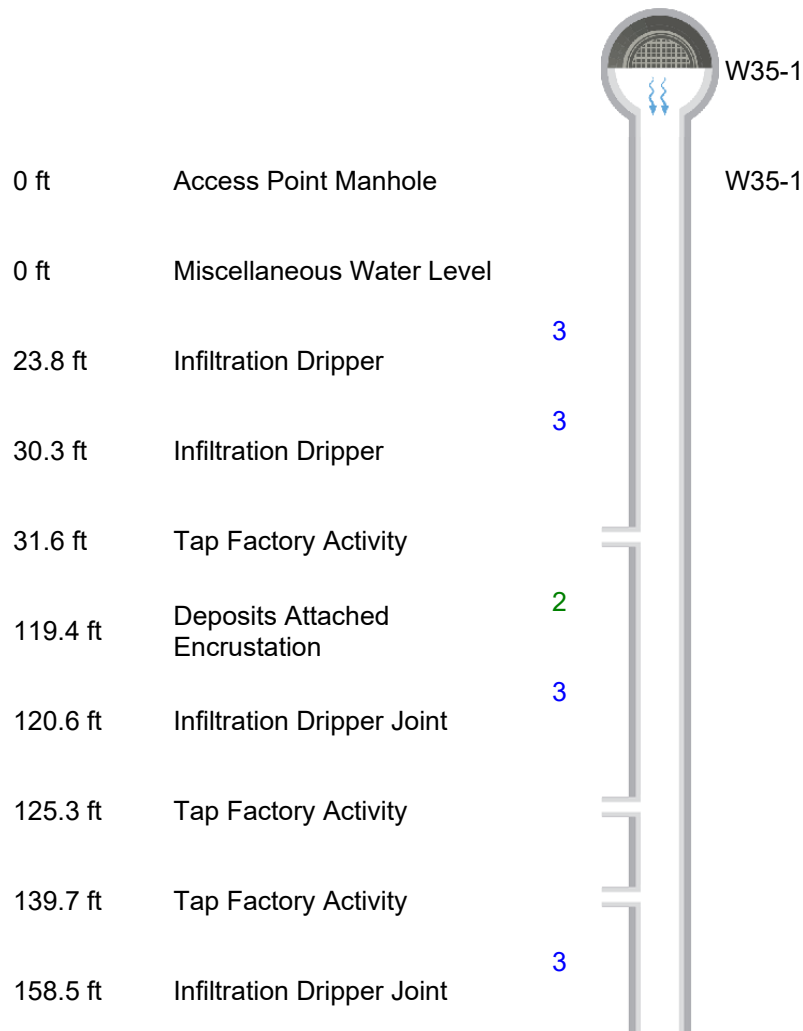
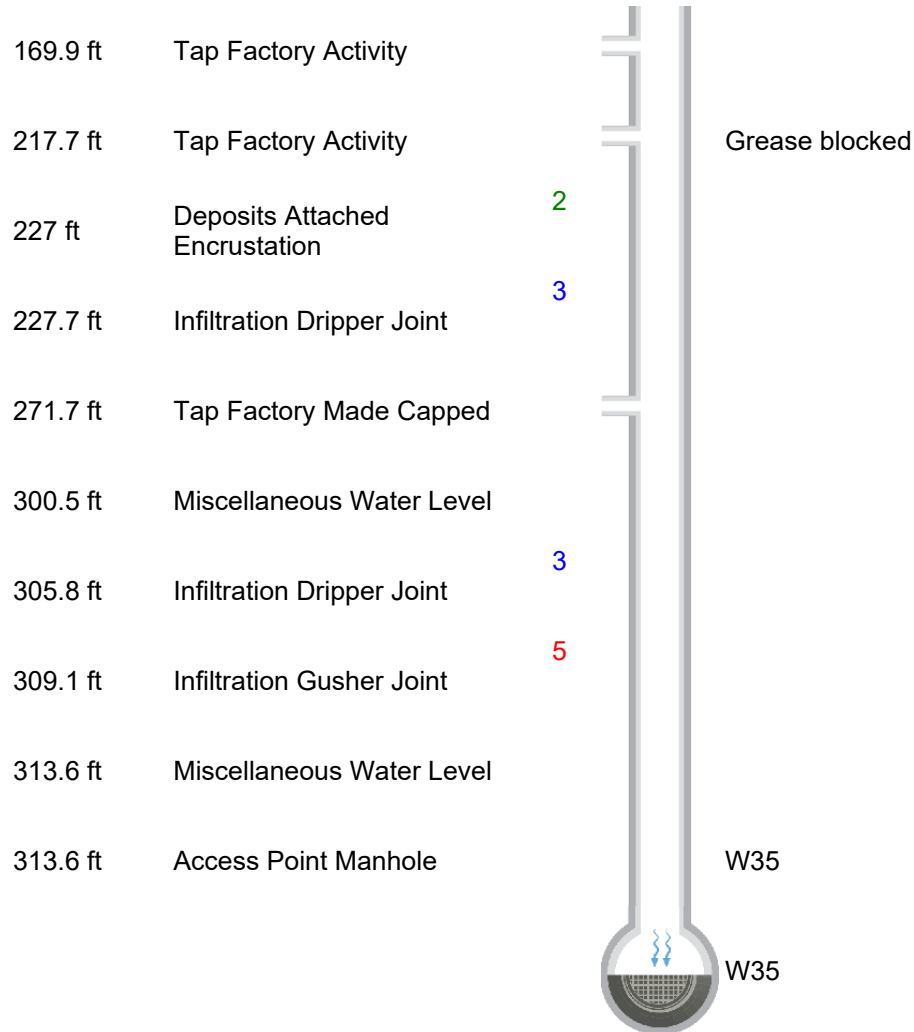
Pipe Segment Reference WWMAIN-476	Street* state street 2100 s		Material* Vitrified Clay Pipe	Location Code	
Upstream MH* W35-1	Total Length	Year Constructed	Location Details		
Downstream MH* W35	Length surveyed 313.6	Year Renewed	Height* 10	Width*	Pipe Joint
SPR 0	MPR 27	PO Number		Customer	
SPRI 0	MPRI 3	Work Order Number		Purpose	
QSR 0000	QMR 5136				
OPR 27	Surveyed By* JHegvik	Direction* Downstream	Date* 10/9/2025 8:53:53 AM	Media label	
OPRI 3	Certificate Number* 123	Pre-Cleaning Light Cleaning	Time 10/9/2025 8:54:20 AM	Weather	
Date Cleaned			End Time 10/9/2025 9:13:53 AM	Additional Info

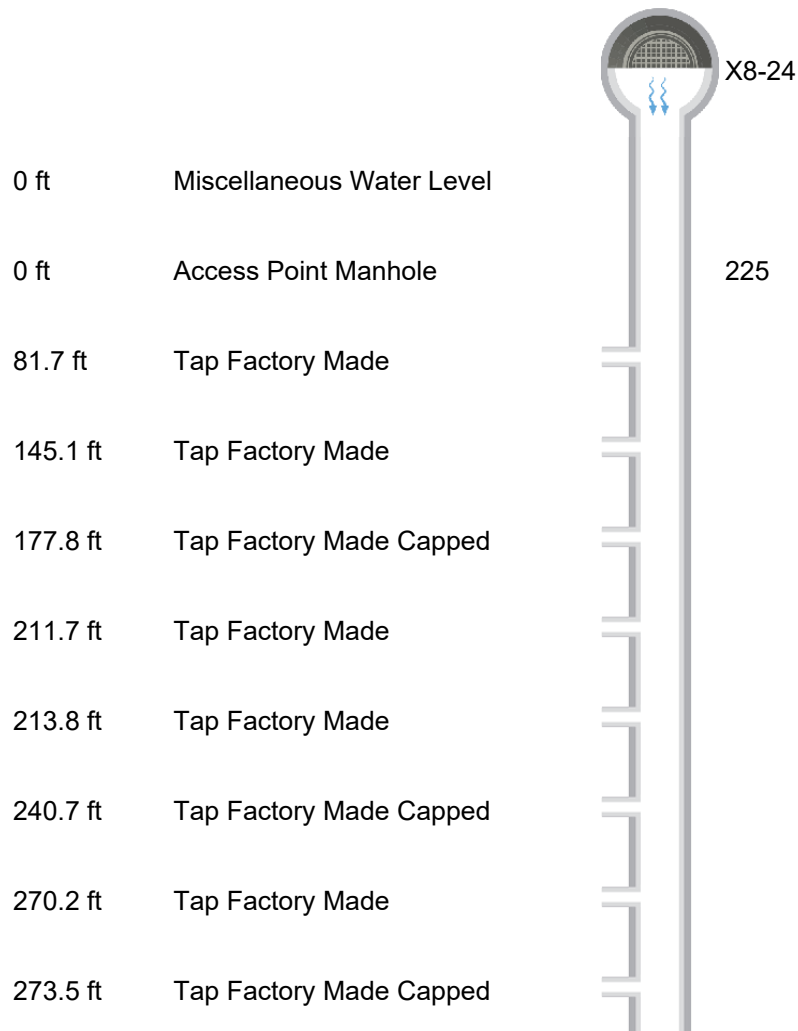
307.4 ft Tap Factory Made

317.1 ft Access Point Manhole

317.1 ft Miscellaneous Water Level

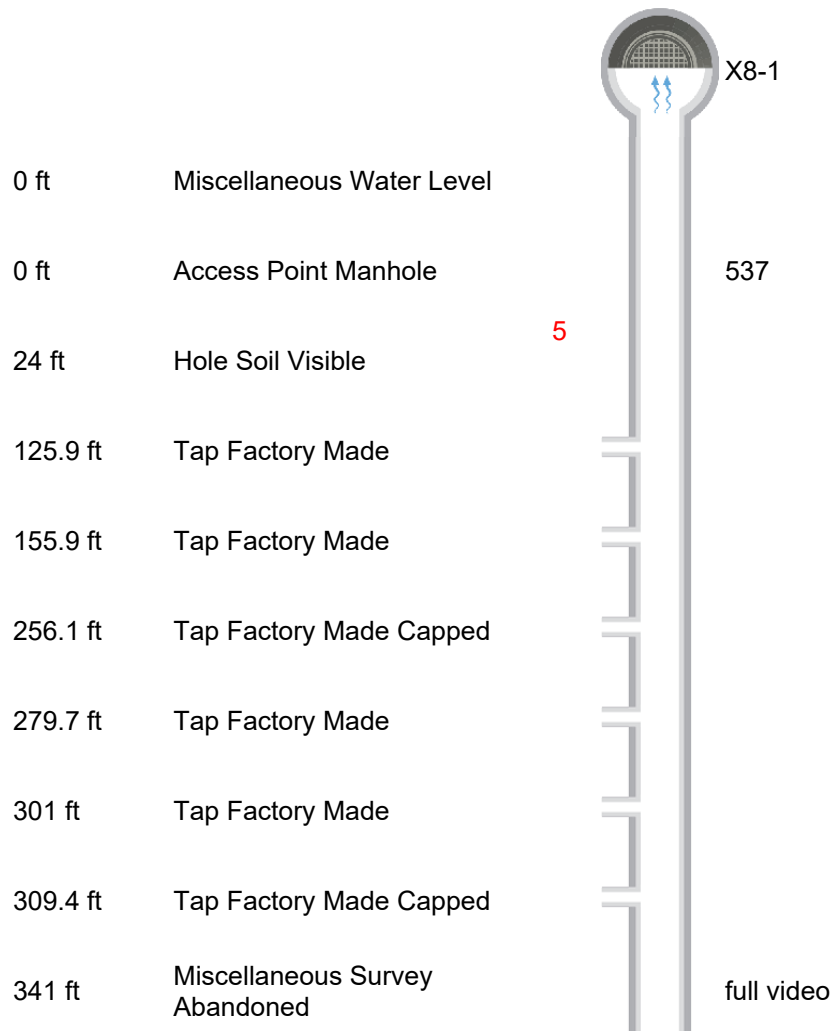
Pipe Segment Reference WWMAIN-126	Street* state streeT 2865 S		Material* Vitrified Clay Pipe	Location Code	
Upstream MH* X8-16	Total Length	Year Constructed	Location Details		
Downstream MH* X8-1	Length surveyed 341	Year Renewed	Height* 10	Width*	Pipe Joint
SPR 5	MPR 0	PO Number		Customer	
SPRI 5	MPRI 0	Work Order Number		Purpose	
QSR 5100	QMR 0000				
OPR 5	Surveyed By* jgillespie	Direction* Upstream	Date* 10/14/2024 11:57:00 PM	Media label	
OPRI 5	Certificate Number* 123	Pre-Cleaning Light Cleaning	Time 10/14/2024 11:57:00 PM	Weather	
Date Cleaned			End Time 10/14/2024 8:59:00 AM	Additional Info

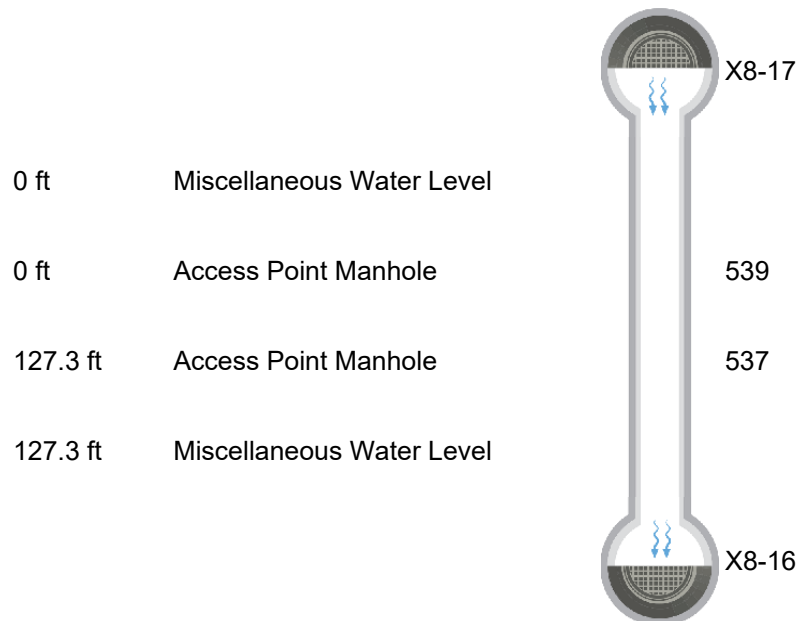
Pipe Segment Reference WWMAN-68	Street* state streeT 2865 S		Material* Vitrified Clay Pipe	Location Code	
Upstream MH* X8-17	Total Length	Year Constructed	Location Details		
Downstream MH* X8-16	Length surveyed 127.3	Year Renewed	Height* 10	Width*	Pipe Joint
SPR 0	MPR 0	PO Number		Customer	
SPRI 0	MPRI 0	Work Order Number		Purpose	
QSR 0000	QMR 0000				
OPR 0	Surveyed By* JGILLESPIE	Direction* Downstream	Date* 10/14/2024 3:44:43 AM	Media label	
OPRI 0	Certificate Number* 123	Pre-Cleaning Light Cleaning	Time 10/14/2024 3:44:43 AM	Weather	
Date Cleaned			End Time 10/14/2024 3:48:55 AM	Additional Info

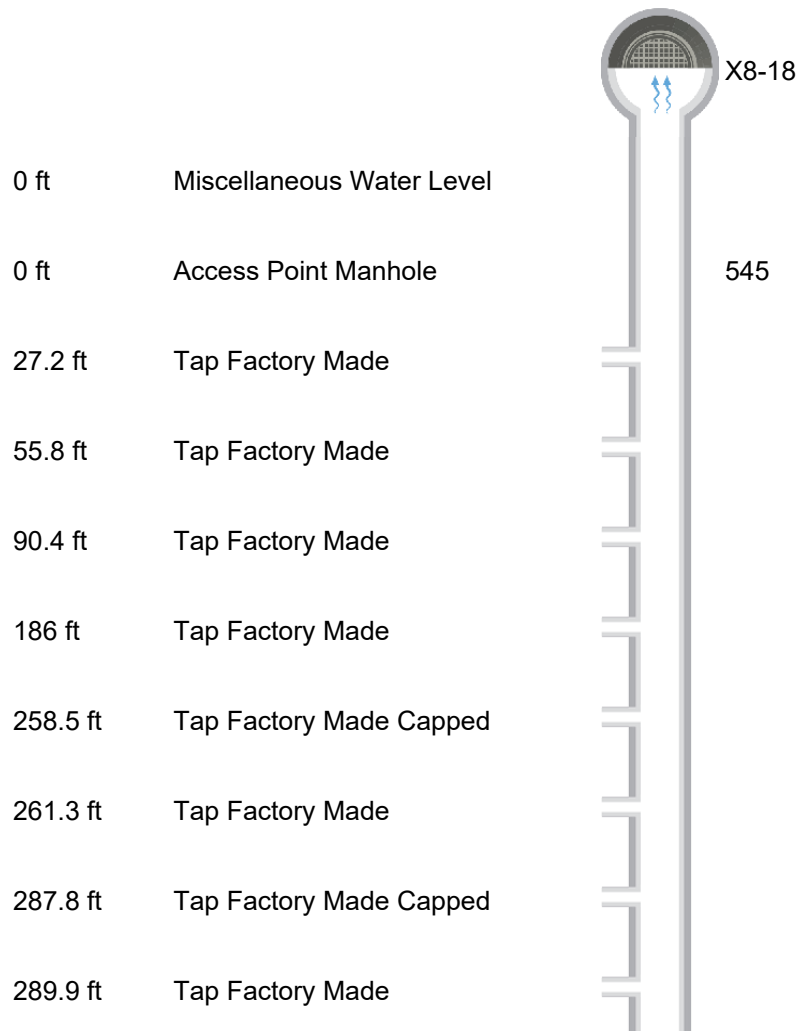
458.3 ft Access Point Manhole

458.3 ft Miscellaneous Water Level

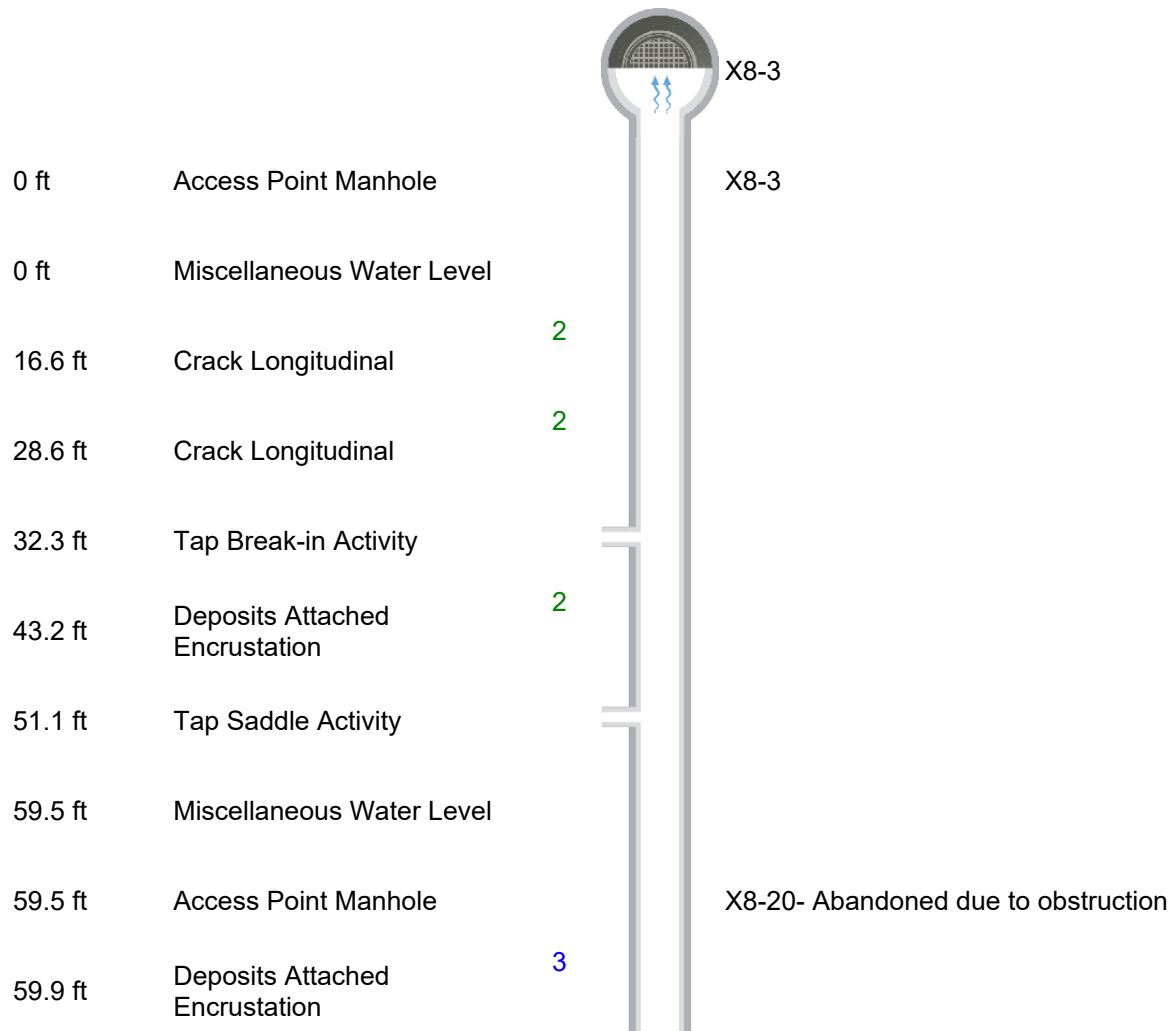
Pipe Segment Reference WWMAN-339	Street* state street GARDEN AVE		Material* Vitrified Clay Pipe	Location Code	
Upstream MH* X8-20	Total Length	Year Constructed	Location Details		
Downstream MH* X8-3	Length surveyed 59.9	Year Renewed	Height* 8	Width*	Pipe Joint
SPR 4	MPR 5	PO Number		Customer	
SPRI 2	MPRI 2.5	Work Order Number		Purpose	
QSR 2200	QMR 3121				
OPR 9	Surveyed By* JHegvik	Direction* Upstream	Date* 10/7/2025 9:38:00 AM	Media label	
OPRI 2.3	Certificate Number* 123	Pre-Cleaning Light Cleaning	Time 10/7/2025 9:38:21 AM	Weather	
Date Cleaned			End Time 10/7/2025 9:49:19 AM	Additional Info

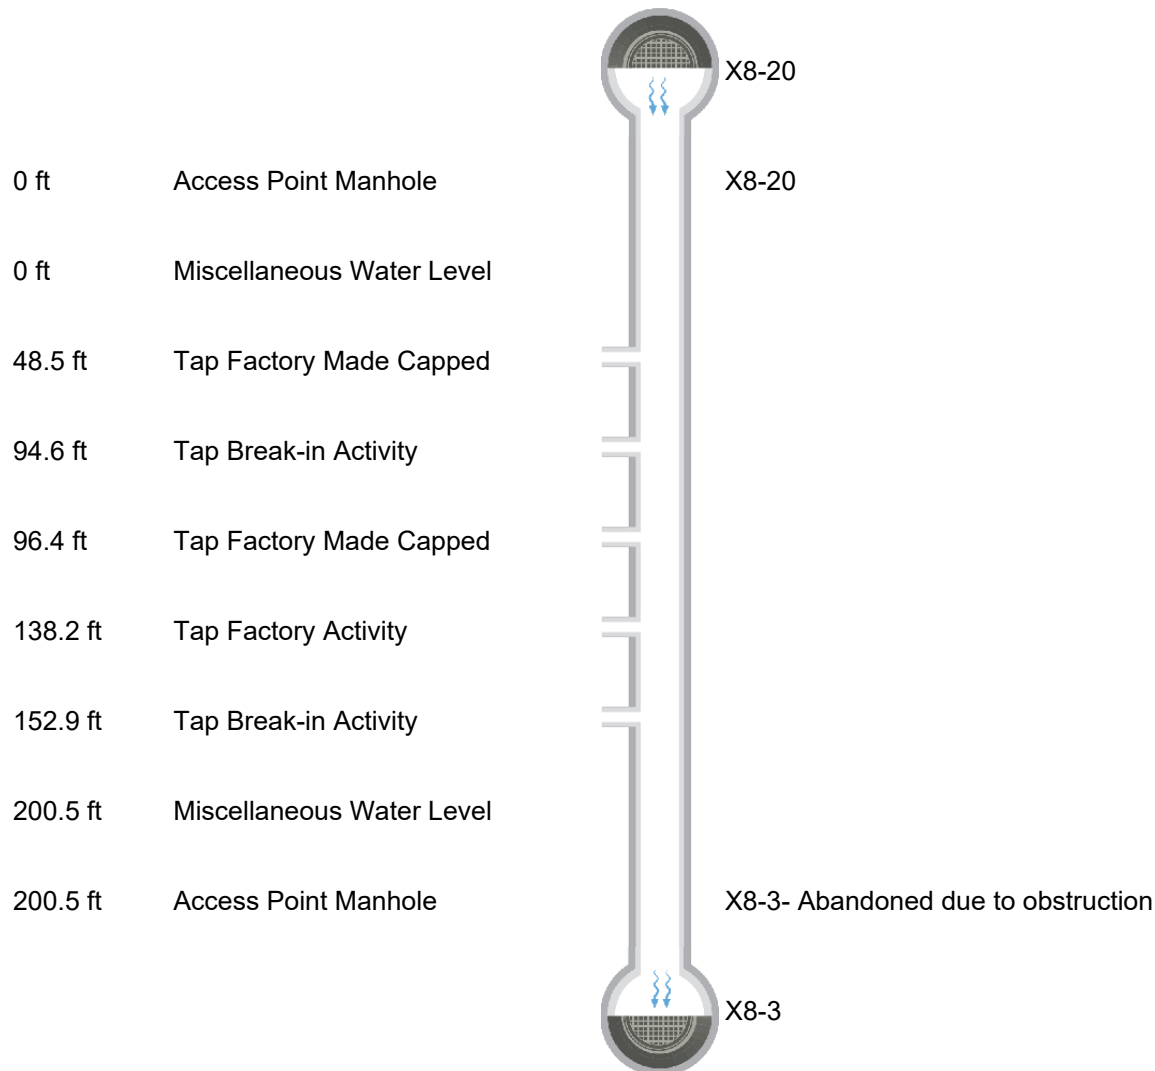
Pipe Segment Reference WWMAIN-339	Street* state street GARDEN AVE		Material* Vitrified Clay Pipe	Location Code	
Upstream MH* X8-20	Total Length	Year Constructed	Location Details		
Downstream MH* X8-3	Length surveyed 200.5	Year Renewed	Height* 8	Width*	Pipe Joint
SPR 0	MPR 0	PO Number		Customer	
SPRI 0	MPRI 0	Work Order Number		Purpose	
QSR 0000	QMR 0000				
OPR 0	Surveyed By* JHegvik	Direction* Downstream	Date* 10/7/2025 11:10:03 AM	Media label	
OPRI 0	Certificate Number* 123	Pre-Cleaning Light Cleaning	Time 10/7/2025 11:10:28 AM	Weather	
Date Cleaned			End Time 10/7/2025 11:18:34 AM	Additional Info

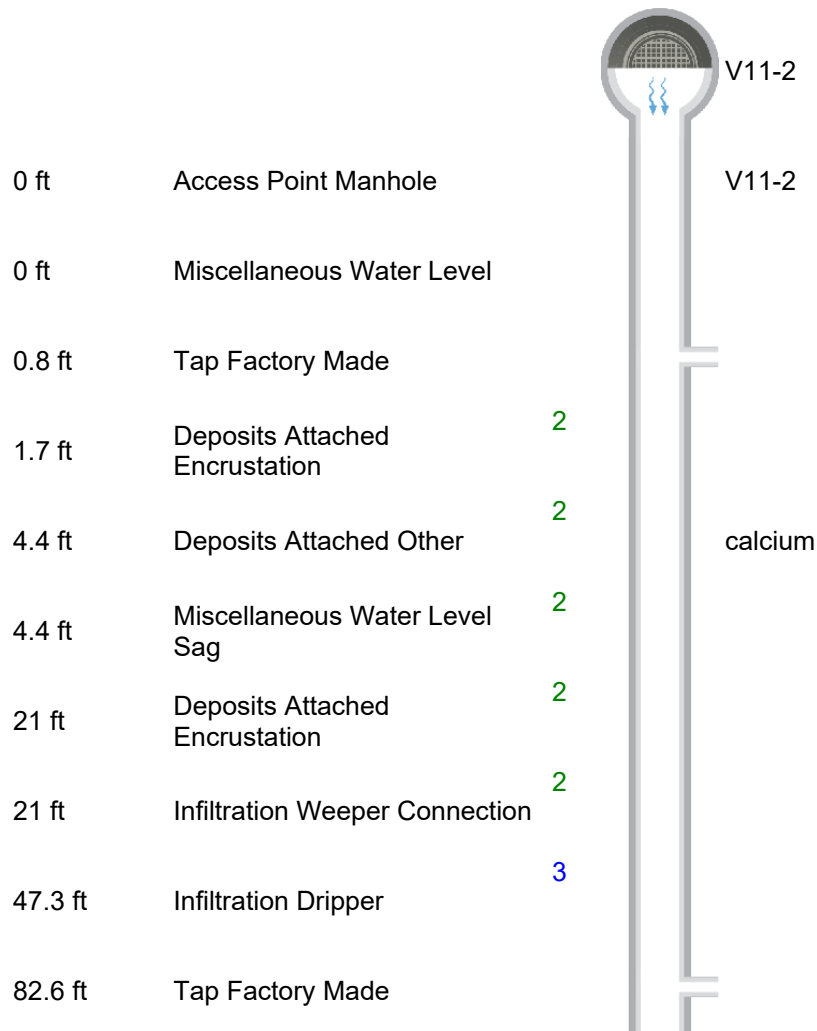
94.2 ft Tap Factory Made

125.6 ft Tap Factory Made

130.2 ft Tap Factory Made

170.9 ft Deposits Attached
Encrustation

182.6 ft Tap Factory Made

182.6 ft Infiltration Gusher Joint

190.5 ft Tap Factory Made

198.3 ft Deposits Attached
Encrustation

200.3 ft Tap Factory Made

259.9 ft Tap Factory Made

268.2 ft Tap Factory Made

282.8 ft Tap Factory Made

285.8 ft Tap Factory Made

343.2 ft Tap Factory Made

382.2 ft Miscellaneous Water Level

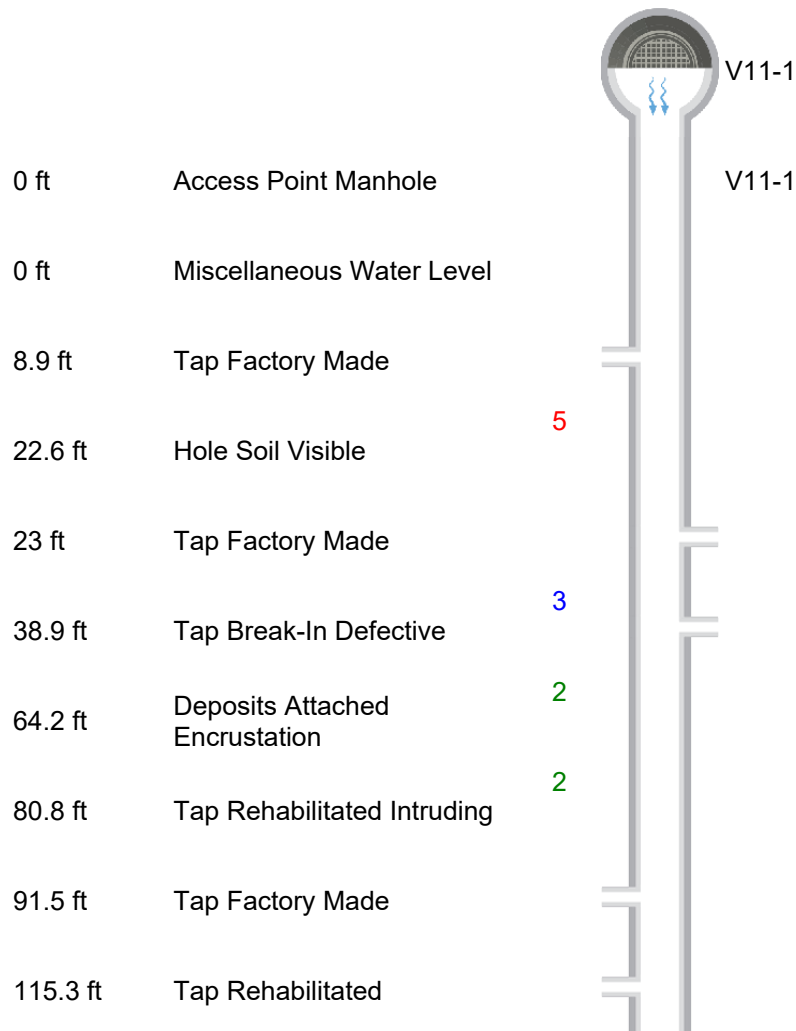
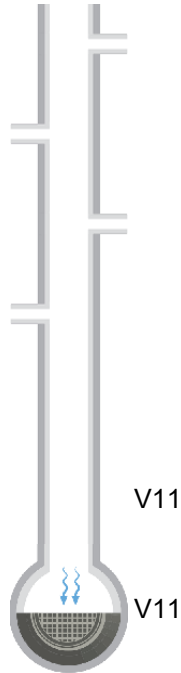
141.3 ft Tap Factory Made

156.2 ft Tap Factory Made

226.7 ft Tap Factory Made

231.8 ft Tap Factory Made

303.6 ft Miscellaneous Water Level

303.6 ft Access Point Manhole
