# KAYSVILLE CITY BUILDING REPORT -

HISTORIC BUILDING CONDITION ASSESSMENT AND RECOMMENDATION REPORT

FFKR ARCHITECTS

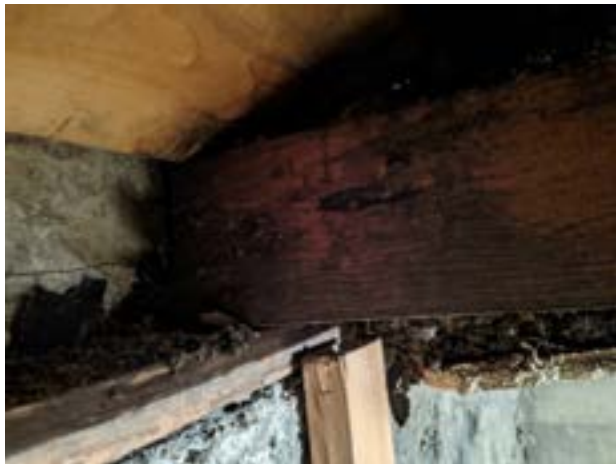
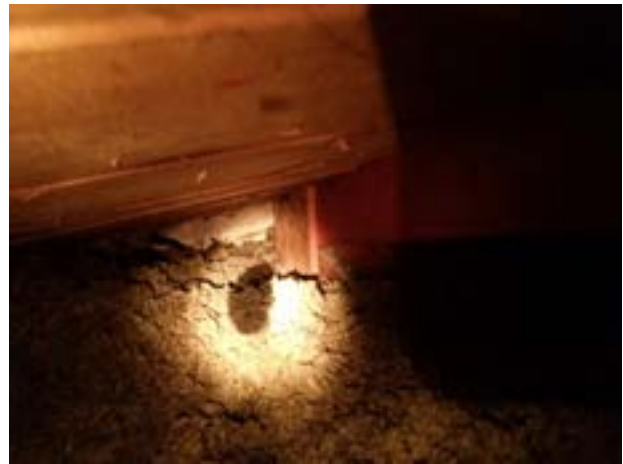
Photograph 7 – Roof truss bearing on sill plate at top of stone wall in mech room (special case) More commonly bearing on interior stud wall. Left: Observed in coal storage room with precast cap beyond, Right: Observed east of attic access

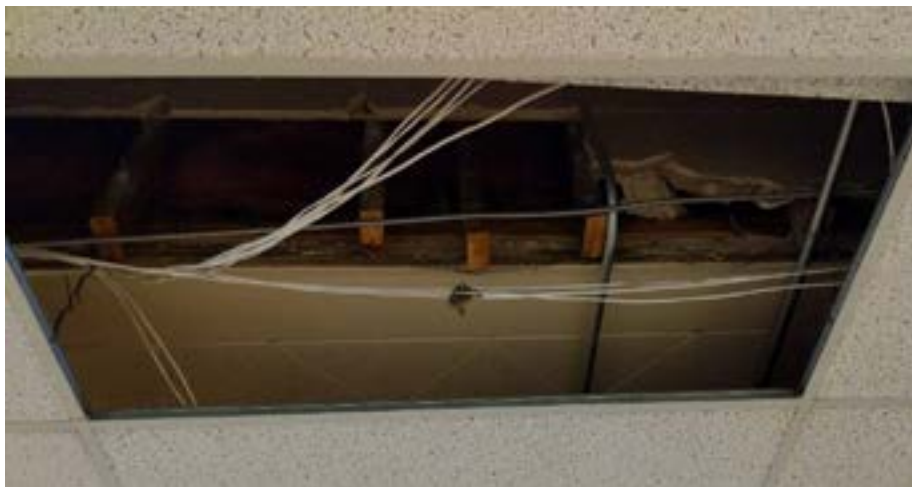
Photograph 8 – Metal lath ceiling exposed above drop ceiling

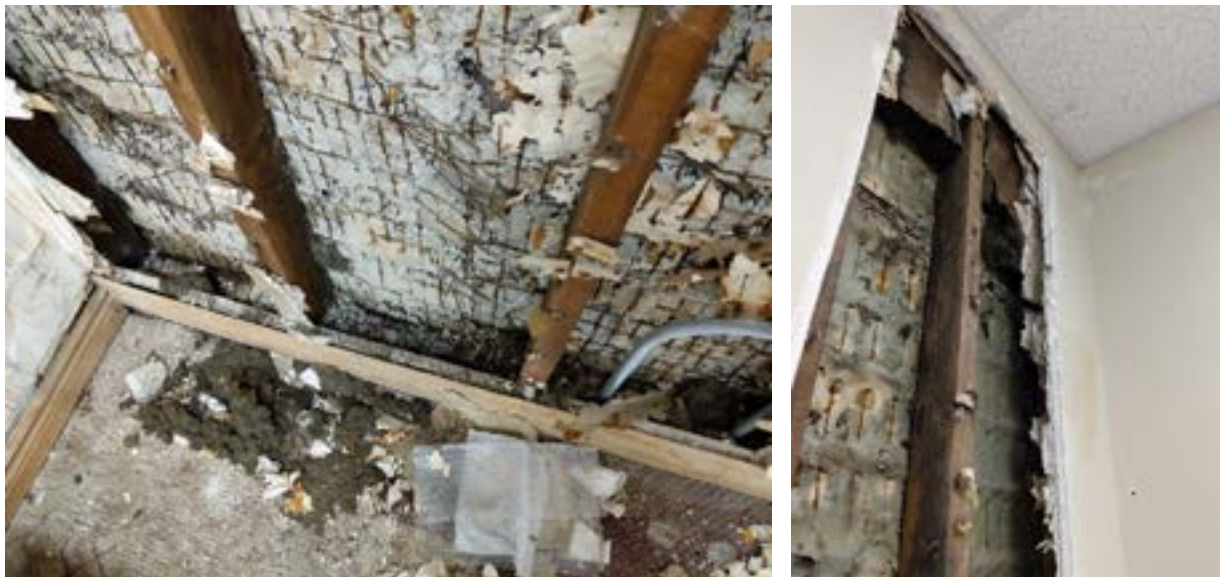
Photograph 10 – Perimeter wood stud walls exposed on the North (left) and South (right) perimeter walls were excessive water damaged was observed.

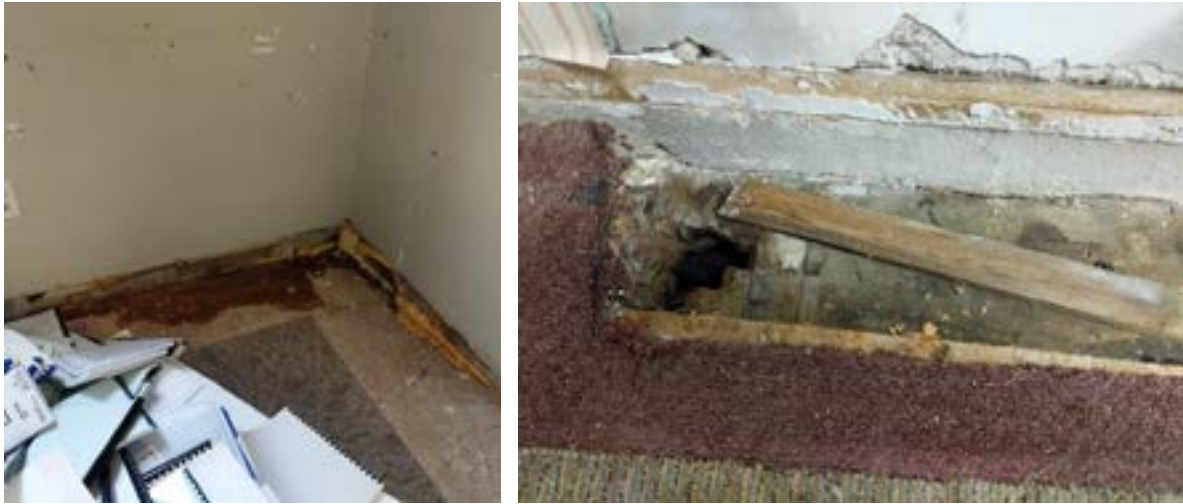
Photograph 11 – Damage to main floor system observed in North-East corner (left), North region (right) and other locations throughout building where water intrusion has occurred.

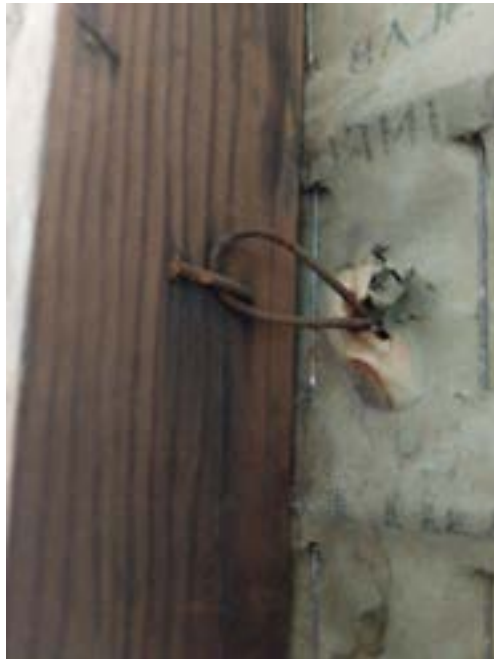
4. **Wall Anchorage:** Noncompliant – Exterior stone walls are dependent on the floor and roof diaphragm for lateral support, but no anchorage was observed for out-of-plane earthquake forces.

Photograph 12 – Wire anchorage observed between stone wall and wood stud interior wall

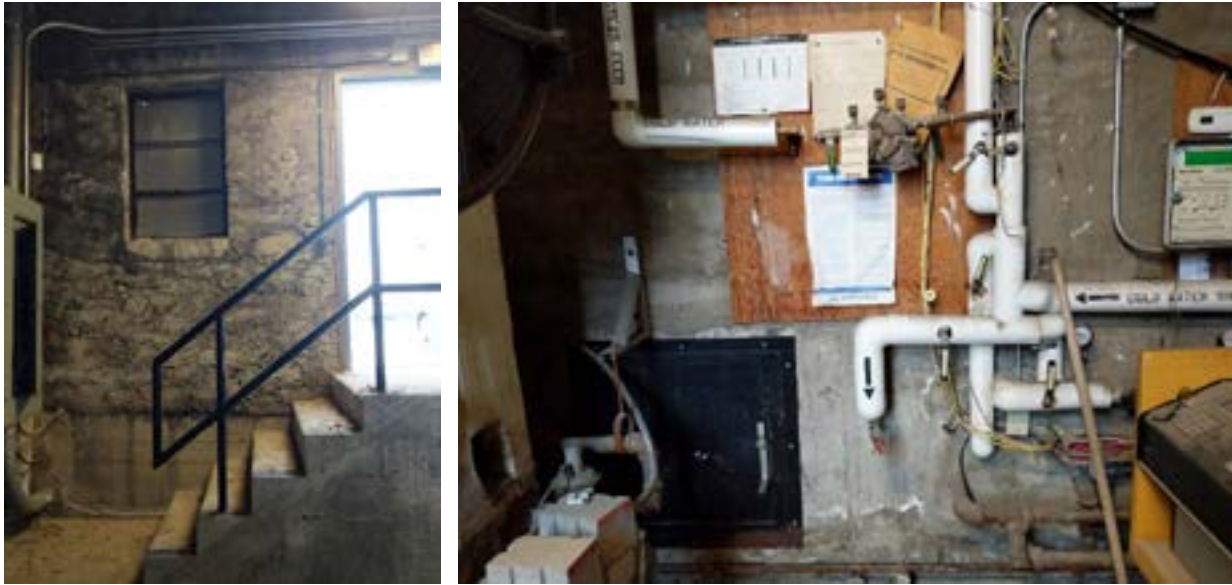
Photograph 13 – Mechanical room interior. Left: interior of stone wall, Right, concrete interior wall at crawl space access.

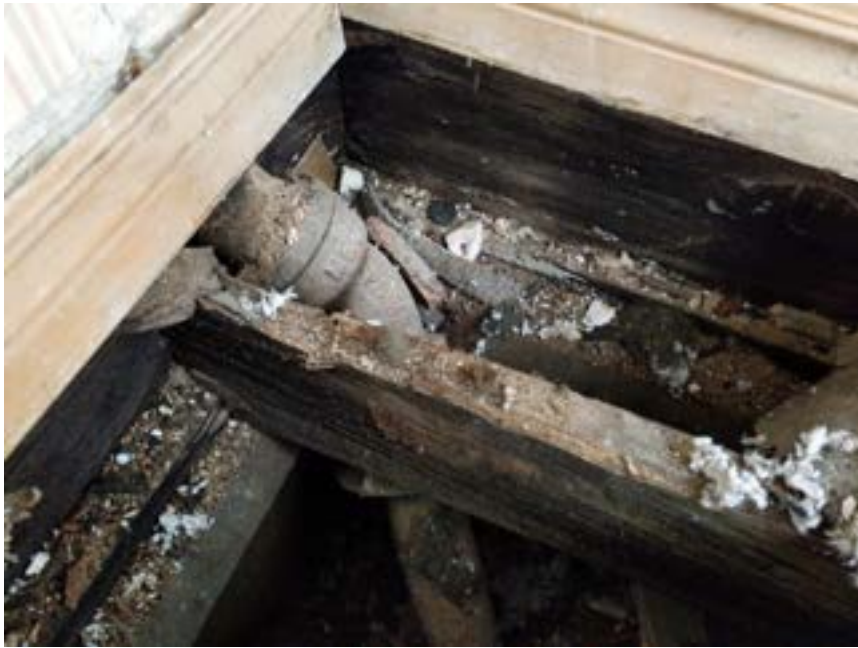
Photograph 17 – Main floor joist bearing condition at corner

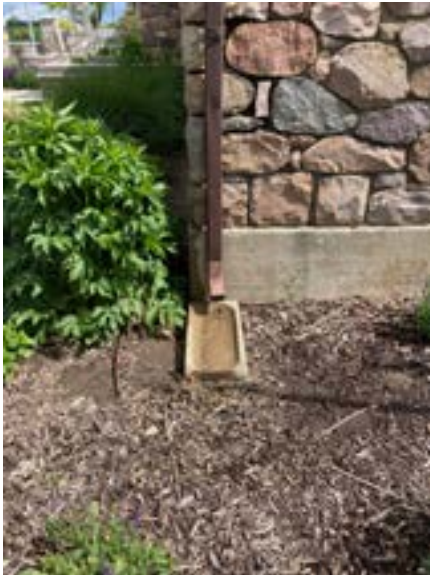
Foundation wall at southwest corner.

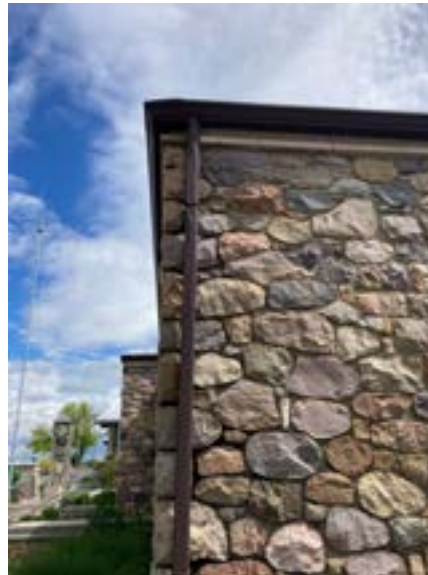
Wall at southwest corner.

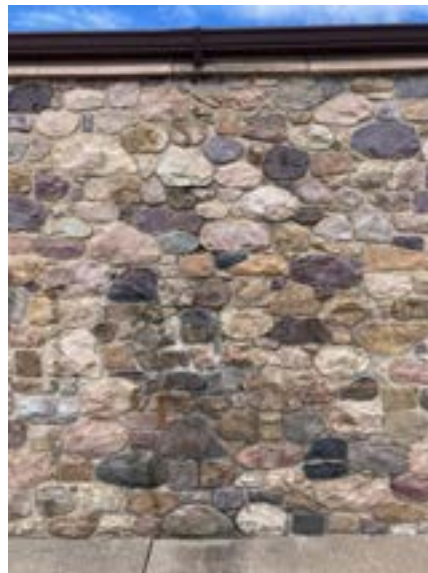
Damage to wall along east elevation.

3. The mortar should be closely inspected and where damaged, loose, missing, etc., or if it consists of a hard cement-based mortar that was installed as a later repair, then it should be removed and repointed. The mortar should be removed using hand tools only, especially on this building which has uneven joints. Power tools such as metal grinders will damage the stone. The damaged mortar should be removed to a minimum depth of 2 to 2-1/2 times the width of the joint to ensure an adequate bond and to prevent mortar "popouts." The new mortar should

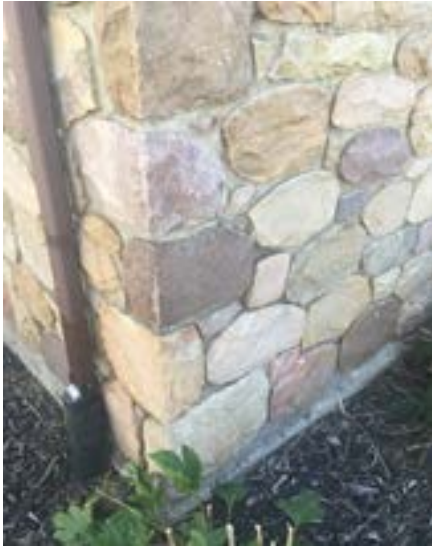
The foundation is subject to water infiltration given that the landscaping abuts the foundation walls. The gutters drain into downspouts at each corner of the building as well as on the front projecting block, on the inside of the two stoops at the west facing entry. The

Landscaping abutting the wall at the northwest corner. .

2. The gutters and downspouts should be replaced and the downspouts should be hard-piped to either a dry sump in the yard or to the storm water system.

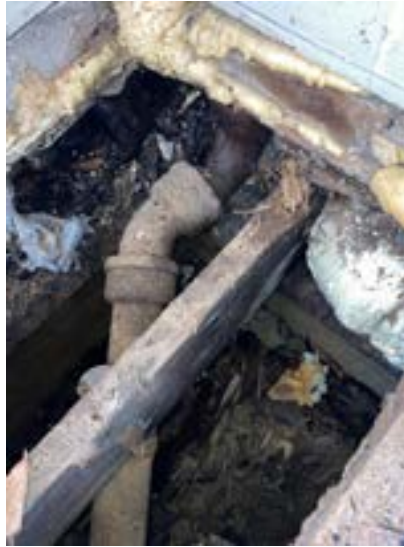
Subfloor condition at northwest corner.

On a subsequent visit, the floor at the northeast and northwest corners had been removed and a closer inspection of the bearing condition of the stud wall on the foundation wall was possible. There was significant water damage in these areas as a result of a faulty drain pipe (more so at the northwest corner). The pipe was ostensibly original to the building and appears to have been connected into the integral gutter system (to be described later). The pipe has for years been leaking onto the wood sole plate (wood 2x atop the foundation wall) as well as the framing, the foundation wall and footing. there is a significant level of wood rot and deterioration in this area.

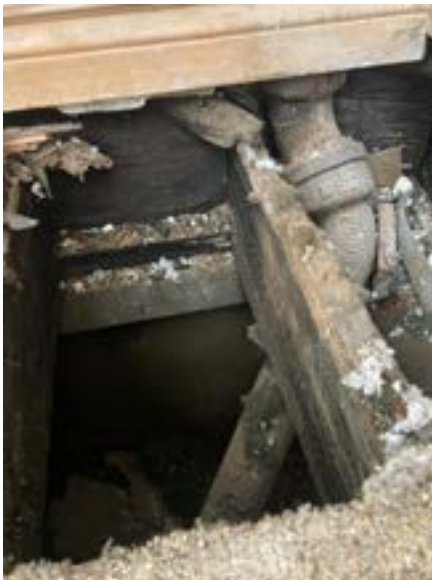
Subfloor condition at northeast corner.

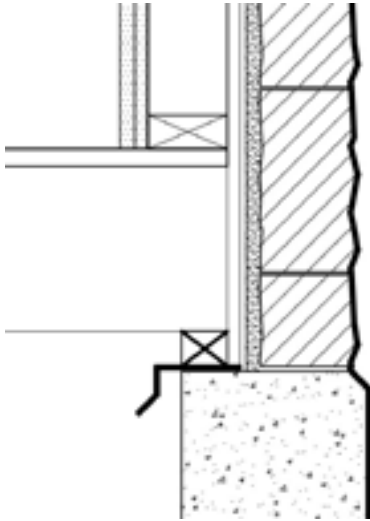
Figure: Existing condition at foundation wall showing sole plate and bearing condition of joists.

- Installation of a new ledger beam around the entire perimeter, anchored into the foundation wall.

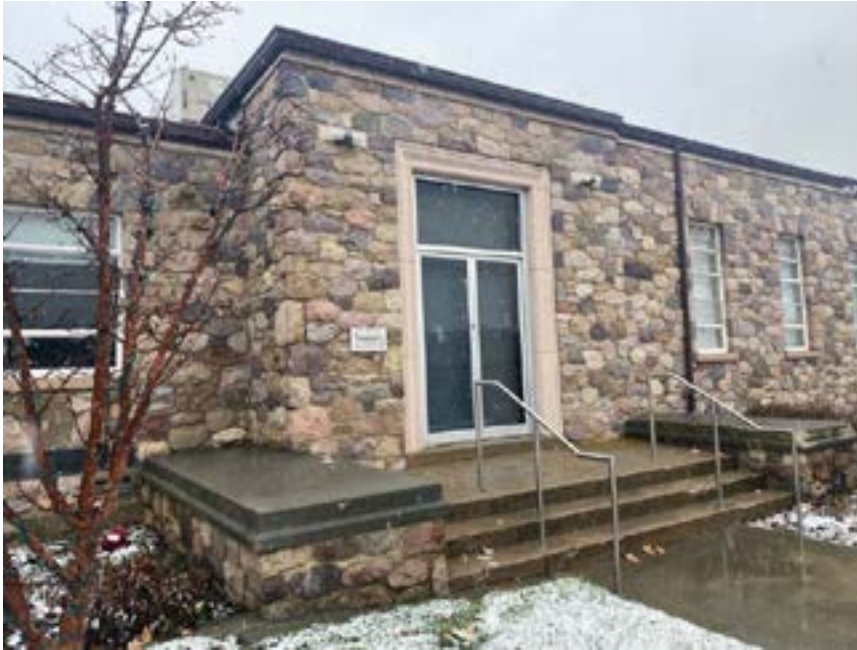
West entry stoop and stair.

1. The concrete steps should be removed and replaced with a standard compressive strength concrete with proper reinforcing. The stairs should be reconfigured to allow even entry into the building at the landings. The concrete landing should be sloped slightly to the stairs and away from

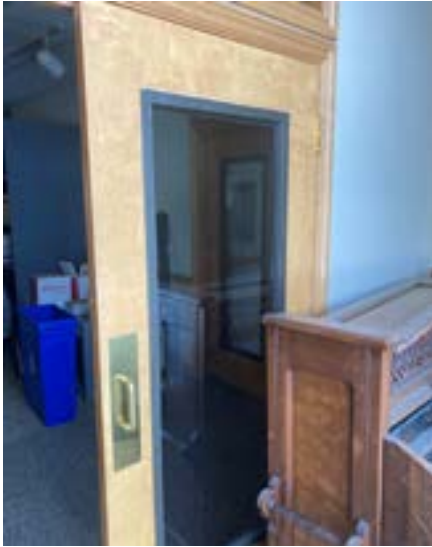
Original door condition, at southwest entry.

1. The existing original doors should be restored. The hardware should be replaced to meet accessibility standards.
2. New doors should replicate the original, especially the new vestibule doors at the entry points.

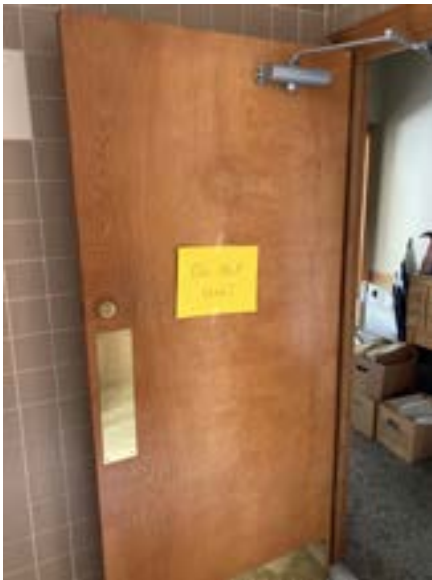
Original door condition, at restroom.

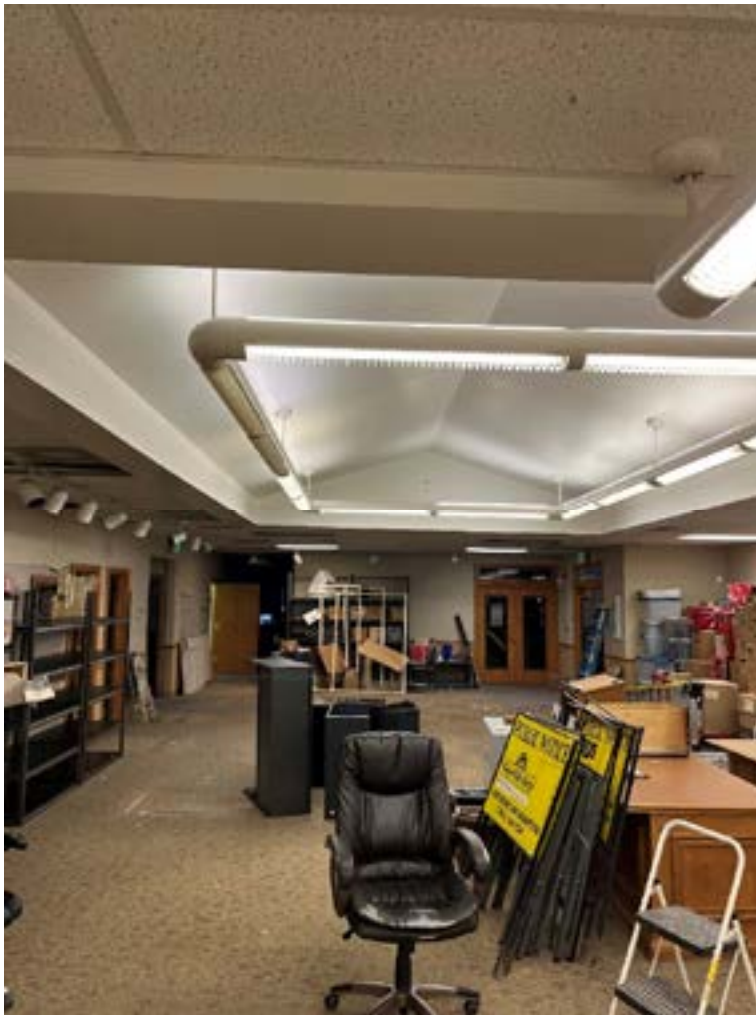
Existing fluorescent lighting. Some track lighting also exists.

Remove all track lighting and incandescent down lights. Provide new LED lighting with integral battery packs where required to meet minimum light levels. Add in occupancy sensors as required by IECC 2018 (I would estimate about 15 would need to be added). Re-locate the branch panel that has plumbing piping underneath it (which does not meet the Electrical Code requirement of having panel clearance from floor to ceiling. Lower light switches to 46" to center so that they comply with ADA codes. Provide additional support straps for M.C. cabling above grid ceiling to comply with NEC required supports.
