# Sign/Sidewalk Assessment and Budget Recommendations

## **Section 1: Introduction**

The purpose of this report is to provide budget estimates and suggested priorities for proper sidewalk maintenance, obstruction removal, and accessibility ramps. Sidewalk maintenance is crucial to preserve infrastructure and enhance the walkability of a city. Data gathering for signs was also performed.

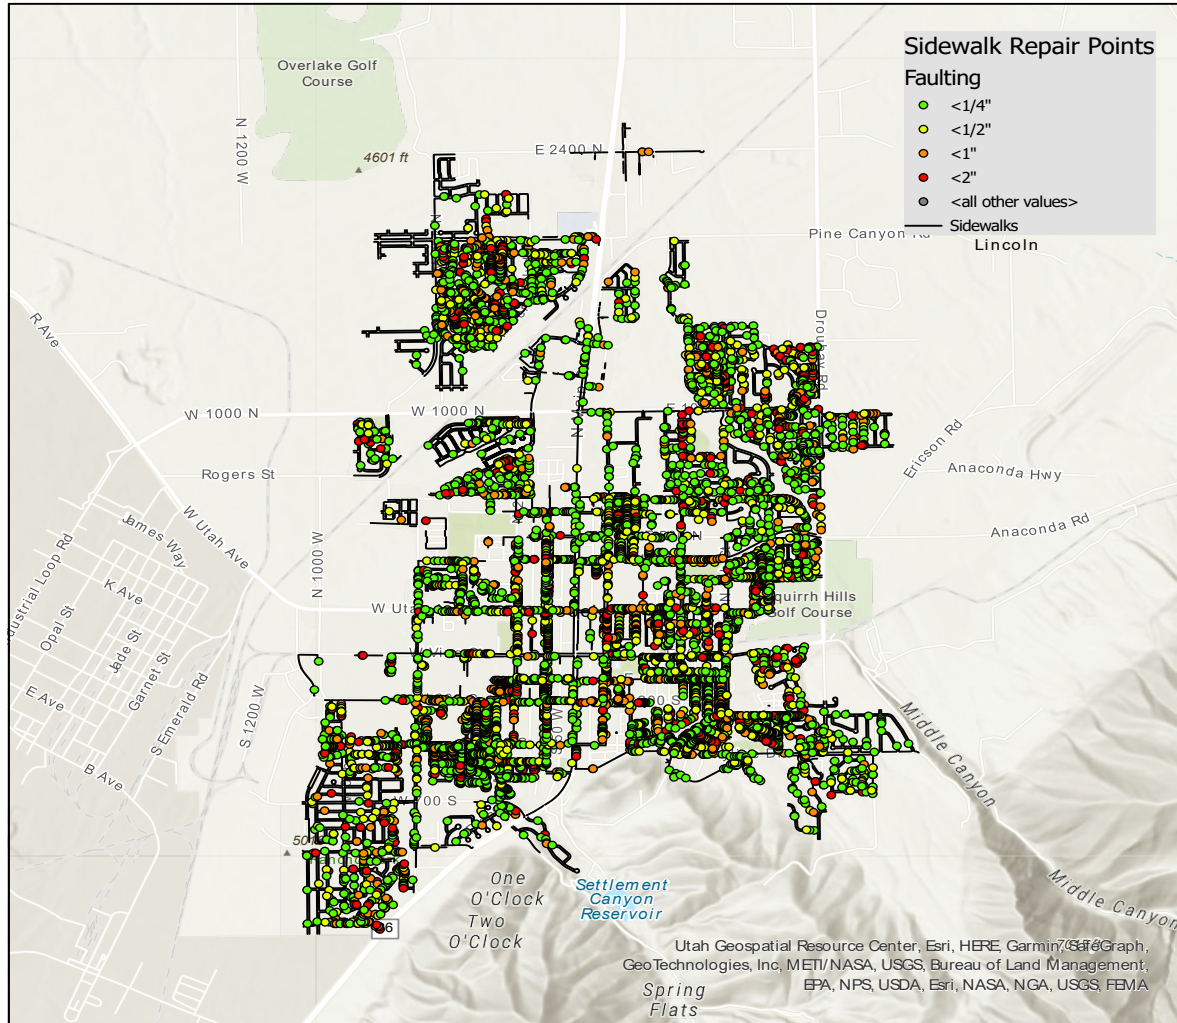
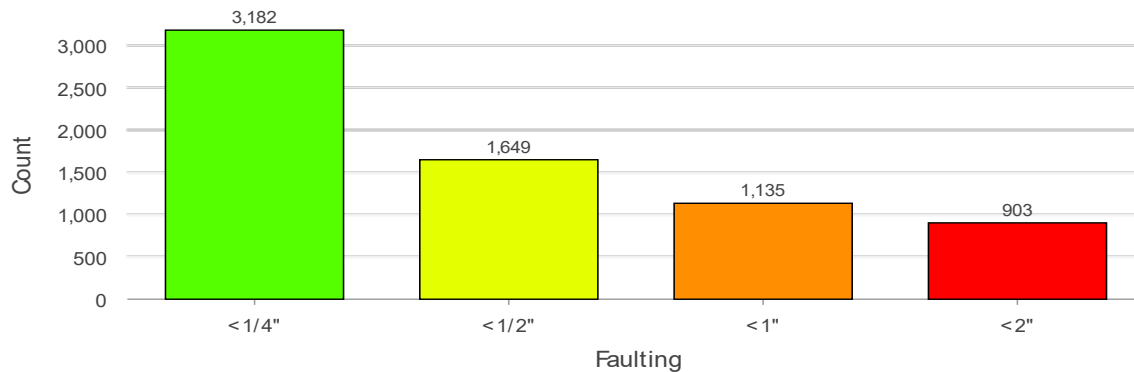
**Figure One - Map/Data of Sidewalk Faults**

**Sidewalk repairs** include the following damage types: vertical separation, sag, and damaged/missing panels. These damage types have varying classifications and repair costs associated with them as seen in Table One. Figure One is a map/chart of the 6,869 damage points recorded throughout the city.

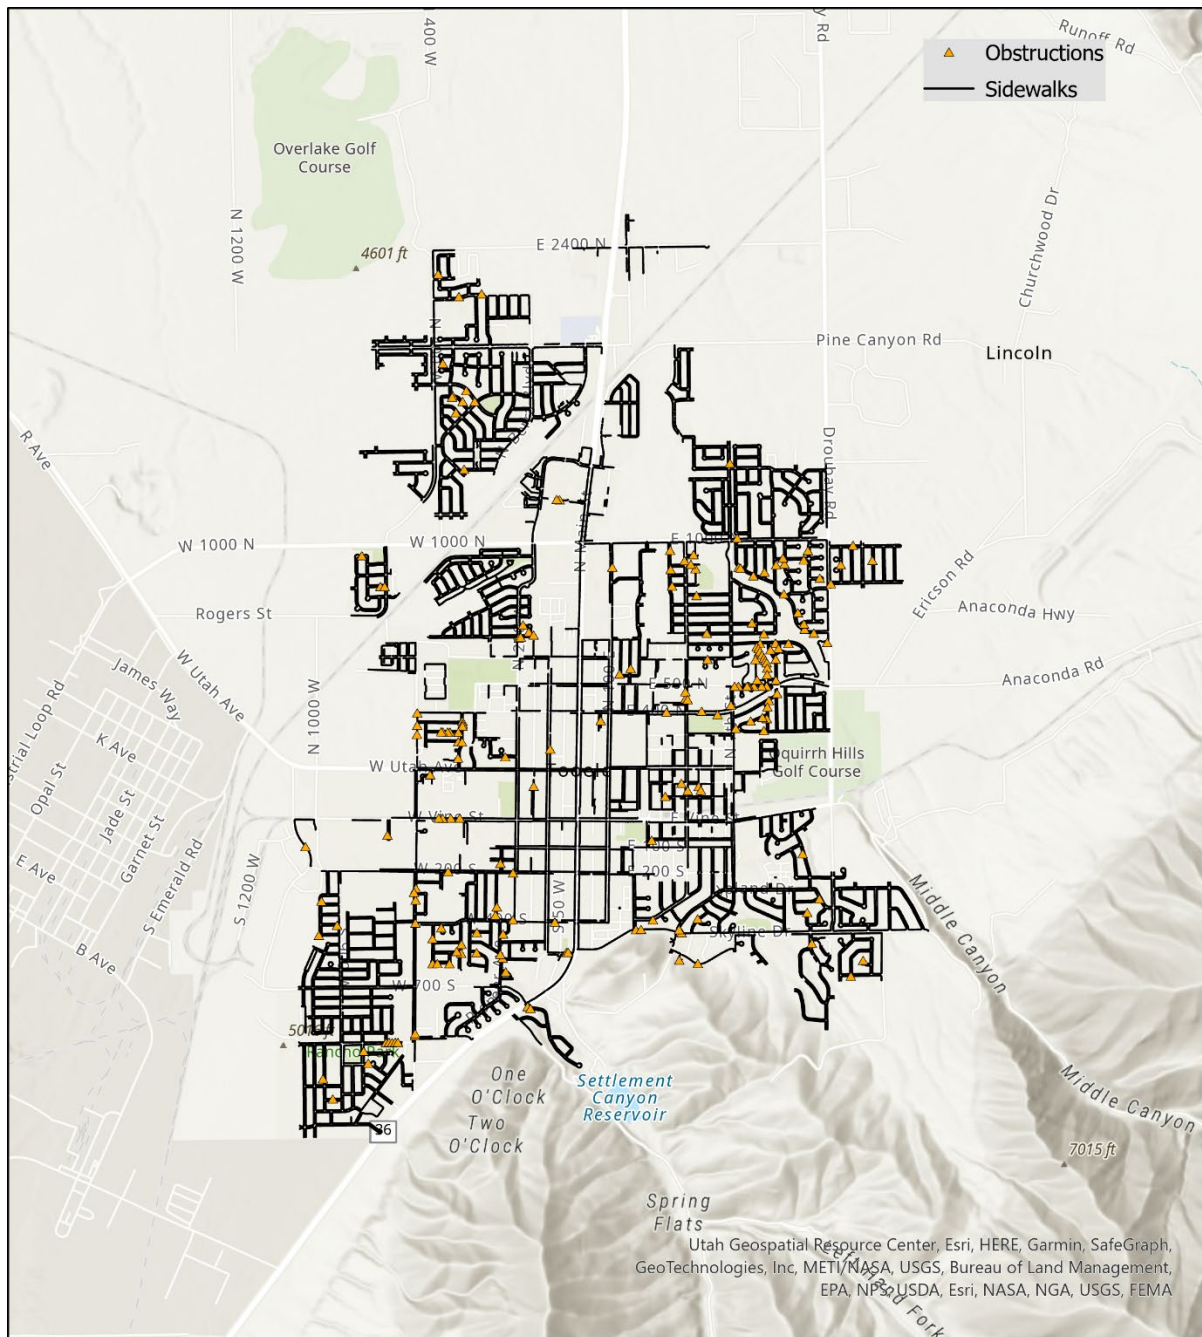
**Figure Two - Map of Sidewalk Obstructions**

**Obstructions** include the following issues that impact full use of the sidewalk: bushes, trees, landscaping, and mailboxes. Obstructions are single points that represent a section of sidewalk that needs to be corrected. Figure Two shows the locations of 188 obstructions.

Obstructions are not calculated as a cost. The cost of repairing these obstructions is left to the property owner. Tooele City is responsible for informing the property owner of said obstructions.

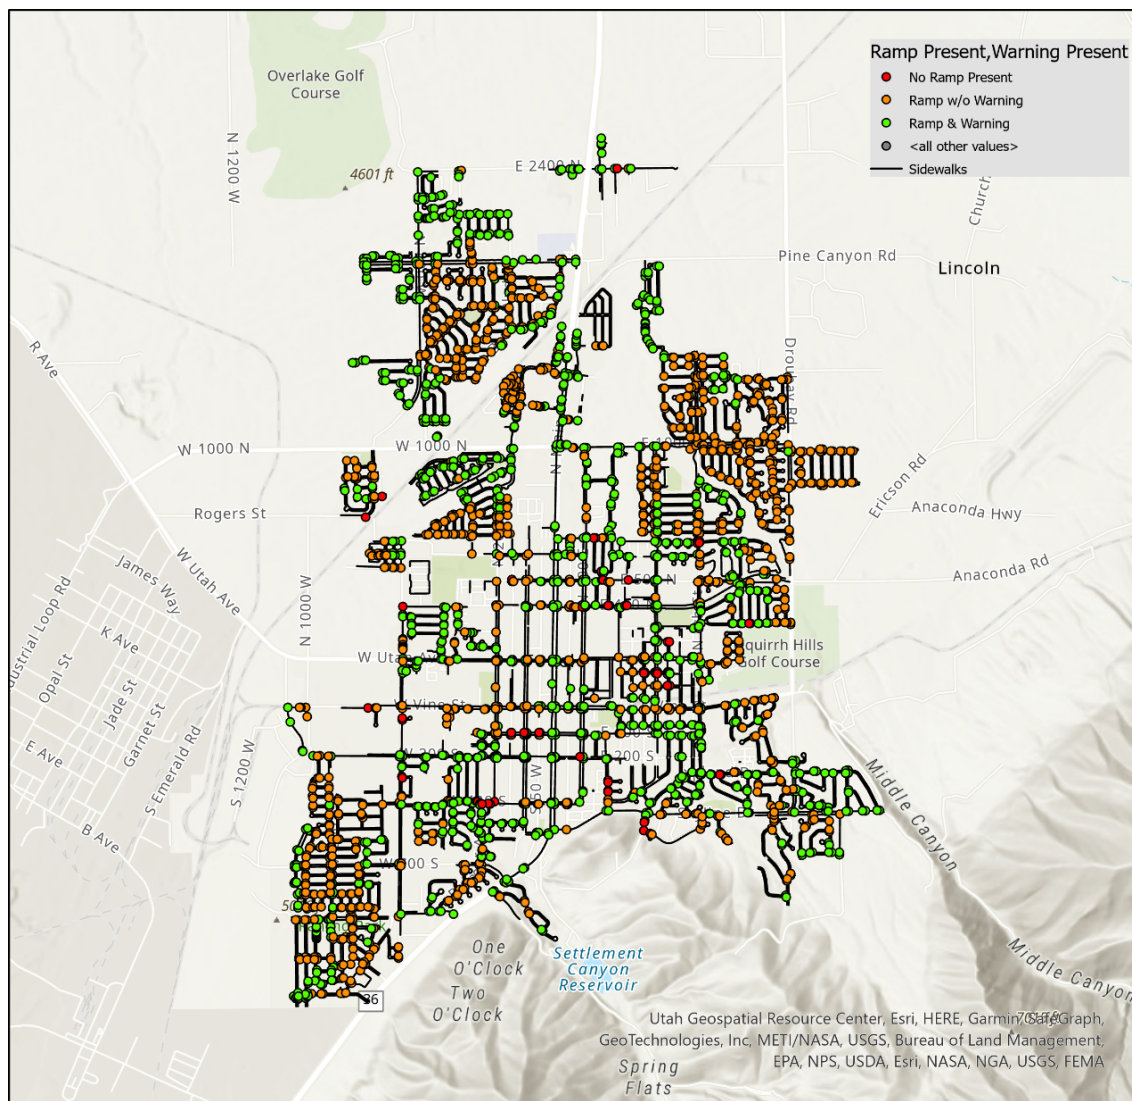
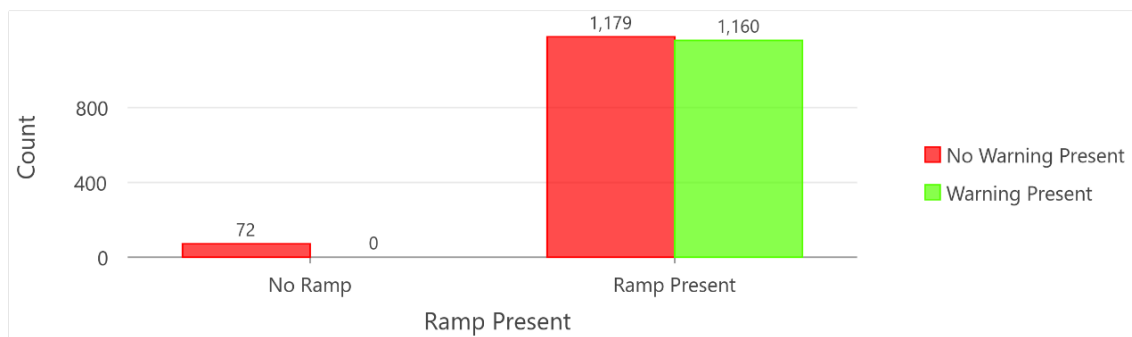
**Figure Three - Map/Data for ADA Ramps**

**ADA ramp** data includes the following: ramp with detectible warning surface, ramp without detectible warning surface, and no ramp/no detectible warning surface. Figure Three is a map/chart that which of the 2,411 crossing locations, over 50 percent need upgrades.

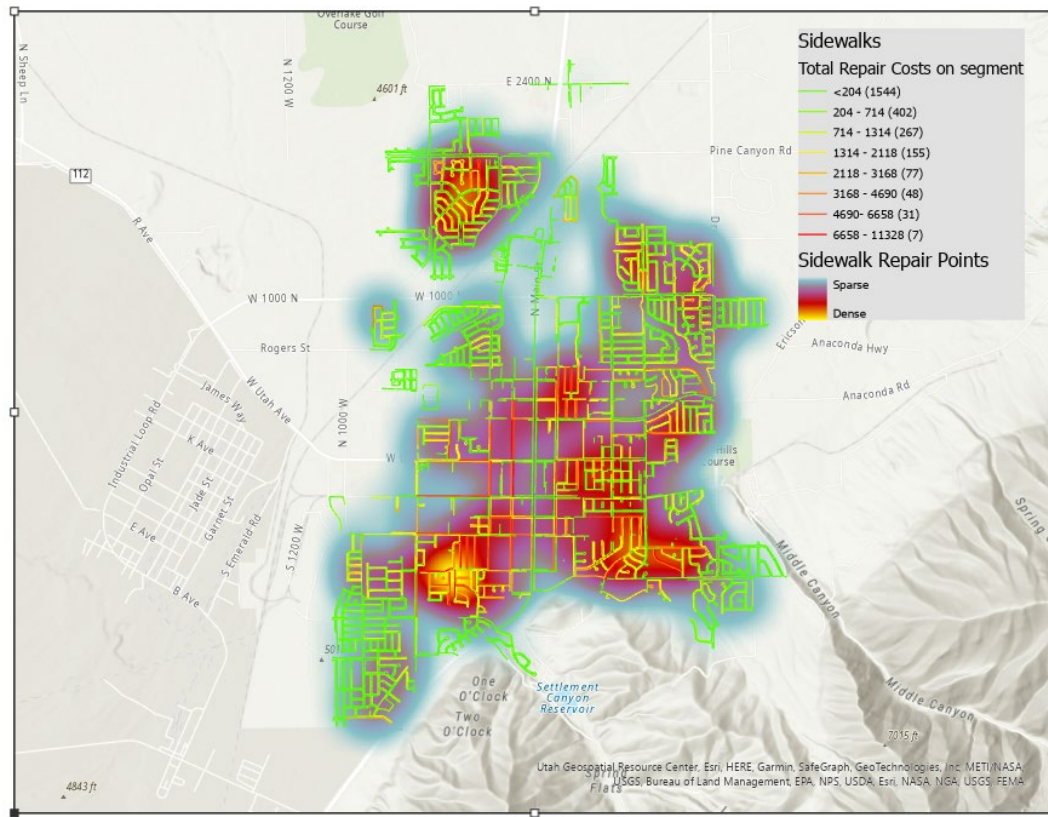
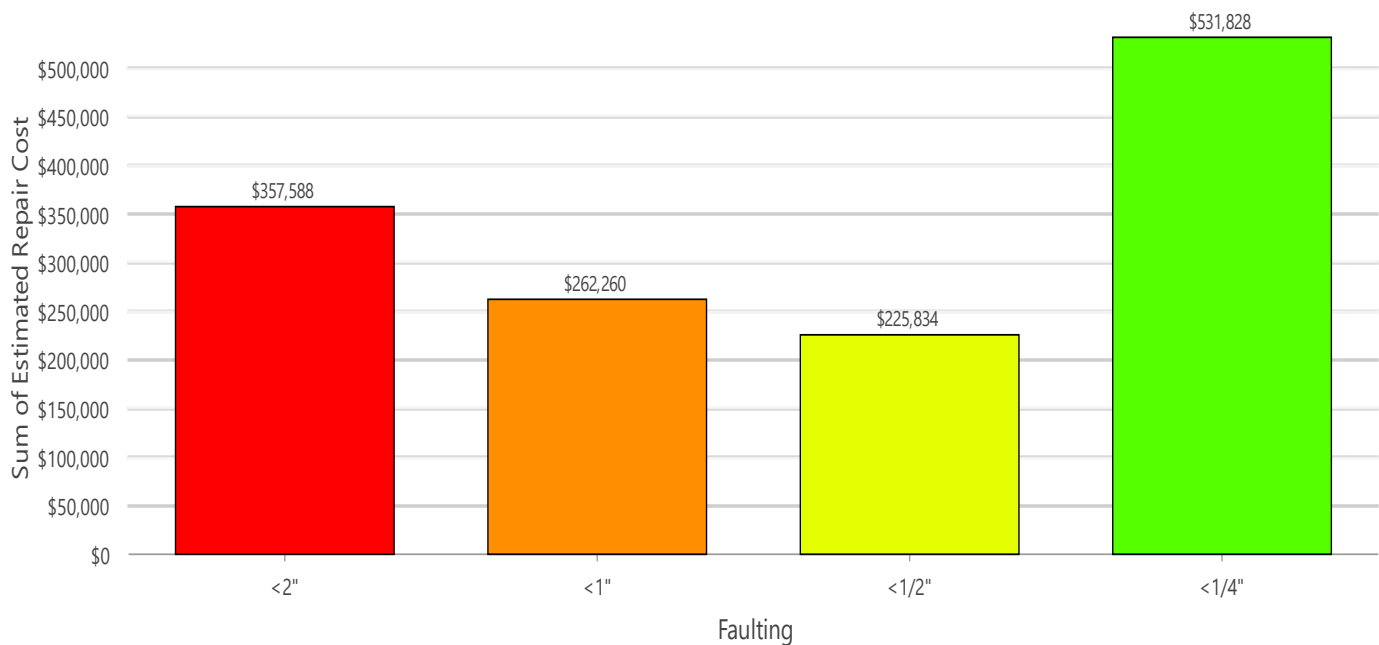
Figure Five - Total Repair Estimates for Sidewalk Distresses

Figure Five shows the total repair estimates for sidewalk distresses. The graphic illustrates a heatmap which shows the most expensive repair areas (shown in yellow). These areas are in the southwest, southeast, and northwest. This heatmap might be used to prioritize locations for initial projects.

Figure Five shows the overall costs of repairing all the sidewalk faults. The total cost of repairing all damage is \$1,377,510. The largest segment of repairs was ¼" trip hazards, totaling \$531,828.

In conclusion, the total estimated sidewalk and ramp repairs for Tooele City is \$2,125,710. It is recommended that budgets should be projected to complete the projects over the next 10 years. Therefore, an annual budget of \$212,000 is recommended for sidewalk repairs. It should be noted that additional distresses will develop over the next 10 years, so sidewalk maintenance will be an on-going requirement.

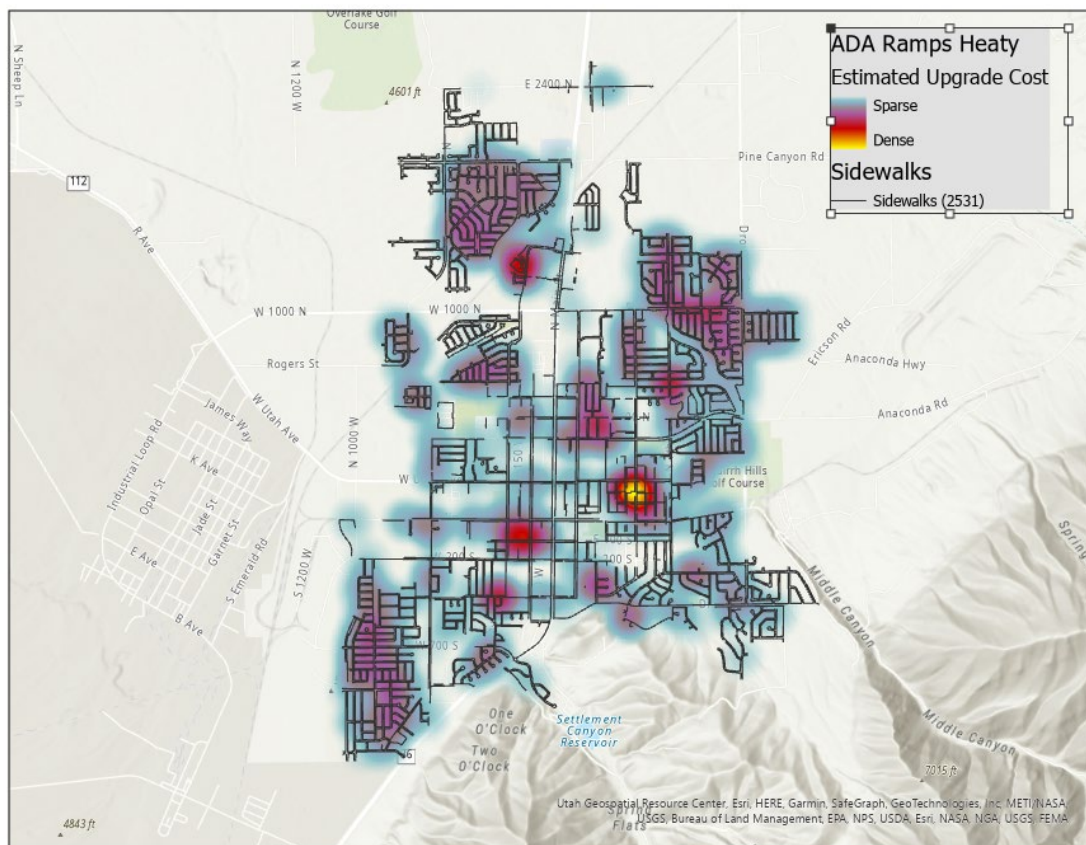
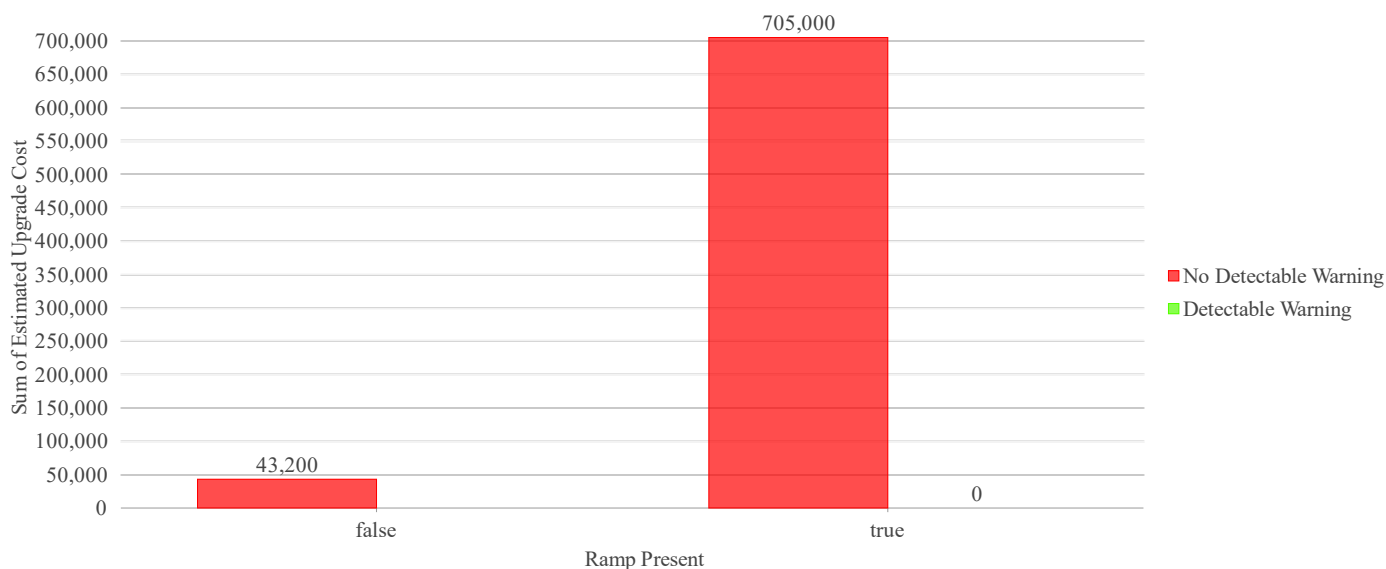
Figure Six - Total Repair Estimates for ADA Ramps

Figure Six shows the overall costs of repairing the ramp repair types. The total cost of repairing all ADA ramps is \$748,200. The heatmap below shows that ramp repair priorities may not be consistent with sidewalk repair priorities.

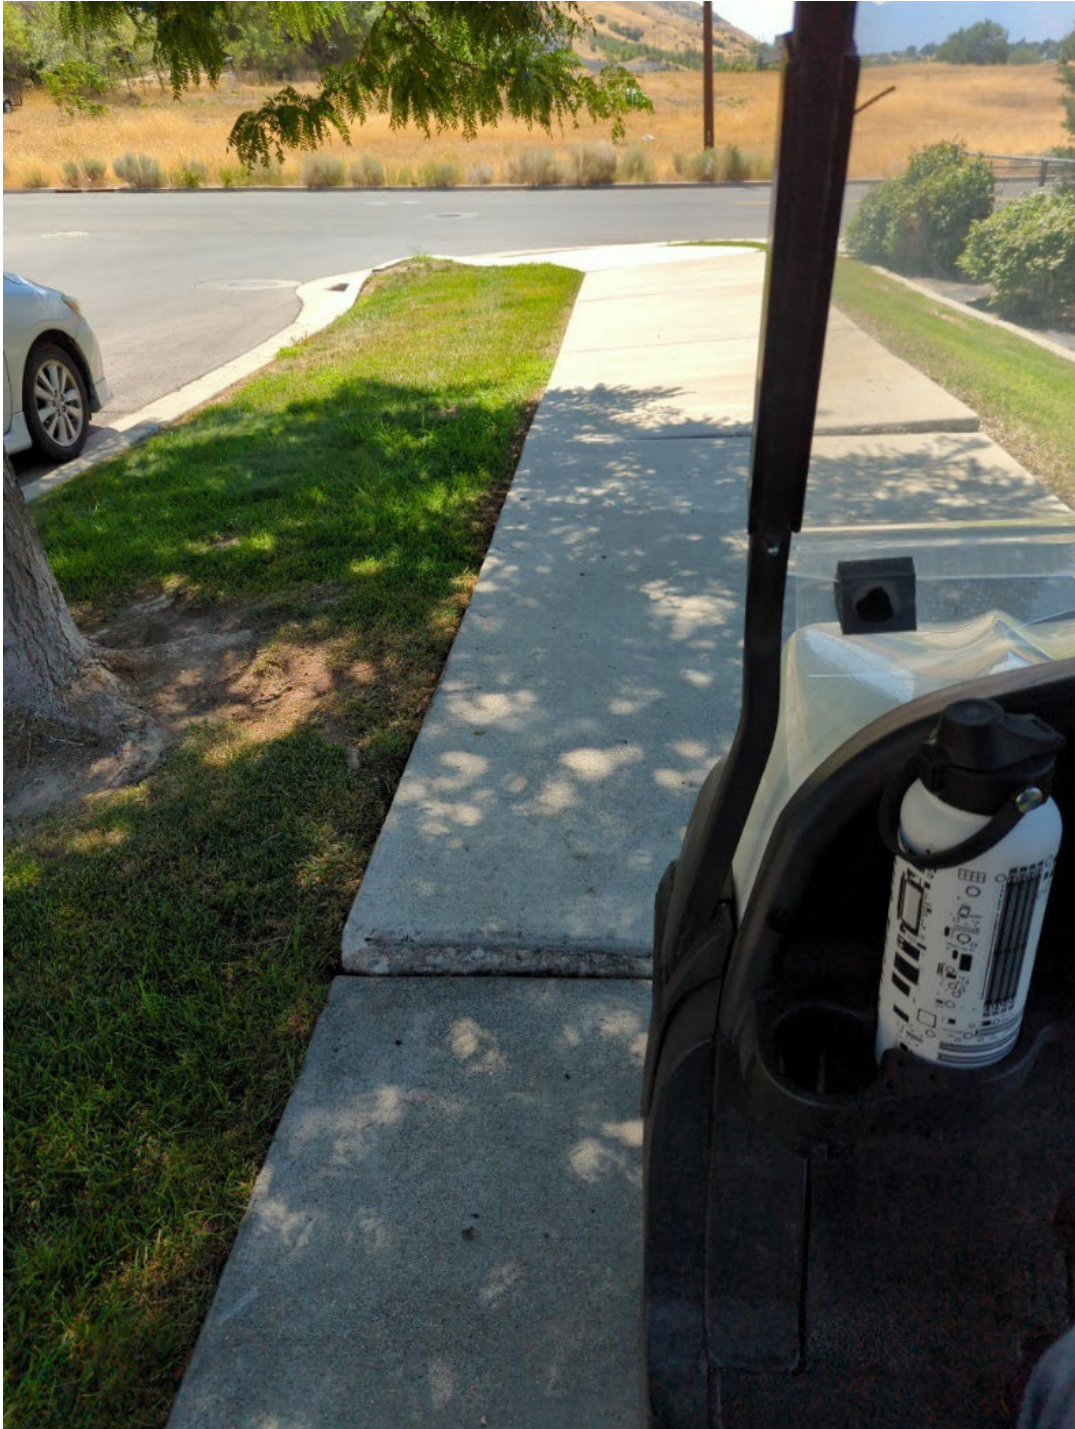
**Vertical Separation** is rated at ¼ inch, ½ inch, 1 inch, 2 inches, and above 2 inches. ADA considers anything over ¼ inch as a trip hazard. The shorter trip hazards can be fixed by grinding down the raised sidewalk slab until flush with the lower sidewalk slab. These distresses are often caused by tree roots and may require removal of the roots to stop the damage from resurfacing.

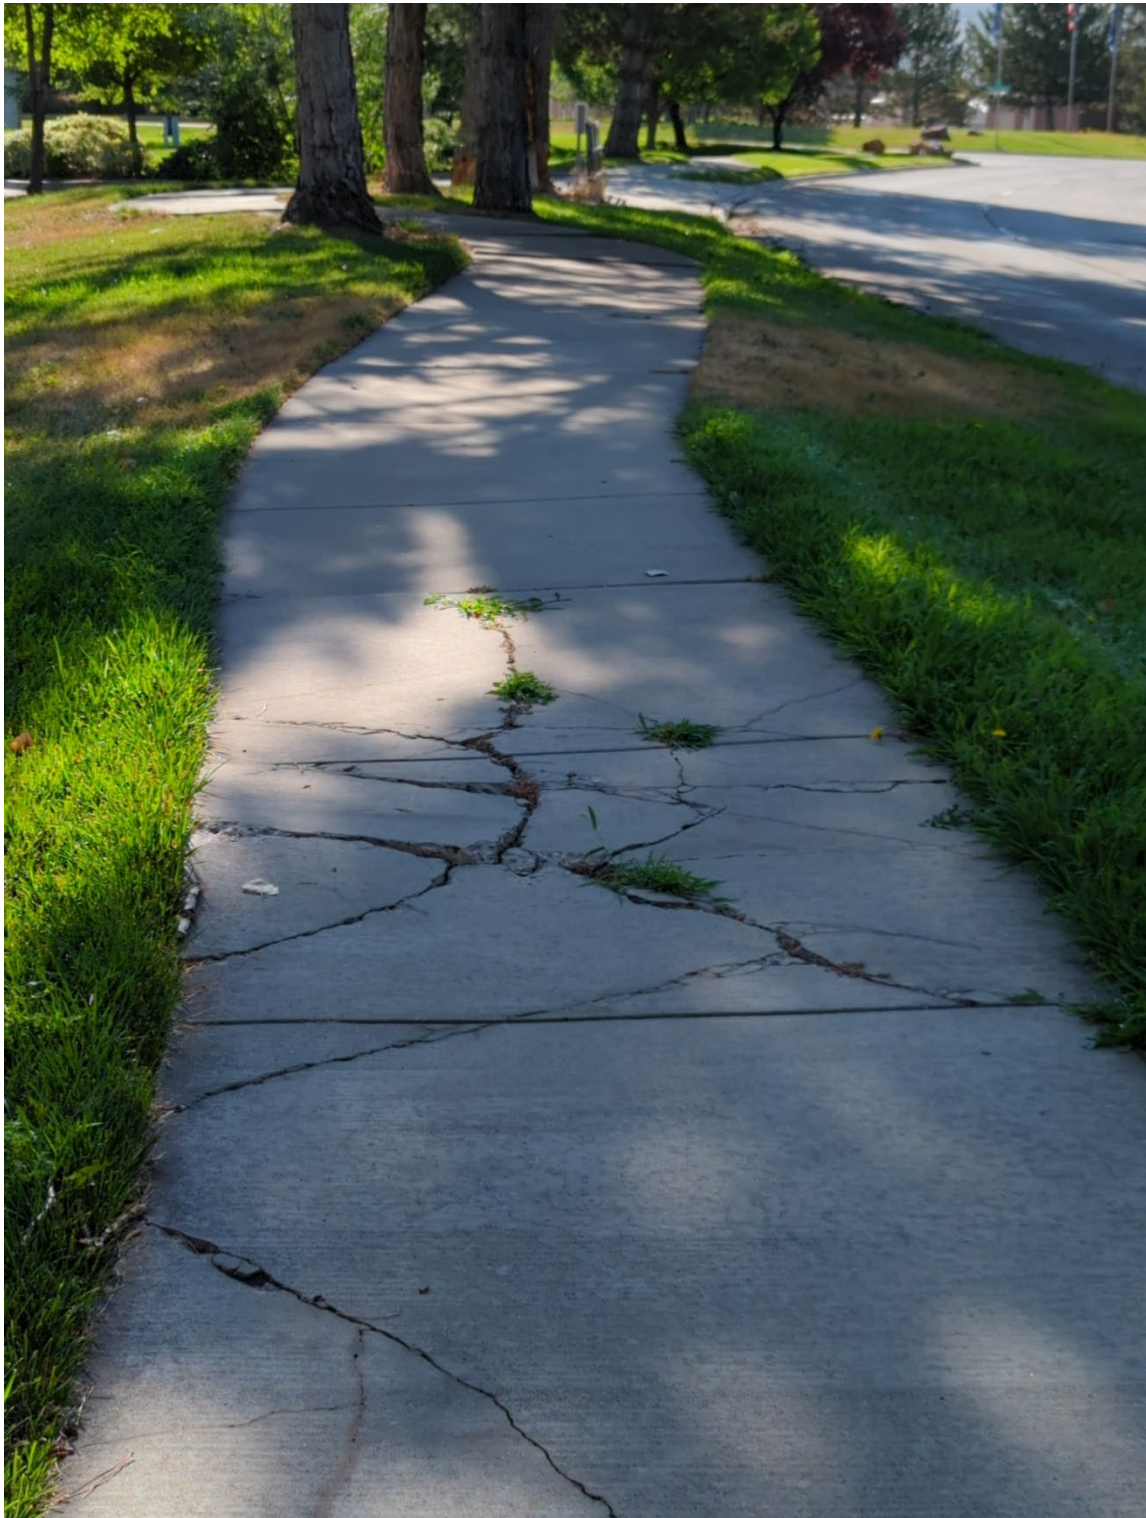
**Multiple Cracks** are rated on the presence of sprawling cracks on a slab. This distress can be fixed by replacing the damaged slab.

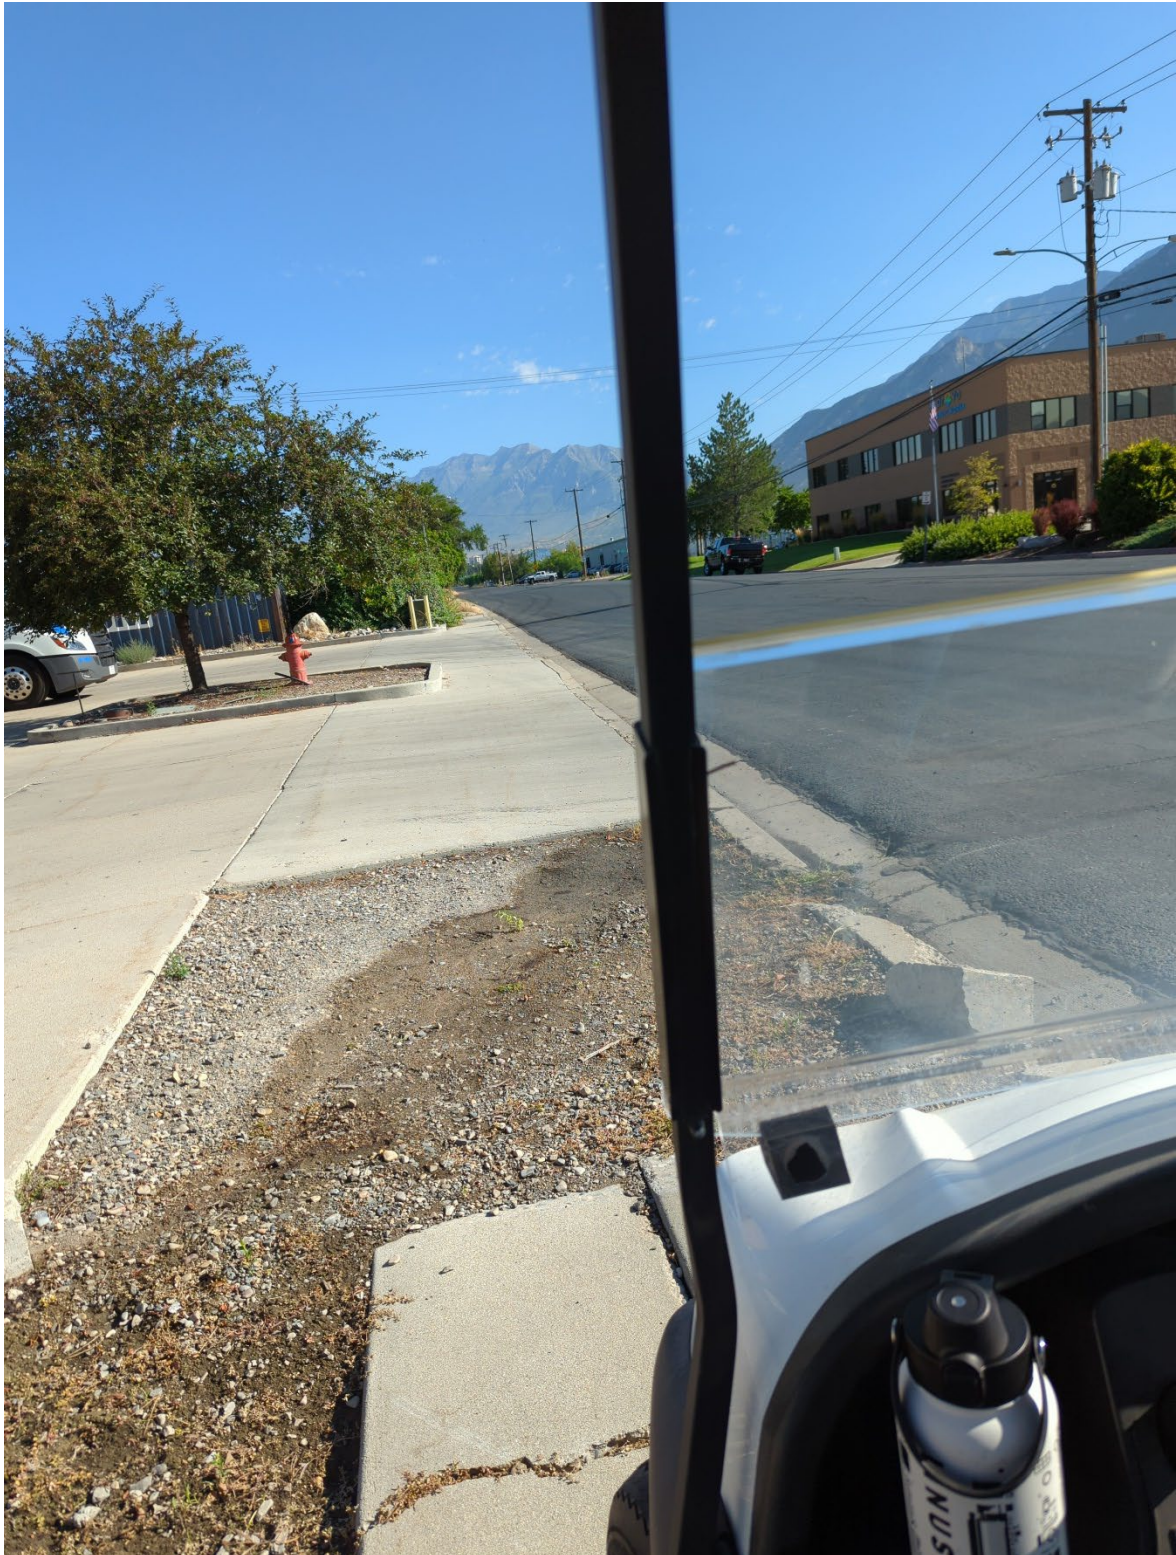
**Missing panels** are fixed by constructing a new sidewalk slab.

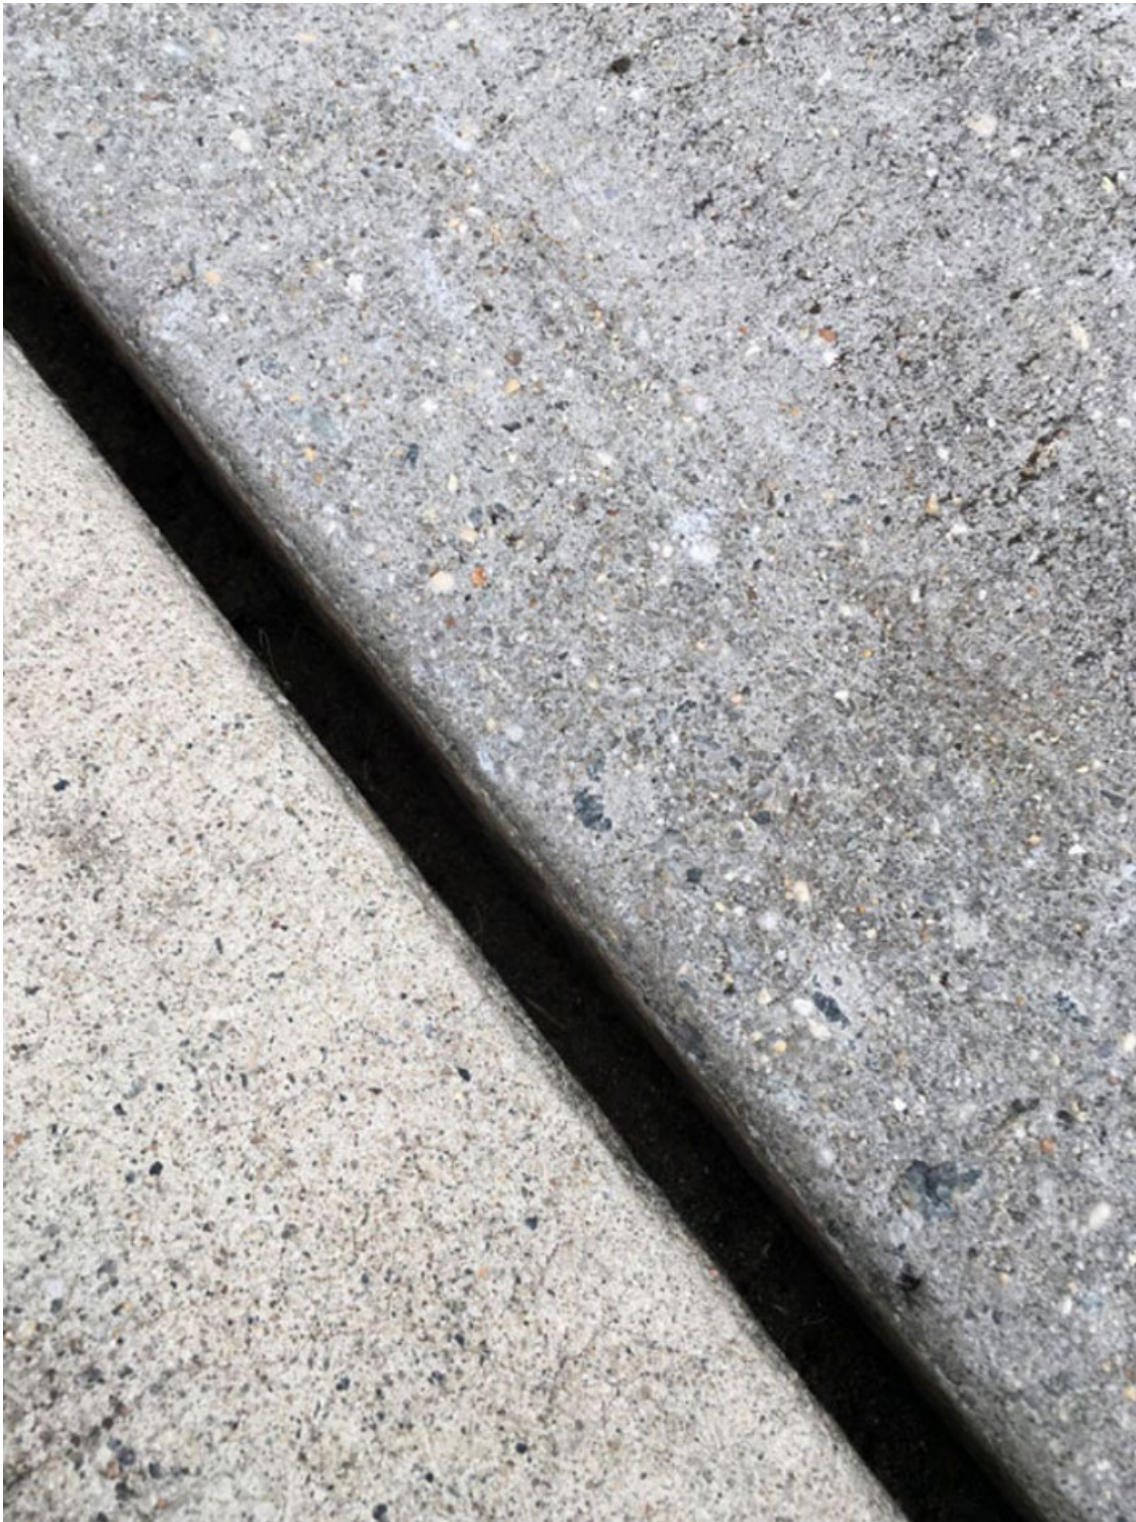
**Horizontal separation** is rated at greater than 1 inch. Horizontal separation above 1 inch can be corrected with sidewalk calking to fill the gap between sidewalk slabs.

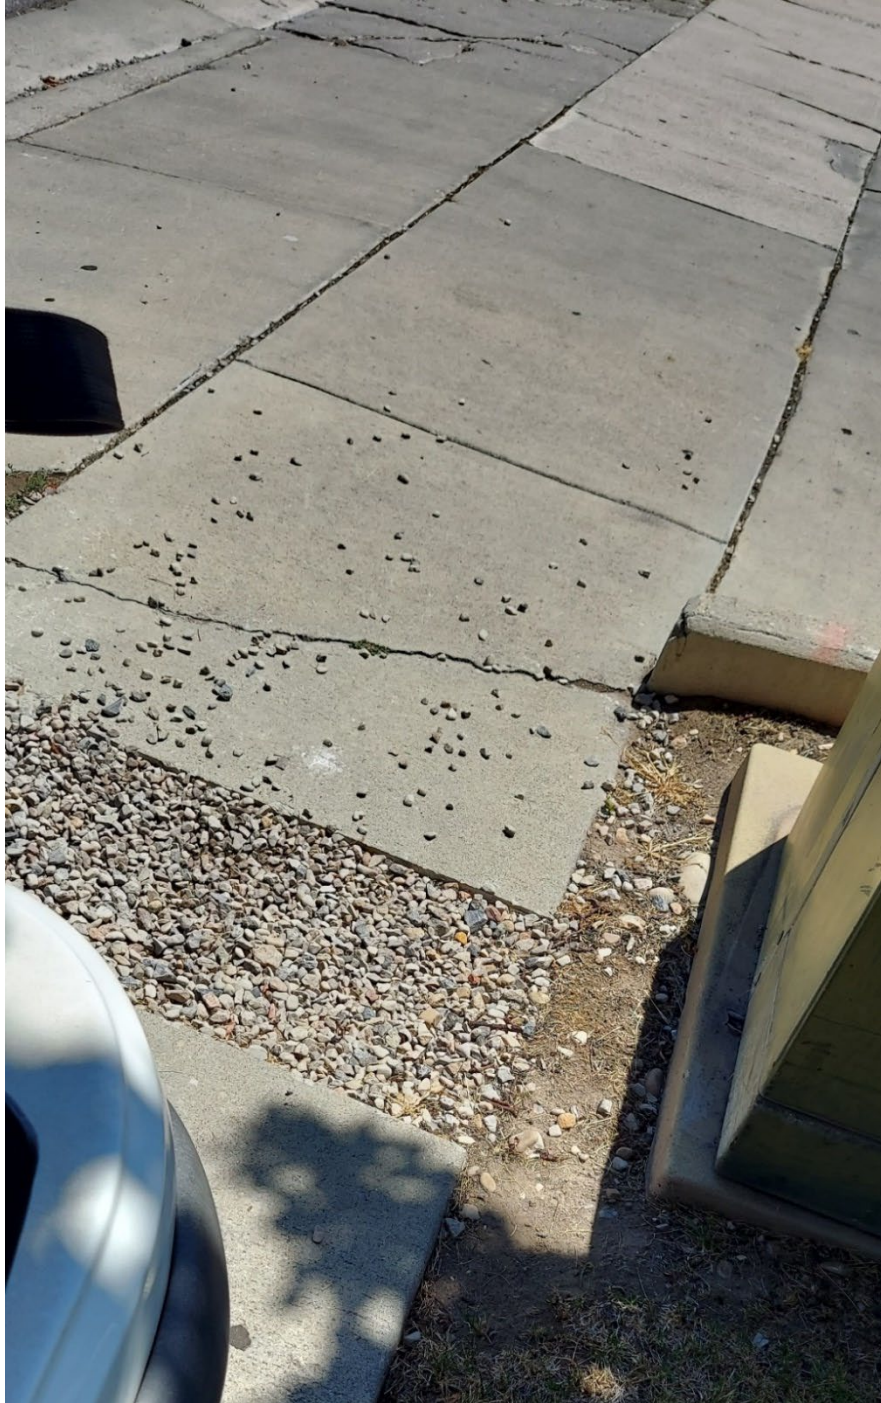
**Missing Pieces/holes** are given fair or poor ratings. A fair rating means the holes or missing piece would require up to half of the slab to be repaired. A poor rating means the holes or missing pieces are significant enough to require slab replacement.

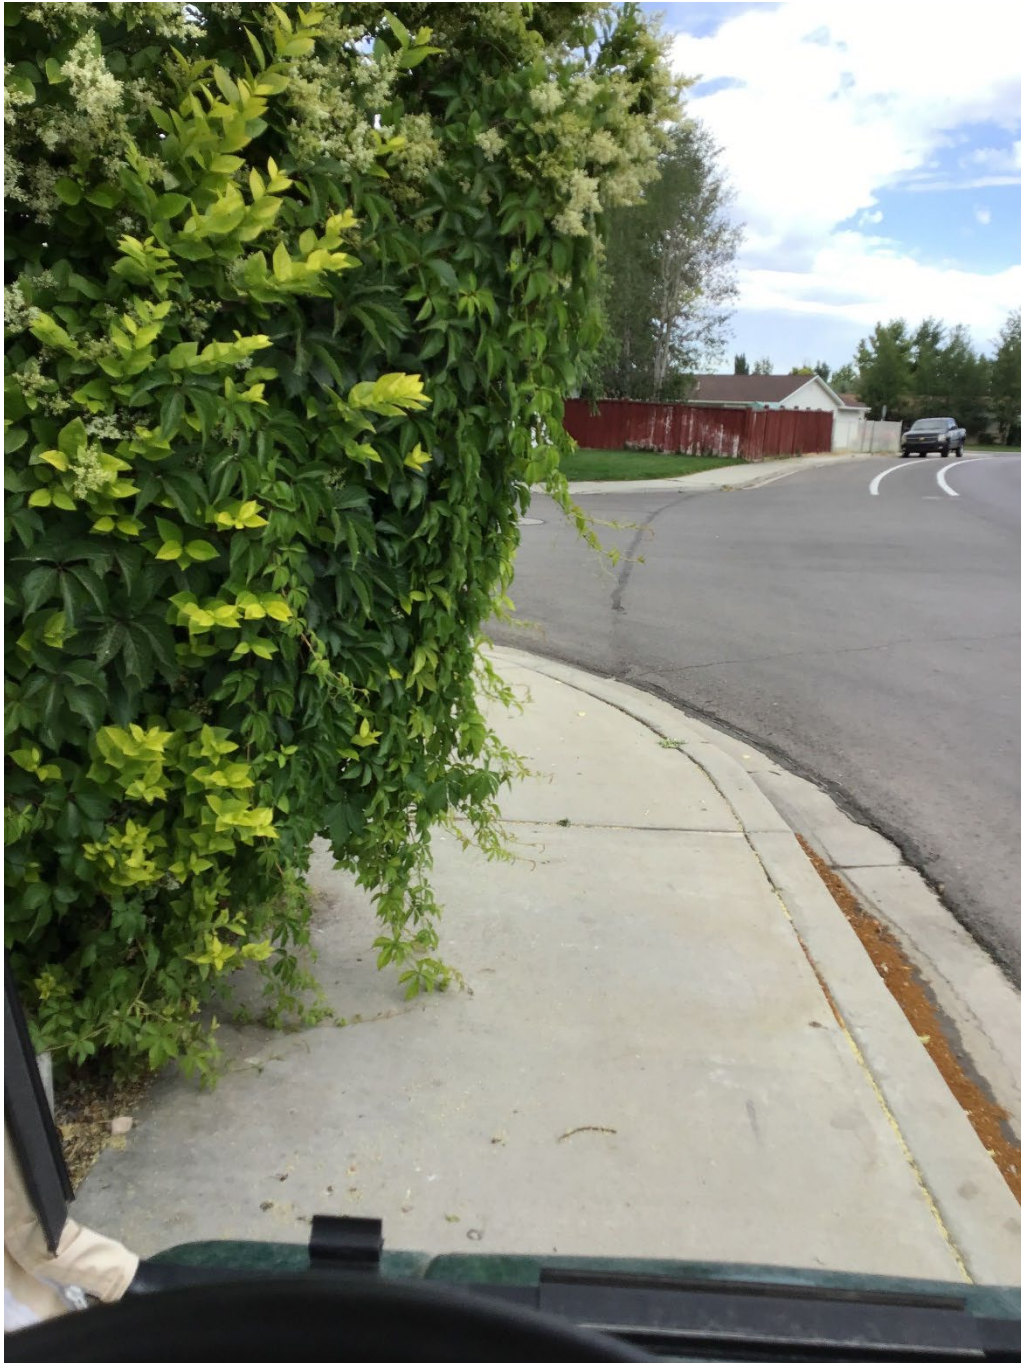
**Trees/bushes** need to be trimmed back in both width and height to allow free passage of pedestrians.

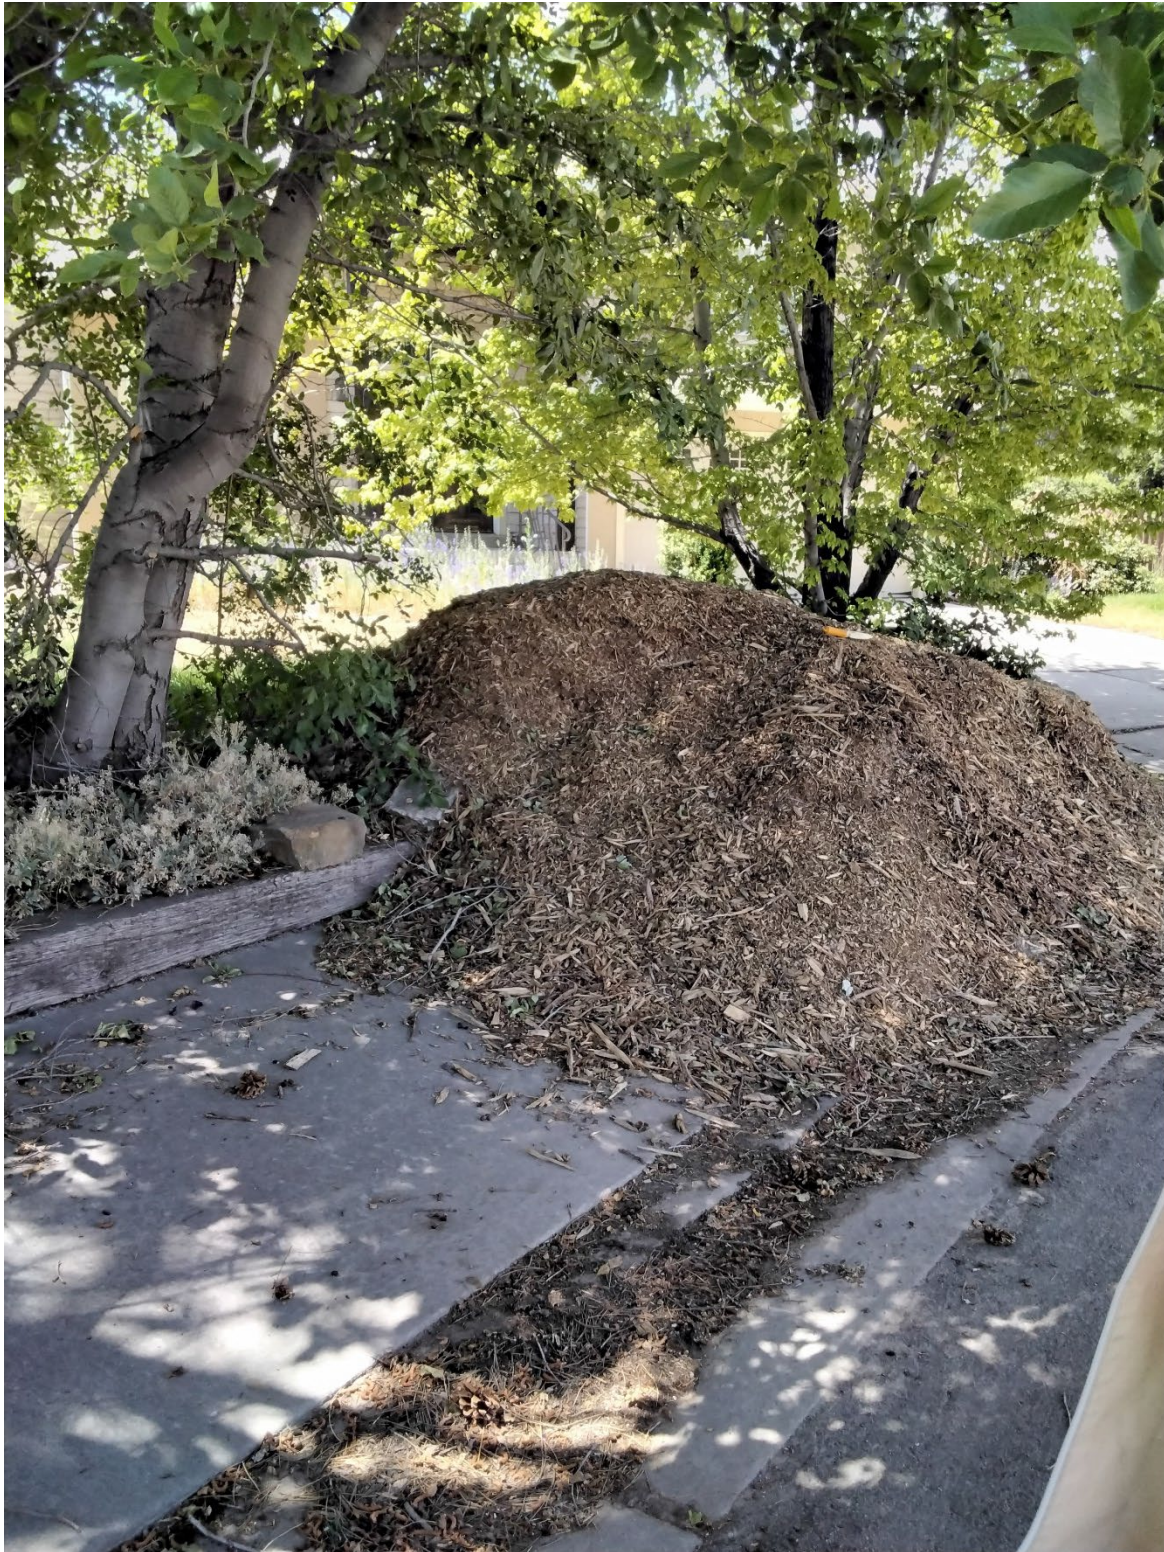
**Rocks/Landscaping** could require a homeowner or city to alter the edges of the property to allow free and safe passage of pedestrians over the sidewalk.

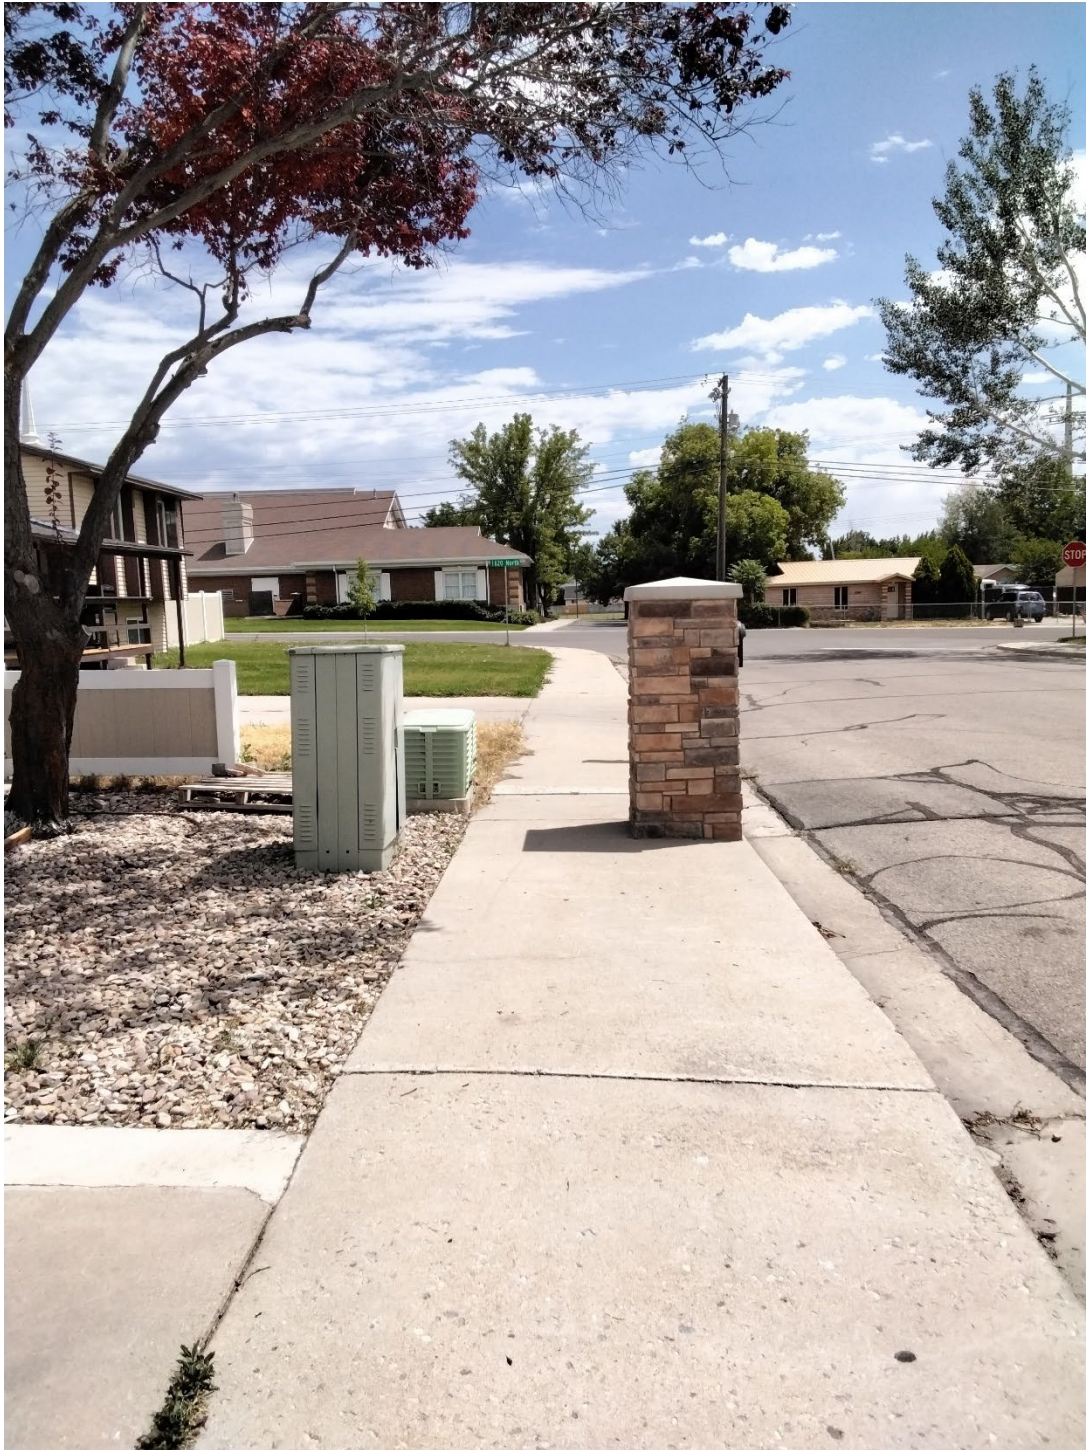
**Mailboxes** have multiple issues to fix. The first issue is when a sidewalk segment has no grass strip between it and the roadway. This causes homeowners to place their mailbox on the edge of the sidewalk causing an obstruction. The second issue is mailbox type and size. Many decorative mailboxes require more space and can obstruct the sidewalk for pedestrians.
