# Sign/Sidewalk Assessment and Budget Recommendations

## **Section 1: Introduction**

The purpose of this report is to provide budget estimates and suggested priorities for proper sidewalk maintenance, obstruction removal, and accessibility ramps. Sidewalk maintenance is crucial to preserve infrastructure and enhance the walkability of a city. Data gathering for signs was also performed.

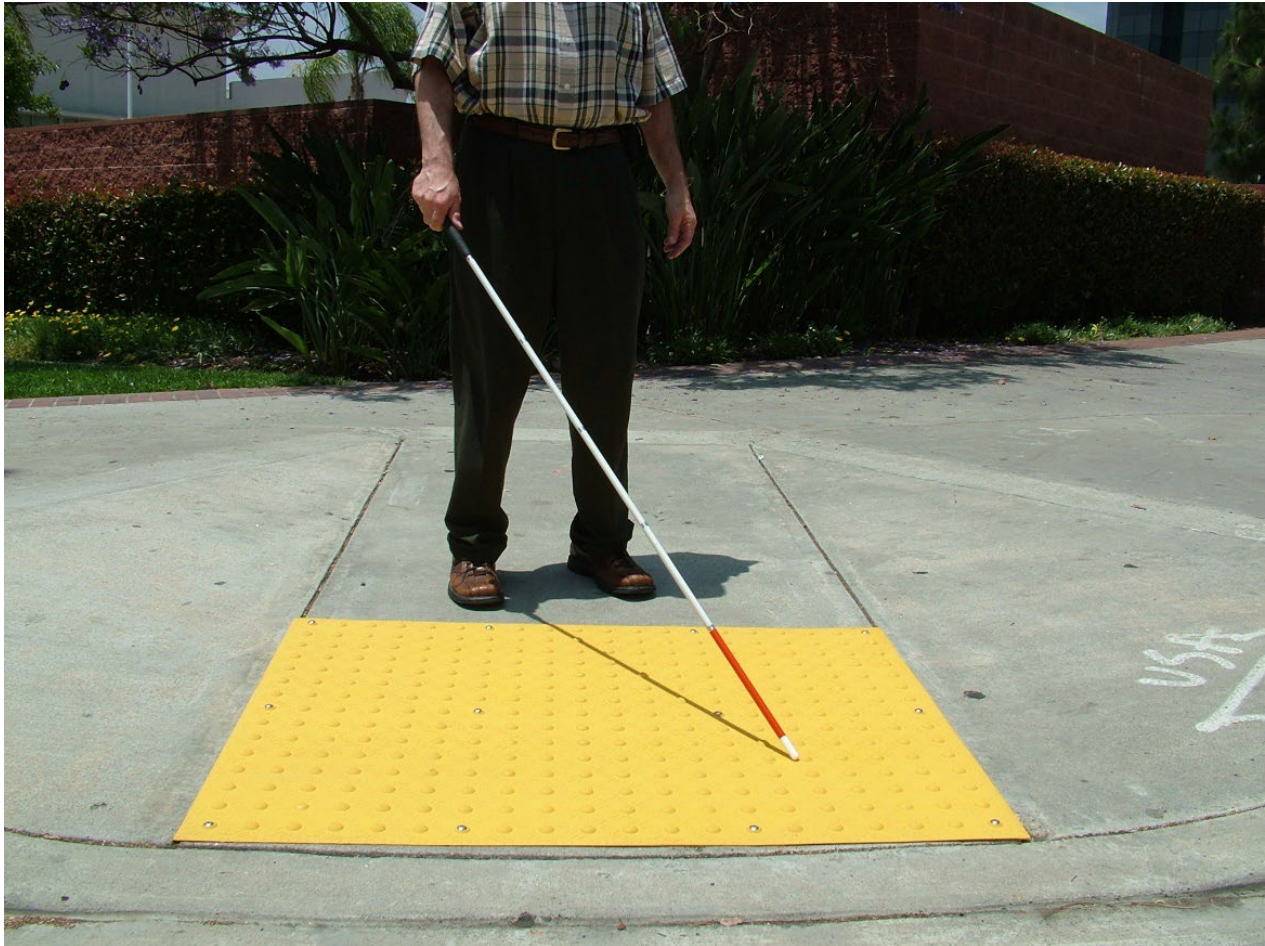
**Ramp with detectable warning surface** requires no reconstruction but may require maintenance depending upon the quality of the ramp or if the ramp isn't following other ADA standards.

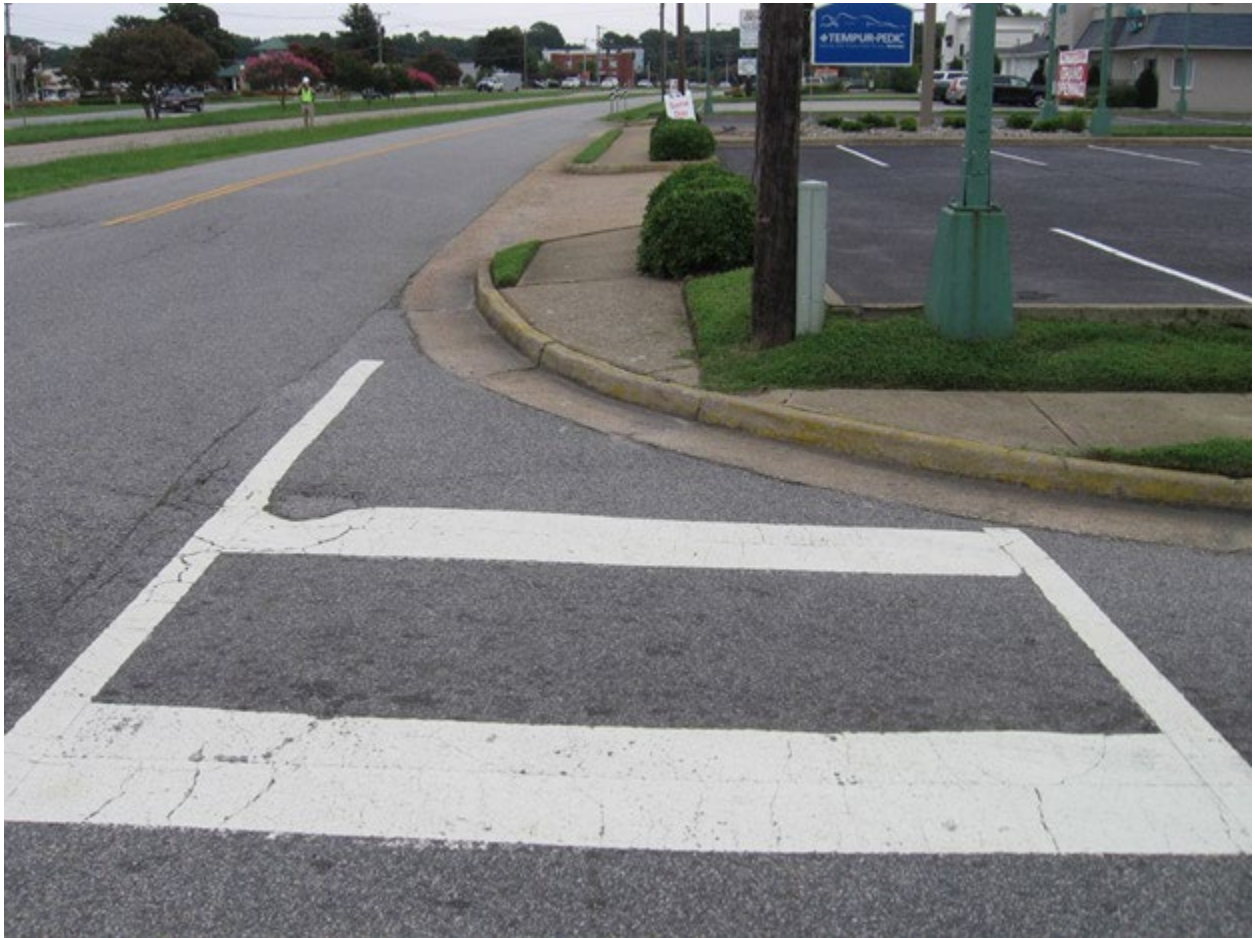
**No ramp no detectable warning surface** requires a removal and reconstruction of the corner on which the ramp is missing. The installed ramp should include proper detectable warning surfaces on the edge of the ramp. A new ramp should be designed to meet all ADA requirements.
