SLOPE EVALUATION REPORT

QUAIL MESA- VIRGIN, UT

PROJECT NO.: 4430.2200018.0000

SEPTEMBER 18th, 2022

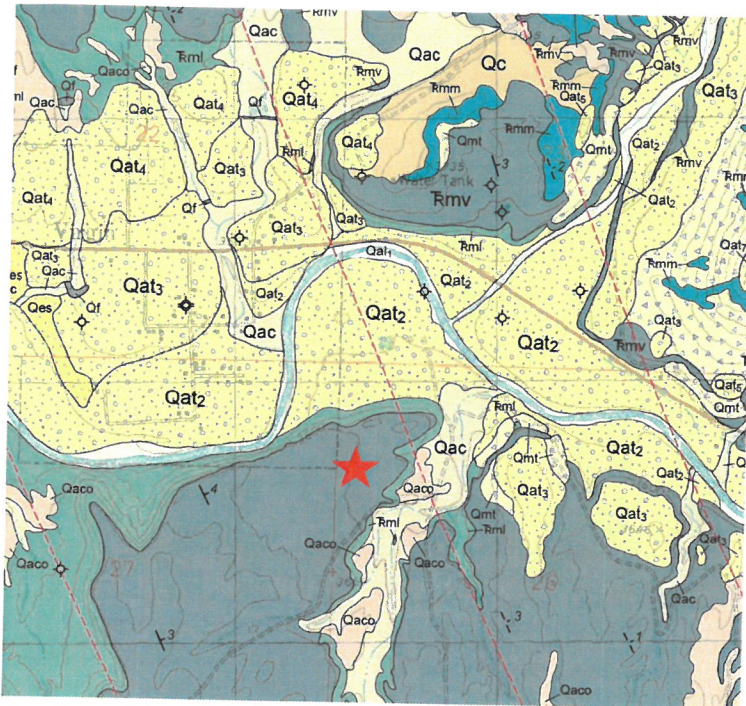
The geology of the area is described by the USGS Virgin, Utah 7.5 minute quadrangle, which is shown below in **Figure 1** (Hayden, J.M. and Sable, E.G., 2008). The uppermost portion of the mesa is capped by the Virgin Limestone Member (TRmv- *Grey*) while the slope is comprised of the underlying Lower red member (TRml- *Olive Green*). As noted in Figure 1, the Lower red member is a "slope forming" unit composed of relatively weaker mudstones, siltstones, and sandstones.

Figure 1: Hayden, J.M. and Sable, E.G., 2008, *Geologic map of the Virgin quadrangle, Washington County, Utah*, Utah Geological Survey, Map 231, 1:24,000. The general location of the project site is marked by the red star.

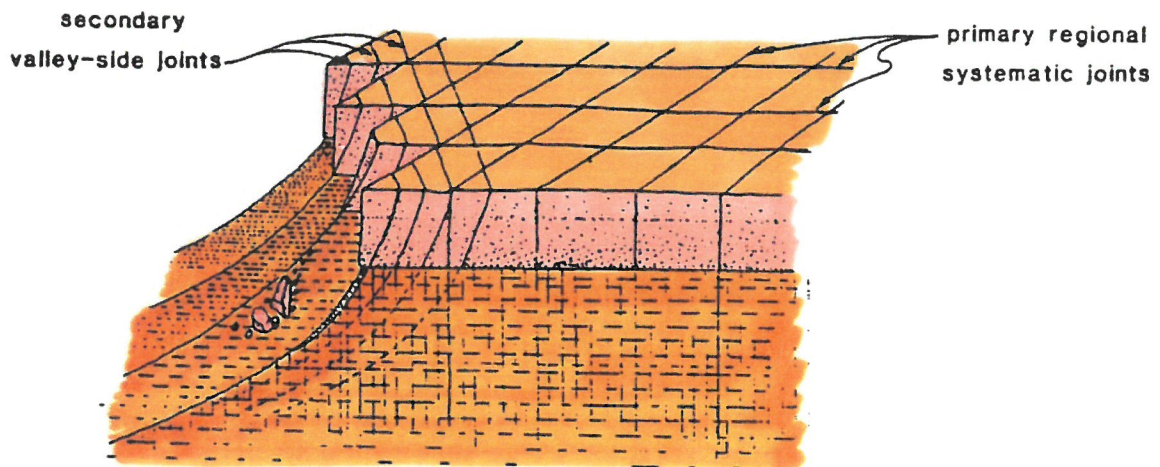
Figure 2: Schematic drawing illustration primary and secondary joint systems found within Zion National Park, UT; taken from an overview of research by J. David Rogers (1982) https://web.mst.edu/rogersda/phd_research/zion_np.htm.

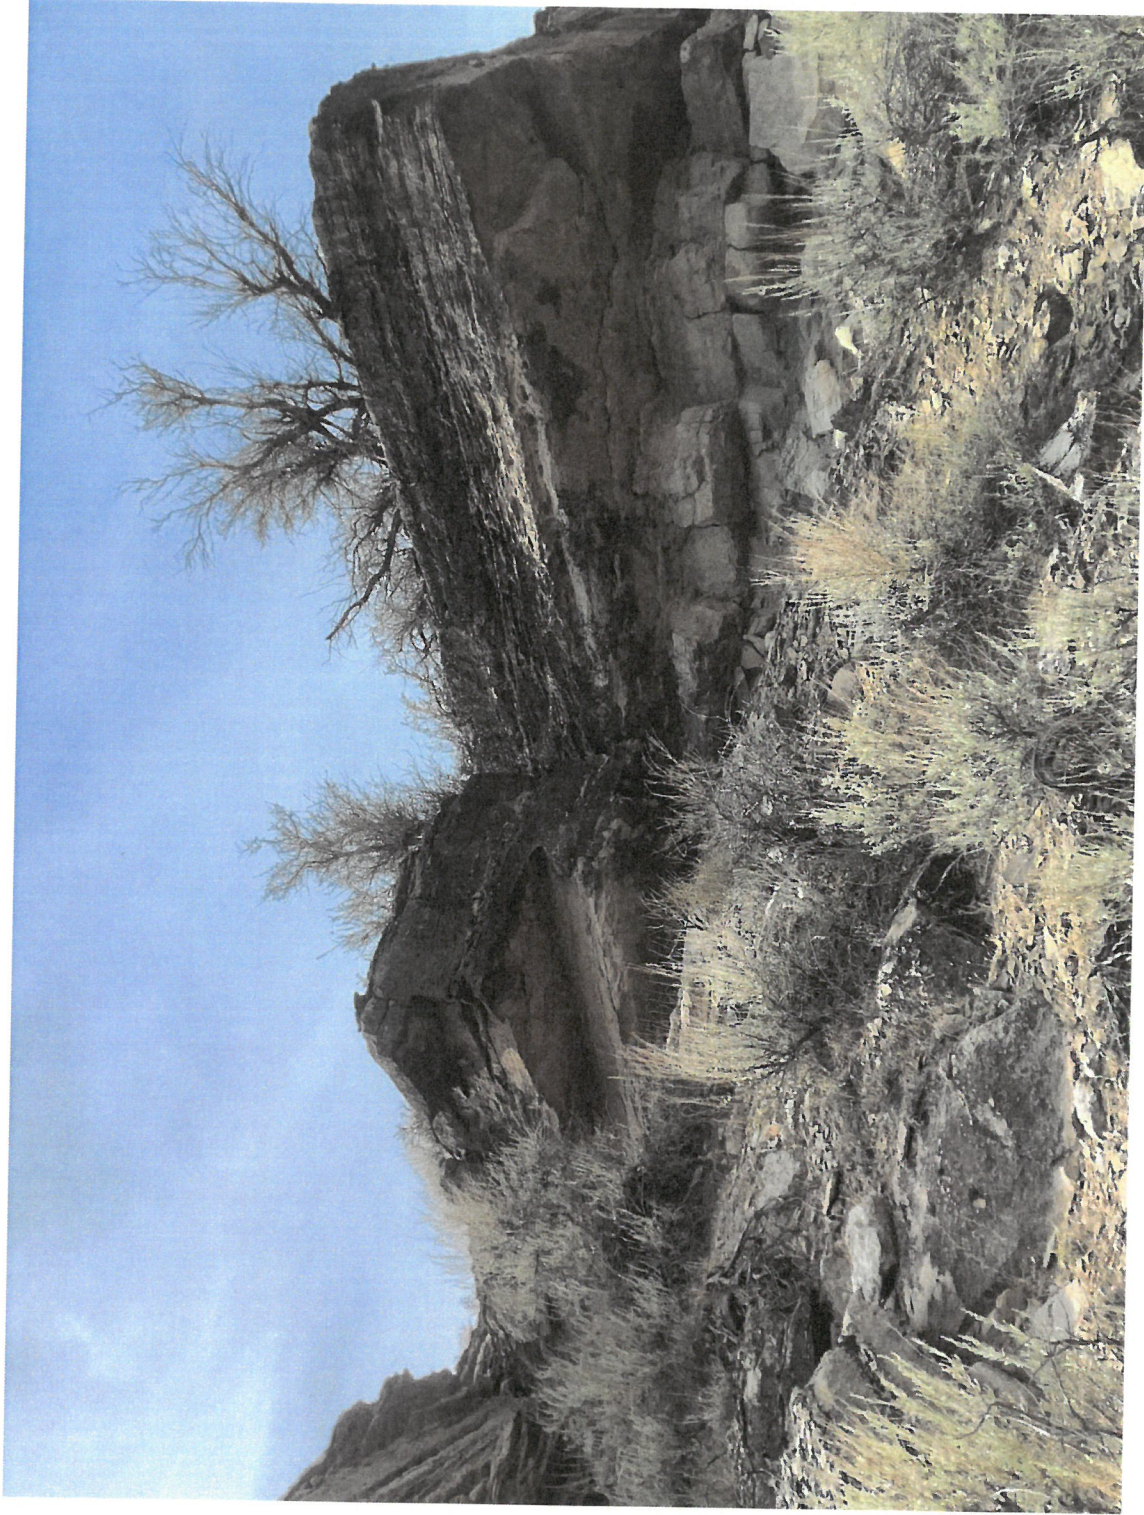
In our opinion, we believe the primary slope forming mechanism at the project site to be due to undercutting of the *Virgin Limestone* by the erosion of the relatively weaker *Lower red member*, as evident in **Photos 3** through **5**. Furthermore, this process is hastened due to the intersection of the conjugant joint sets and valley side joints, which can result in wedge failures as the underlying material erodes, as shown in **Photo 4**.

Photo 3: View from near the top of the mesa slope looking up towards the *Virgin Limestone*. Wedge failures are apparent within the interior of the cognate joints.

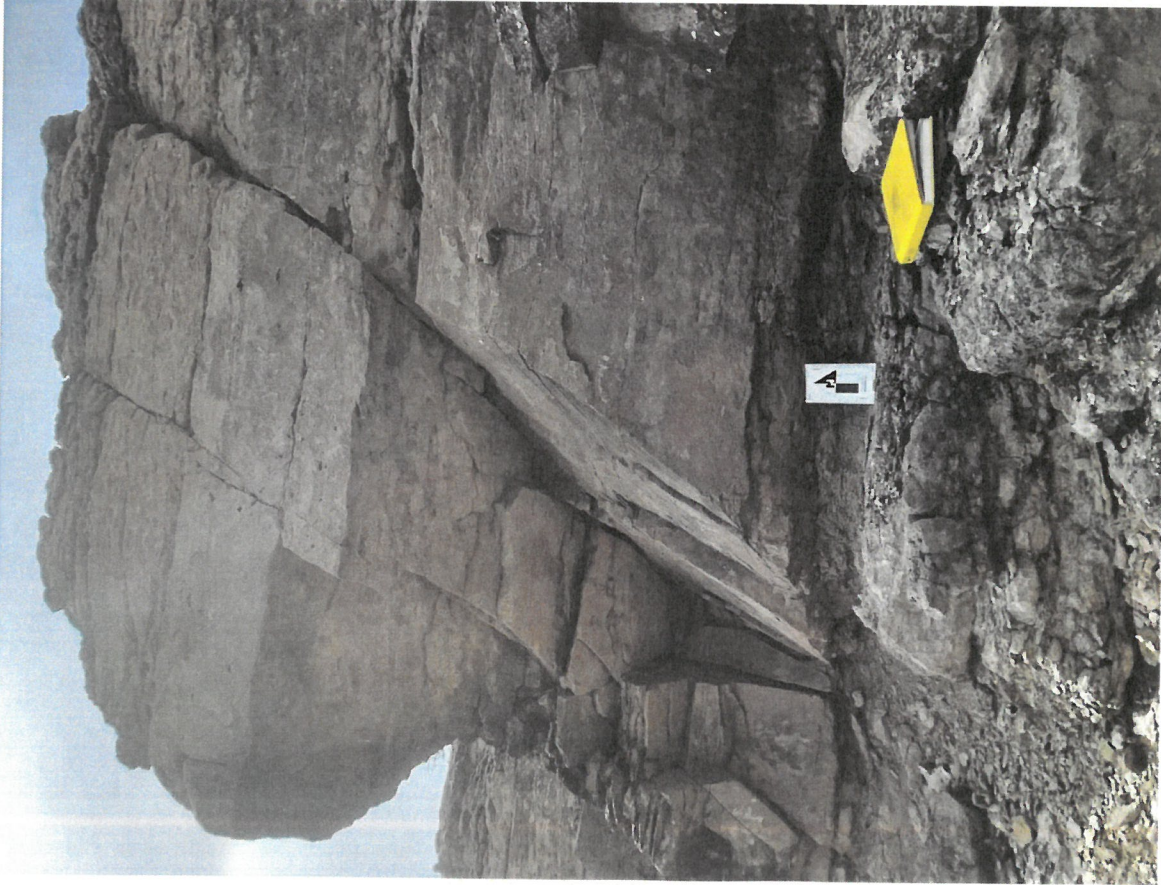
Photo 4: View from near the top of the mesa slope looking parallel to the cliff face. Apparent valley-side joints can be seen in the *Virgin Limestone*.

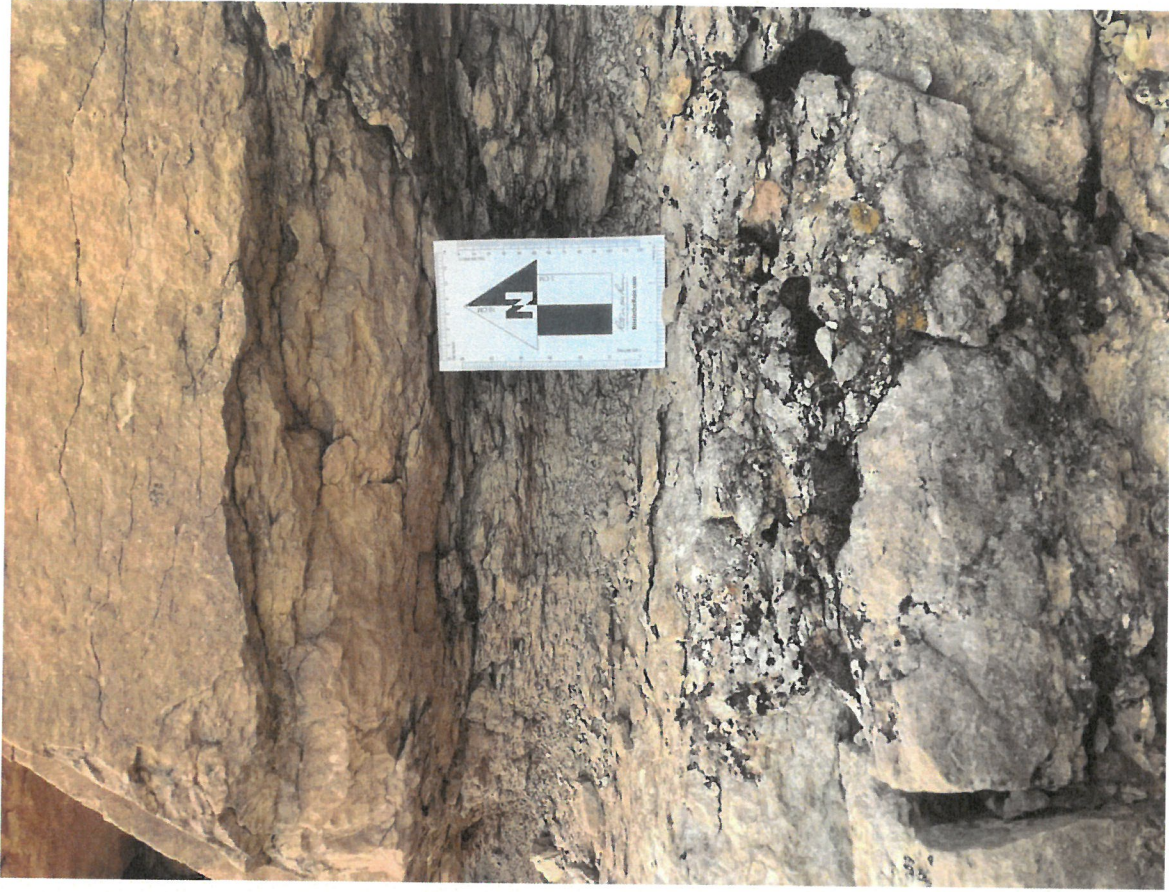
Photo 5: Undercutting of the relatively weak formation beneath the *Virgin Limestone*.

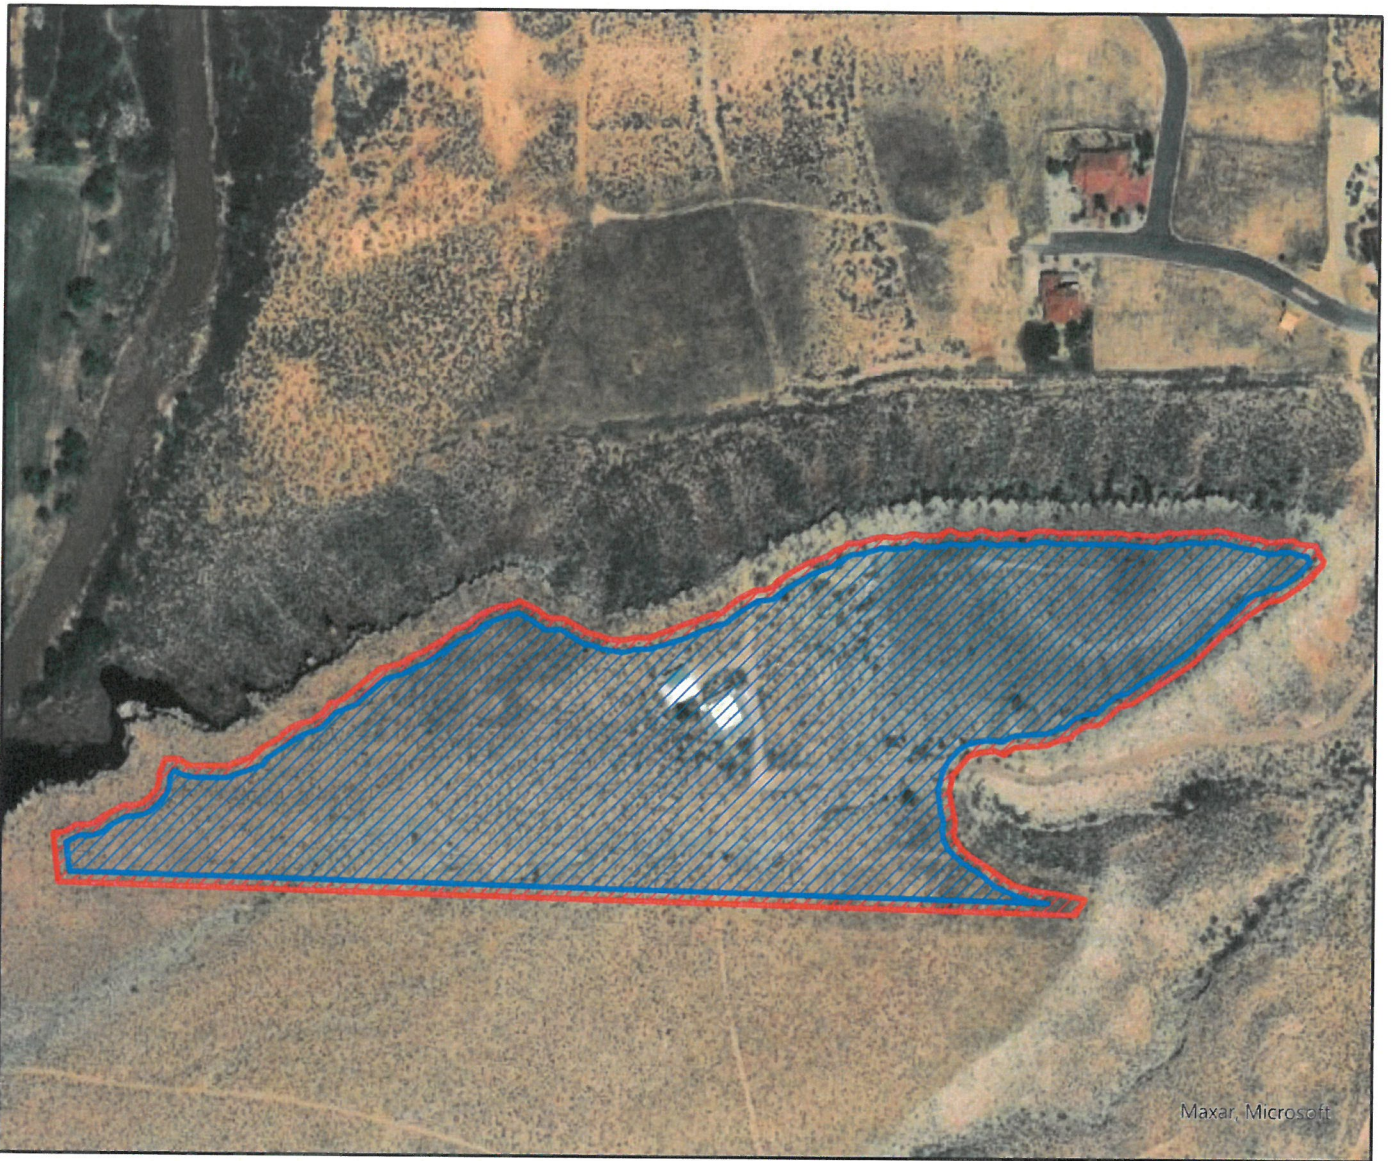
To delineate the area suitable for development based upon these criteria, UES constructed a Digital Elevation Model (DEM) of the parcel using using 0.5m LiDAR elevation data. Slopes greater than 30% were then identified from the DEM and deducted from the developable area of the parcel. In addition, building setbacks from the slope were also subtracted from the developable area. UES evaluated both the minimum building setback in accordance with the 2018 International Building Code (IBC), which we determined to be approximately 33 feet, and a recommended building setback of 50 feet. Due to unregulated nature of the mesa cliff, as well as the presence of the joint systems and potential for wedge failure, we recommend the latter value for occupied buildings developed on the mesa top. Our map of developable area for this property is provided as an attachment to this report. Furthermore, upon request, UES is available to provide GIS data and files of the developable area.
