**PARK CITY HISTORIC PRESERVATION BOARD MEETING
SUMMIT COUNTY, UTAH
May 7, 2025**

- 1. MEETING CALLED TO ORDER AT 5:00PM**
- 2. ROLL CALL**
- 3. SWEARING-IN CEREMONY**
 - 3.A. Swearing-In Ceremony for Dalton Gackle, Douglas Stephens, Katie Noble, and Randy Scott.

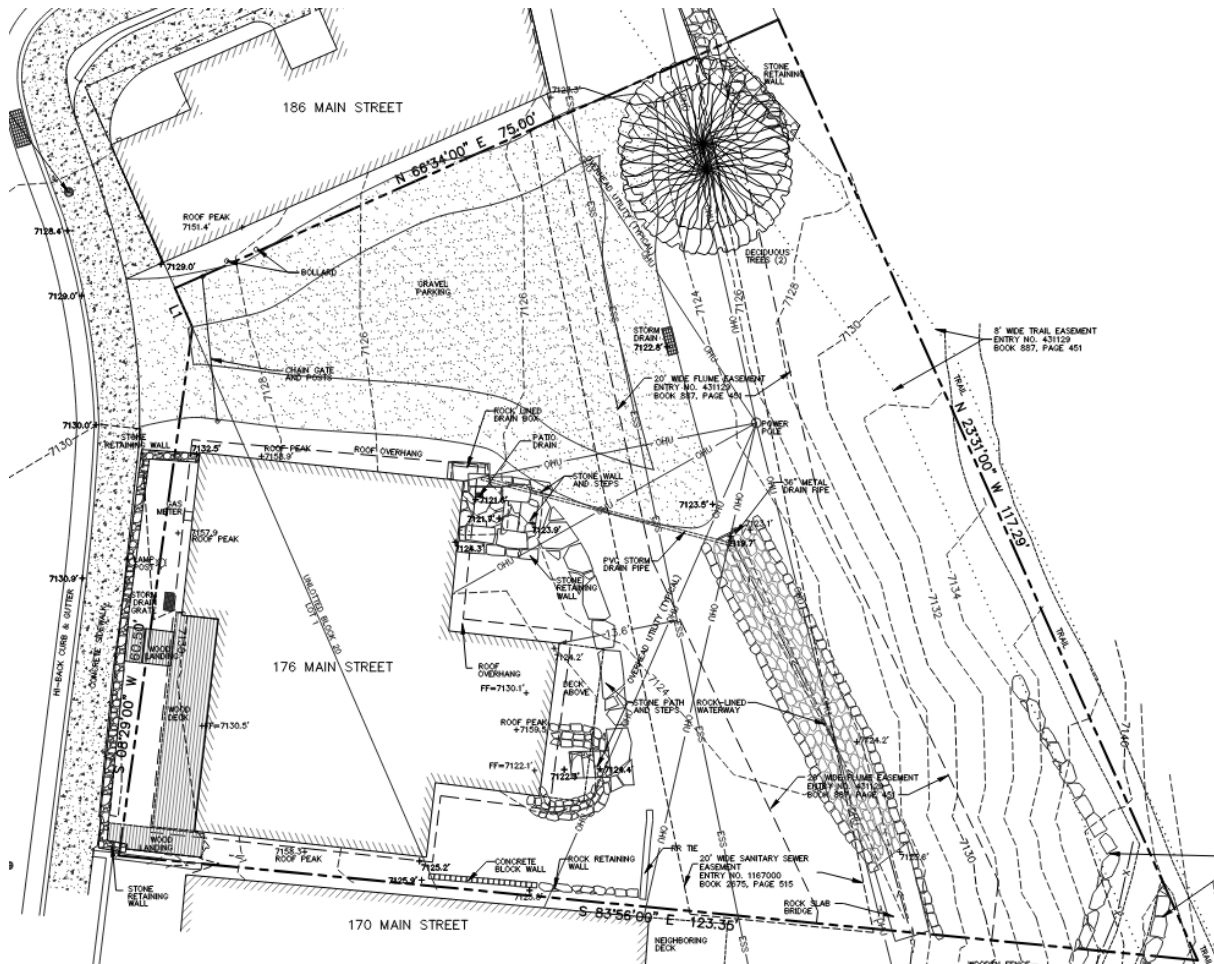
Existing Conditions Survey provided by the Applicant showing easements

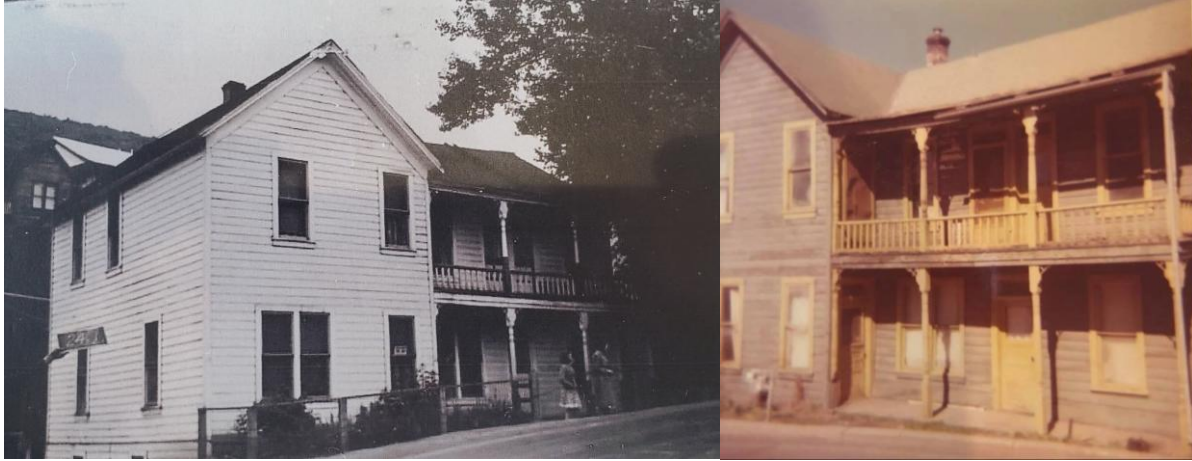
176 Main prior to 1978, images provided by the Applicant

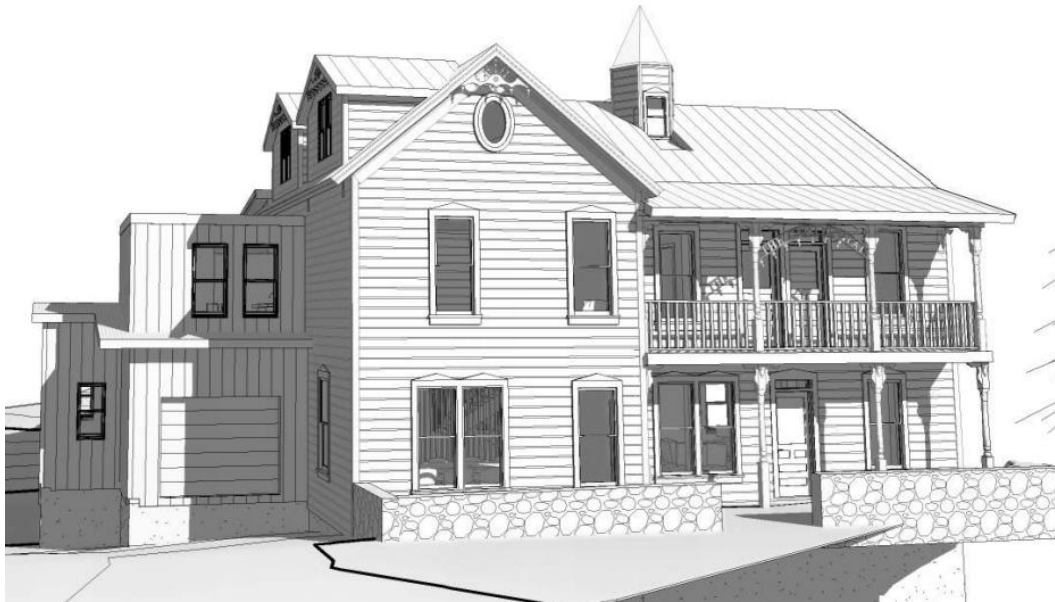
Proposed elevation of 176 Main when viewed from Main Street

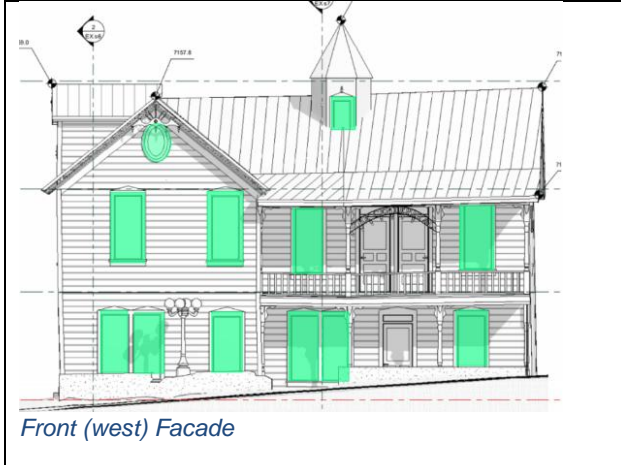
<p><i>Existing Elevations – Windows proposed to be removed are shown in red, windows to be retained are shown in green</i></p>	<p><i>Proposed Elevations – Windows proposed to be added are shown in blue, windows retained from existing conditions are shown in green</i></p>

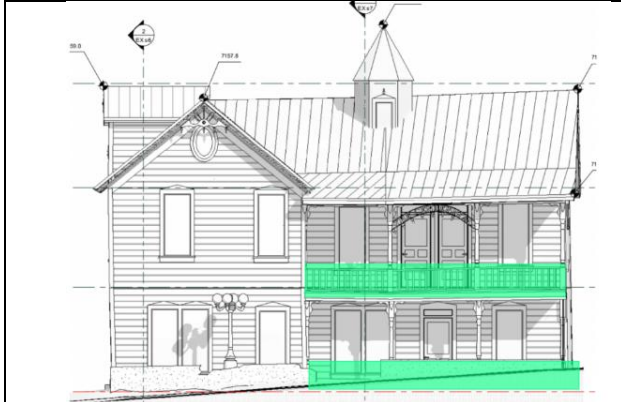
<p><i>Existing Elevations – Porches proposed to be removed are shown in red, porches to be retained are shown in green</i></p>	<p><i>Proposed Elevations – Porches proposed to be added are shown in blue, porches retained from existing conditions are shown in green</i></p>

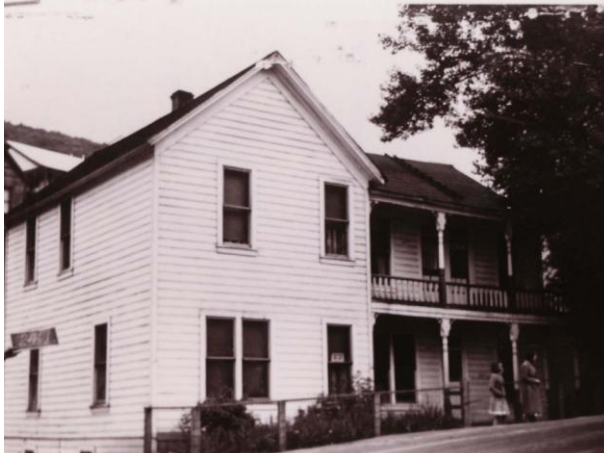
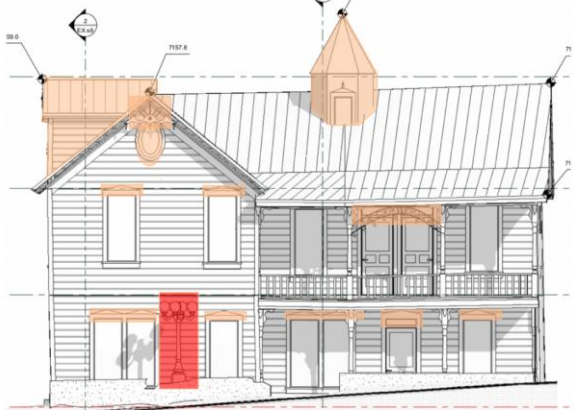
<p>Mechanical Equipment</p> <p>Mechanical equipment and utilities, including heating and air conditioning units, meters, and exposed pipes, shall be located on the tertiary façade or another inconspicuous location. If located on a secondary façade, it shall be screened from view by incorporating it into the appearance as an element of the</p>	<p>Condition of Approval Recommended:</p> <p>There is currently mechanical equipment located on the front façade. Condition of Approval 27 requires that the mechanical equipment be relocated to the tertiary façade or other inconspicuous location. All new mechanical equipment shall be located in a manner that is visually minimalized from the primary public right-</p>

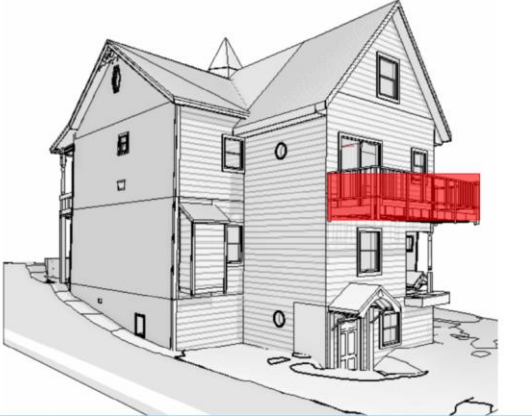
<p><i>Rear (east) and Side (south) Facade</i></p>

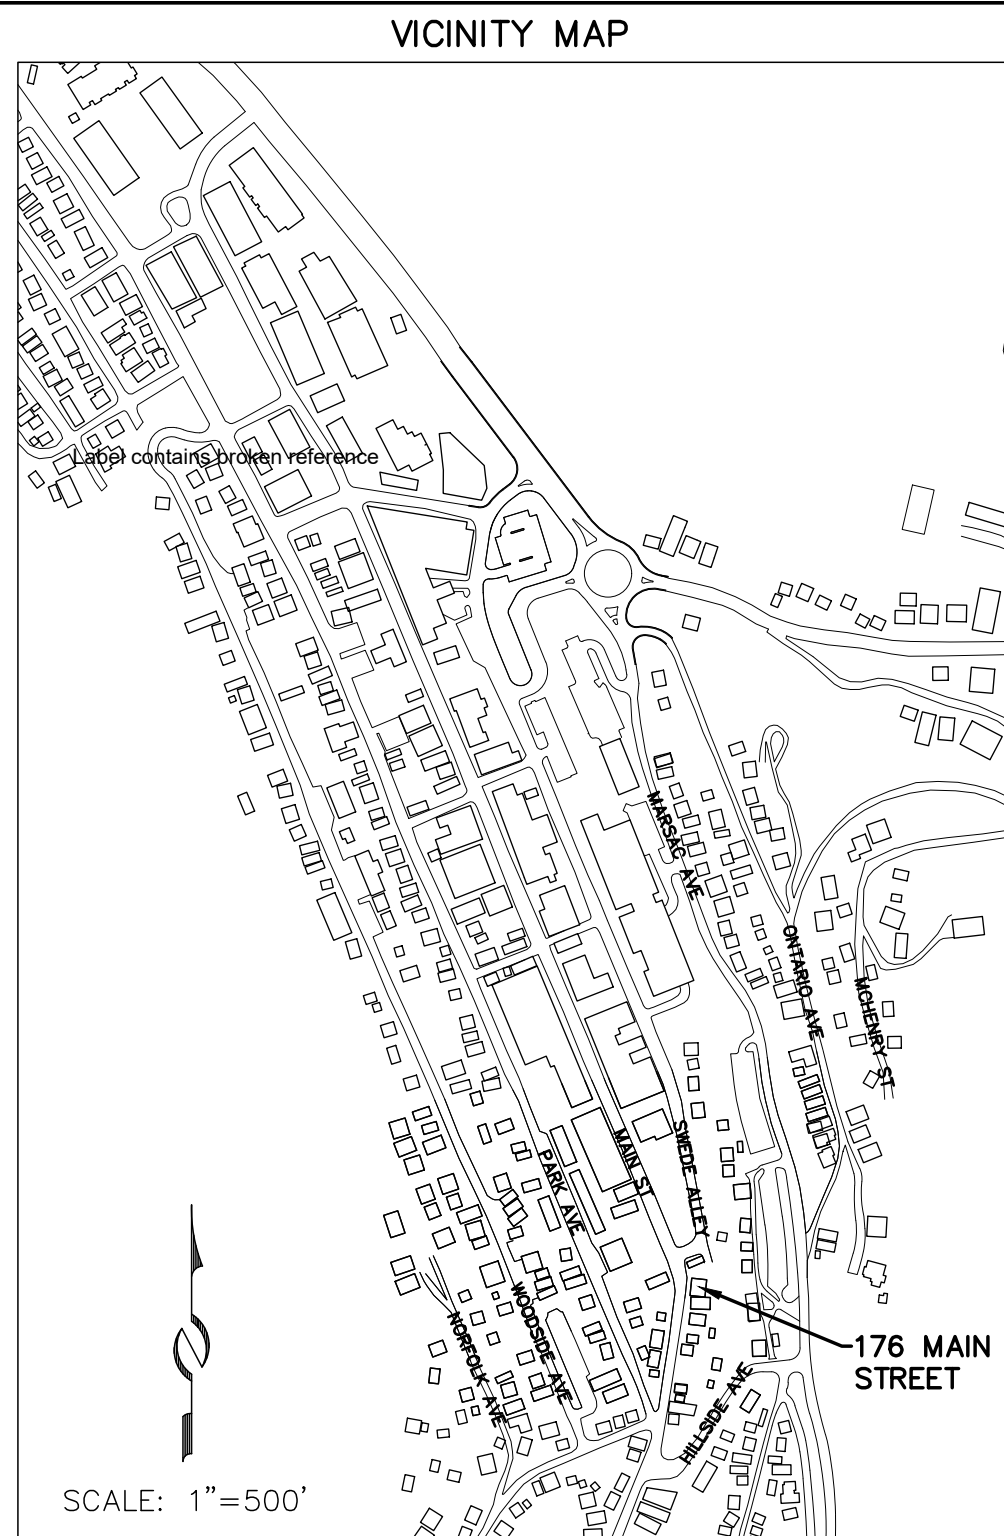
LINE TABLE		
LINE	BEARING	DISTANCE
L1	N 23°31'00" W	4.94'

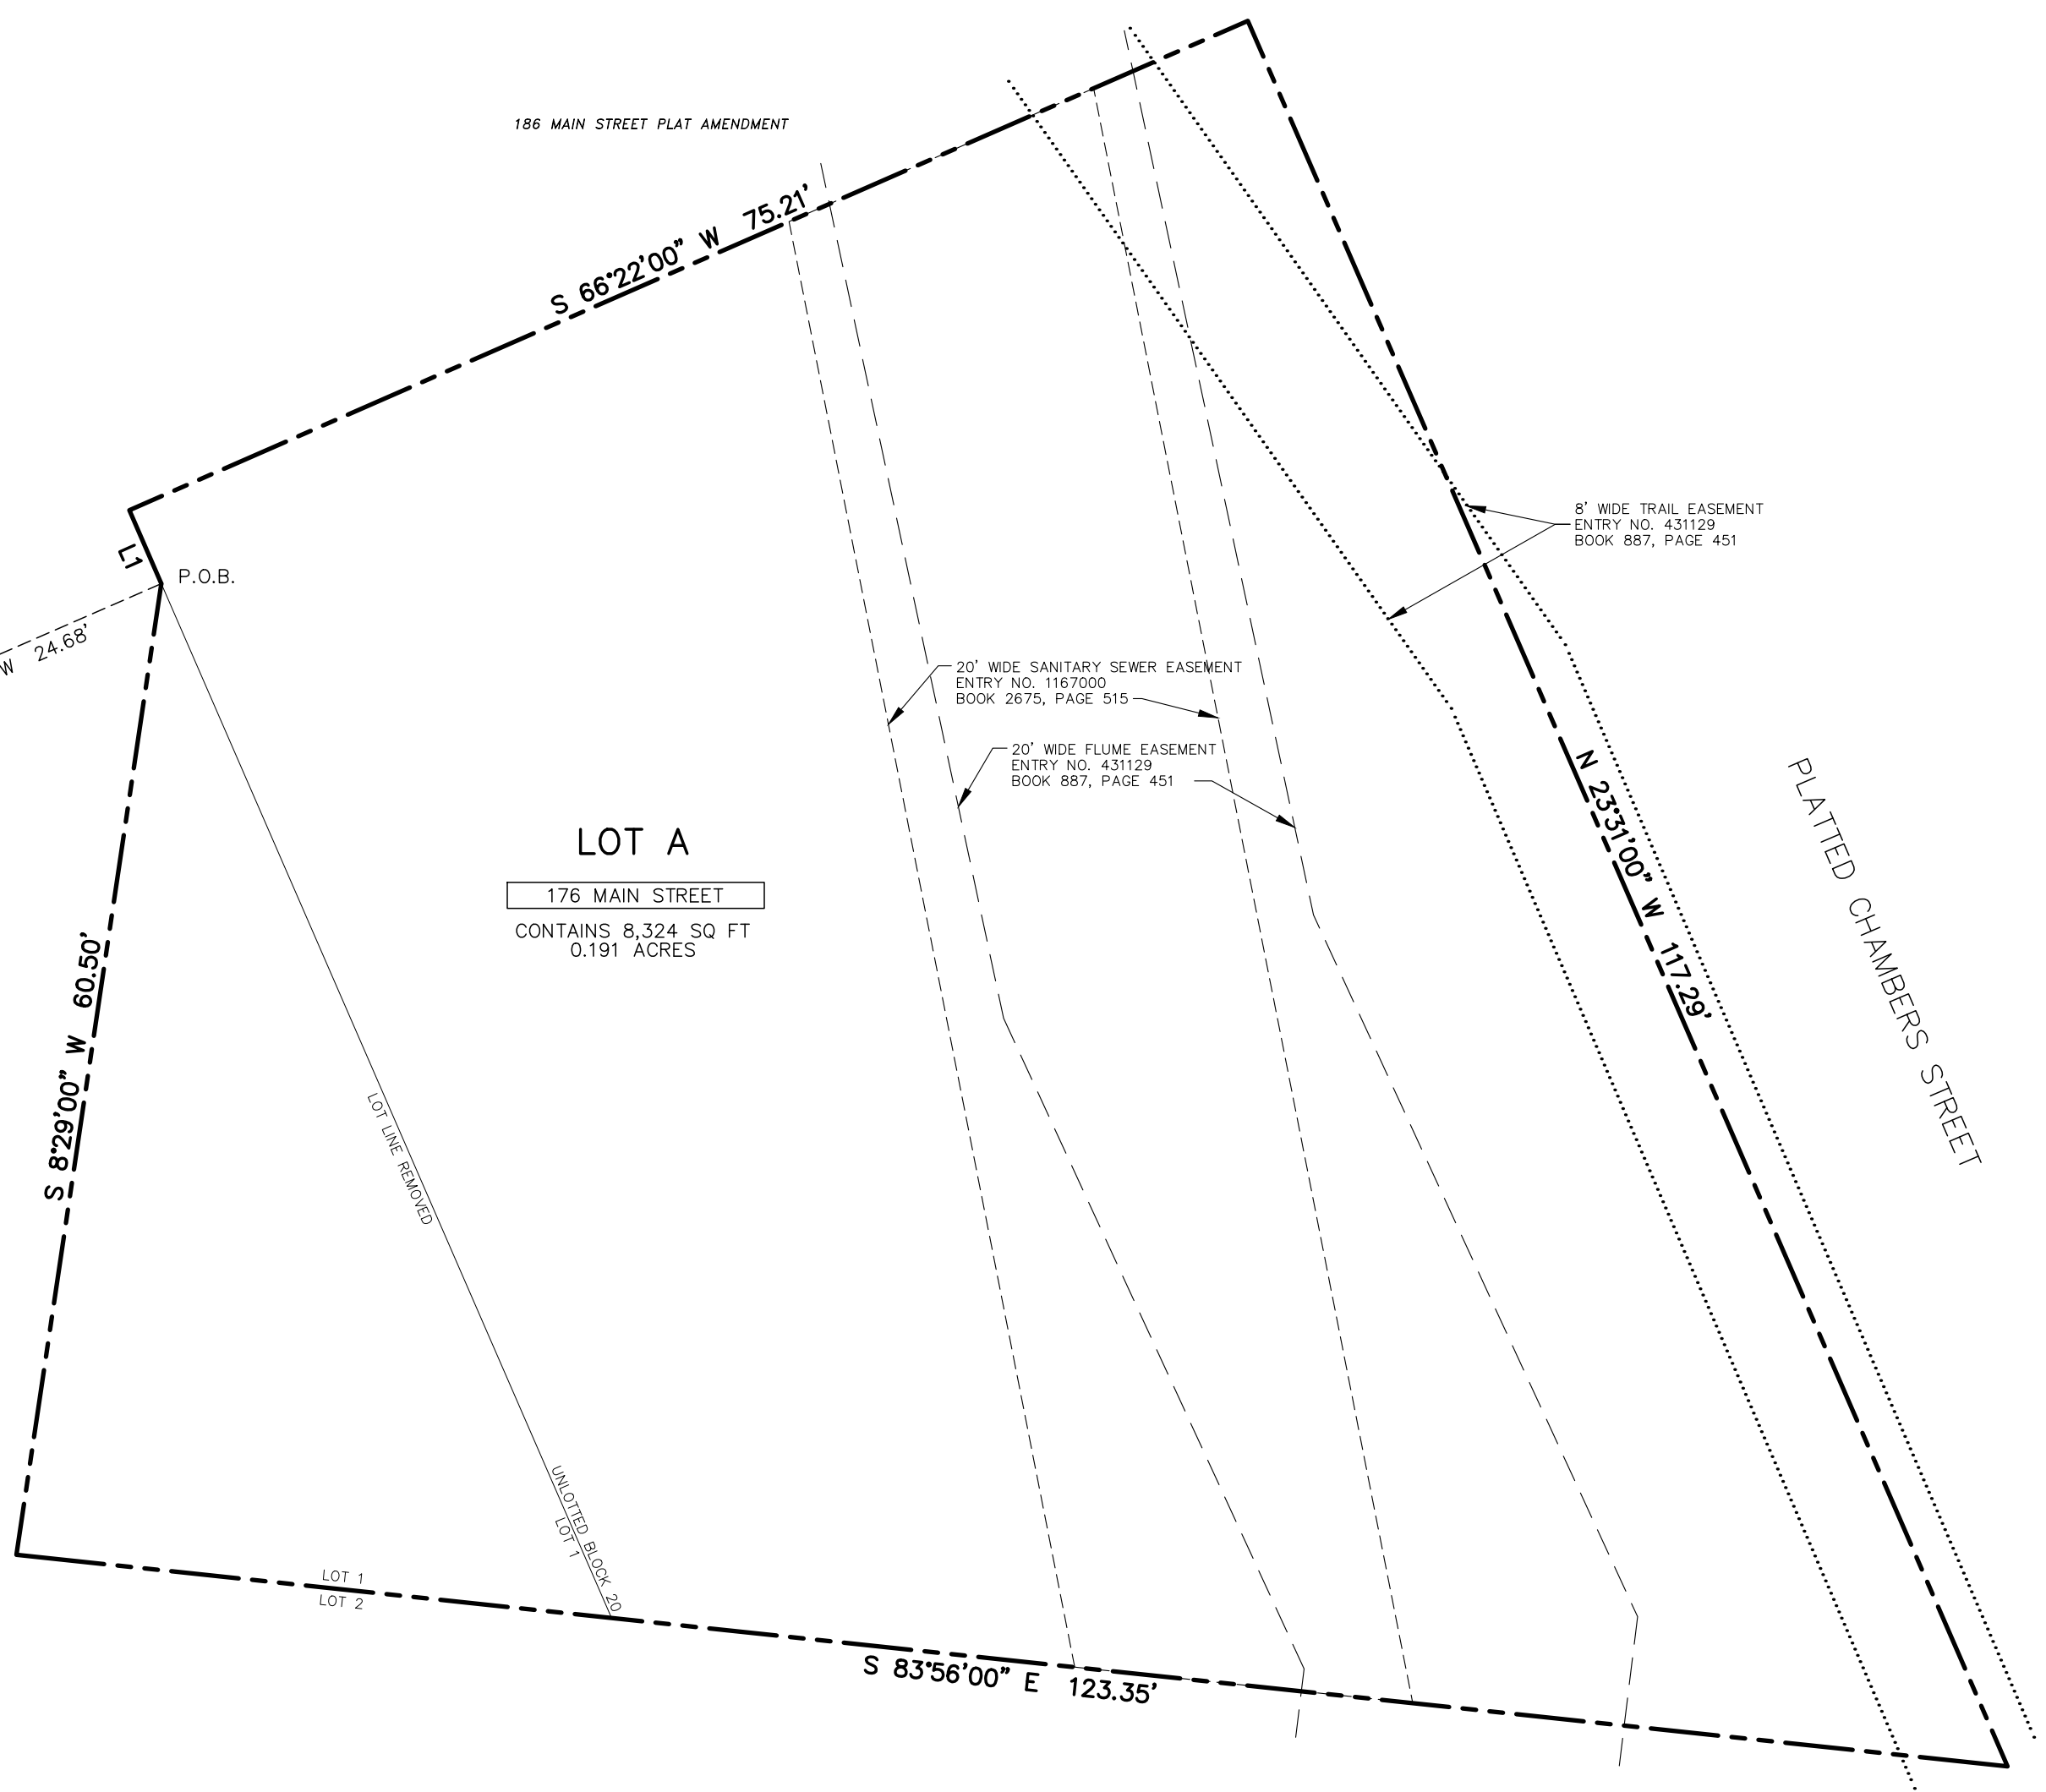
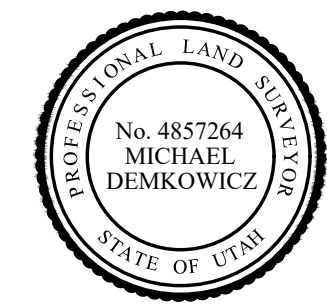
SURVEYOR'S CERTIFICATE

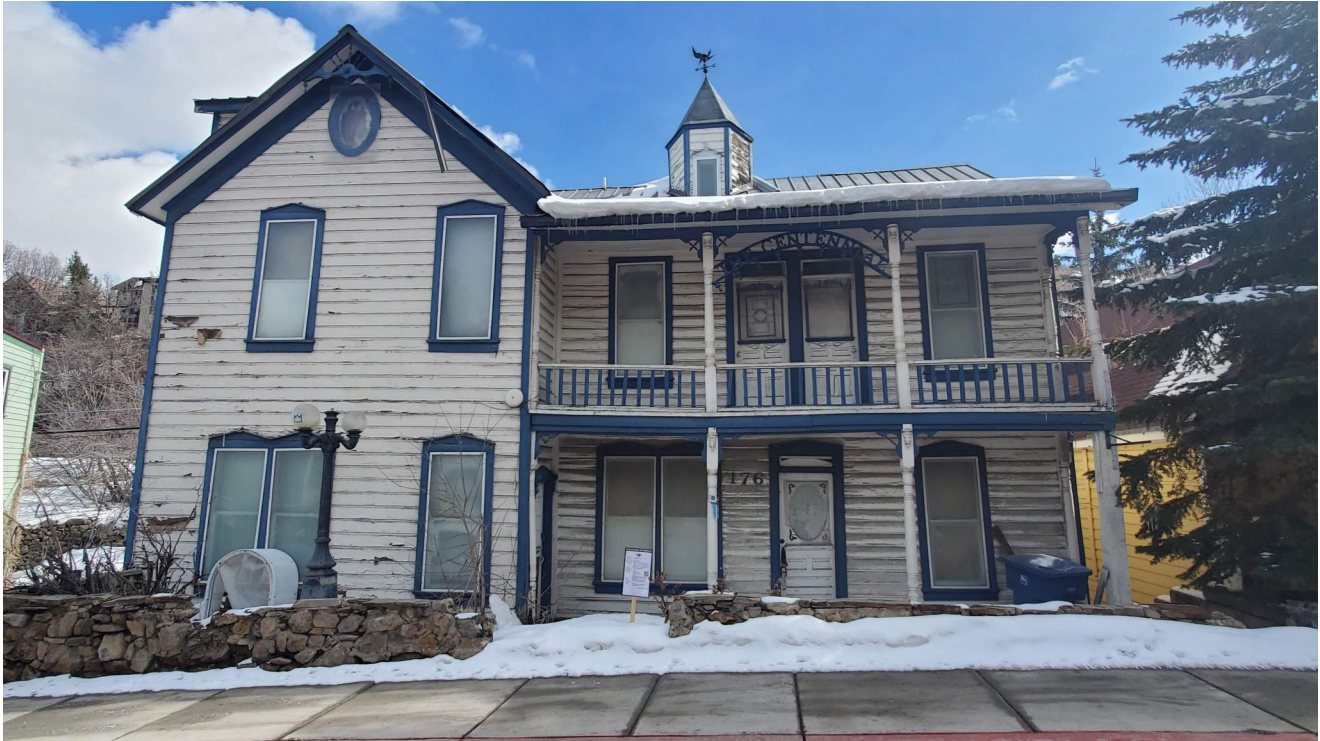
ILLUSTRATION # 1 - WEST FACADE

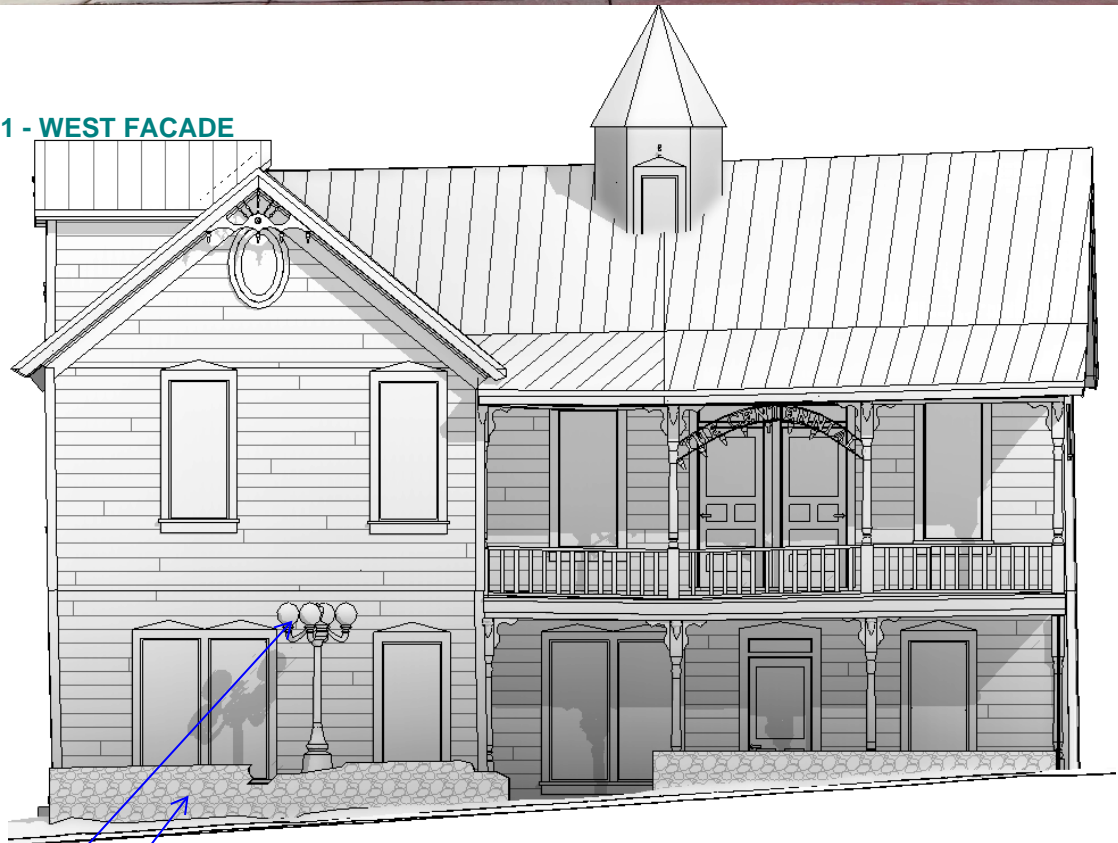
Non-Historic Light Post

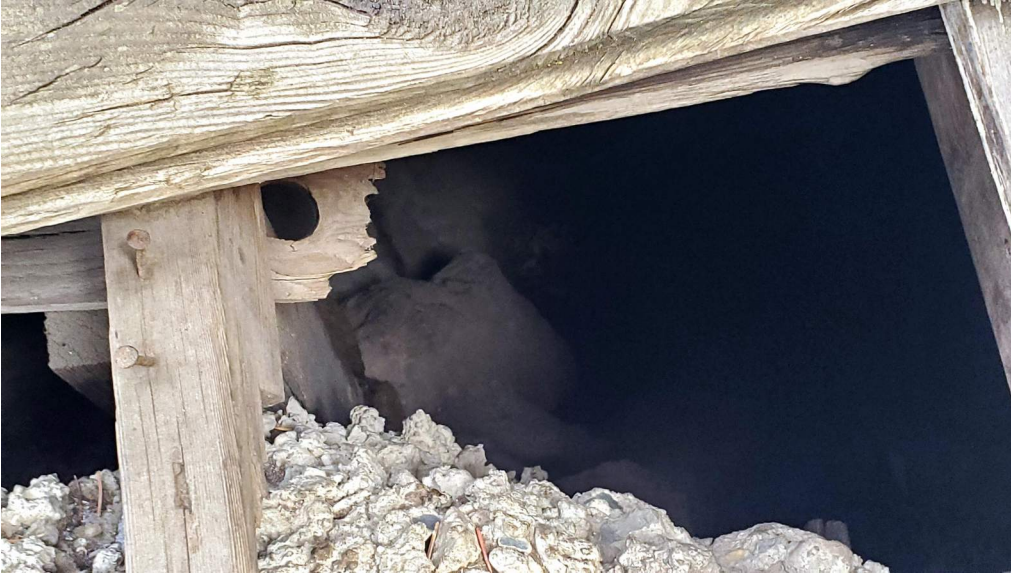
ILLUSTRATION # 2 - EXISTING SECTION

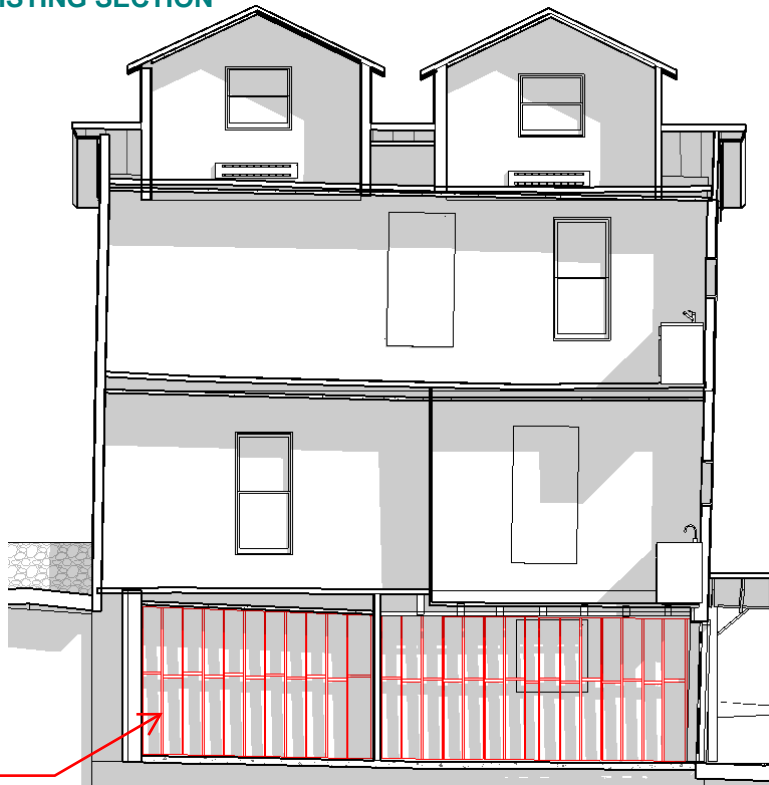
Example of Shoring required to support building found in as-built drawing set

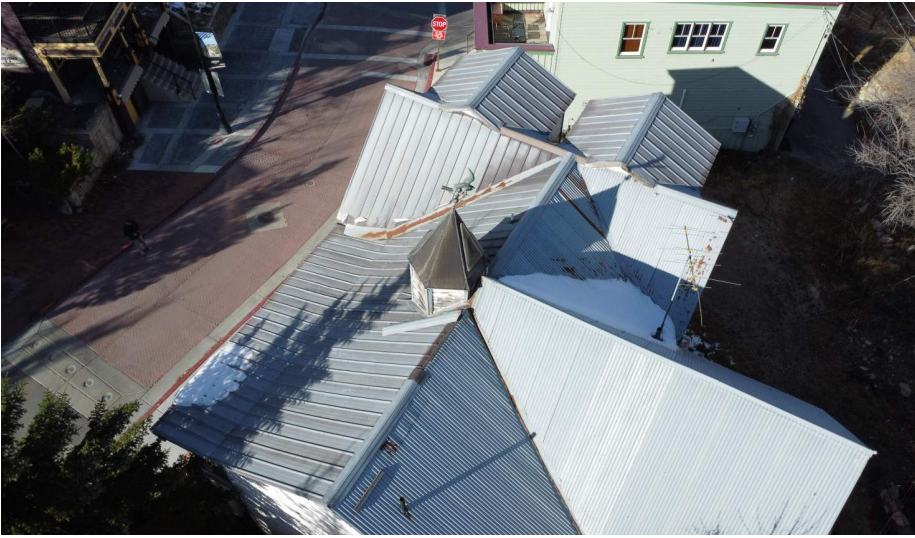
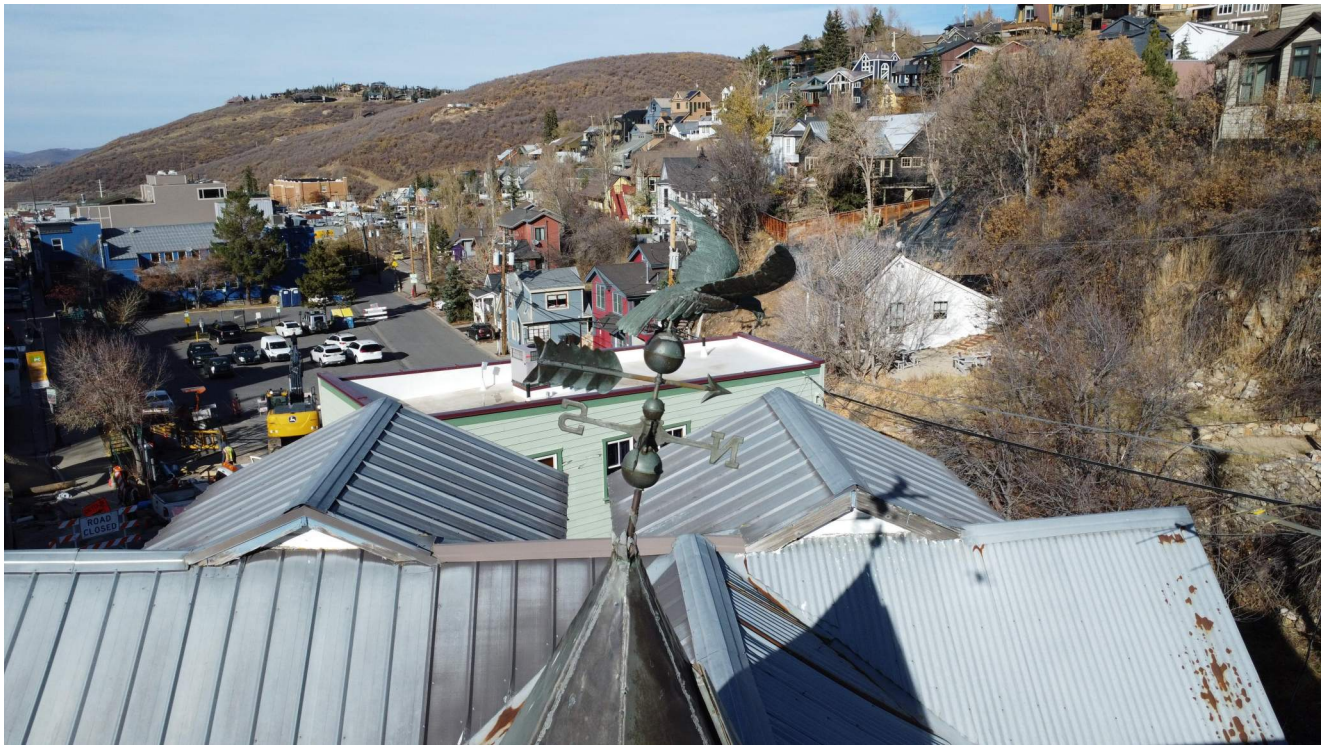
PHYSICAL CONDITIONS REPORT

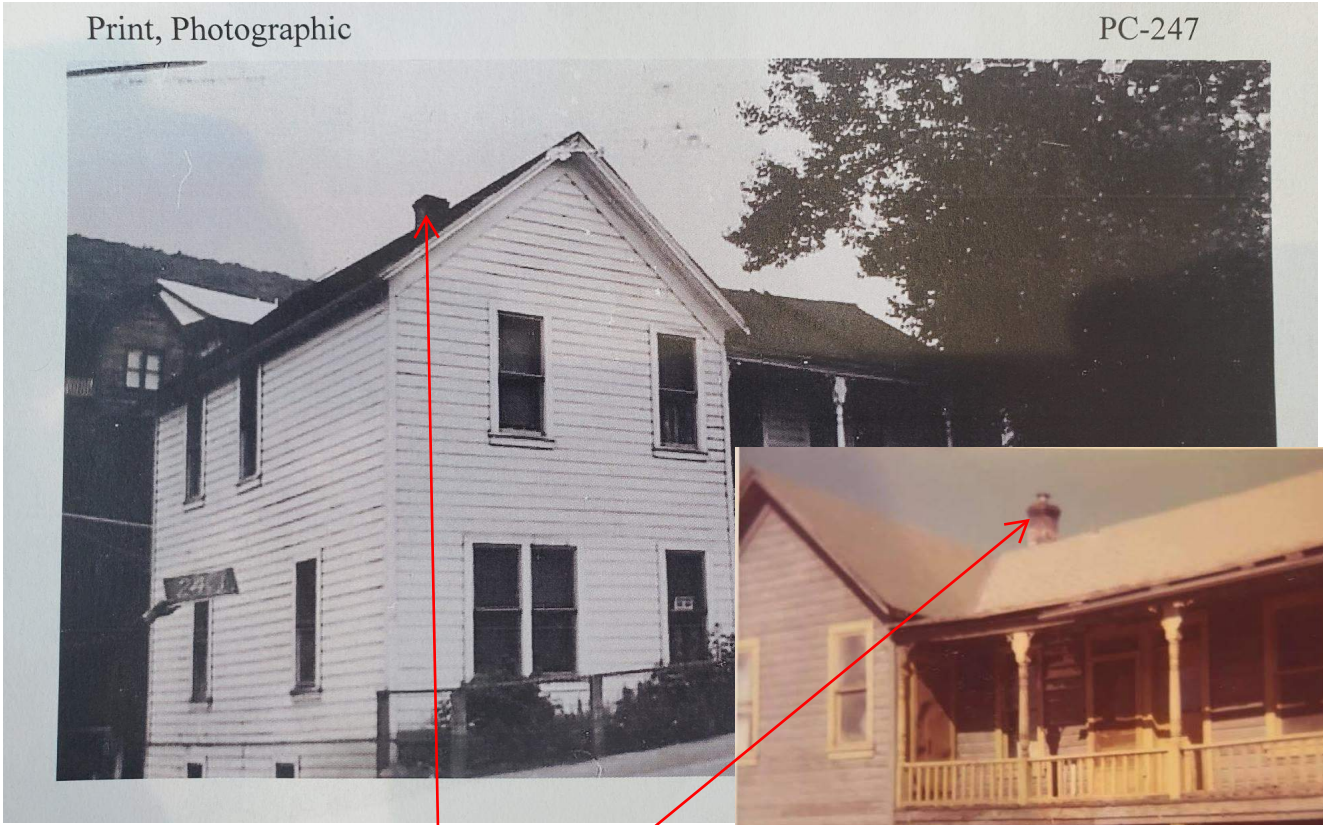
PHOTO #3,4 - CHIMNEY

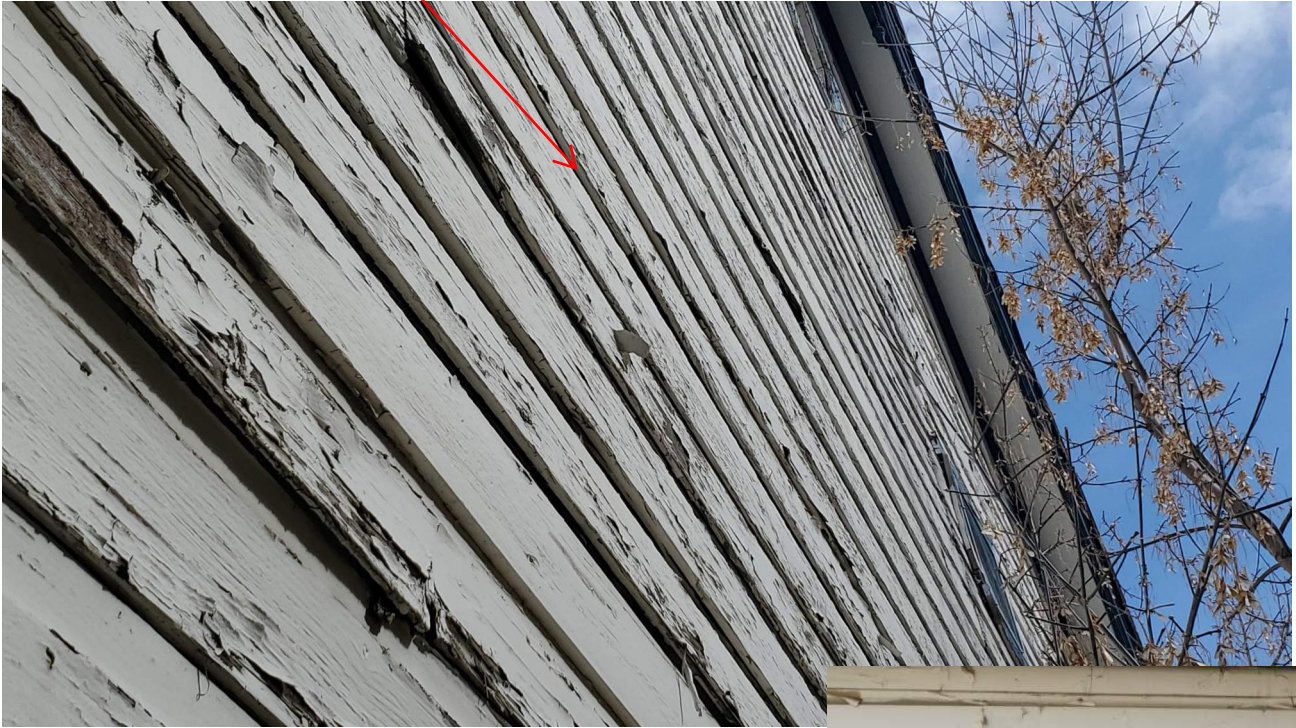
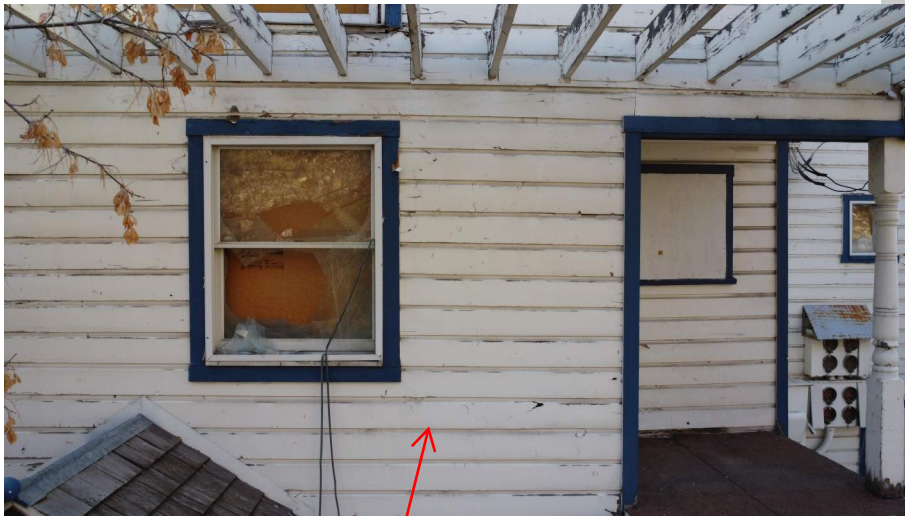
Newer Siding on more
recent addition to 1907
structure

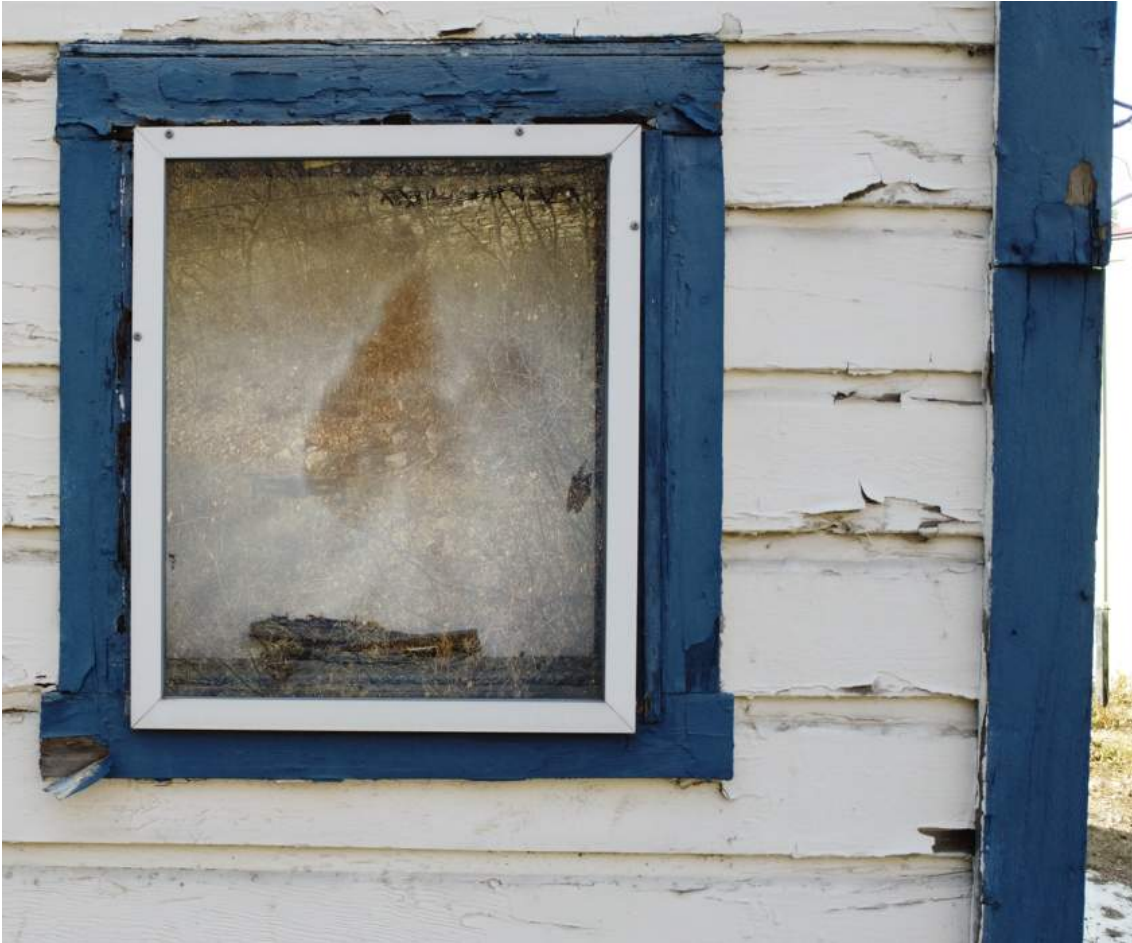
Element/Feature: Fascia Boards

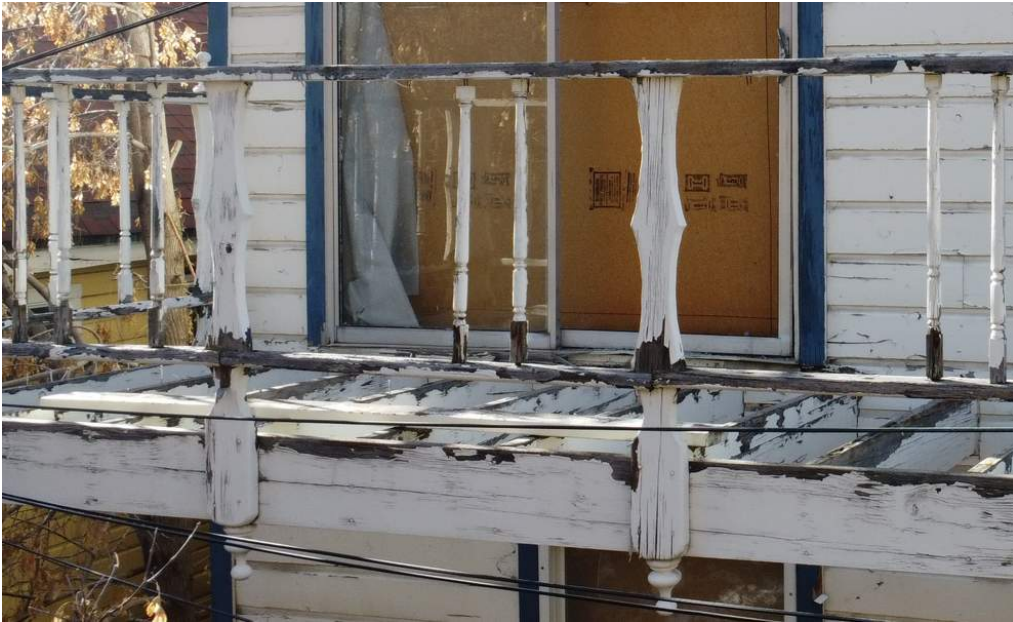
8. Mechanical System, Utility Systems, Service Equipment & Electrical

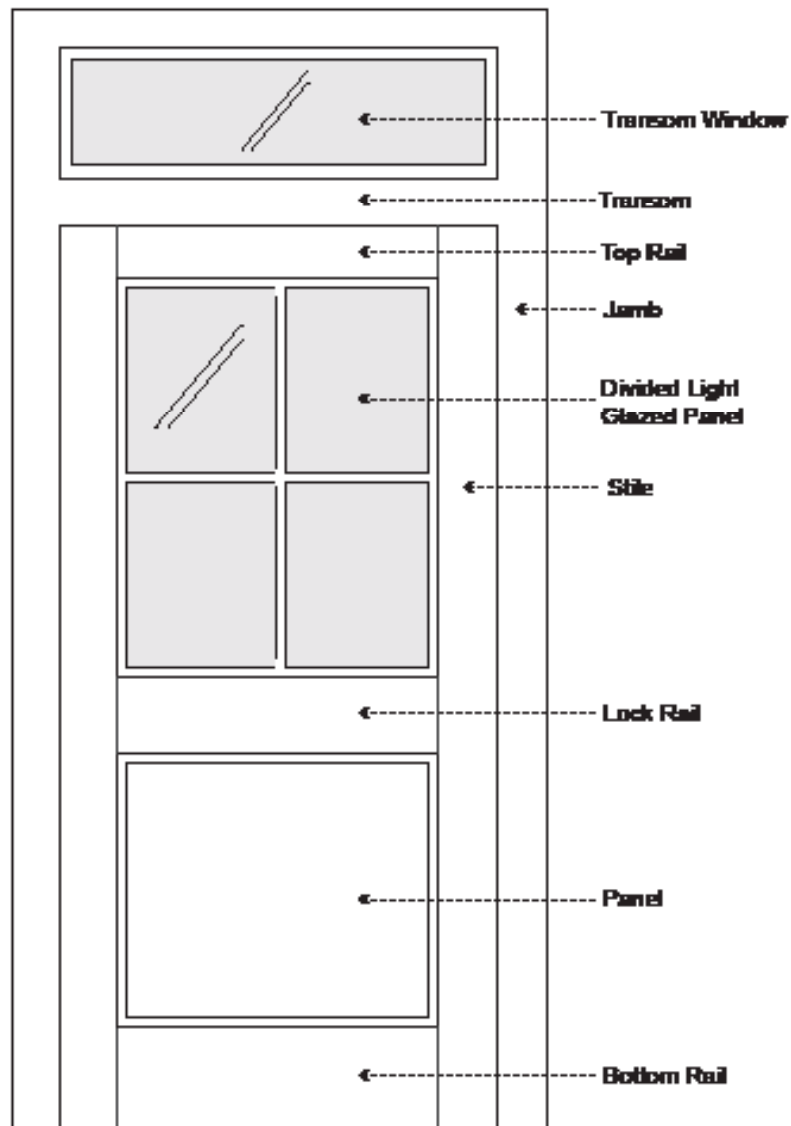
If you have questions regarding the requirements on this application or process please contact a member of the Park City Planning Staff at (435) 615-5060 or visit us online at www.parkcity.org. Updated 10/2014.

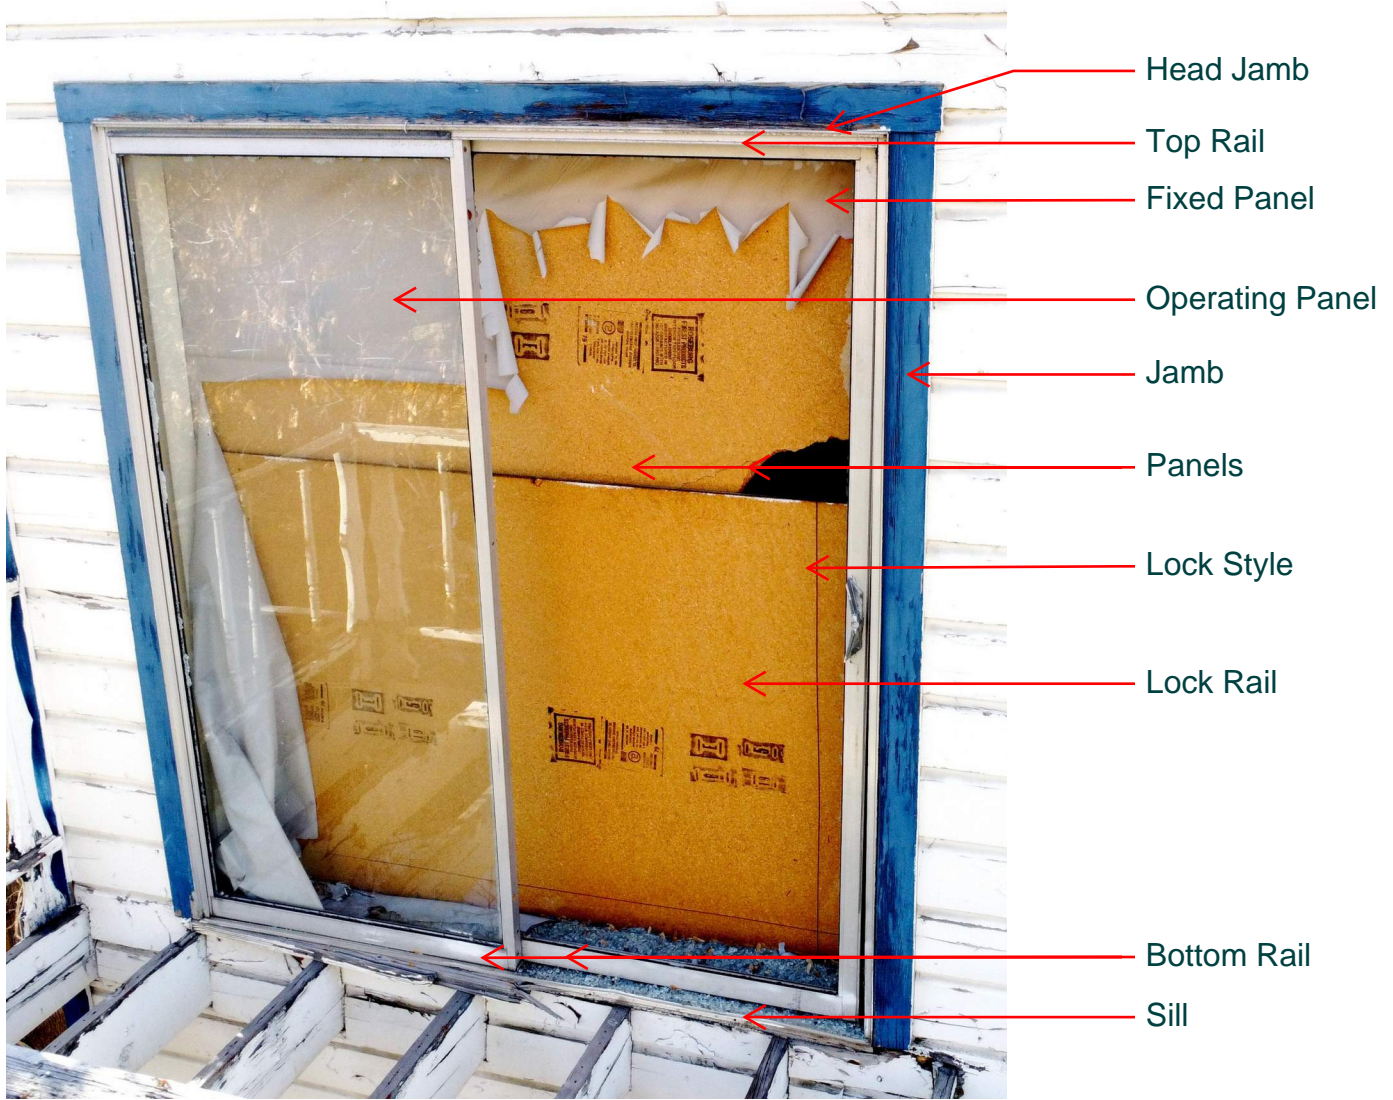
See Door Schedule
for More information

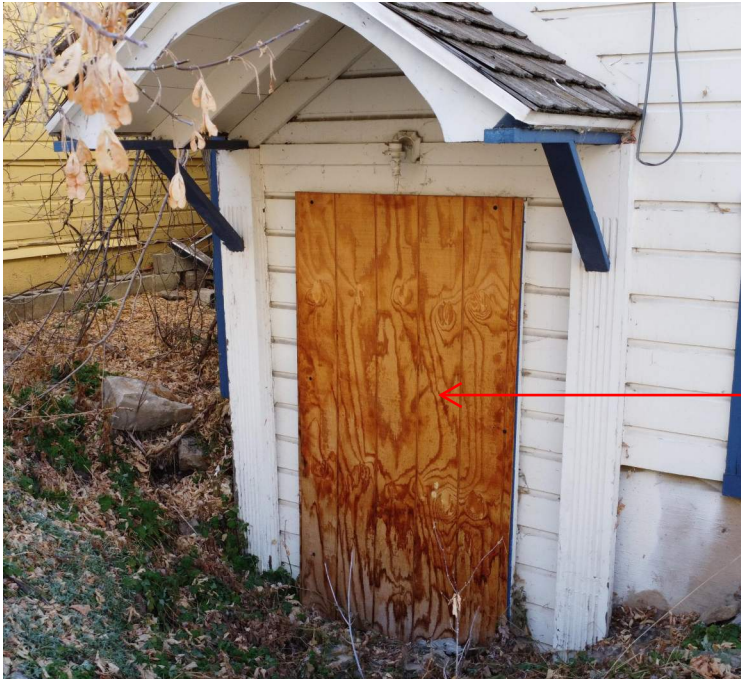
← Boarded up door - See door schedule

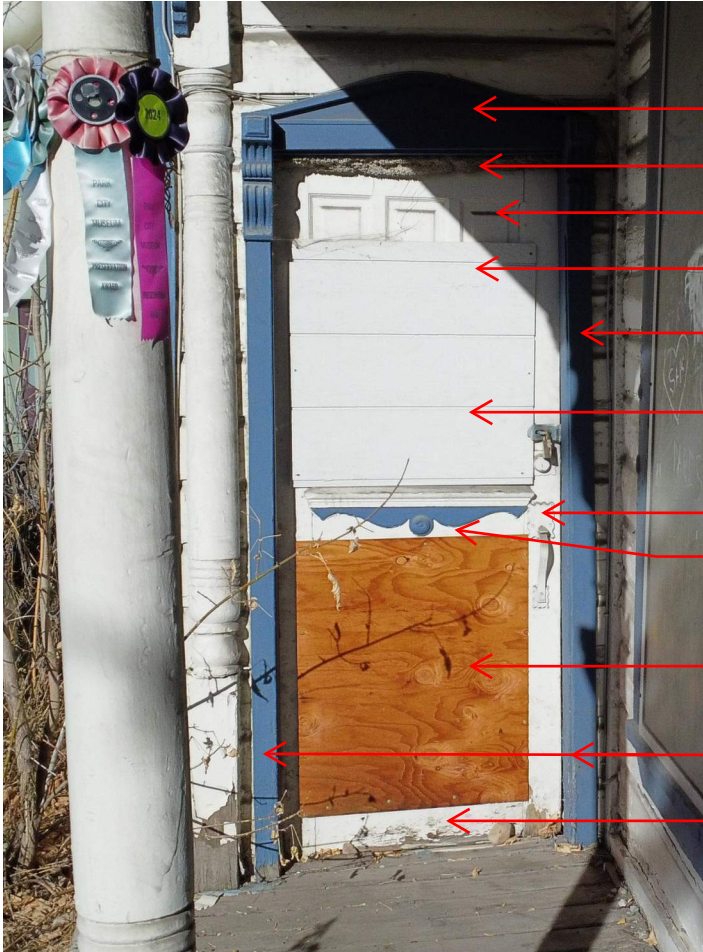
Decorative Peaked Cap Pediment

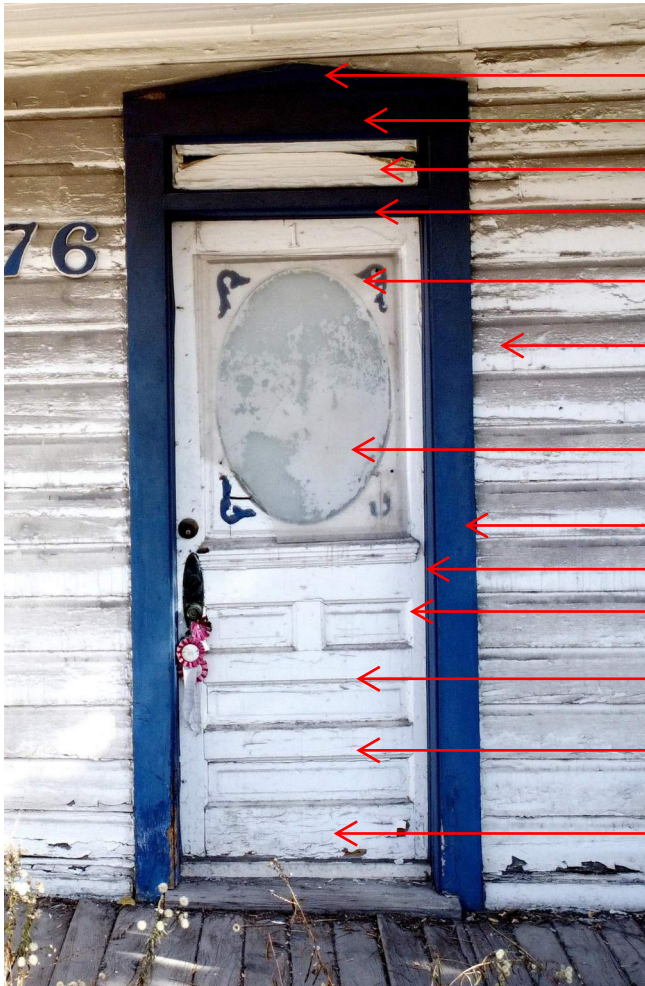
Decorative Peaked Cap Pediment
