**PARK CITY HISTORIC PRESERVATION BOARD MEETING
SUMMIT COUNTY, UTAH
May 7, 2025**

- 1. MEETING CALLED TO ORDER AT 5:00PM**
- 2. ROLL CALL**
- 3. SWEARING-IN CEREMONY**
 - 3.A. Swearing-In Ceremony for Dalton Gackle, Douglas Stephens, Katie Noble, and Randy Scott.

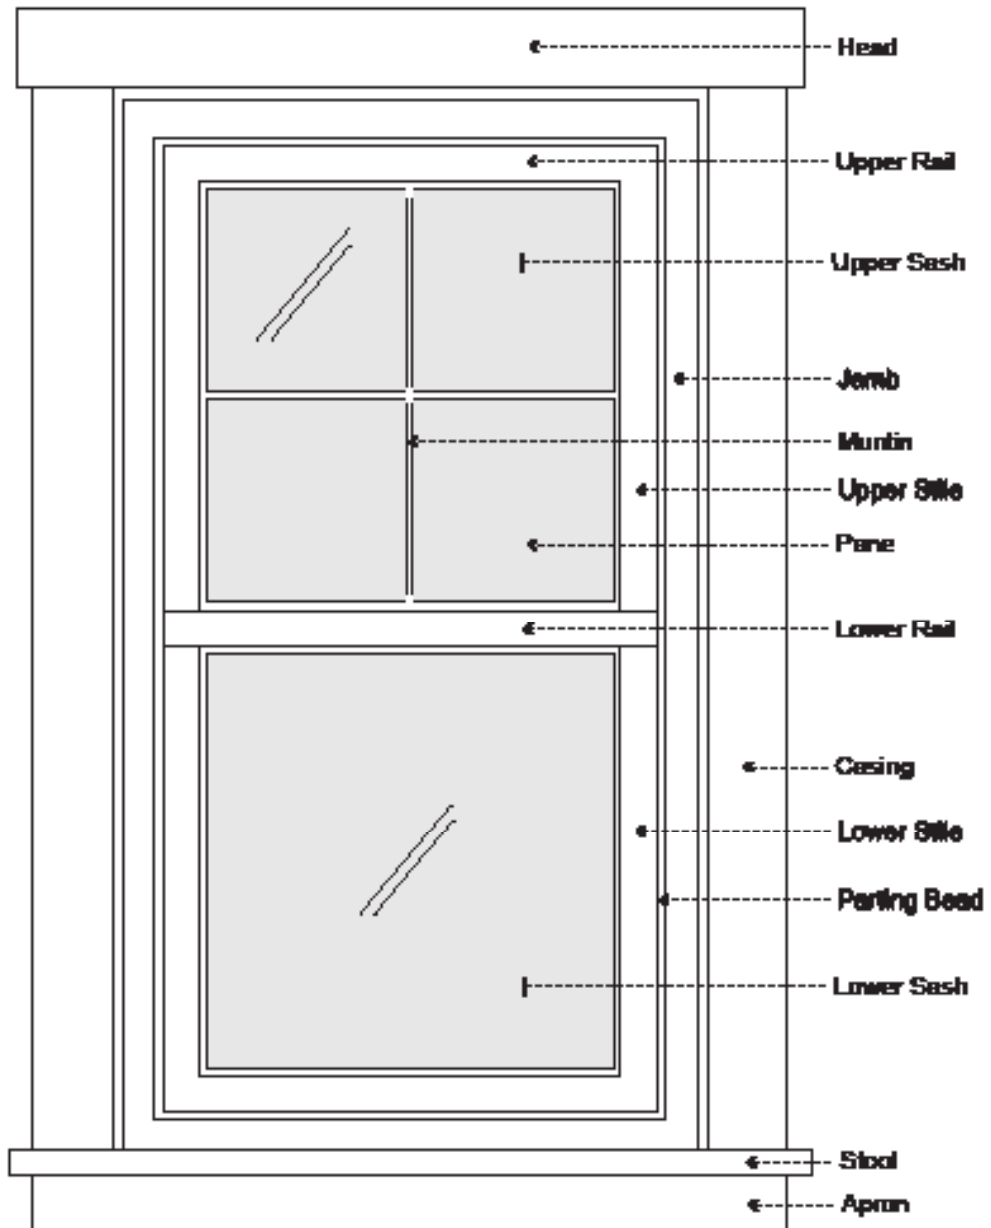
If you have questions regarding the requirements on this application or process please contact a member of the Park City Planning Staff at (435) 615-5060 or visit us online at www.parkcity.org. Updated 10/2014.

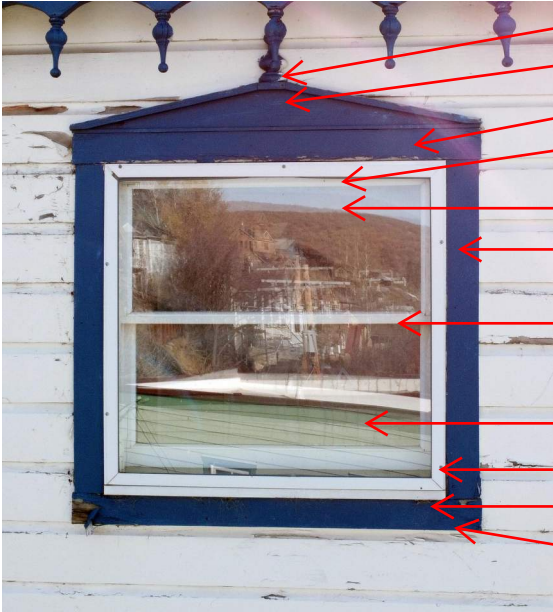
- Final
- Decorative Peaked Cap Pediment
- Head
- Upper Rail
- Upper Sash
- Jamb
- Lower Rail
- Lower Sash
- Storm Window Cover
- Stool
- Apron

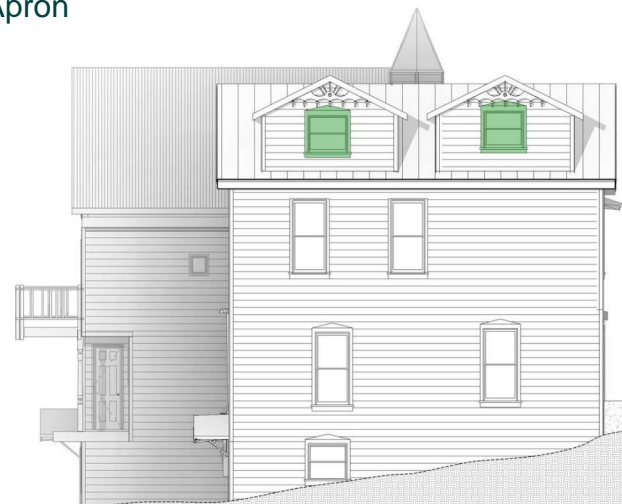
PHYSICAL CONDITIONS REPORT

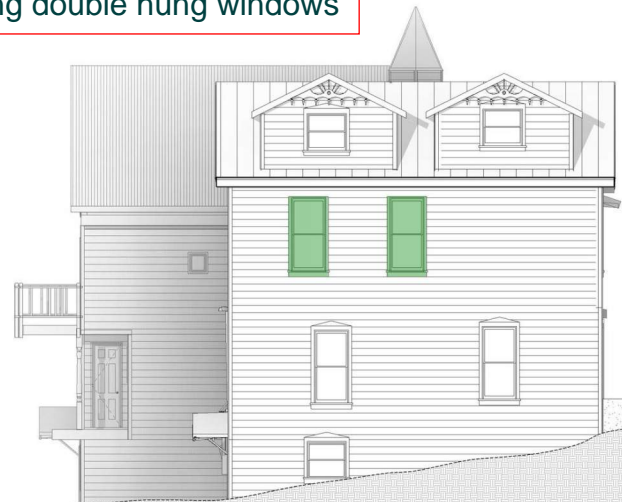
PHYSICAL CONDITIONS REPORT

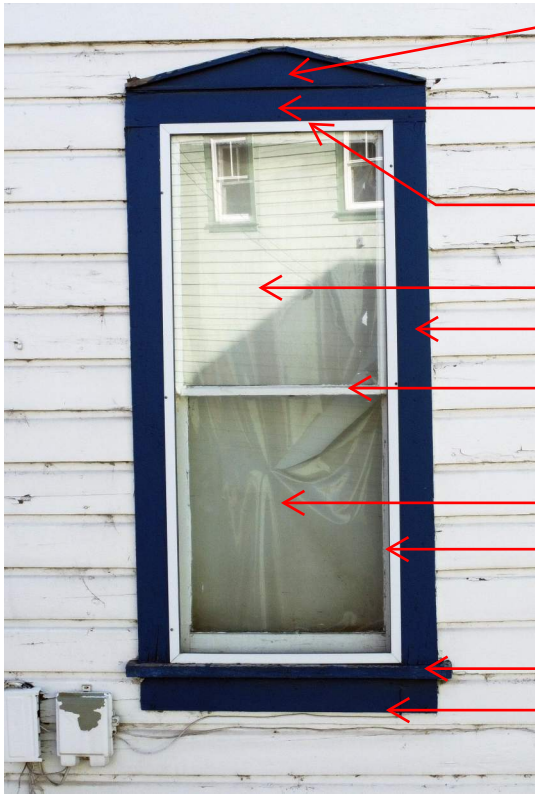
Decorative Peaked Cap Pediment

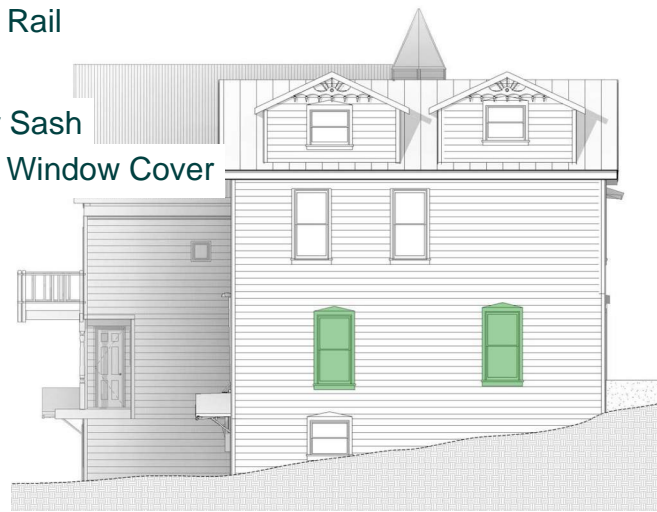
PHYSICAL CONDITIONS REPORT

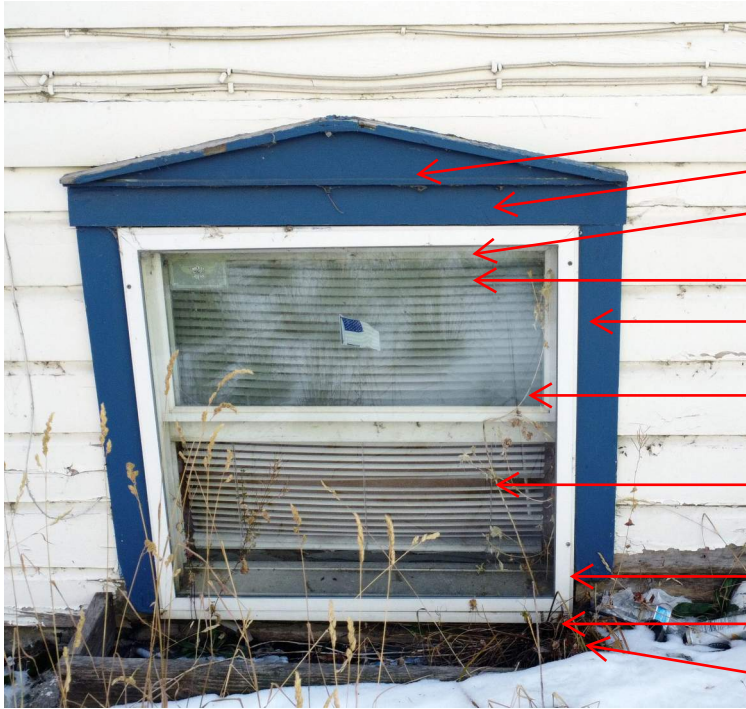
- Decorative Peaked Cap Pediment
- Head
- Upper Rail
- Upper Sash Jamb
- Lower Rail
- Lower Sash
- Storm Window Cover
- Stool
- Apron

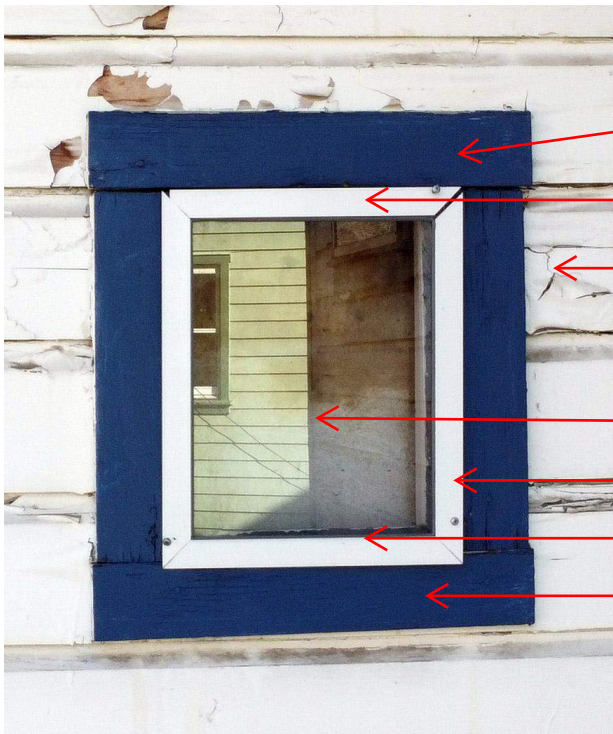
- Head
- Upper Rail
- Jamb
- Single Pane Glazing Missing
- Storm Window Cover
- Lower Rail
- Apron

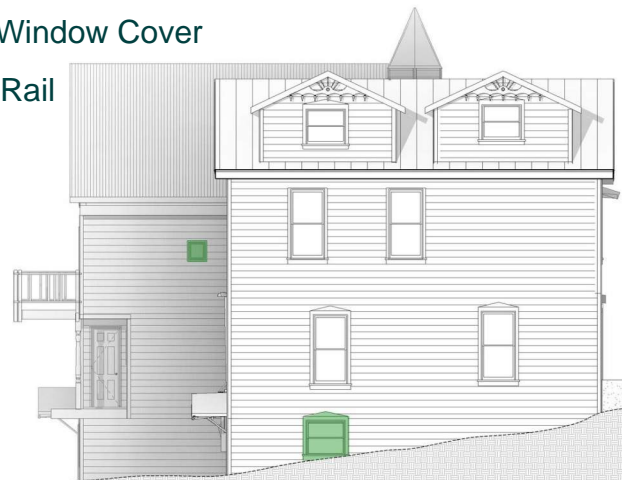
PHYSICAL CONDITIONS REPORT

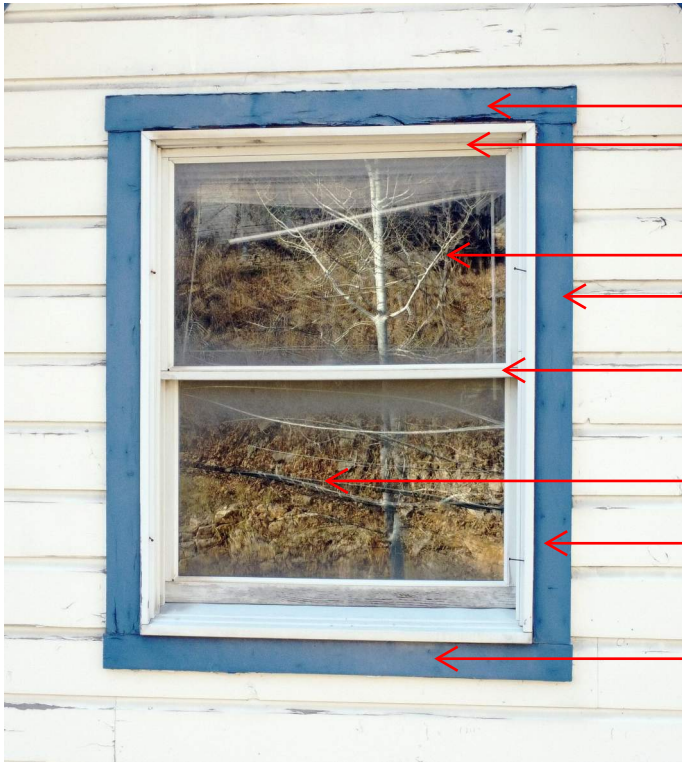
- Head
- Upper Rail
- Upper Sash Jamb
- Lower Rail
- Lower Sash
- Storm Window Cover
- Apron

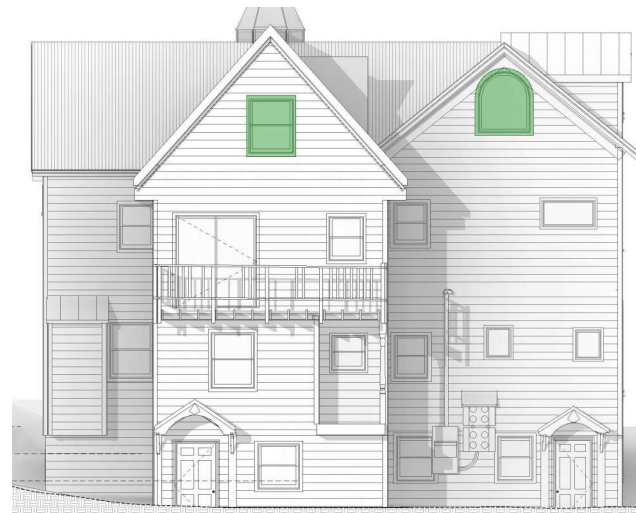
PHYSICAL CONDITIONS REPORT

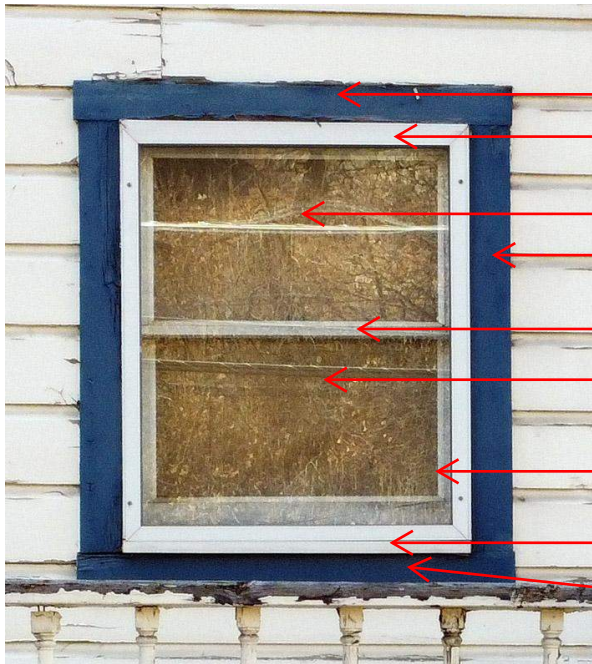
- Head
- Upper Rail
- Upper Sash
- Jamb
- Lower Rail
- Lower Sash
- Storm Window Cover
- Sill
- Apron

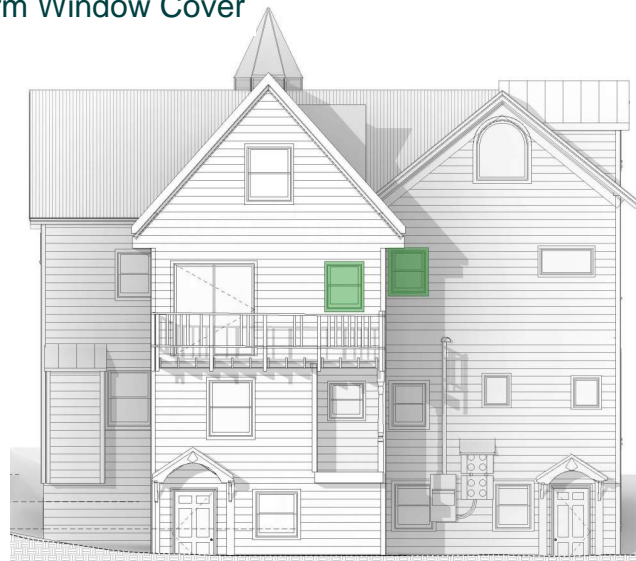
PHYSICAL CONDITIONS REPORT

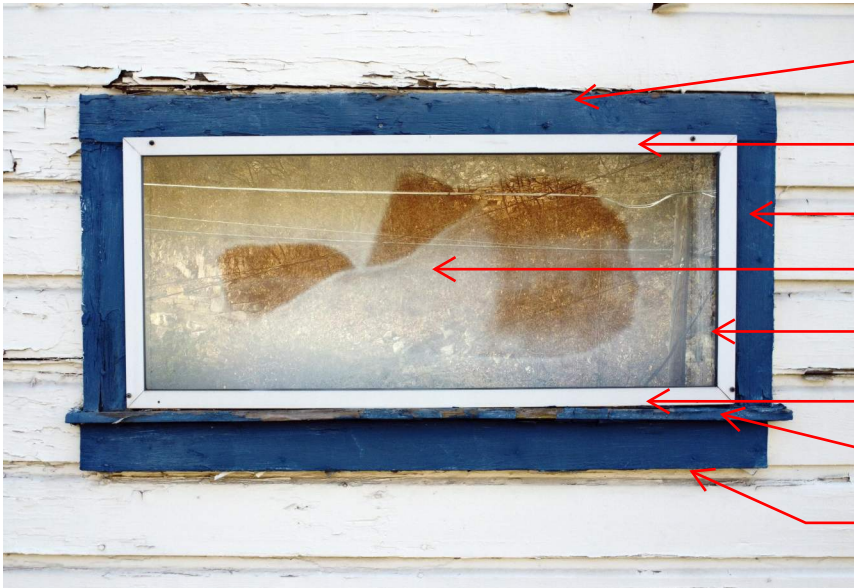
- Head
- Upper Rail
- Jamb
- Single Pane
- Storm Window Cover
- Lower Rail
- Stool
- Apron

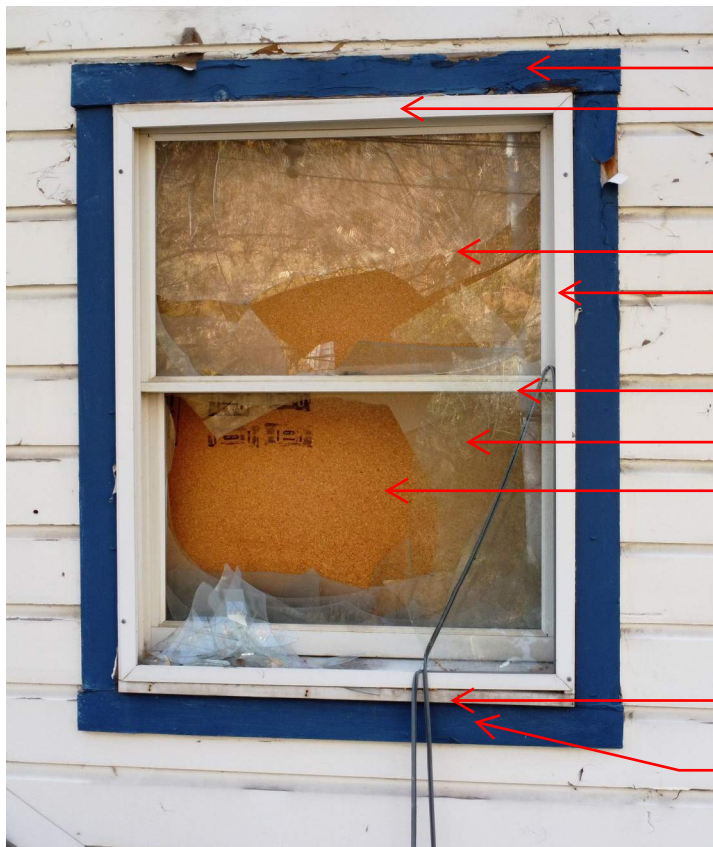
- Head
- Upper Rail
- Upper Sash
- Jamb
- Lower Rail
- Storm Window Cover (Broken)
- Lower Sash

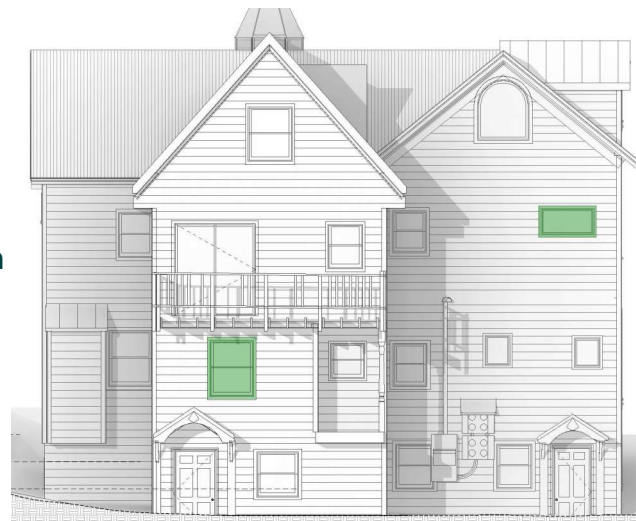
PHYSICAL CONDITIONS REPORT

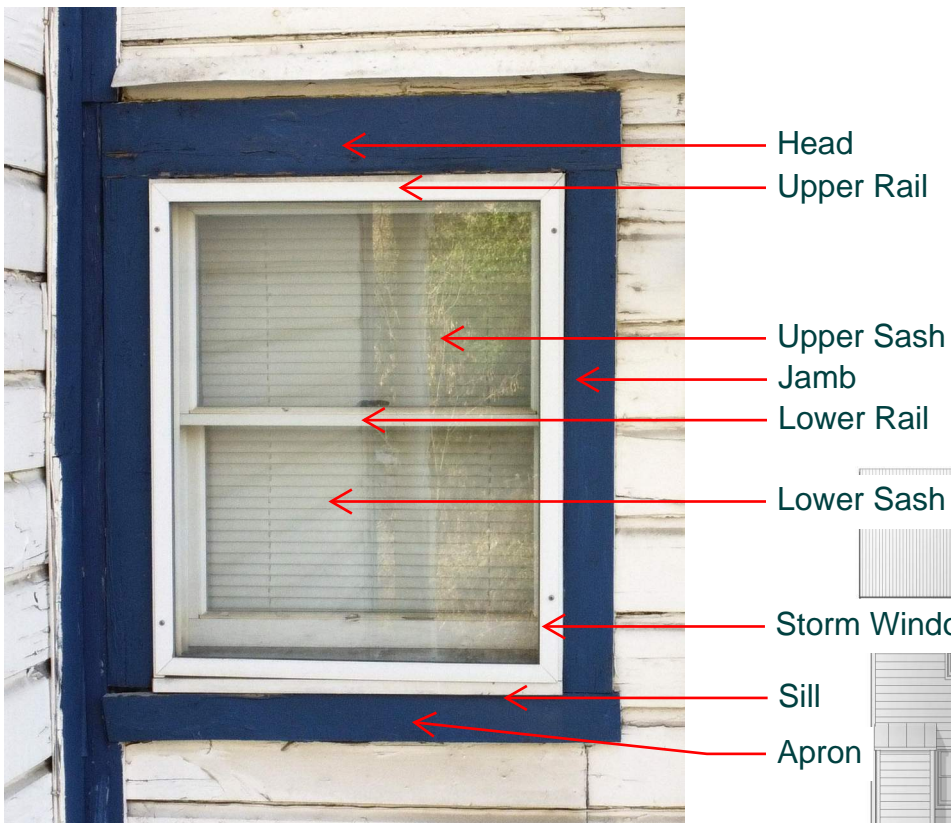
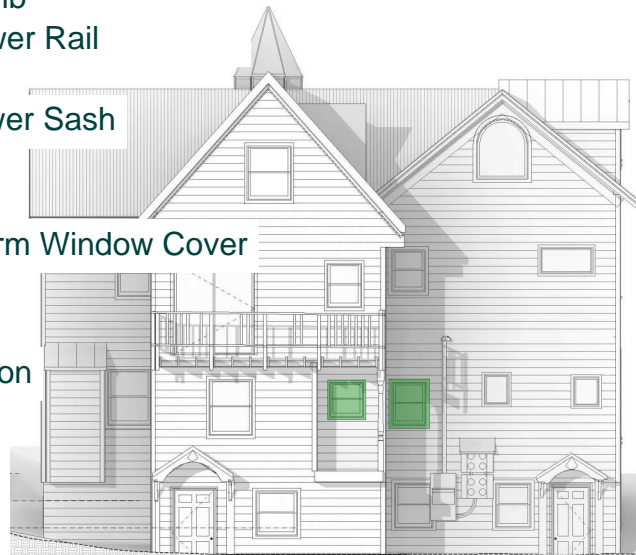
PHYSICAL CONDITIONS REPORT

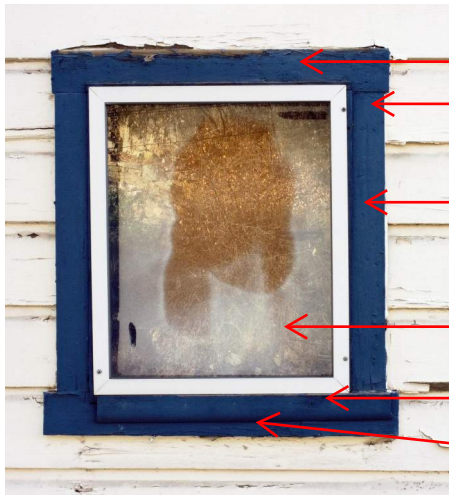
- Head
- Upper Rail
- Jamb
- Storm Window Cover
- Sill
- Apron

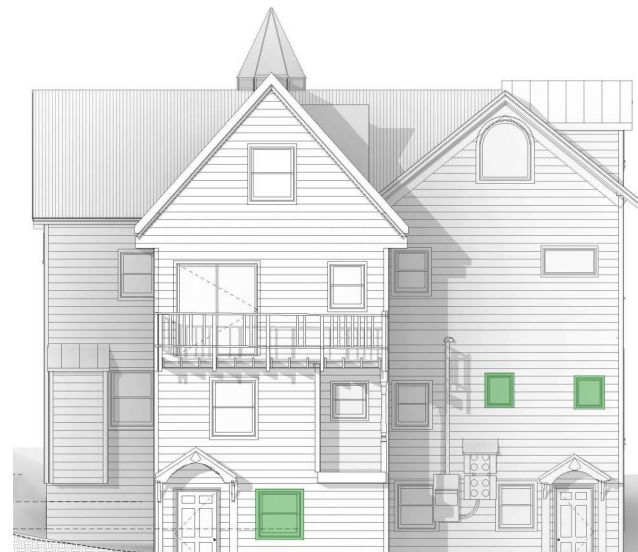
PHYSICAL CONDITIONS REPORT

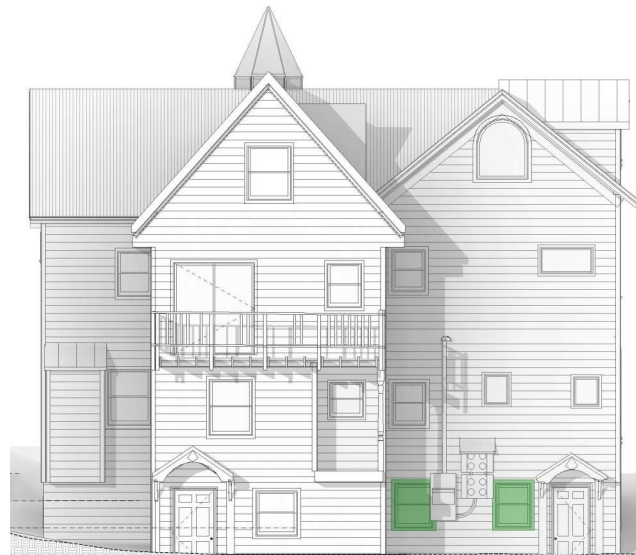
PHYSICAL CONDITIONS REPORT

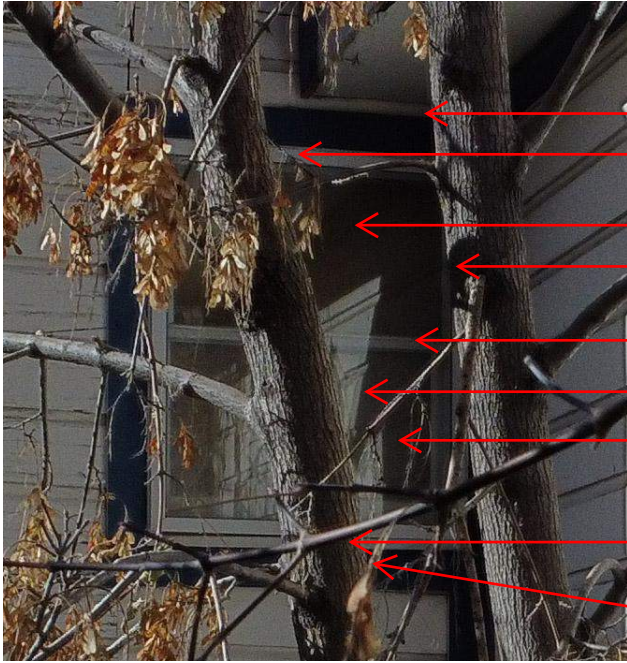
- Head
- Upper Rail
- Upper Sash
- Jamb
- Lower Rail
- Storm Window Cover (Broken)
- Lower Sash
- Sill
- Apron

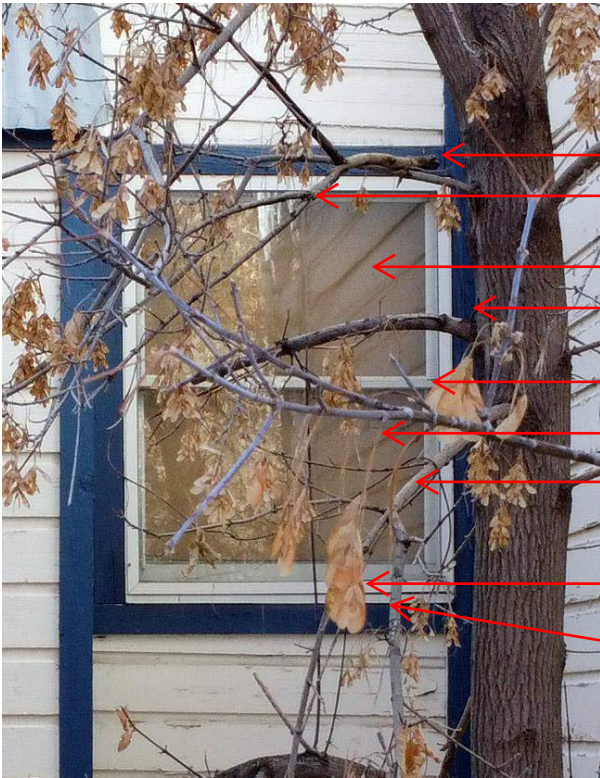
- Head
- Upper Rail
- Upper Sash
- Jamb
- Lower Rail
- Storm Window Cover (Broken)
- Lower Sash
- Sill
- Apron

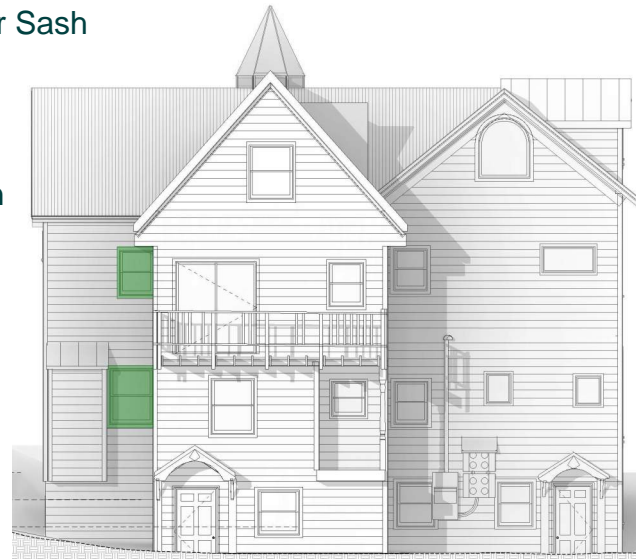
PHYSICAL CONDITIONS REPORT

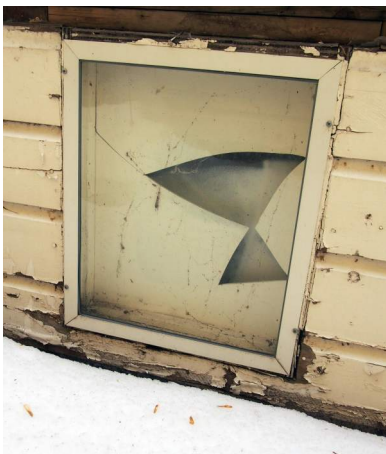
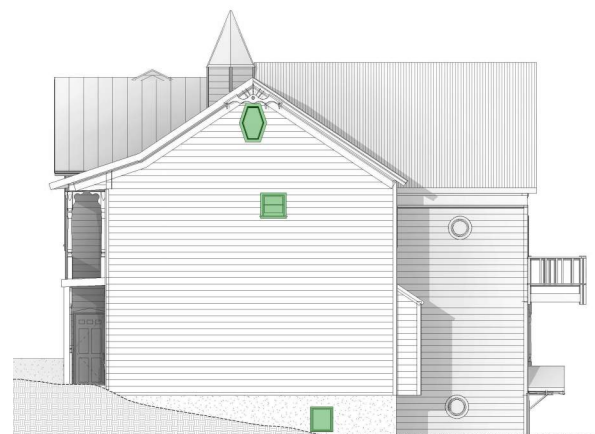
PHYSICAL CONDITIONS REPORT

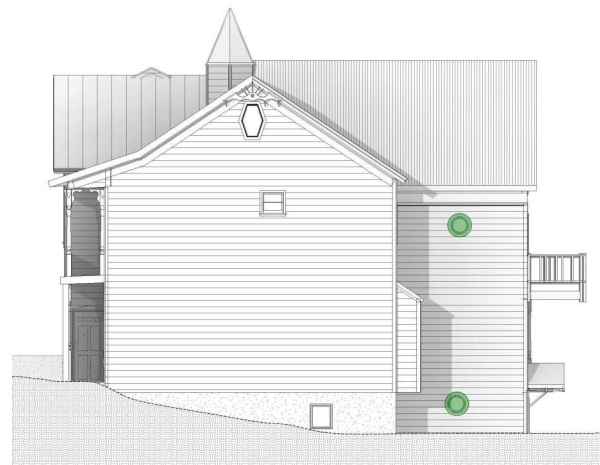
PHYSICAL CONDITIONS REPORT

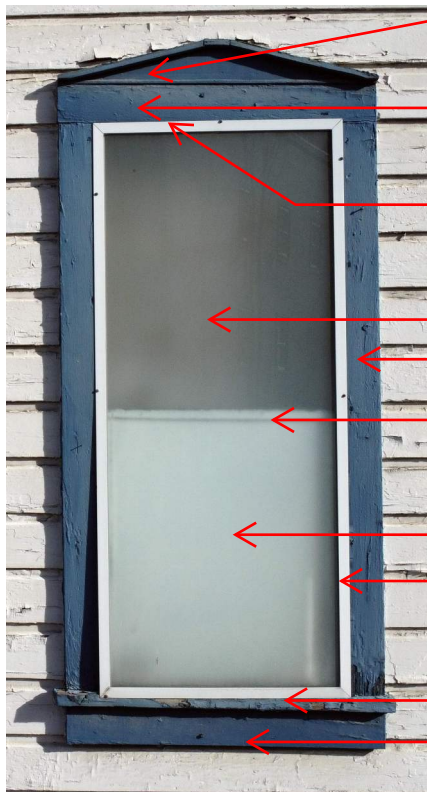
Decorative Peaked Cap Pediment

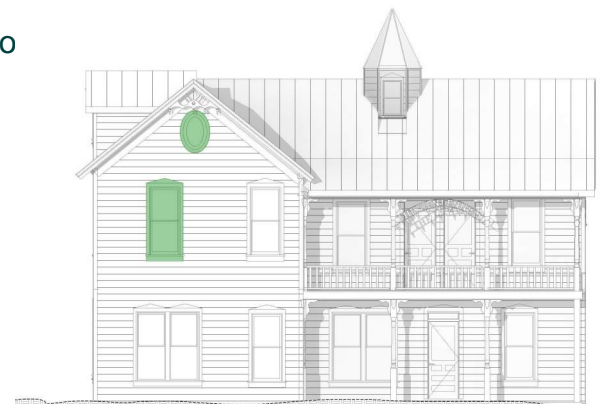
PHYSICAL CONDITIONS REPORT

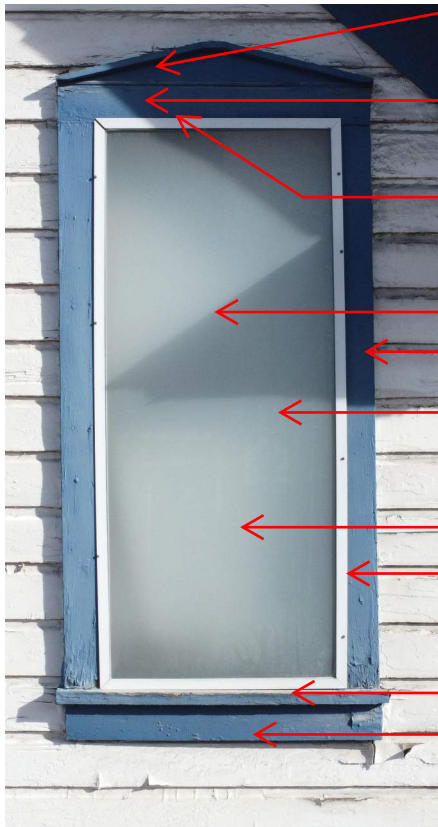
Decorative Peaked Cap Pediment

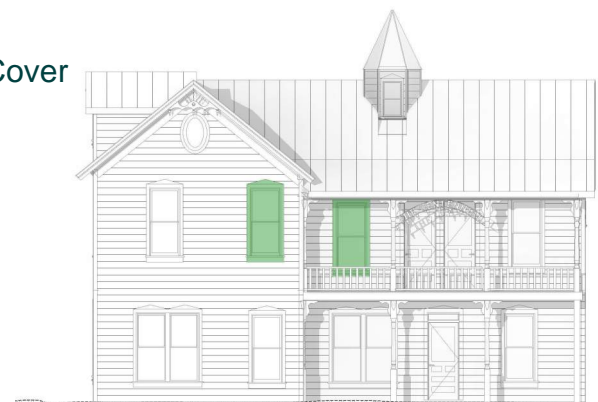
PHYSICAL CONDITIONS REPORT

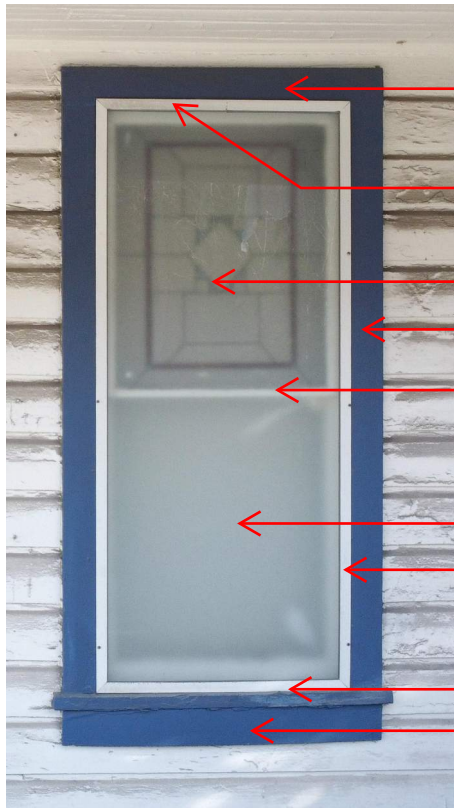
- Head
- Upper Rail
- Upper Sash
- Jamb
- Lower Rail
- Lower Sash
- Storm Window Cover
- Stool
- Apron

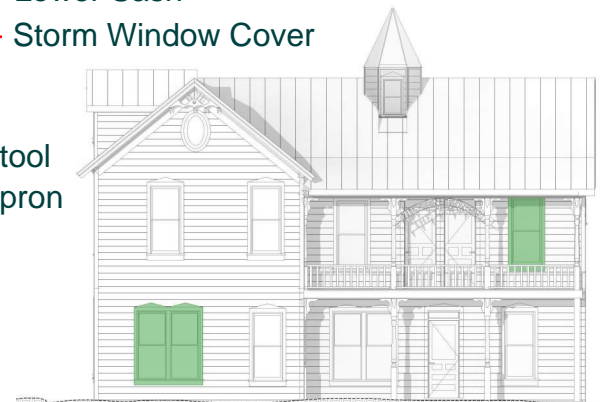
PHYSICAL CONDITIONS REPORT

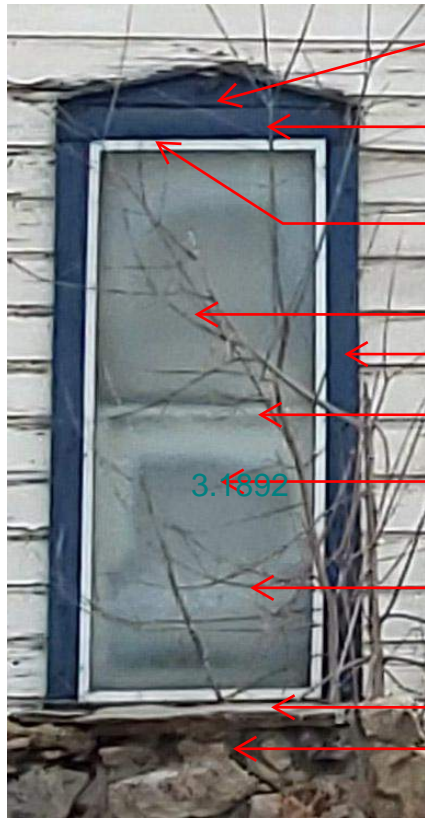
Decorative Peaked Cap Pediment

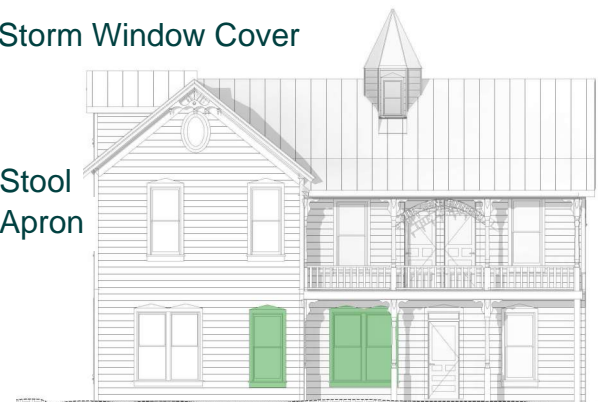
PHYSICAL CONDITIONS REPORT

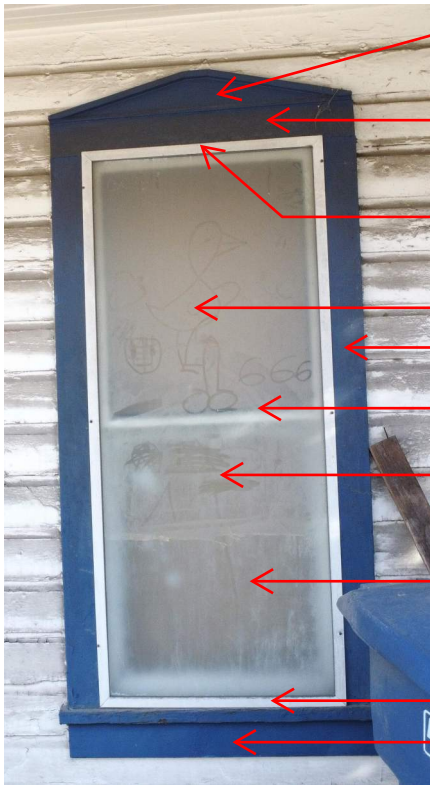
Decorative Peaked Cap Pediment

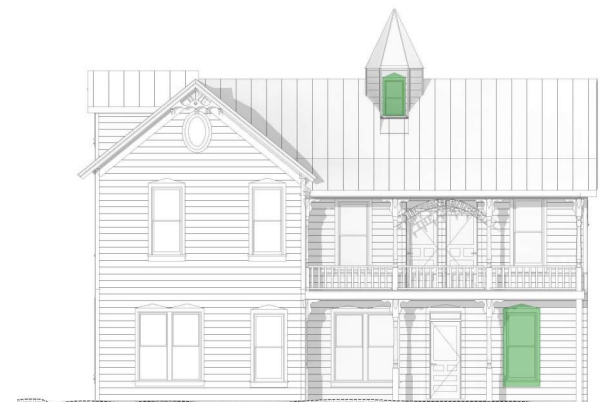
11. Interior Photographs

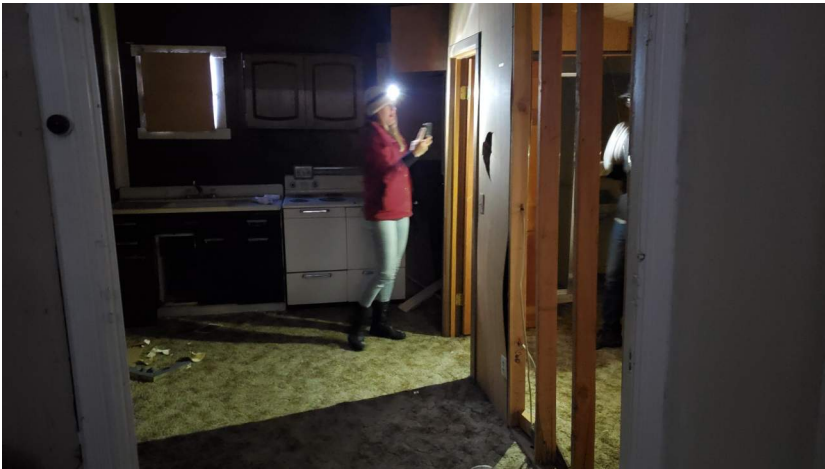
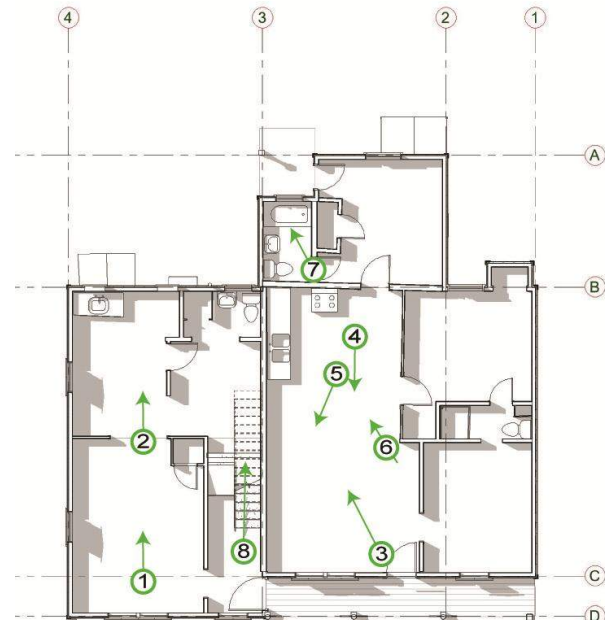
PHYSICAL CONDITIONS REPORT

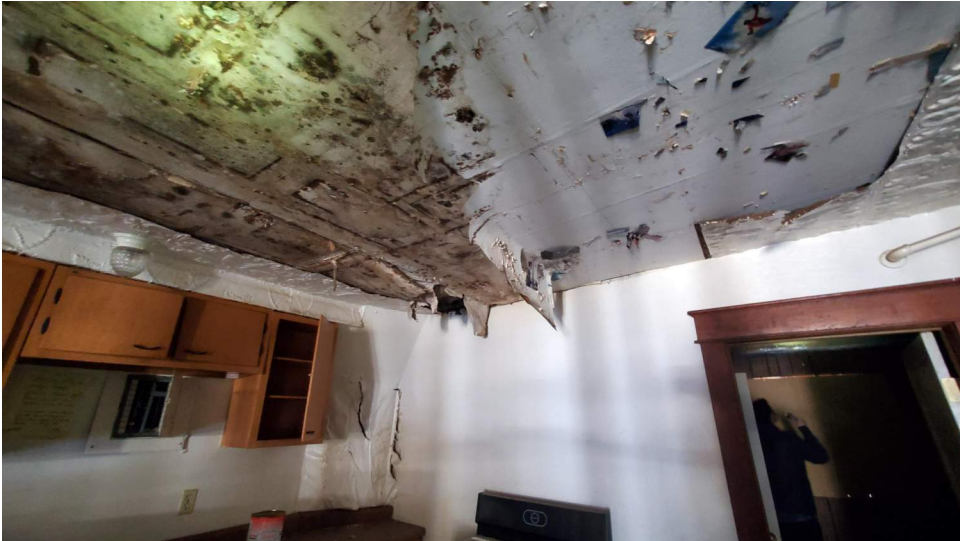
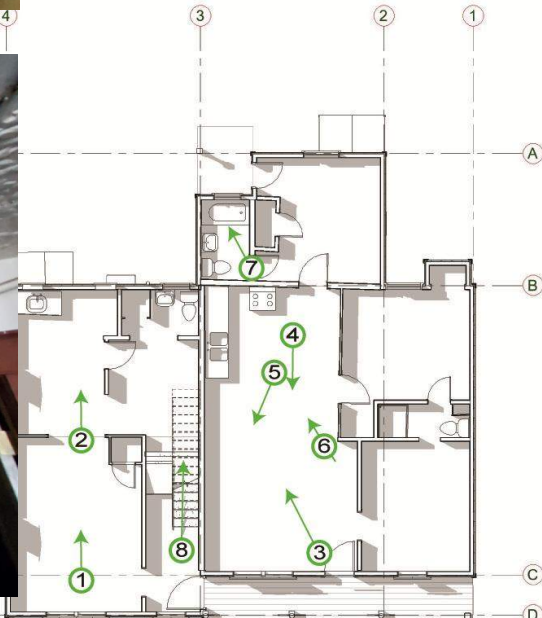
PHYSICAL CONDITIONS REPORT

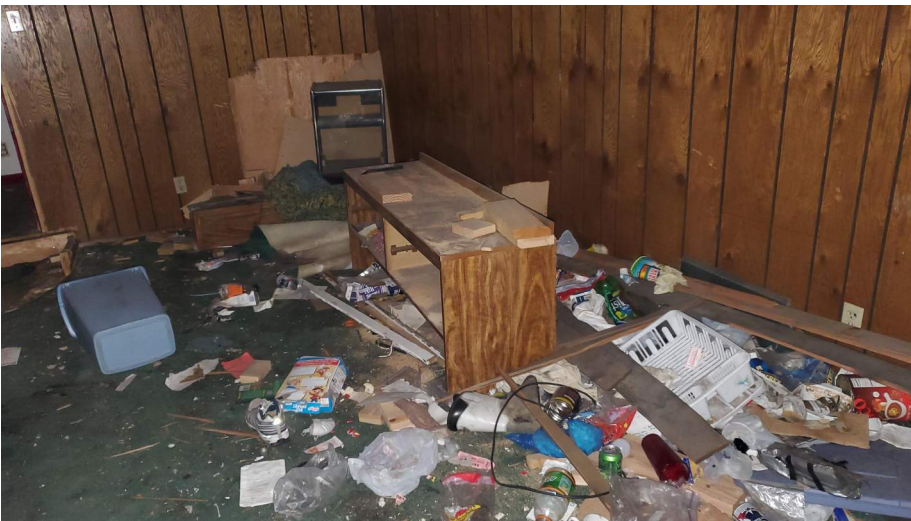
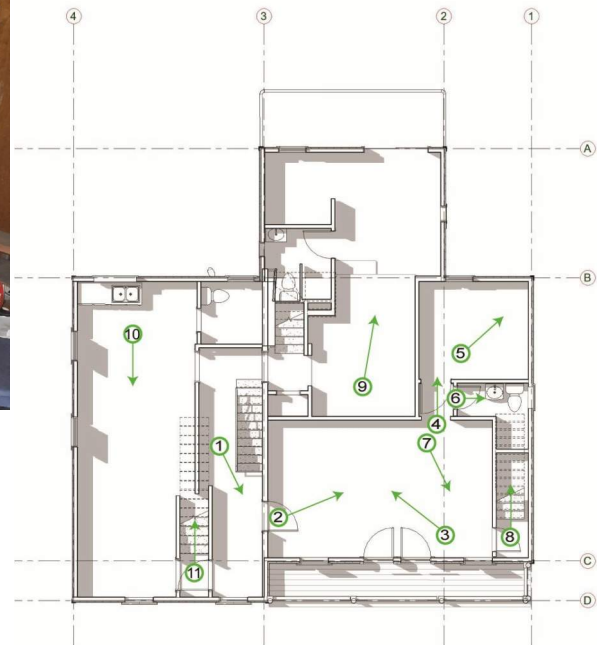
PHYSICAL CONDITIONS REPORT

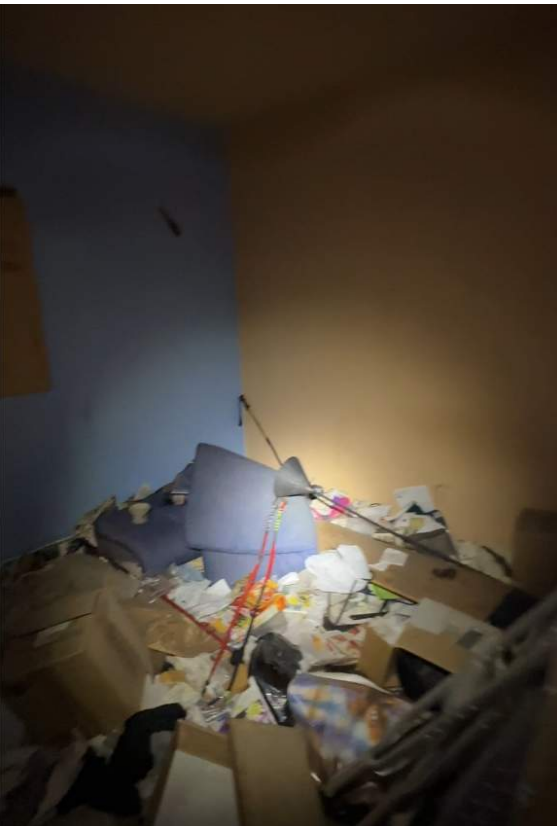
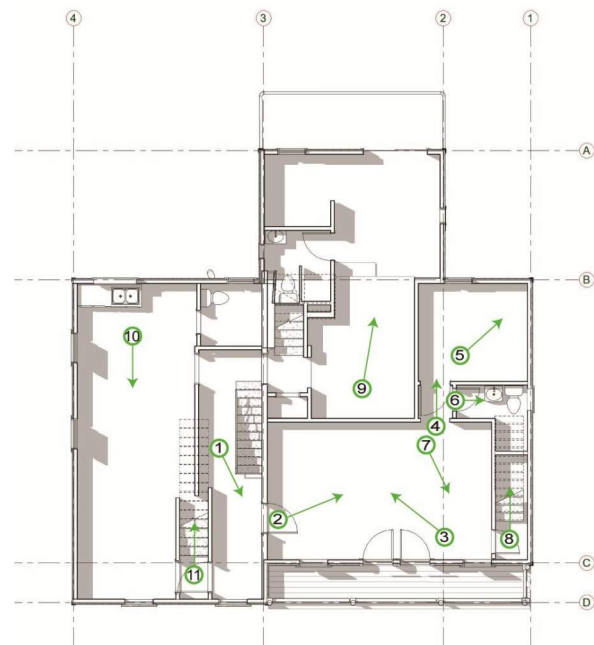
PHYSICAL CONDITIONS REPORT

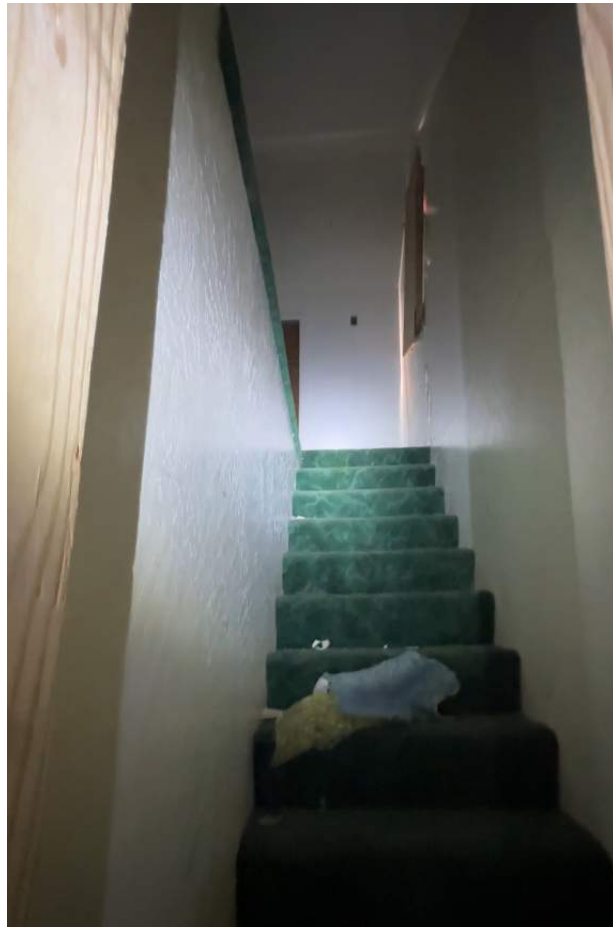
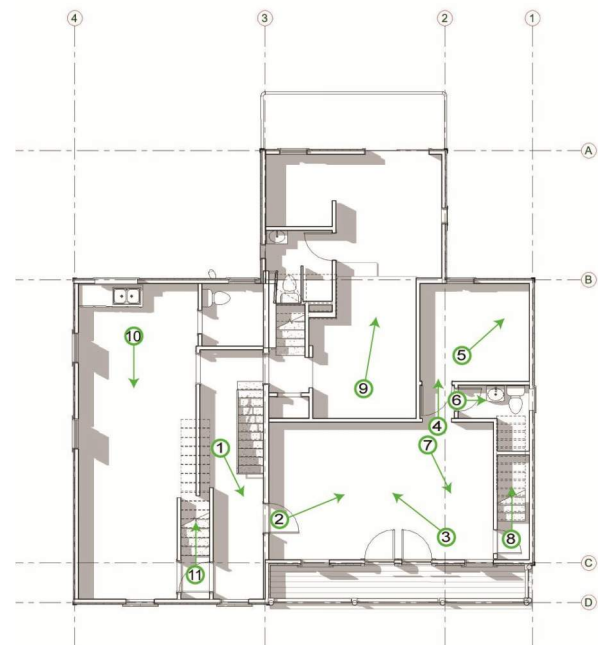
PHYSICAL CONDITIONS REPORT

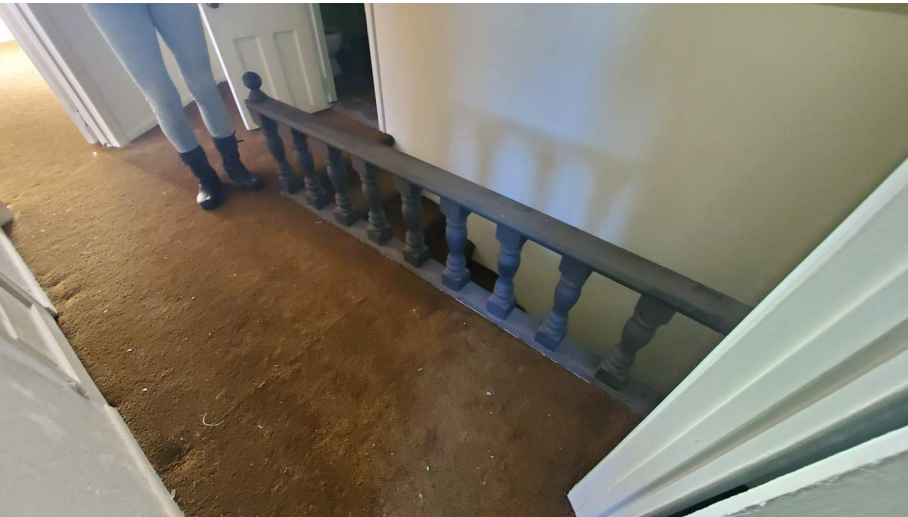
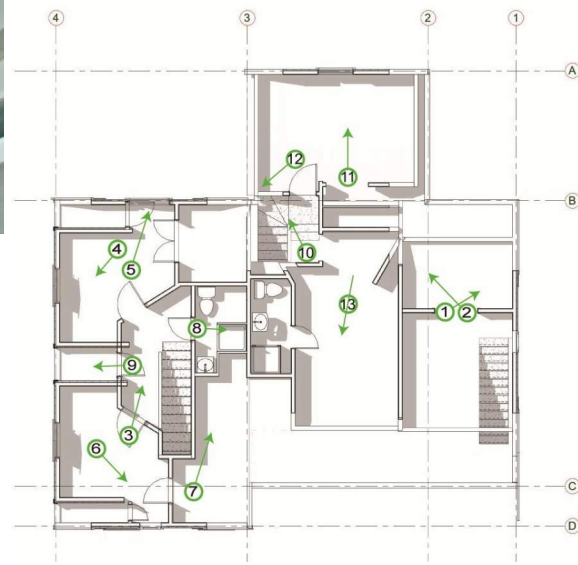
PHYSICAL CONDITIONS REPORT

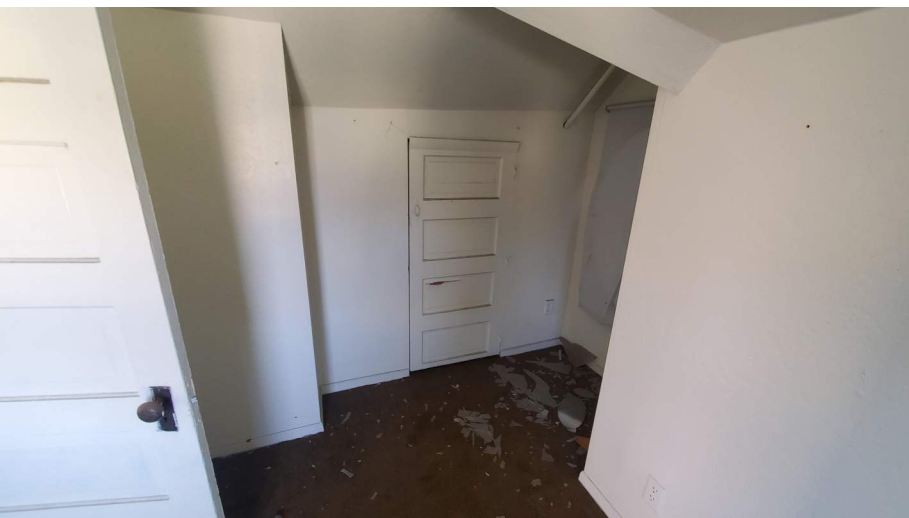
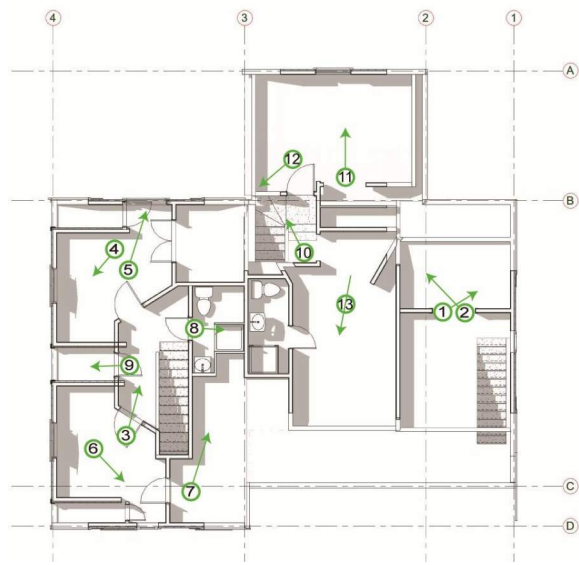
PHYSICAL CONDITIONS REPORT

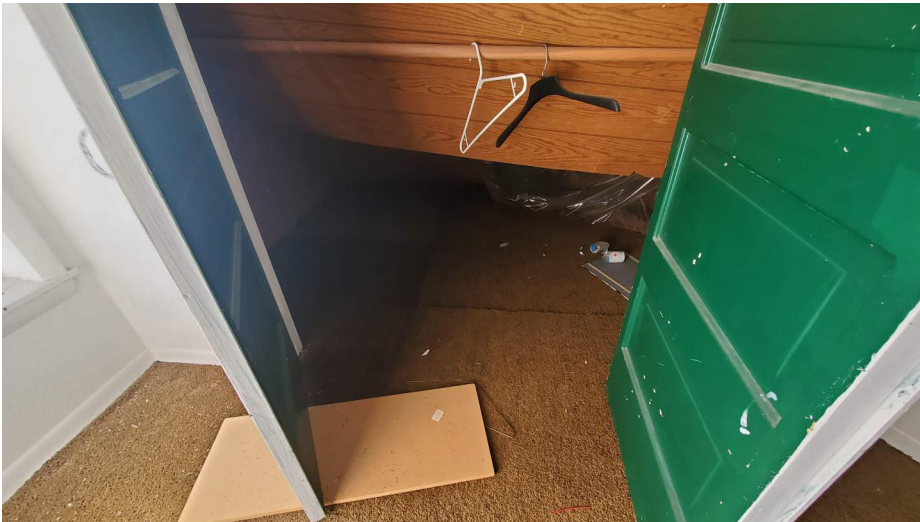
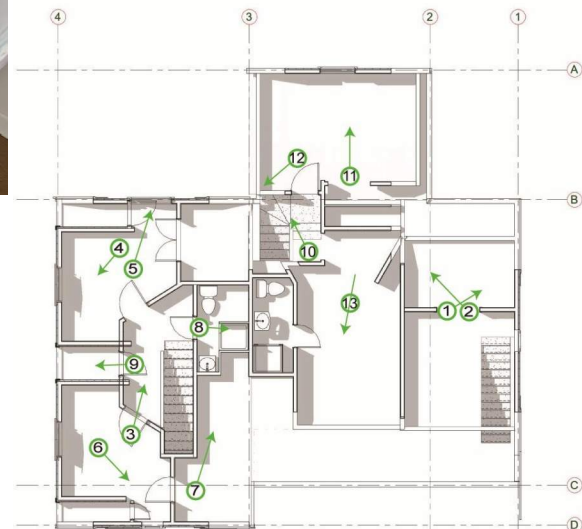
PHYSICAL CONDITIONS REPORT

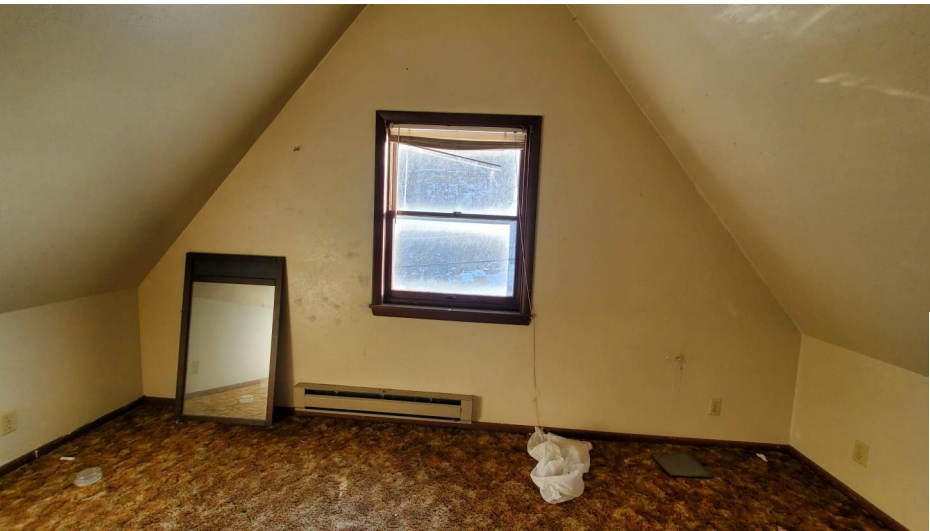
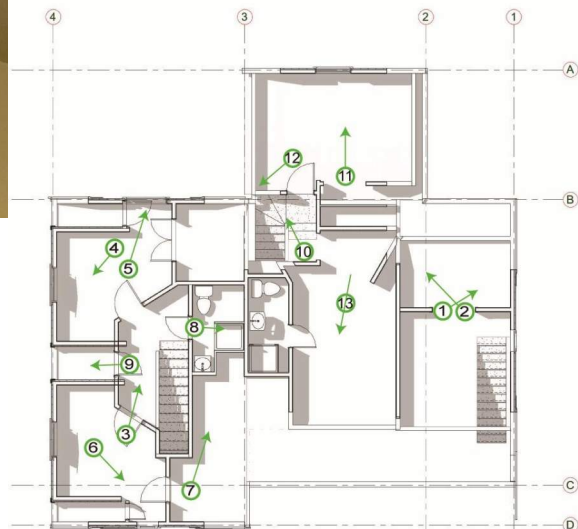
PHYSICAL CONDITIONS REPORT

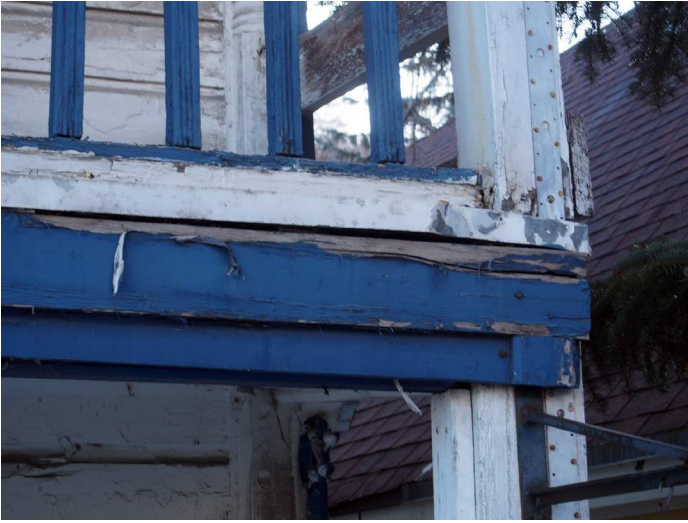
Trim at Front Porch SW corner

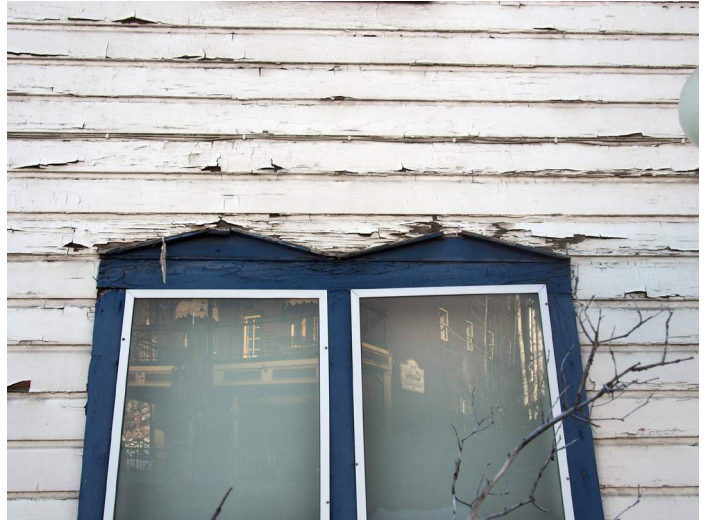
Missing finials on window trim and peeling paint
