**PARK CITY HISTORIC PRESERVATION BOARD MEETING
SUMMIT COUNTY, UTAH
May 7, 2025**

- 1. MEETING CALLED TO ORDER AT 5:00PM**
- 2. ROLL CALL**
- 3. SWEARING-IN CEREMONY**
 - 3.A. Swearing-In Ceremony for Dalton Gackle, Douglas Stephens, Katie Noble, and Randy Scott.

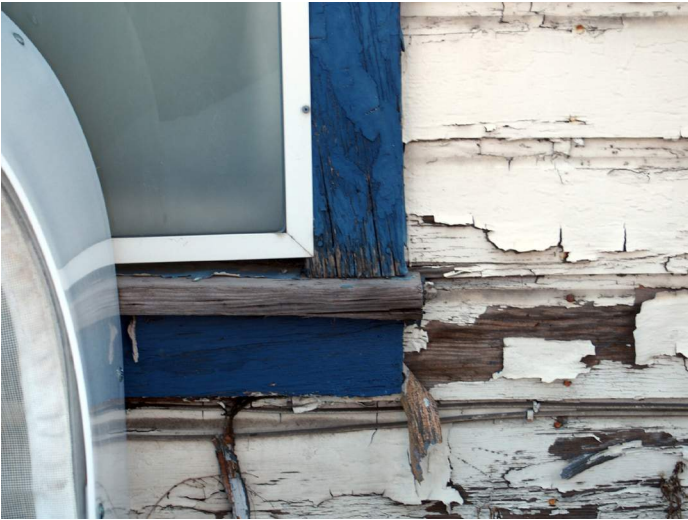
Window Trim at West Elevation

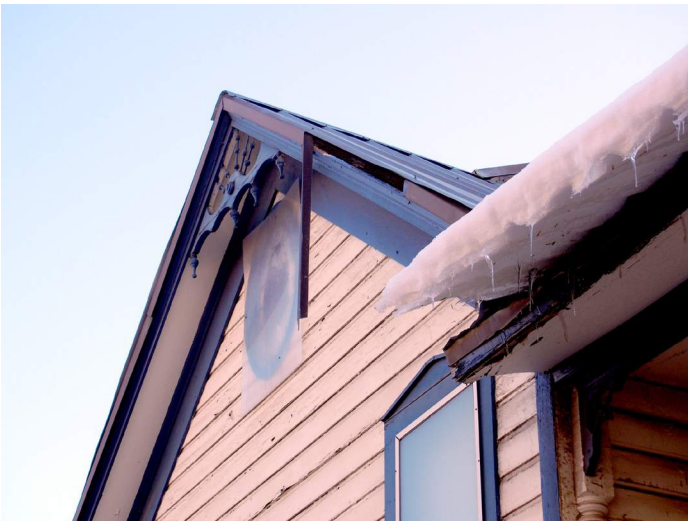
Drip edge failing and saturated soffit

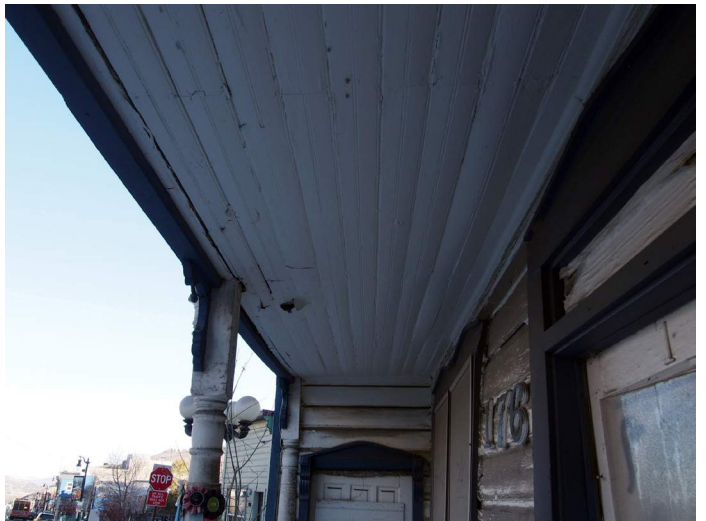
Front Deck soffit bowing

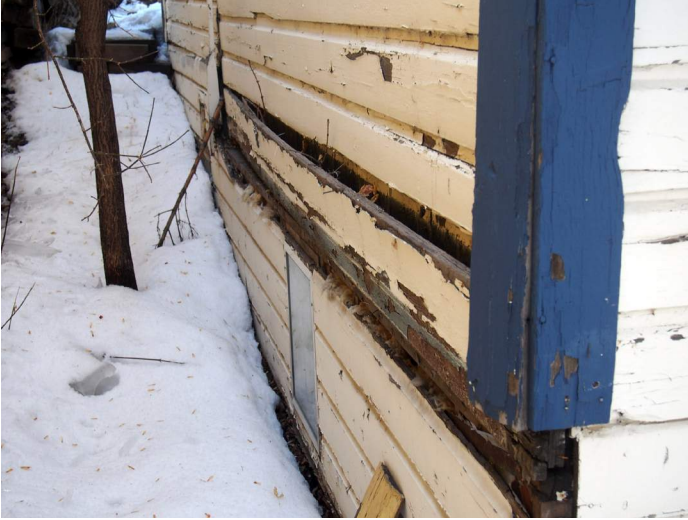
South facade siding and trim failing

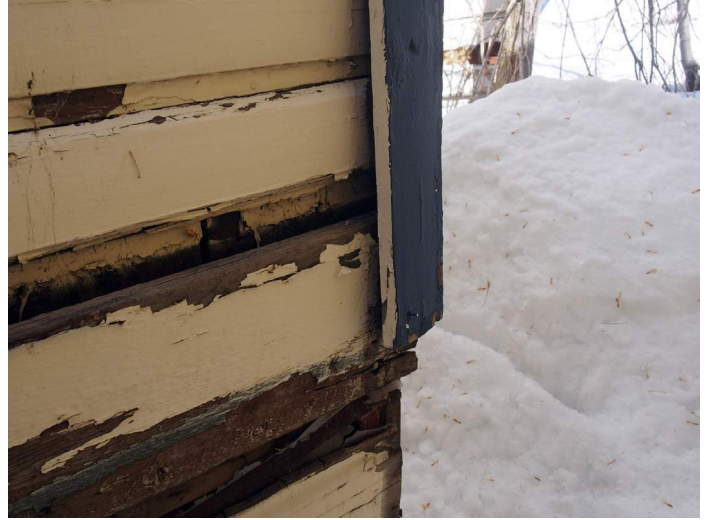
South facade siding and trim fail - opposite

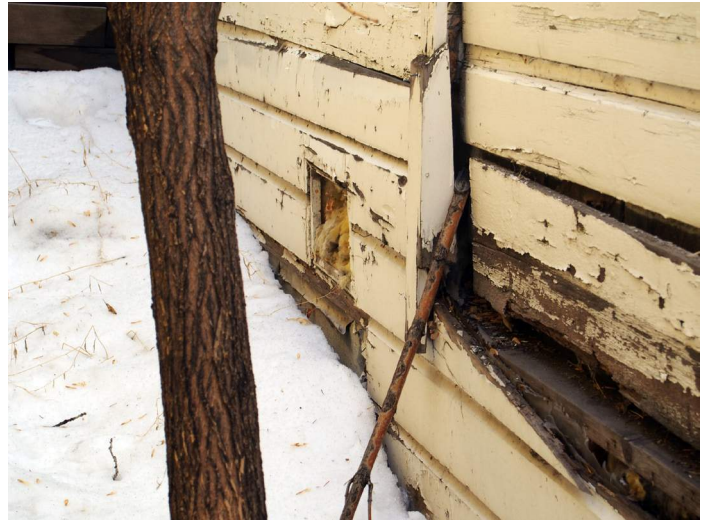
South facade trim issues

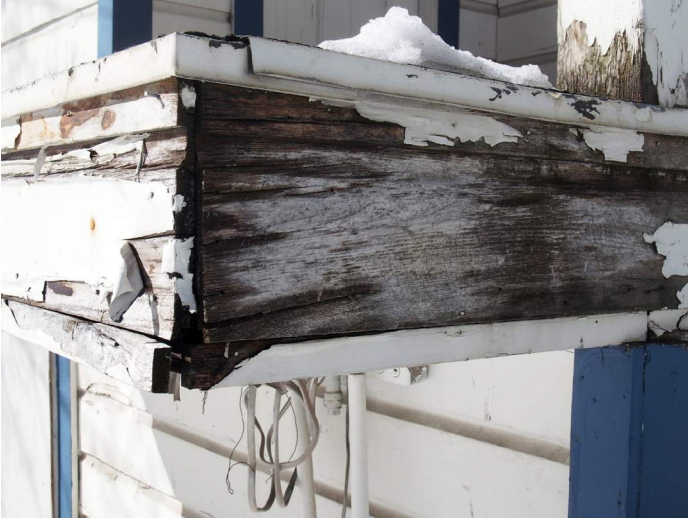
Trim compromised at rear Level 1 deck

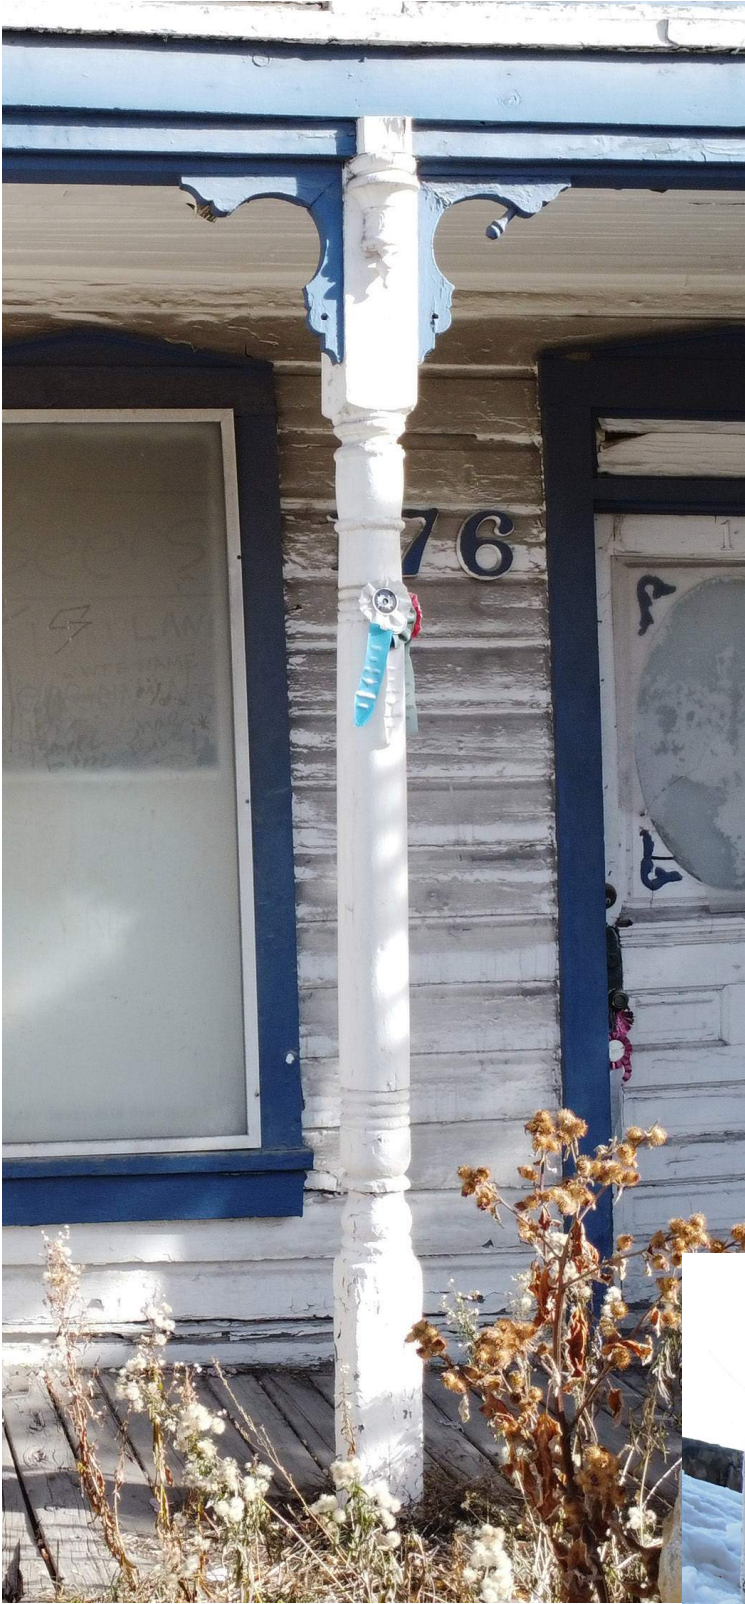
PHYSICAL CONDITIONS REPORT

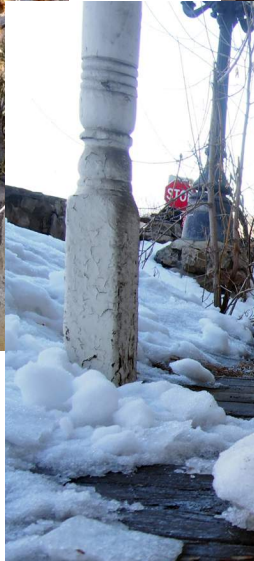
Base of Front Porch Post

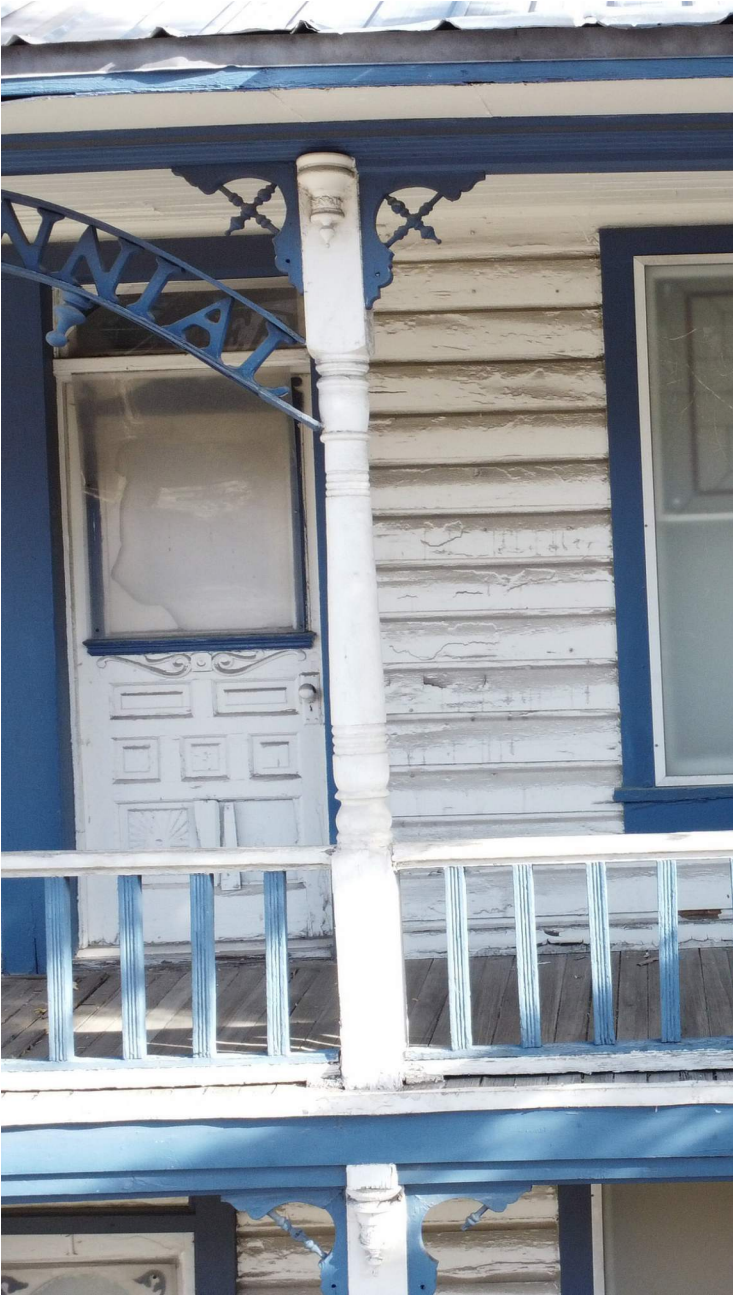
Upper Front Deck post

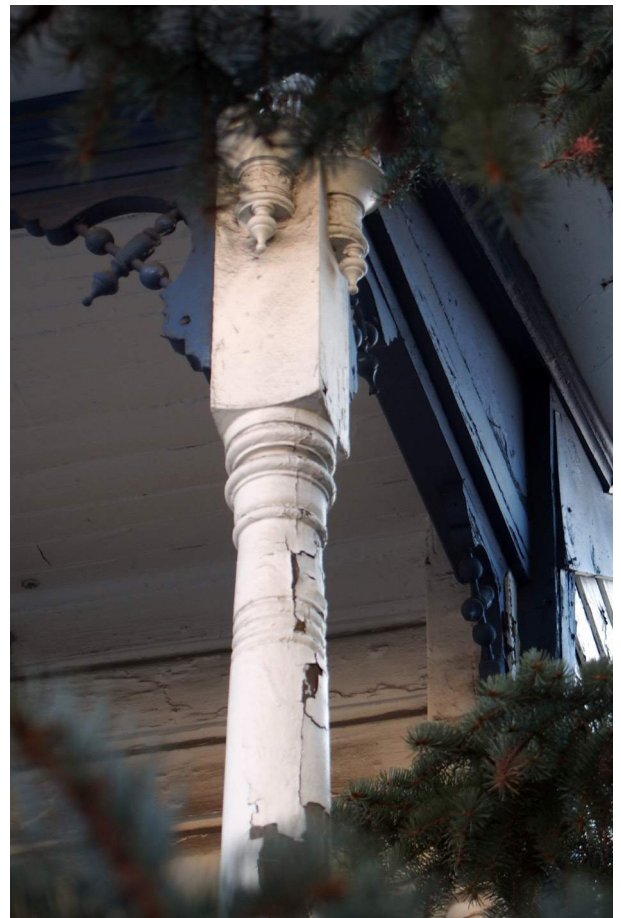
Upper Front Deck corner post

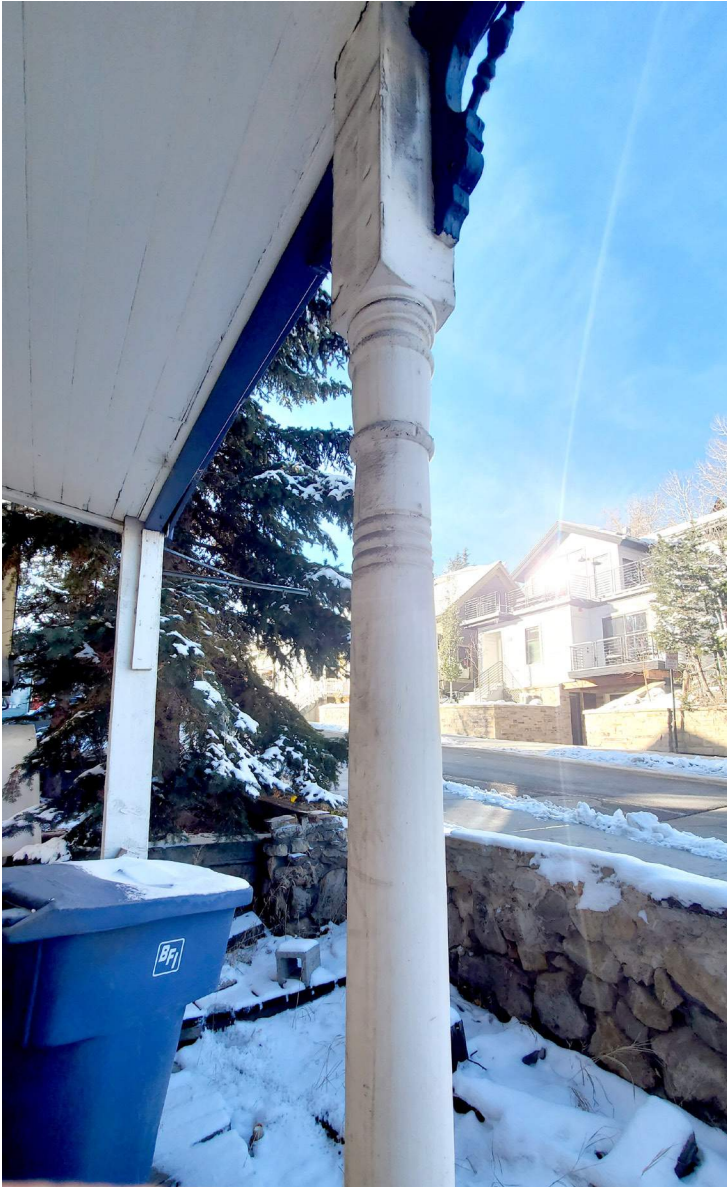
Back of Front Deck Post

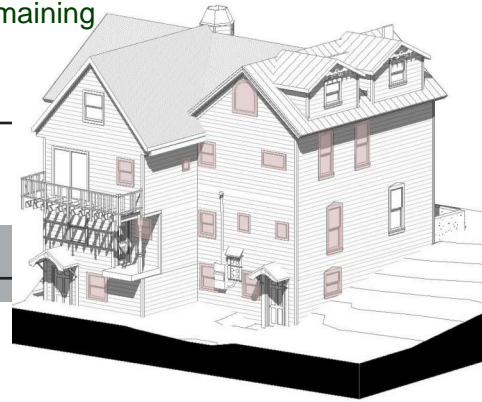
Element/Feature: _____

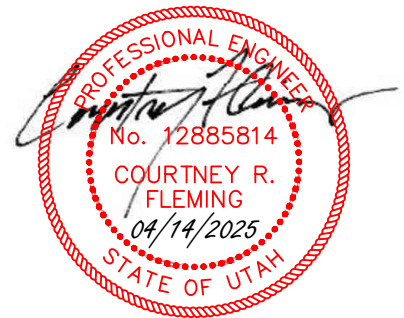
Courtney Fleming, PE
Principal Consultant

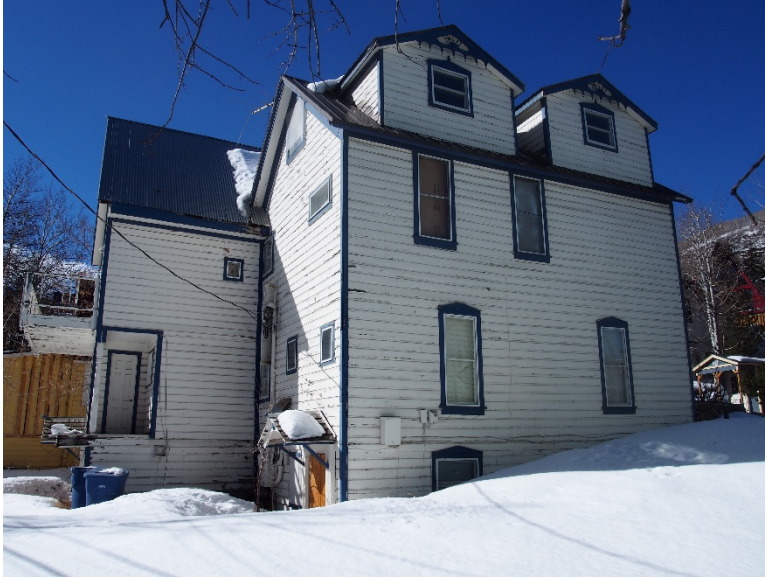
Figure 1- NE Corner (structure leaning)

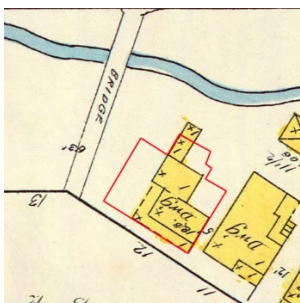
Several interior photos have been provided, though not exhaustive to be certain. The initial walk through highlighted the dilapidated nature of the building and recent visits to the exterior are quite frankly scary with the front wall buckling. This visual condition and the recollection of large and visible moldy areas in the basement have foregone any additional interior excursion.

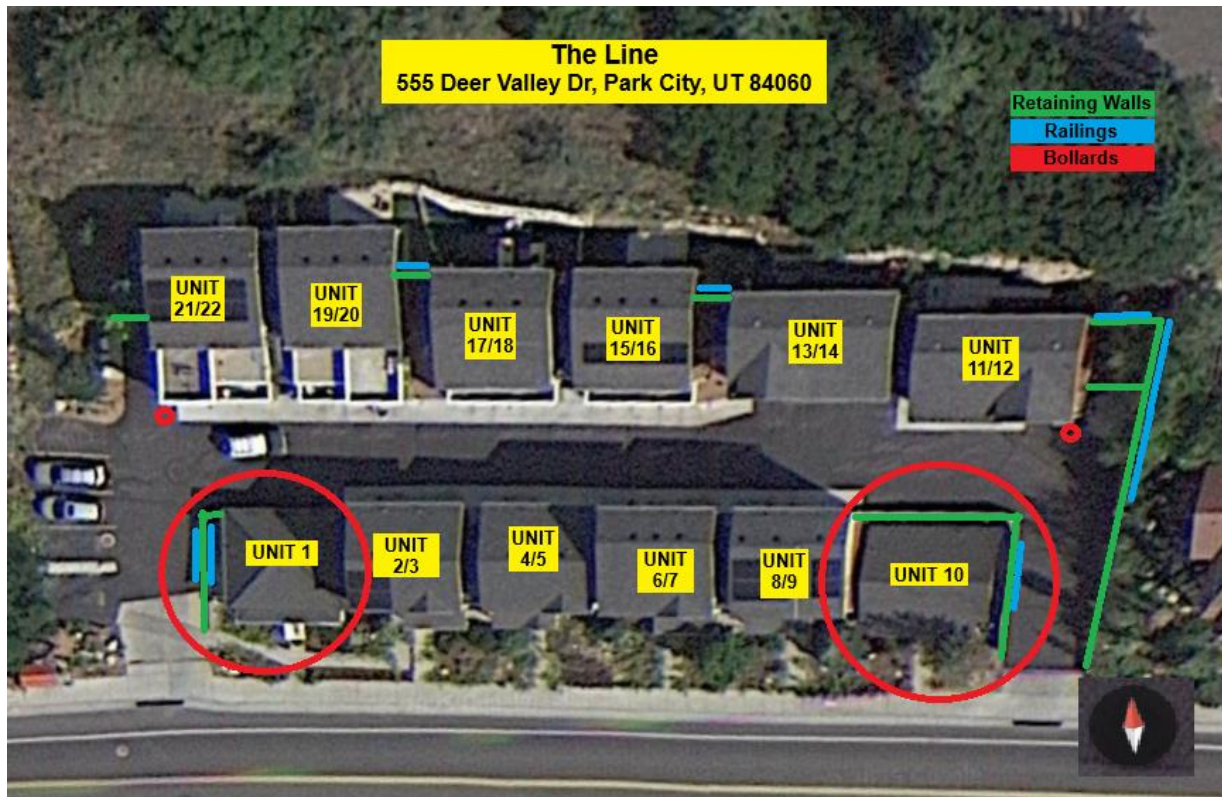
Figure 1: The Line Condominiums and Significant Historic Sites Unit #1 and #10 on each end of the development

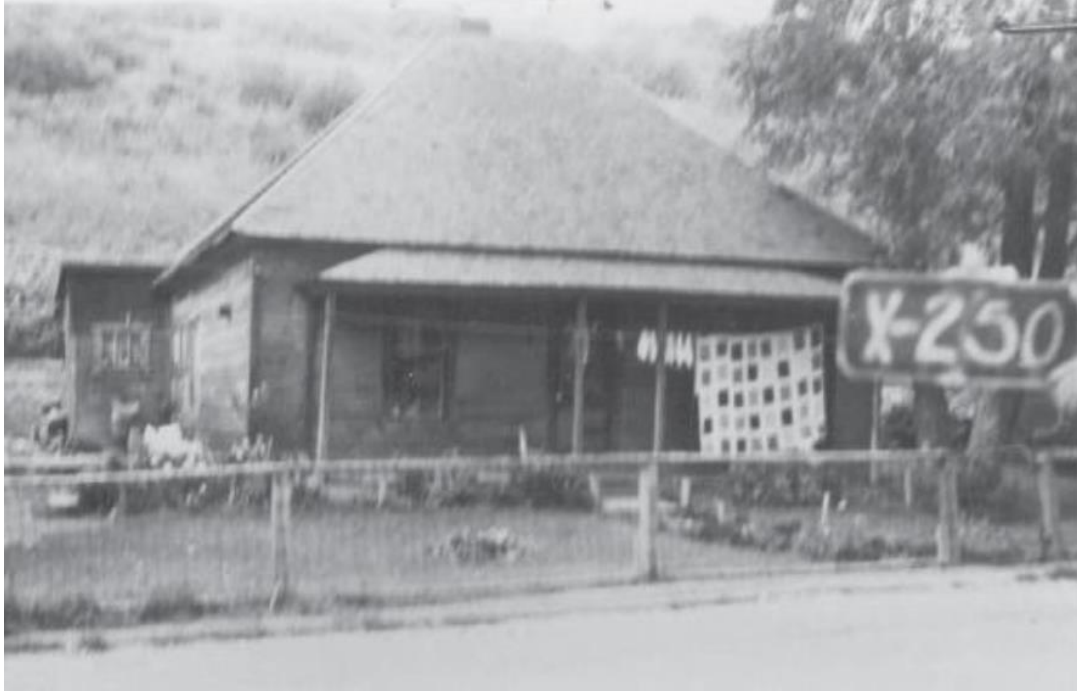
Figure 4: 555 Deer Valley Drive, Unit #1 in 1941

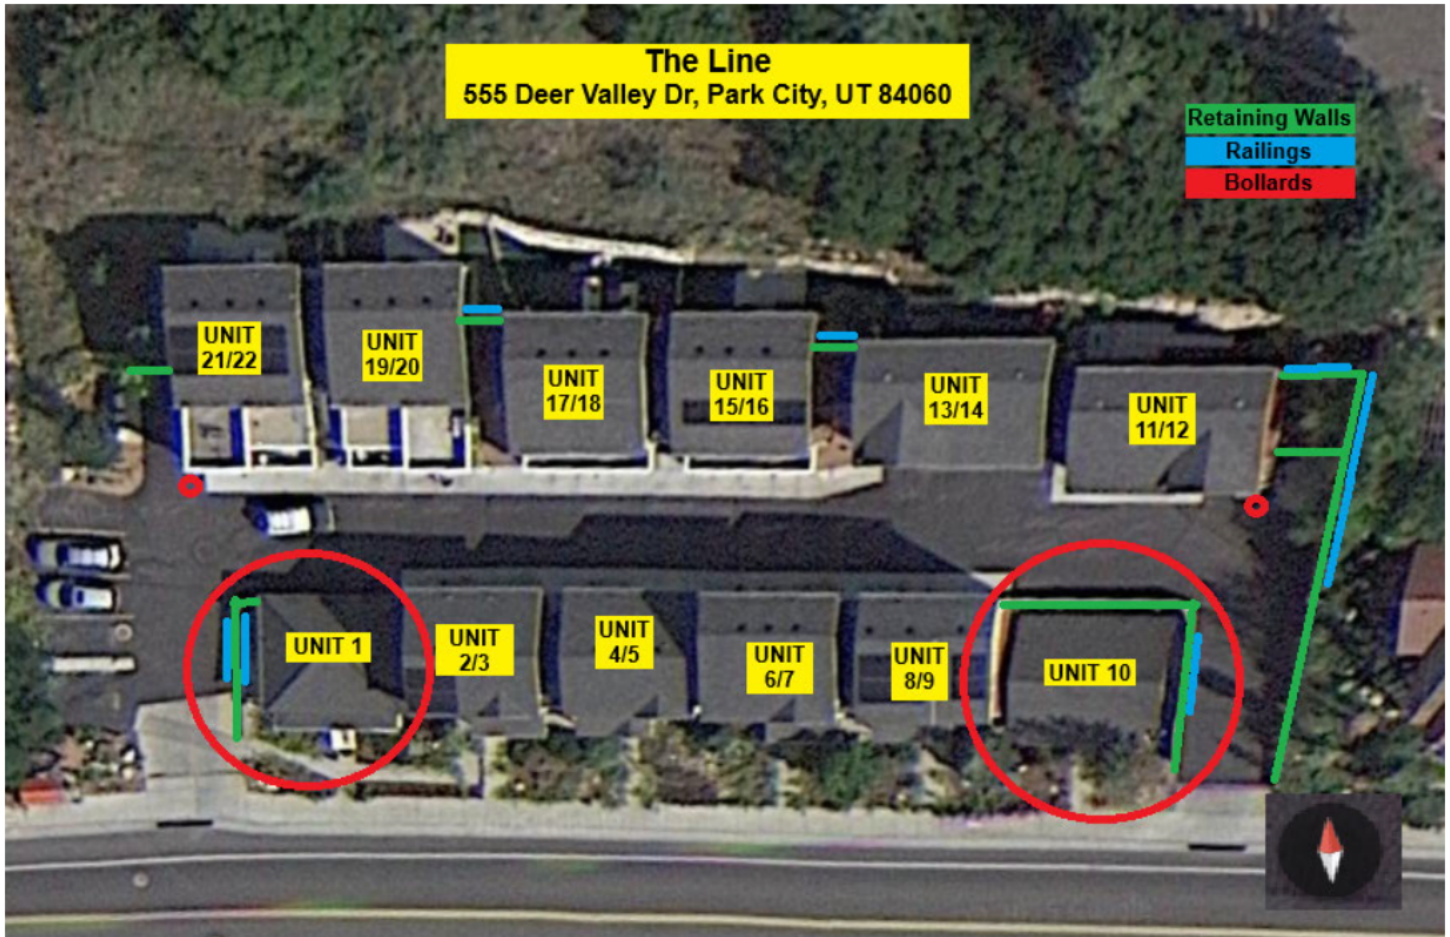
<p>*Unless otherwise clearly defined above, all work shall be performed at the Level 3 Surface Preparation and Finish Appearance standard (see below)</p>
