**PARK CITY HISTORIC PRESERVATION BOARD MEETING
SUMMIT COUNTY, UTAH
June 30, 2025**

**PRE-DEMOLITION/RENOVATION INSPECTION
FOR ASBESTOS, LEAD, UNIVERSAL,
HAZARDOUS AND TOXIC WASTES**

**The Centennial House
176 Main Street
Park City, Utah 84060**

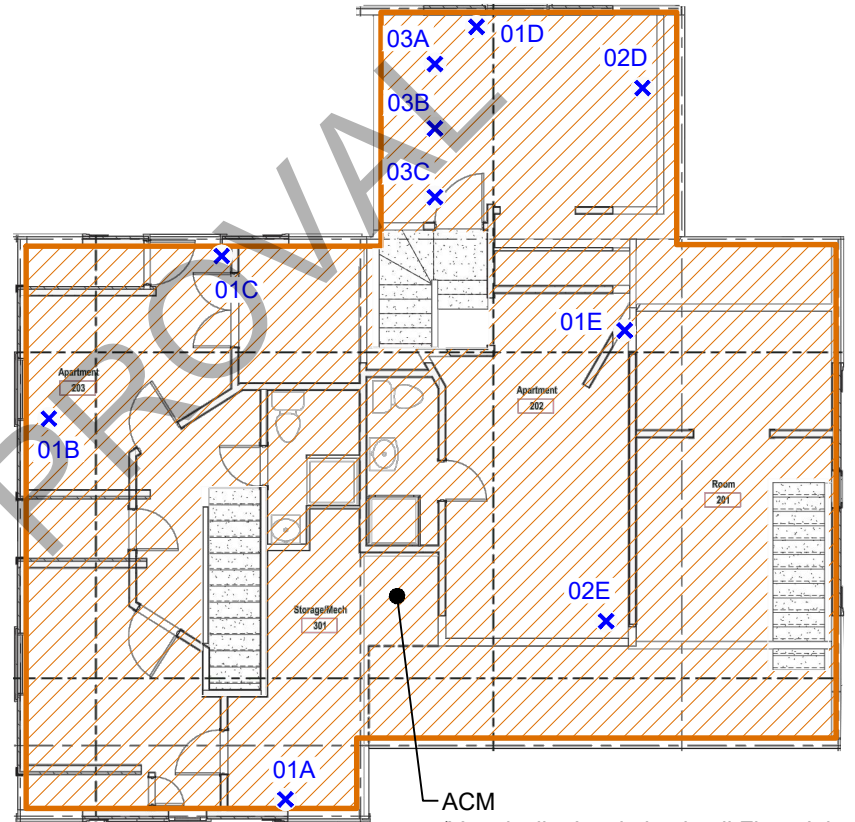
3RD FLOOR

ACM
(Vermiculite Insulation in all Floor Joists)

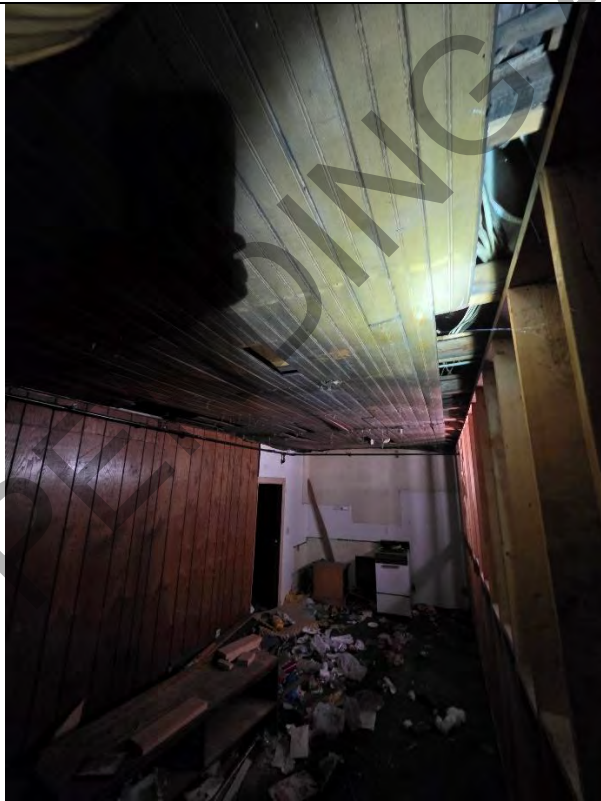
Green wood ceiling positive for lead

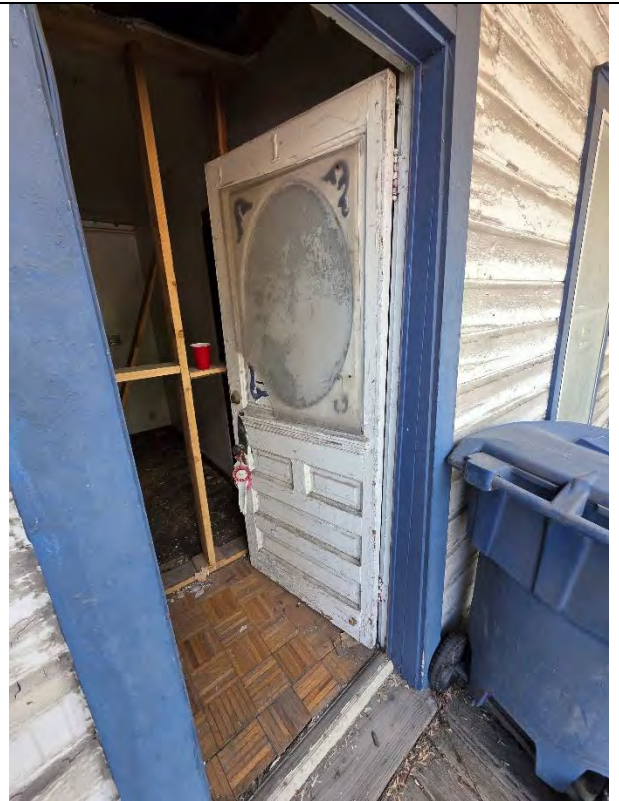
Lead exterior door, siding and door frame

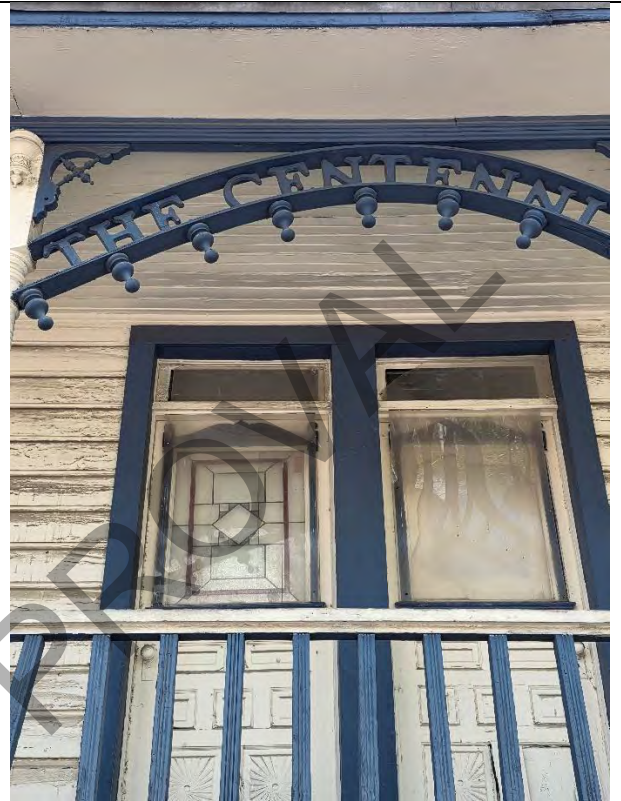
Exterior window frame, stair stringers and trim

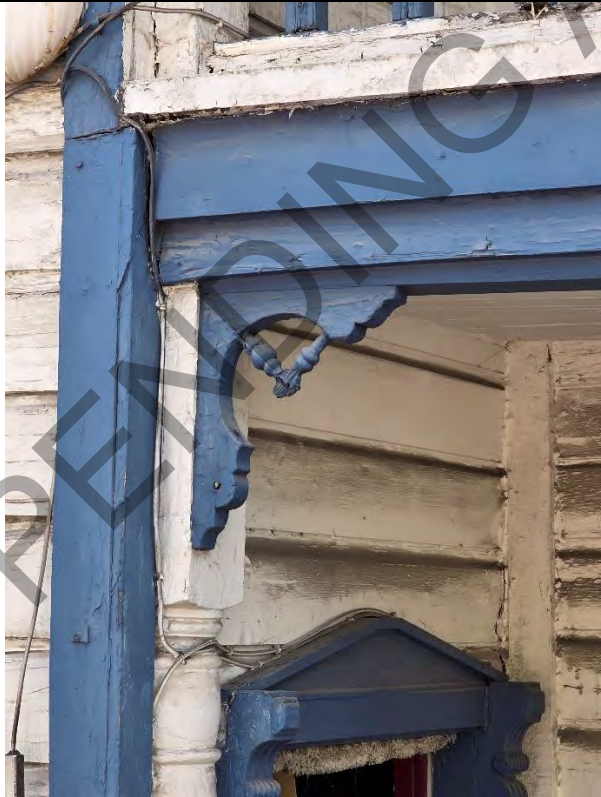
Lead exterior trim

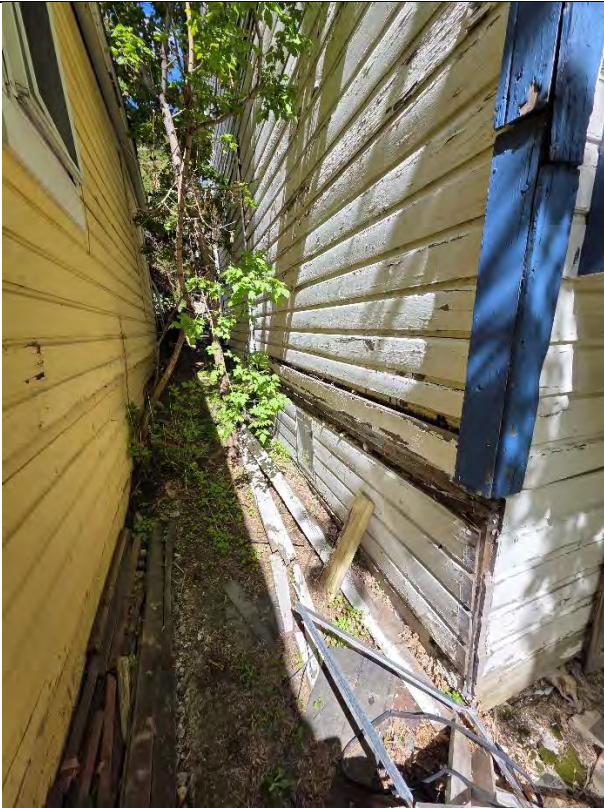
Lead exterior siding and trim

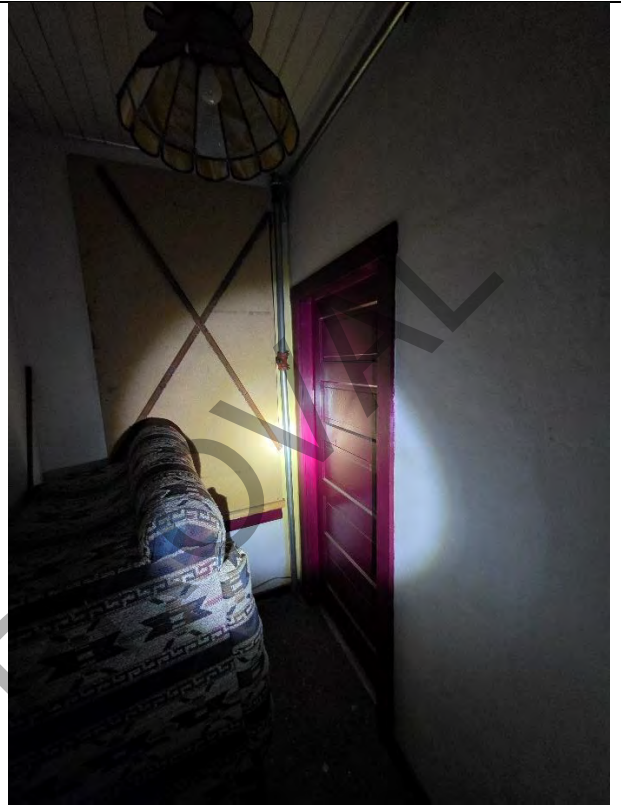
Lead interior door and frame

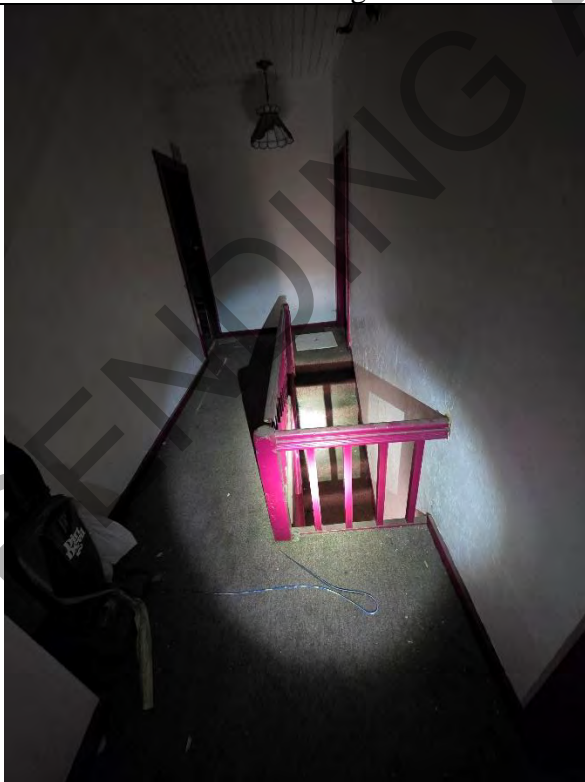
Lead stairwell components positive for lead

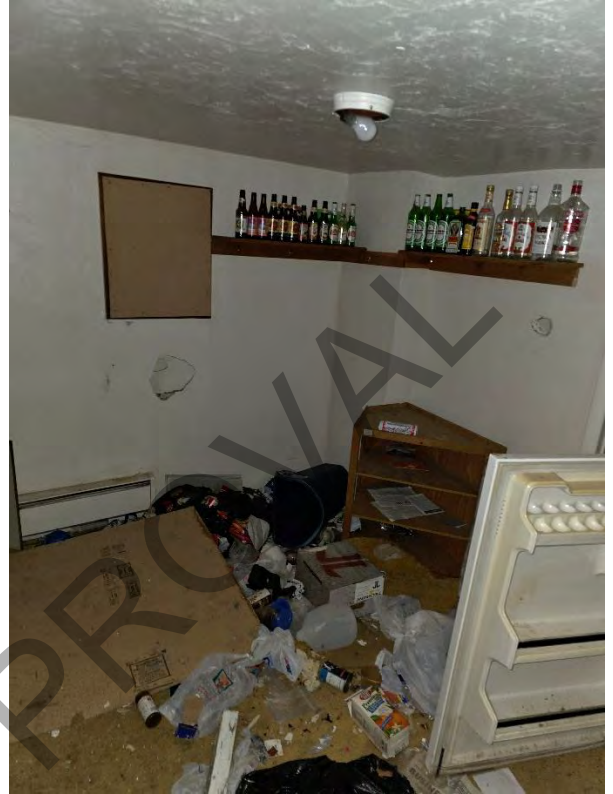
Basement Kitchen area garbage old food

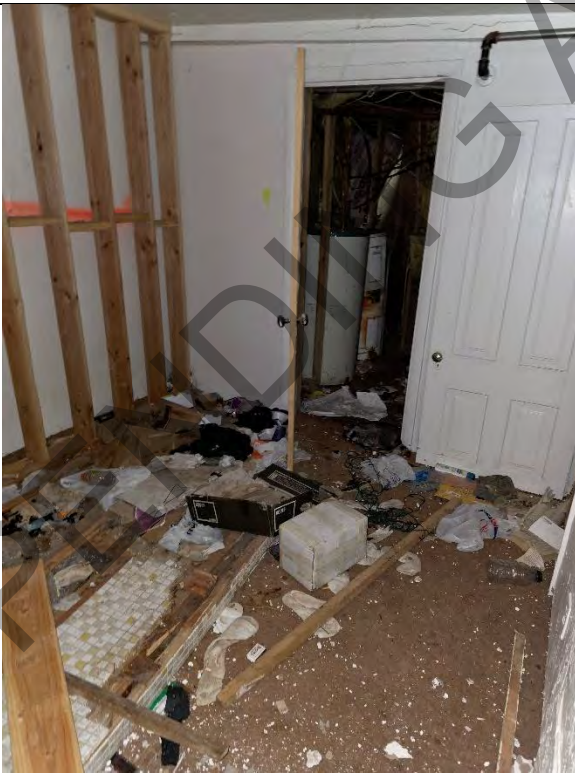
Basement South Apartment NW Bedroom with dead raccoon and garbage

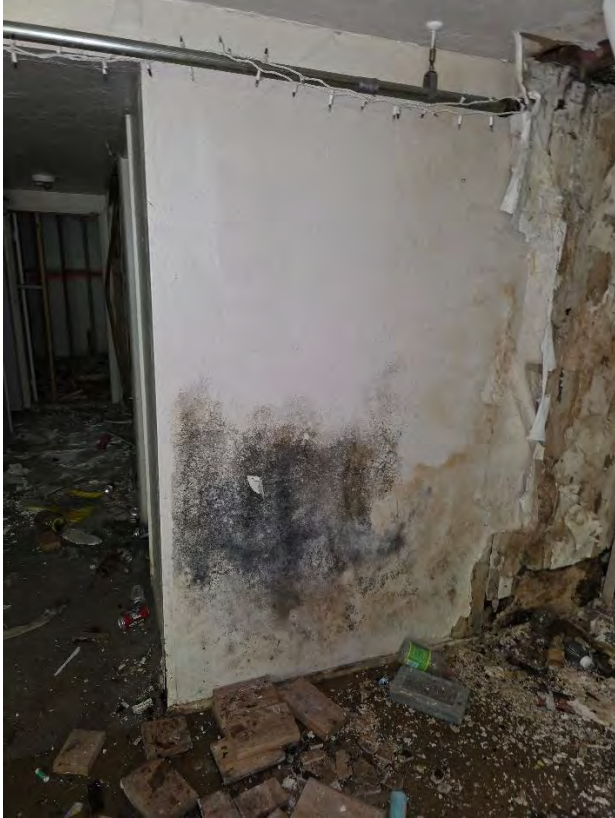
Basement South Apartment visible mold growth, animal feces and garbage

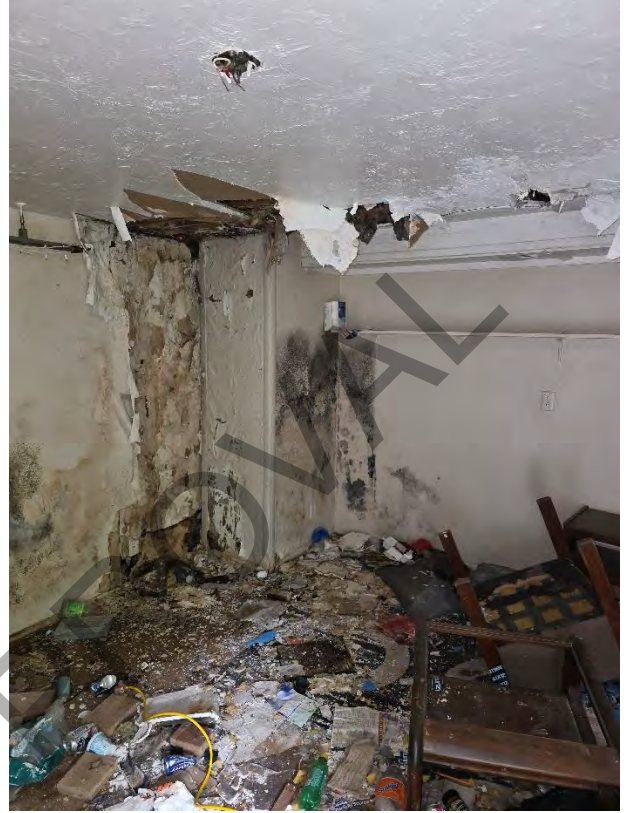
Basement South Apartment visible mold growth, animal feces, three dead raccoons and garbage

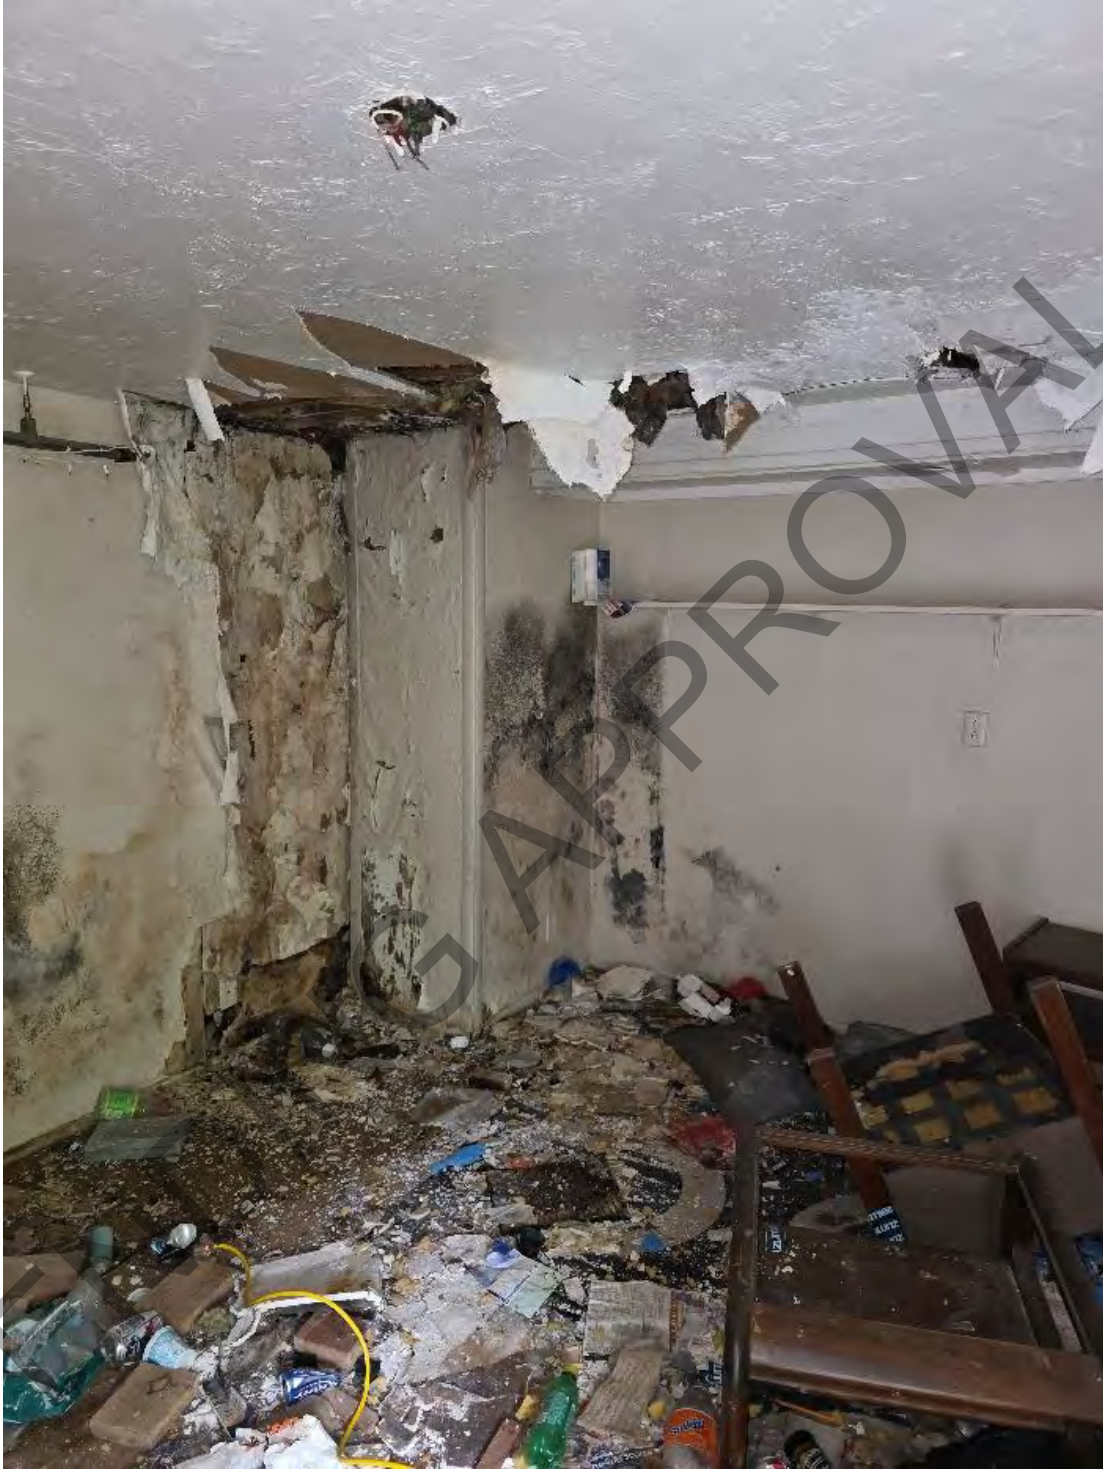
South Basement Apartment Living Room – Three (3) dead raccoons, feces, visible mold on all walls within the basement area.

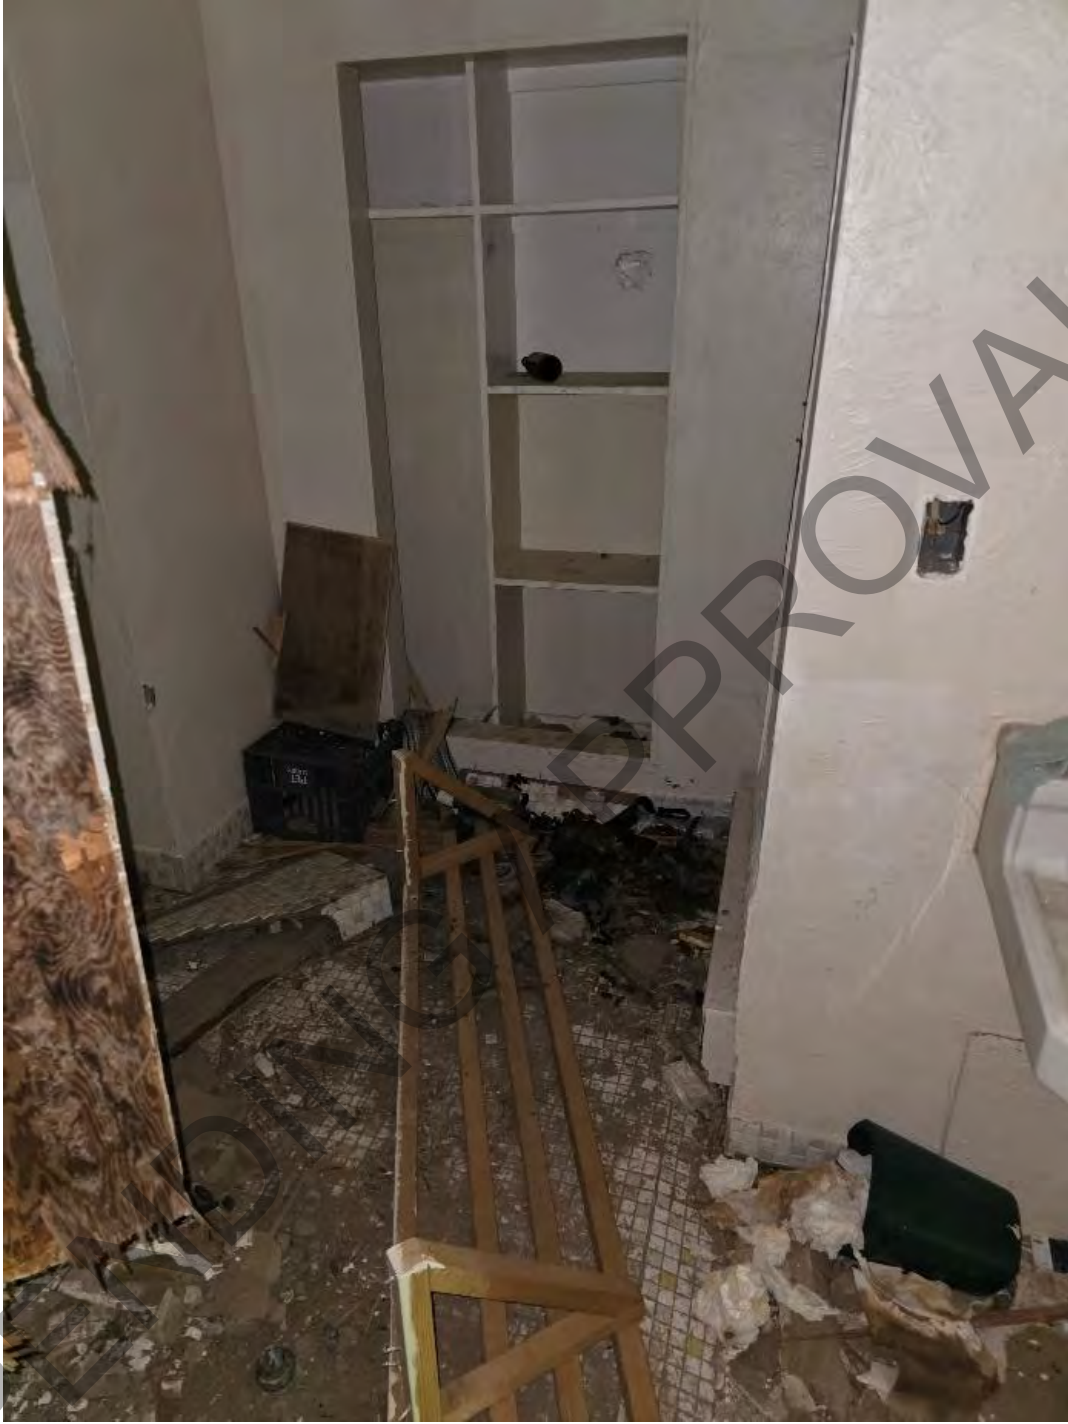
Visible mold growth on sheetrock wall Basement South Apartment Bathroom.

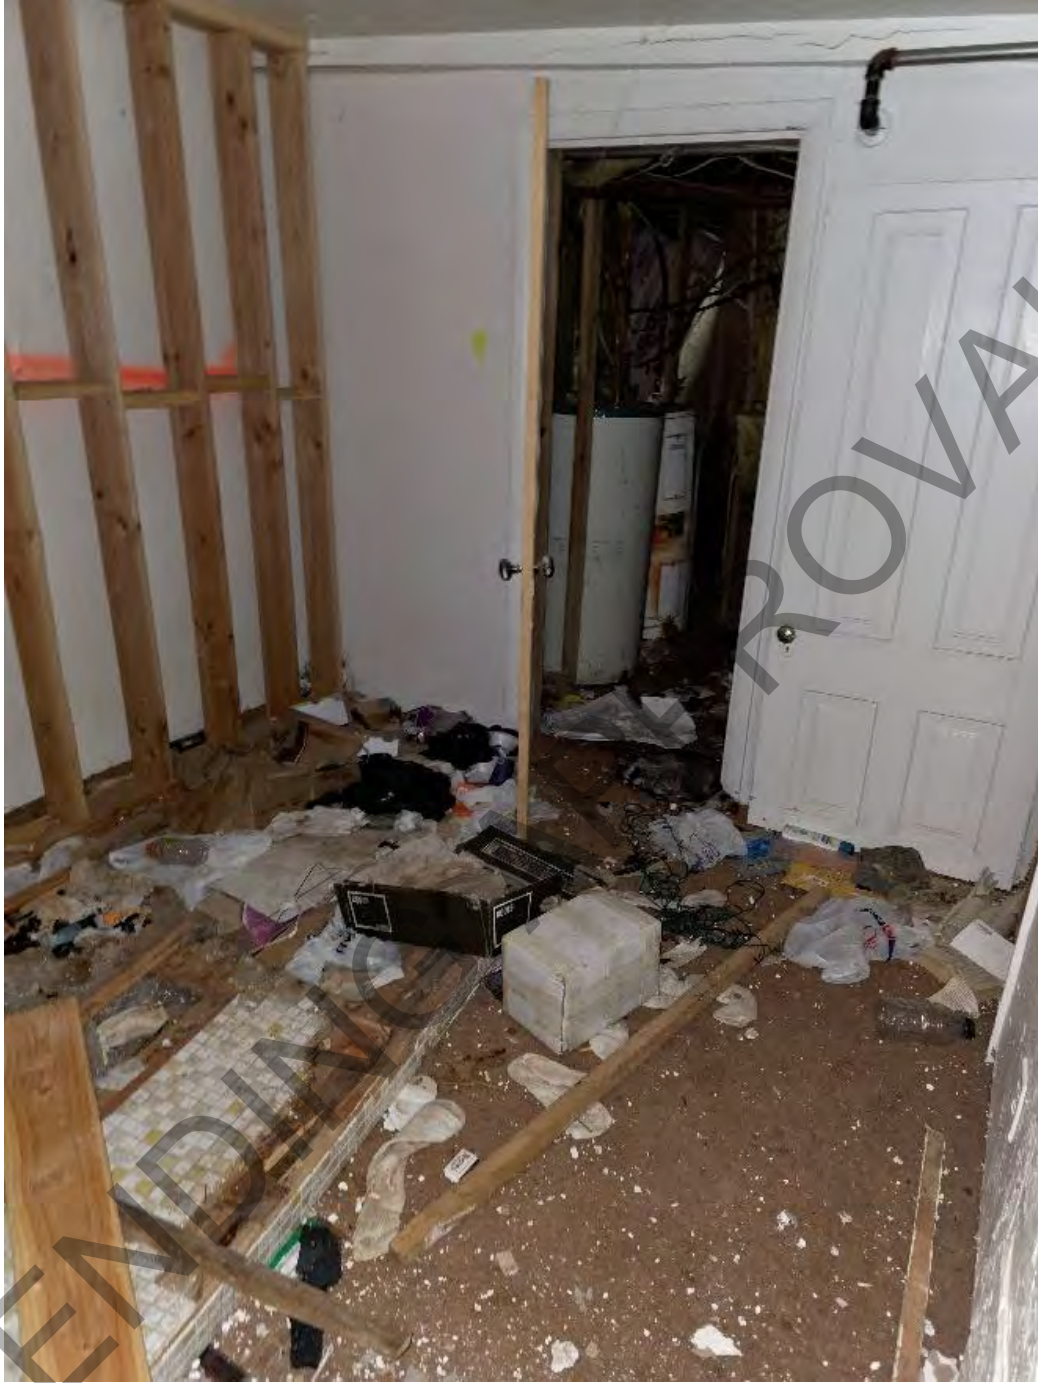
Visible mold growth with dead raccoon and feces throughout room.

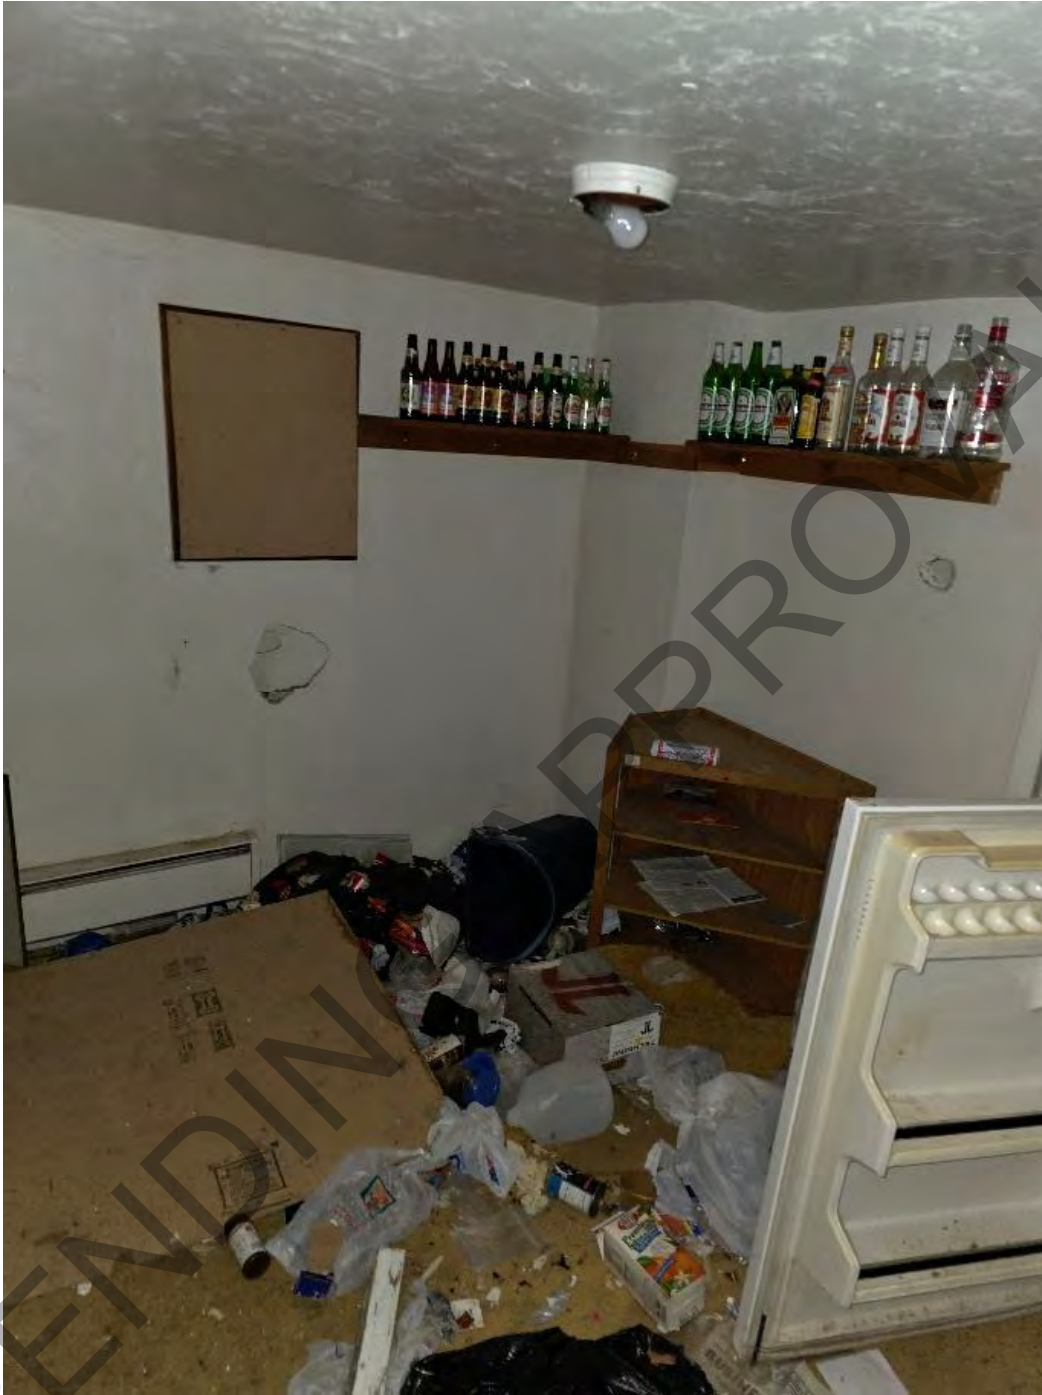
Basement South Apartment Kitchen with visible mold growth and feces.

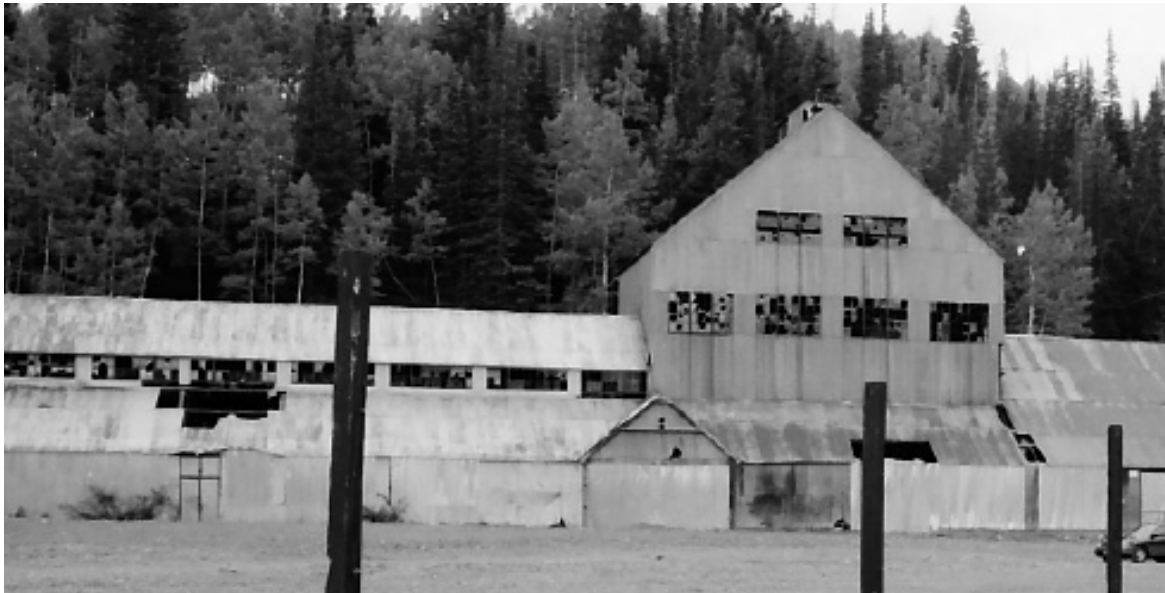
Figure 2: Silver King Coalition Mine main building, pictured in 1999

The ground floor windows at the main mine building have been covered with metal sheets which will be removed.
