Asbestos Abatement Services

Lamplighter Property

Hazardous Materials Inspection

Re: Hazardous Materials Inspection
Lamplighter Hotel
120 East Main Street, Vernal, Uintah County, Utah
Terracon Project No. 61237186 Task 4.26
EPA Cooperative Agreement #95815230
EPA ACRES Property ID #257935

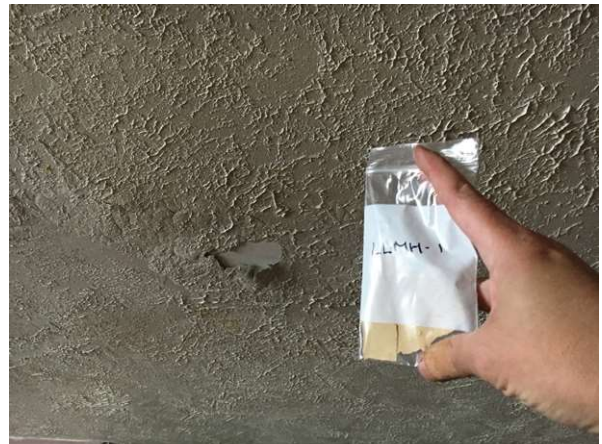
Photo #2 HA1: White rough ridge like ceiling texture, <1% asbestos by point count

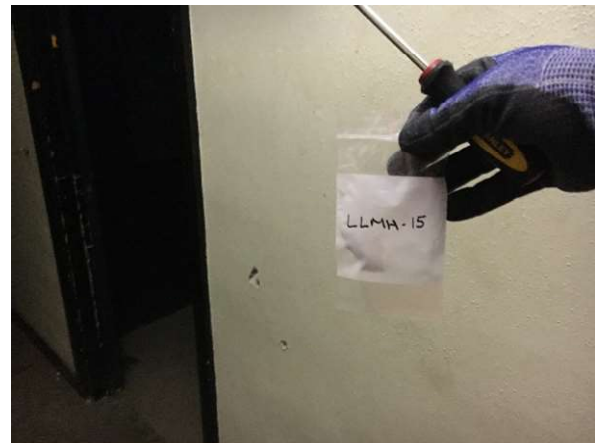
Photo #4 HA3: Plaster walls and ceilings, not asbestos containing

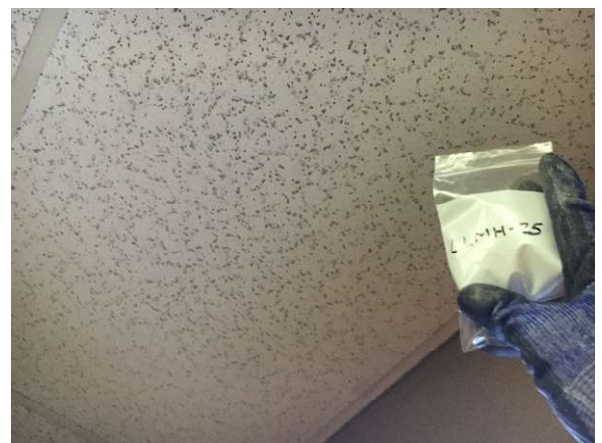
Photo #6 HA5: White 2'x4' ceiling tile with many small gouges and pinholes, not asbestos containing

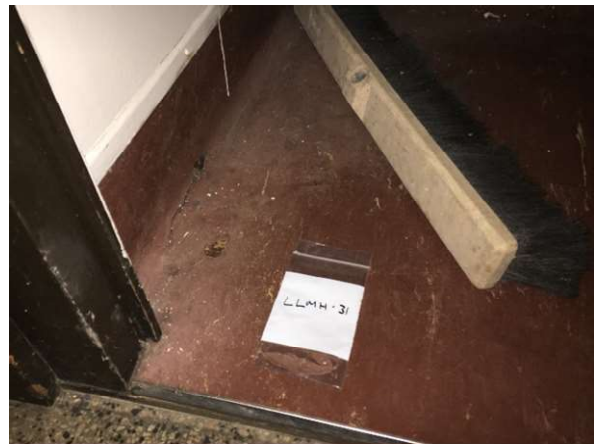
Photo #8 HA7: Red vinyl sheet flooring with white streaks and mastic, not asbestos containing

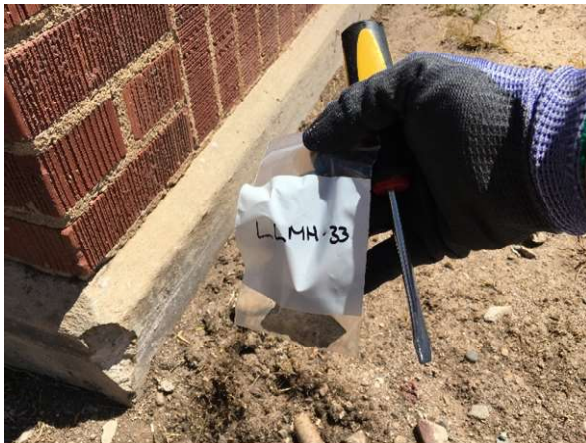
Photo #9 HA8: Concrete, not asbestos containing

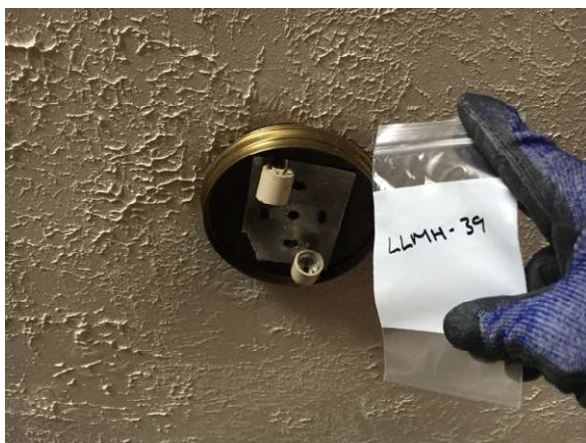
Photo #11 HA10: Heat shield (lamp fixtures), asbestos containing

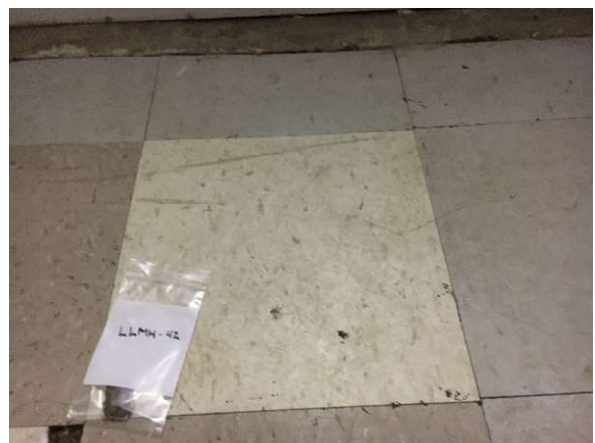
Photo #12 HA11: White 12"x12" floor tile and mastic and cementitious material, asbestos containing

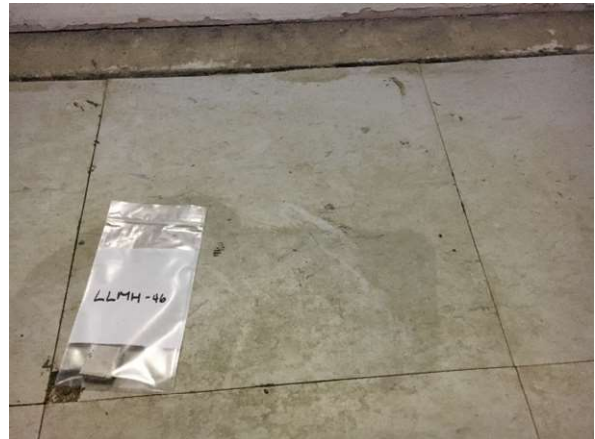
Photo #14 HA13: Gray 12"x12" floor tile and mastic and cementitious material, asbestos containing

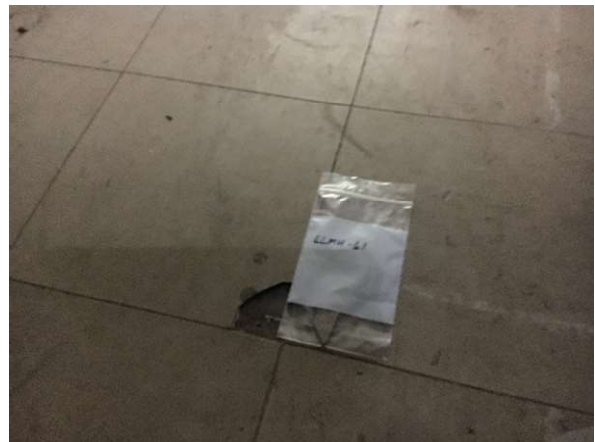
Photo #20 HA19: Pink 9"x9" floor tile with brown and white streaks and mastic, asbestos containing

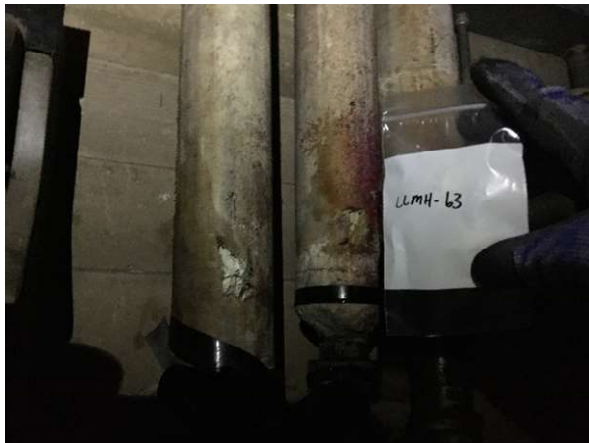
Photo #21 HA20: Corrugated pipe insulation, asbestos containing

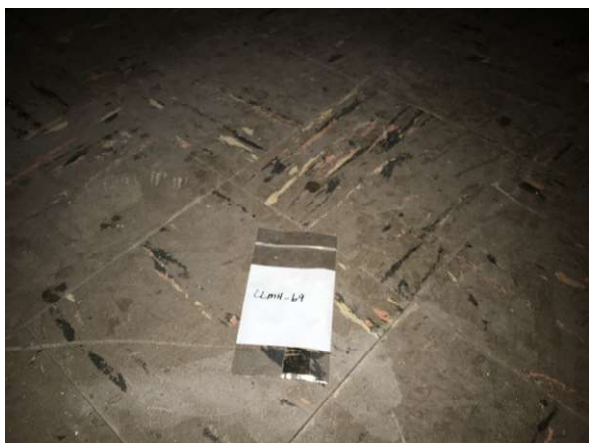
Photo #23 HA22: Brown 9"x9" floor tile with black, red, and white streaks and mastic, asbestos containing

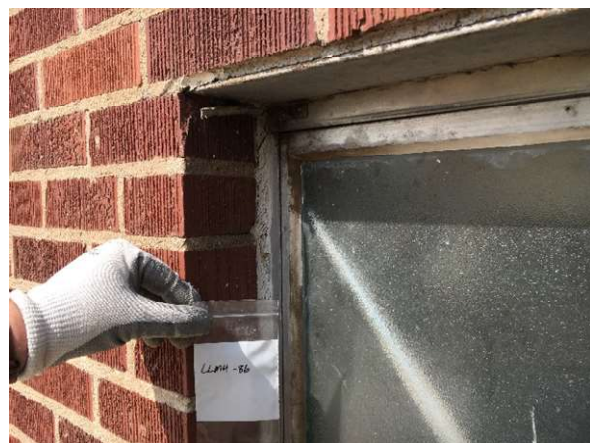
Photo #30 HA29: Beige window caulking, asbestos containing

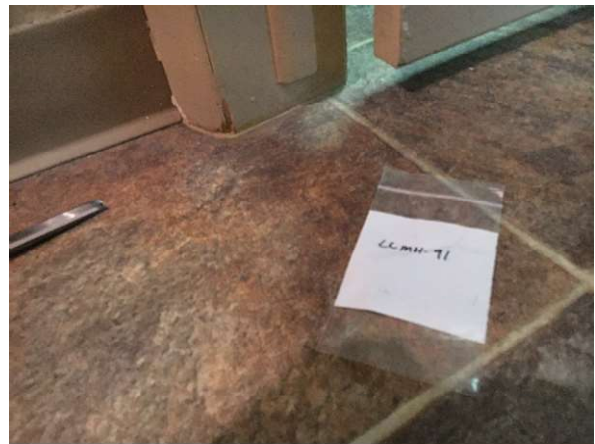
Photo #32 HA31: Brown flagstone pattern vinyl sheet flooring and yellow mastic (multiple layers), asbestos containing

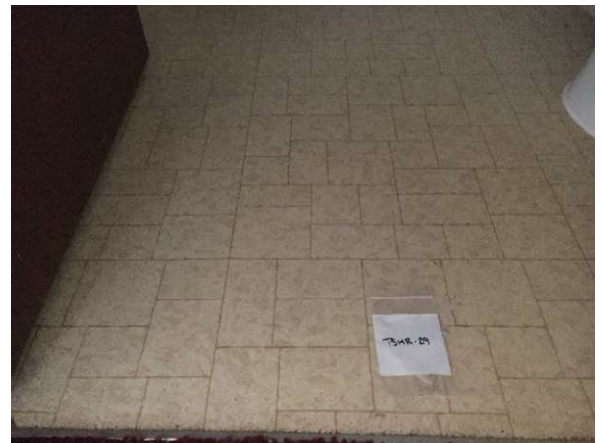
Photo #64 HA64: Tan rectangle and square pattern vinyl sheet flooring and mastic, asbestos containing

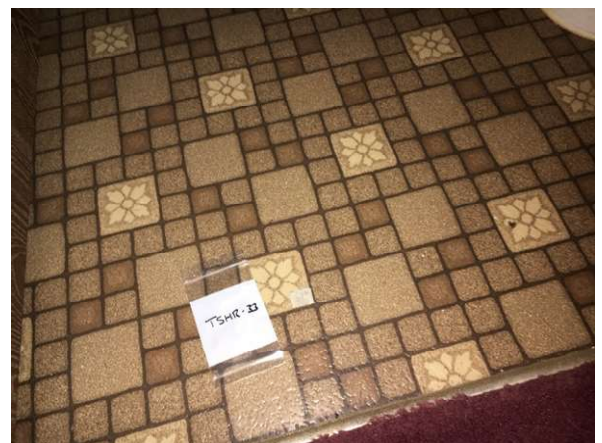
Photo #66 HA66: Brown small and large square with flower vinyl sheet flooring and mastic, not asbestos containing
