NOTICE OF MEETING  
HILLSIDE REVIEW BOARD  
CITY OF ST. GEORGE  
WASHINGTON COUNTY, UTAH

**HILLSIDE REVIEW BOARD AGENDA REPORT: 11/30/2022**

| <b>150 N. Donlee Drive</b><br>Hillside Development Permit (Case No. 2022-HS-018) | | |

# **Retaining Wall Engineering Report**

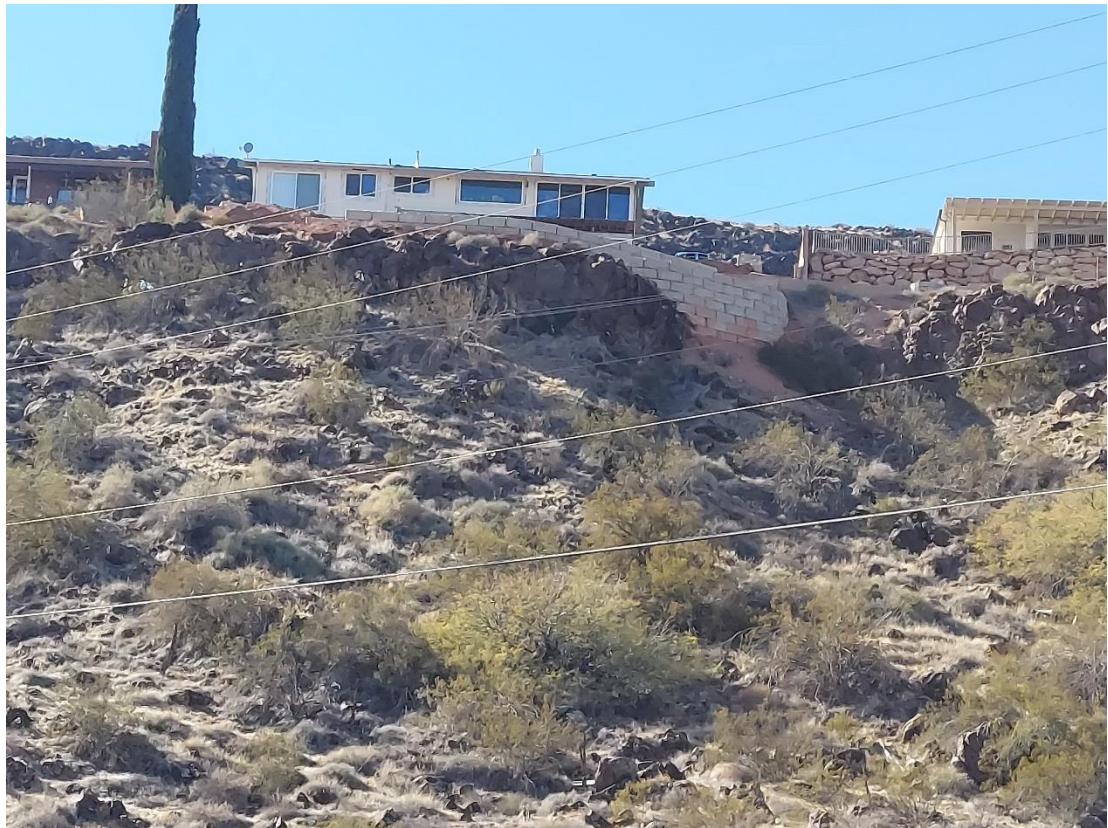
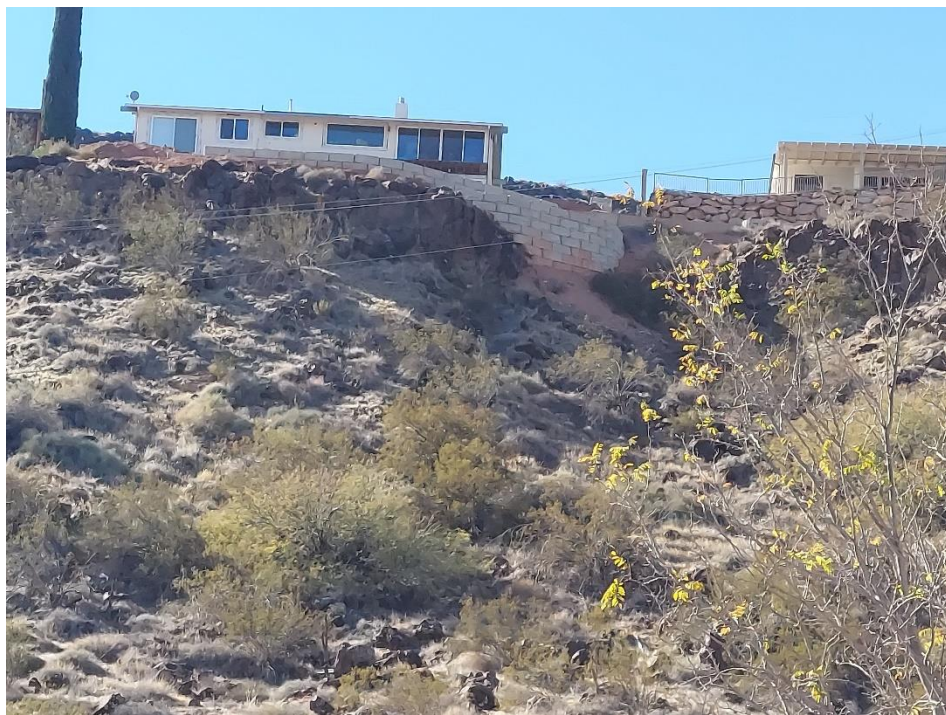
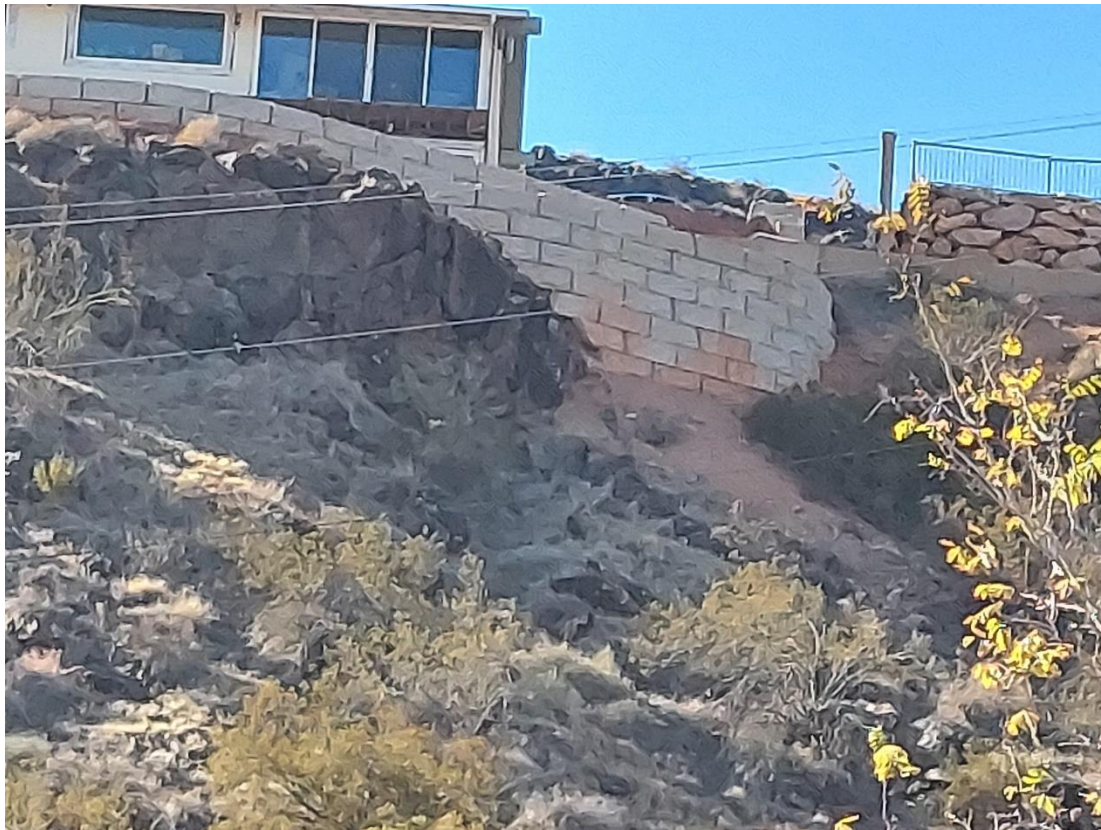
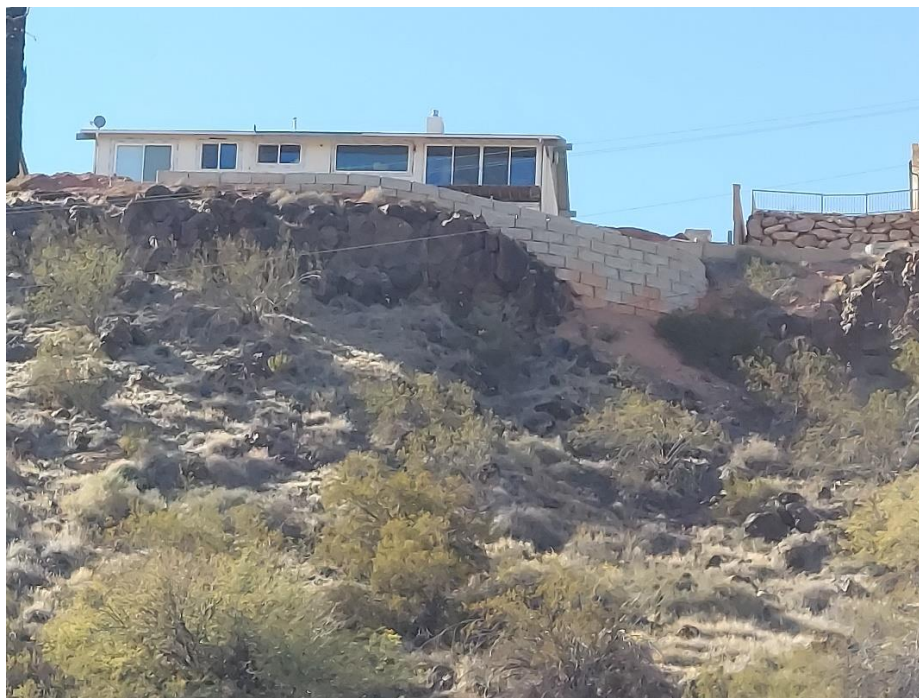
It was observed that the blocks used for the block walls were Redi Rock blocks that were 41 inches deep. The lower tier was observed to be 10.5 feet in height at its highest point. The bench between walls was measured to be 8 feet. The upper tier was observed to be 9 feet in height.

It is the opinion of Landmark Testing and Engineering that the block walls as constructed meet minimum factors of safety and will function as intended. At the time of our visit the lower tier had a maximum wall height of 10.5 feet and the upper tier had a maximum wall height of 9 feet. The wall heights should be decreased to meet city requirements either by removing blocks or increasing the embedment of the walls.

Rear of House – 11/21/2022
