**Geotechnical Data Report  
I-84 & Weber River Water Line Crossing  
Riverdale, Utah**

**March 1, 2023**

**Geotechnical Data Report**  
**I-84 & Weber River Water Line Crossing**  
**Riverdale, Utah**  
**CG Project No.: 140-007**

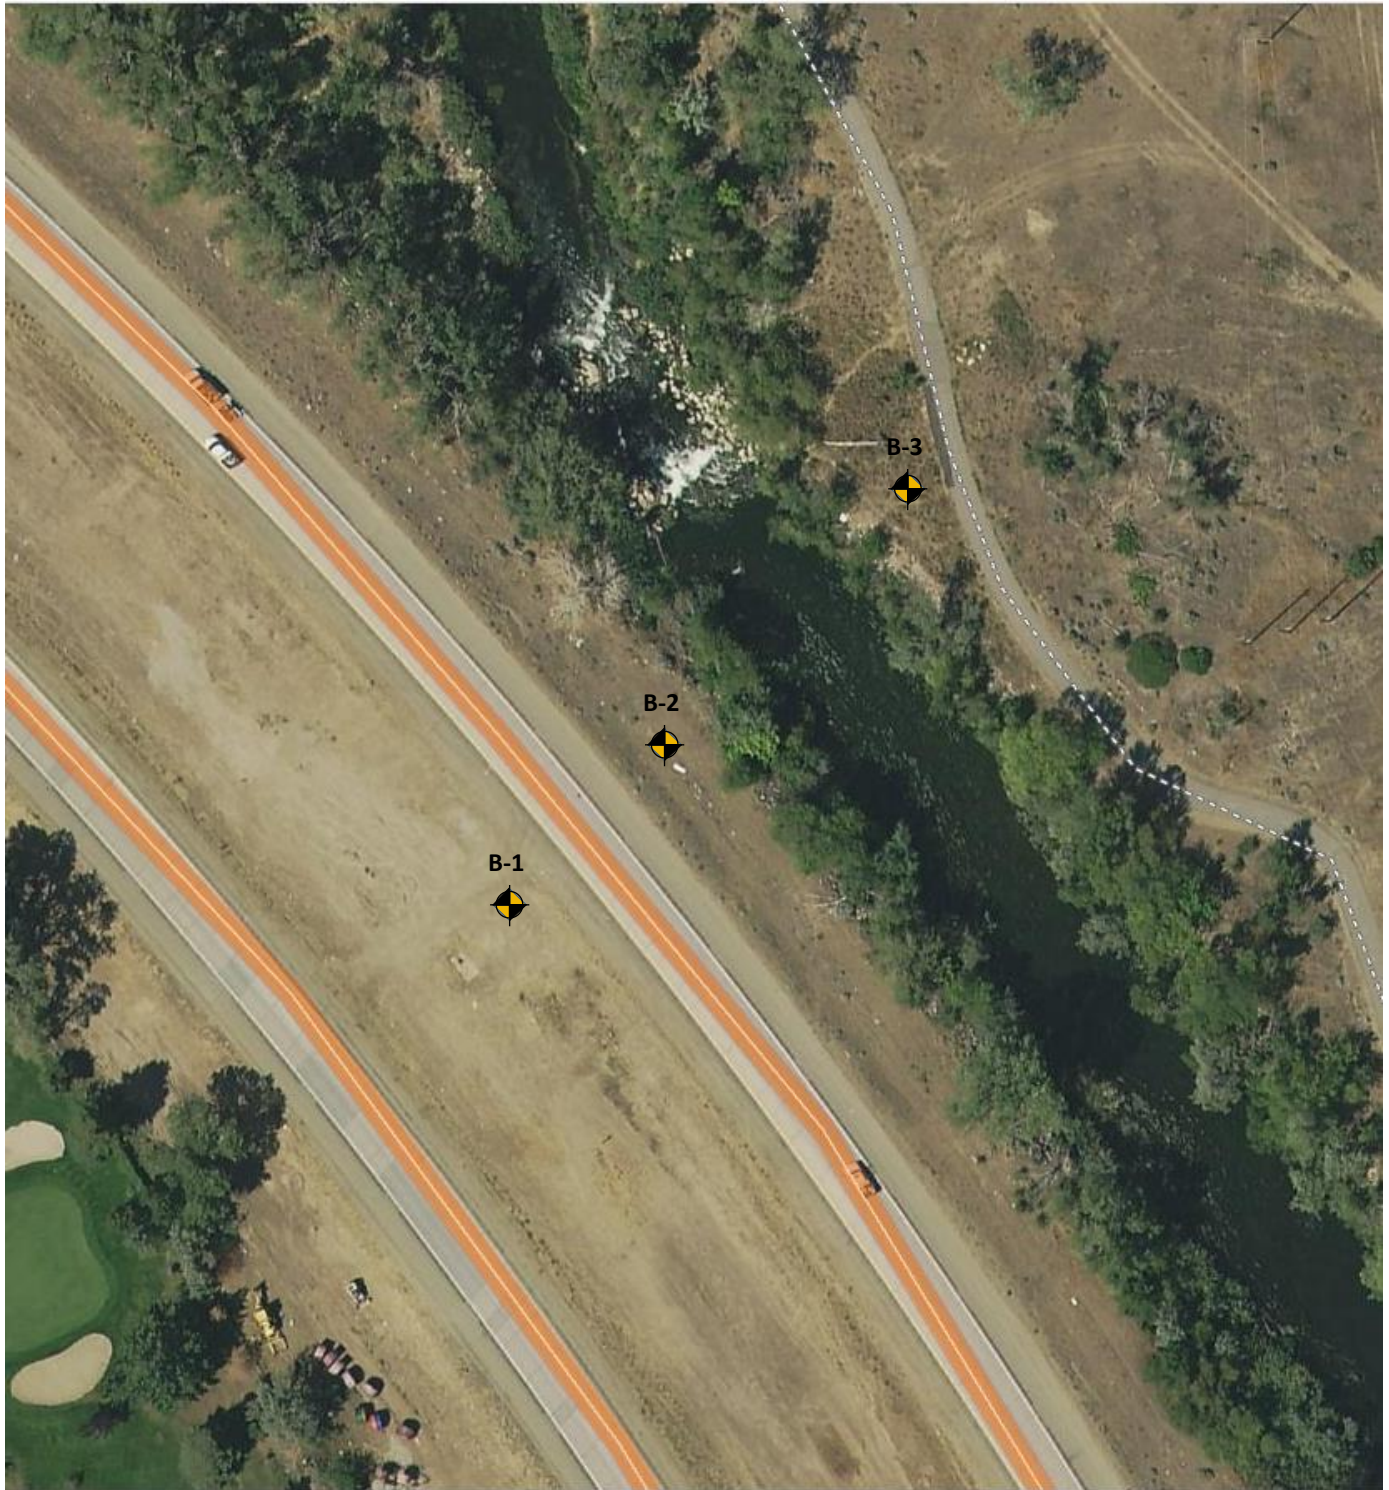
Plate  
2

Approximate Boring Location

Exploration Location Map

The subsurface conditions at the site of the crossing were explored by completing three borings with a Mobile B-80 truck-mounted drill rig equipped with hollow-stem augers. The approximate locations of the borings are shown on the Exploration Location Map, Plate 2. The depths of the borings ranged from 21½ to 31½ feet below the existing site grade. The subsurface conditions as encountered in the borings were recorded at the time of drilling and are presented on the attached Boring Logs, Plates 3 through 5. A key to the symbols and terms used on the Boring Logs may be found on Plate 6.
