# CUP23016

## Bailey Comments

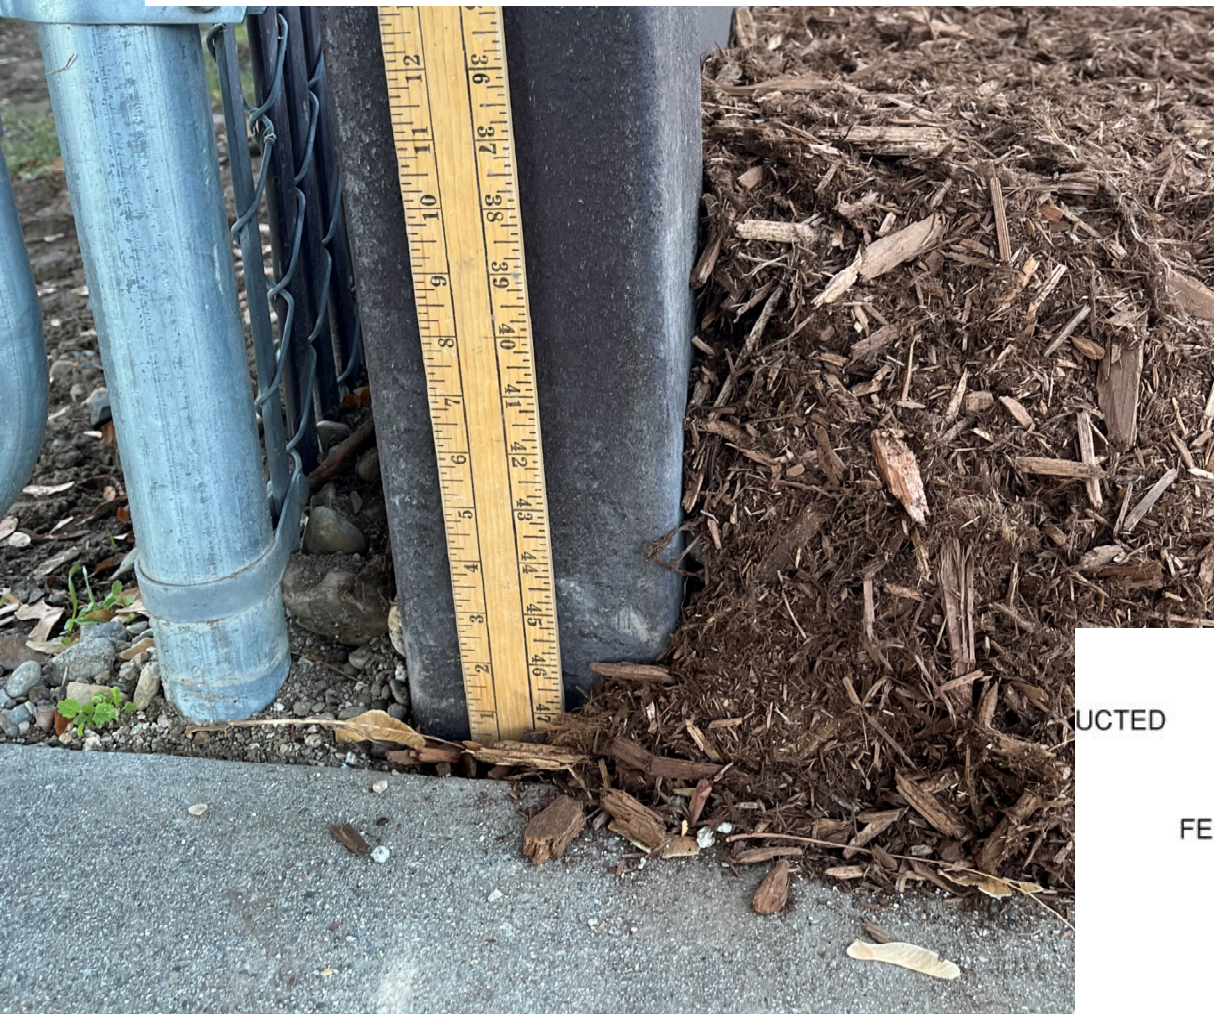
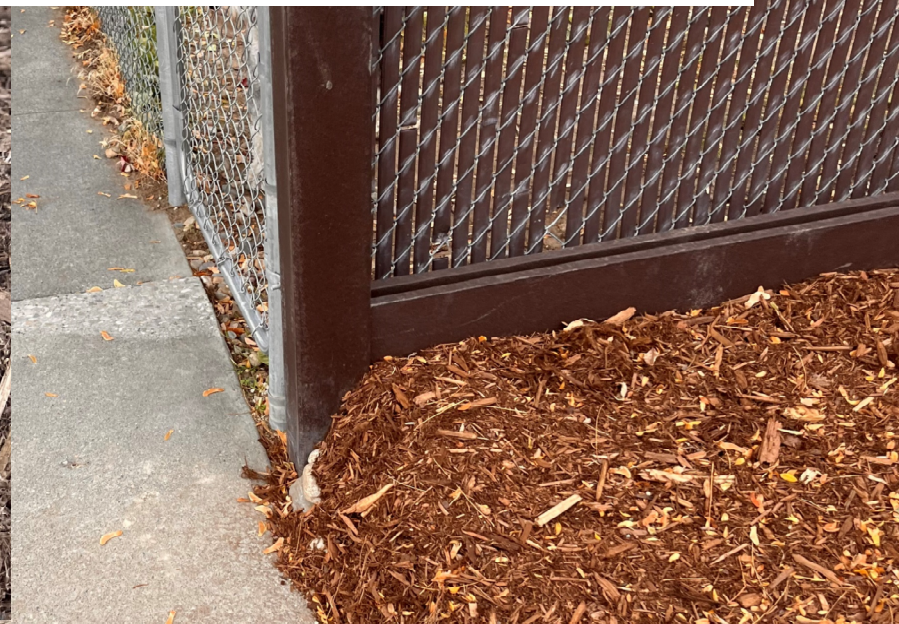
Modified grade is built up ~11" near the sidewalk to fill in the gap below the fence

Existing fence retaining dirt under the new fence

Without the existing fence dirt would spill into our yard

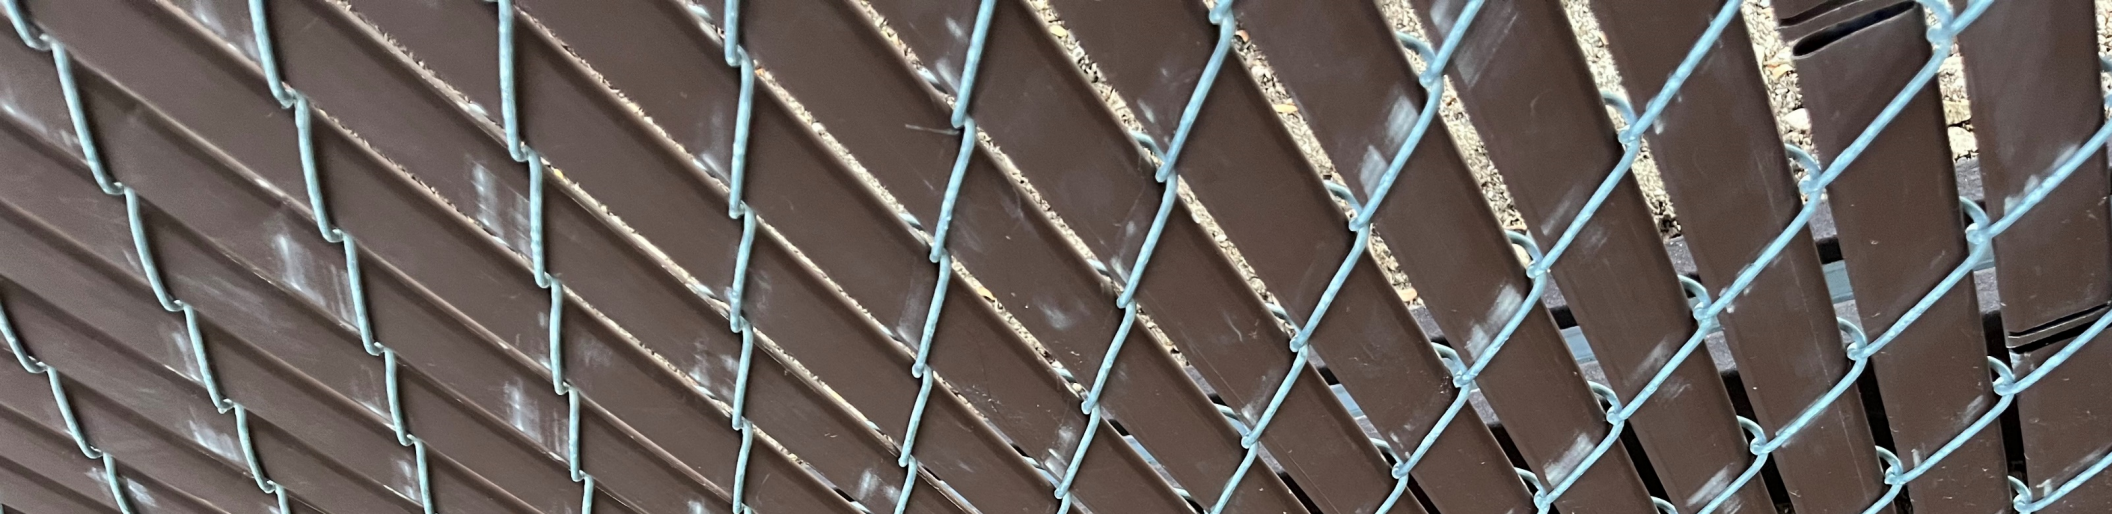
Bulging fence and dirt spilling through the fence. The existing fence is not built to retain dirt, but is being used as a retaining wall.

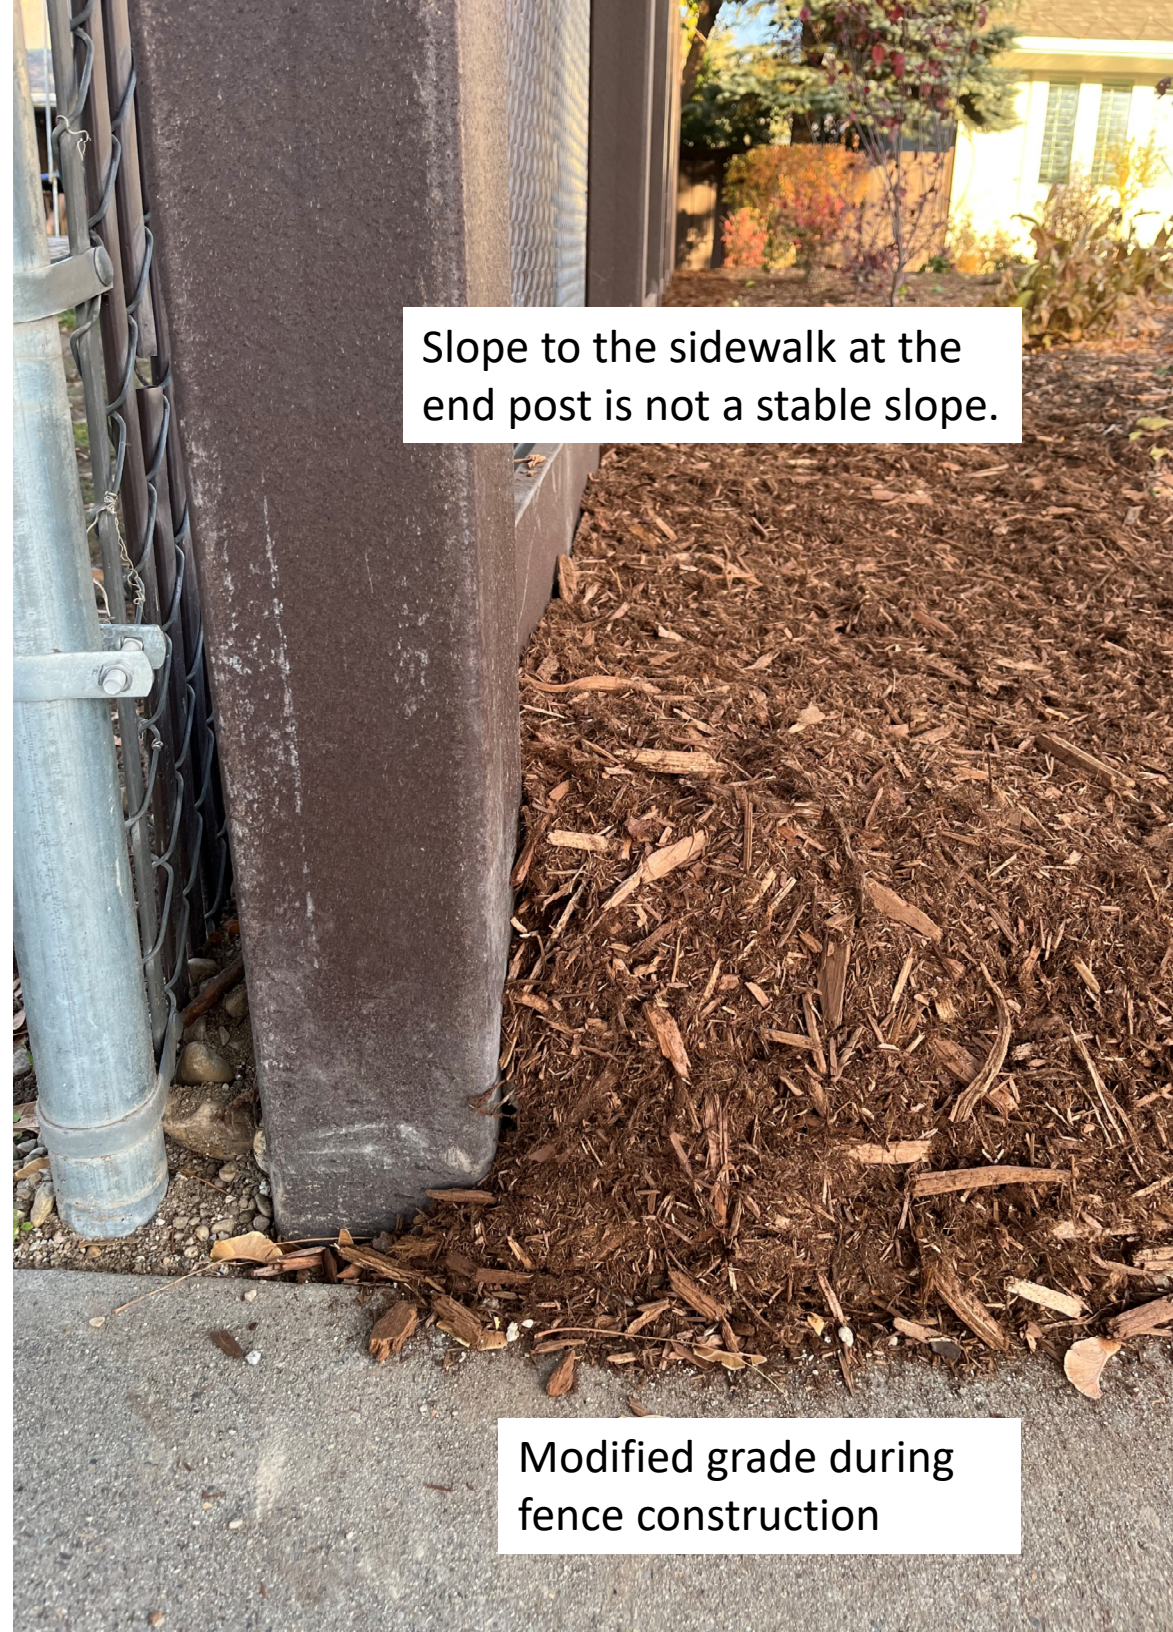
Grade has been built up along the property 7-"11" with the existing chain link fence used as a retaining wall.

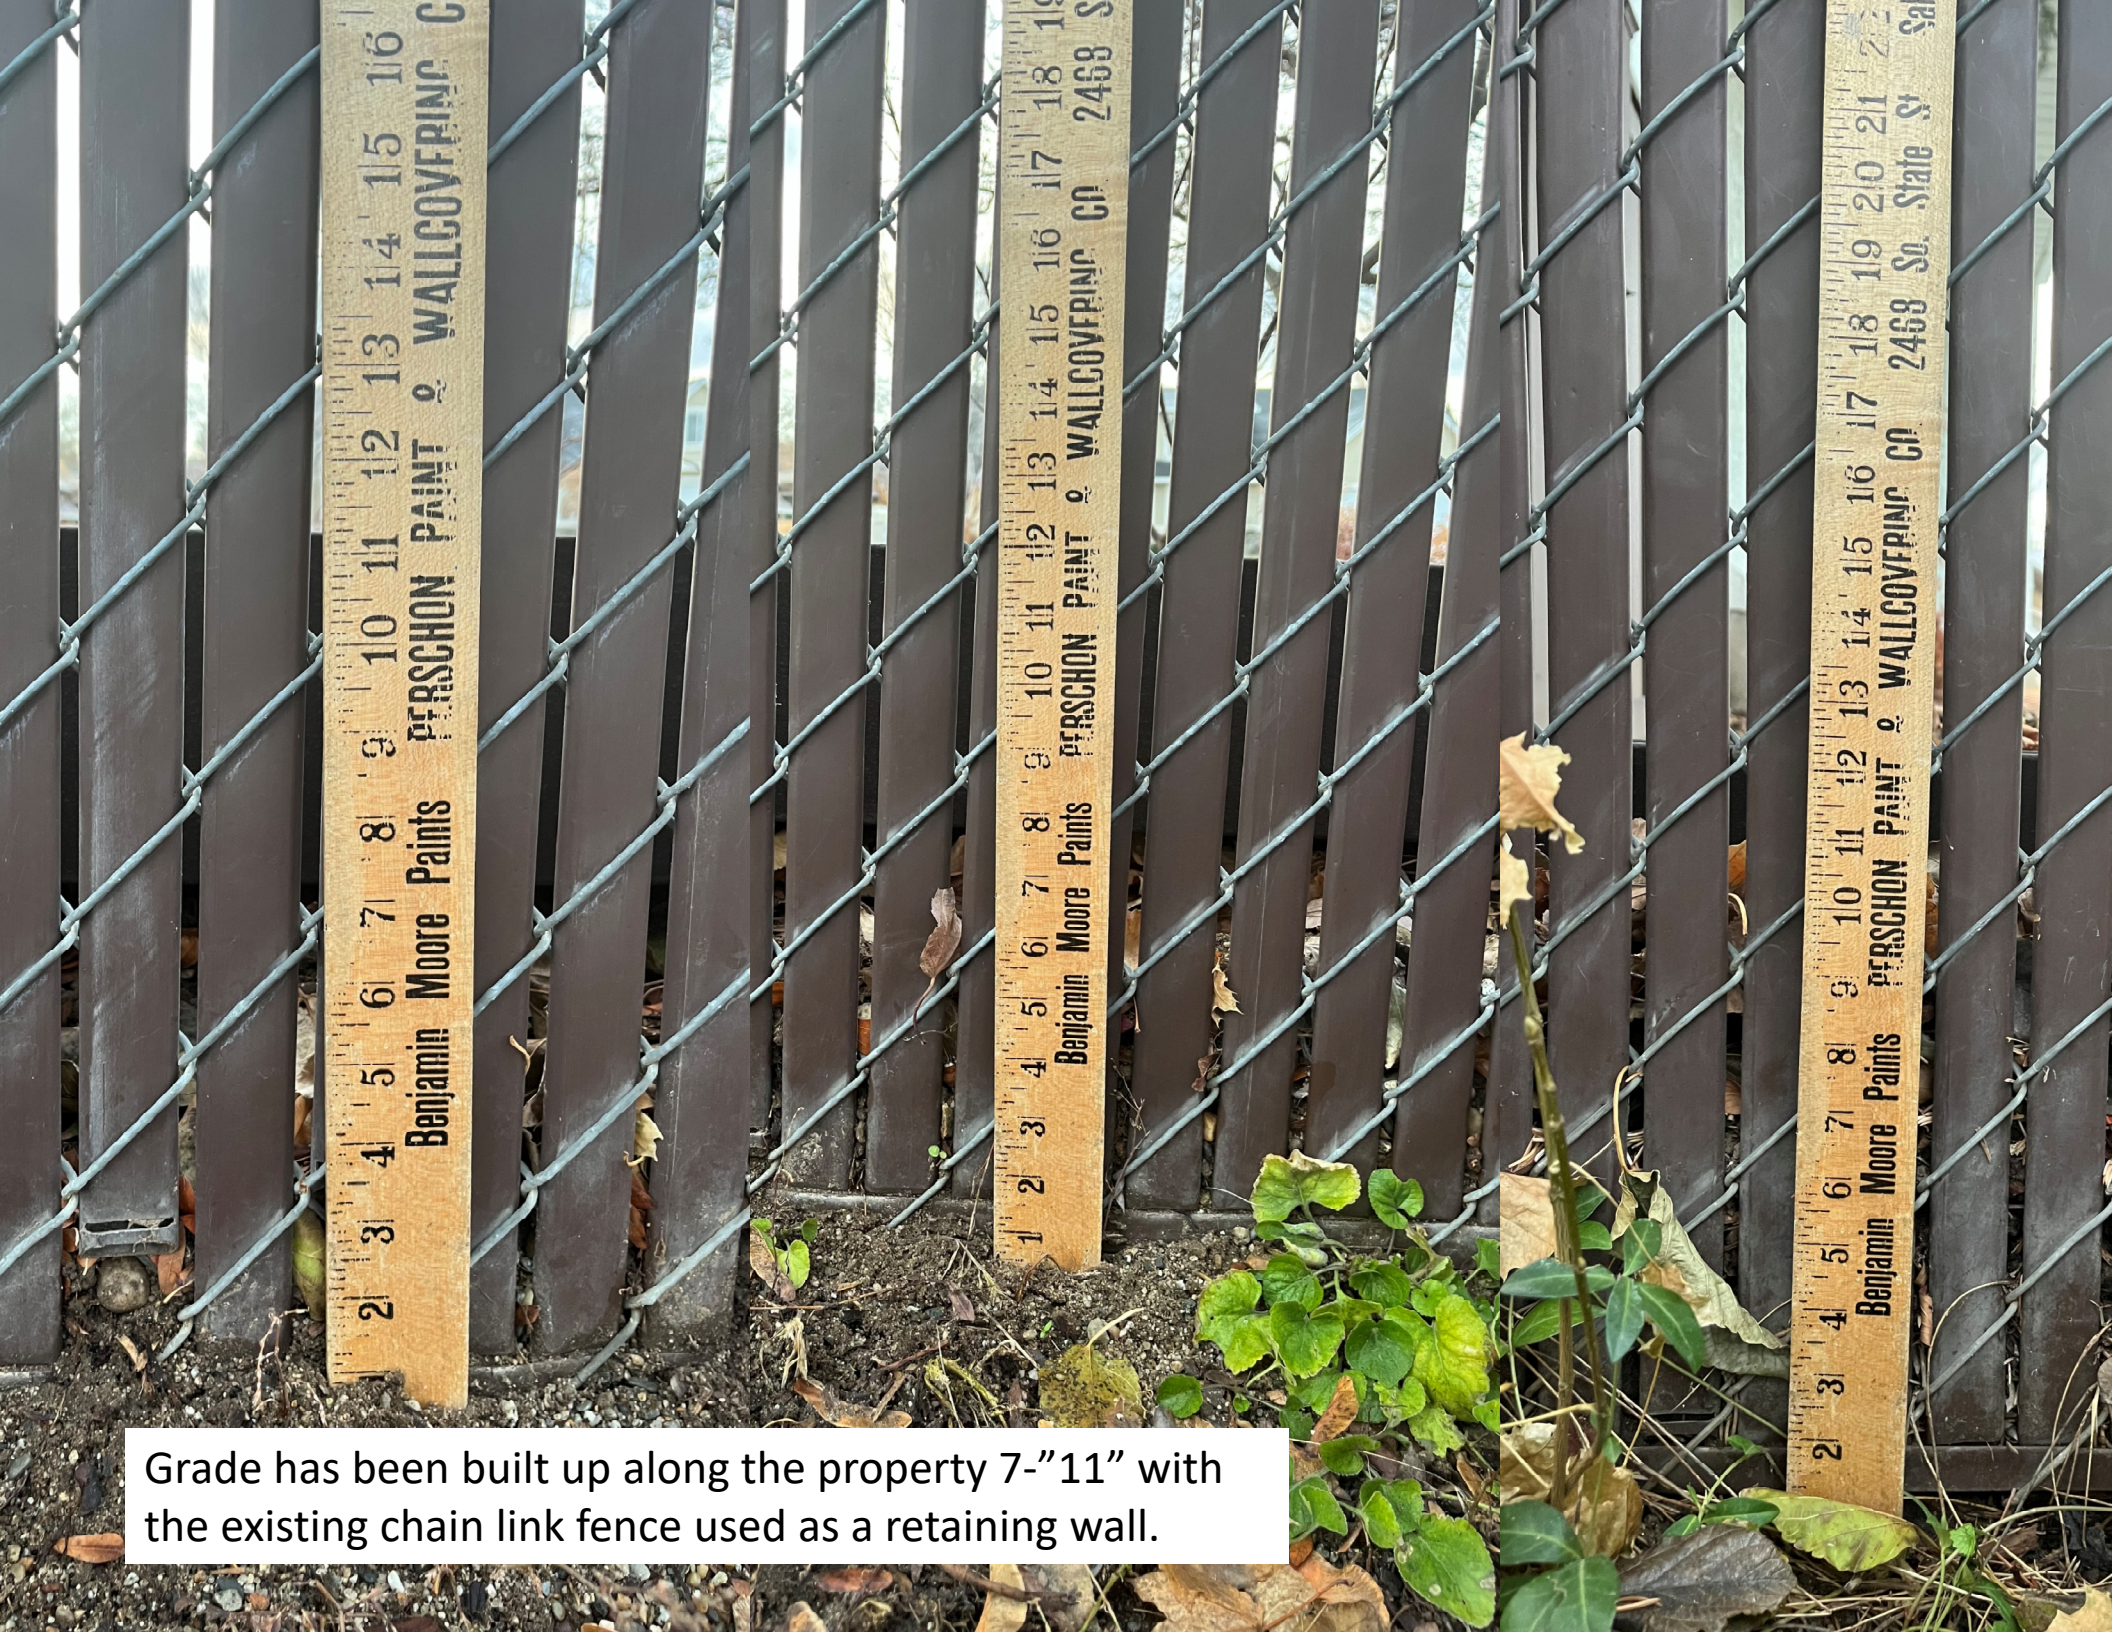
Grade has been built up along the property 7-"11" with the existing chain link fence used as a retaining wall.

As constructed, the fence would require us to apply for a conditional use permit if we replaced the fence along our west property line to have a consistent height along the sidewalk.

Fence height is nearly 7' at the sidewalk where the grade cannot be modified. A 7' fence along the sidewalk is not consistent with the neighborhood.

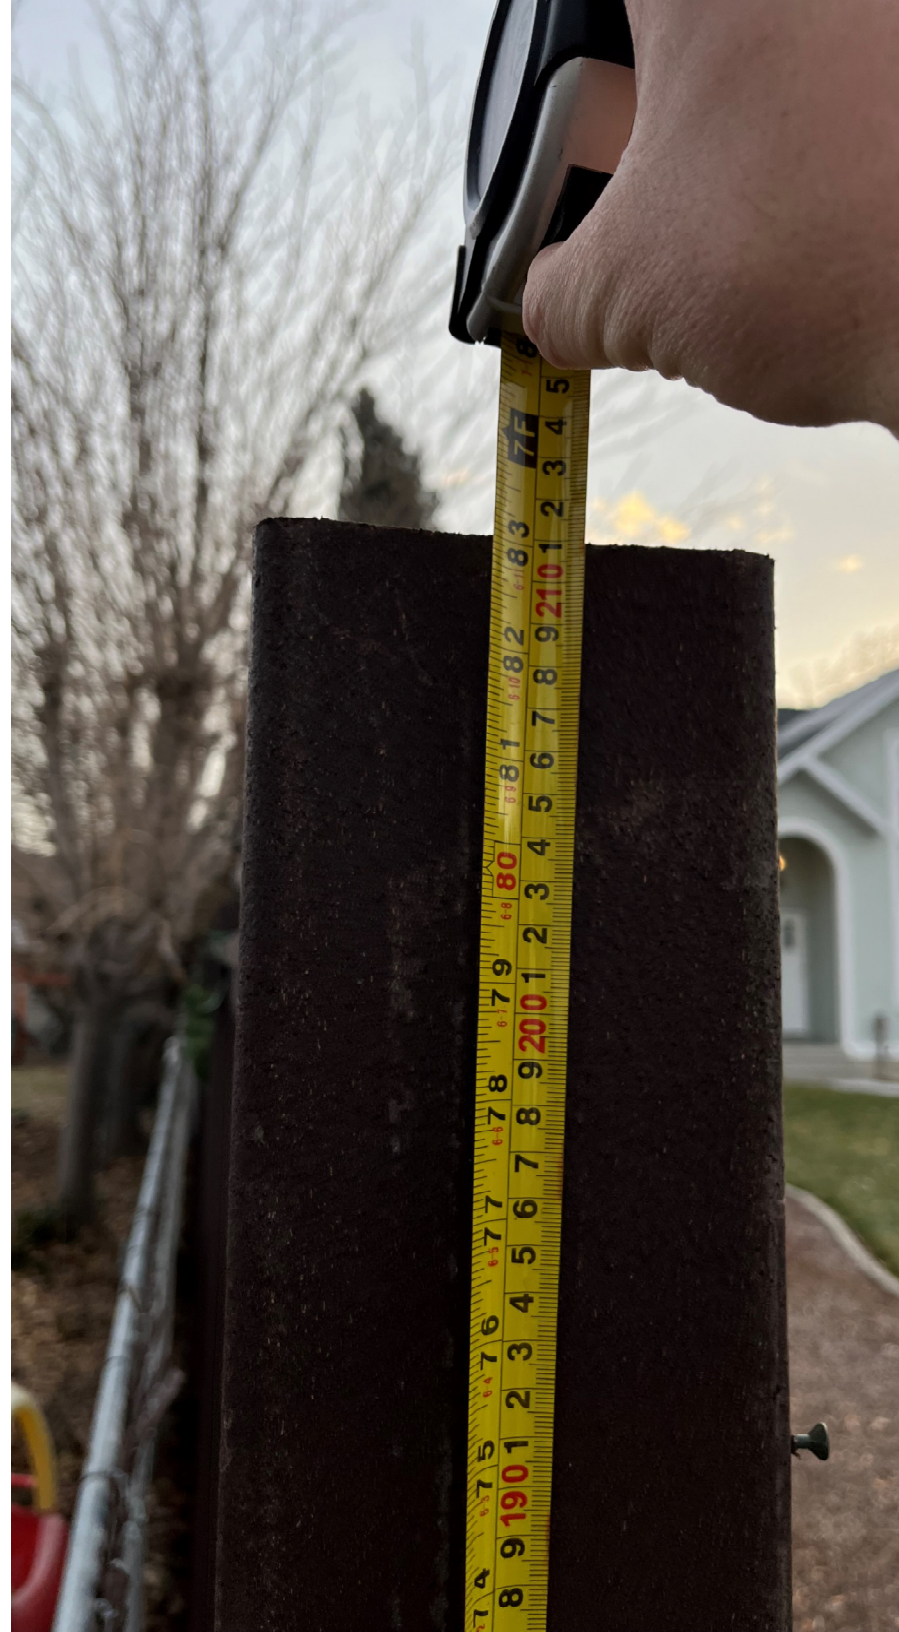
## Potential Structural Issue

The fence under construction is intended to be a 6' fence (6'-4" to top of posts) but is constructed as a 6'-8" to 7' fence. The foundations may not be deep enough to support the added height. Even if the grade is built up on the south side of the fence and compacted appropriately the fence would be less supported on the north and/or west side of the posts.

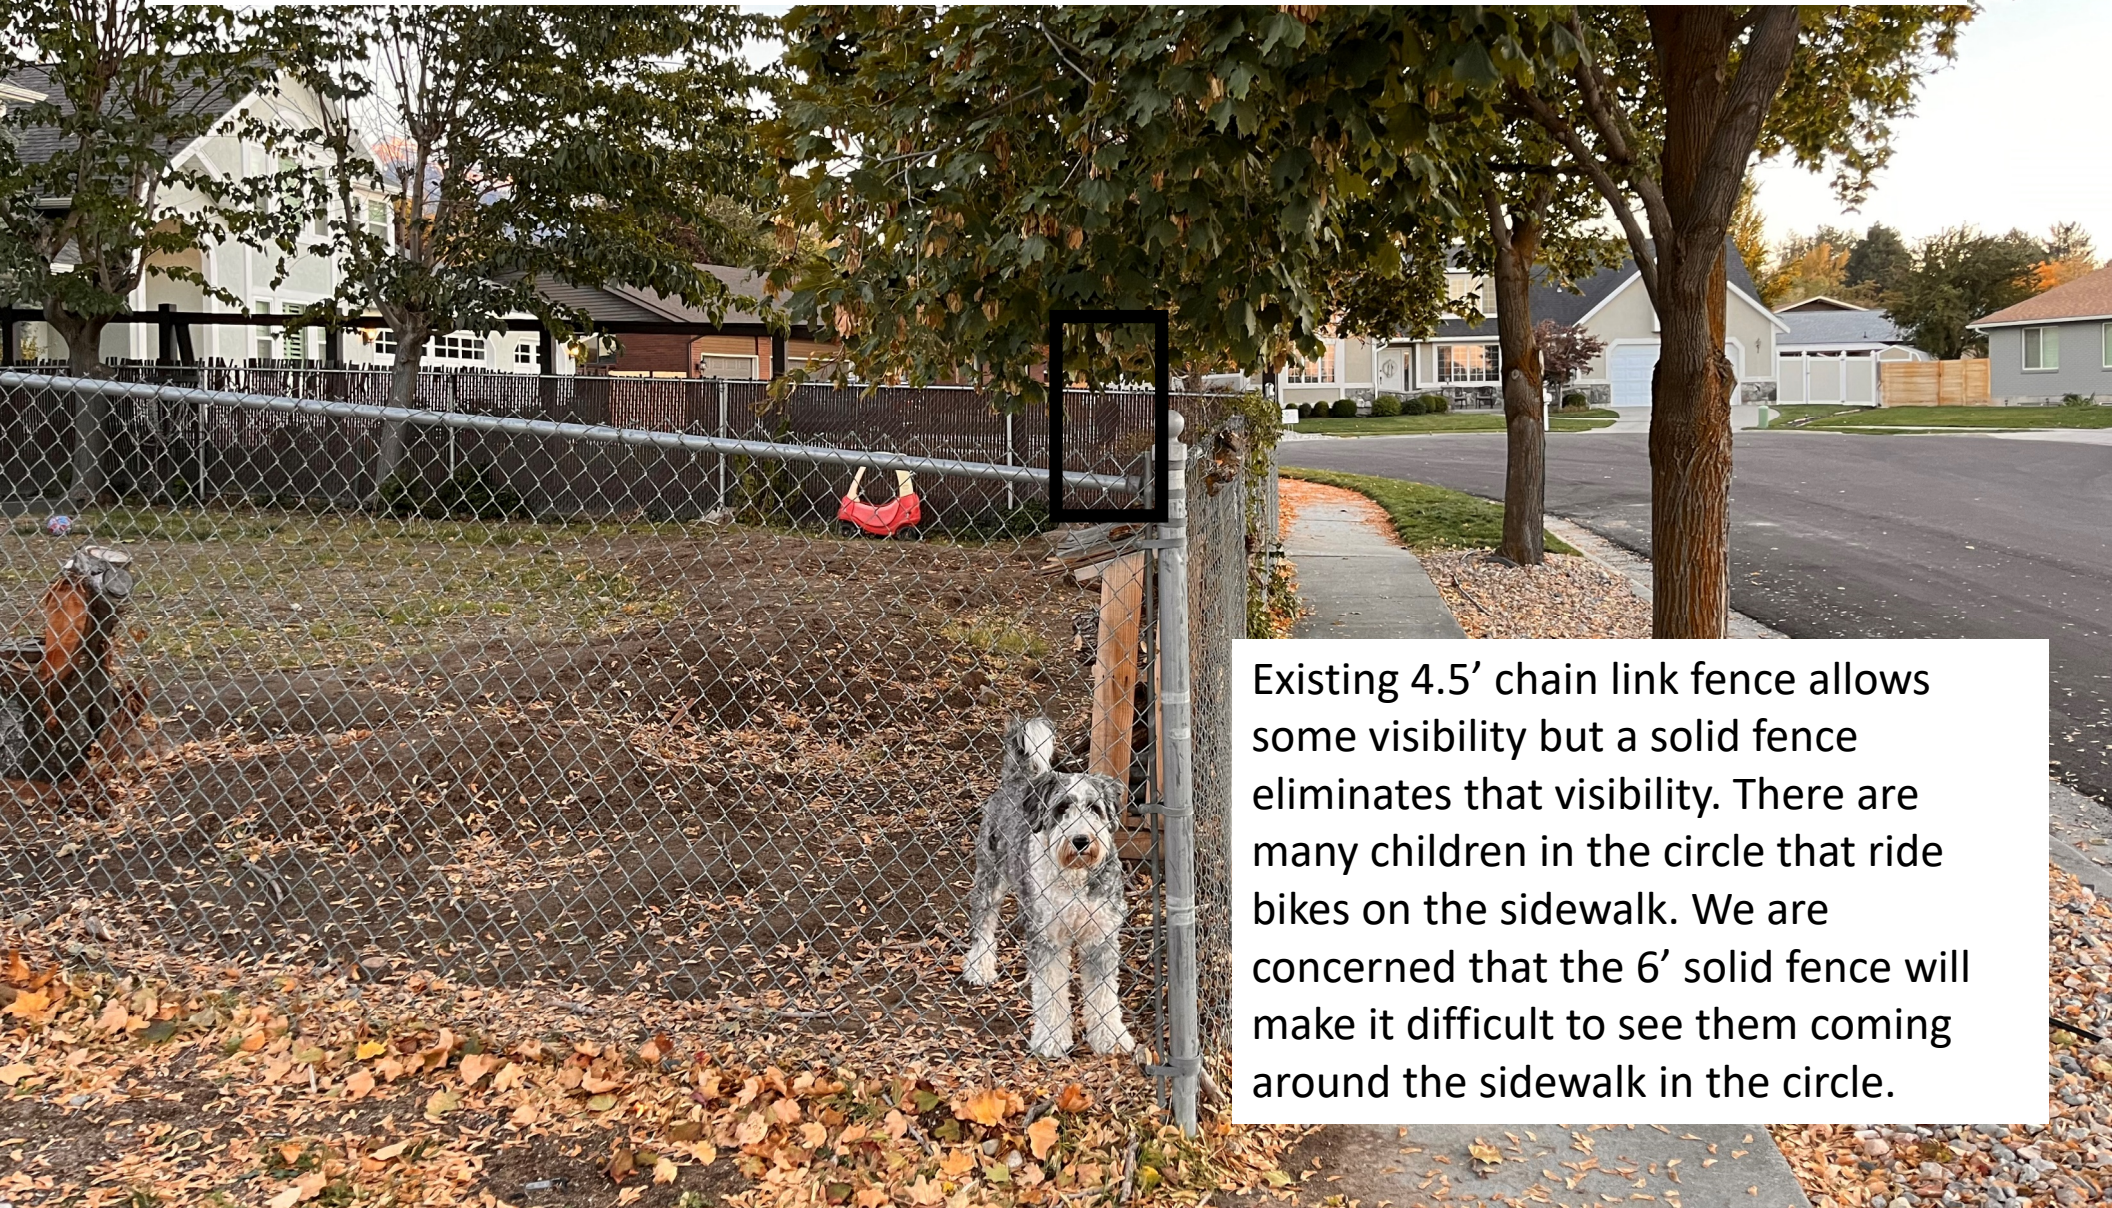
# Fence Impacts Visibility

Existing 4.5' chain link fence allows some visibility but a solid fence eliminates that visibility. There are many children in the circle that ride bikes on the sidewalk. We are concerned that the 6' solid fence will make it difficult to see them coming around the sidewalk in the circle.
