**PARK CITY HISTORIC PRESERVATION BOARD MEETING  
SUMMIT COUNTY, UTAH  
April 3, 2024**

6.A. **2465 Doc Holiday Drive – Material Deconstruction** - The Applicant Requests the Historic Preservation Board Determine Whether a Second Story Rear Deck on a Significant Historic Structure Located in the Single Family (SF) Zoning District May Be Removed. PL-23-05940 (Continued from March 6, 2024)  
(A) Public Hearing; (B) Action

7.A. **Land Management Code Amendment – Discussion Regarding Materials, Paint and Stain Opacity in Historic Districts** – The Historic Preservation Board Will Conduct a Work Session to Discuss Existing Standards in the Regulations for Historic Districts and Historic Sites Regarding Permitted/Prohibited Materials and Opacity Minimums for Paint and Stains. PL-24-06041

- 7.B. **Land Management Code Amendment – Historic District Regulations Illustrations** – The Historic Preservation Board Will Review Draft Illustrations of the Historic District Requirements and Provide Feedback to Staff. PL-24-06002

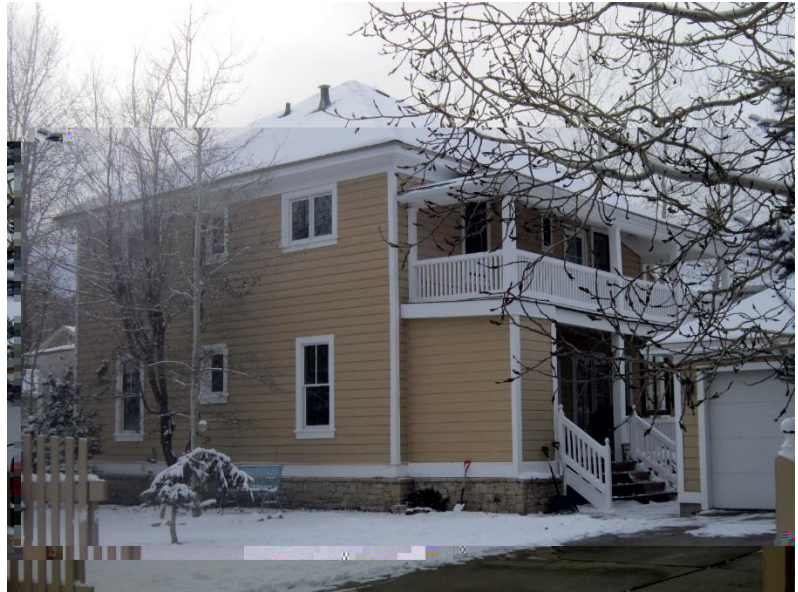
*Figure 1: View of rear second-story deck. (Nov 2013, HSI Form)*

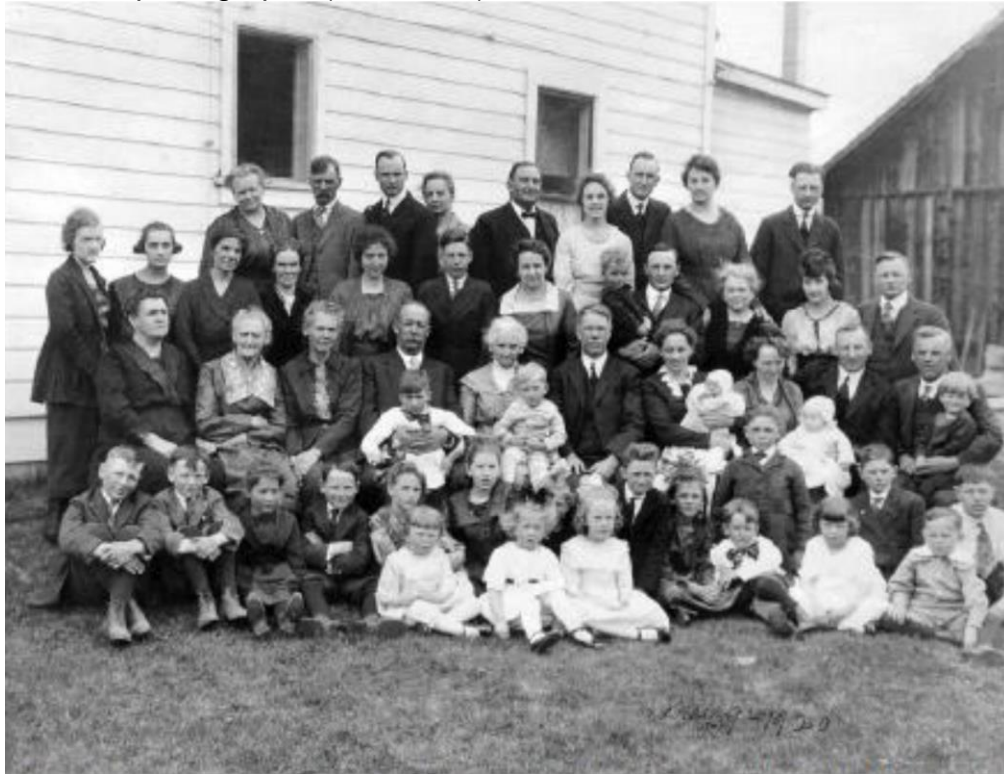
*Figure 4: Carruth family photograph, May 1920. Please see the column support for second-story deck seen in upper right-hand corner.*

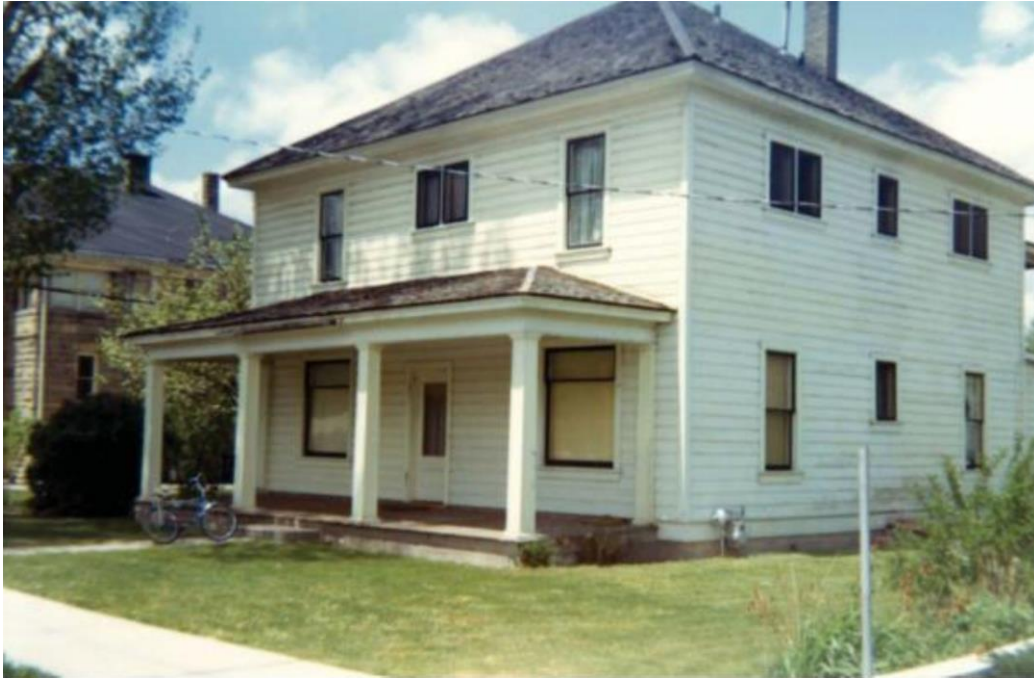
*Figure 5: 1970 photograph of house at original Coalville site; see Summit County Courthouse (left) and second-story rear covered deck (right).*

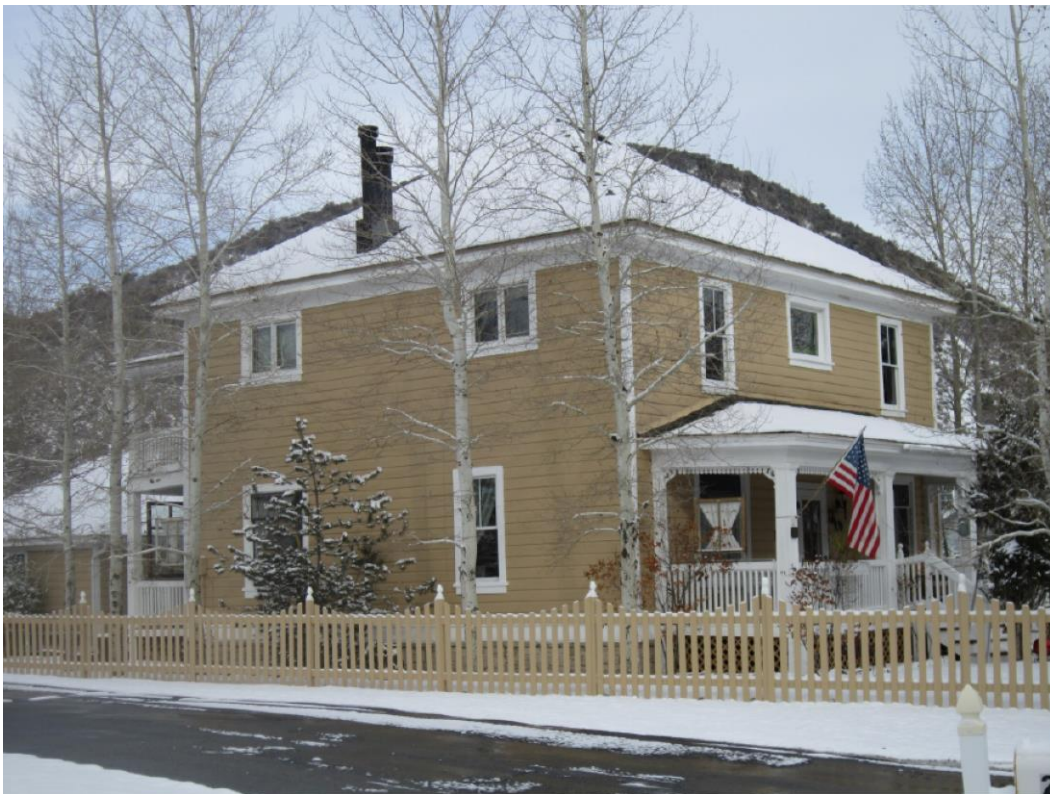
*Figure 6: 2013 Photograph of home showing front facade and corner of second story deck.*

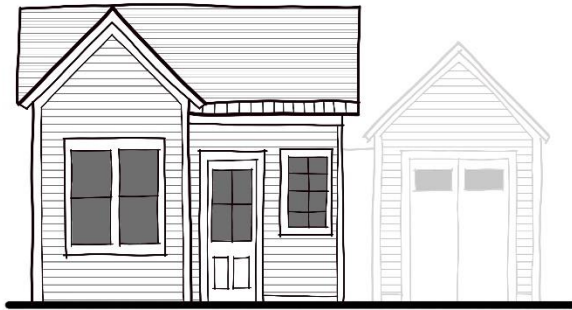
Additions should be visually subordinate to historic buildings when viewed from the primary public right-of-way.
