# SPRINGDALE Utah

## **Memorandum**

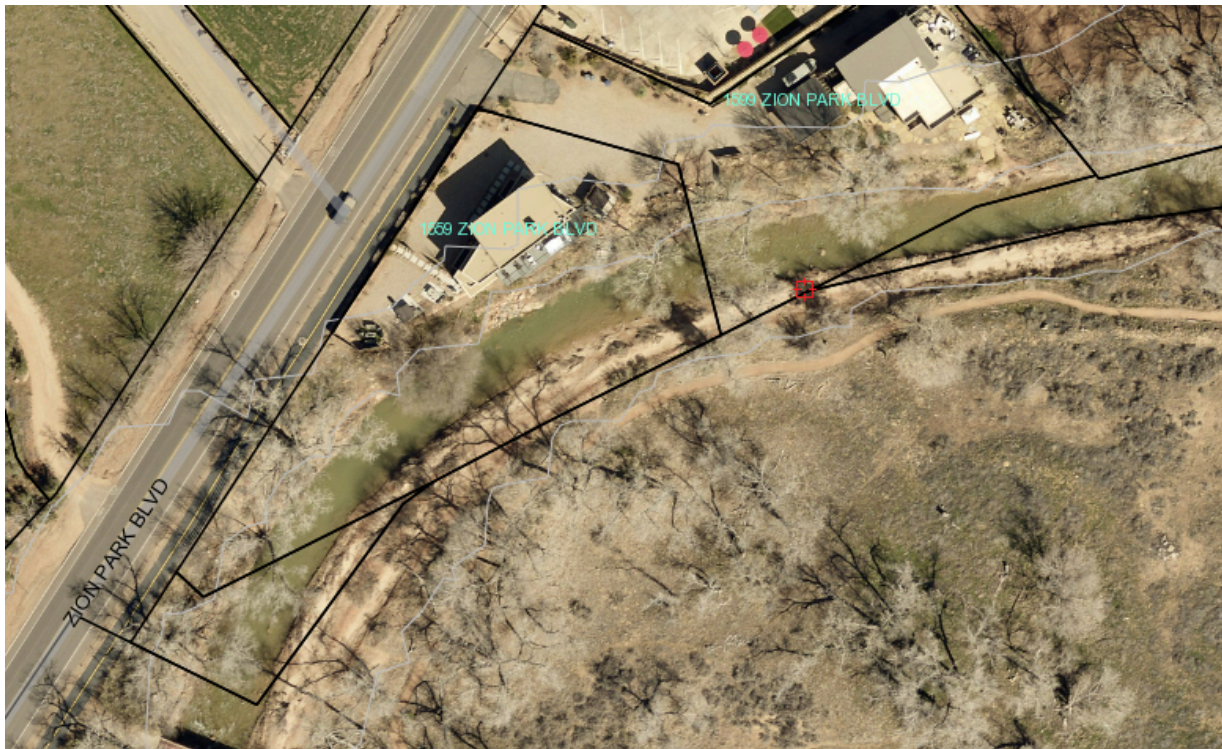
**Figure 4. Aerial view of the Spainhower's property**

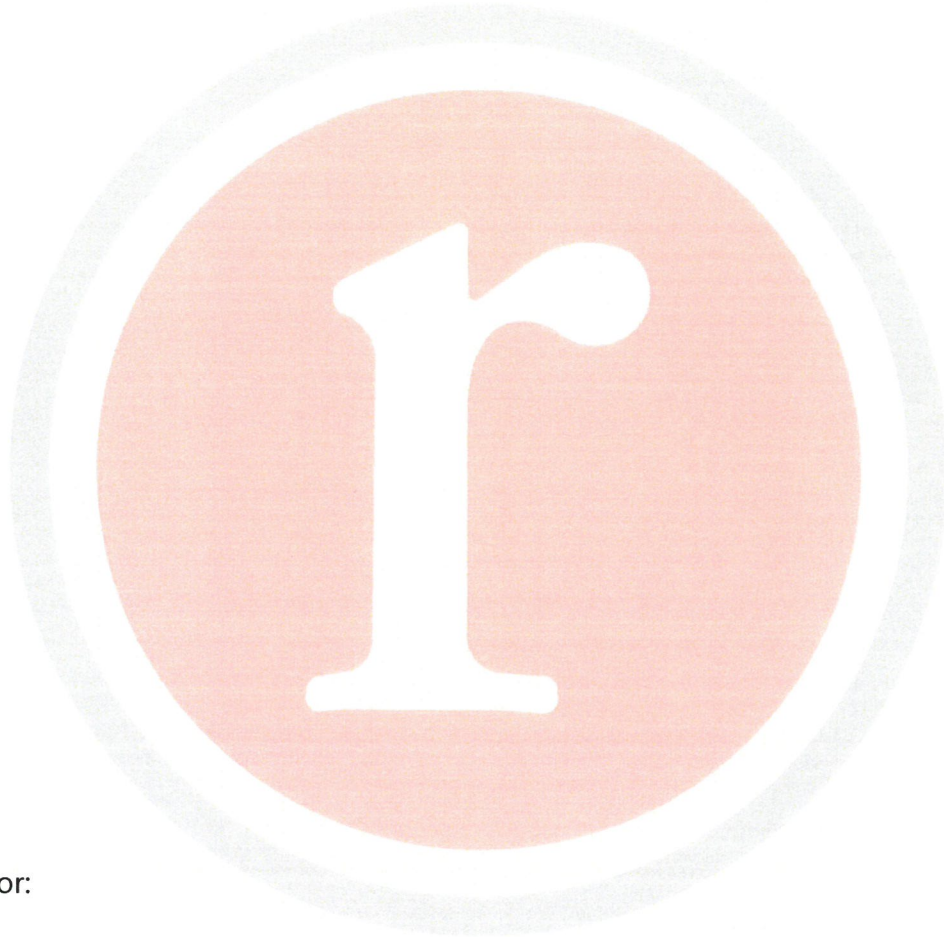
Zion Park Boulevard Erosion Protection  
Springdale, Utah

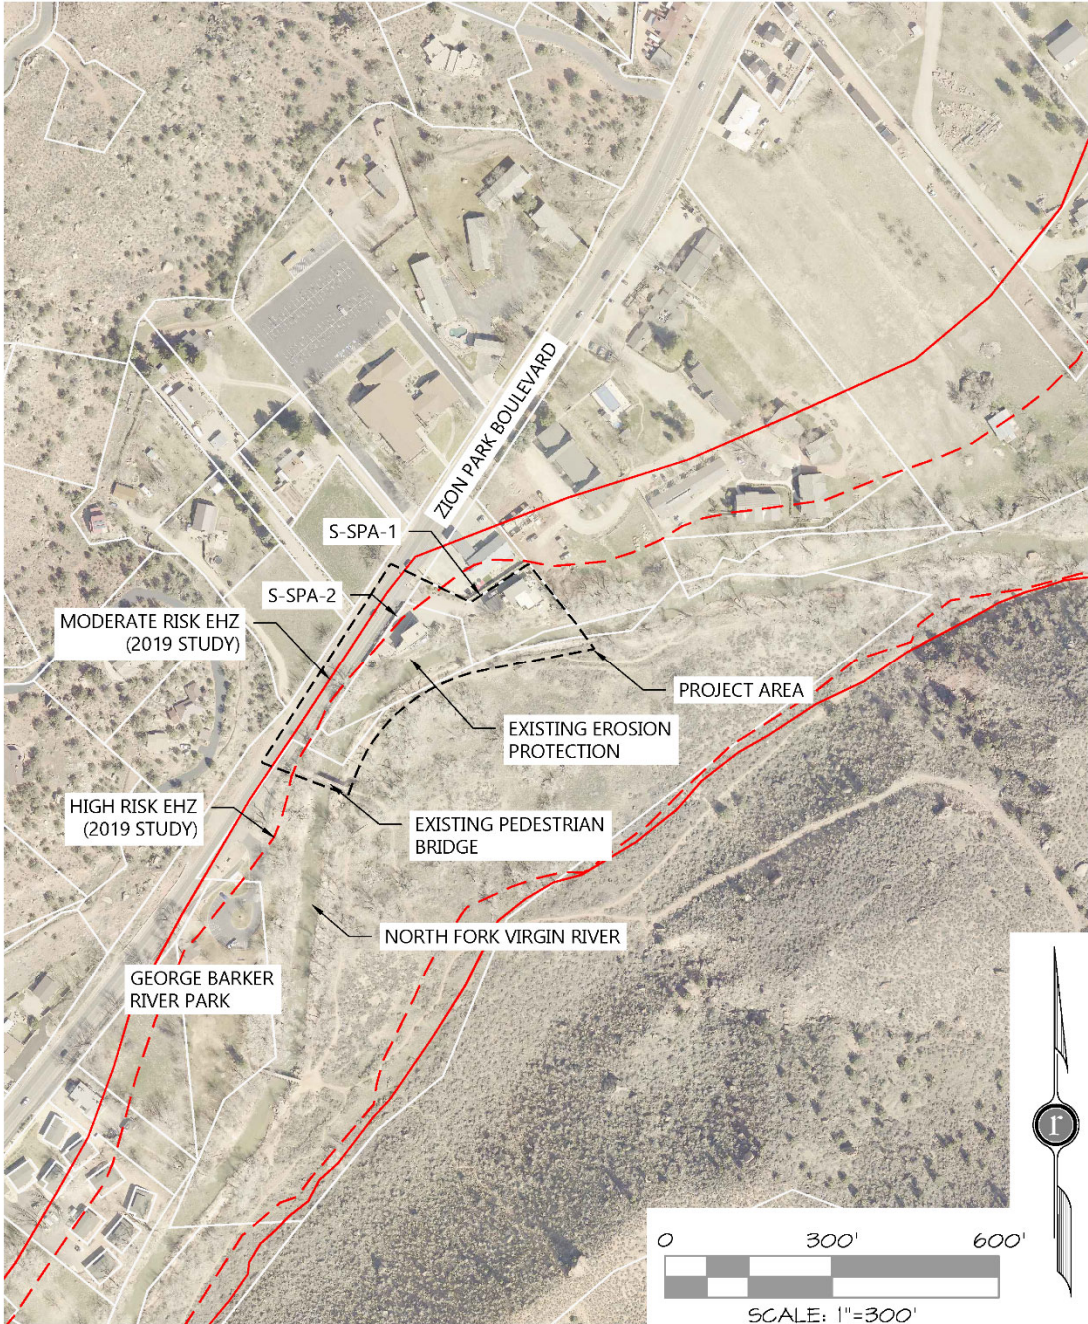
The Erosion Hazard Zone (EHZ) consists of areas adjacent to the river channel likely to suffer flood related damage by a typical series of flood events over a 60 year period, plus the erosion caused by a single 100 year flood event. The EHZ also includes areas prone to natural channel movement due to geomorphic processes such as meander migration or channel avulsion. It is important to recognize an EHZ is not a “no build” zone, but it serves notice to landowners of the inherent risk that should be addressed through engineering design, insurance, appropriate land uses or avoidance. The Town of Springdale requires an Erosion Hazard Assessment be completed as part of any proposed development or building permits issued on properties impacted by the established EHZ.

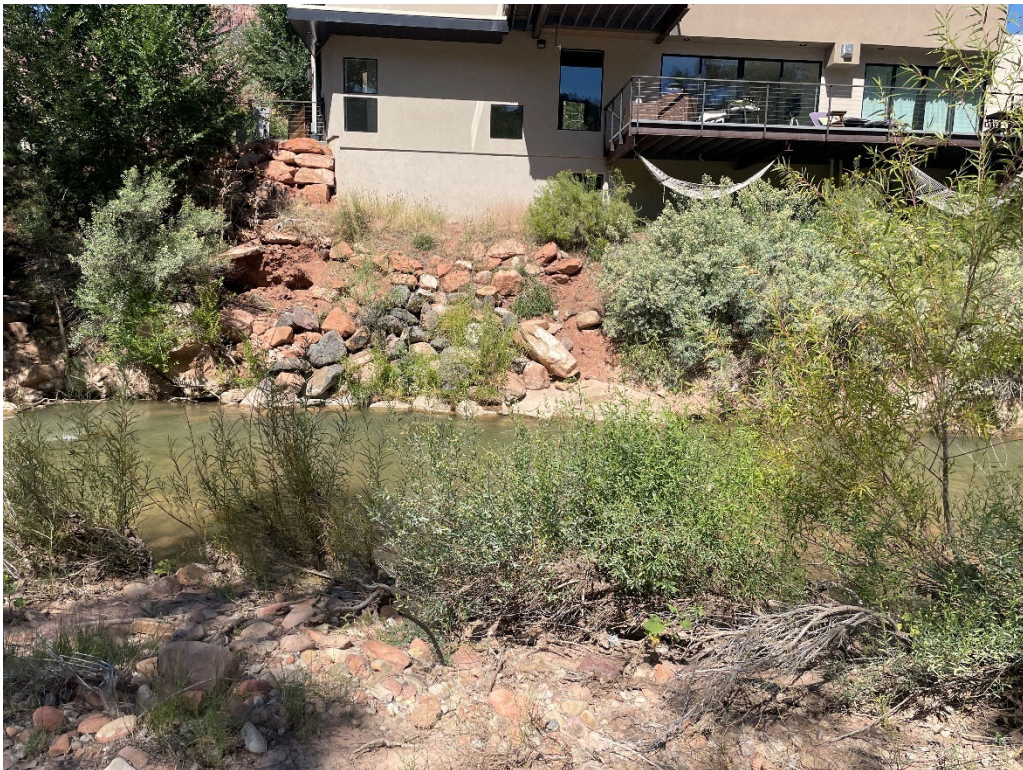
**Figure 5** – September 26, 2023. Looking across the North Fork of the Virgin River from the left (east) overbank at the existing erosion protection, located adjacent to the downstream residence. This erosion protection has previously been damaged by high flow events.

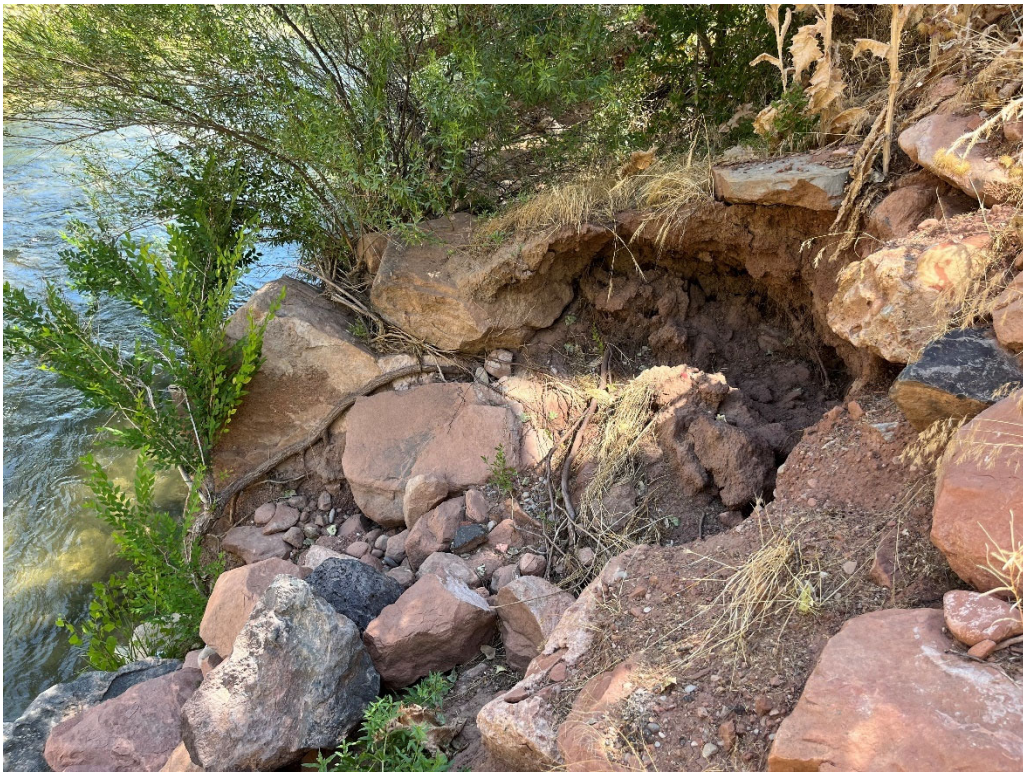
**Figure 6** – September 26, 2023. Closeup image of the damaged existing erosion protection adjacent to the downstream residence.

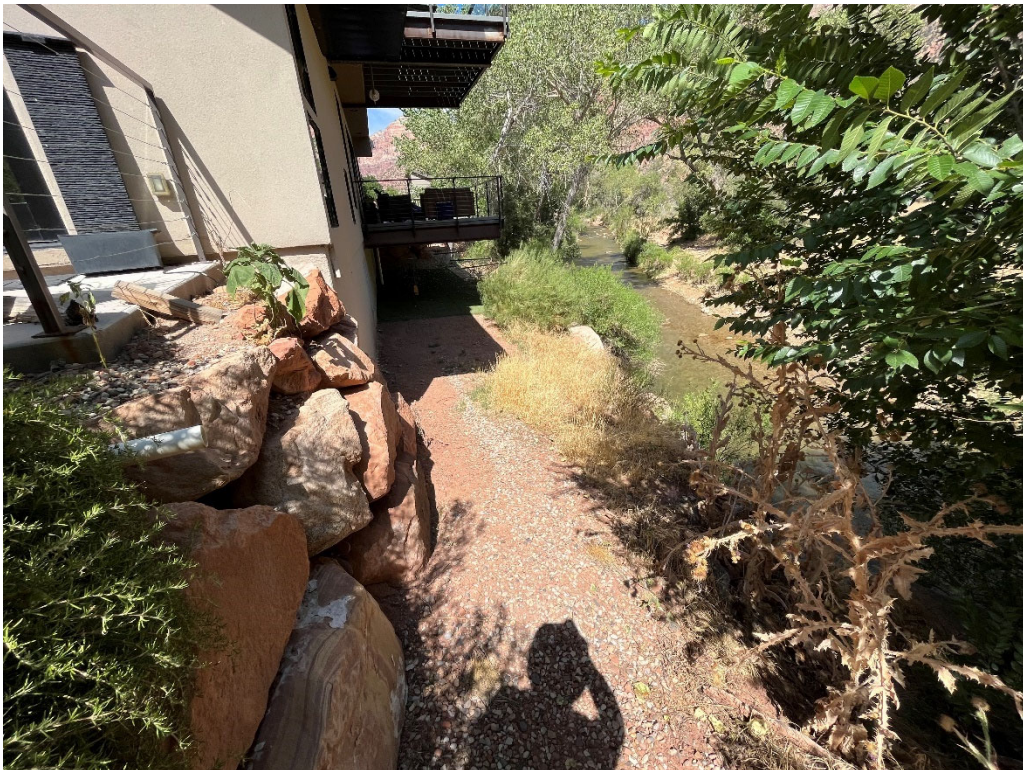
**Figure 7** – July 27, 2023. Looking upstream along the right (west) overbank at the downstream residence. This image depicts the proximity of the residential infrastructure to the top of the bank.

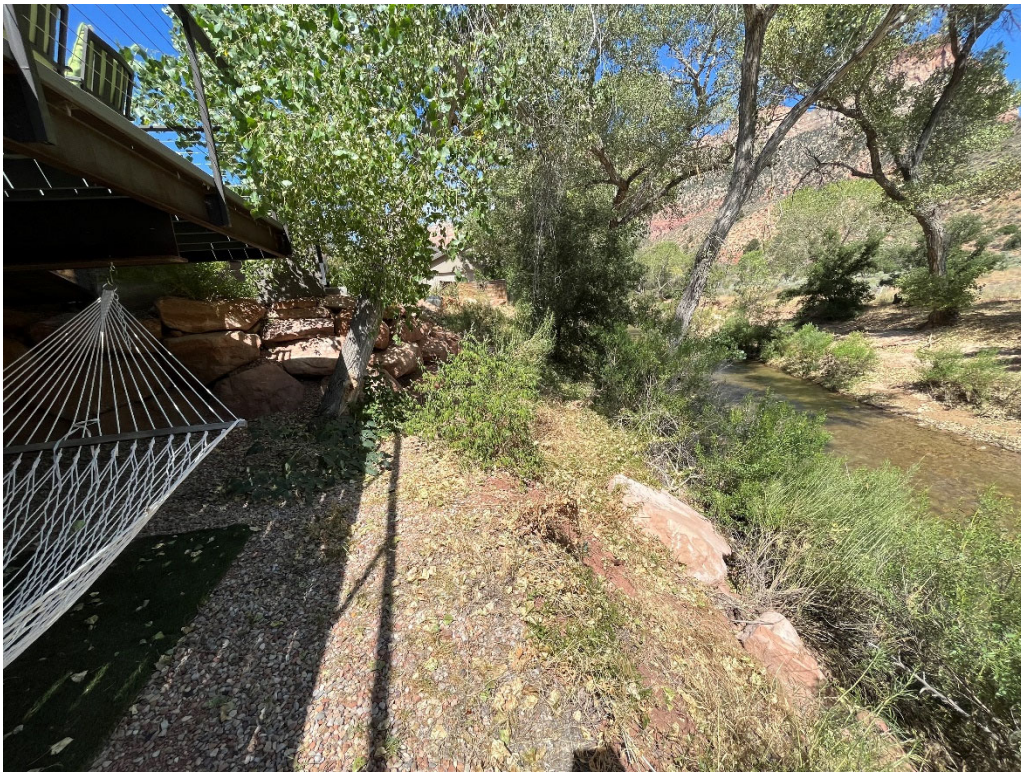
**Figure 8** – July 27, 2023. Looking upstream along the right (west) overbank adjacent to the downstream residence. A narrow band of riparian vegetation is present at the base of the damaged existing erosion protection.

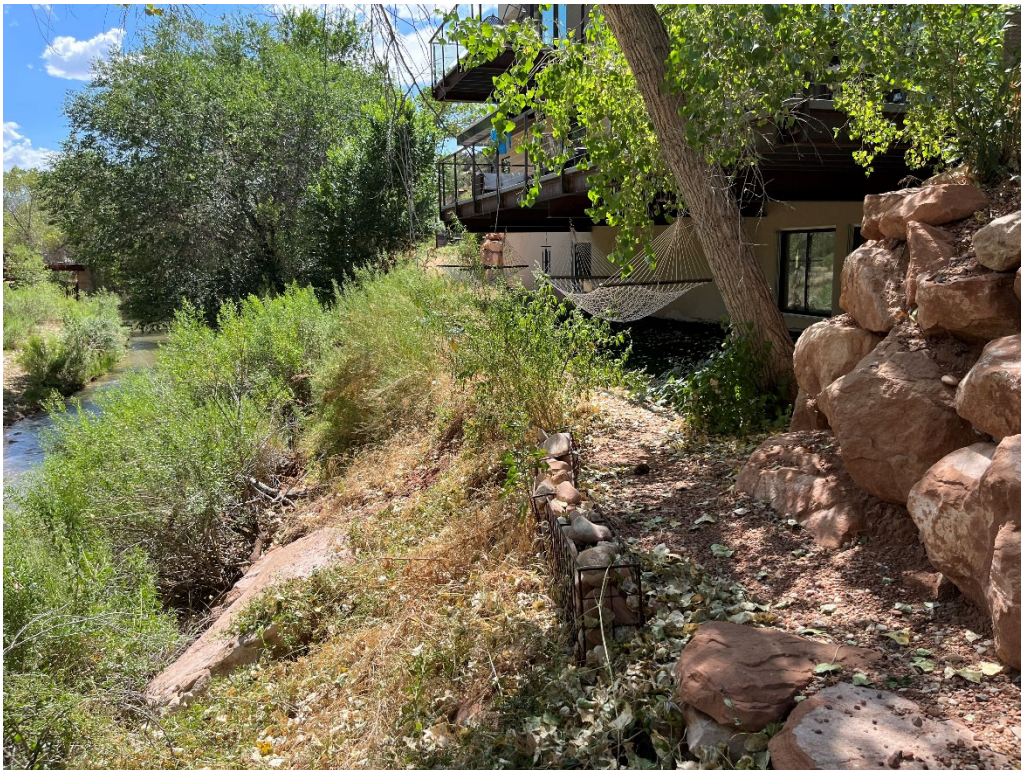
**Figure 9** – July 27, 2023. Looking downstream along the right (west) overbank adjacent to the retaining wall. This image depicts the proximity of the residential infrastructure to the top of the bank. A narrow band of riparian vegetation is present at the base of the bank.

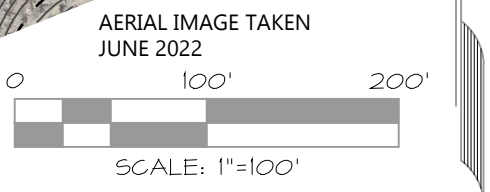
STA: 8+096.55  
 EFFECTIVE WSEL: 3817.8  
 EXISTING WSEL: 3818.19  
 PROPOSED WSEL: 3818.17

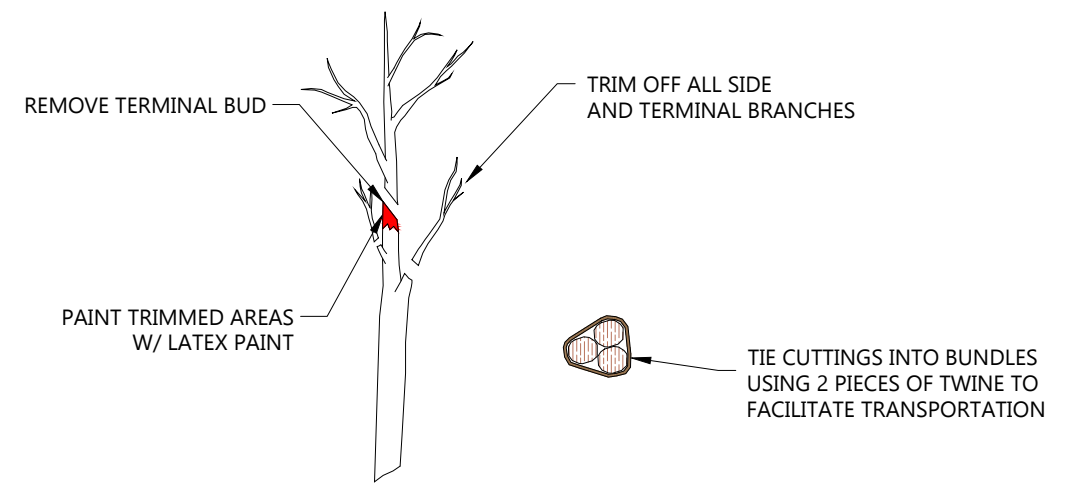
**C HARVESTED WILLOW**  
SCALE: 1"=2'

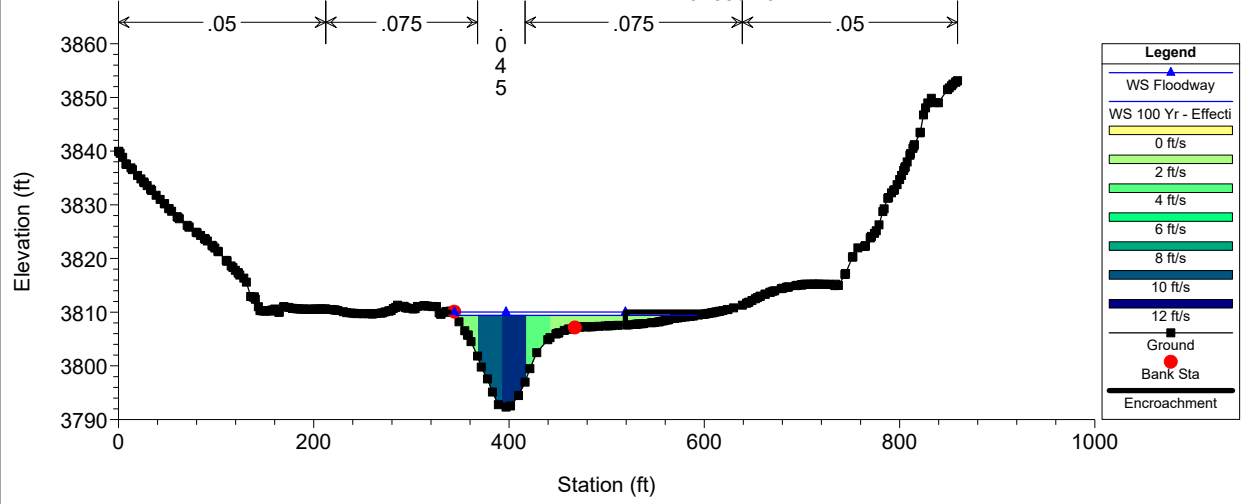
**HEC-RAS Model Results - Existing Conditions - North Fork Virgin River**

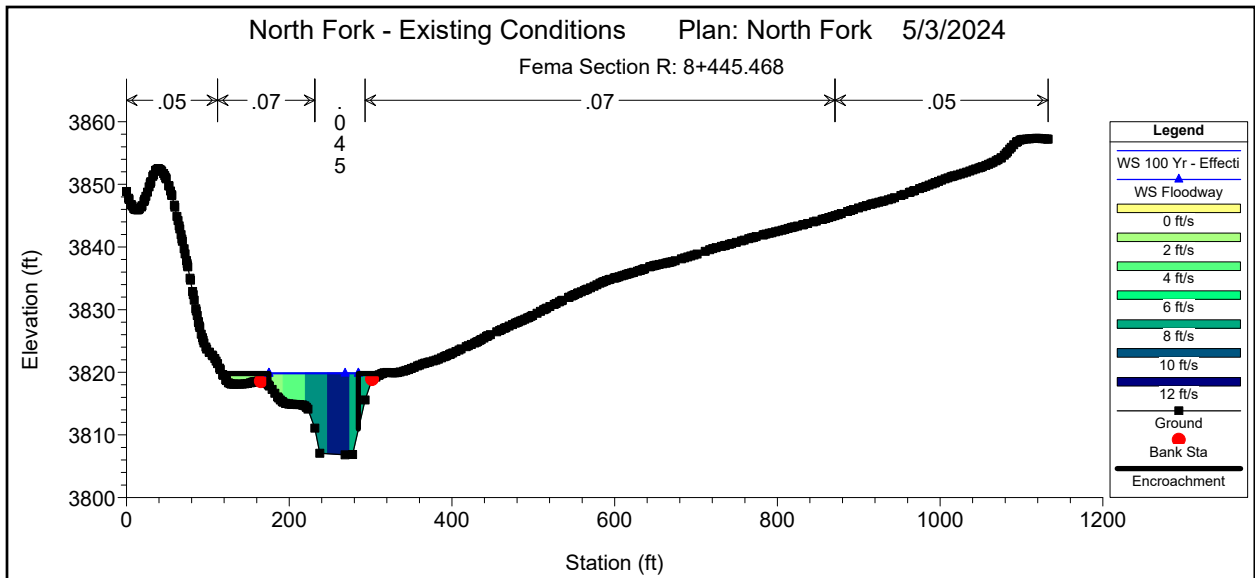
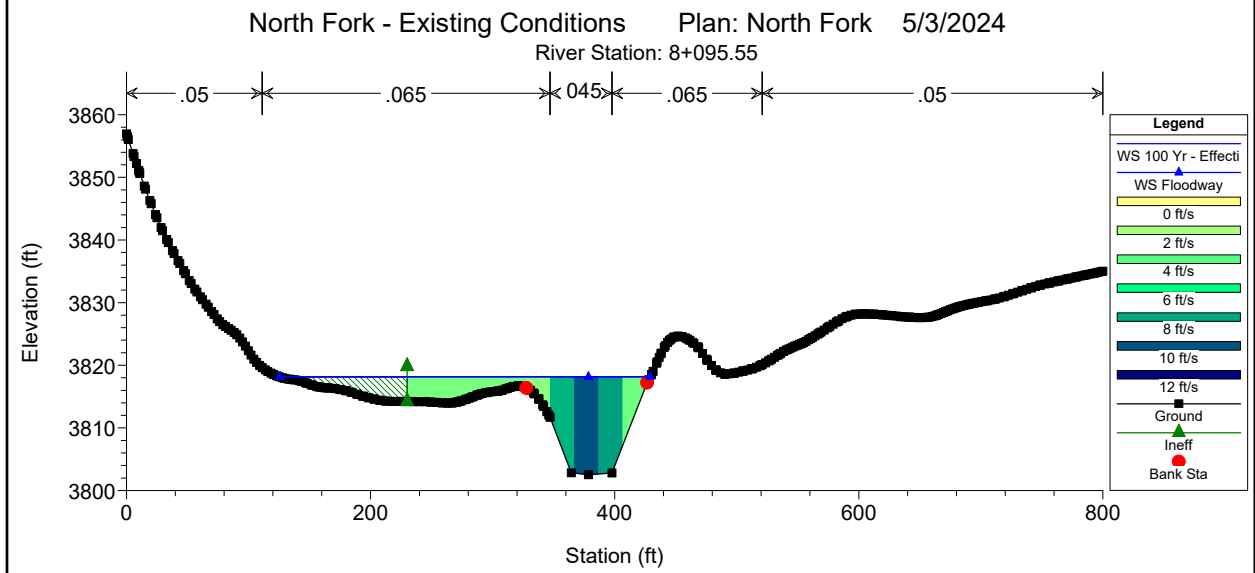
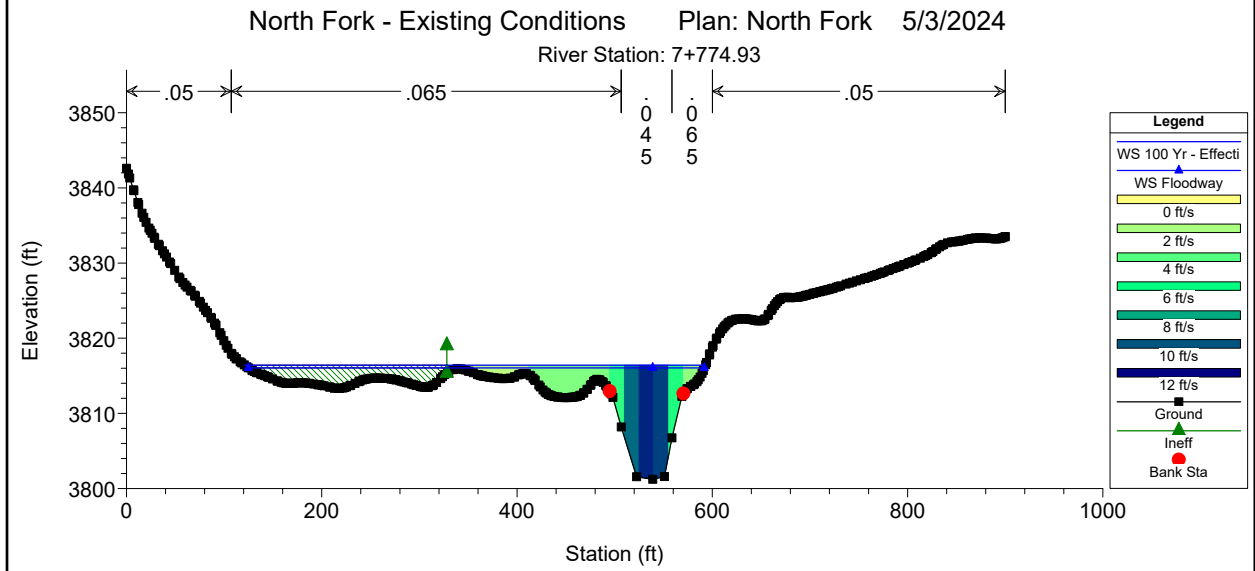
North Fork - Existing Conditions Plan: North Fork 5/3/2024

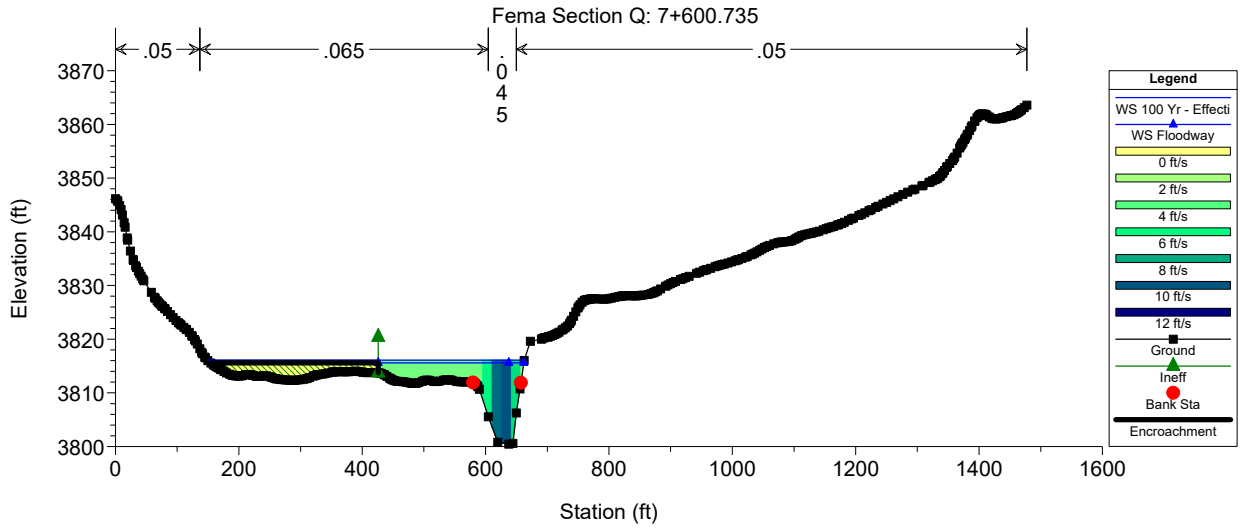
North Fork - Existing Conditions Plan: North Fork 5/3/2024

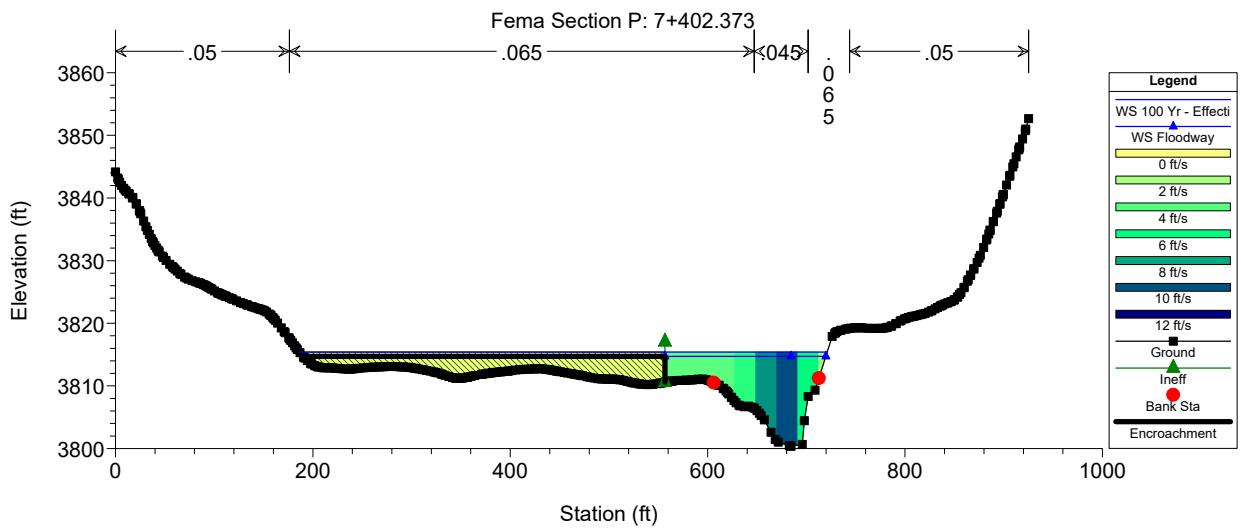
North Fork - Existing Conditions Plan: North Fork 5/3/2024

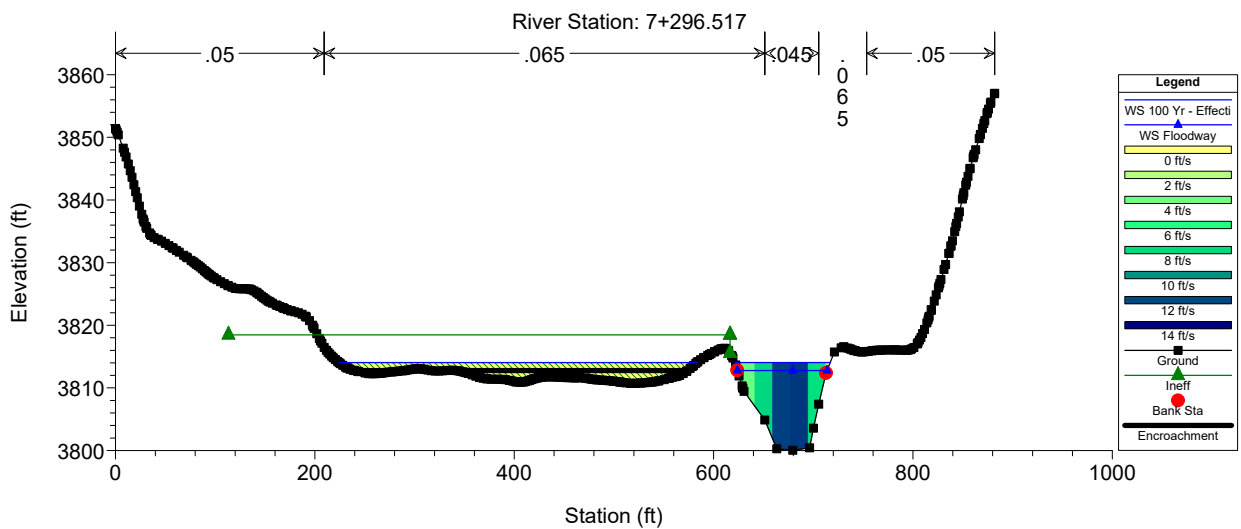
North Fork - Existing Conditions Plan: North Fork 5/3/2024

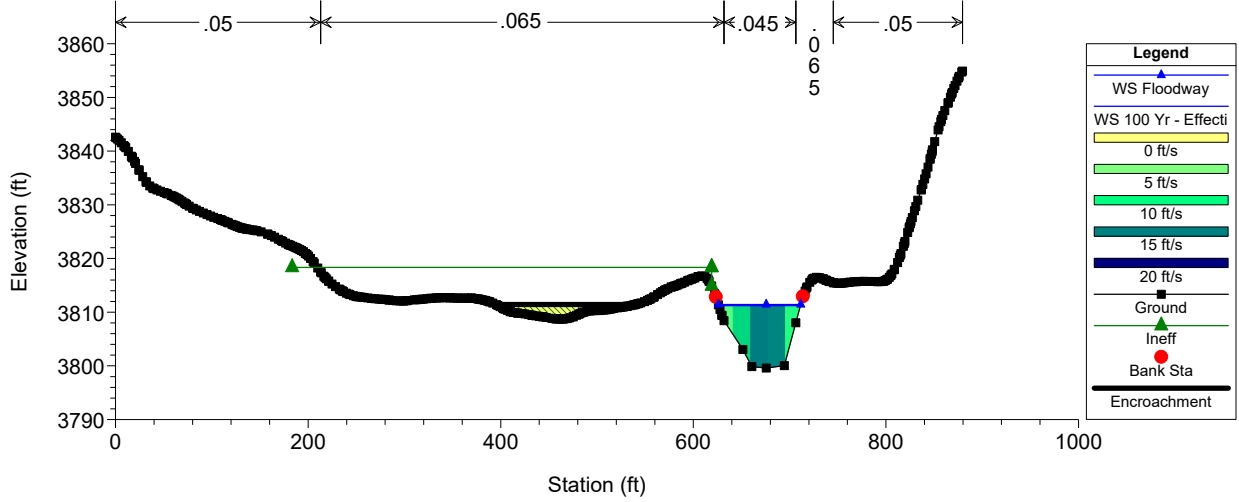
North Fork - Existing Conditions Plan: North Fork 5/3/2024

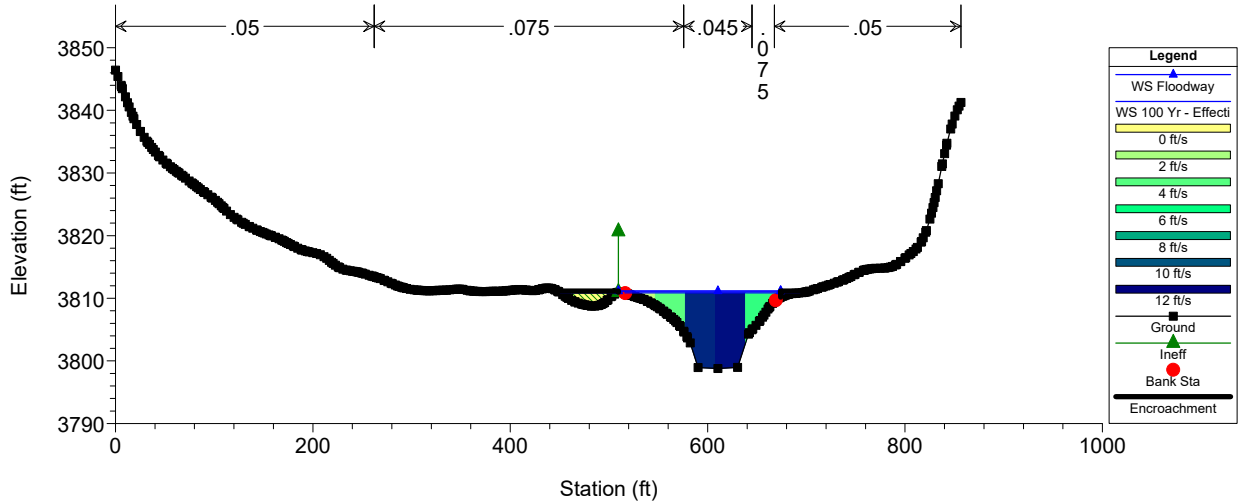
North Fork - Existing Conditions Plan: North Fork 5/3/2024

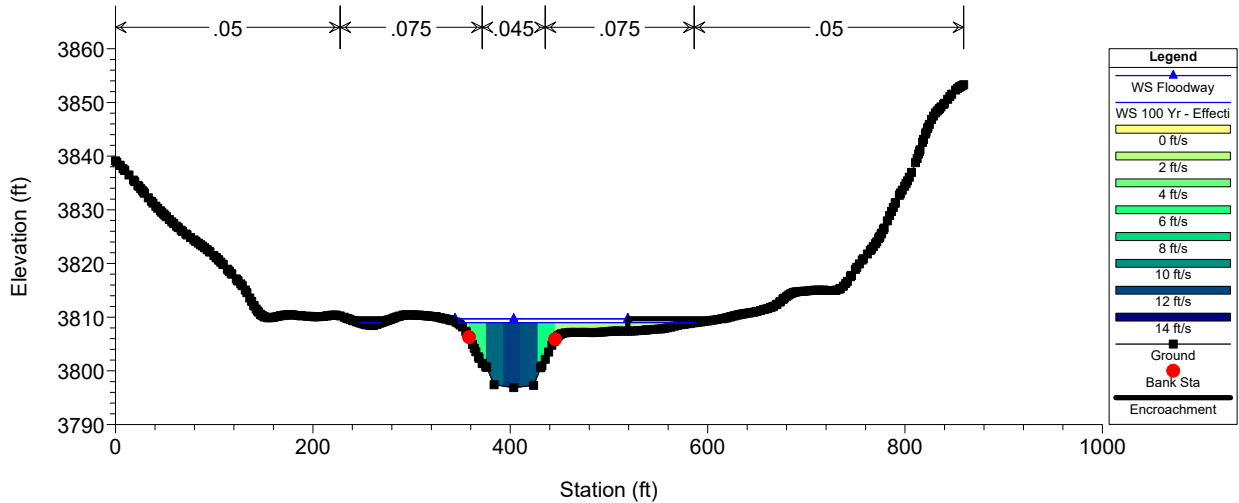
**HEC-RAS Model Results - Proposed Conditions - North Fork Virgin River**

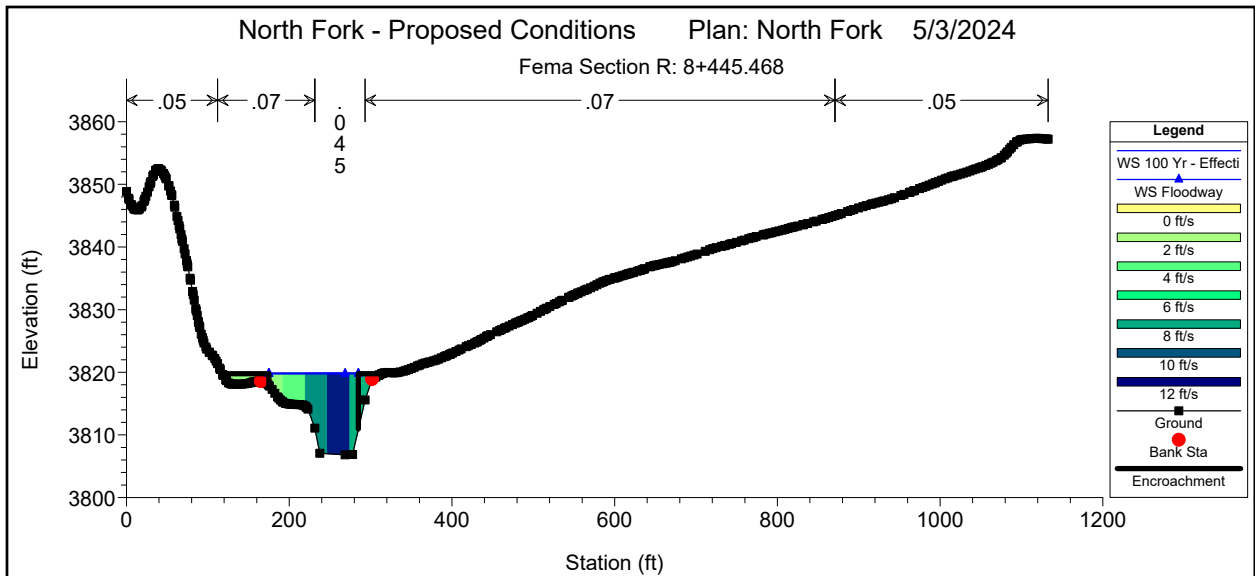
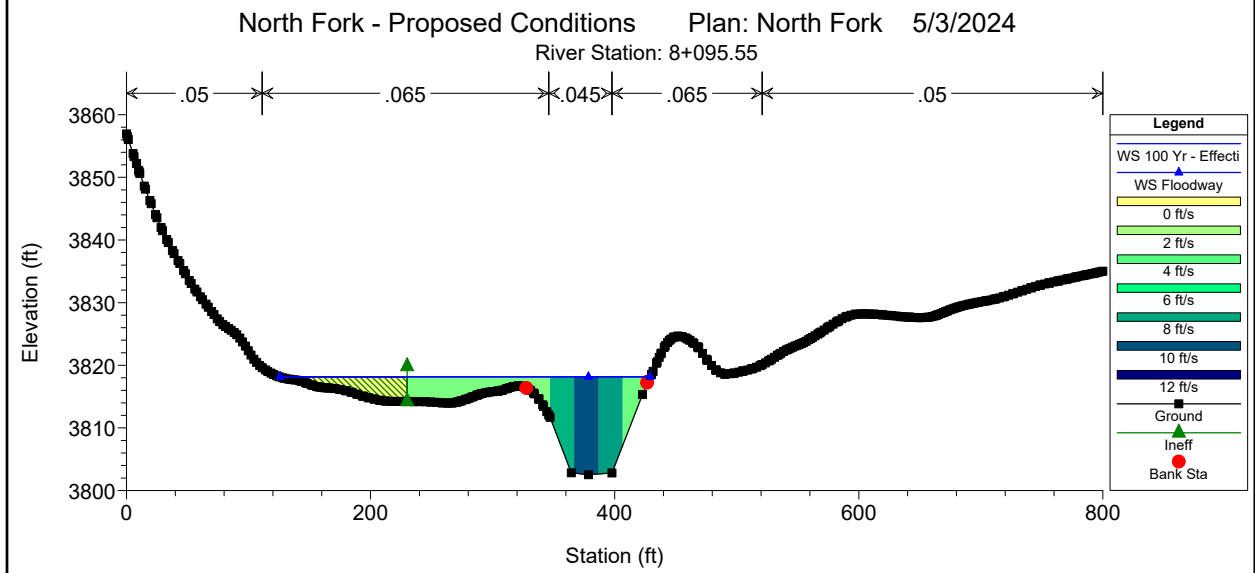
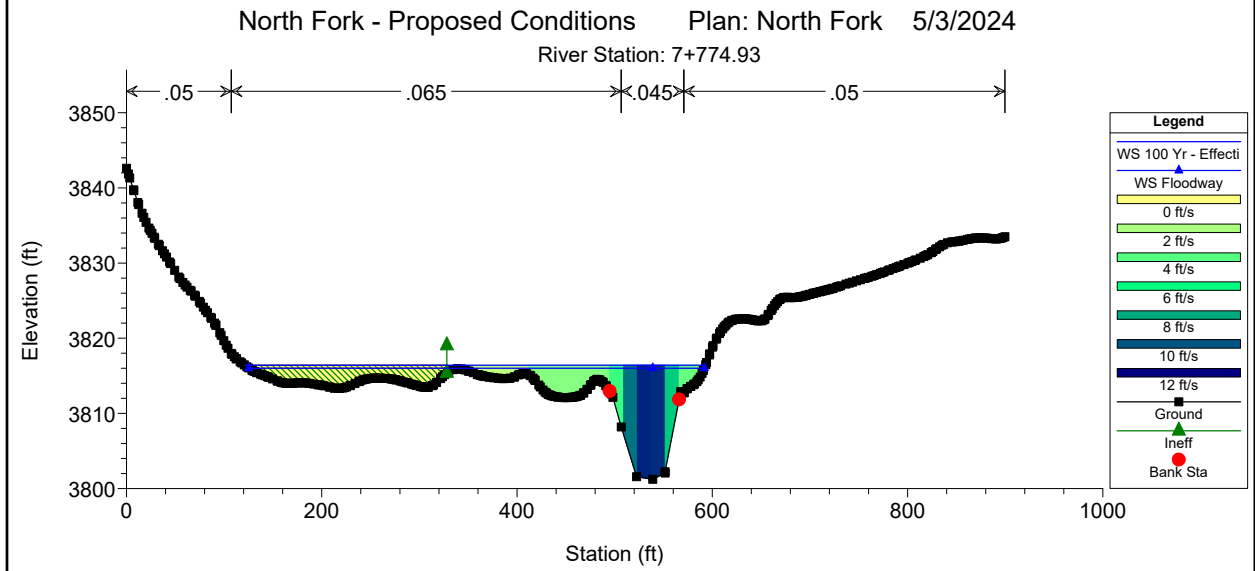
North Fork - Proposed Conditions Plan: North Fork 5/3/2024

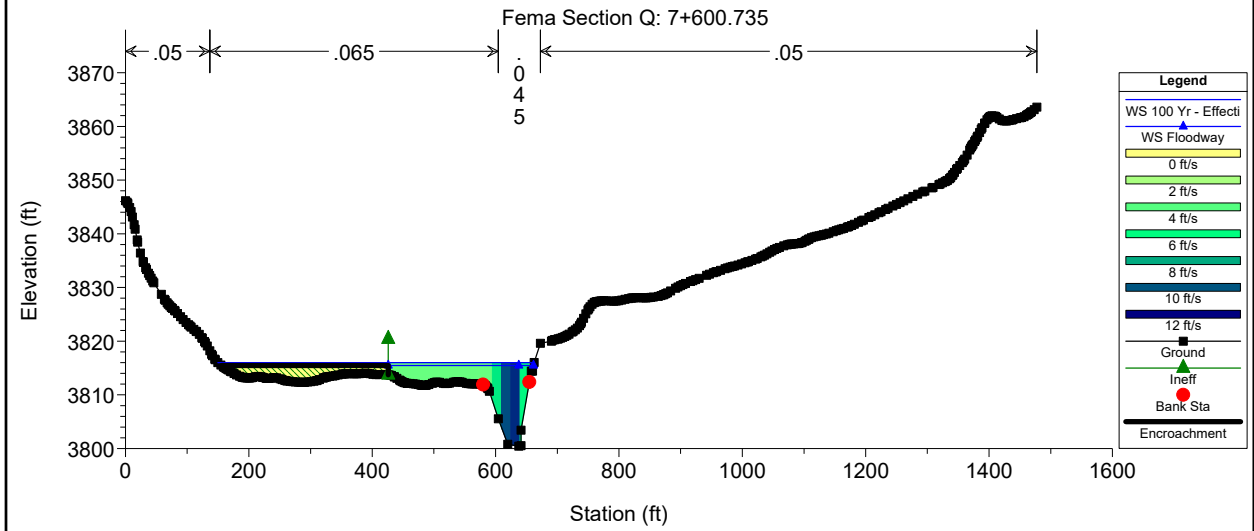
North Fork - Proposed Conditions Plan: North Fork 5/3/2024

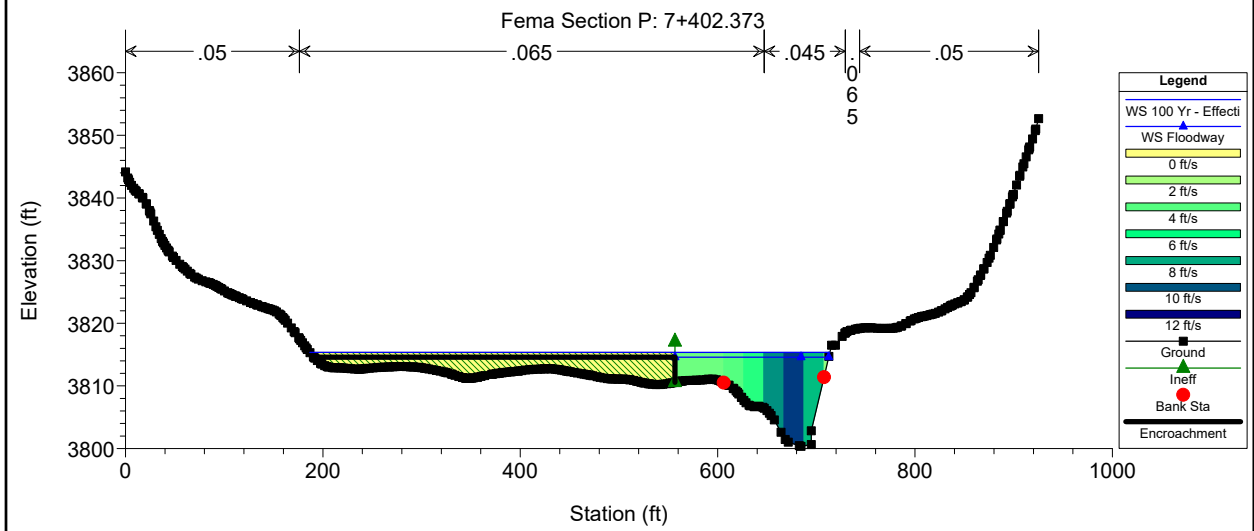
North Fork - Proposed Conditions Plan: North Fork 5/3/2024

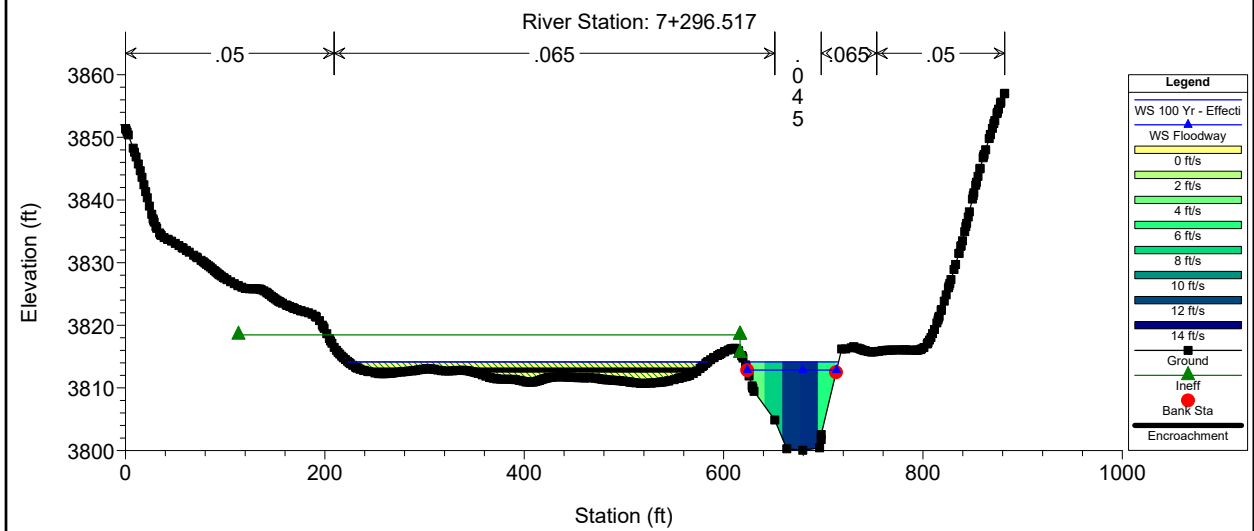
North Fork - Proposed Conditions Plan: North Fork 5/3/2024

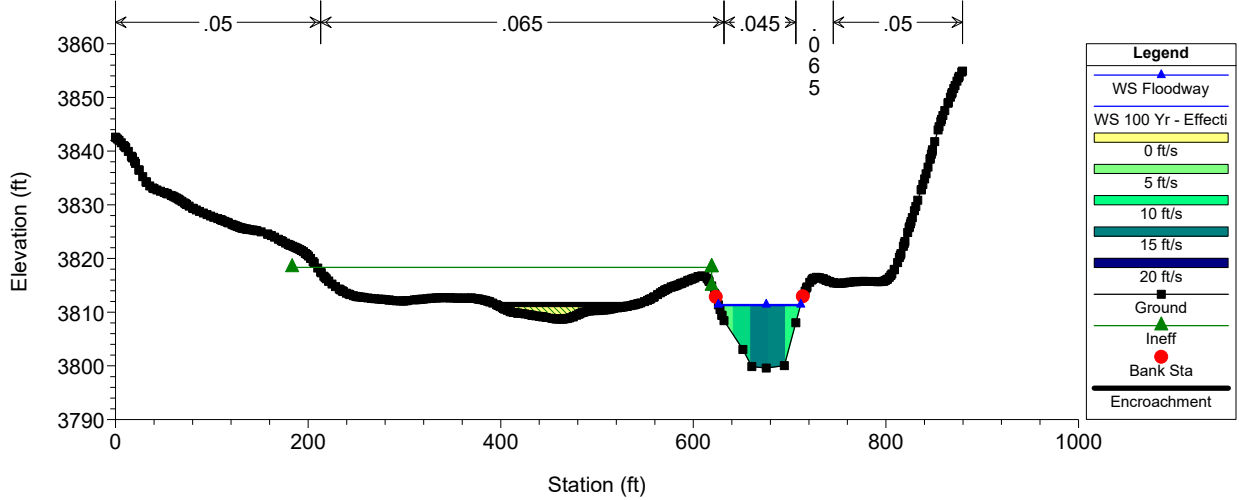
North Fork - Proposed Conditions Plan: North Fork 5/3/2024

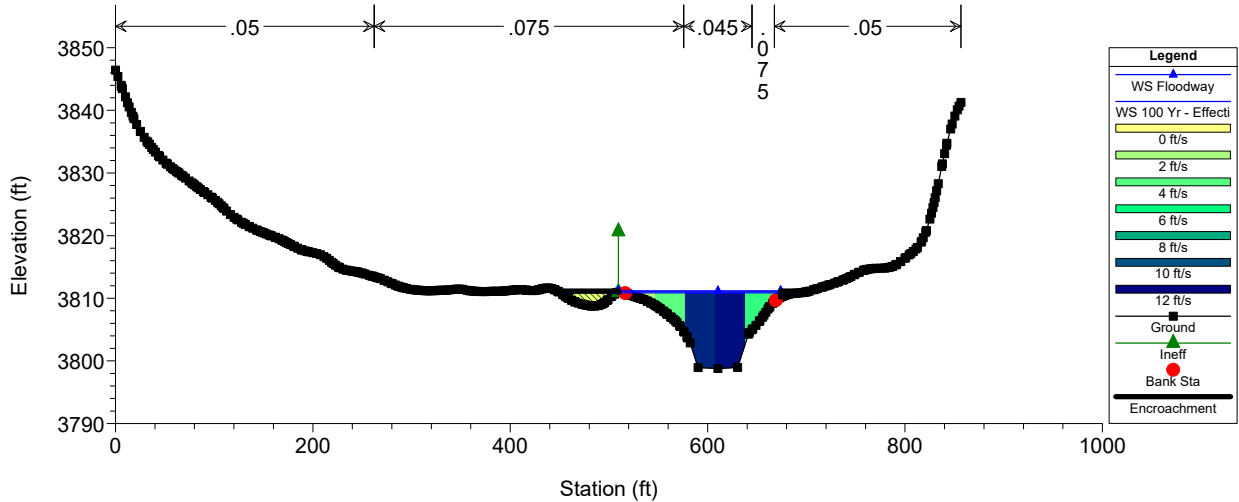
North Fork - Proposed Conditions Plan: North Fork 5/3/2024

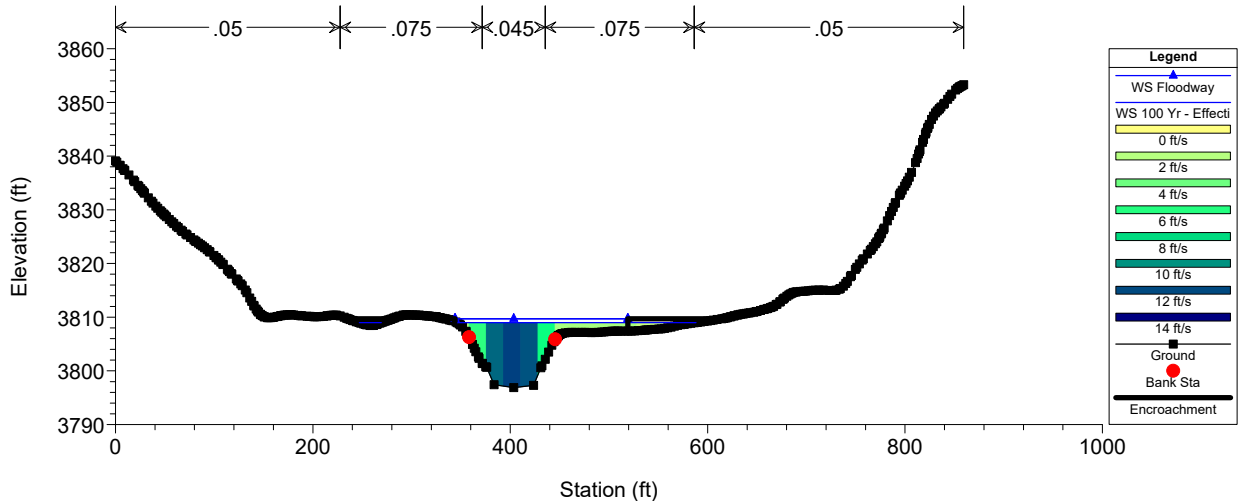
FEMA Section M: 6+886.104

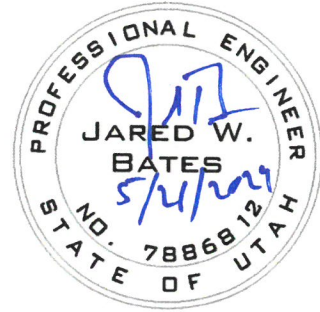
Below in red are the responses to the comments provided by the Town Engineer.
