## MOAB PEDESTRIAN ROAD SAFETY ASSESSMENT

### MAIN STREET FROM EMMA BOULEVARD TO 4TH EAST

GRAND COUNTY  
UTAH

June 2024

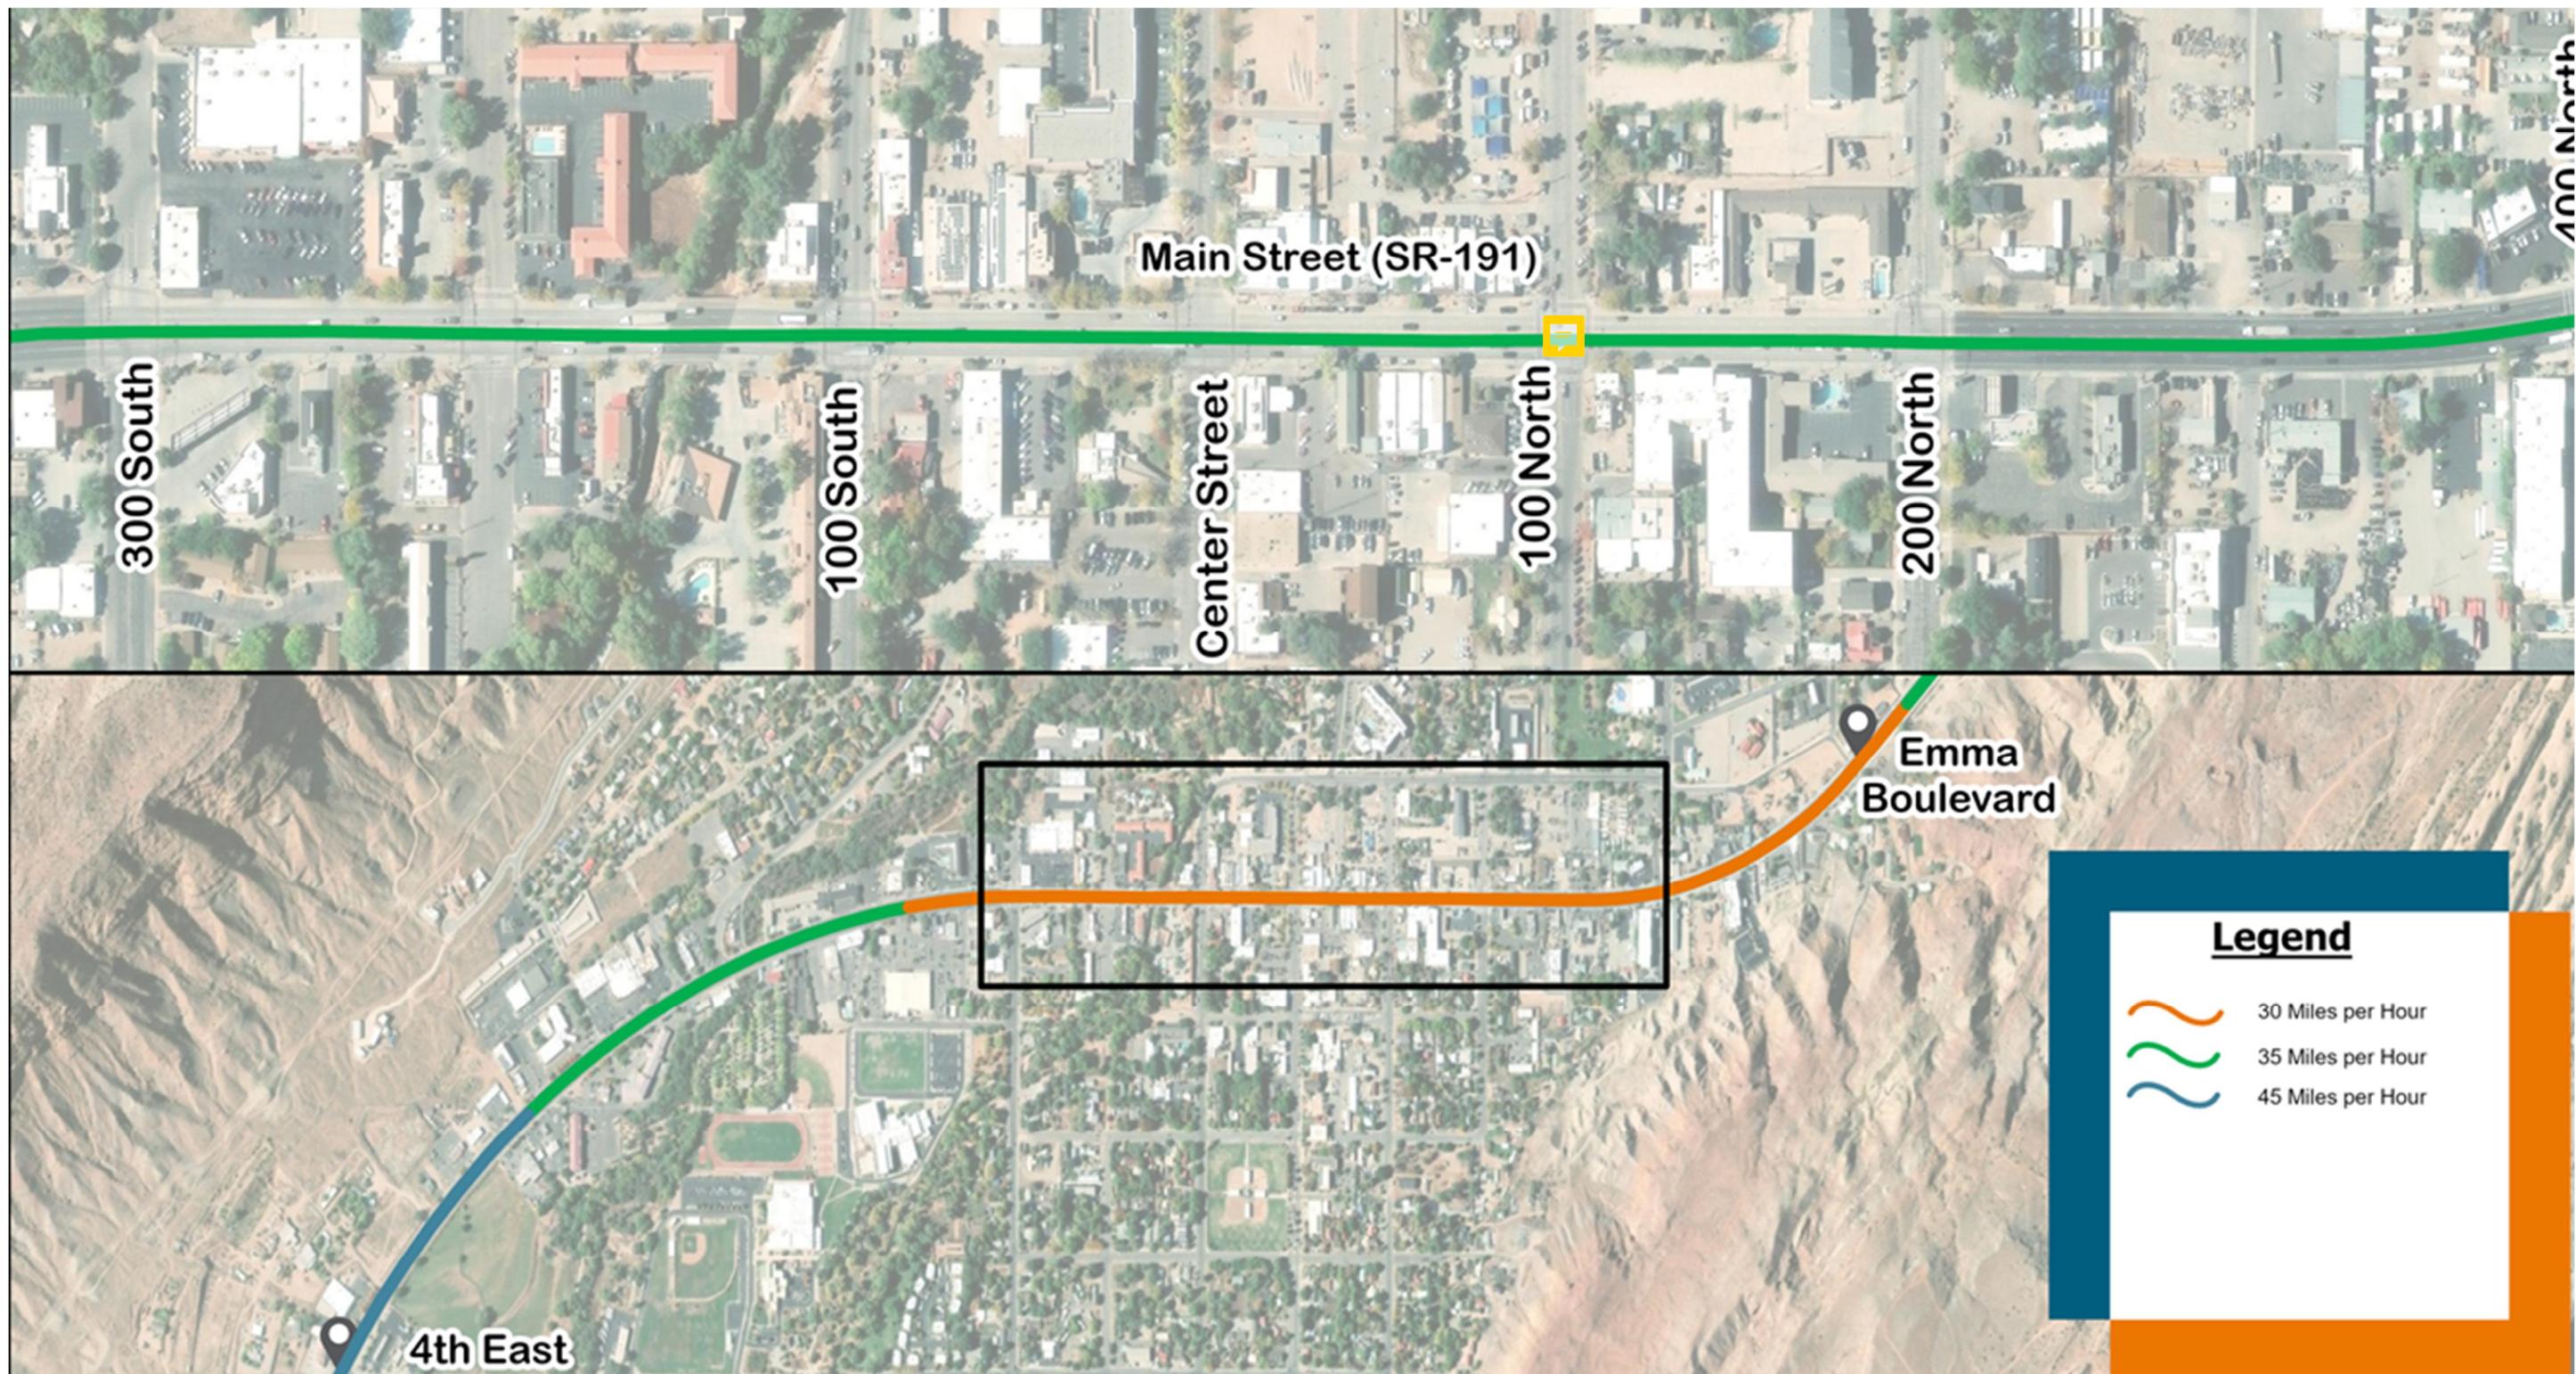
Figure 1 – Overview of Moab RSA Study Area

The Utah Department of Transportation (UDOT) authorized a pedestrian-focused Road Safety Assessment (RSA) to be conducted on a portion of State Route 191 (Main Street) in Moab, Utah. The study area was from Emma Boulevard to 4th East. The study area generally consists of a roadway cross section with two travel lanes in each direction, a two-way left-turn lane (TWLTL), various areas of on-street parking, and no bicycle lane. The Pedestrian RSA was performed in conjunction with an upcoming corridor visioning project occurring at the same location. The purpose of the RSA was to have a diverse team review existing conditions and identify existing or potential road safety issues and suggest countermeasures to mitigate those safety issues. **Figure 1** shows the RSA study area.

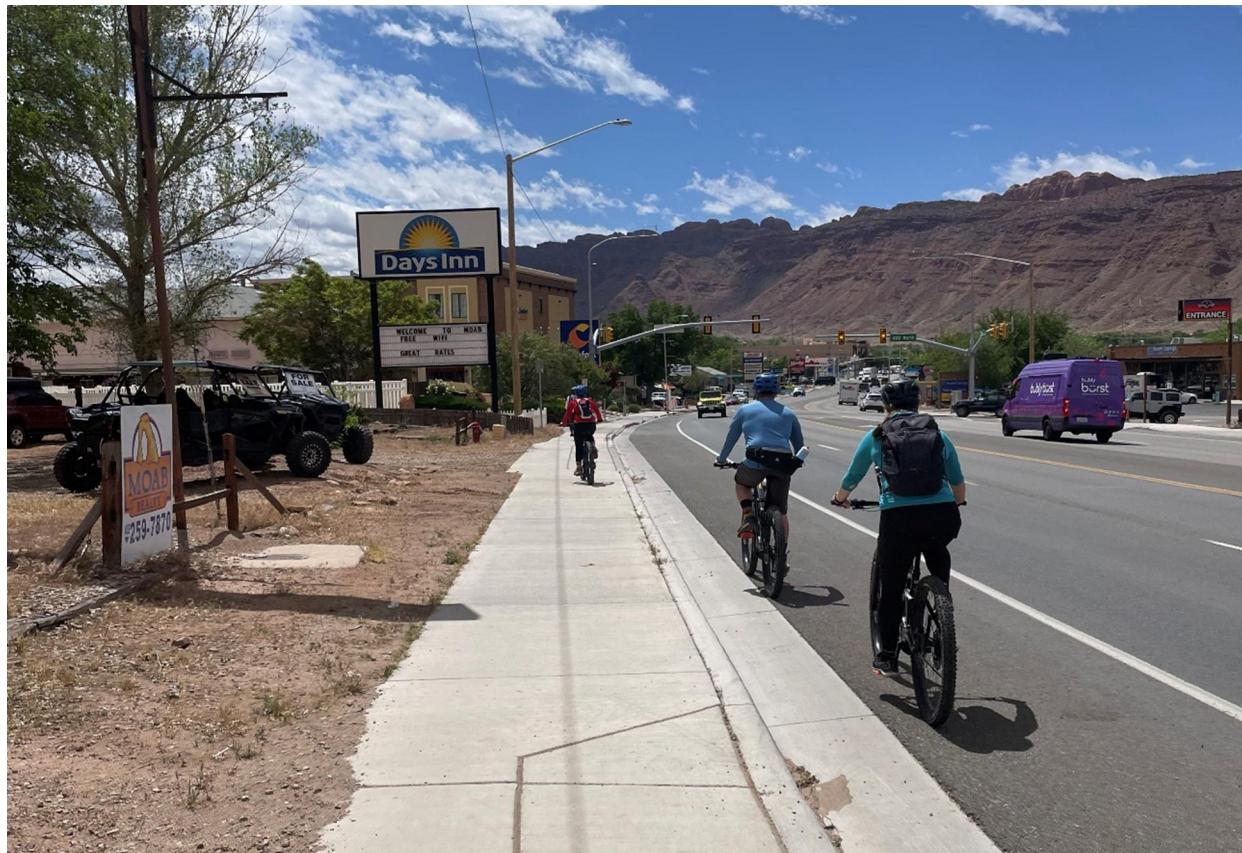
**Photograph 1 – Bicyclists on Sidewalk**

The RSA Field Review Team observed several bicyclists on the sidewalk, interfering with pedestrian traffic. Signs exist through sections of the corridor discouraging bikes on the sidewalk; however, there is not a consistent network of bicycle facilities along Main Street. It was also noted that most bicyclists will avoid Main Street because they feel unsafe. See **Photograph 1**.

***Priority 2: Consider installing buffered or protected bike lanes. Likely would require the removal of on-street parking and/or reduced shoulder width (UDOT/Moab)***

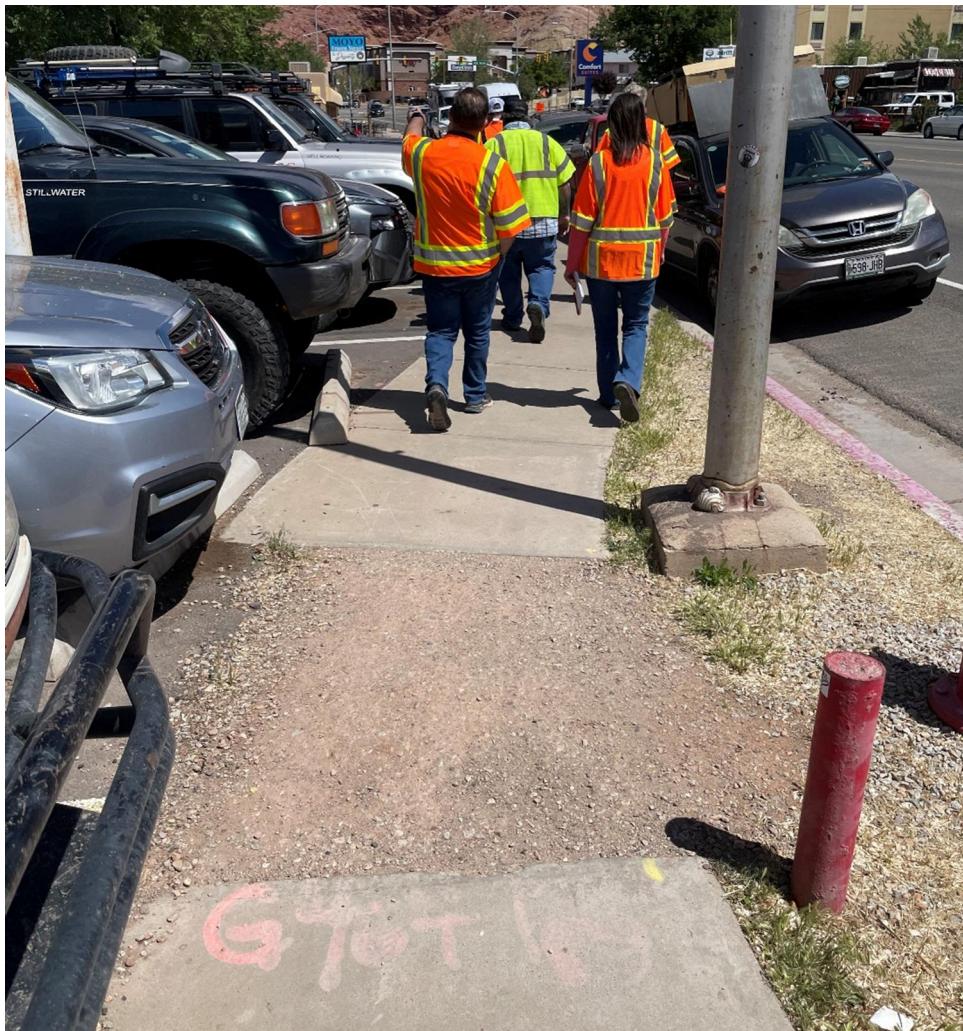
**Photograph 2 – Missing Sidewalk**

Along Main Street several sections of sidewalk were observed to be uneven, damaged, or missing. The goal to complete the sidewalk network would be ideal for all active transportation users. Specific locations noted to have sidewalk damage include surrounding the Walker Stores, the Moab Information Center, Fiesta Mexican driveway, and areas near the City Market. See **Photograph 2** and **Photograph 3**.

***Priority 1: Repair locations with broken or uneven sidewalks (Moab)***

***Priority 1: Repair sidewalks where tree roots have upheaved or broken in sections (Moab)***

***Priority 3: Investigate less disruptive tree species to install near the sidewalk and gutter (Moab)***

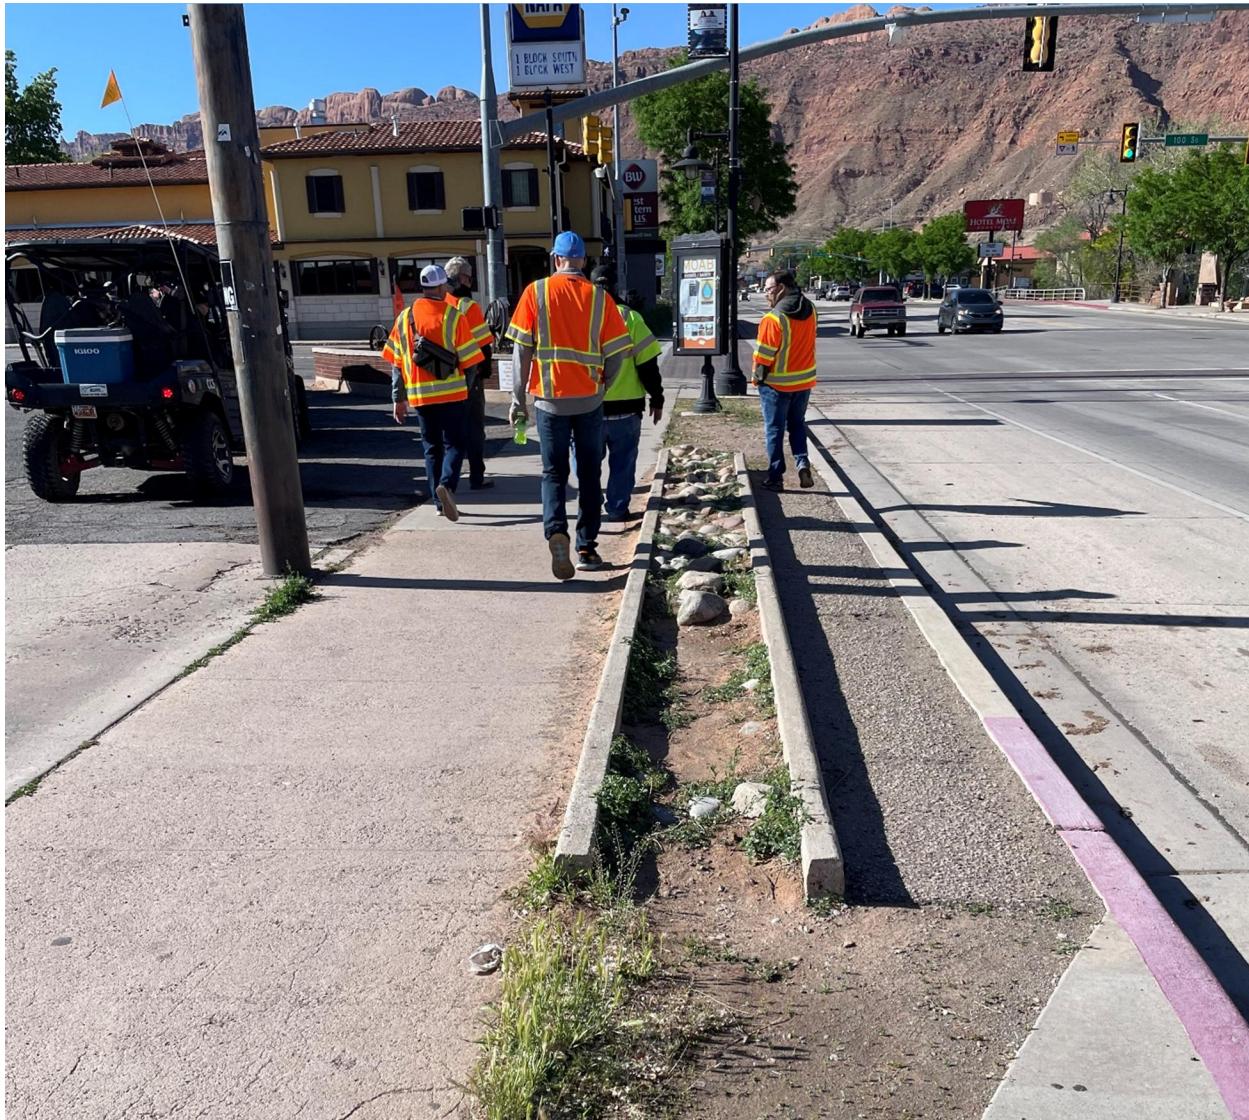
**Photograph 6 – Example Location for Additional Sidewalk Width**

The RSA Field Review Team noted that there were several sections in which the space between the curb and existing sidewalk was empty or unpaved. Empty portions currently have no landscaping or useable pavement/pavers that pedestrians could utilize. The existing sidewalk could be expanded in these areas. See **Photograph 6**.

***Priority 1: Consider paving with concrete to convert to sidewalk, providing additional sidewalk width as a short-term solution (Moab)***

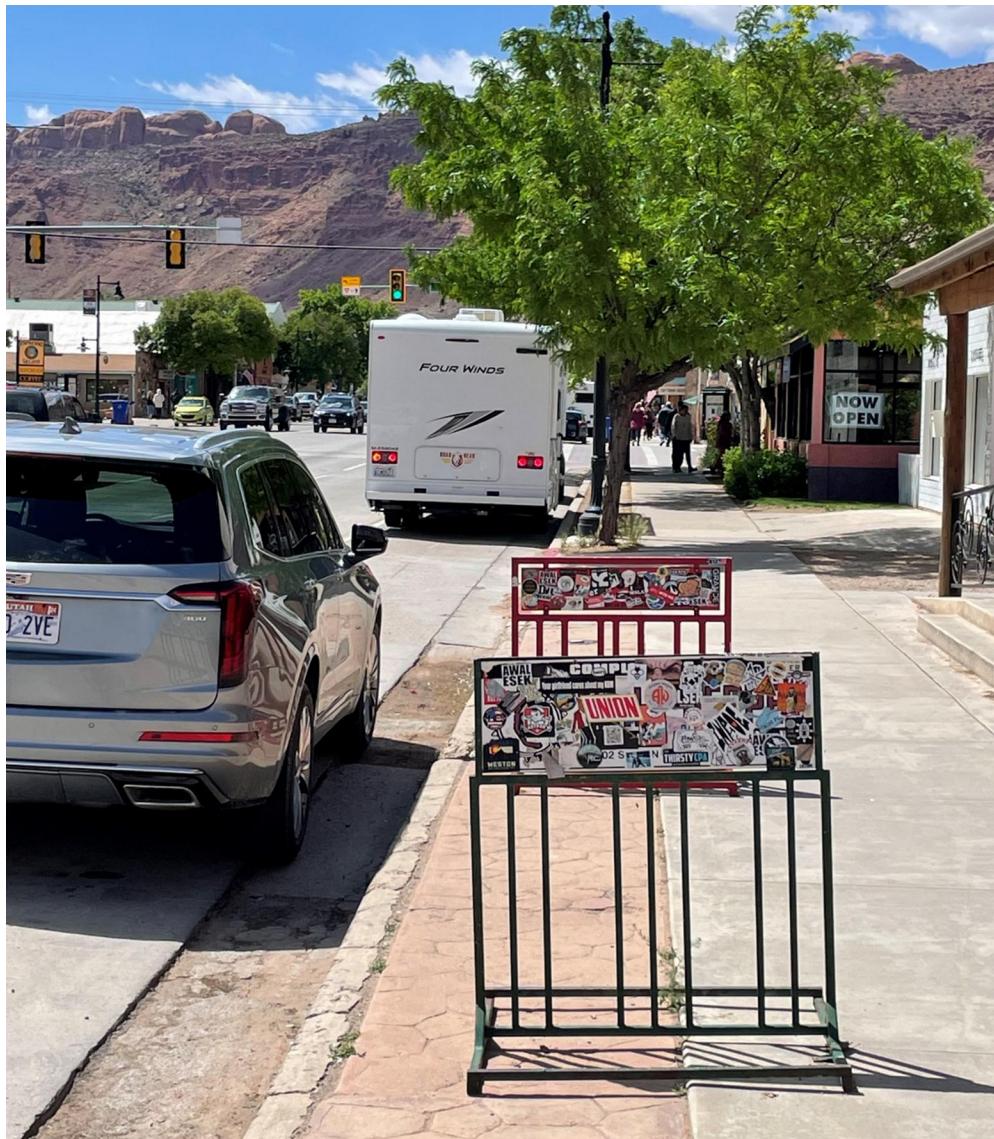
**Photograph 7 – Non-Permanent Obstruction**

Encroachments into the sidewalk right-of-way were noted as an issue, obstructing the travel path for pedestrians and bicyclists. Signs, sale racks, and other similar items were observed blocking portions of the sidewalk. If continuous, unobstructed sidewalks are desired, there may also need to be removal of existing obstacles like light poles and pavement furniture. See **Photograph 7**.

**Priority 1: Work with local businesses to address right of way infringements and sidewalk obstructions (Moab)**

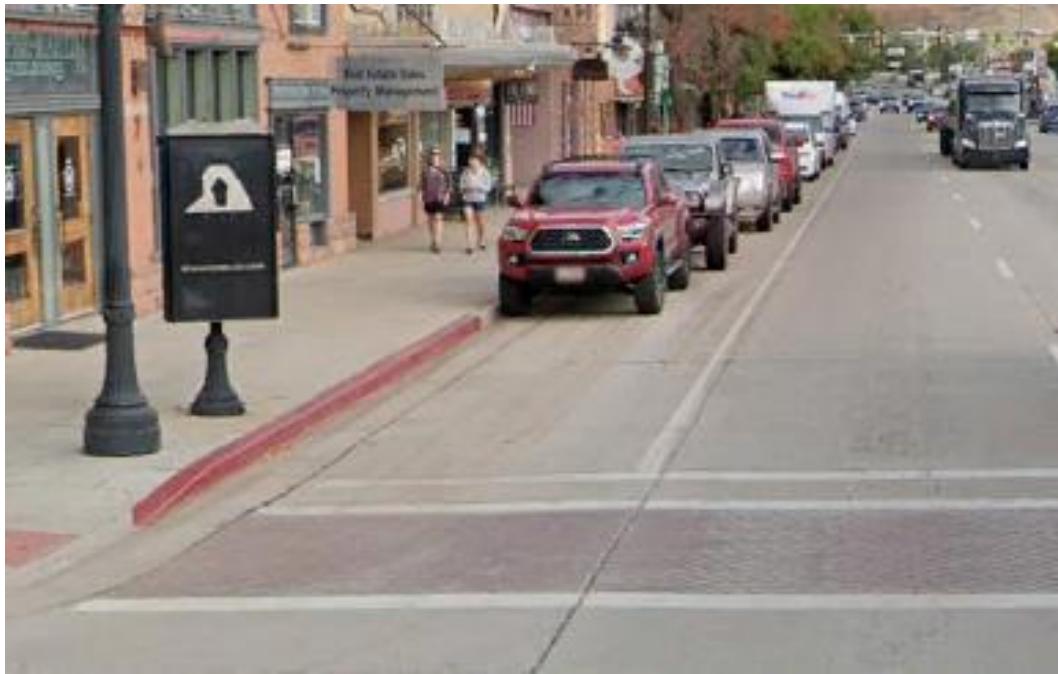
**Photograph 8 – Example Location for Right-Turn Lane or Bulbout**

The RSA Field Review Team observed vehicles using the roadway shoulder at intersections to make right turning movements. Multiple intersections do not have a striped right turn lane and the right turning vehicles conflict with pedestrians crossing the minor streets. See **Photograph 8**.

***Priority 2: Stripe a right turn lane or install bulbouts to restrict turning in the shoulder. Some portions of the curb are already painted red and bulbouts would not reduce existing parking. (UDOT)***

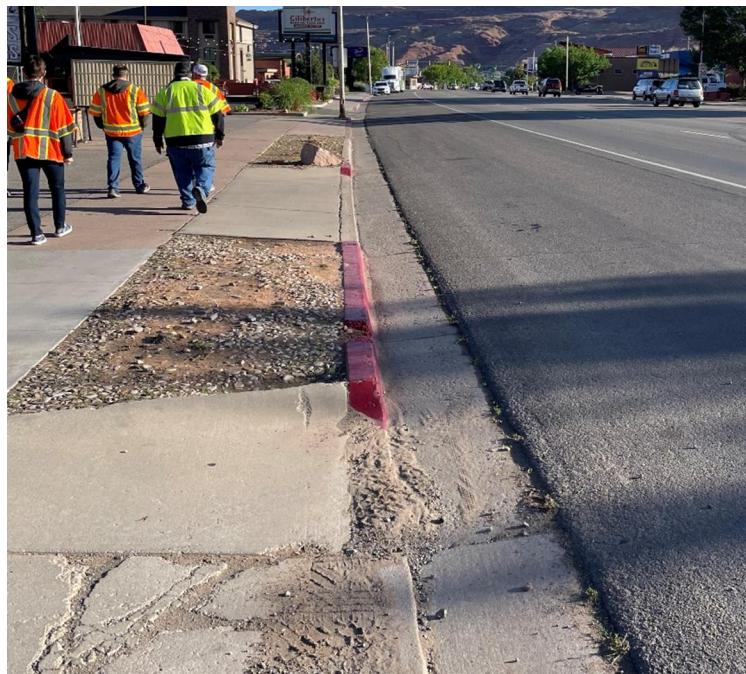
**Photograph 9 – Segment with Multiple Access Drives**

Along Main Street there are multiple minor streets, access driveways, and other intersections with the corridor. Most access driveways are full movement accesses where vehicles turning left onto Main Street are vulnerable to opposing vehicles and often experience delays. Vehicles hoping to turn left onto Main Street also experience conflicts with groups of pedestrians as they cross access driveways. See **Photograph 9**.

***Priority 3: Evaluate locations for median installation along the entire corridor to reduce left turn conflicts (UDOT/Moab)***

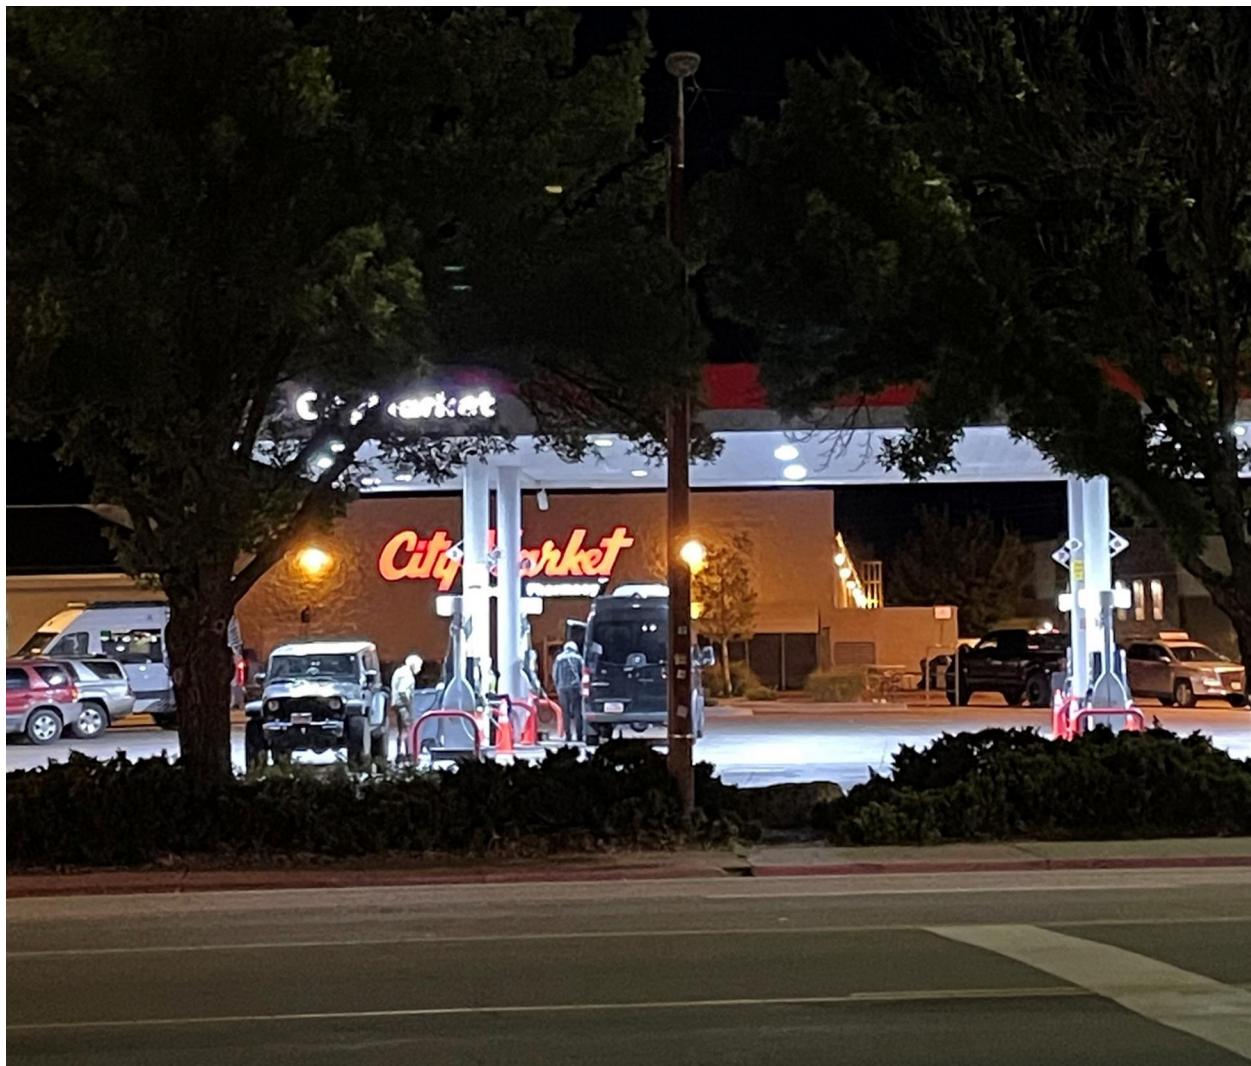
**Photograph 10 – Dim Sidewalk Section**

During the nighttime field review, the RSA Field Review Team noted some of the existing luminaires were dim and certain intersections didn't have sufficient lighting. Moab city has been conducting a lighting study on the Main Street corridor and the results of that study should inform additional improvements. With any transition to LED lights, the range and spacing of new lights should be reevaluated before installation. See **Photograph 10**.

***Priority 1: Moab to continue working with Rocky Mountain Power to transition all lights to LEDs (Moab)***

***Priority 2: Consider undermast arm lighting at intersections in addition to regular intersection lights at locations that appear dim. (UDOT/Moab) – Further evaluation needed***

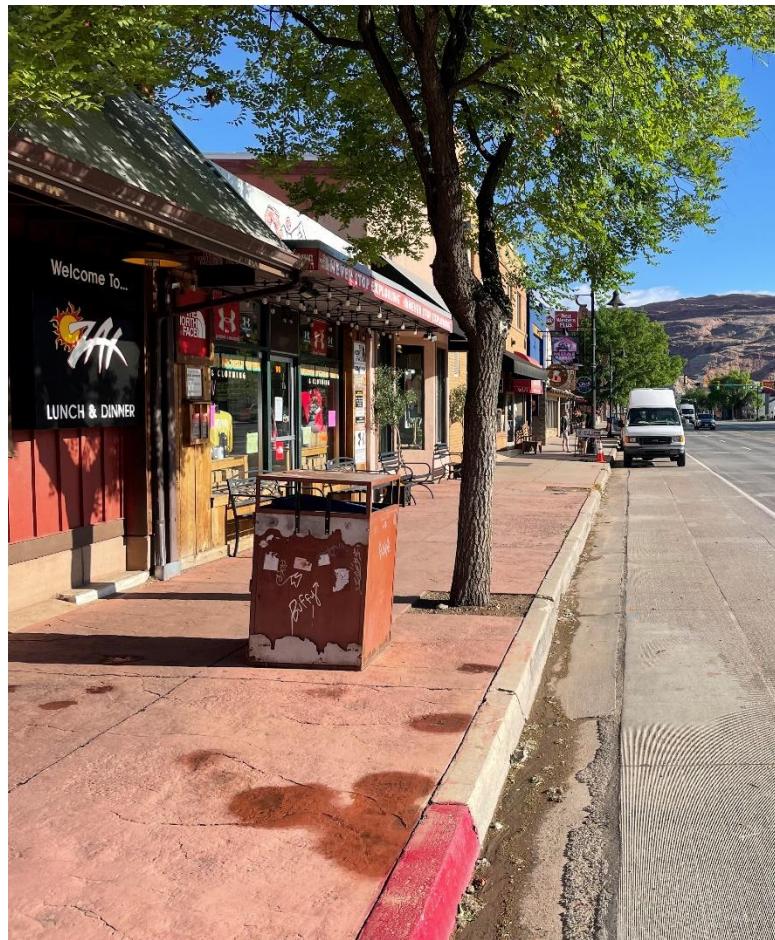
**Photograph 12 – Example Sidewalk Obstructions**

The RSA Field Review Team observed several locations where objects were obstructing the walking path. Obstructions included utilities, light posts, trees, and local business's items. As there is no on-street bicycle network, bicyclists often use the sidewalk, further limiting the space on the walkway. See **Photograph 12**.

***Priority 1: Evaluate sidewalk obstructions that can be removed or relocated (Moab)***

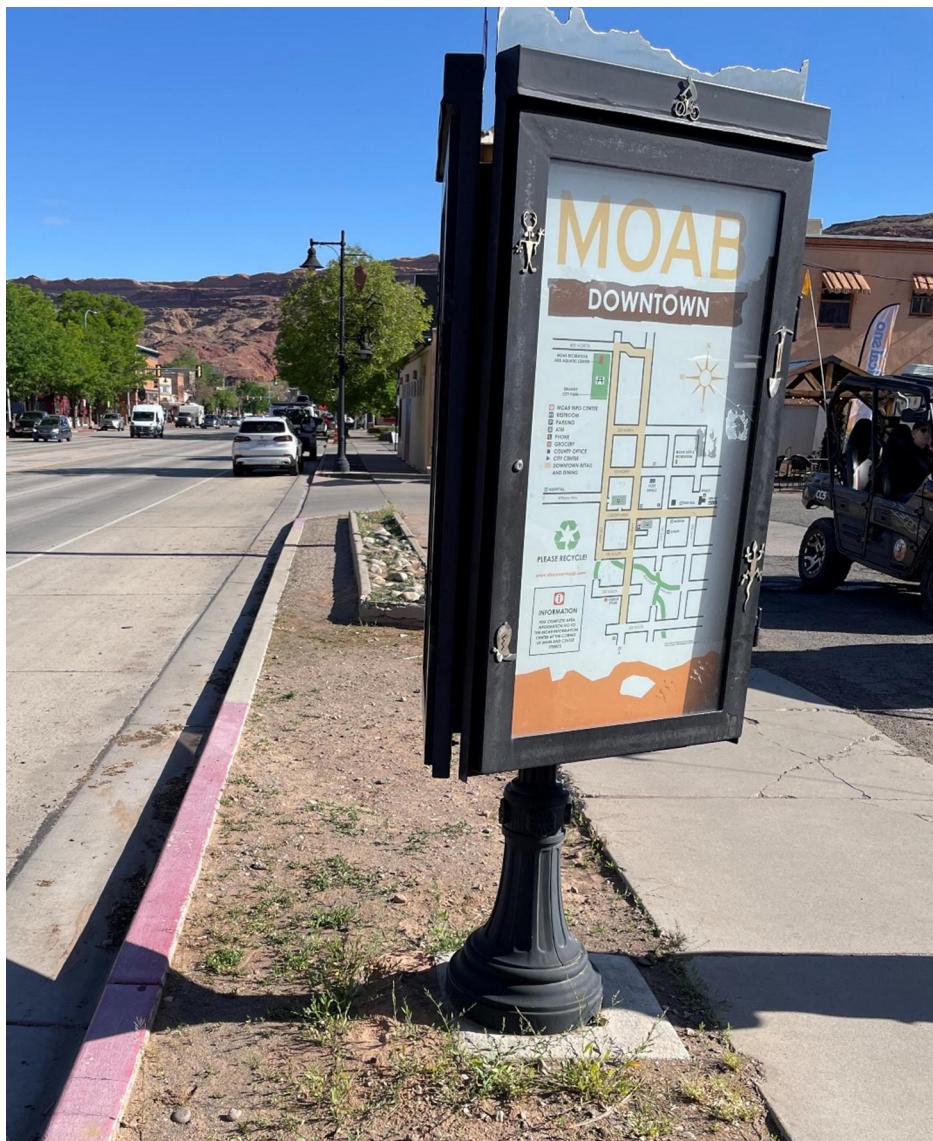
**Photograph 13 – Moab Downtown Map**

Moab city is the gateway to some of Utah's southern national parks and a center for tourism and active transportation users. Main Street (SR 191) services recreational vehicles, freight, and public transportation so it is imperative that sufficient wayfinding is in place to reduce congestion and confusion. To remove additional parking off of Main Street would require additional wayfinding elements to public parking areas, alternative on-street parking locations, and transit facilities. The downtown maps are an existing structure that have the potential to be updated and used by all to locate these areas. It should also be considered to improve the digital wayfinding elements by adding significant areas to digital maps. See **Photograph 13**.

**Priority 2: Consider ways to update digital wayfinding (Moab)**

**Priority 2: Consider wayfinding elements marking public parking areas, on-street parking, preferred bike routes, and transit facilities. Include these items on the downtown maps. (Moab)**

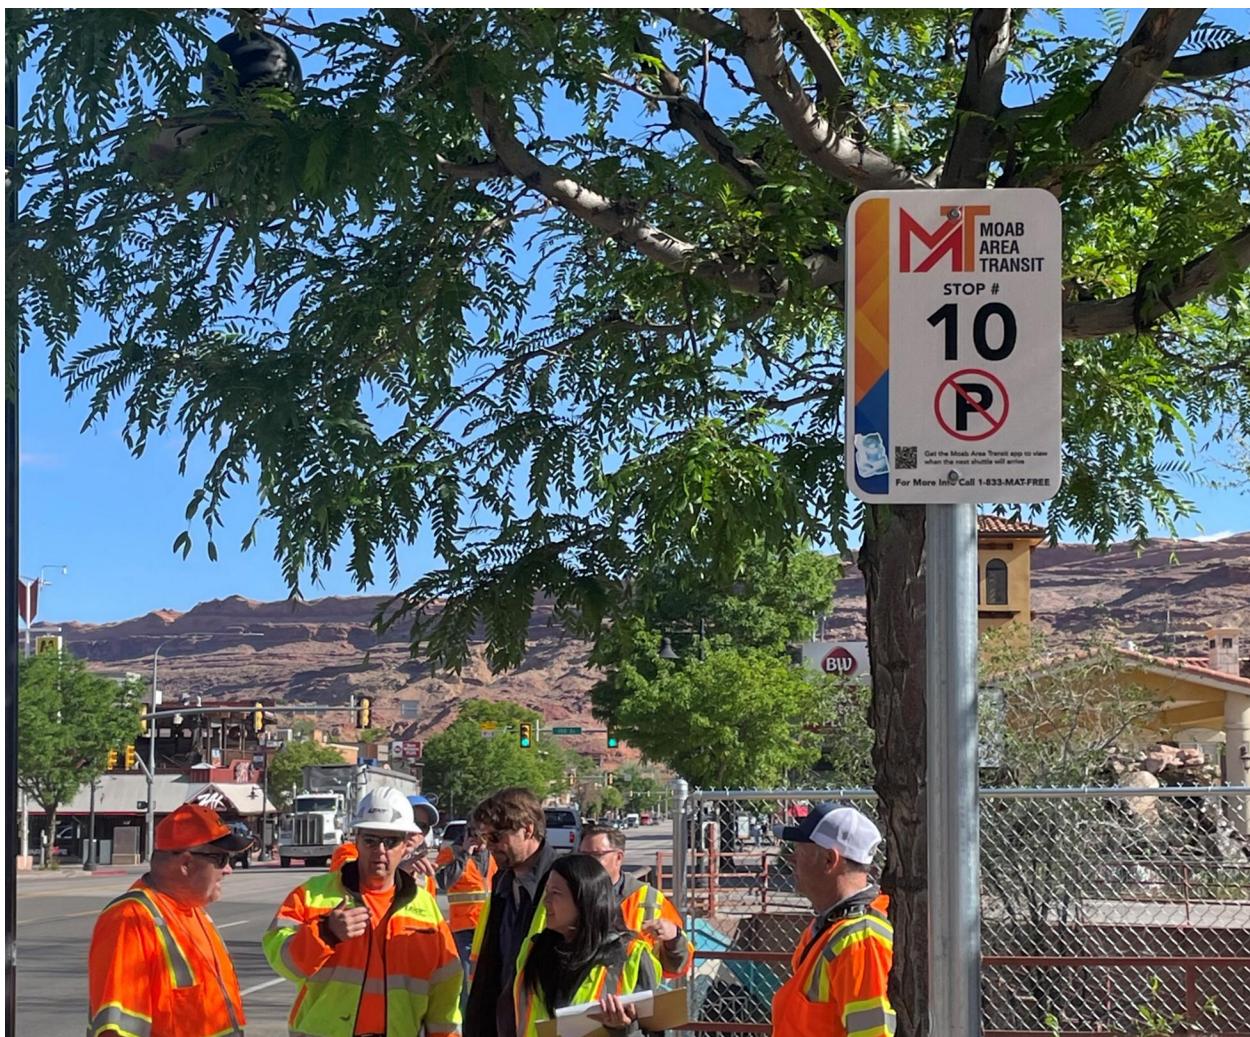
**Photograph 14 – Moab Area Transit Stop Signage**

Moab city council members noted that the recently implemented micro-transit system is underutilized by residents and visitors. The micro-transit system includes an on-demand service and one Main Street fixed route. However, the transit stops were observed to be hard to notice from the walkway and the roadway. There are also no existing elements along Main Street with maps of the service area. An easily accessible micro-transit system has the potential to remove traffic and parking on Main Street. See **Photograph 14**.

***Priority 2: Include transit routes and stop locations on downtown maps (Moab)***

***Priority 3: Consider partnering with hotels/local businesses to coordinate bus routes or alternative transportation for visitors (Moab)***

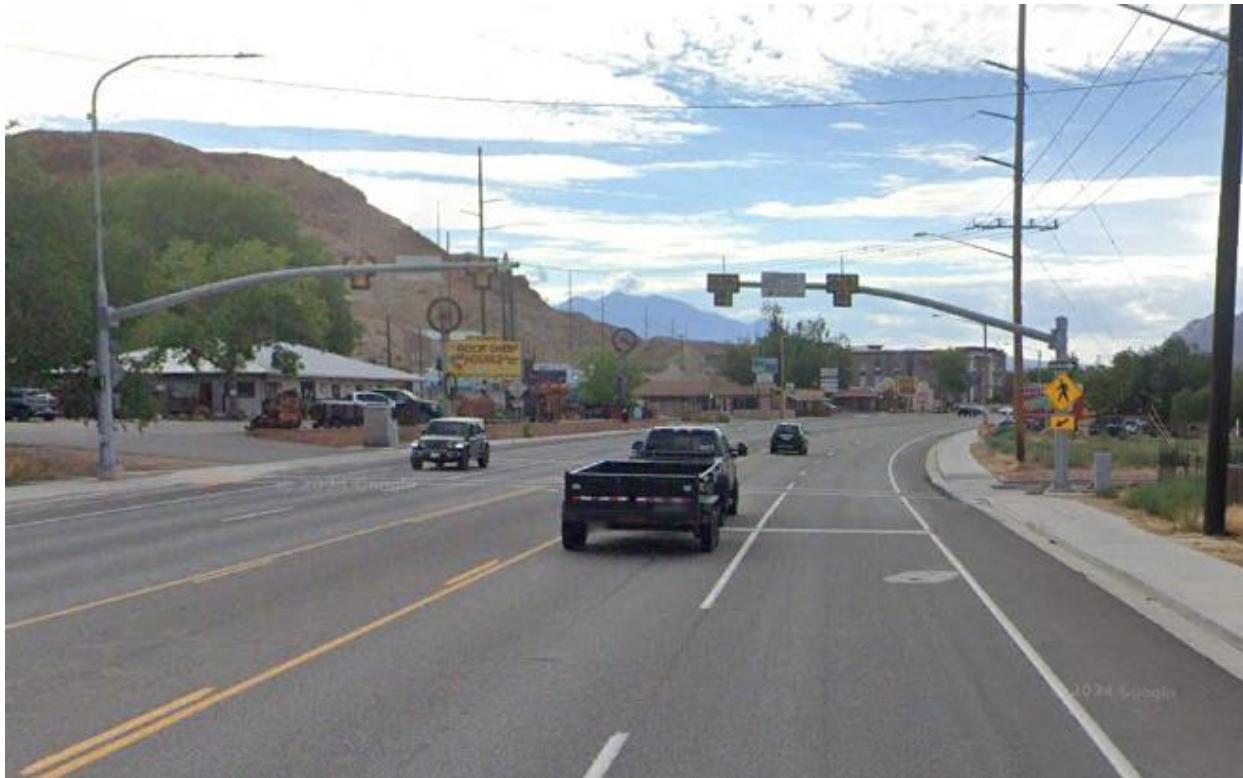
**Photograph 15 – PHB Crossing at Emma Boulevard**

The RSA Field Review Team noted that the pedestrian crossing times did not seem to be sufficient to cross the five lane cross section of Main Street. The crossing is wide, and vehicles were observed speeding through the intersection. See **Photograph 15**.

***Priority 1: Evaluate pedestrian crossing time and updated as needed (UDOT)***

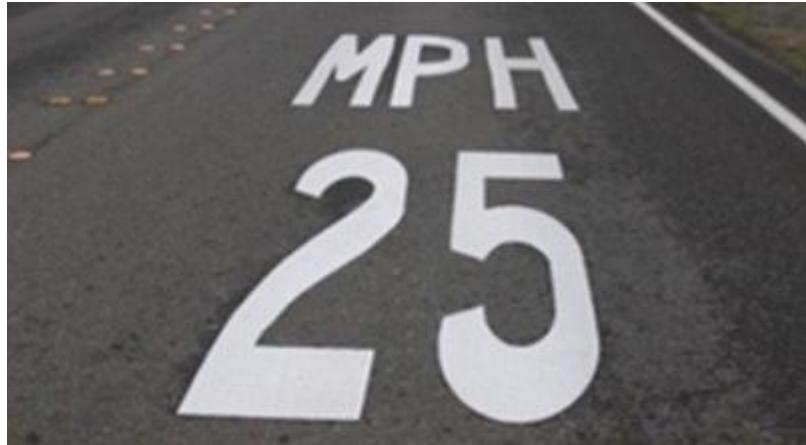
**Photograph 16 – Example Speed Limit Pavement Markings**

This intersection is where the speed limit changes from 35 mph to 30 mph entering Moab from the north. Despite this speed change, vehicles were observed traveling at high speeds through the PHB or being confused by its signage. See **Photograph 16**.

***Priority 2: Install in-pavement speed limit markings to remind drivers of the speed transition (UDOT)***

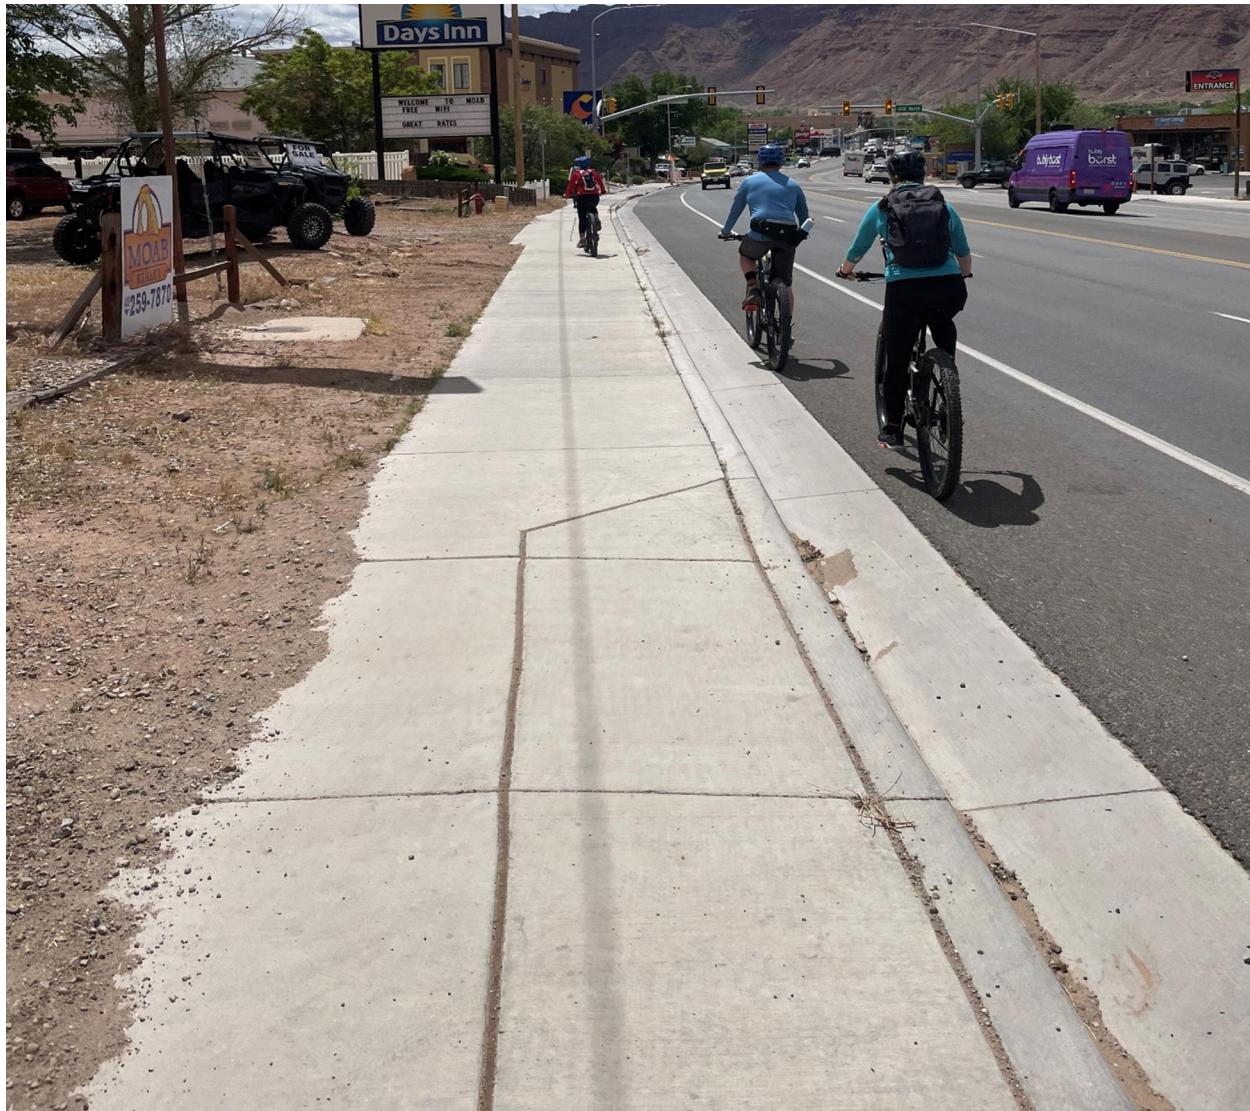
**Photograph 17 – Bicyclist using the Shoulder and Sidewalk South of Emma Boulevard**

The intersection of Emma Boulevard and Main Street is one of the first intersections between Moab city and Arches National Park. Therefore, there is a large number of cyclists and other non-motorists that travel along Main Street. There are no clearly marked bicycle lanes north of this intersection, so cyclists are forced to use the shoulder or the sidewalk. See **Photograph 17**.

**Priority 3: Evaluate ability to include bike lanes on Main Street to the north and south of Emma Boulevard (UDOT/Moab)**

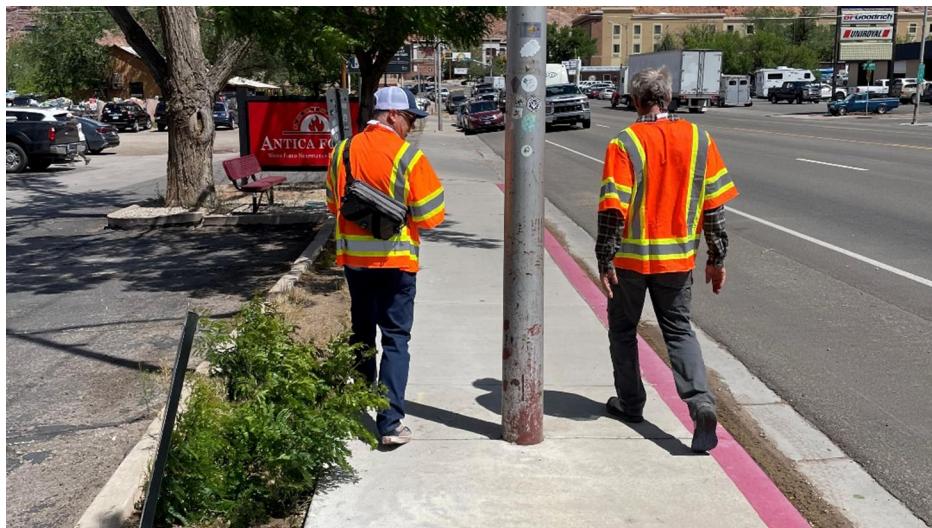
**Photograph 19 – Light Pole Obstruction**

The RSA Field Review Team members noted that the light post on the west sidewalk on the west side of Main Street in front of Jenn's Jeep Rentals is located in the middle of the sidewalk and obstructing the walkway. This section of sidewalk is not ADA compliant due to the obstruction. See **Photograph 19**.

***Priority 2: Relocate light post (Moab)***

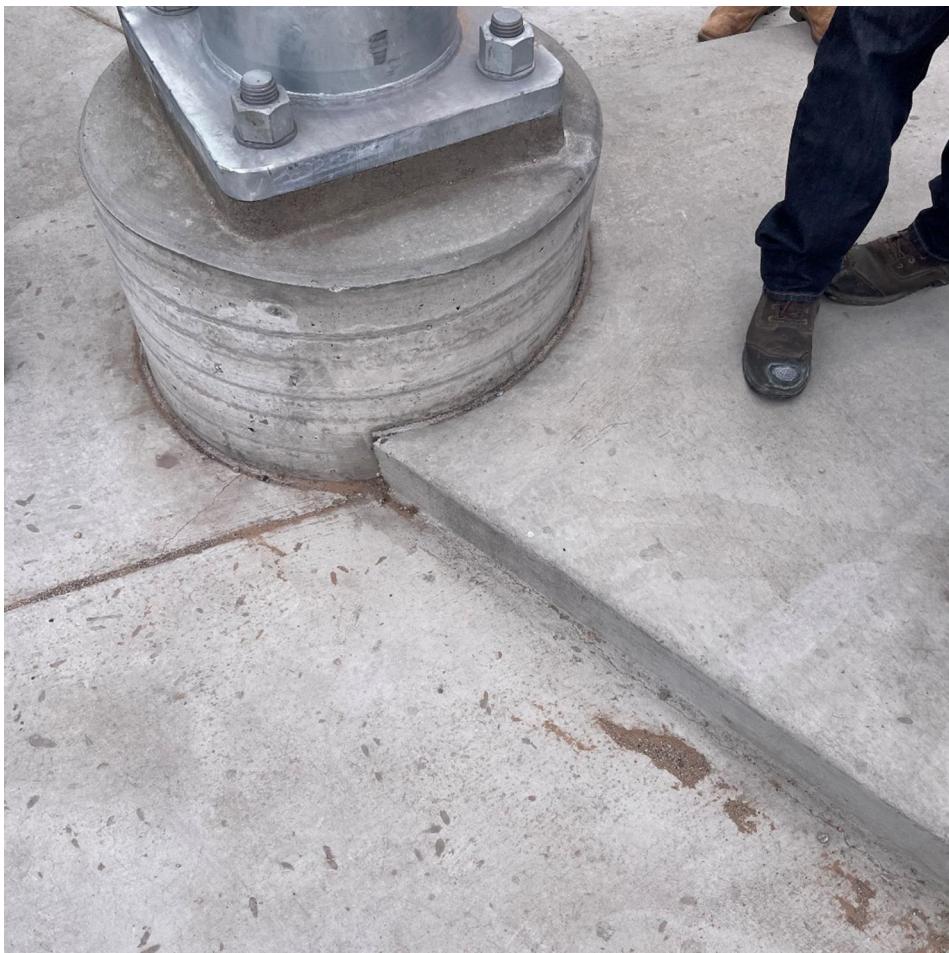
**Photograph 20 – Raised Sidewalk Lip**

On the southwest corner of this intersection there is a portion of raised curb around the signal post. The curb was put in place with the installation of the signal post and cannot be removed. As the raised curb is near the pedestrian ramps, it presents a tripping hazard and an obstruction to the travel way. See **Photograph 20**.

***Priority 1: Paint the raised curb (Moab)***

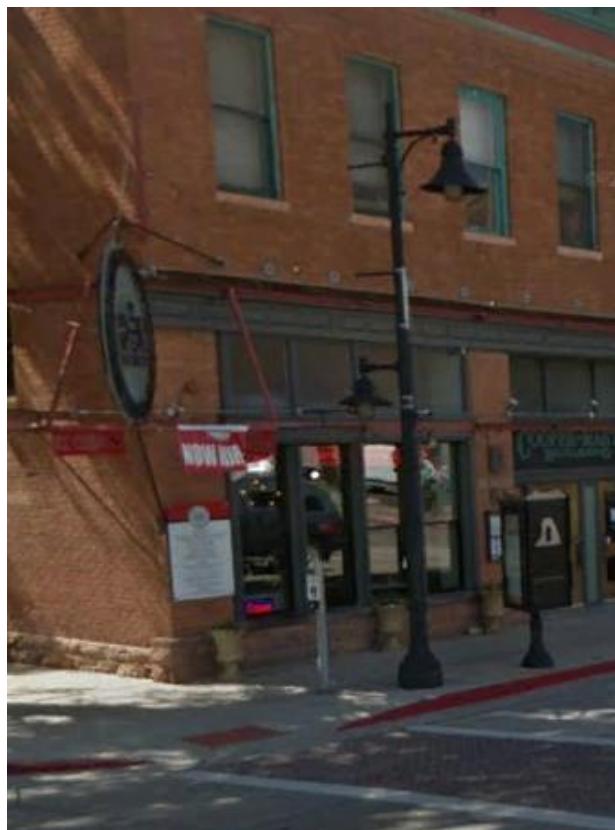
**Photograph 21 – Burnt Out Decorative Lighting on Northwest Corner**

The RSA Field Review Team noted that the decorative lighting on the northwest and southeast corners of the intersection were burnt out. See **Photograph 21**.

***Priority 1: Replace luminaire (Moab/Rocky Mountain Power)***
