# Planning Commission Staff Report

## General Plan Amendment

# PLEASANT VIEW CITY FOOTHILL AREA LAND PLANNING STUDY

# Aquatic Resources Delineation

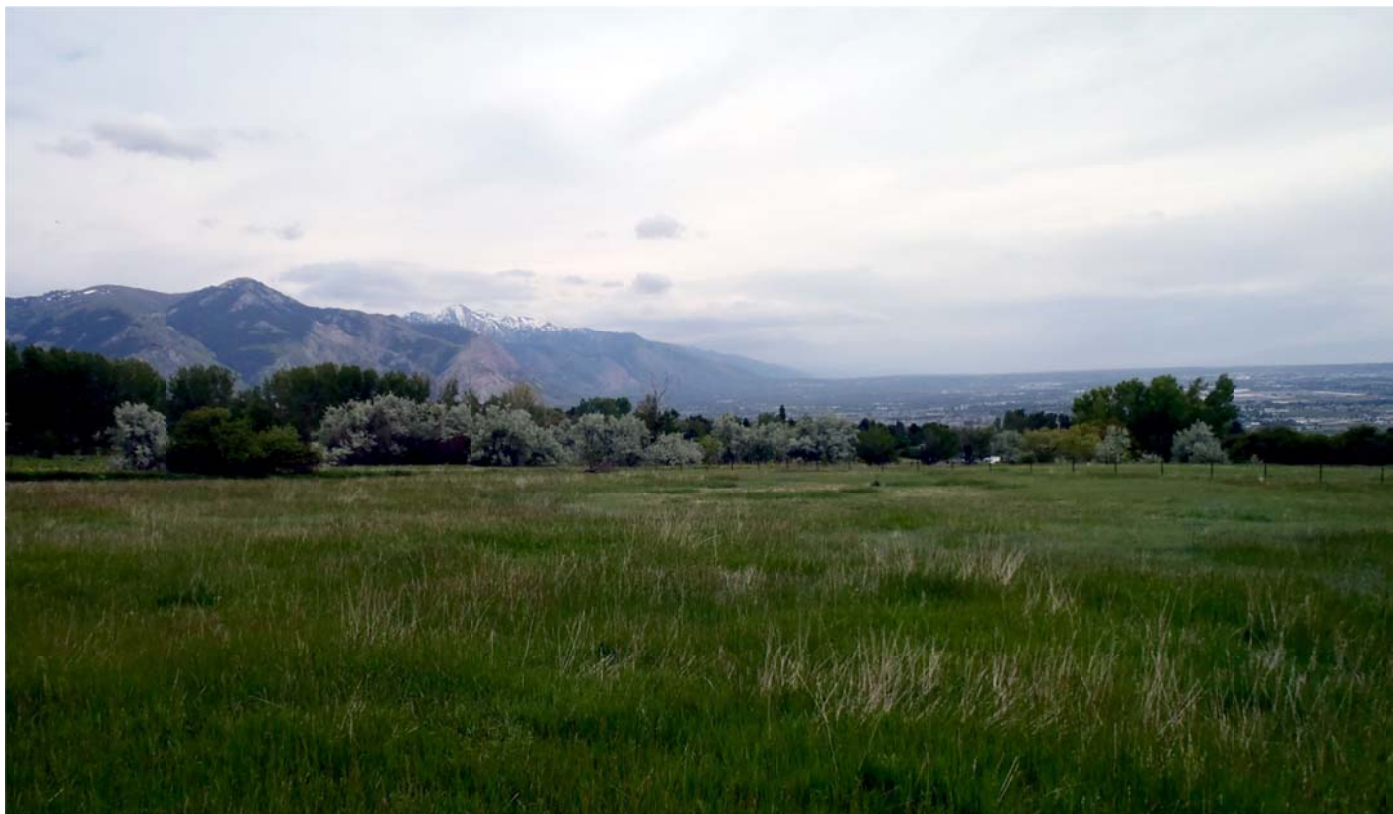
**Photo 1.** A characteristic view of the Salt Lake Valley toward the southeast of the study area.

The City lies in the north-central part of Weber County in northern Utah, approximately 40 miles north of Salt Lake City (see Figure 1). Beyond the City limits, to the north and the east lie the Wasatch Mountains, part of the Wasatch-Cache National Forest. Ben Lomond, to the northeast, peers majestically over the City. In this part of the Salt Lake Valley, the Wasatch Mountains protrude sharply upward from the valley floor. The study area elevation ranges from 9,700 feet at Ben Lomond Peak to 4,400 feet near Pleasant View Drive. Because of its foothill location, surrounded by mountains to the north, the City commands a panoramic view of the Salt Lake Valley to the west and south (see Photo 1).

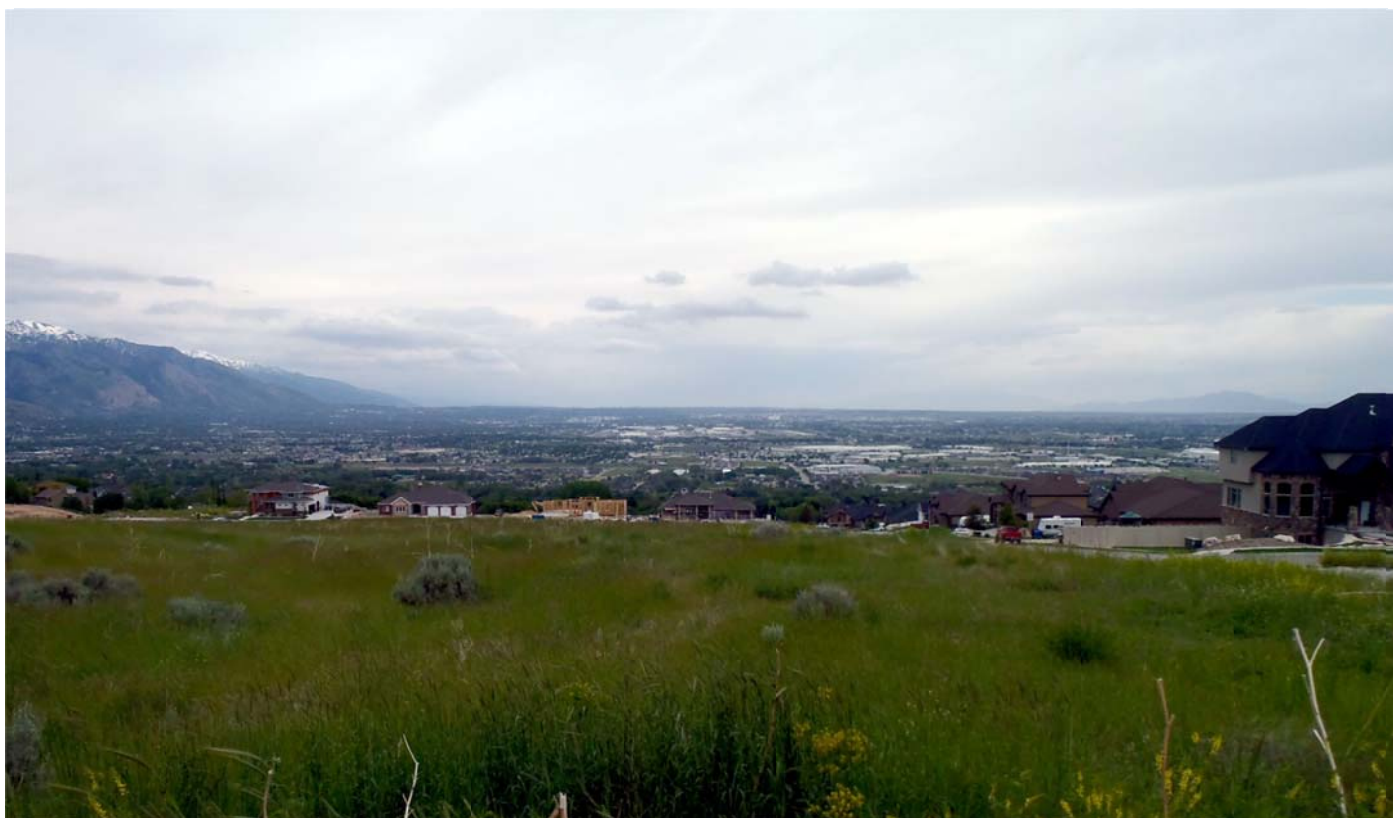
**Photo 2.** Residential development is expanding northward through the study area.

Residential subdivisions currently exist in the southern and eastern portions of the study area and are rapidly developing towards the north and west (see Photo 2). There are approximately 1,631 acres, or 48 percent of the lands that are currently undeveloped within the study area. Approximately 965 acres lie within incorporated city limits and 666 acres that lie in the unincorporated county. Under current zoning, there is the potential for over 2,100 additional residential units that could be developed within the study area.

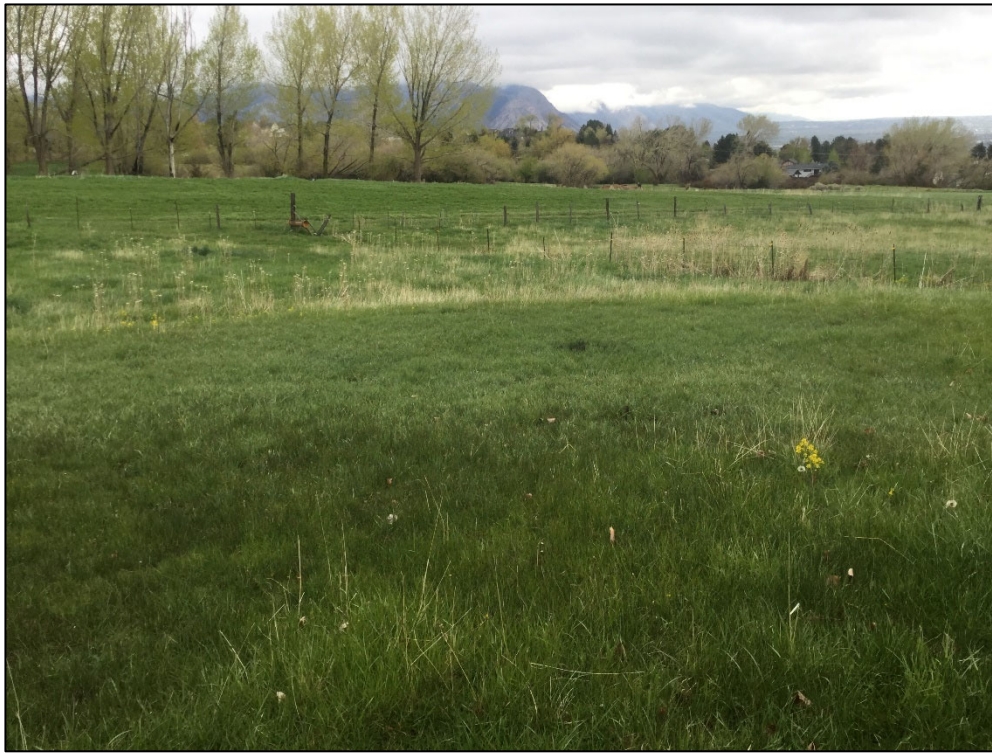
**Photo 1.**  
**Wetland W1,**  
**view SE.**

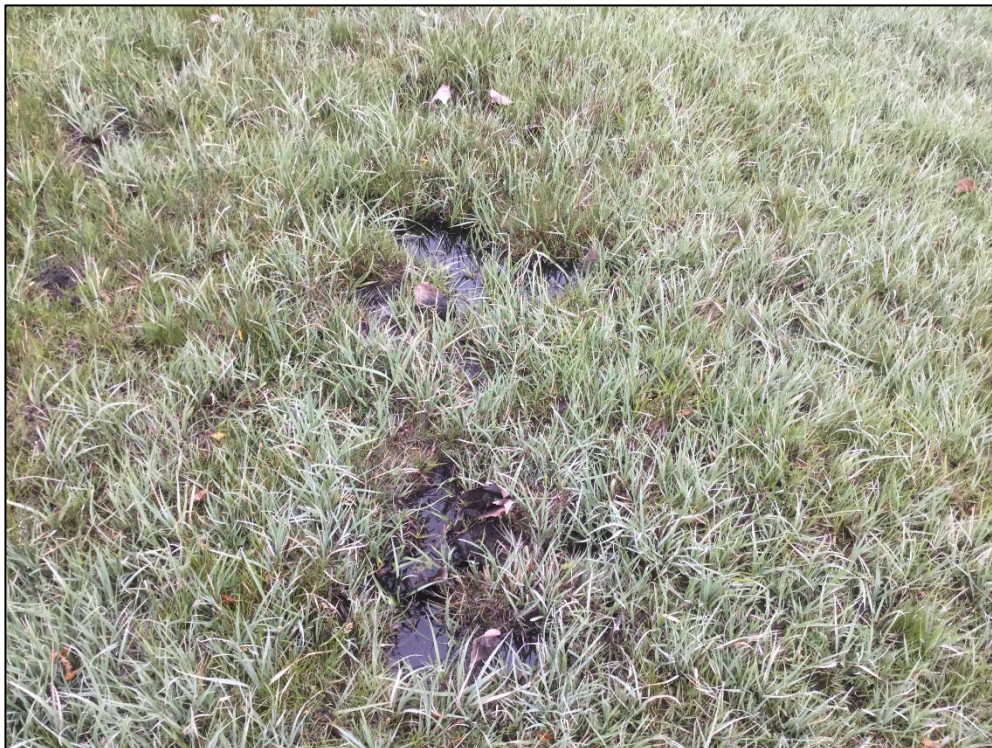
**Photo 2.**  
**Shallow**  
**inundation in**  
**Wetland W1,**  
**while the**  
**immediately**  
**surrounding**  
**areas are dry.**

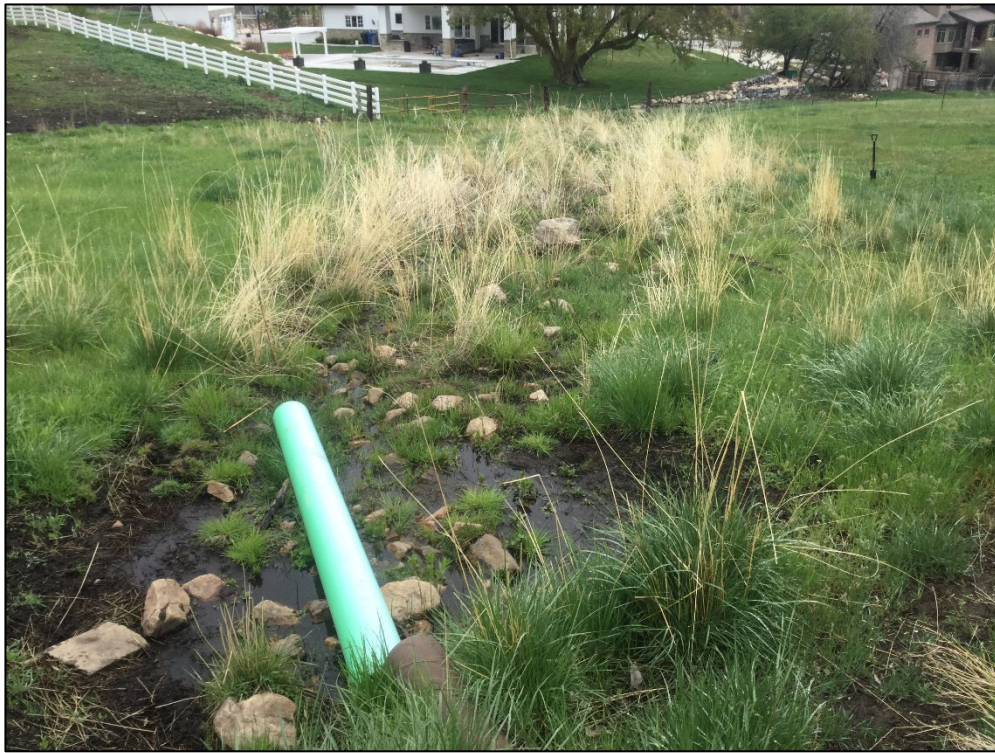
**Photo 3.**  
**Wetland W2 with**  
**pond outlet pipe.**  
**View SE.**

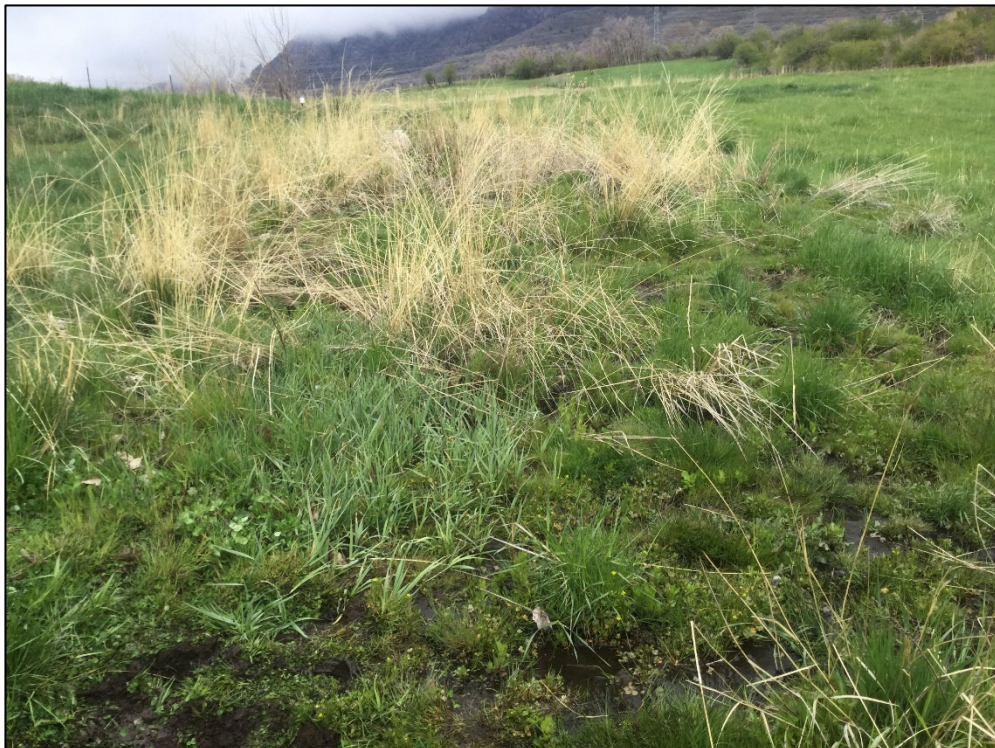
**Photo 4.**  
**Wetland W2,**  
**View North.**

**W-2** - This palustrine emergent (PEM) wetland occurs below a small manmade irrigation pond, and is supported by the overflow from the pond. The wetland is dominated by tall wheatgrass, Nebraska sedge, and meadow foxtail. The soils have a matrix color of 10YR2/2 with no redox, which does not meet any of the hydric soil indicators. They are classified as Timpanogos variant-Draper complex soils. The soils were saturated at the surface in the wetland area due to water flowing from the pond outlet, but the soils were not saturated below 10 inches, an indicator that the hydrology is provided solely by the pond overflow. The pond is supported by a buried irrigation pipe that inputs water into the pond. There is a valve that can potentially turn off all of the water flowing into the pond. If the water can be completely turned off, this wetland will likely dry out and not be jurisdictional. The water enters a pipe at the bottom end of this wetland, enters the lower irrigation pond, then into a small ditch with no OHWM, and completely dries out before reaching a raised pipe inlet into a storm sewer pipe. Sample Points 3 and 4, Photos 3 and 4.

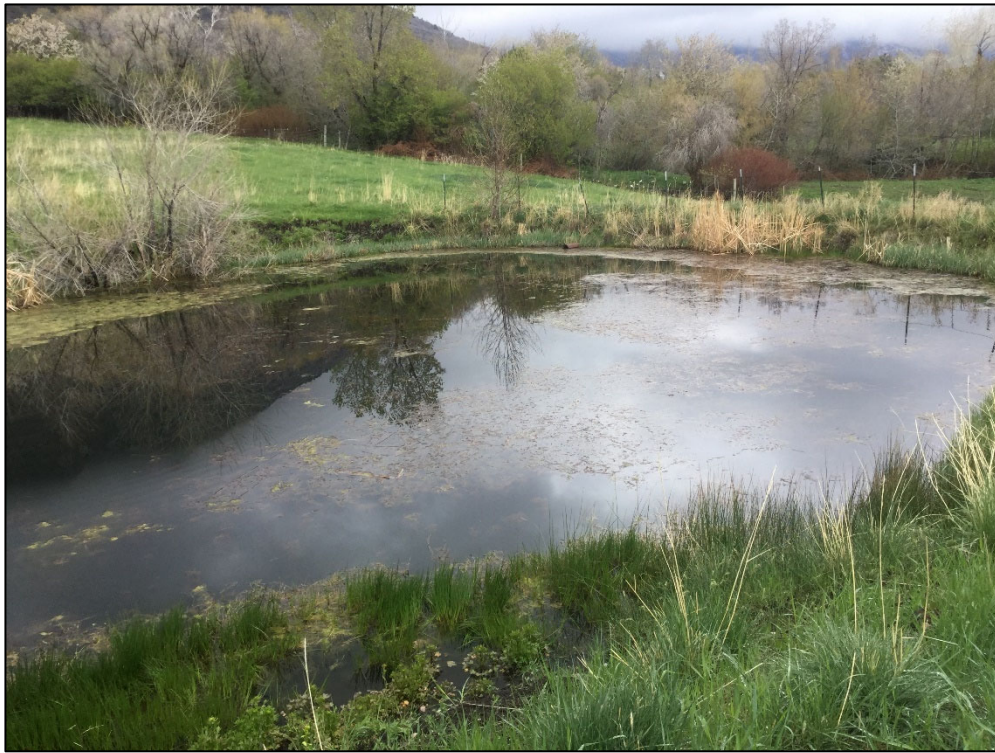
**Photo 5.**  
**Upper irrigation**  
**pond.**

There are no other aquatic resources within the project area other than the wetlands. There are two small man-made irrigation ponds that have a valve to shut off the input of water from the irrigation pipe. The upper pond is open water (Photos 5 and 6), and the lower pond has filled in with common reed (Photos 7 and 8). These man-made ponds are not jurisdictional because they are excavated in uplands and do not have a natural hydrology source.

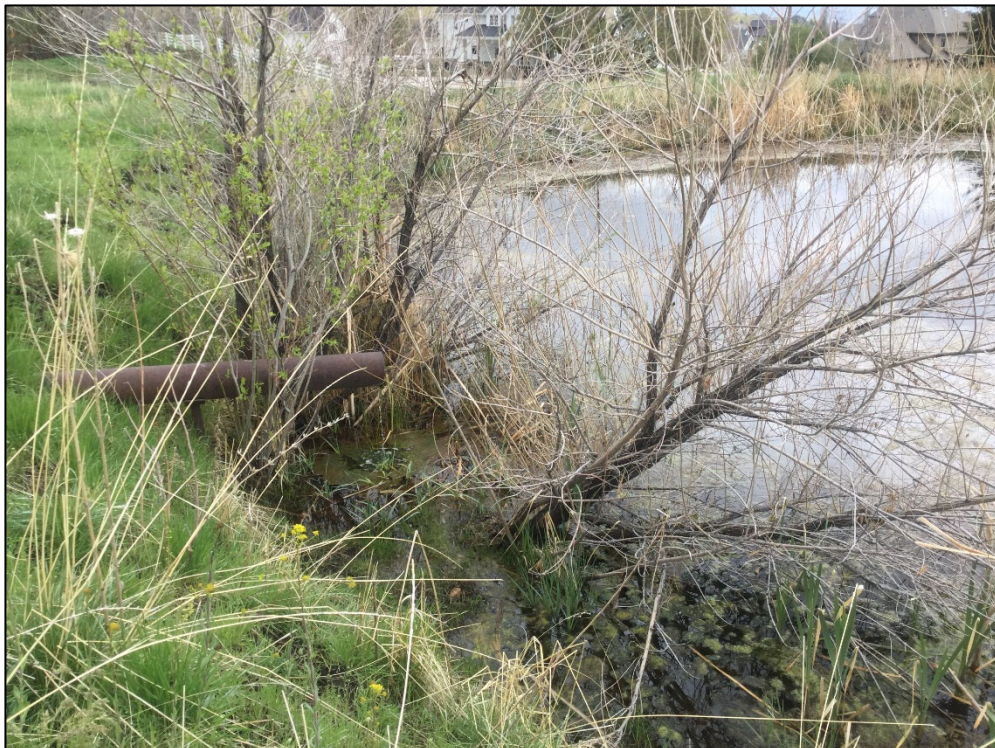
**Photo 6.**  
**Upper irrigation**  
**pond inlet pipe.**

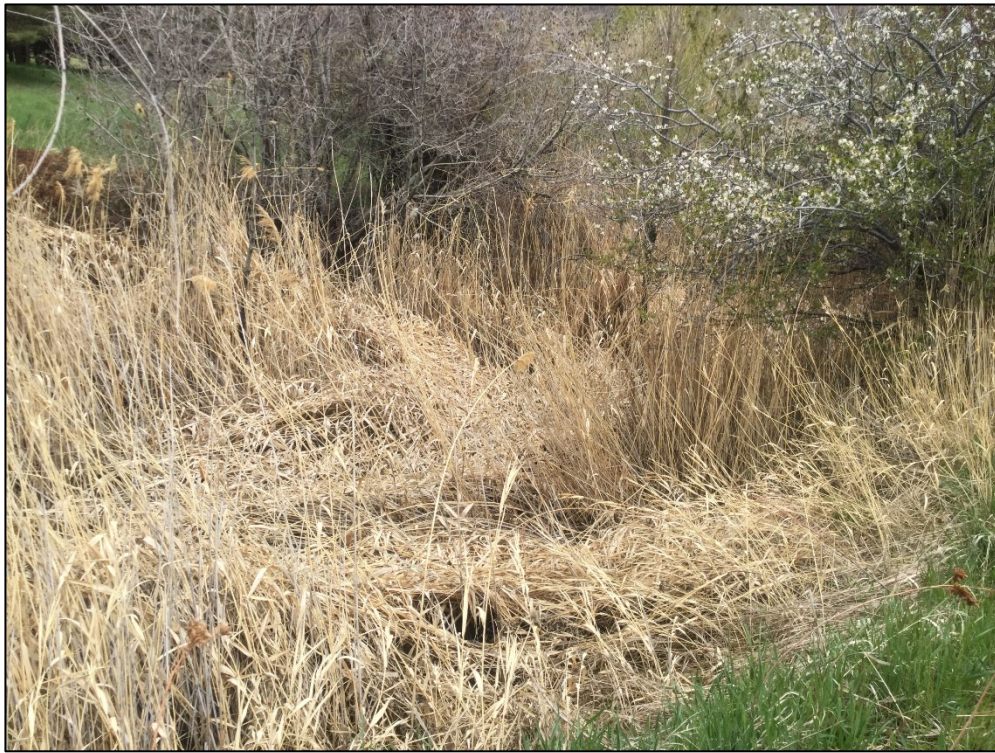
**Photo 7.**  
**Lower irrigation**  
**pond, overtaken**  
**by Phragmites.**

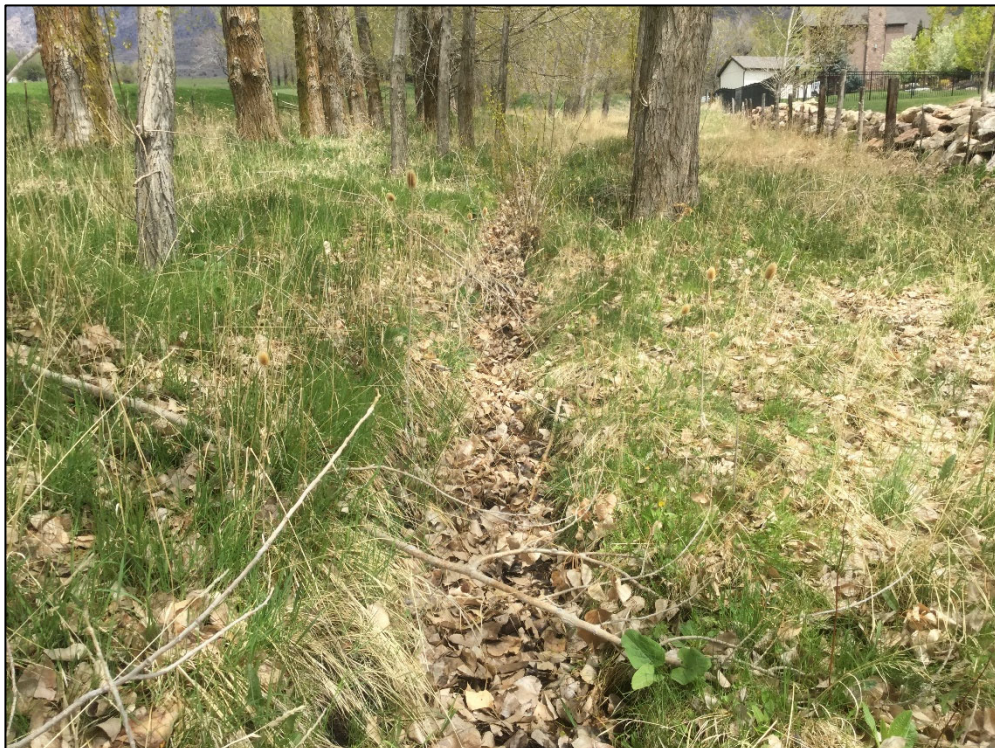
**Photo 8.**  
**Small ditch with**  
**no OHWM below**  
**lower pond.**

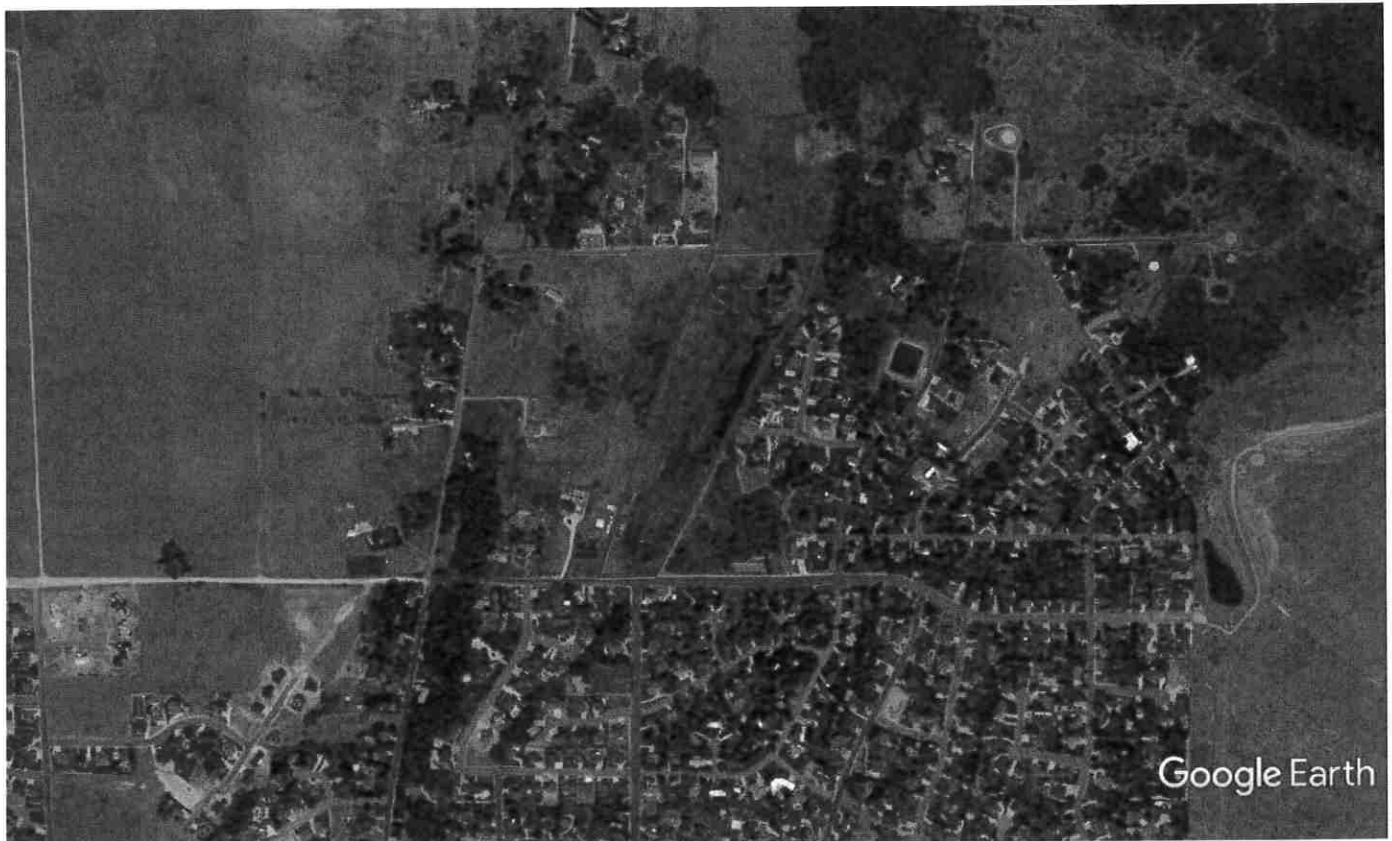
VICINITY MAP

CMT Technical Services (CMT) was retained to conduct a geotechnical subsurface study for the proposed development of approximately 26.7 acres as a single-family residential subdivision. The parcel is situated on the north side of 4300 North Street at about 500 West in Pleasant View, Utah, as shown in the **Vicinity Map** below.
