**PARK CITY HISTORIC PRESERVATION BOARD MEETING  
SUMMIT COUNTY, UTAH  
January 6, 2025**

- 6.A. **1455 Woodside Avenue – Relocation of Historic Structure** – The Applicant Proposes Removing a 580-square-foot 1960s Rear Addition to Rehabilitate the 1904 Significant Historic Form, Restoring a Historic Porch, and Relocating the 1904 Significant Historic Structure 14 Feet Towards the Southeast of the Property in the Recreation Commercial Zoning District in Order to Create Up to Four Lots. PL-23-05777  
(A) Public Hearing; (B) Action

**PARK CITY MUNICIPAL CORPORATION  
HISTORIC PRESERVATION BOARD MEETING  
MARSAC MUNICIPAL BUILDING  
COUNCIL CHAMBERS  
445 MARSAC AVENUE  
PARK CITY, SUMMIT COUNTY, UTAH  
MINUTES OF NOVEMBER 6, 2024**

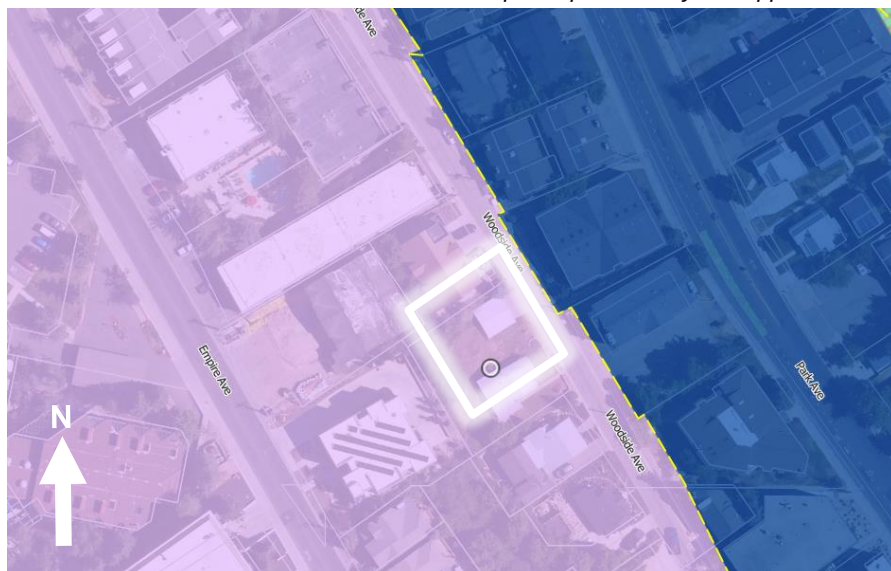
*1455 Woodside Avenue highlighted by staff in white on a Zoning Map excerpt with the RC Zoning District shown in purple.*

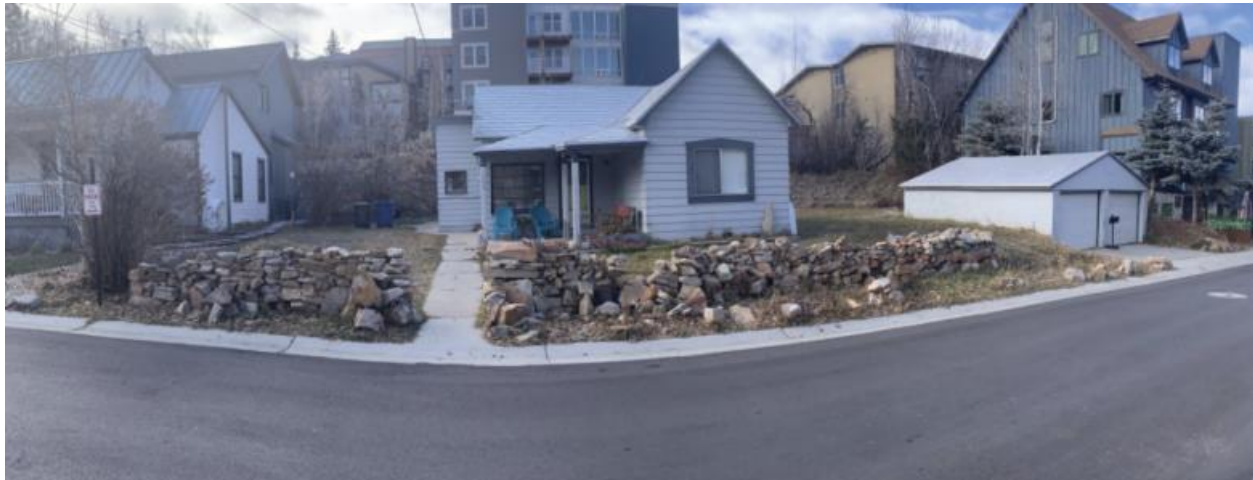
*1455 Woodside Avenue, viewed from Woodside Avenue; photo provided by the Applicant.*

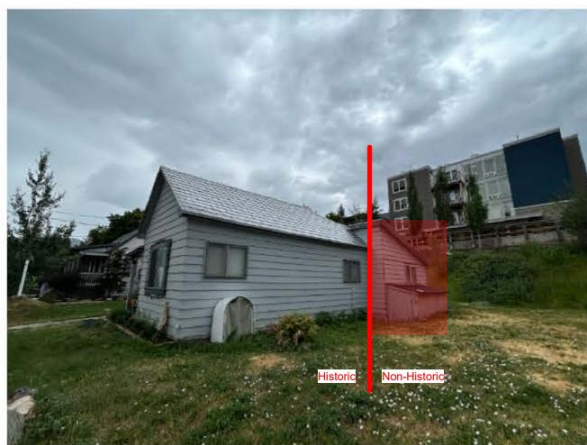
North East View @ Front With Non-Historic Addition

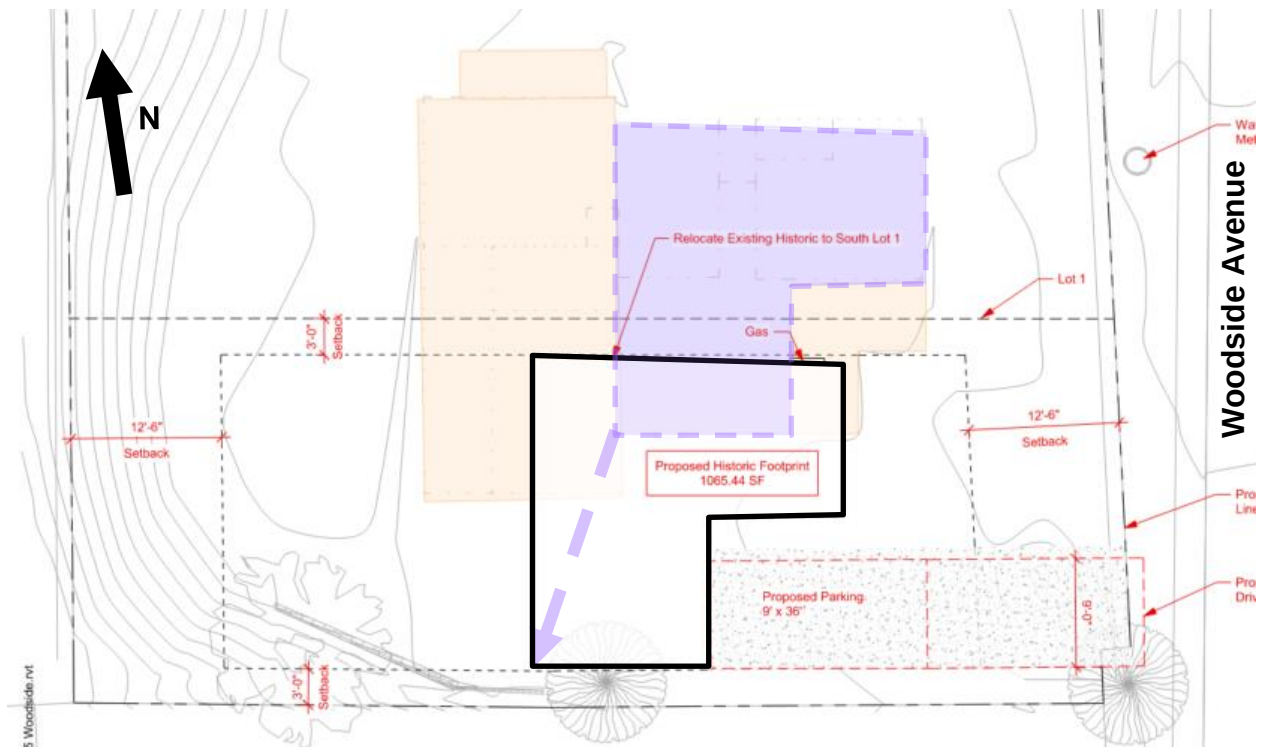
Finally, the Applicant proposes Relocation of the 1904 form of the Significant Historic Structure to the south by approximately 14 feet to further subdivide the property into up to four Lots – one for the Historic Structure and three for new SFDs (see Exhibit E).

Site plan provided by the Applicant showing the existing Significant Historic Structures' location in purple, the 1960s rear addition and front porch in orange, and the modified structure in the proposed new location in black and white.

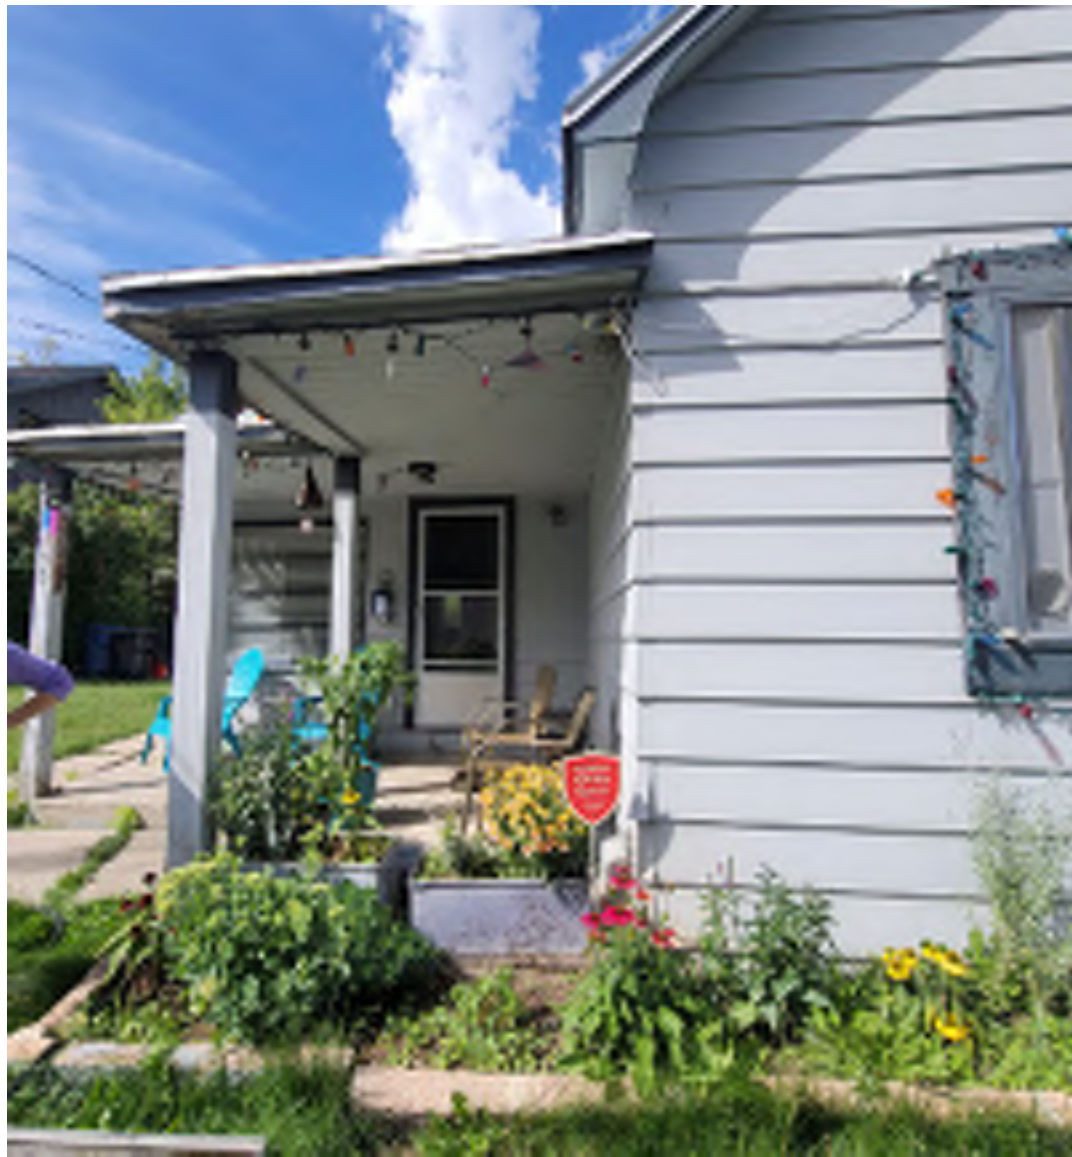
Sheet 8 Photo 1

Paint peeling on columns and ceiling. The side of the concrete slab is slightly weathered and cracked by the front door. Soffit wood is deteriorating and falling off in corners causing holes or tears in the soffit.

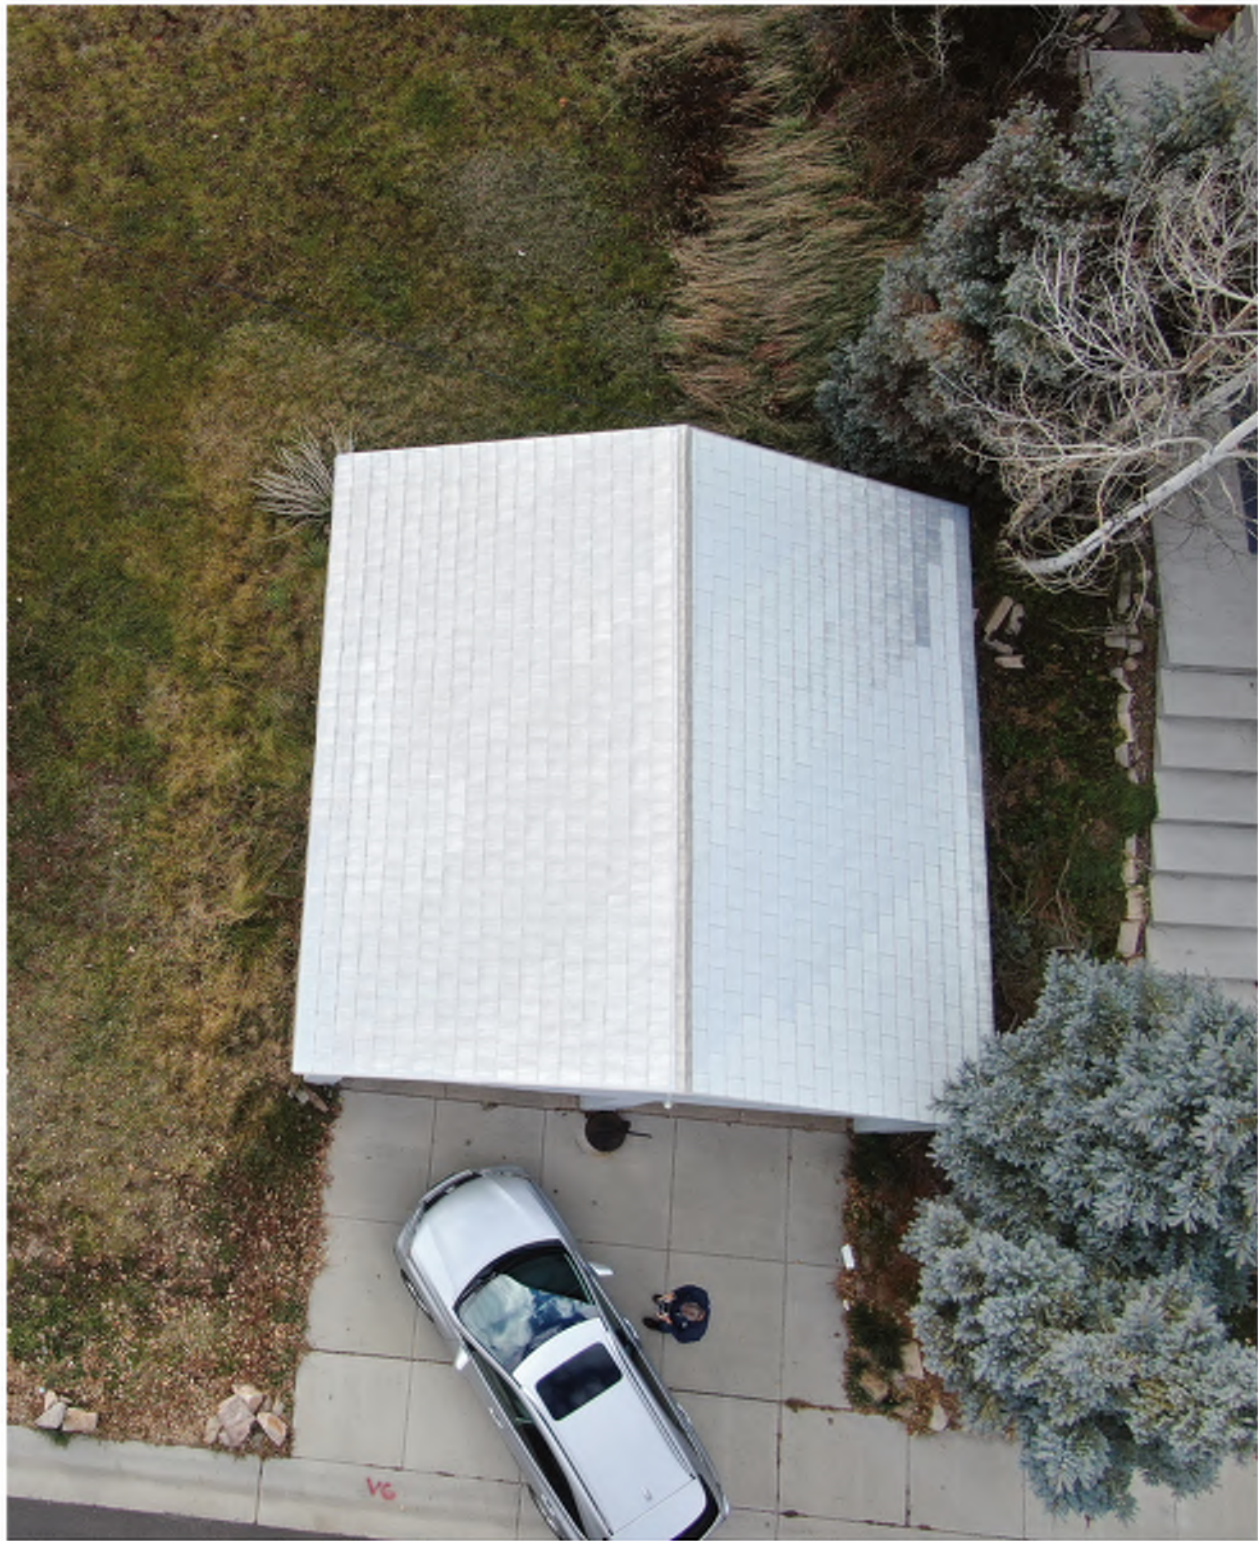
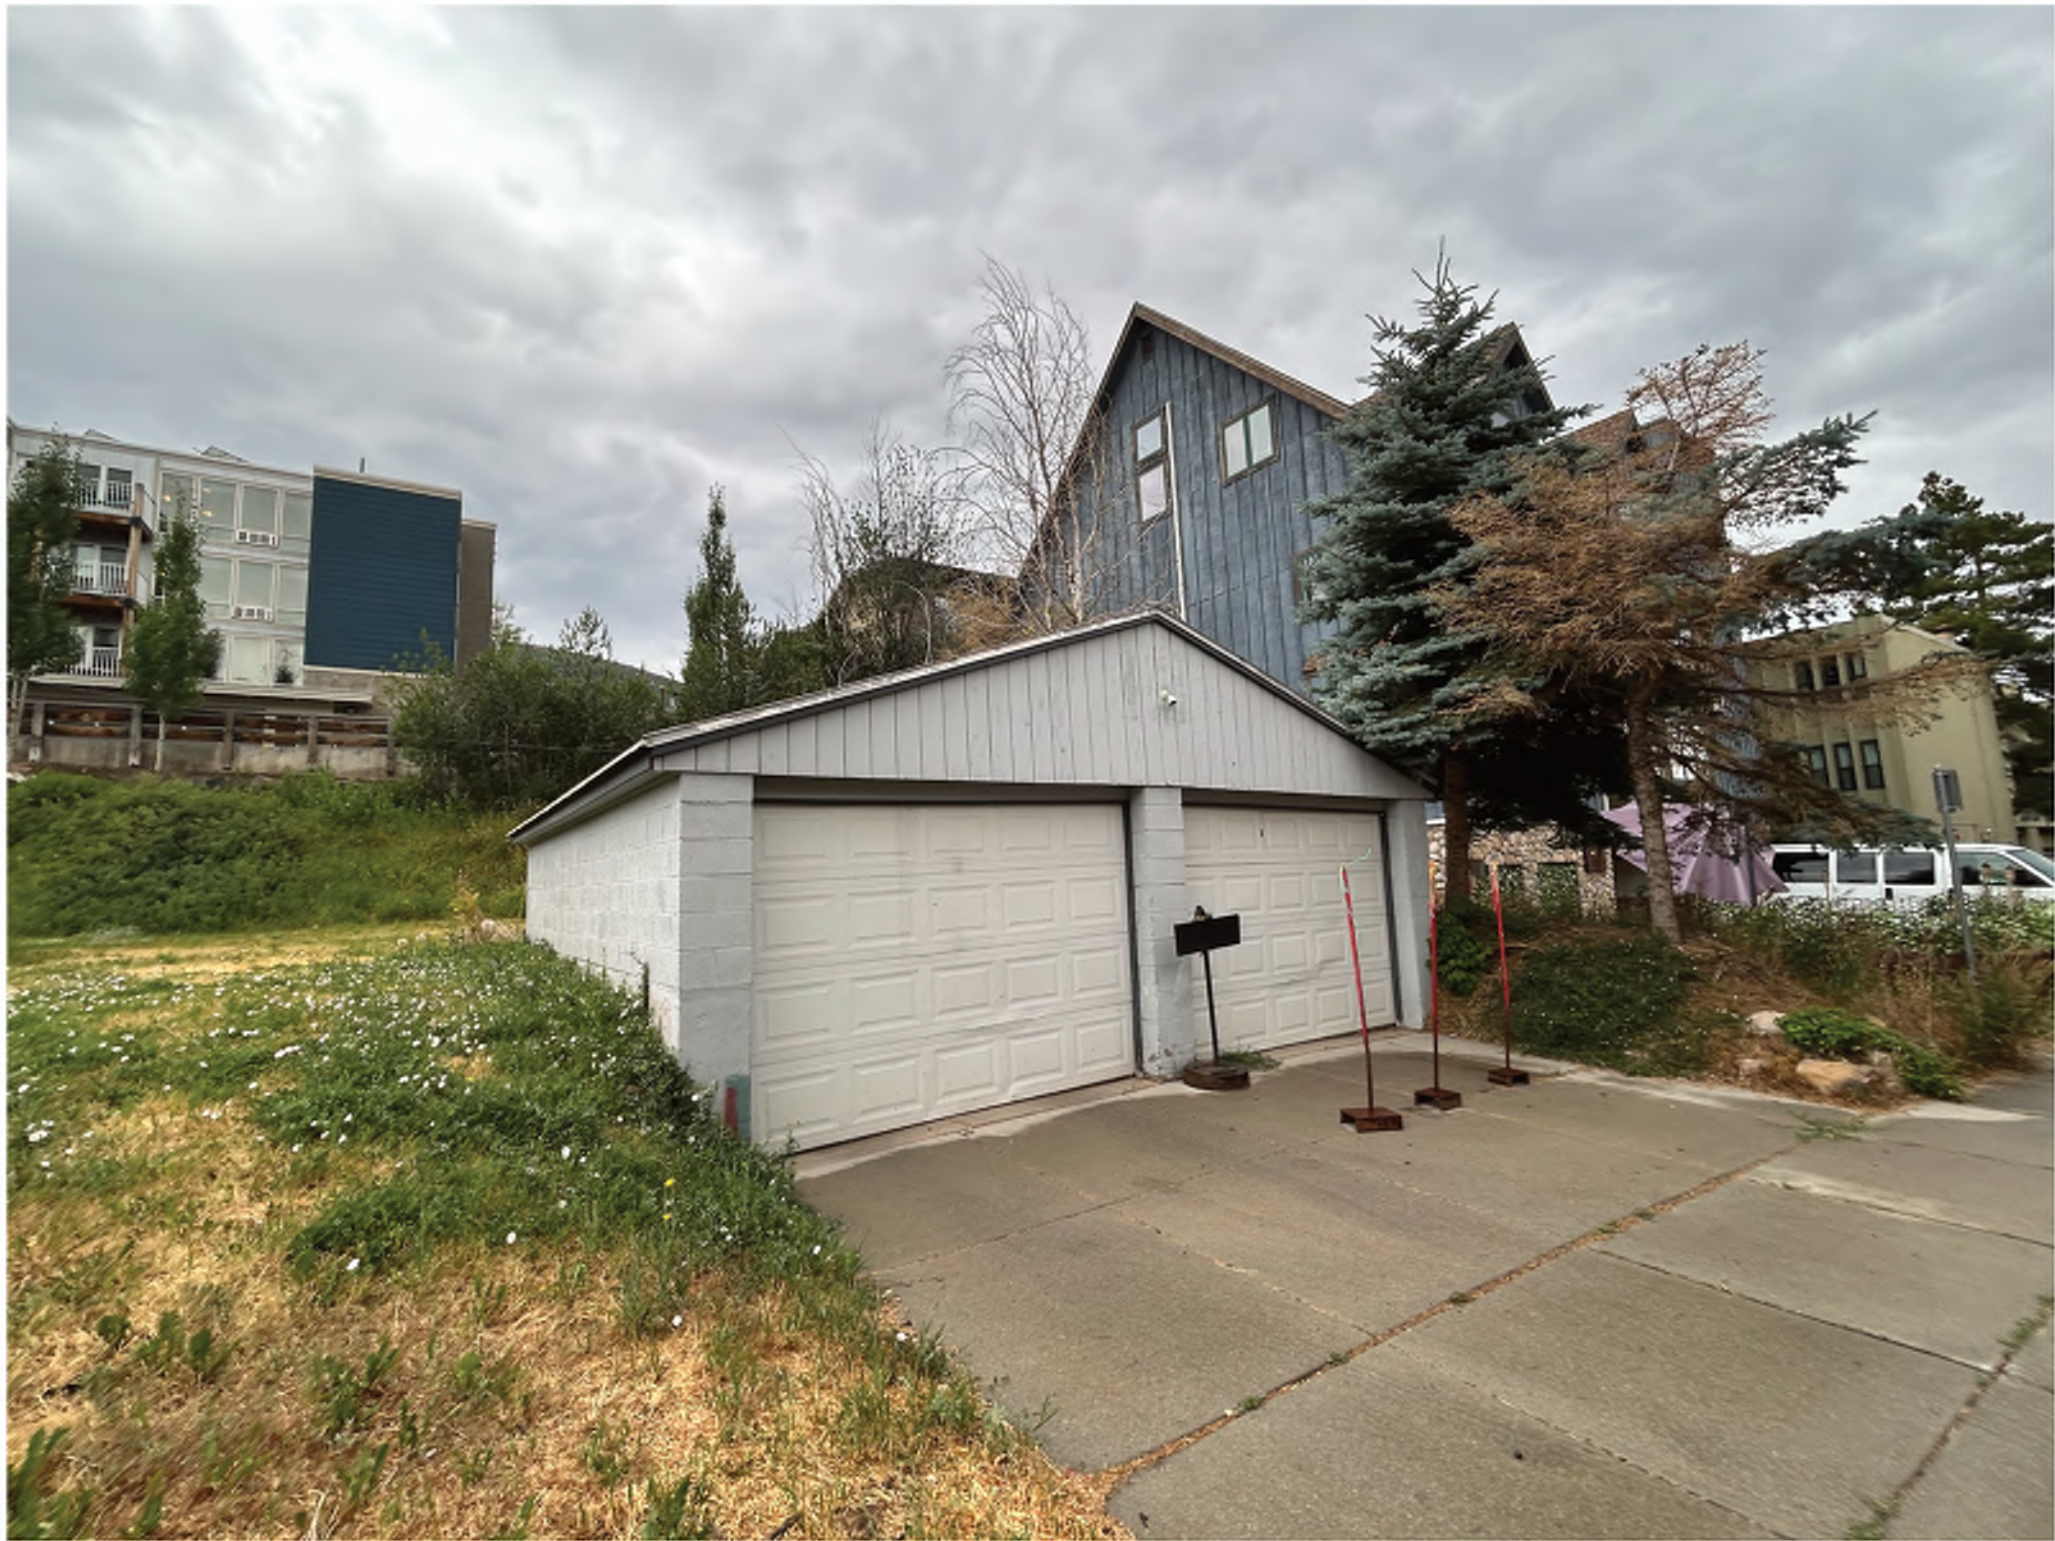
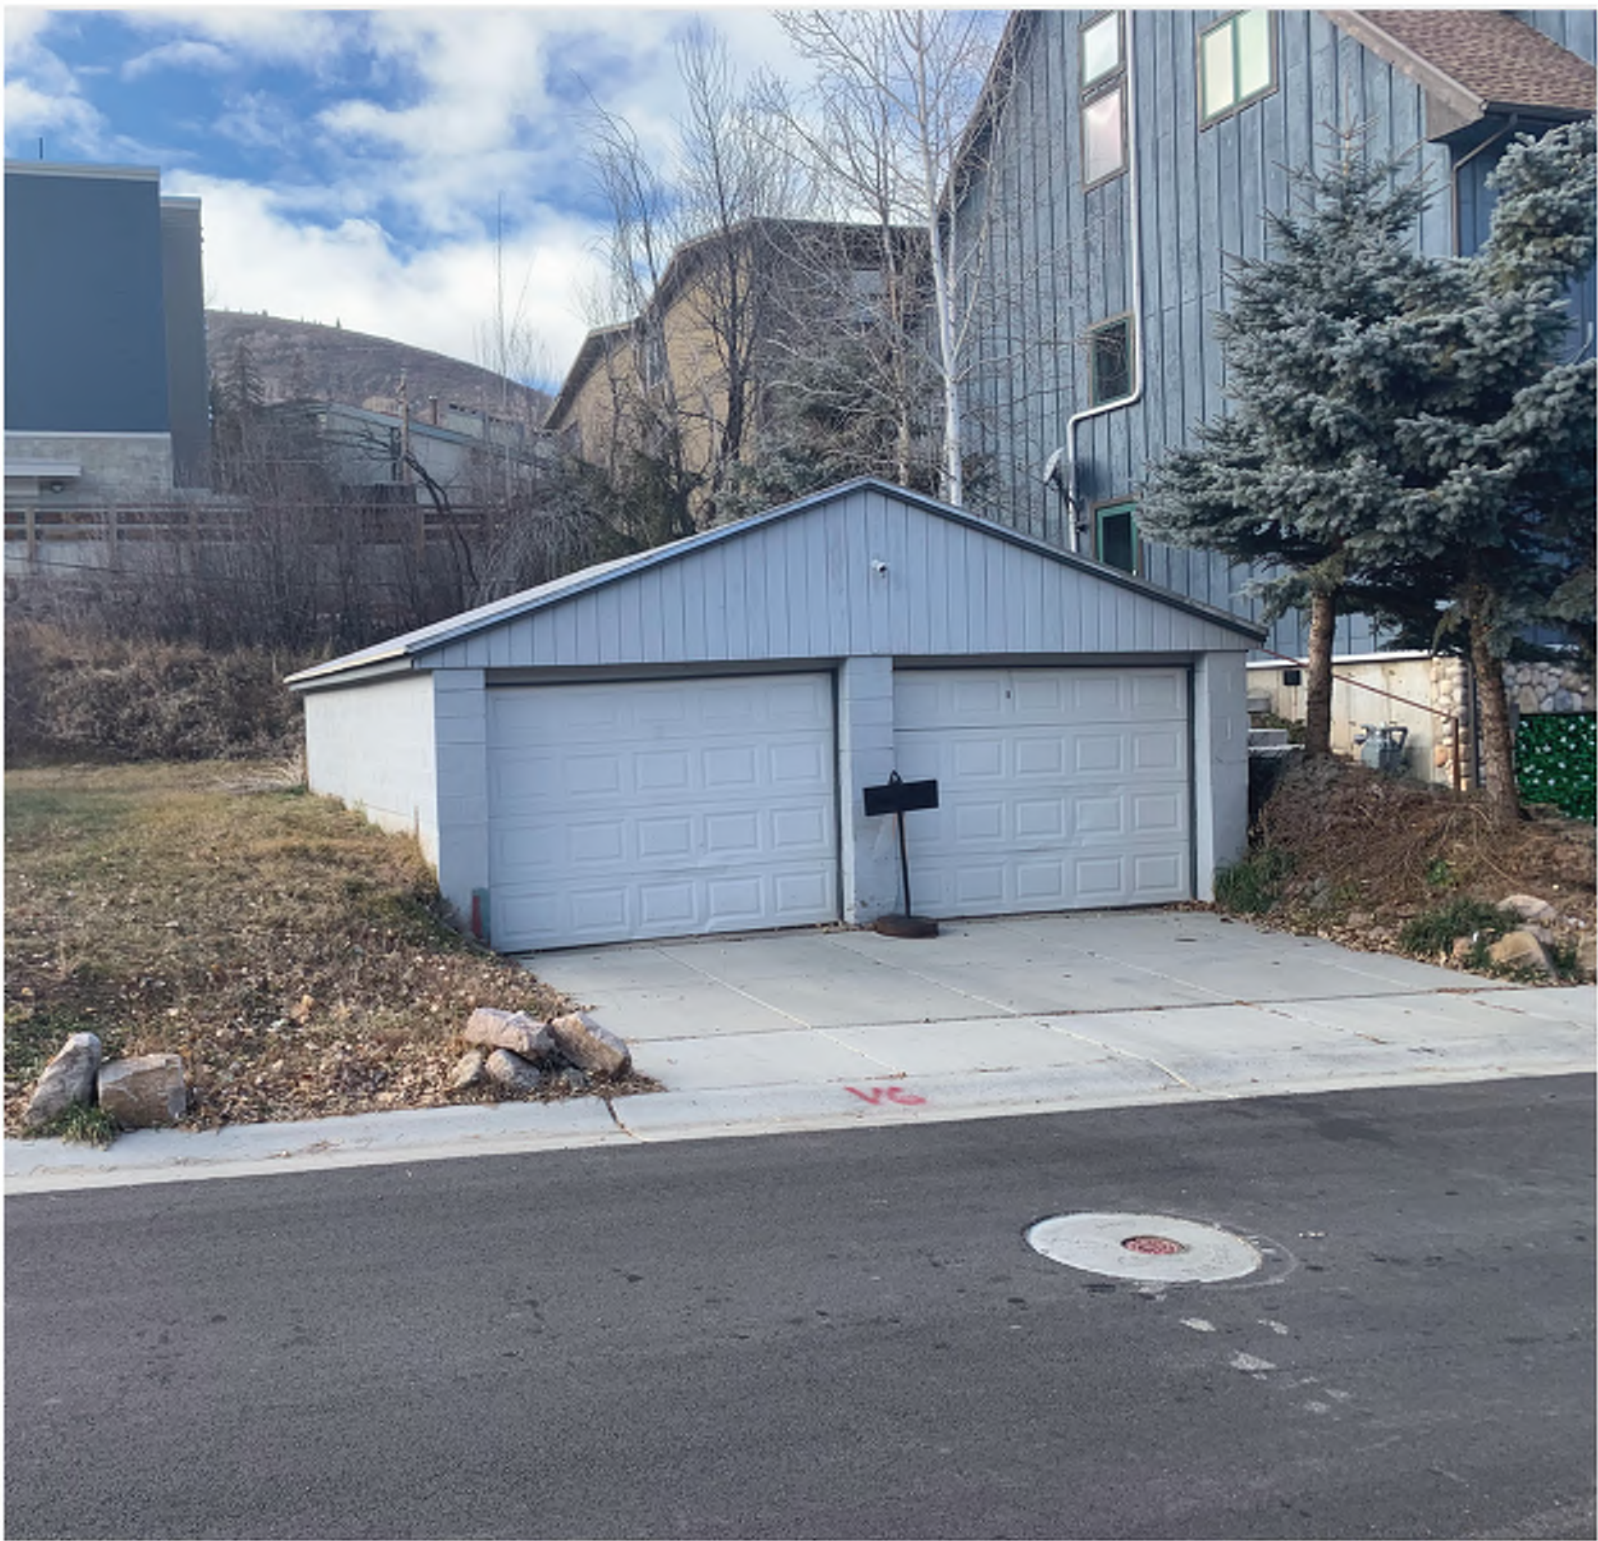
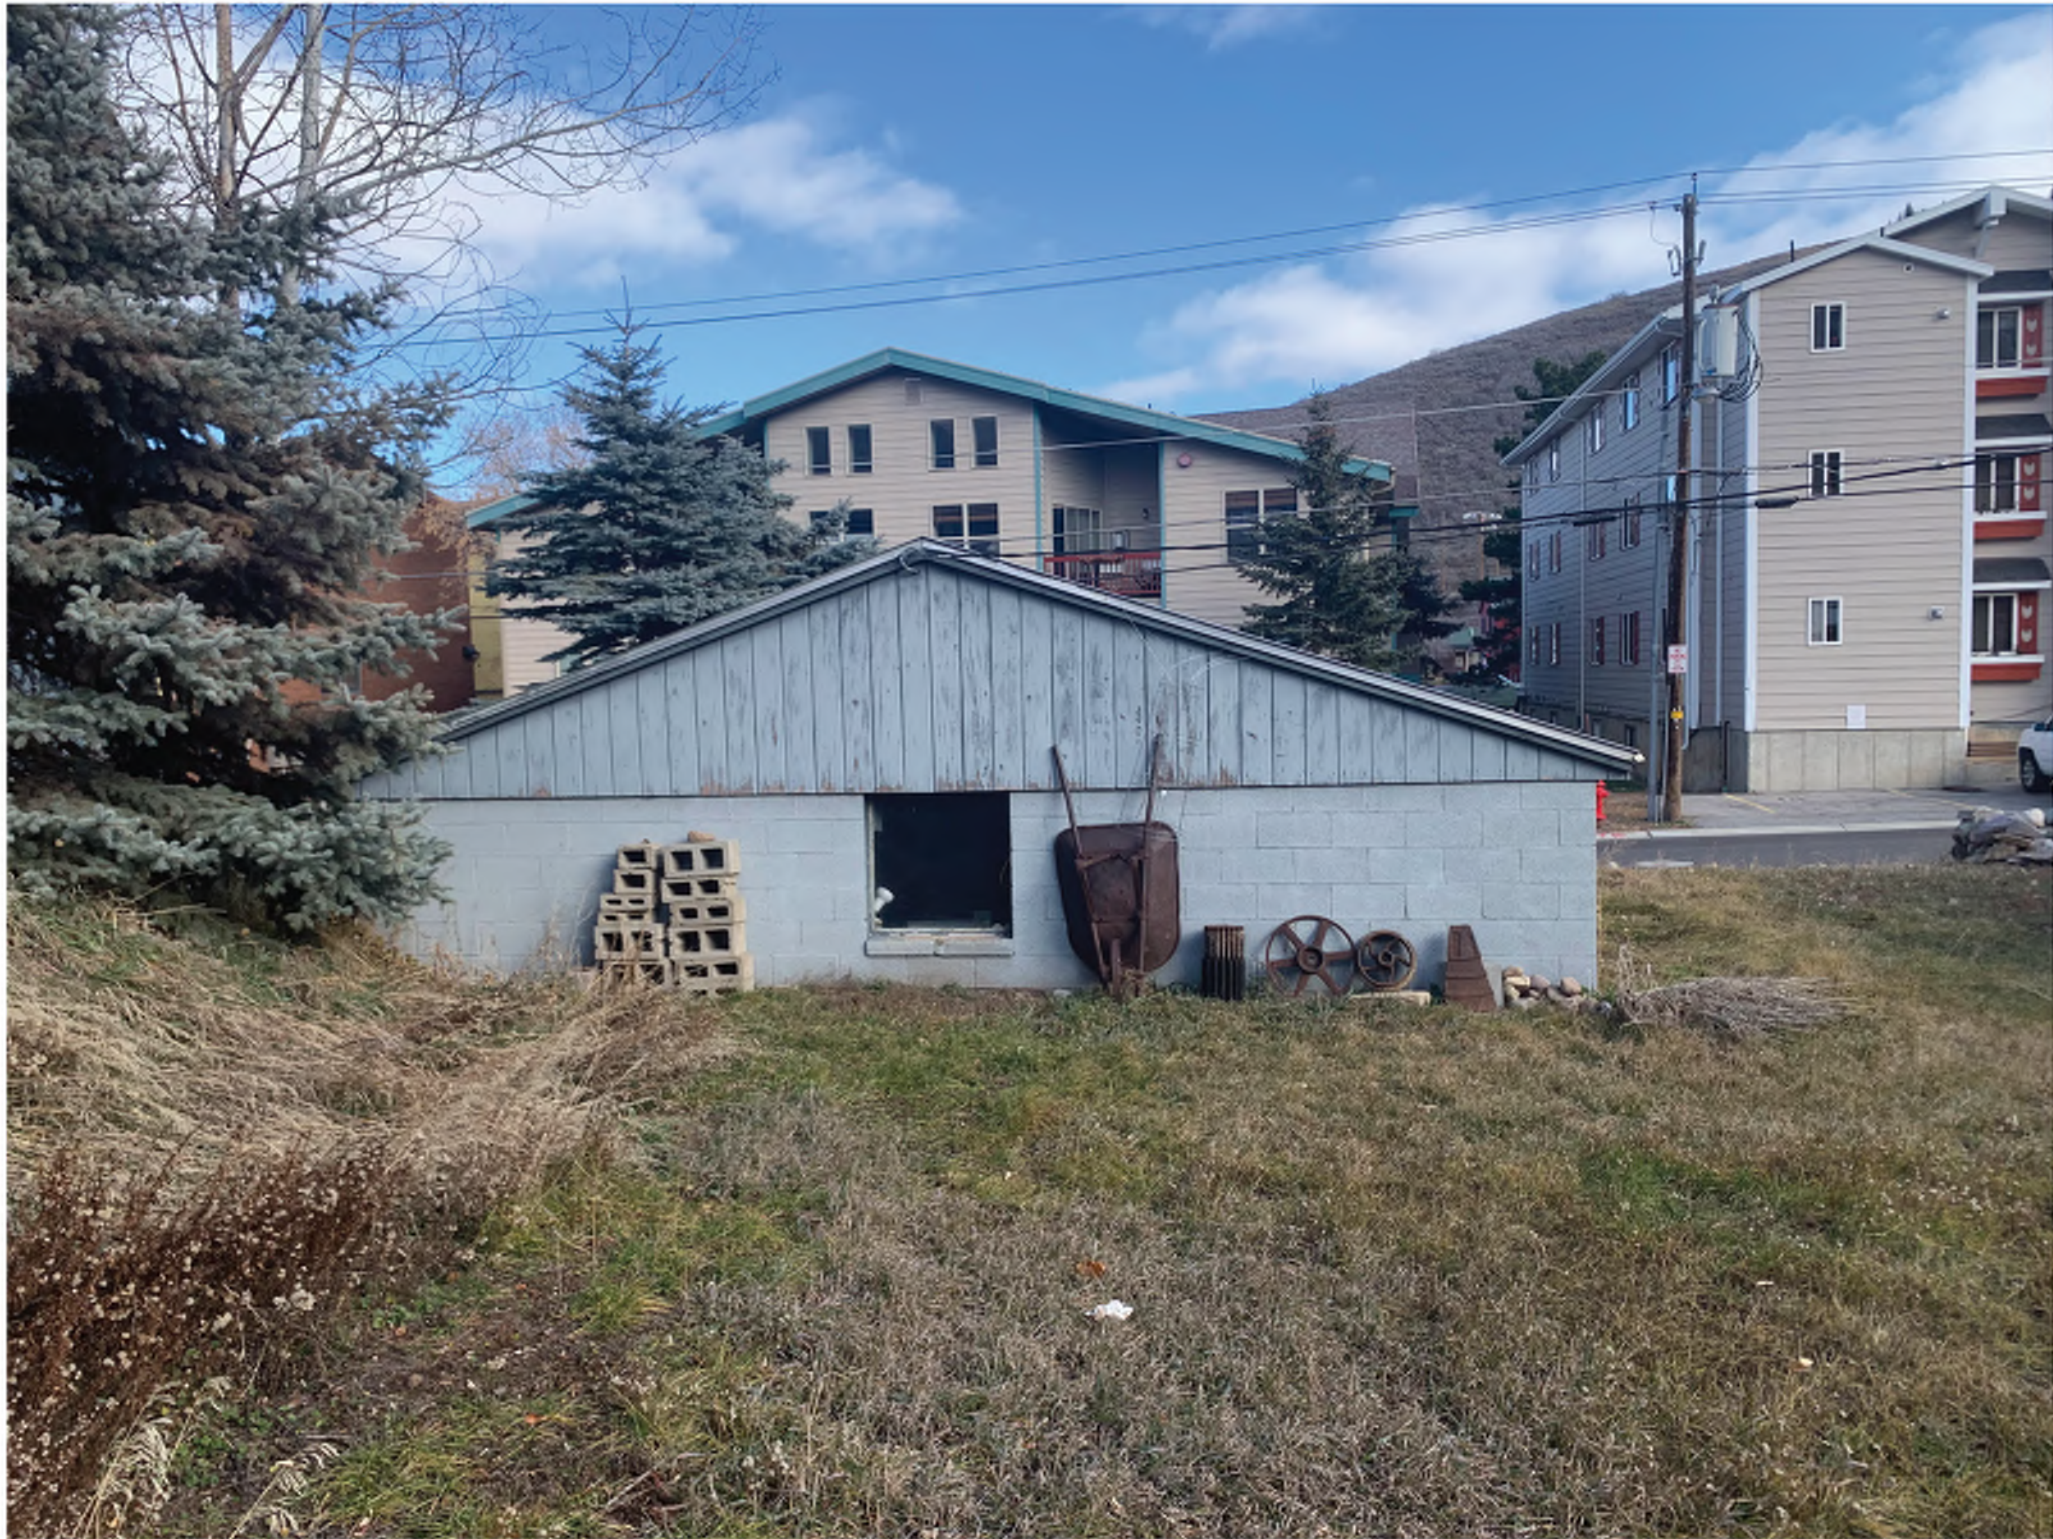
Metal flashing is weathered. Paint is peeling on wood portion of rear. The window in rear is deteriorating.

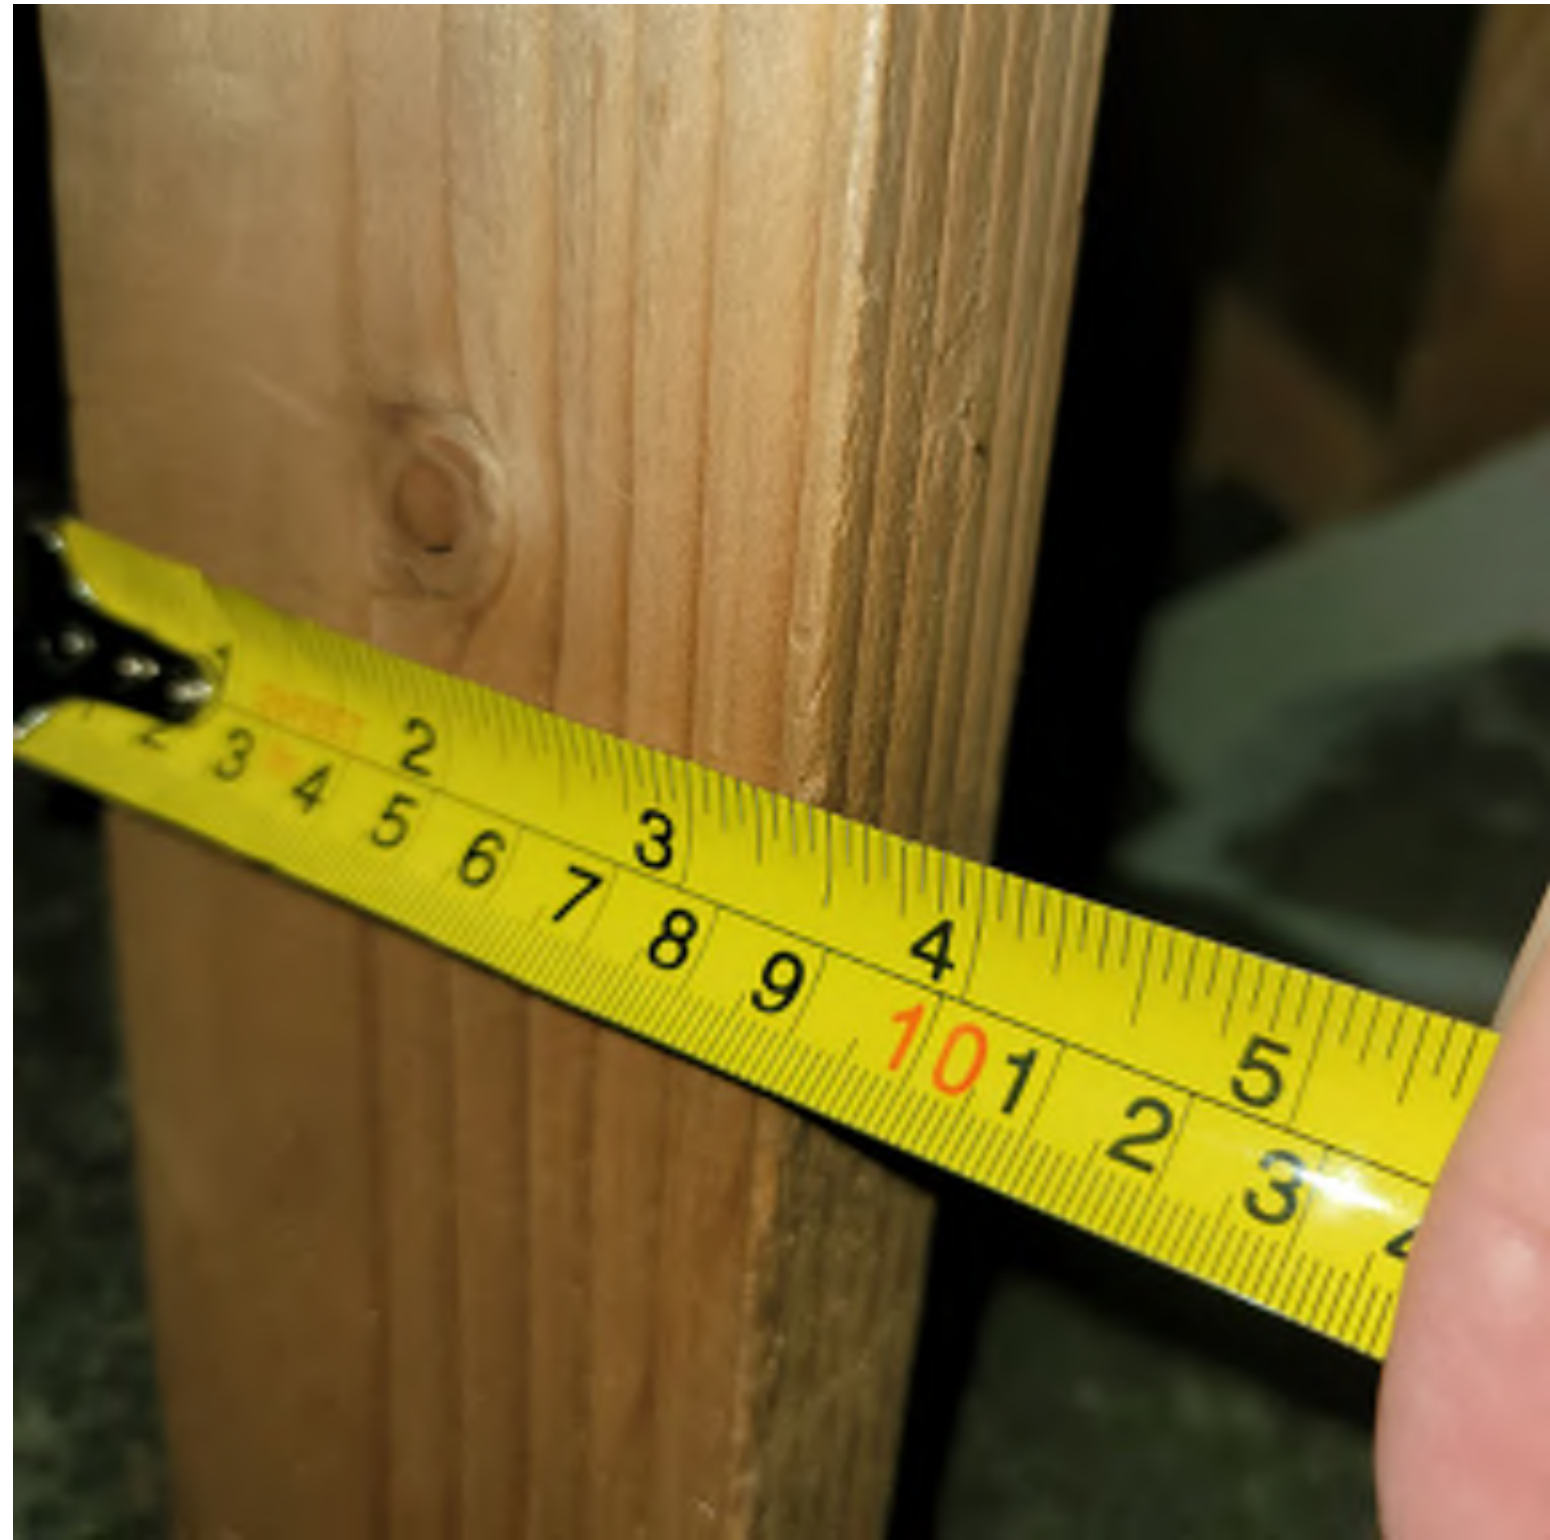
Measurement of an upright in the rear shed roof addition. Showing width and depth of 3 1/2" x 1 1/2" which is modern lumber dimensioning

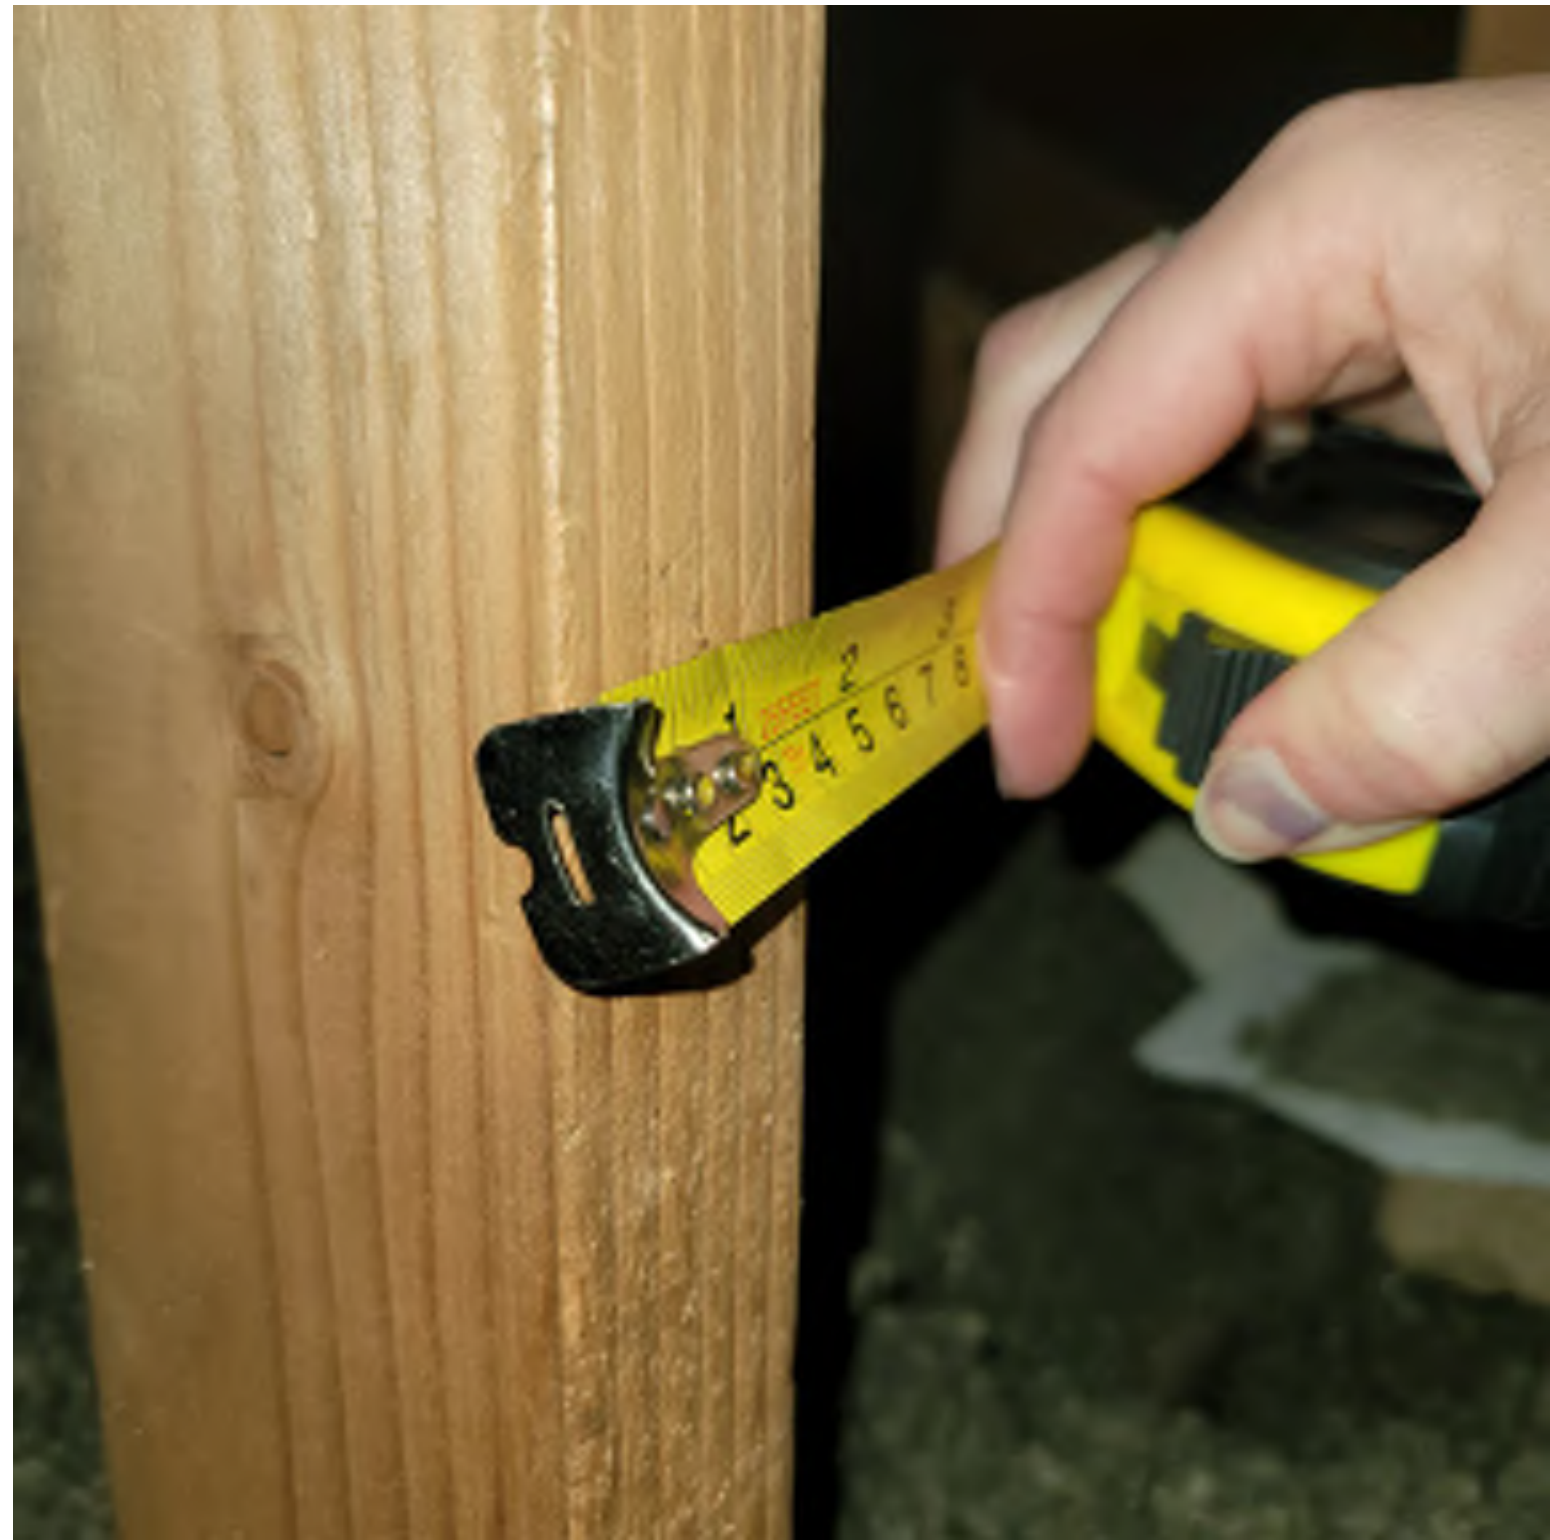
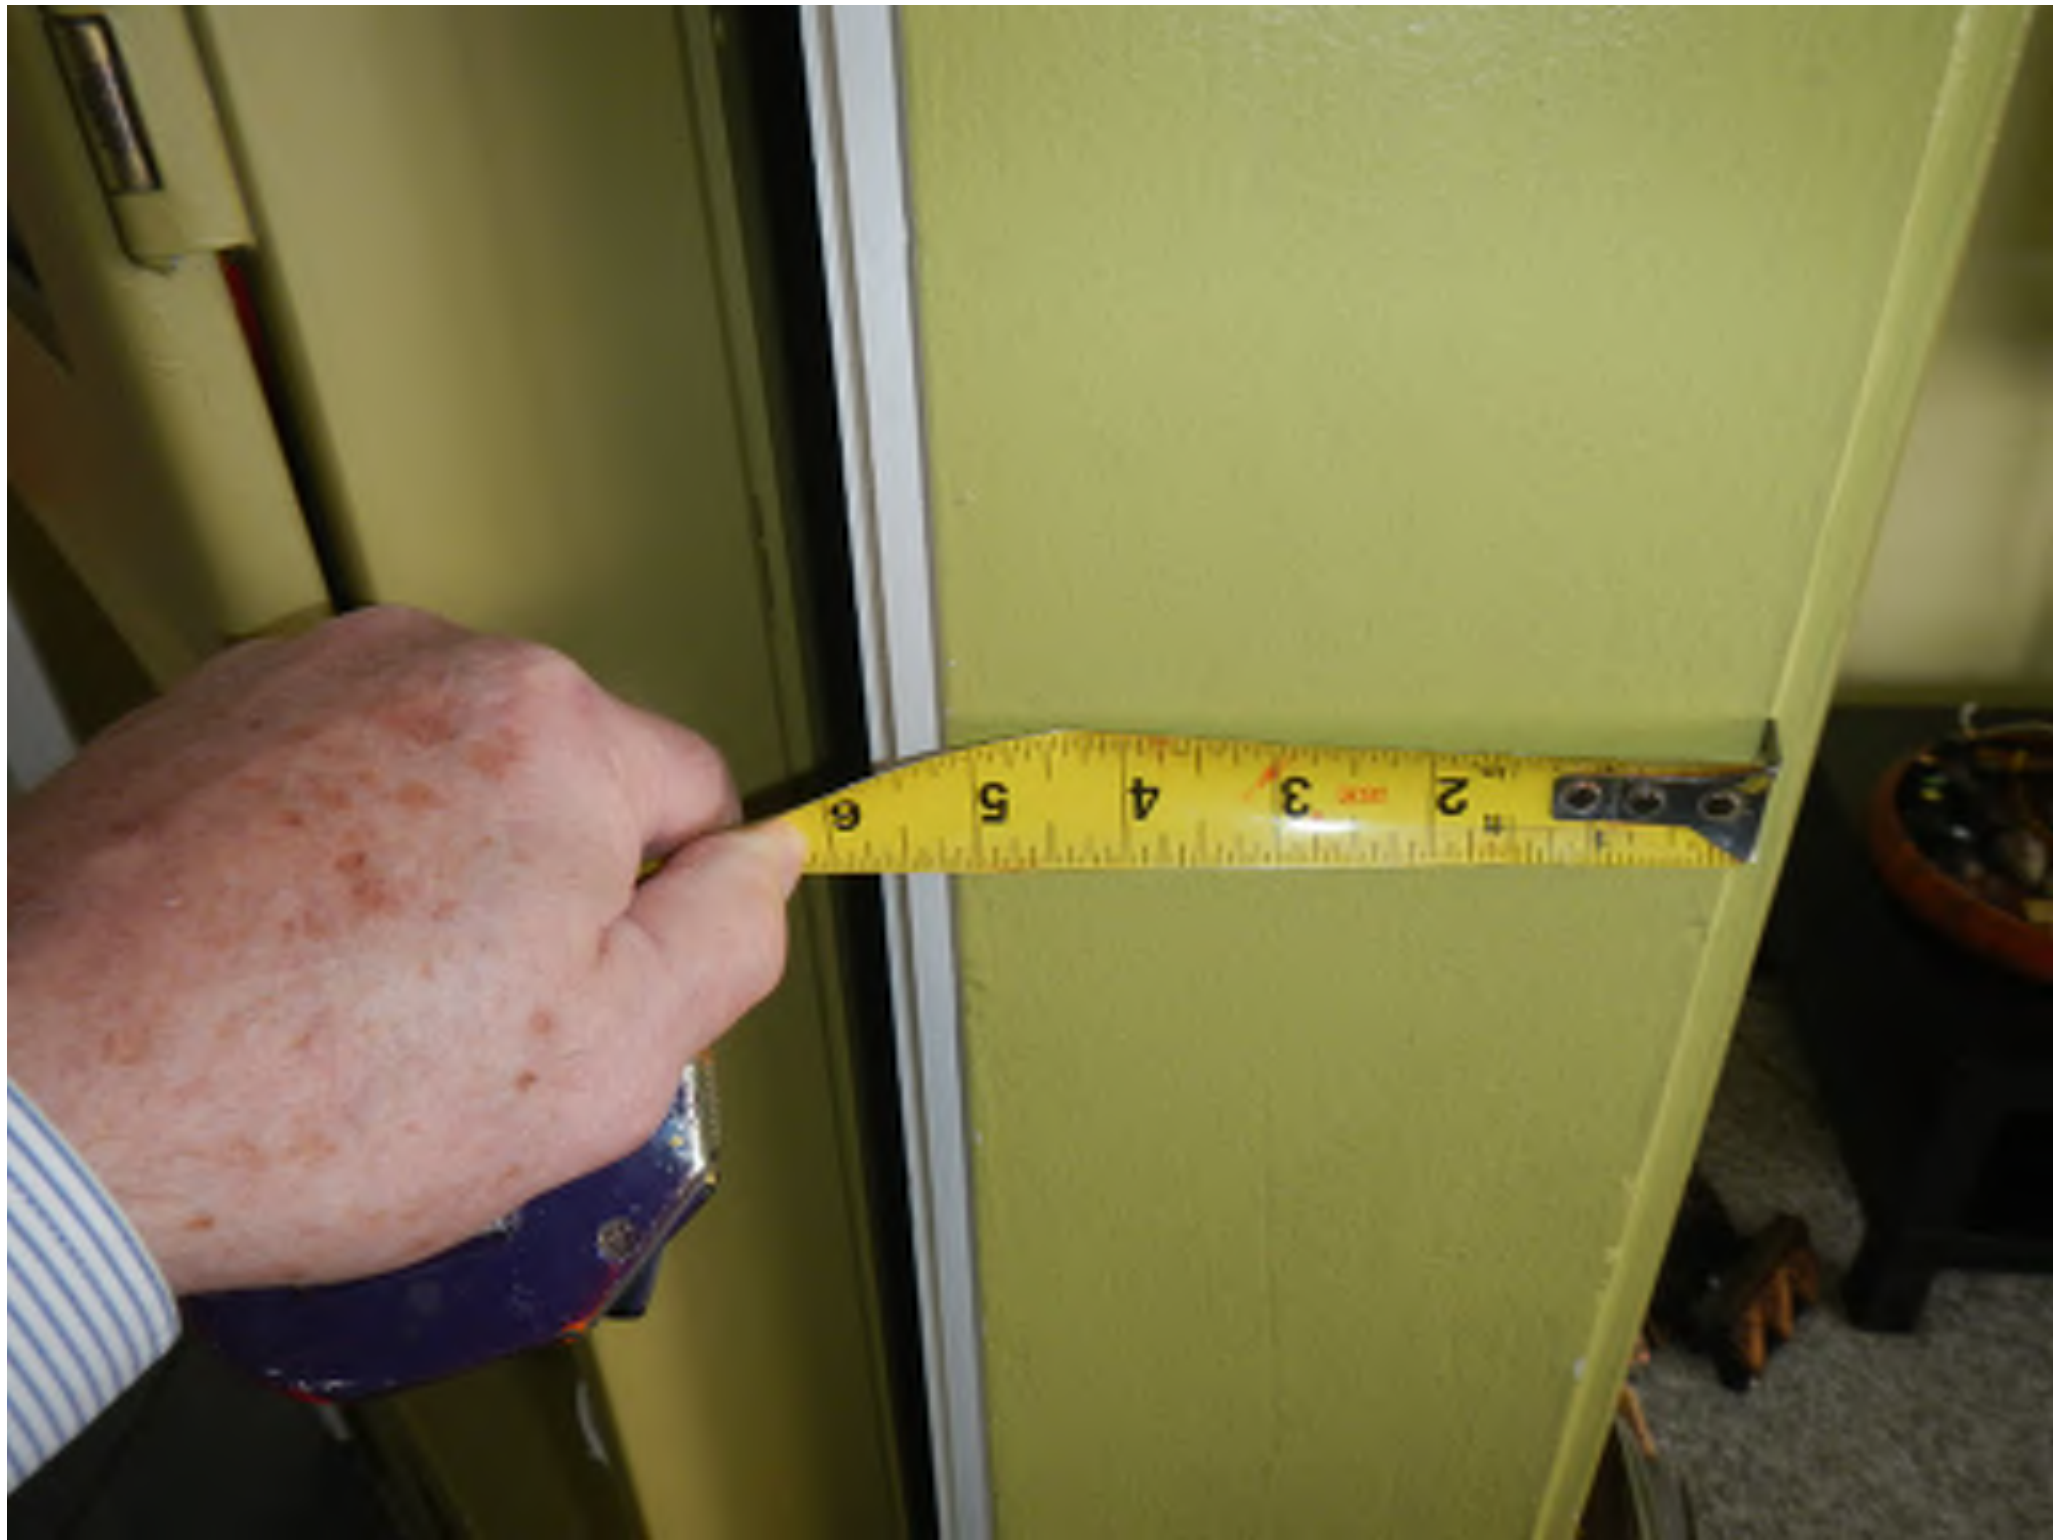
Measurement of original 1904 rear exterior wall between original 1904 L-shape structure and rear addition. Now interior wall
