**PARK CITY HISTORIC PRESERVATION BOARD MEETING  
SUMMIT COUNTY, UTAH  
January 6, 2025**

- 6.A. **1455 Woodside Avenue – Relocation of Historic Structure** – The Applicant Proposes Removing a 580-square-foot 1960s Rear Addition to Rehabilitate the 1904 Significant Historic Form, Restoring a Historic Porch, and Relocating the 1904 Significant Historic Structure 14 Feet Towards the Southeast of the Property in the Recreation Commercial Zoning District in Order to Create Up to Four Lots. PL-23-05777  
(A) Public Hearing; (B) Action

**PARK CITY MUNICIPAL CORPORATION  
HISTORIC PRESERVATION BOARD MEETING  
MARSAC MUNICIPAL BUILDING  
COUNCIL CHAMBERS  
445 MARSAC AVENUE  
PARK CITY, SUMMIT COUNTY, UTAH  
MINUTES OF NOVEMBER 6, 2024**

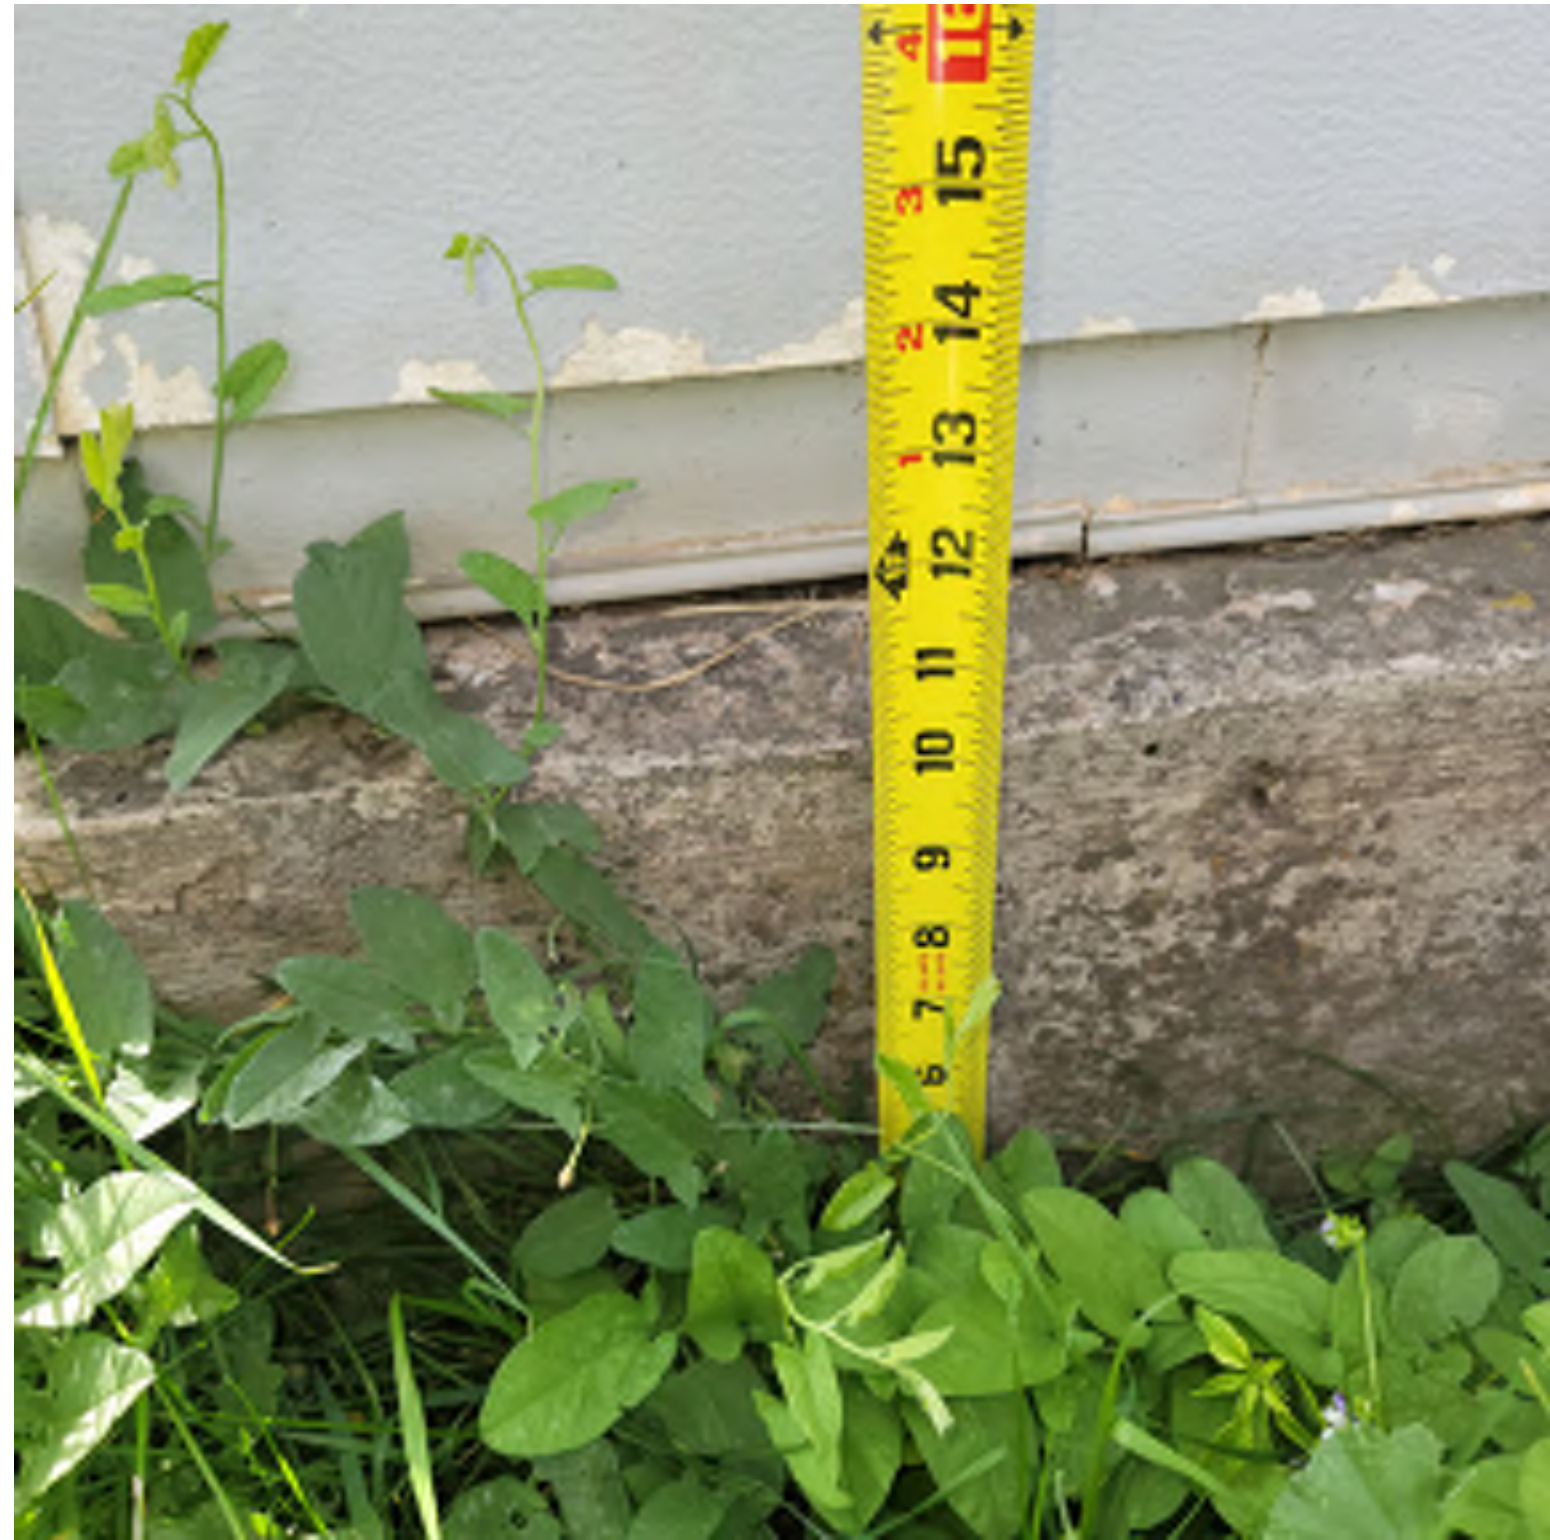
Measurement of concrete grade beam perimeter band (north)
