## **Memorandum**

**To:** Planning Commission  
**From:** Niall Connolly, Principal Planner  
**Date:** June 13th 2025  
**Re:** Erosion Hazard Zone Permit, 517 Watchman Drive

# EROSION HAZARD ASSESSMENT

Parcel S-CSD-4  
Springdale, Utah

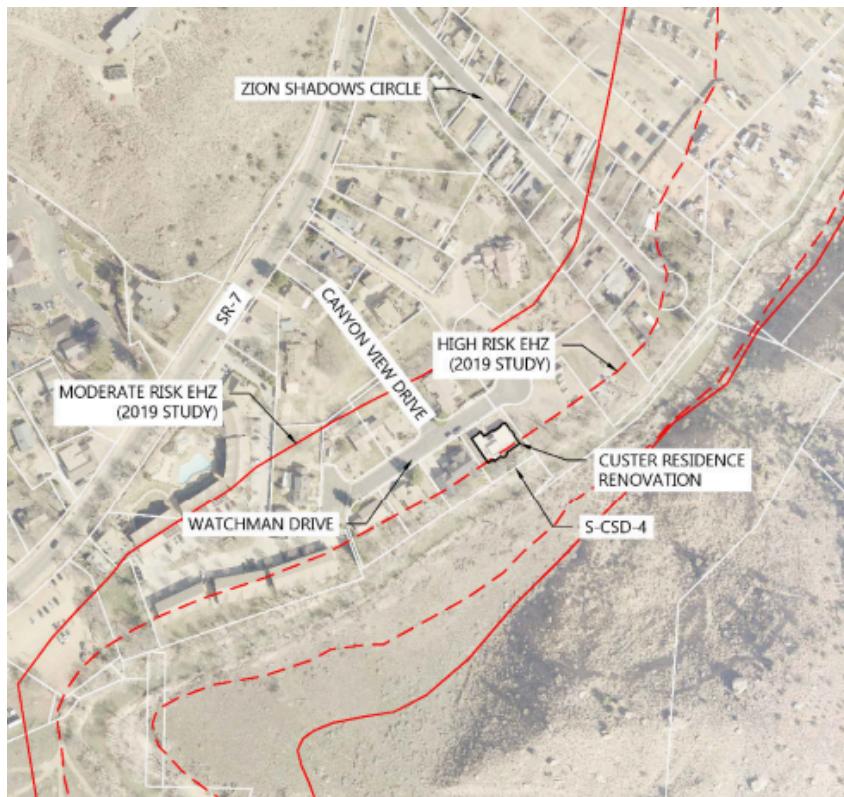
**Figure 1. Aerial view of the property, with the erosion hazard zones overlaid.**

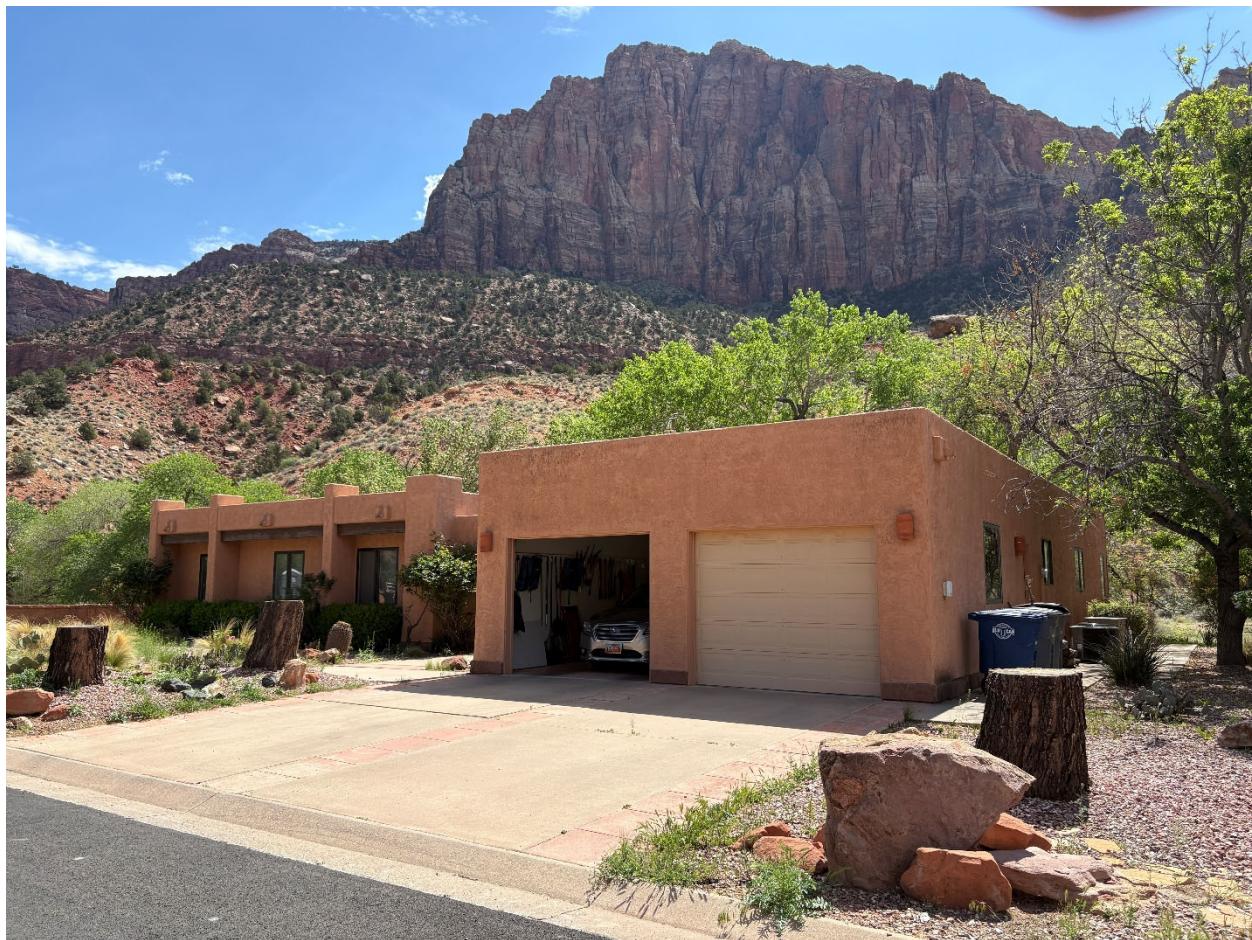
**Figure 2** – April 17, 2025. Image of the Custer Residence, looking east from Watchman Drive. The North Fork of the Virgin River is located behind the structure. The proposed improvements are partially located within the HREHZ and MREHZ.

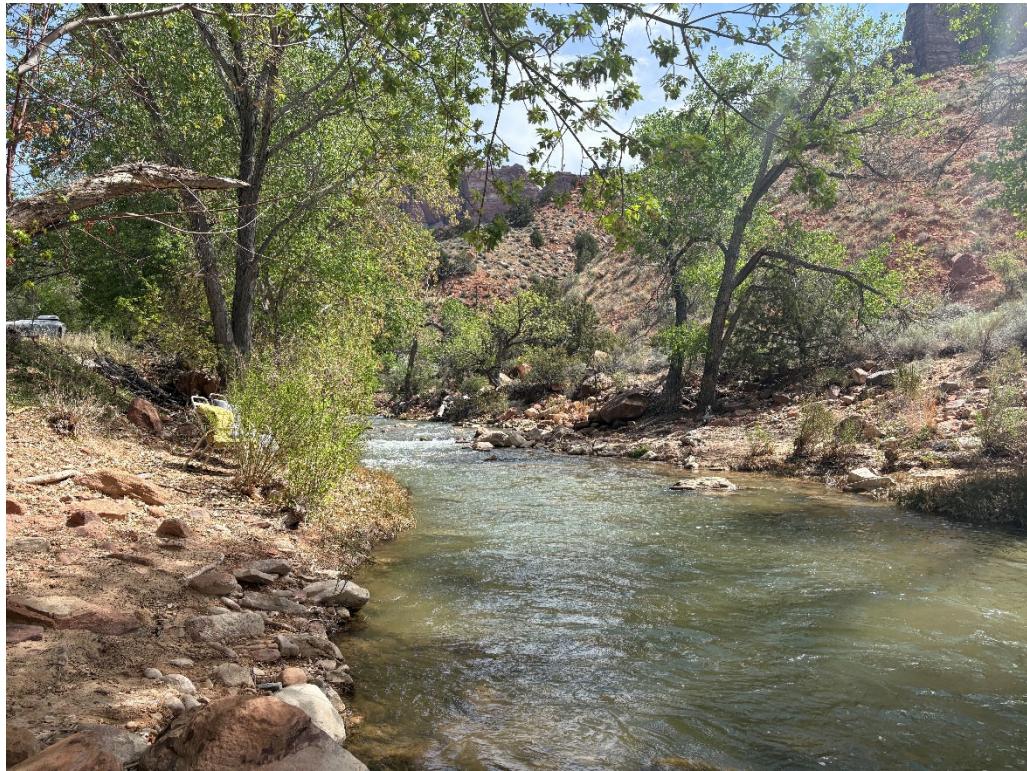
**Figure 3** – April 17, 2025. Looking upstream adjacent to the northern edge of Parcel S-CSD-4 along the right (west) overbank. The active floodplain along the right (west) overbank is steeper than the left (east) overbank throughout the study reach. The low flow channel of the river consists of a wide, gravelly sand bed with cobbles and the occasional boulder.

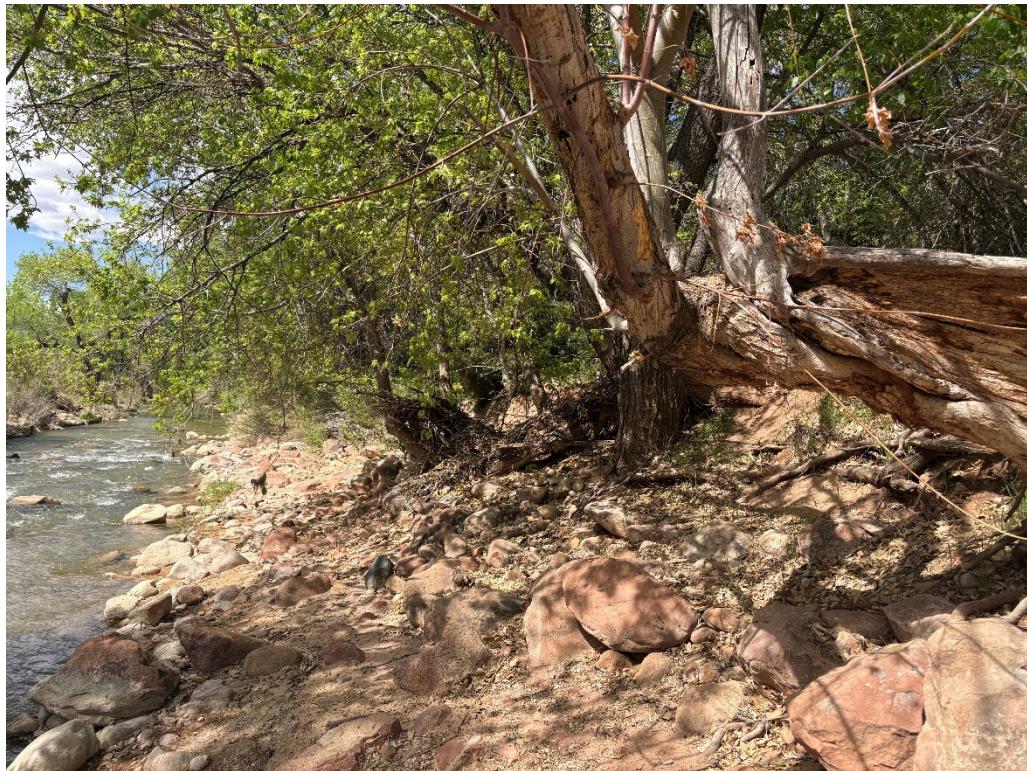
**Figure 4** – April 17, 2025. Looking downstream along the right (west) overbank of the North Fork of the Virgin River upstream of Parcel S-CSD-4. A few of the mature cottonwoods along this stretch of the river are undercut, with debris piles accumulating on the low lying branches or trunks.

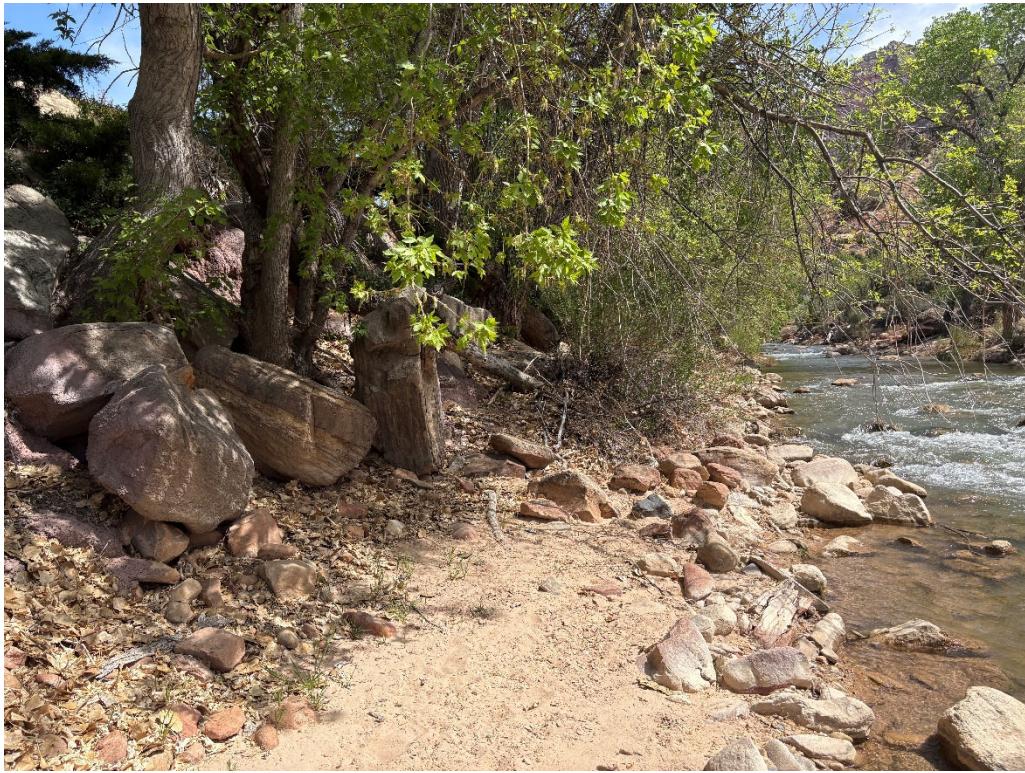
**Figure 5** – April 17, 2025. Looking upstream along the west (right) overbank adjacent to Parcel S-CSD-4. The bank armoring that was previously completed plays a significant role in the stability of this section of streambank. The grout located around some of the larger cottonwoods has limited erosion, preventing undercutting from occurring.

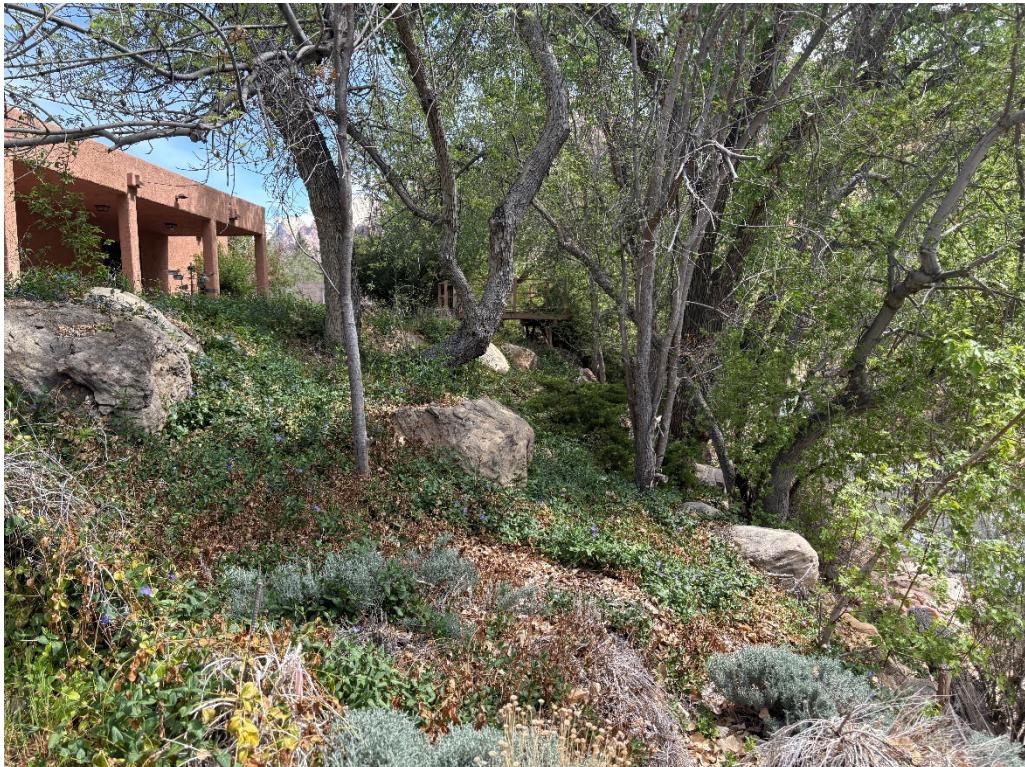
**Figure 6** – April 17, 2025. Looking upstream partway up the right (west) overbank of the North Fork of the Virgin River. The covered patio area of the Custer Residence is visible on the left side of the image. The tiered, large boulders that are keyed into the bank are visible in the center of the image. The area between these boulders is heavily vegetated with herbaceous and woody vegetation.

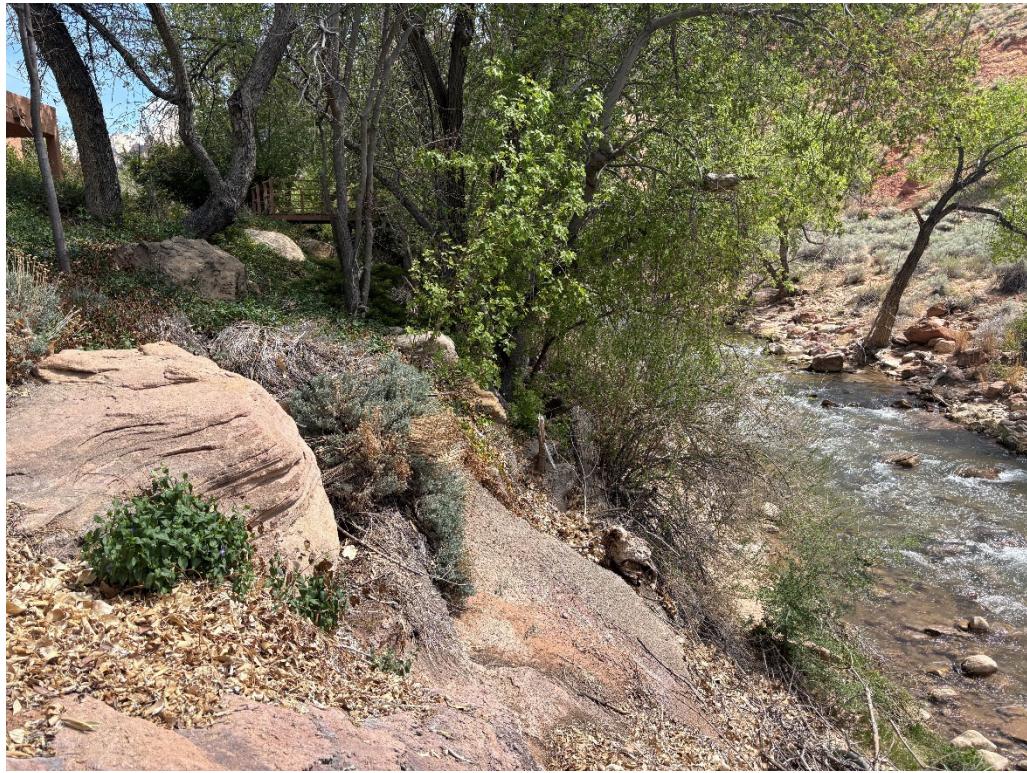
**Figure 7** – April 17, 2025. Looking upstream partway up the right (west) overbank of the North Fork of the Virgin River. The apron of grout is visible in the forefront of the image. This grout is present between the lower tiers of keyed in boulders and appears to be between 2 and 6 inches thick. The overbank adjacent to the Custer Residence is heavily vegetated.

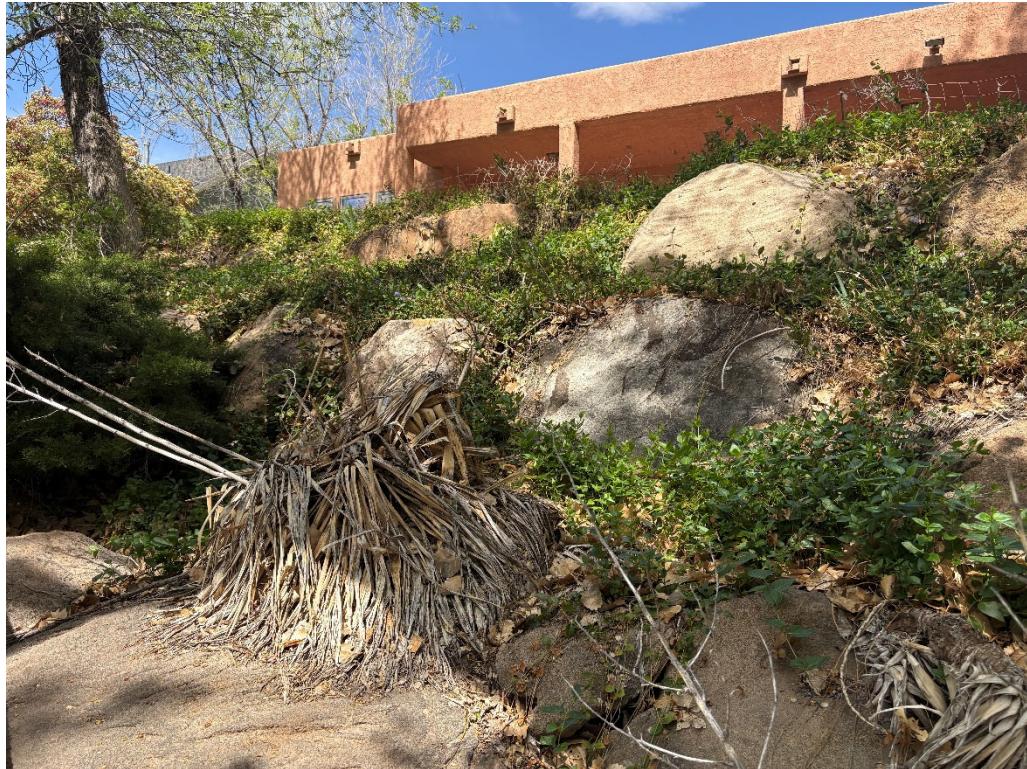
**Figure 8** – April 17, 2025. Image of the keyed boulders and vegetation along the right (west) overbank of the North Fork of the Virgin River adjacent to the residential structure.

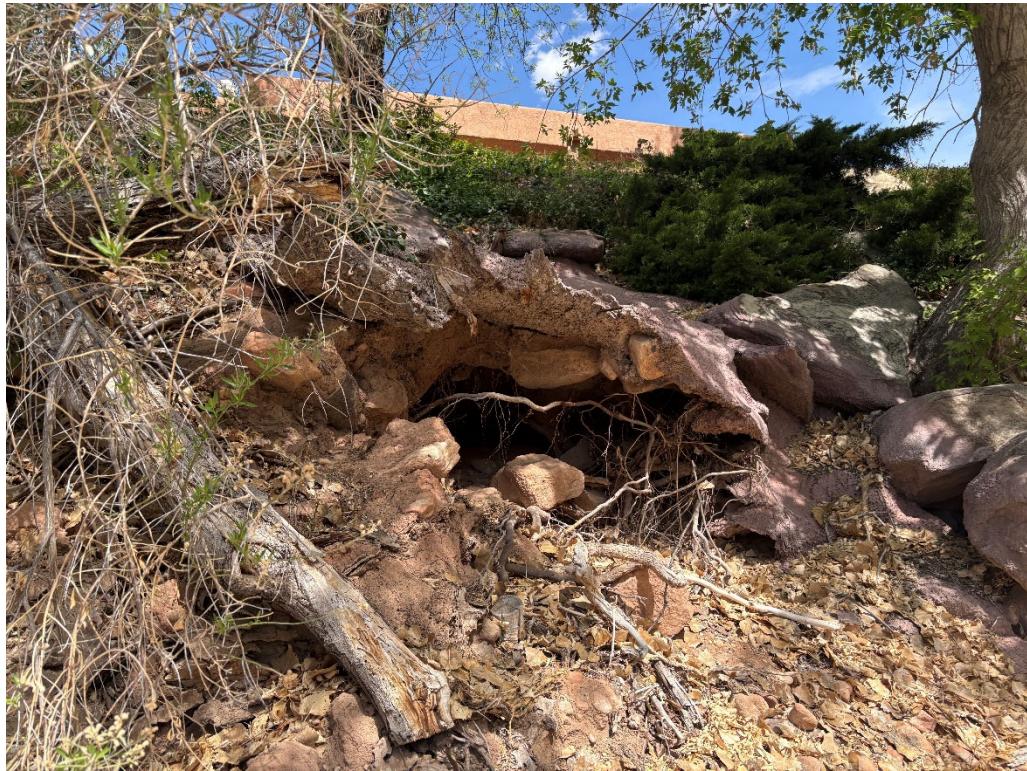
assortment of ash trees, mature cottonwoods, woody shrubs, vines and forbs. Almost no bare earth is present above the lowest keyed in boulders. Damage to a portion of the grouted area is present at the base of the tiered wall, where a large boulder or tree was previously displaced, leaving a hole that is approximately 4' wide and 3' tall.

**Figure 9** – April 17, 2025. Image of damage to a grouted section of the streambank armoring. It appears that the damage was caused by either a large mature cottonwood falling into the river, or a large boulder being displaced. The damage is approximately 4' wide and 3' tall.

Maintenance of the existing erosion protection is recommended to protect the proposed improvements from potential scour resulting from future flood events. Over time, the grouted vegetation will die and decompose, leaving behind voids. These voids are to be backfilled with concrete or large (min D50=24") rocks when established to maintain the integrity of the structure. Any damage to the large boulders or grout observed after major flood events is to be repaired in a timely manner, with the repairs matching pre-existing conditions.

Perpetual maintenance of the existing erosion protection improvements and legal access to the area between the proposed improvements and the existing erosion protection is required. Routine inspection of the existing erosion protection and access should be completed at least annually and immediately following any major flood event in the river. The 10' setback from the northeastern property boundary is to be kept clear and maintained for access. Maintenance of the existing erosion protection and access will be the responsibility of the property owner. Any required repair of the existing erosion protection or access shall be completed in a timely manner as per the direction of a professional engineer or his assignee.

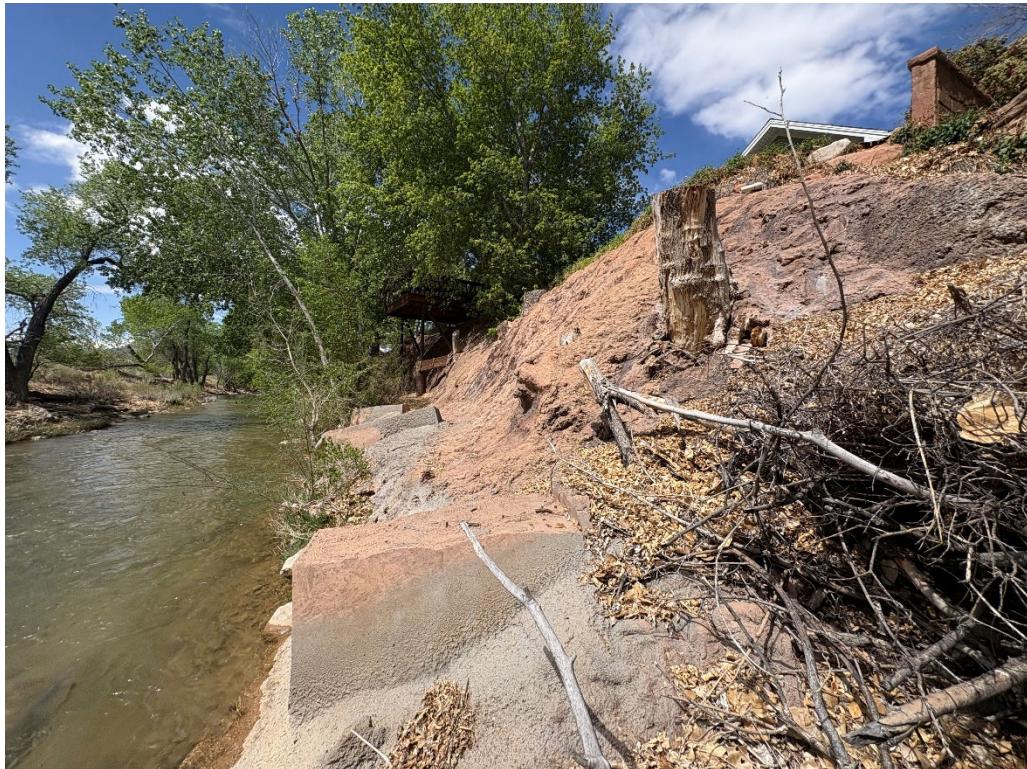
The overbank adjacent to the property downstream of the project area is also armored to varying extents. A curtain of reinforced grout is located along the overbank, with holes where tree stumps have rotted away. The grout begins at the low flow water surface elevation and continues up the streambank to the elevation of the finished floor of the residential structure. Three large "stream barbs" are located at the waters edge that appear to be composed of reinforced concrete. The presence of the bank armoring and vegetation have provided resistance to erosion and are likely partially responsible for preventing larger scale vertical cutbanks from forming previously.

**Figure 10** – April 17, 2025. Looking downstream along the right (west) overbank of the North Fork of the River at the grouted apron adjacent to the property downstream of Parcel S-CSD-4. Many of the cottonwood trees that had grout placed around them have decayed, leaving holes in the structure. Three "stream barbs" are present adjacent to the waters edge, which will help push high velocity flows away from the bank. The presence of this bank armoring provides limited protection to the proposed improvements by providing stability to the main channels location.
