Alta Town Council Meeting Packet - July 9, 2025

July 2025 Town Council Meeting

DRINKING WATER SYSTEM CAPITAL IMPROVEMENT PLAN

SANITARY SEWER SYSTEM CAPITAL IMPROVEMENT PLAN

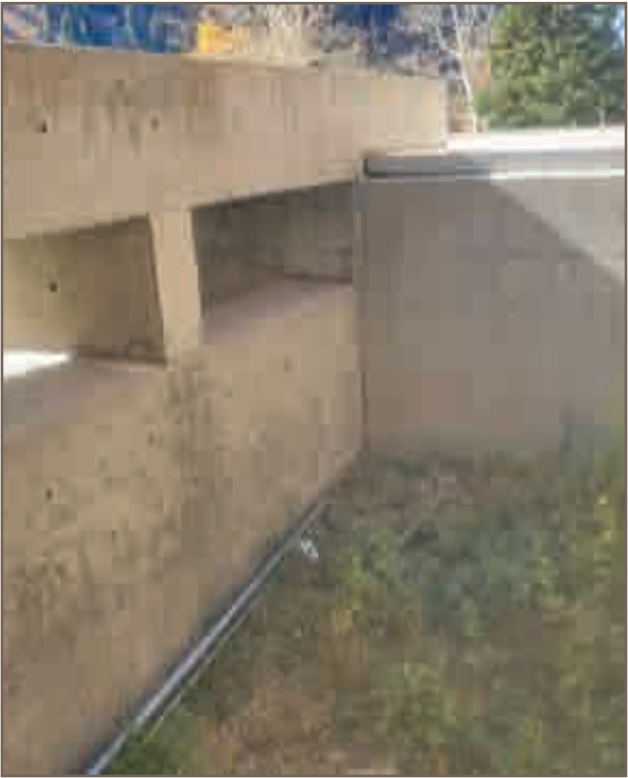
The concrete foundation and retaining walls are in good overall condition and do not exhibit areas of spalling, honeycomb or significant cracking.

Good – Periodic pressure wash cleaning and inspection of the foundation and retaining walls.

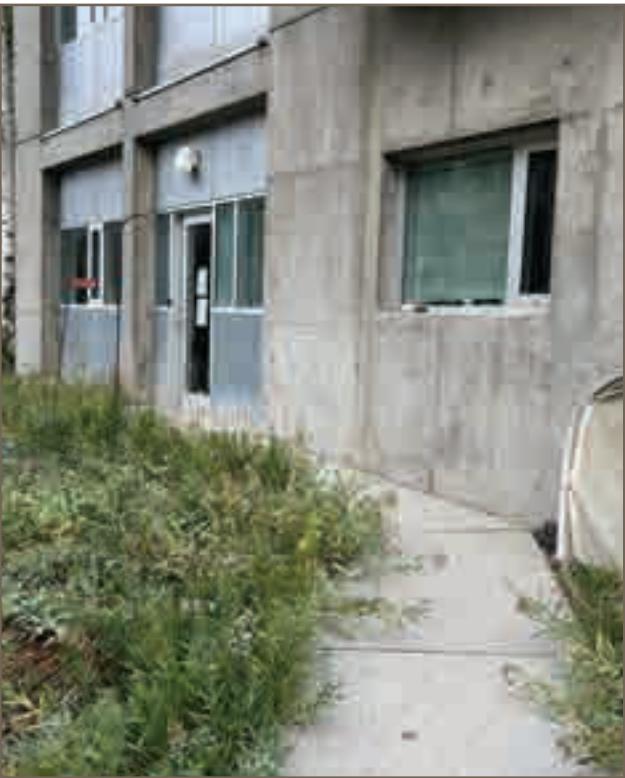
The north wall is acting as a retaining wall and only the top of the wall is exposed to view. The hill slopes gently from east to west and the wall exposure increases from about four (4) feet to about seven (7) feet as the slope extends to the west.

Good – Periodic pressure wash cleaning and inspection of the foundation and retaining walls. Periodic inspection of the sealant at the metal panel to concrete interface.

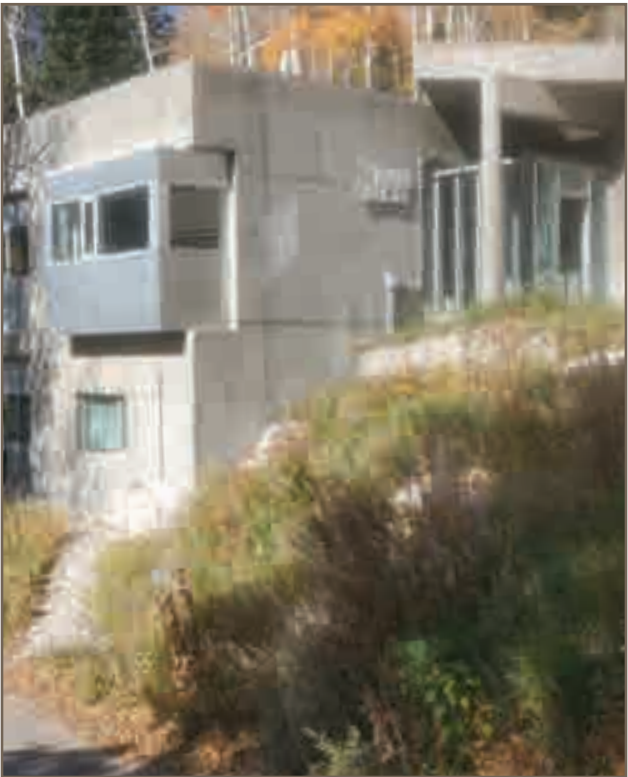
The parapet walls are an extension of the cast-in-place concrete walls and terminate with a low slope to the exterior. There is a galvanized parapet cap that covers half the width of the exterior wall and extends down the inside face about four-inch (4"). The cap appears to be in good condition with the vertical seams not exhibiting damage or open gaps. The concrete canopy membrane extends up the face of the parapet, over the top and terminates with a termination bar located about 1/4 the width of the wall from the outside edge. There is no parapet cap at the concrete canopy. The lack of a parapet cap on the canopy and the cap not extending to the outside face of the main parapet walls was a conscious design decision based on the aesthetic of the clean concrete edge at the top of the wall. This decision results in a compromise to the performance of the roofing membrane termination on the top of the wall.

Good – Frequent removal of the leaves and other debris from the membrane to protect the drain from clogging.

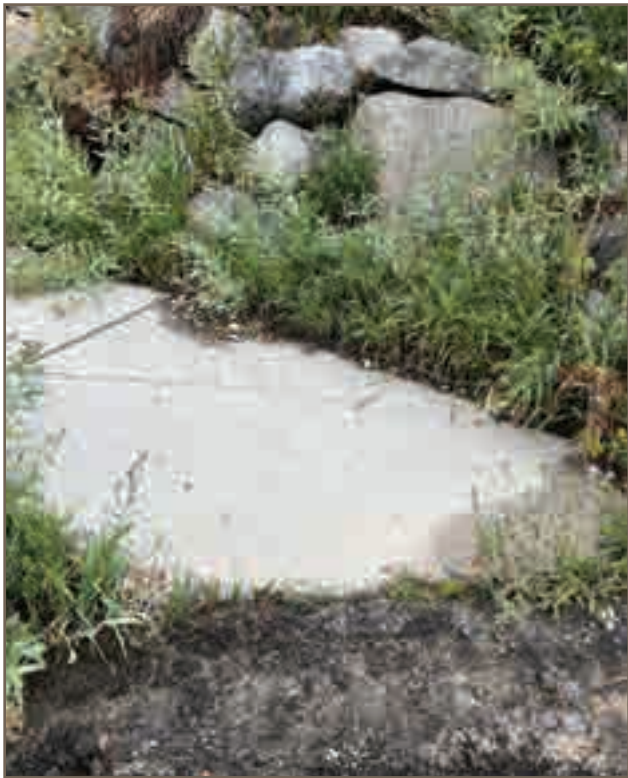
Because the building is built into a steep hill, the building does not have an accessible path from a parking area. The two sidewalk approaches to the entries are both close to being accessible but have glaring failures. Despite the accessibility failures, the walks are comfortable to navigate, and most visitors will likely have no issues gaining access to the building. Of the two walks, the first-level entrance is the closest to an accessible path, but the sidewalk stops short of the road and has a short section of vegetation interrupting the path. The second-level walk has a step at the bottom that also interrupts the walk from the road. Both approach walks appear to be close to the 5% maximum slope, but likely exceed that limit.

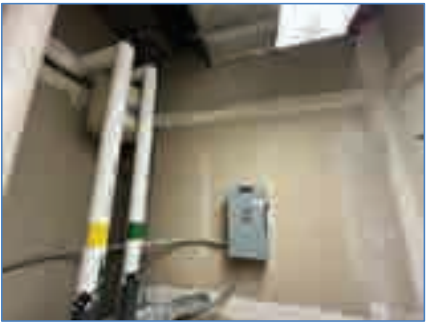
Exhibit 7 – Mechanical duct above the boiler disconnect

- i. A large mechanical duct is located above the boiler disconnect switch which not in compliance with *NEC 110.26 (E)*. This should be fixed in by relocating the duct or the disconnect.
- j. The wiring devices (light switches, receptacles, etc.) appear to be in good conditions.
- k. The women's restroom receptacle outlet is not GFCI protected as required in *NEC 210.8 (B)(1)*. It is unknown if the outlet is protected by an upstream GFCI outlet. This should be further investigated and a proper GFCI protection should be provided.

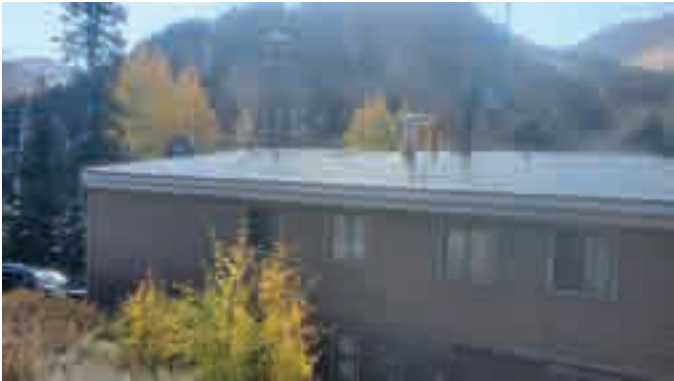
The main-level entrance deck over the generator addition consists of wood sleepers over a white roofing membrane. It is suspected that the roof membrane, which is almost entirely concealed from view is TPO to match the roof membrane on the City Hall building. The only visual access to this membrane is through the ends of the sleeper joists near the stair. A photo of the area reveals that the roof appears to be in very good condition. No obvious signs of roof leakage were visible inside the generator addition.

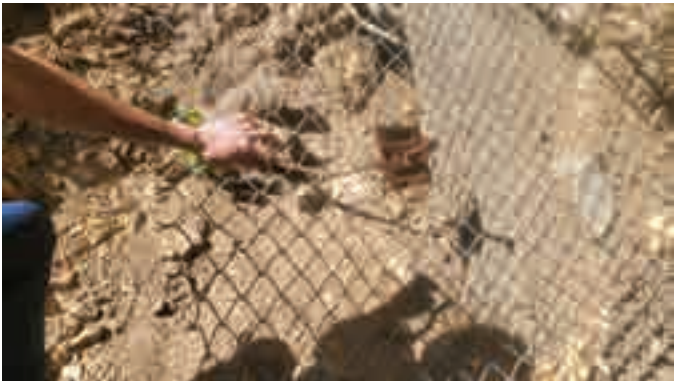
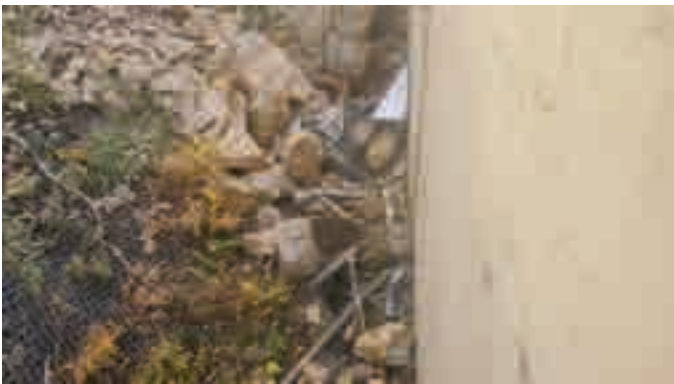
The foundation for the additions visible from the road on the south elevation is cast-in-place concrete. The concrete is not plastered and has some honeycombing and form lines but appears to be in fair condition.

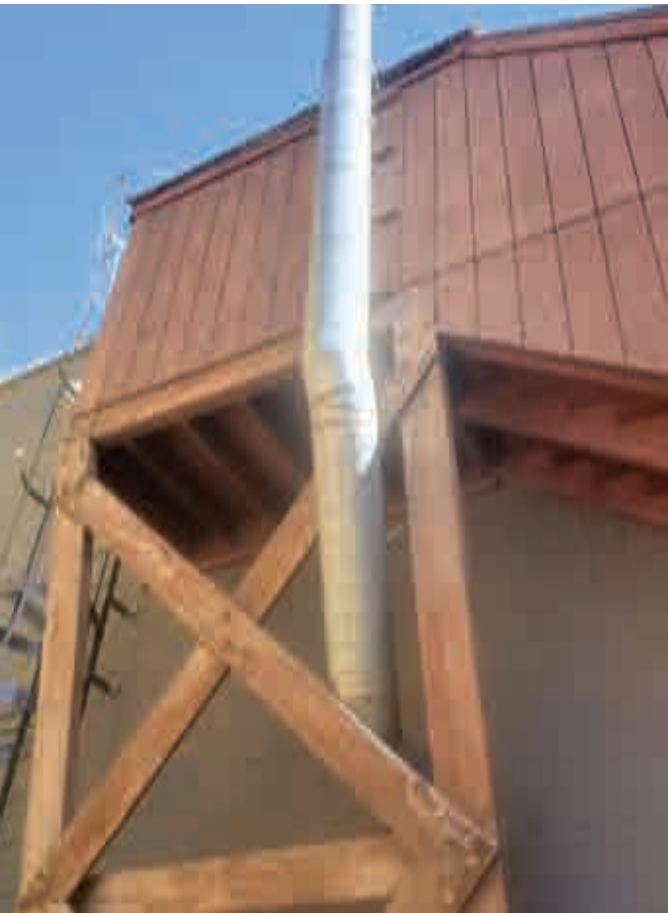
Both the post office addition on the east and the residential addition to the west overhang the original garage and are supported by a timber brace that is painted to match the T1-11 siding. The braces appear to be in good condition.

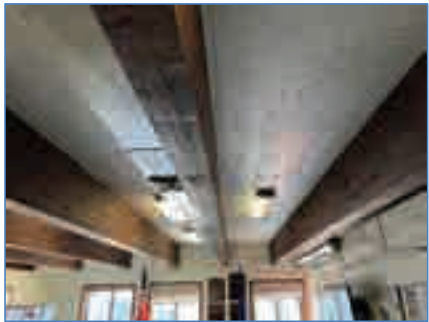
Exhibit 7 – Fluorescent troffers – upper level

- a. Most of the building has florescent lights. The existing light sources are outdated and inefficient. All existing light fixtures and bulbs are recommended to be replaced with new LED lighting. Each space will need to be evaluated individually to determine the extent of the upgrade needed.
- b. The egress lighting is provided using emergency bug-eyes. We were not able to field verify the egress light levels (1 fc average, and 0.1 fc minimum). If the lighting upgrade is considered in the future, the egress lighting should be completely upgraded at that time.
- c. Existing lighting controls consist solely of the toggle switches.
- d. Significant upgrades to the interior and exterior lighting control systems are needed to meet the latest energy codes. There are opportunities for energy savings by installing lighting controls such as occupancy sensors and timed relay controls.

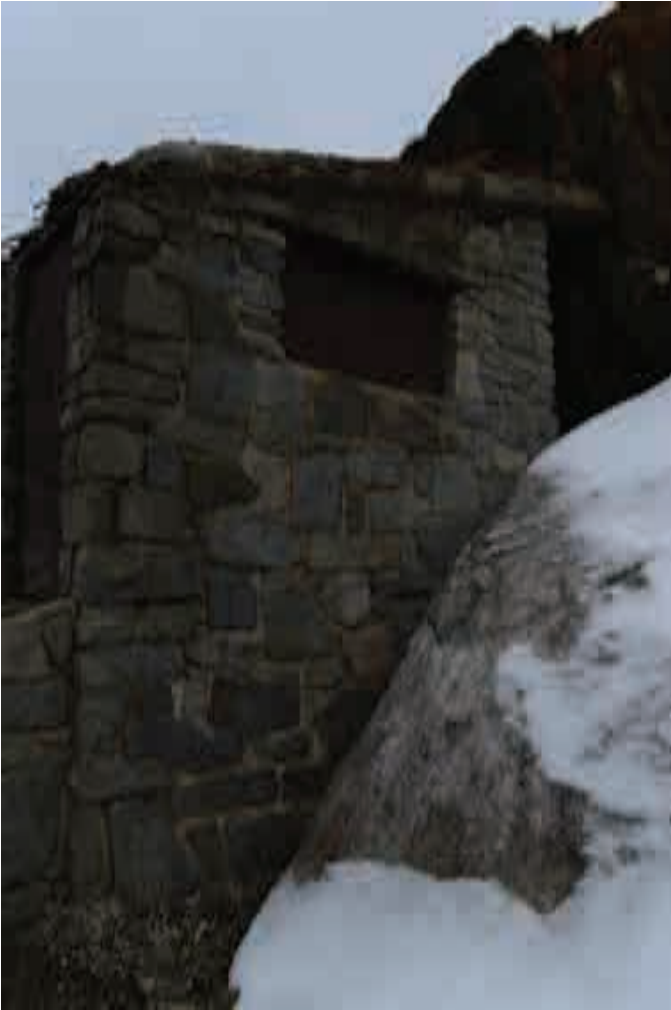
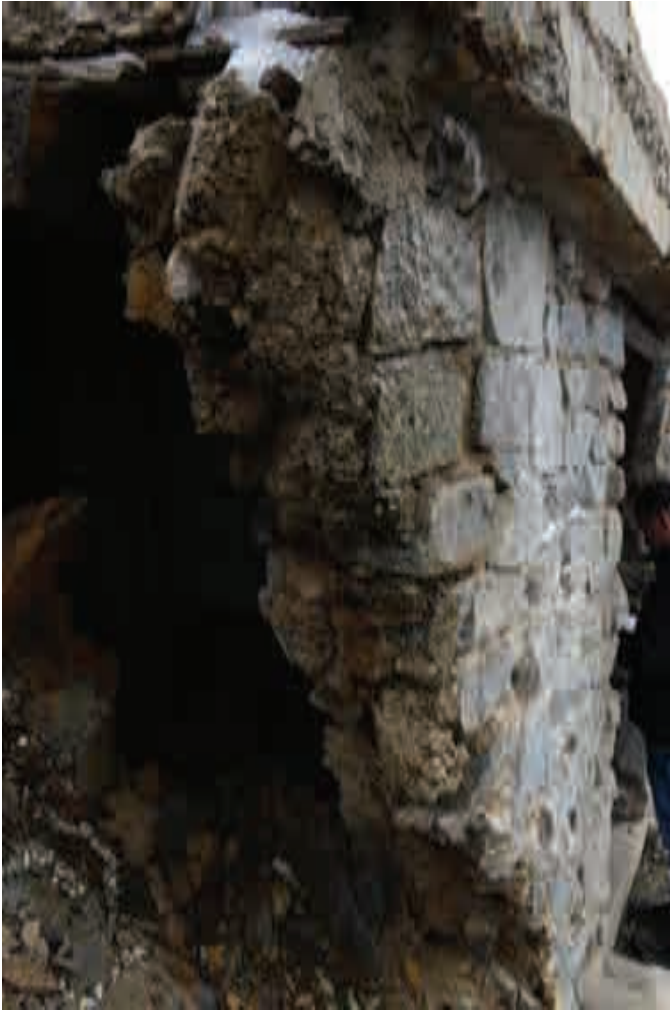
The stacked stone walls on the south and east facades are themselves in fairly good condition. There does not appear to be any significant step cracks in the mortar joints, and the stones themselves appear to be intact. There is however a significant amount of mortar deterioration between the stones, as would be expected of a building of its age. Namely, the mortar has eroded away from the face of the wall thus providing a shelf for the water to pool on. Additionally, there is a significant amount of mortar deterioration between the stone wall and the concrete roof. Lastly, on the south wall as the wall extends to the west and meets the rock, there has been significant ruination of the wall due to erosion.

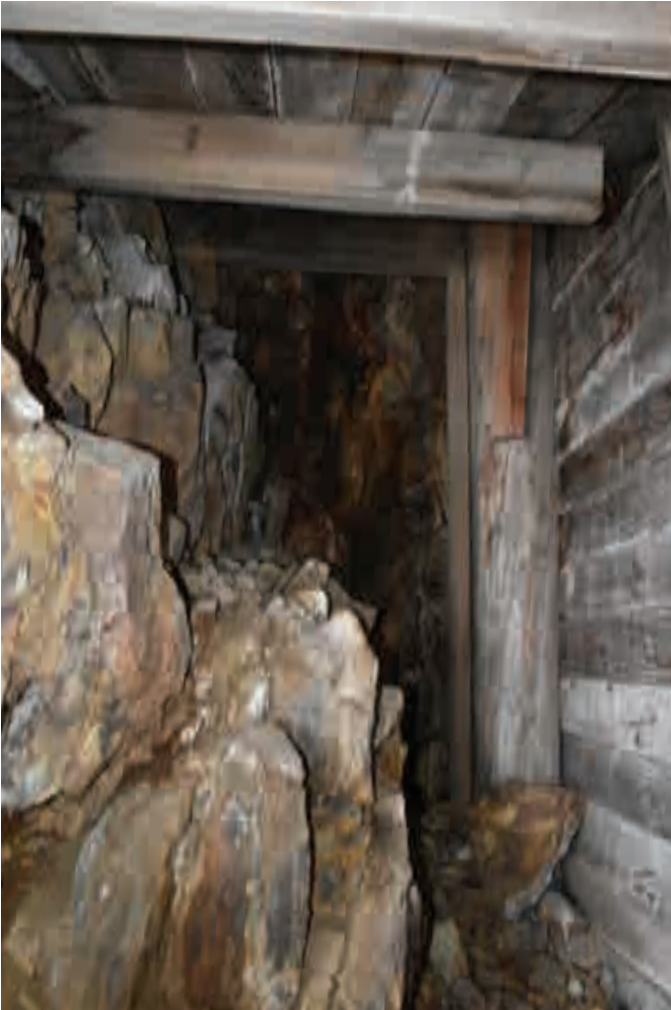
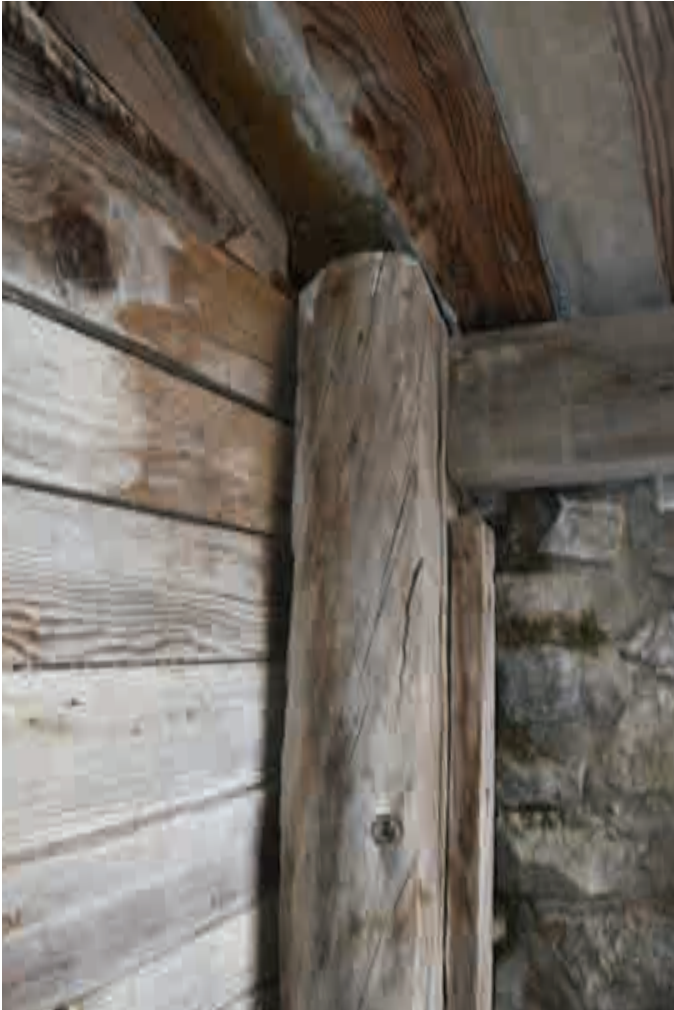
The logs are embedded in the dirt and extend up to the roof, but rest most likely on a reinforced concrete foundation, or pier in this case, though the below grade condition was not observed. Wood beams are carried by the logs and extend about two feet to the edge of the roof. The beams run through the interior to the opposite side. In some cases, there is a stud on the outside face of the log to provide additional support for the beam above. Its not clear if this is original or was added later. The wood-framed walls are highly under-structured. The logs carry the weight of the roof and transfer that weight to the foundation system. The 1x4 wood slats between the logs are simply infill and not load bearing. It is unclear if the logs have the structural capacity to carry the roof loads. The logs appear to be in good condition, however the wood infill wall between the logs is in very poor condition. In addition to being coated in a lead-based paint, there is heavy deterioration in the wood itself. In addition, as stated above there appears to be a thin wood veneer over the 1x4's but this has entirely failed.

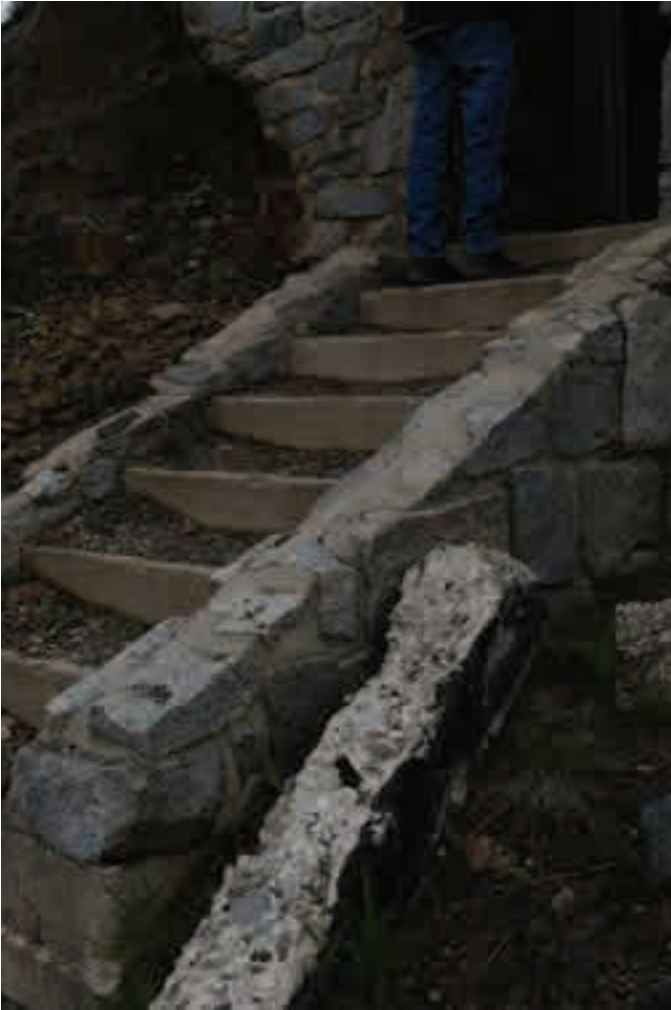
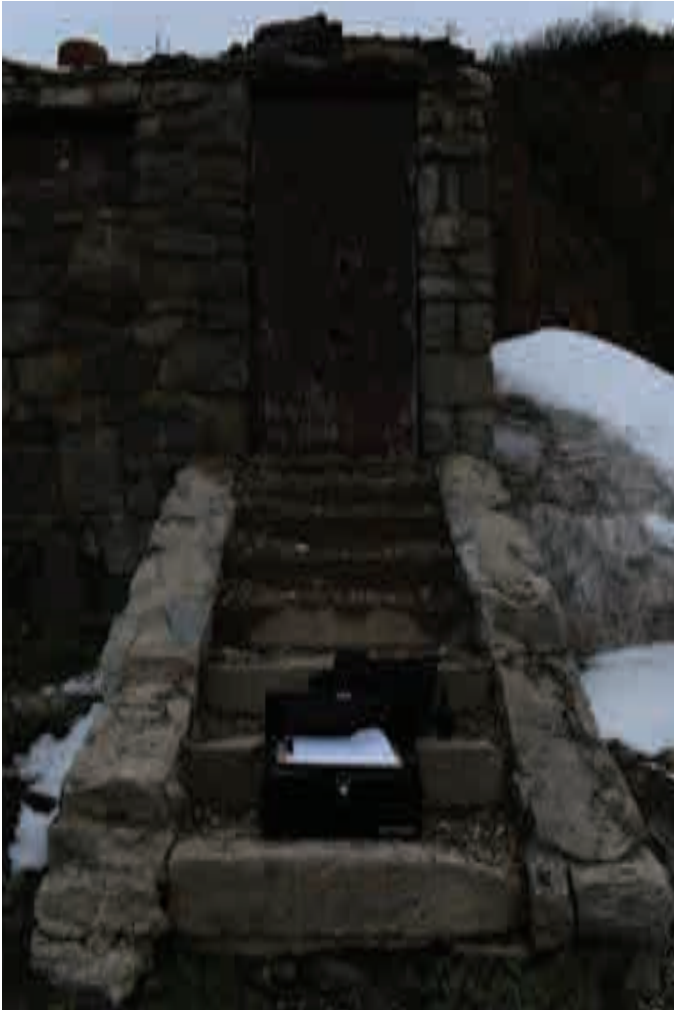
The stone stoops situated along the south face of the building are in good condition structurally speaking. Though they provide access to the elevated structure, current code requirements dictate that a landing be present outside the doors and that a landing is at level with the floor. Furthermore, code requires accessible entry to the building. This is not the case with these stoops. As one exits, the building one steps directly down one step from the door. The steps appear to meet current code with regard to the rise and run, however, there are no handrails or guard rails associated with this component. The final step down to grade is about 18 inches and is. due to erosion.

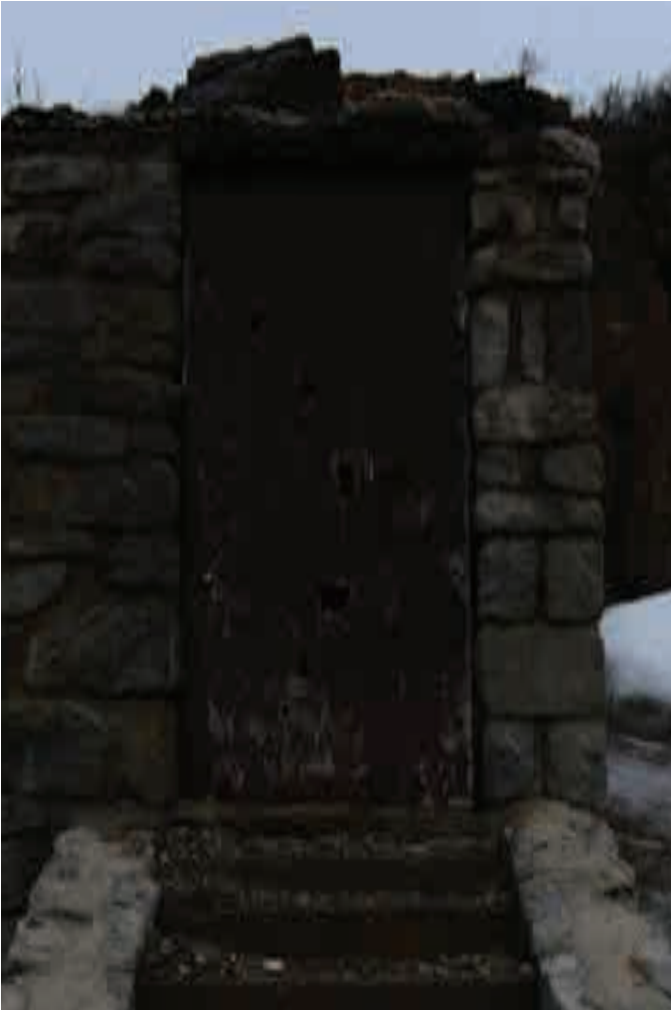
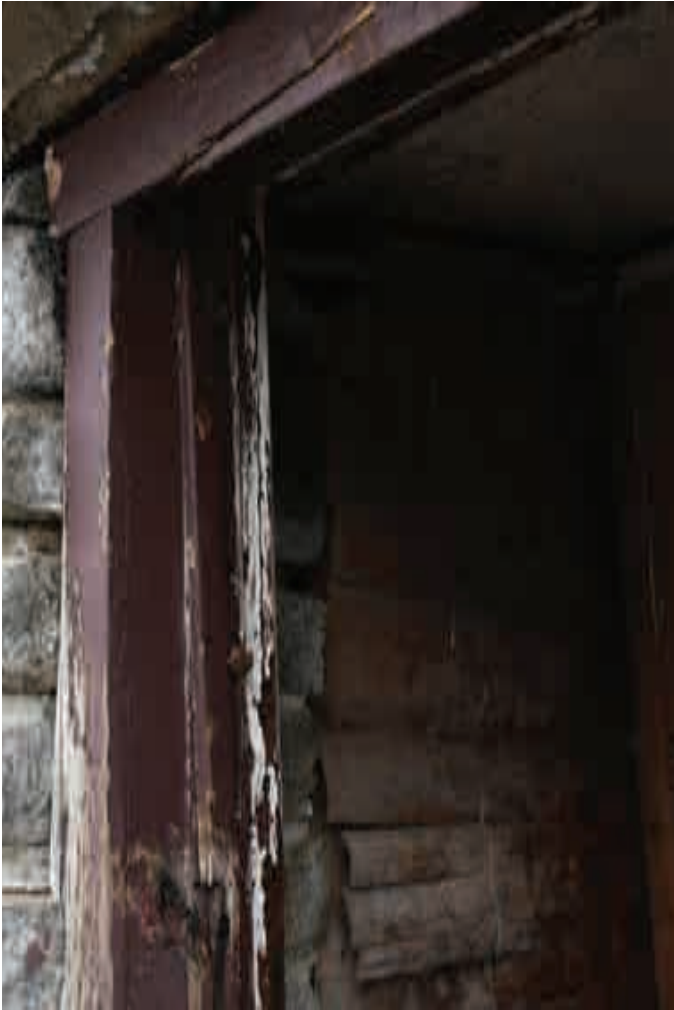
Both doors are currently missing. Each of these doors has been covered with a plywood sheet. There is a door on the interior of the building which has a wood panel below and a single light above. This may be the original door. However, because it is in such poor condition it is likely not usable. The door frame is one of the more interesting features of the building. It is a simple door frame, about three inches wide, but it is scribed to the stone jamb surrounding it.

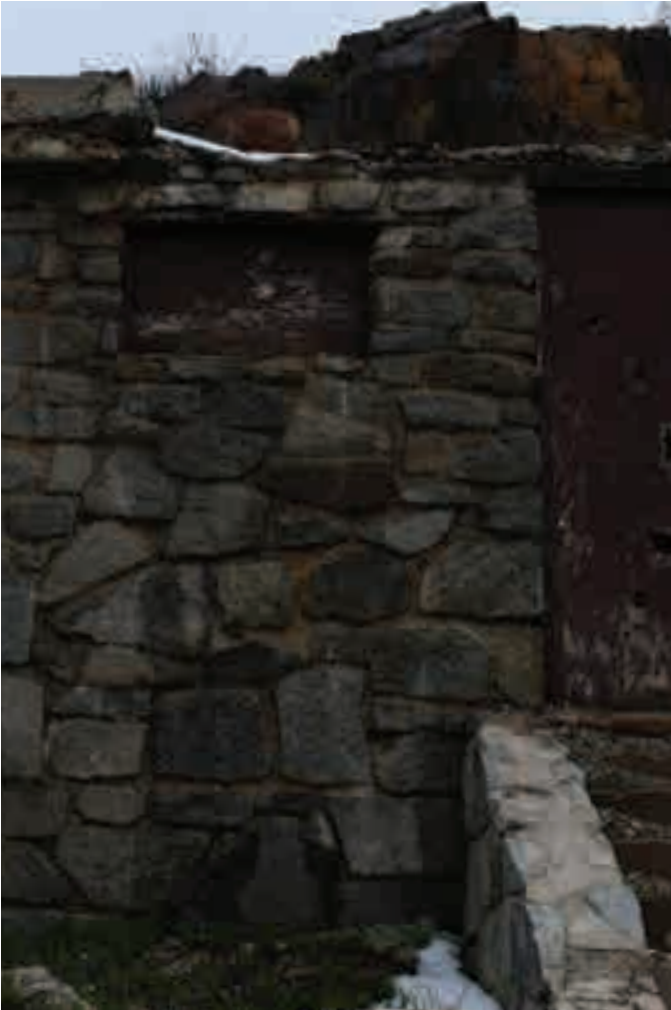
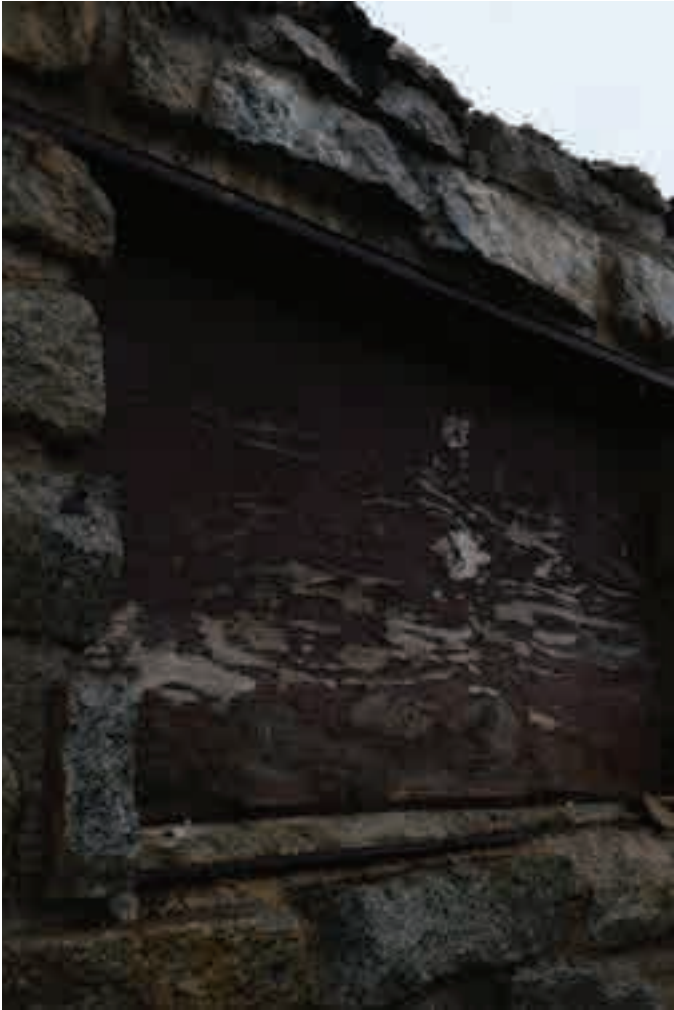
The two windows in the building are extant. They are currently covered in a plywood sheet on the outside. Both windows appear to be in fairly good condition.
