## **CLINTON CITY COUNCIL WORK SESSION AGENDA**

# CLINTON CITY COUNCIL STAFF REPORT

| SUBJECT: | Further discussion of TUF, street funding |

## PAVEMENT MANAGEMENT PLAN AND STREETS FUNDING

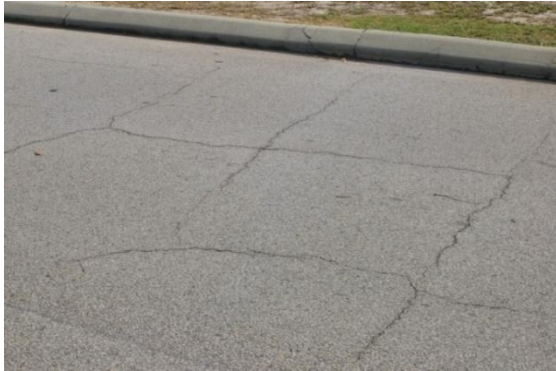
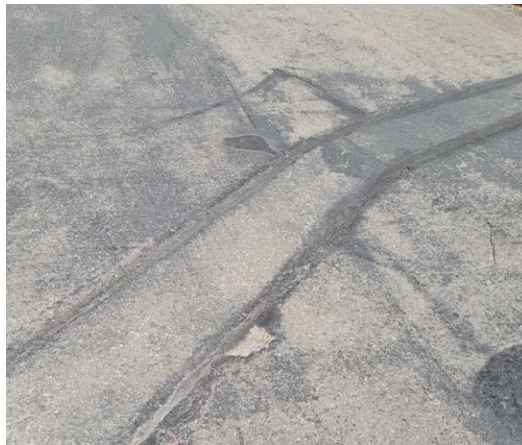
# Evaluation Process

PASER Condition Rating

Longitudinal Cracking: Approximate Length (ft)

Block Cracking: Approximate Percent

Alligator Cracking: Approximate Percent

Visible Patching: Approximate Percent

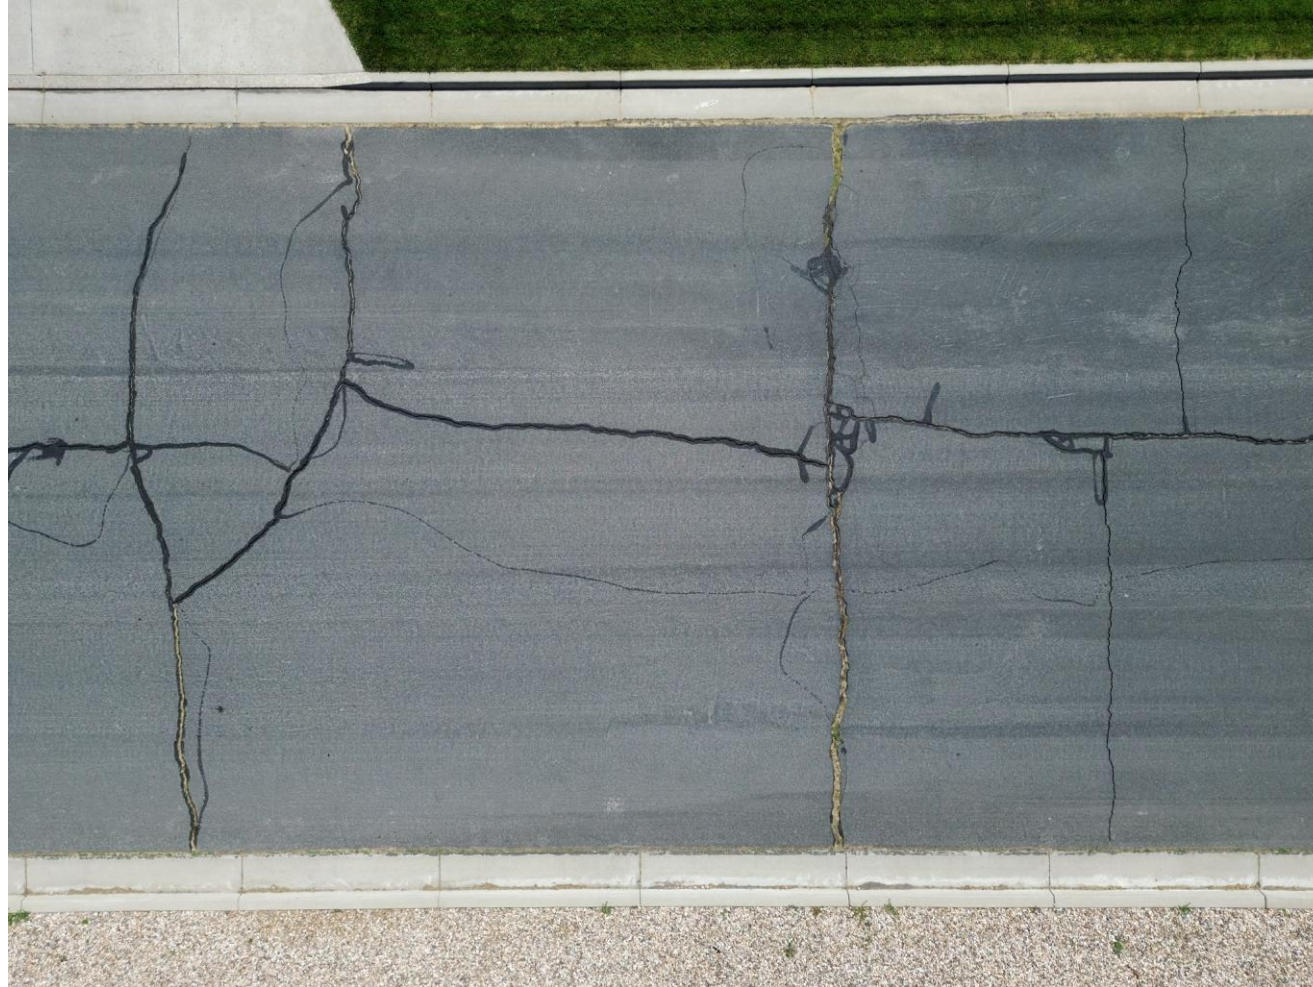
2870 West, Near 960 North

# Example Evaluation

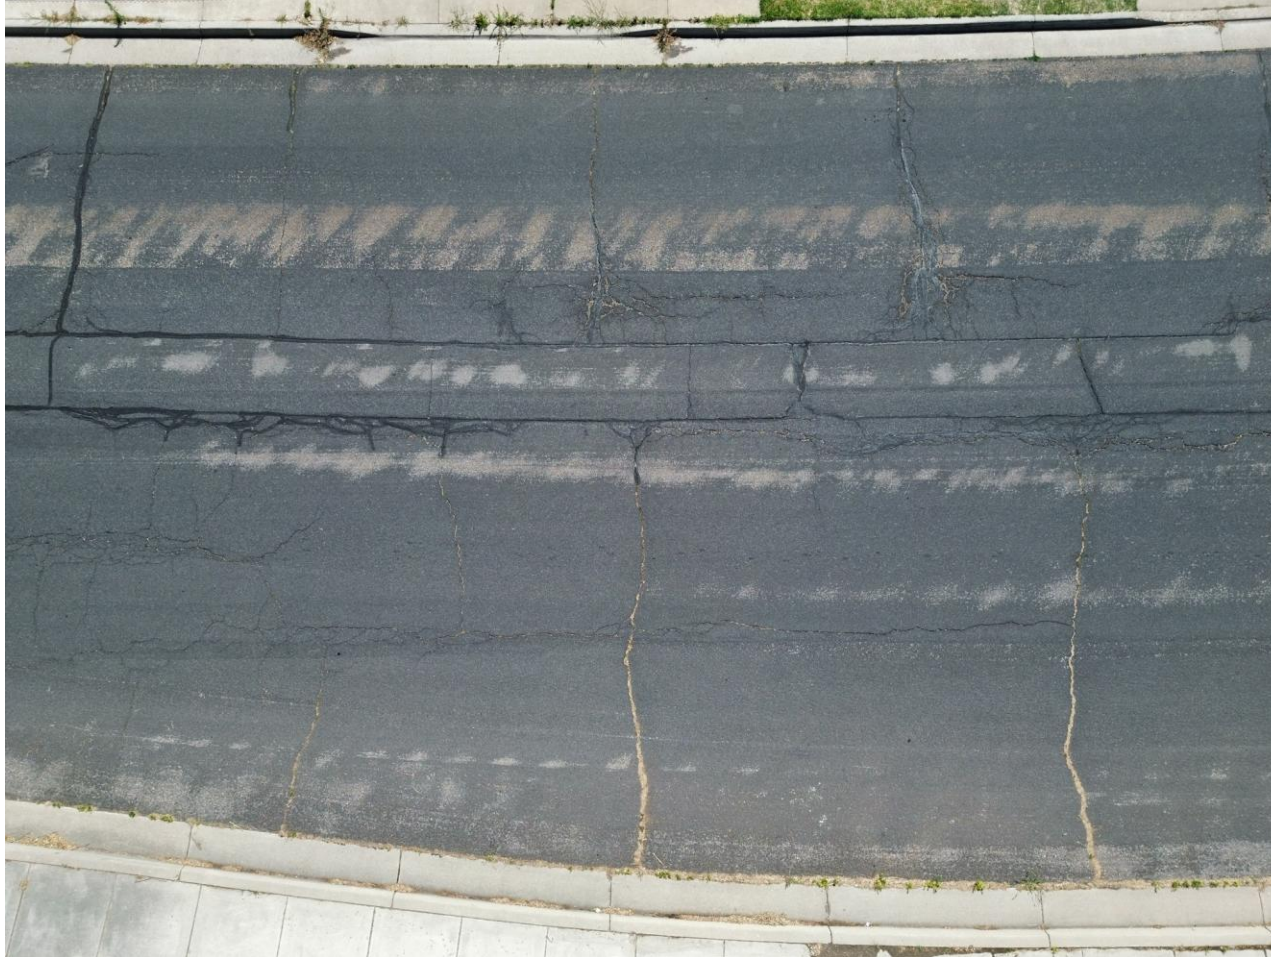
750 West, Near 1300 North

GOOD

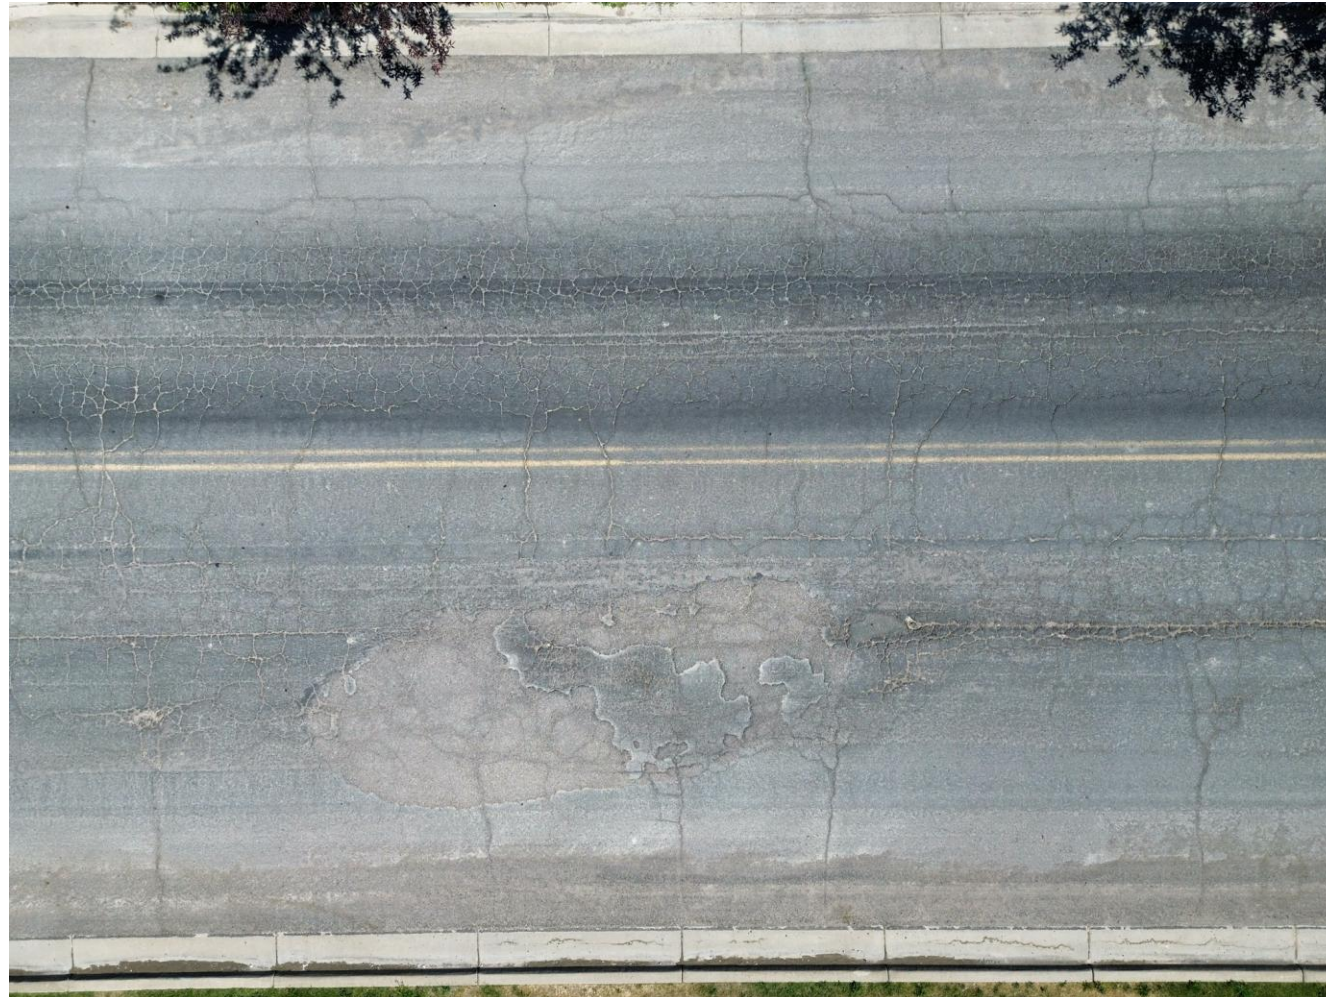
2300 North, Near 3600 West

FAIR

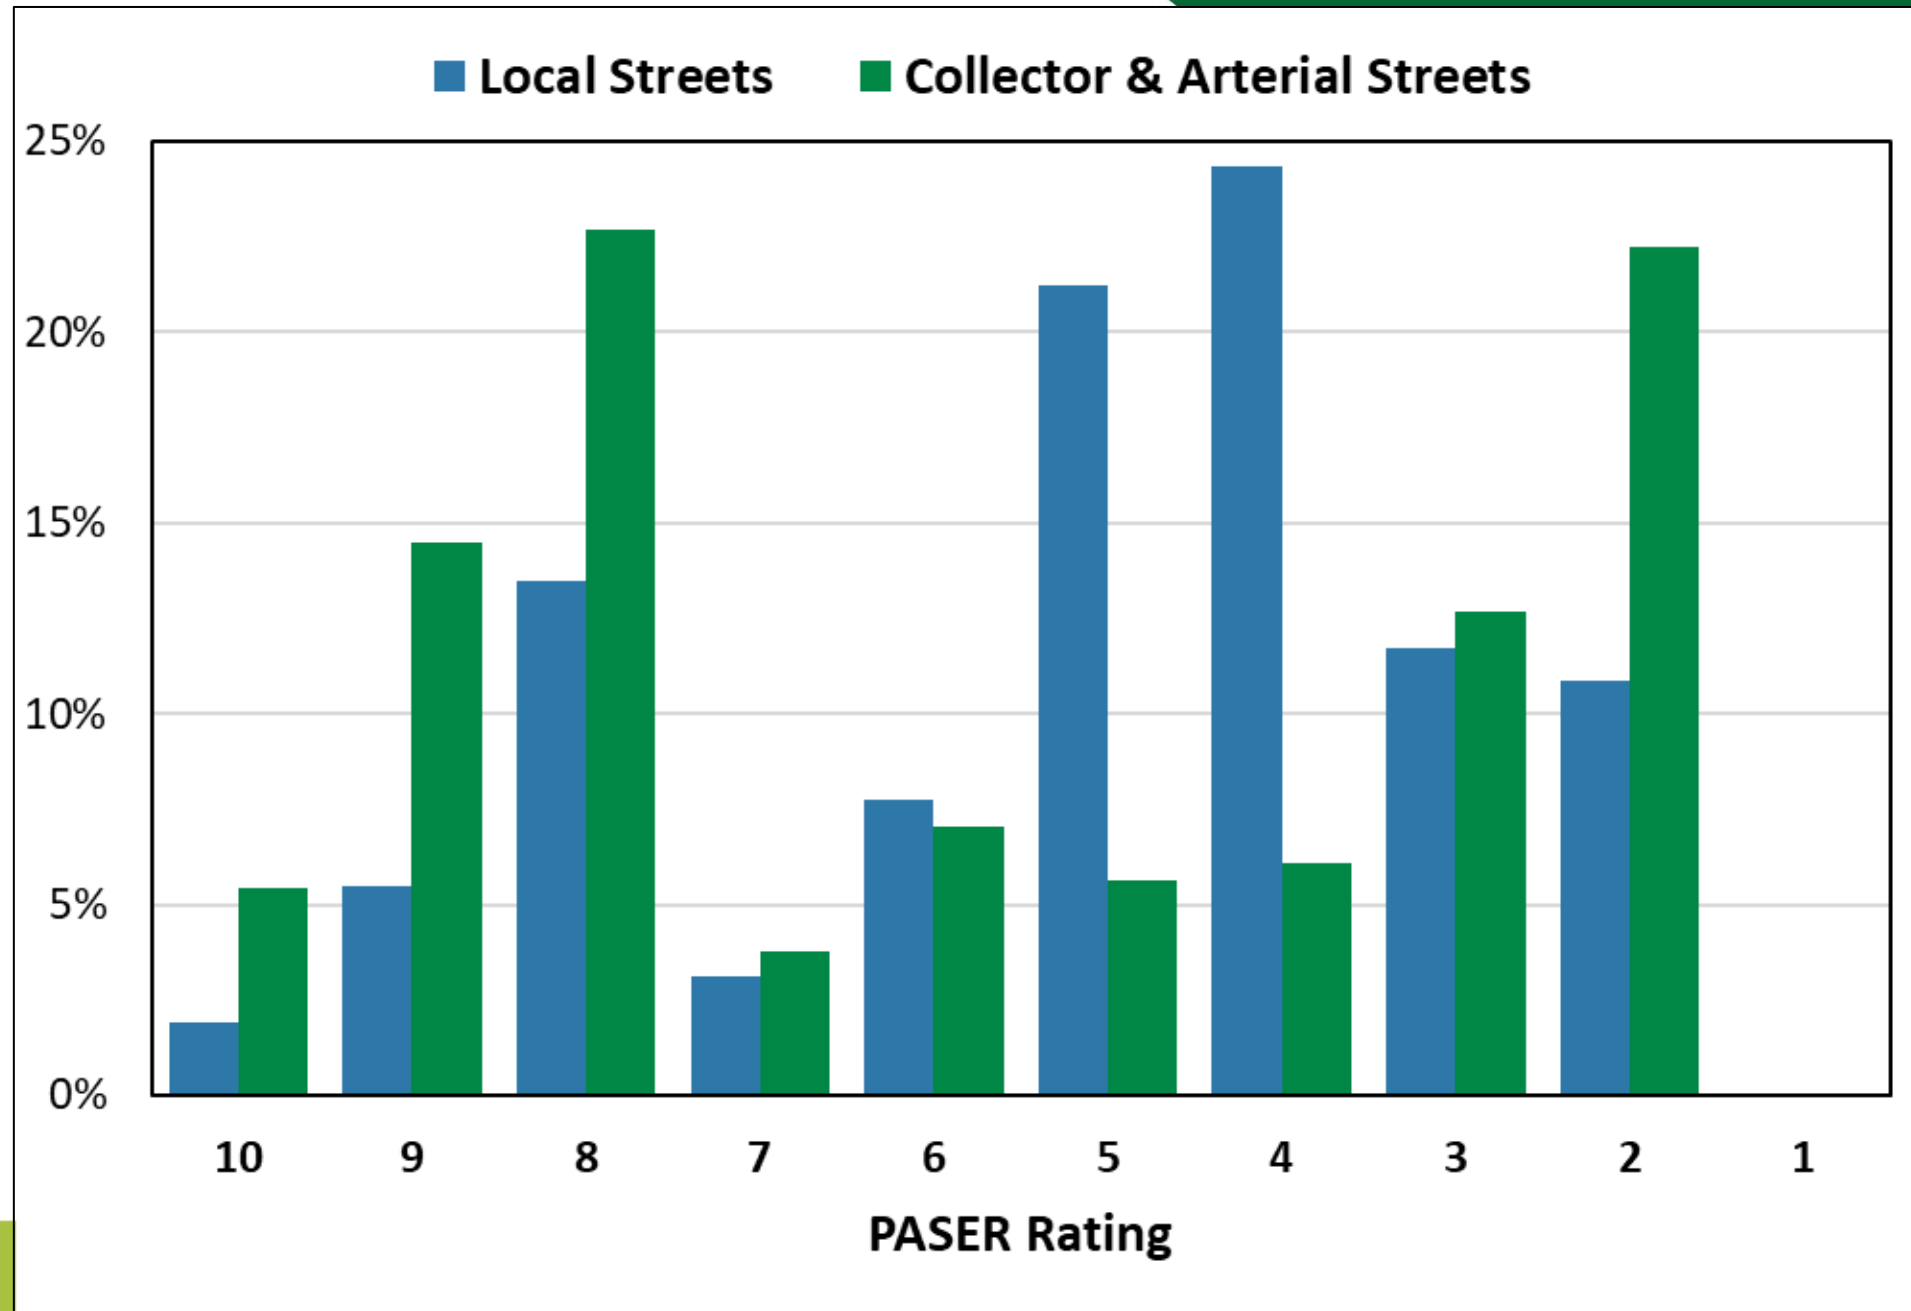
# Evaluation Results
