**NOTICE OF MEETING  
HILLSIDE REVIEW BOARD  
CITY OF ST. GEORGE  
WASHINGTON COUNTY, UTAH**

**1. IHC St George Regional Hospital Parking Lot Expansion**

**2. Desert Haven**

| Intermountain Health St George Regional Hospital Parking Expansion<br>Hillside Development Permit (Case No. 2025-HS-002) | | |

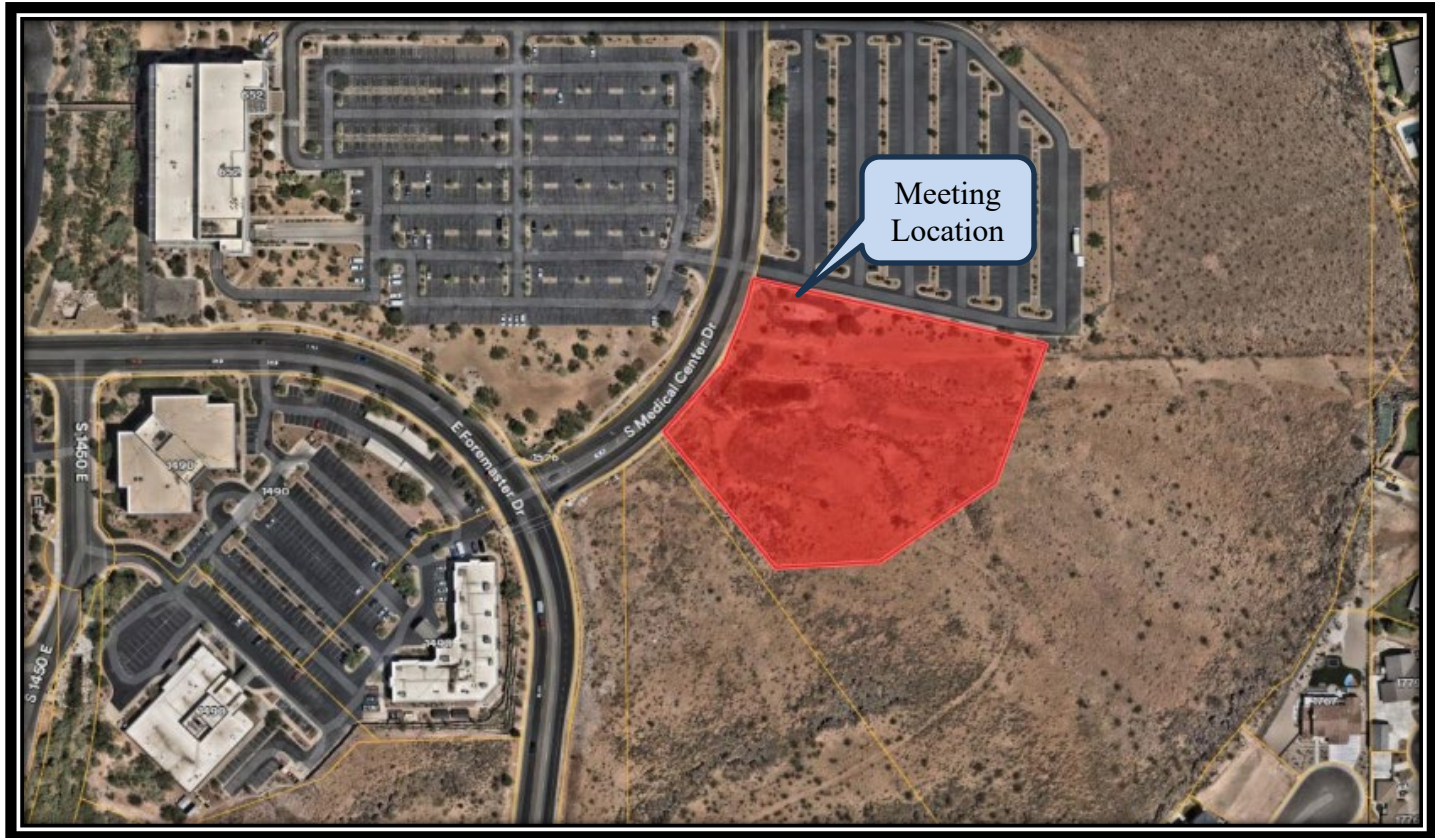
## Meeting #1 Location

A request to obtain a Hillside Development Permit to allow disturbance of areas in the 20-30%, 30-40% and 40% and above slope areas for a parking lot expansion to add 137 additional parking spaces to the off-site parking lot. **Meeting time is approximately 8:30 am at the Southeast parking lot on Medical Center Dr. (See map #1 below)**

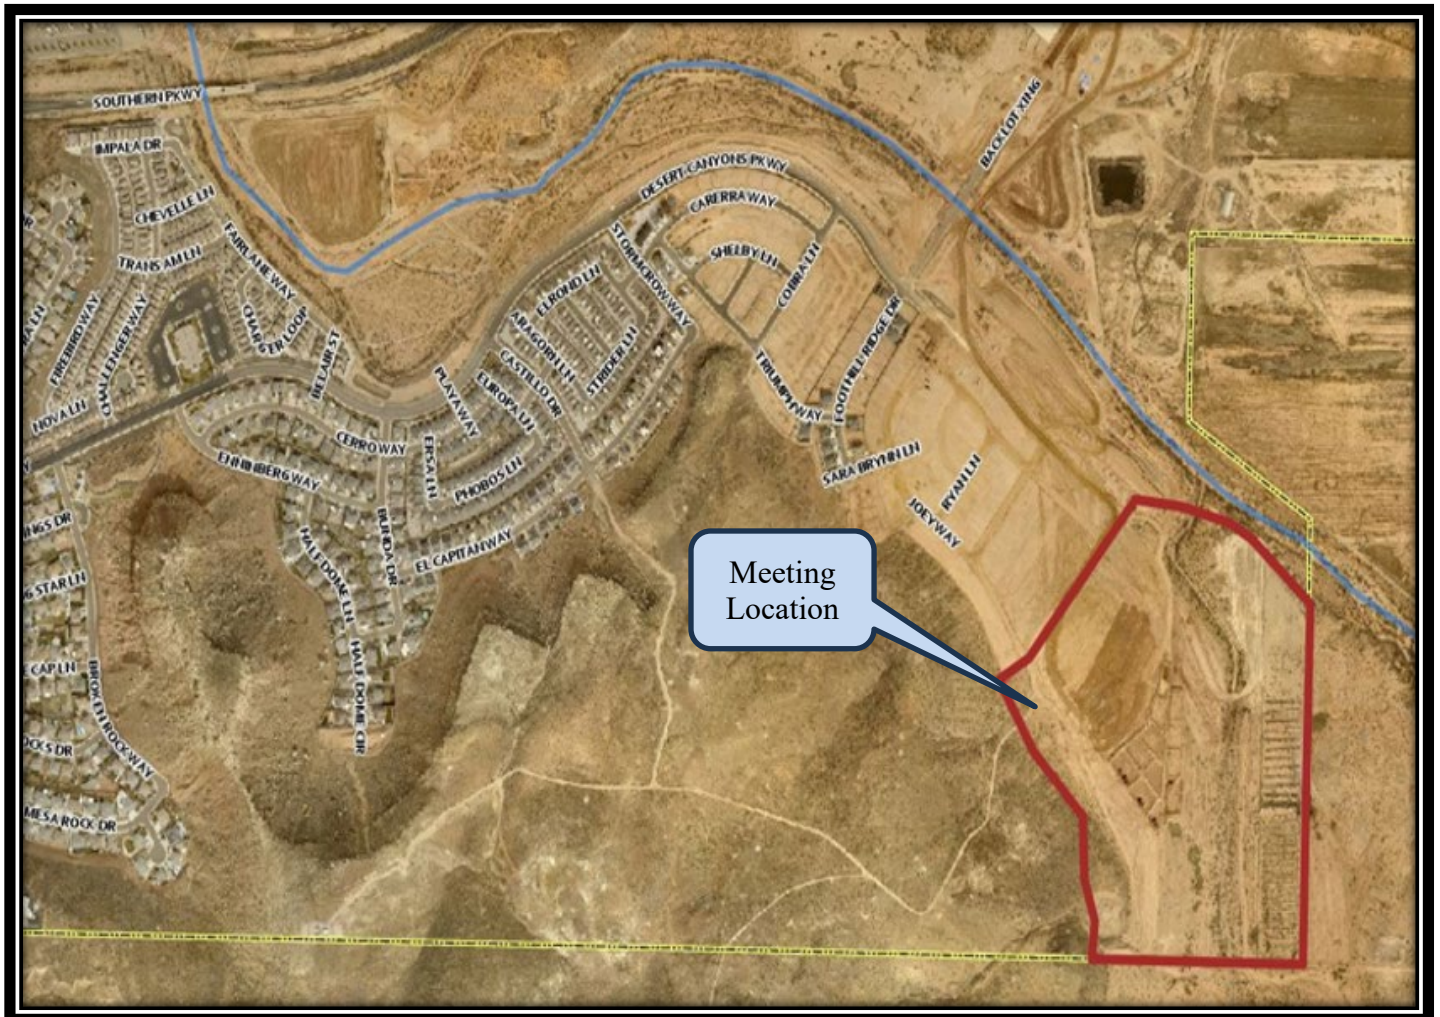
## Meeting #2 Location

A request to obtain a Hillside Development Permit to allow disturbance of areas in the 20-30%, 30-40%, and 40% and above slope areas, to develop single-family homes. **Meeting time is approximately 9:30 am at the Southeast end of Joey Way in Desert Canyons. (See map #2 below)**

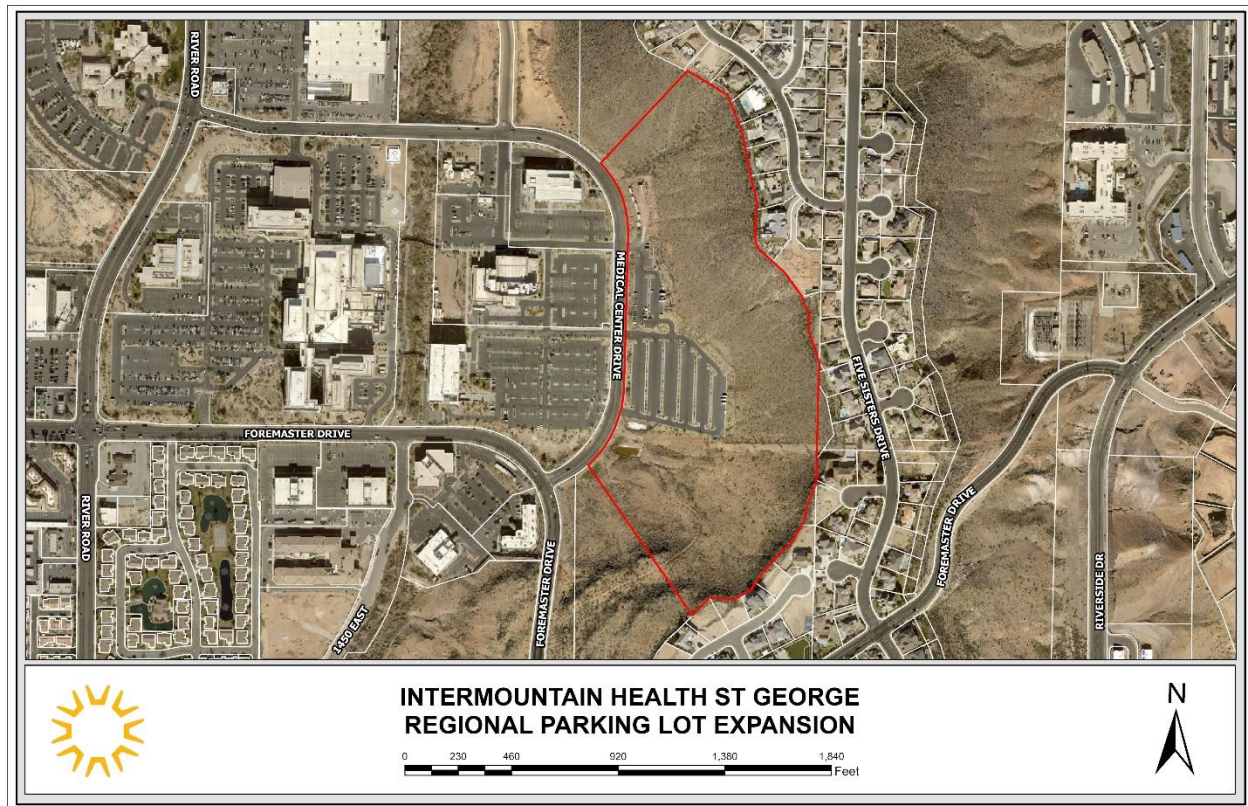
The first phase of the parking lot received Planned Development Commercial zoning as well as a Hillside Development Permit in 2016. This application proposes an expansion of the original parking lot, adding 137 additional parking spaces. This parking lot is part of a large parcel shown on the map below.

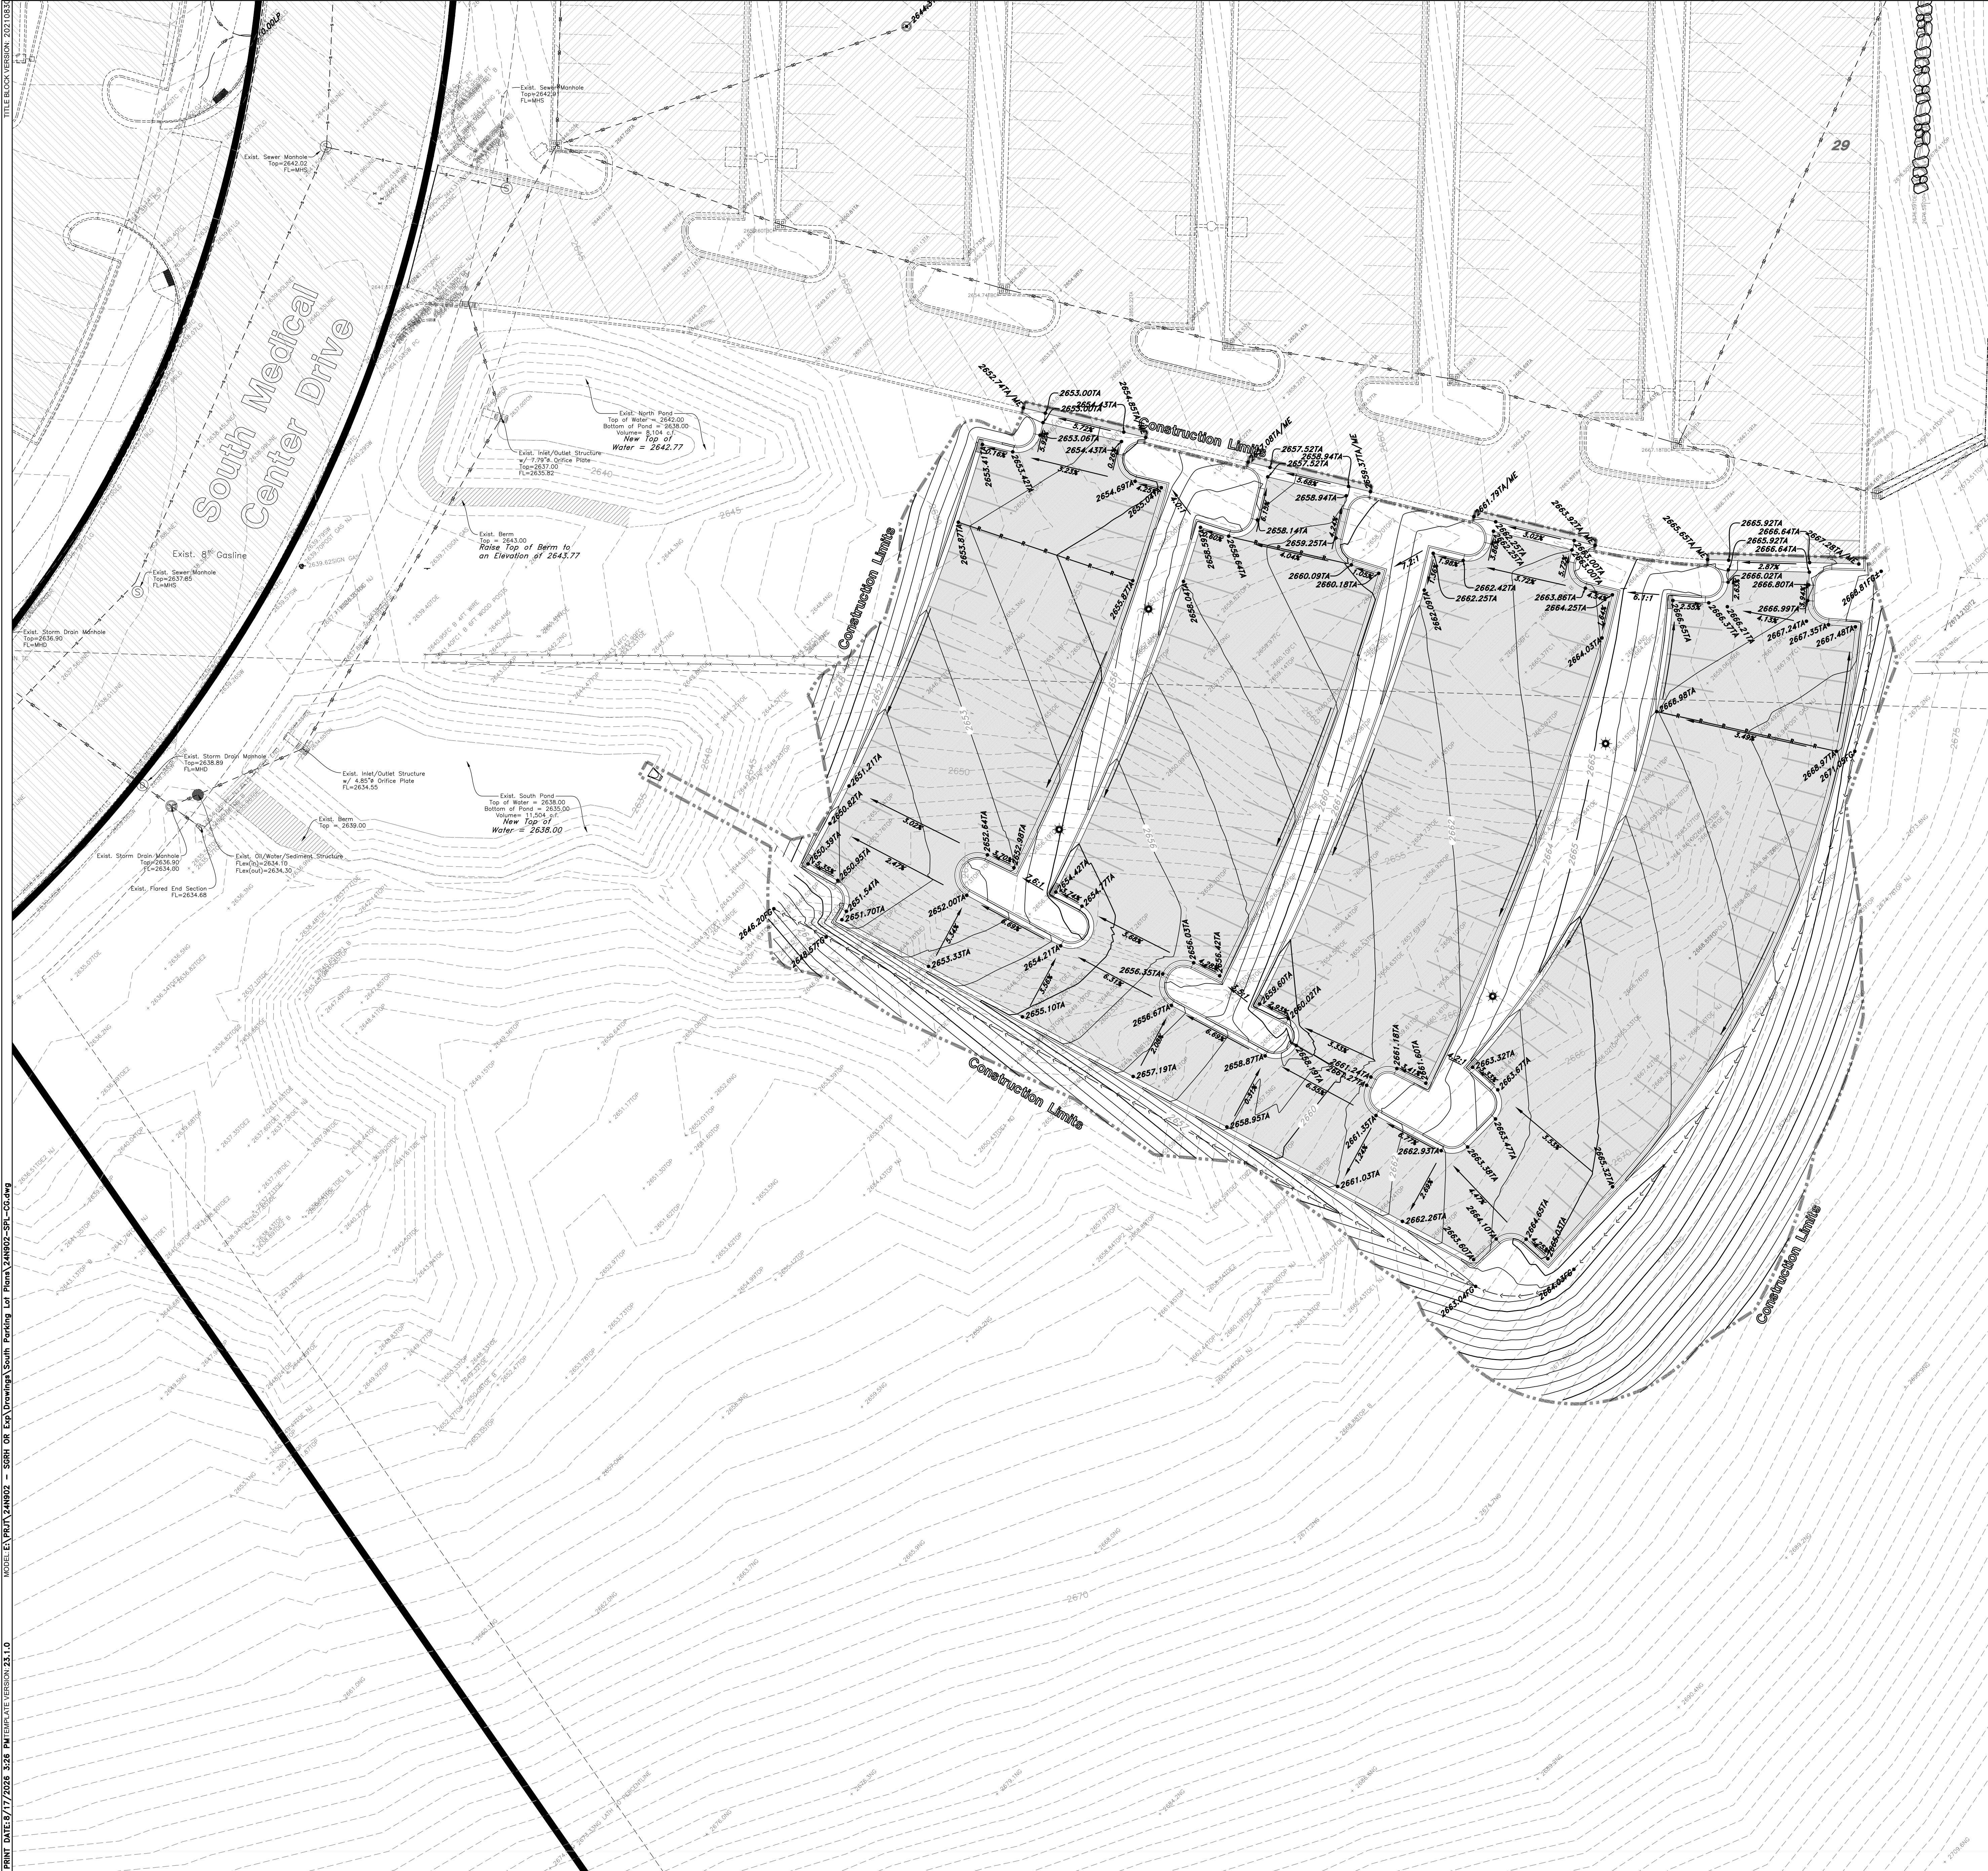
**C101**

PRELIMINARY EARTHWORK  
Cut 2,076 cy  
Fill 3,840 cy  
Imported Fill (required cut) 1,340 cy  
Net 433 cy (Fill)

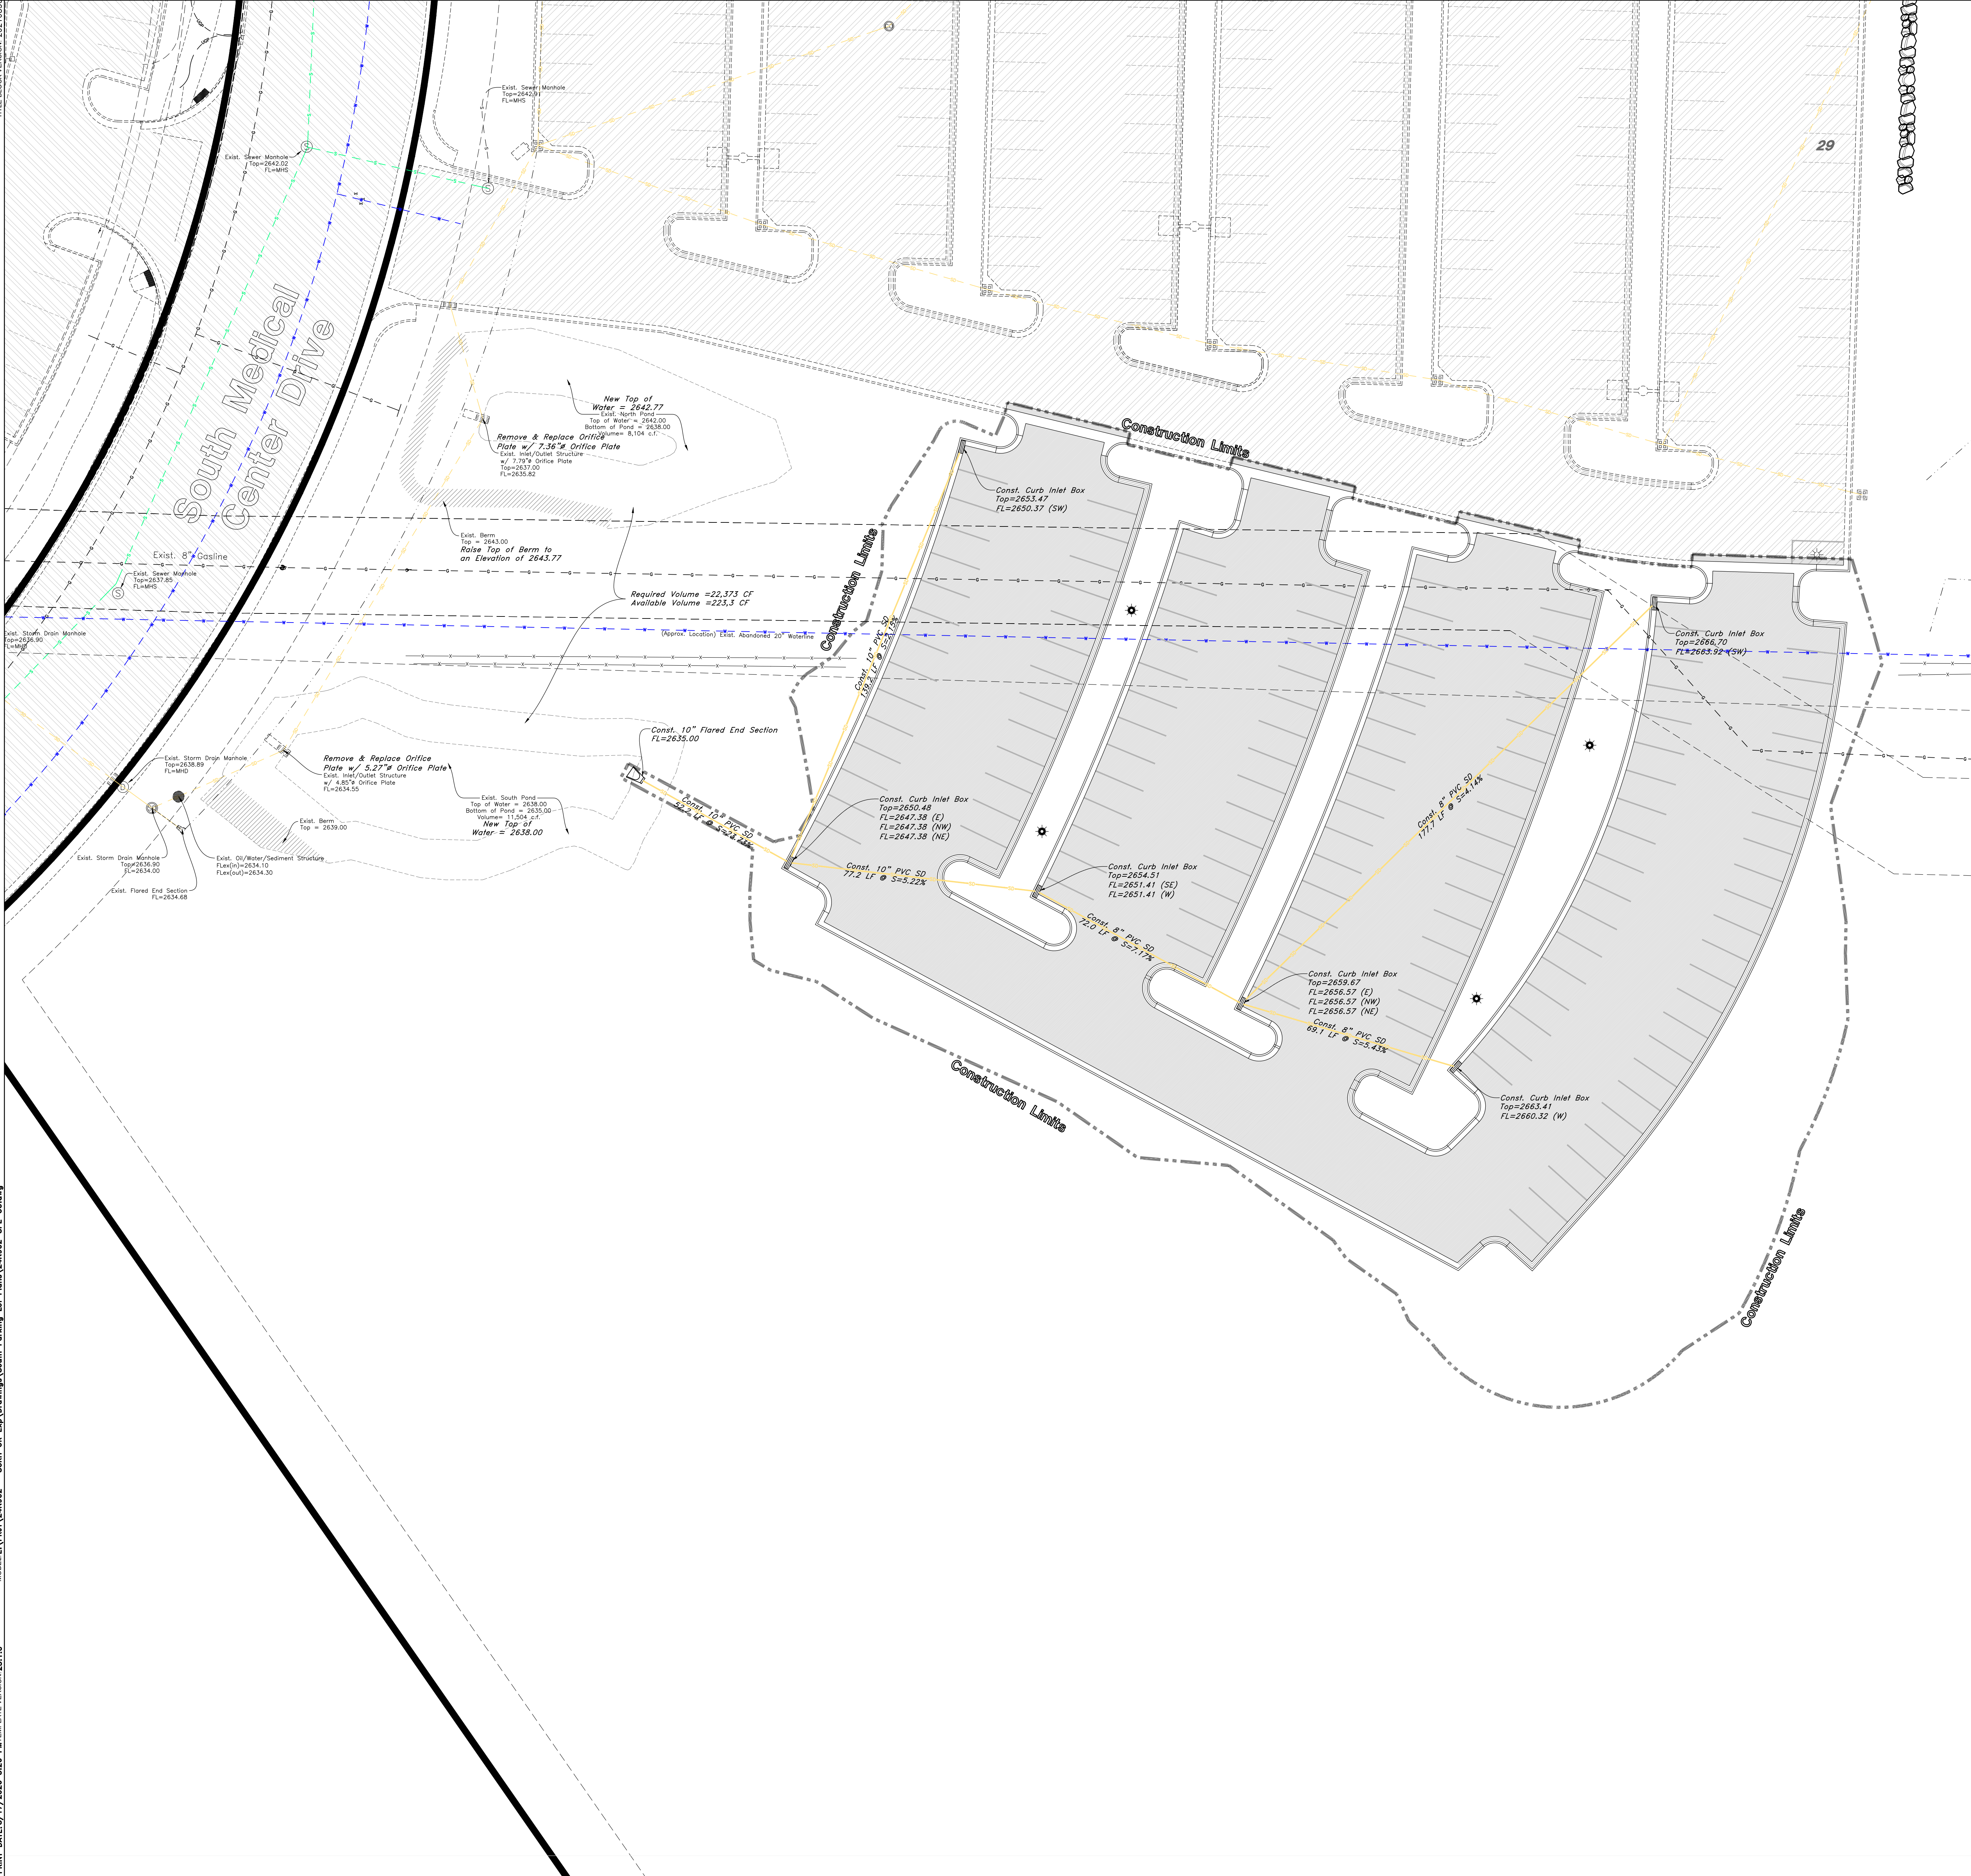
SHEET NO.  
**C201**

- All catch basin and inlet box grates are to be bicycle proof.
- All inlet boxes located in curb and gutter are to be placed parallel to the curb and gutter and set under the frame and grate. Improperly placed boxes will be removed and replaced at no additional cost to the owner. Precast or cast in place boxes are acceptable.

- Refer to the site electrical plan for details and locations of electrical lines, transformers and light poles.
- Gas lines, telephone lines, and cable TV lines are not a part of these plans unless otherwise noted.

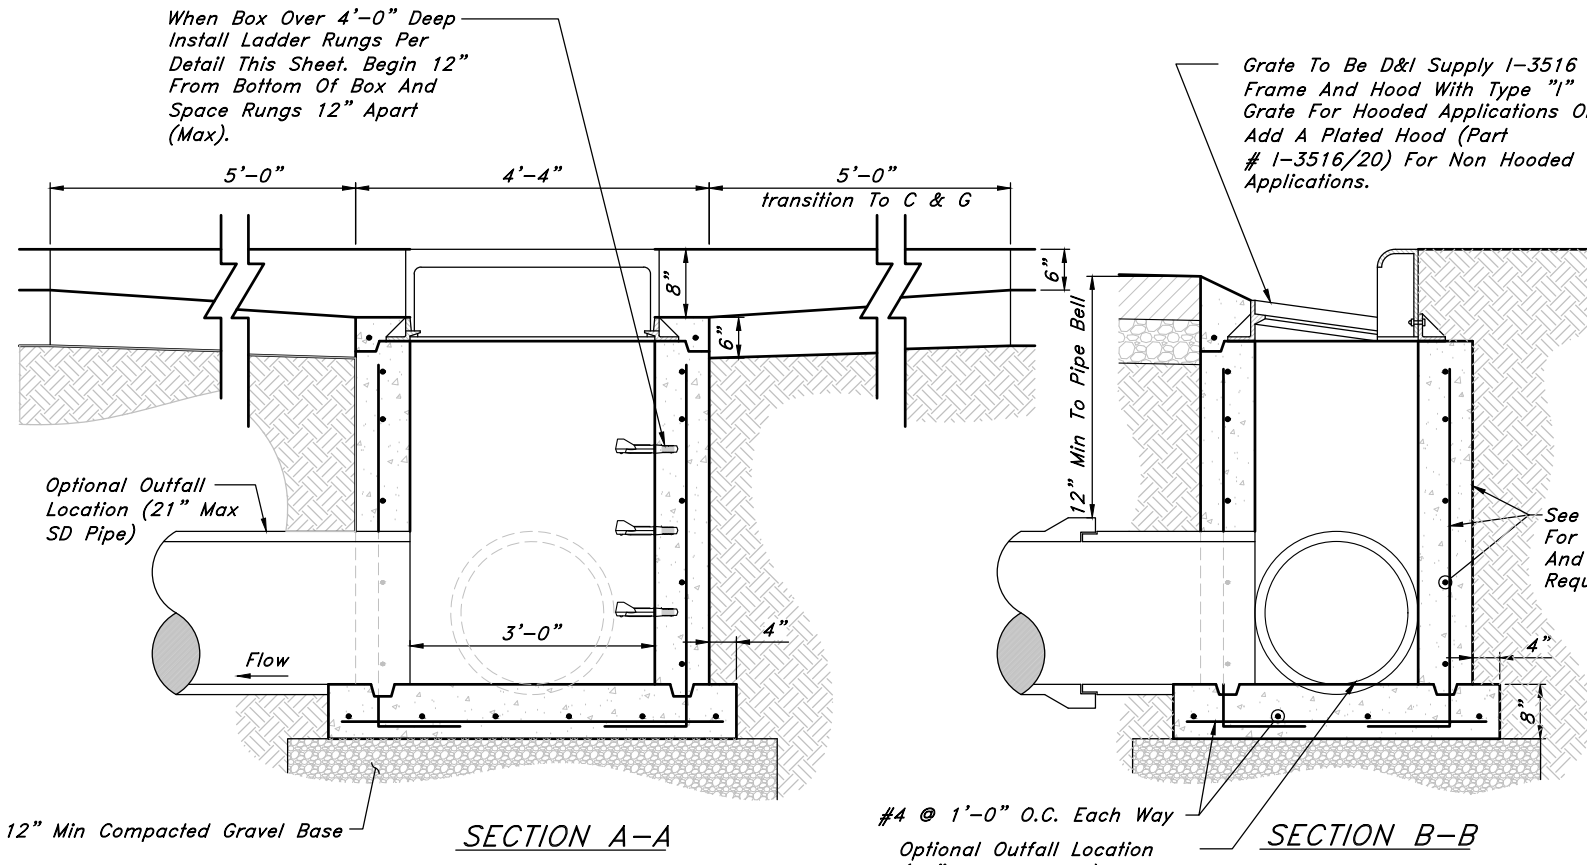
Typical Inlet Box

In Curb & Gutter  
Not to Scale

- Notes:
1. All Boxes Must Be Formed Inside And Out. The City Inspector Must Observe Prior To Placing Concrete.
  2. All Reinforcing Steel Shall Be Intermediate Grade 40, And Shall Have A Minimum Of Two Inches Cover Or Clearance From All Surfaces And Openings, Unless Otherwise Specified.
  3. All Concrete Shall Be Class AA(A), Unless Otherwise Specified.
  4. Hawking Elevations, Pipe Sizes, And Locations Shall Be Shown On Other Drawings.
  5. Rebar Splice Shall Not Be Less Than 18 Inches.
  6. 2x4 Shear Keys Are Required As Shown.
  7. Compact Base Material To 96% Of Maximum Dry Density Per ASTM D-1557.
  8. Precast Storm Drain Box May Be Used In Lieu Of Cast-In-place. Must Provide Submittals To The Design Engineer For Approval Prior To Use.

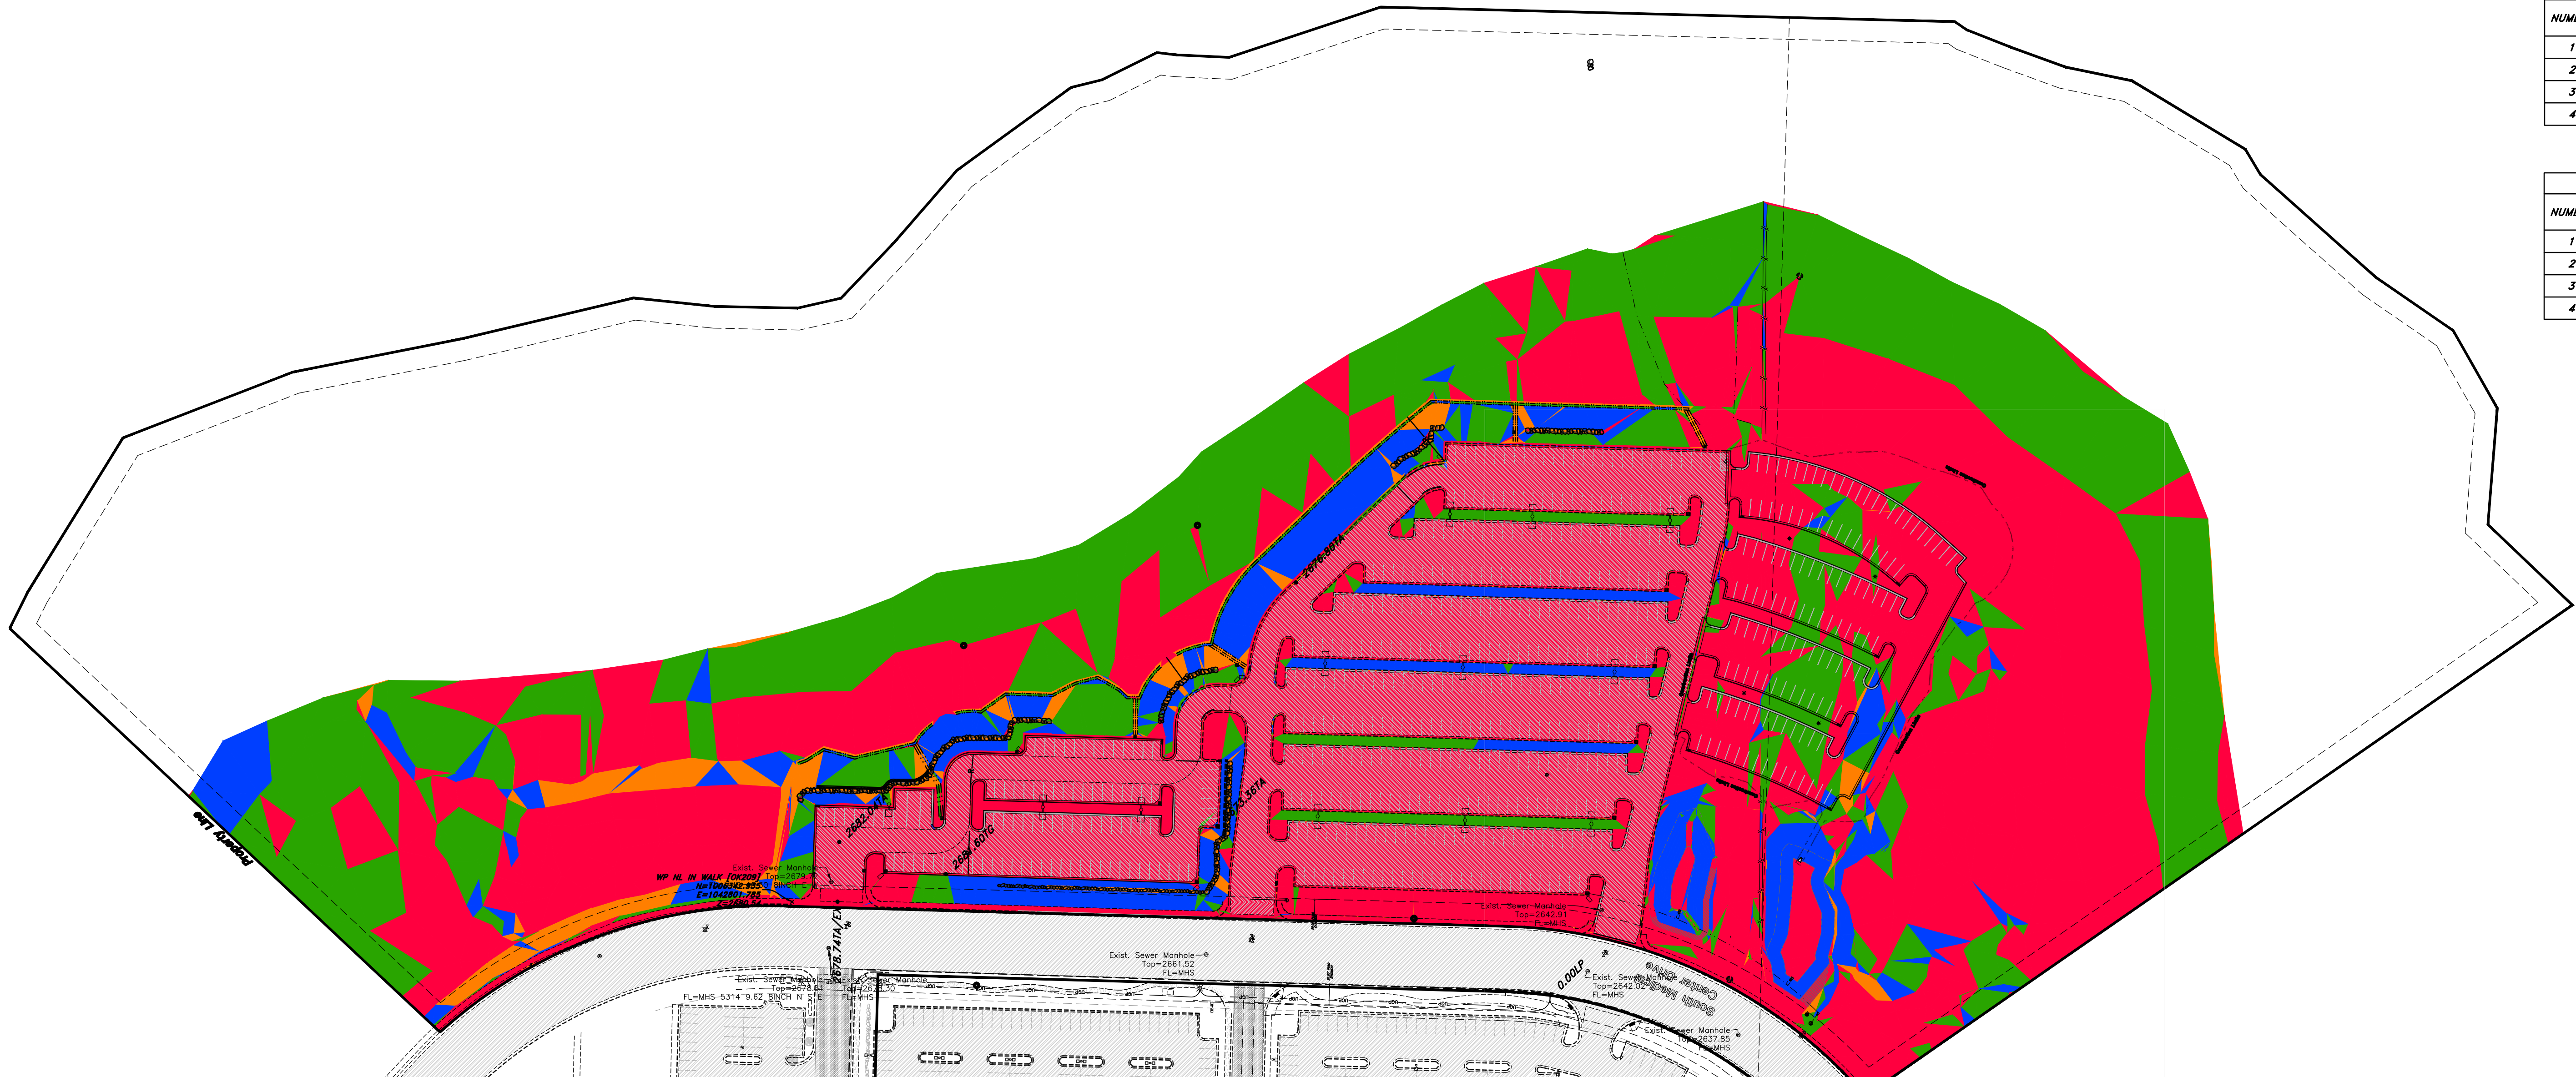
| SURFACE SLOPE DATA | | | | | |
| NUMBER | MINIMUM SLOPE | MAXIMUM SLOPE | COLOR | TOTAL AREA (ACRES) | DISTURBED AREA (ACRES) |

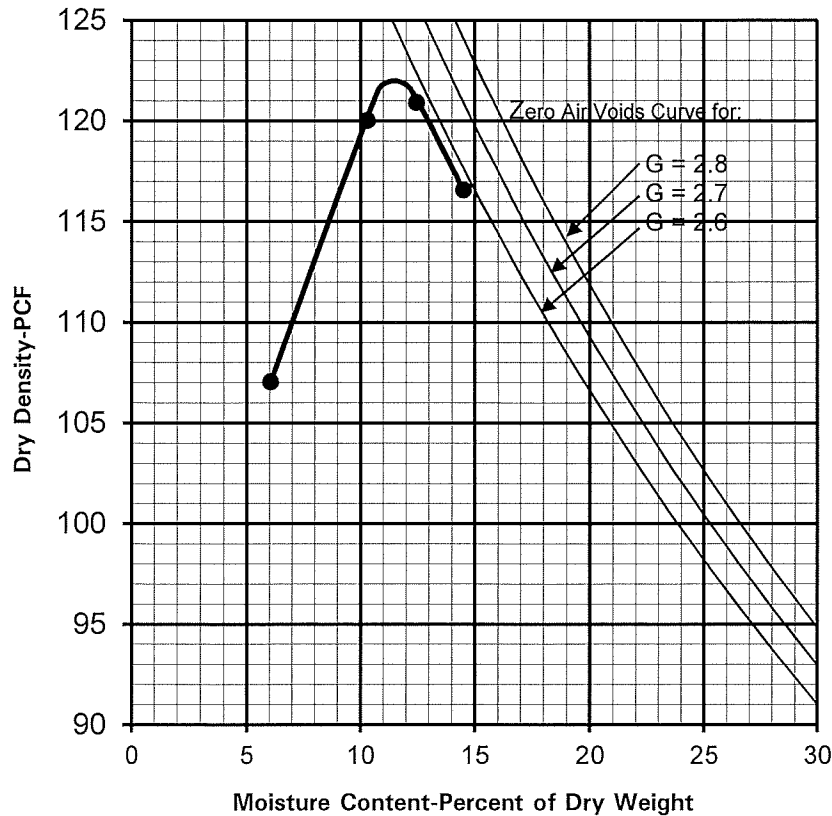
Sample Date: 12/4/15  
Sample No. 151208A  
Maximum Dry Density: 122.0  
Optimum Moisture: 11.5  
Atterberg Limits  
Liquid Limit:  
Plasticity Index: Non-Plastic  
Gradation  
Gravel: 0%  
Sand: 19%  
Silt & Clay: 81%

Moisture - Density Relationship Test Procedure: ASTM D-698 B  
Sample Description: silt with sand (ML)  
AASHTO Classification: A-4  
Sample Location: P-9 @ 2-4'

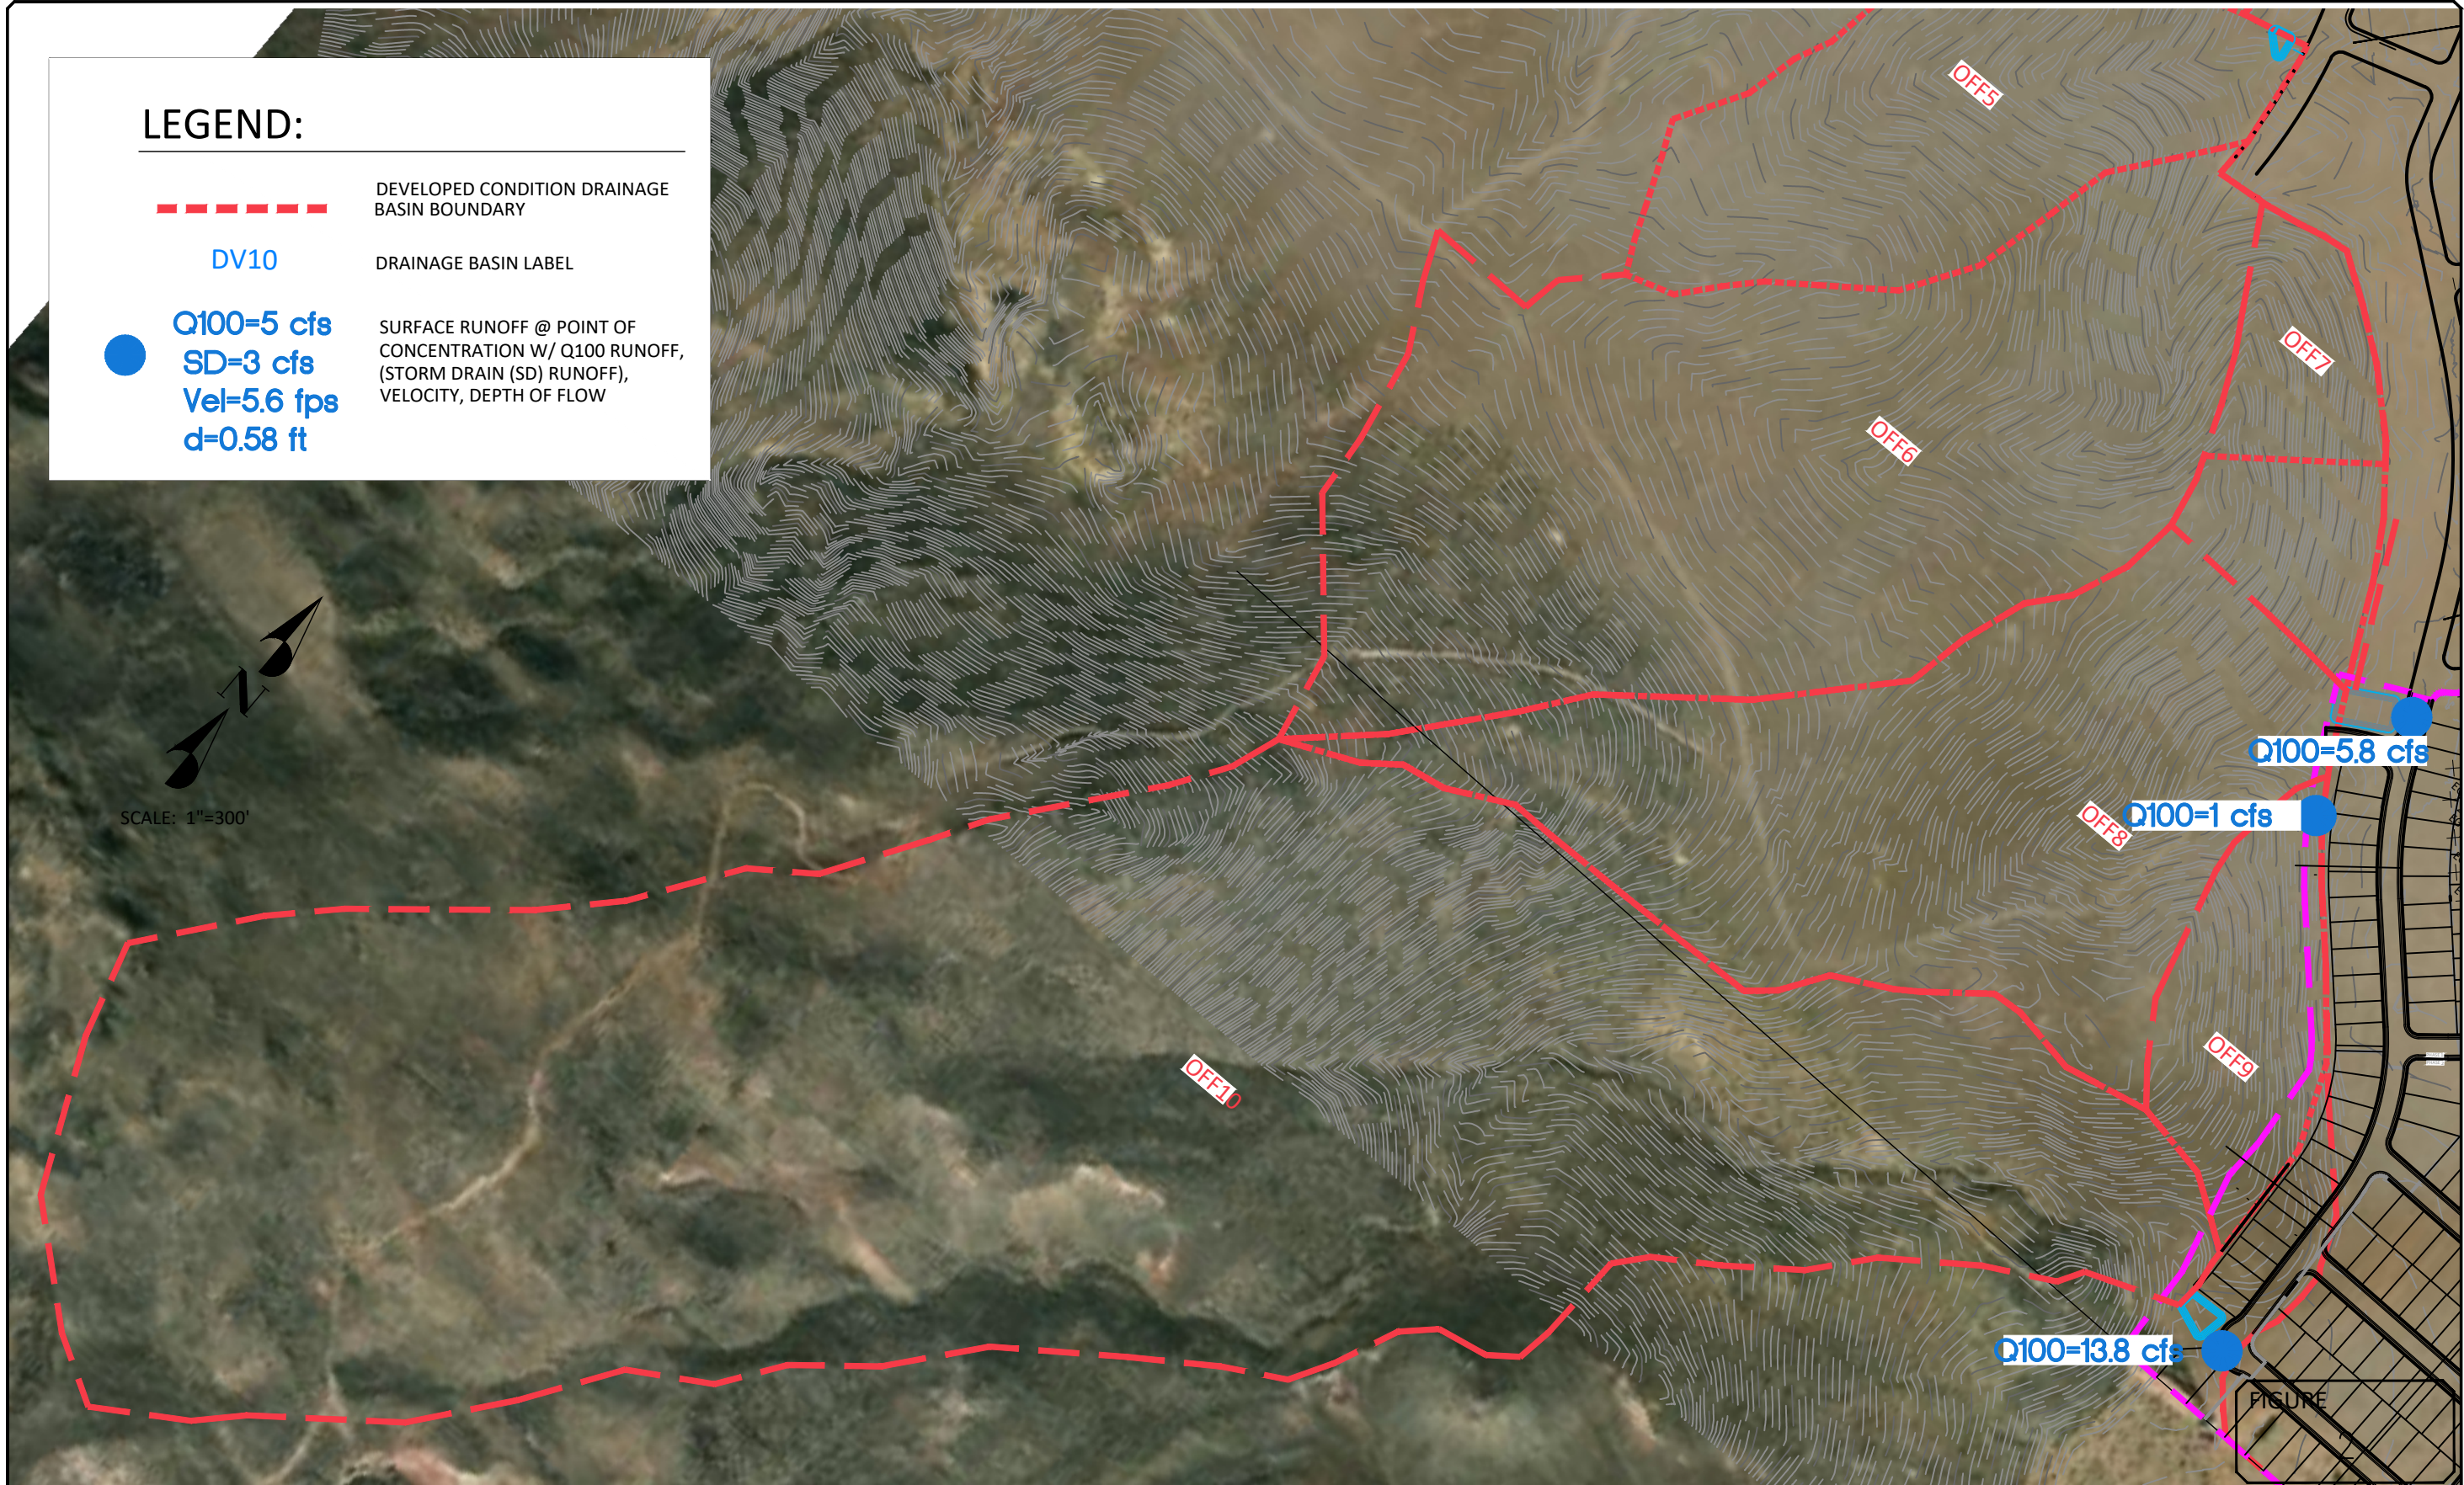
SURFACE RUNOFF @ POINT OF  
CONCENTRATION W/ Q100 RUNOFF,  
(STORM DRAIN (SD) RUNOFF),  
VELOCITY, DEPTH OF FLOW
