## Utah Geological Survey

| Project:<br>Reconnaissance of the April 9, 2006, 1650 East landslide, South Weber, Utah | | |
| By:<br>Richard E. Giraud, P.G. and<br>Greg N. McDonald, P.G. | Date:<br>07-26-06 | County:<br>Davis |

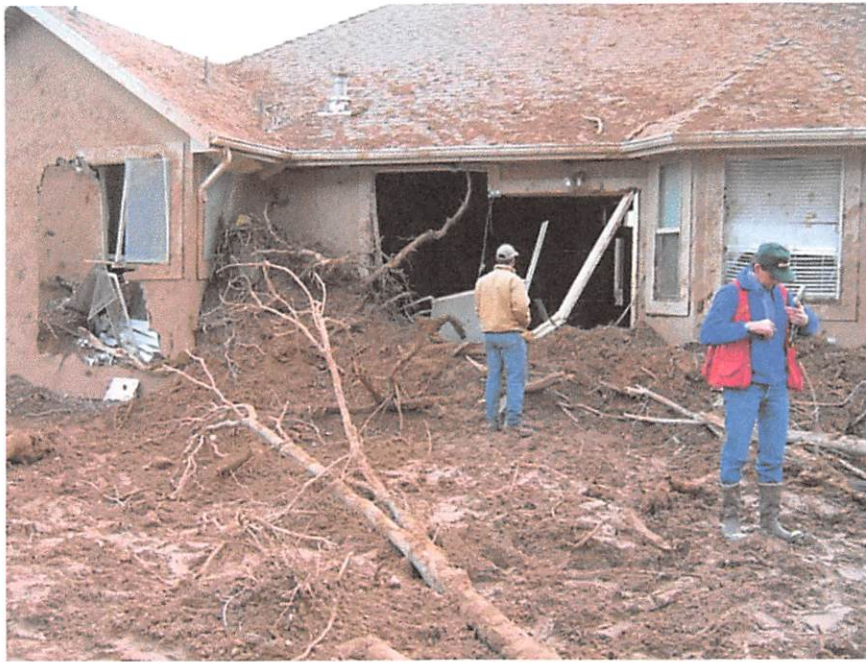
**Figure 3.** Landslide damage to the house at 1650 East 7687 South.

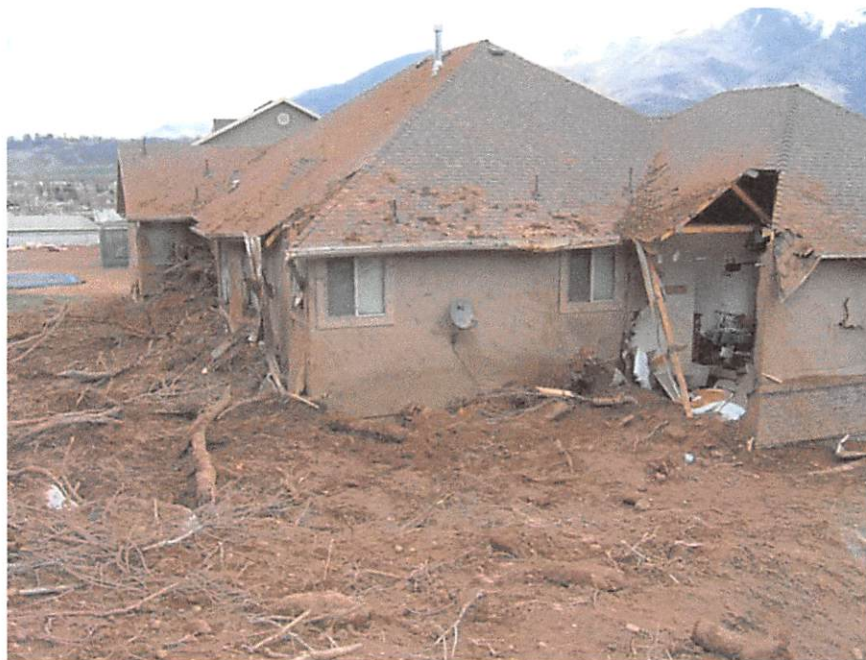
**Figure 4.** Damage to the house and garage at 1650 East 7687 South.

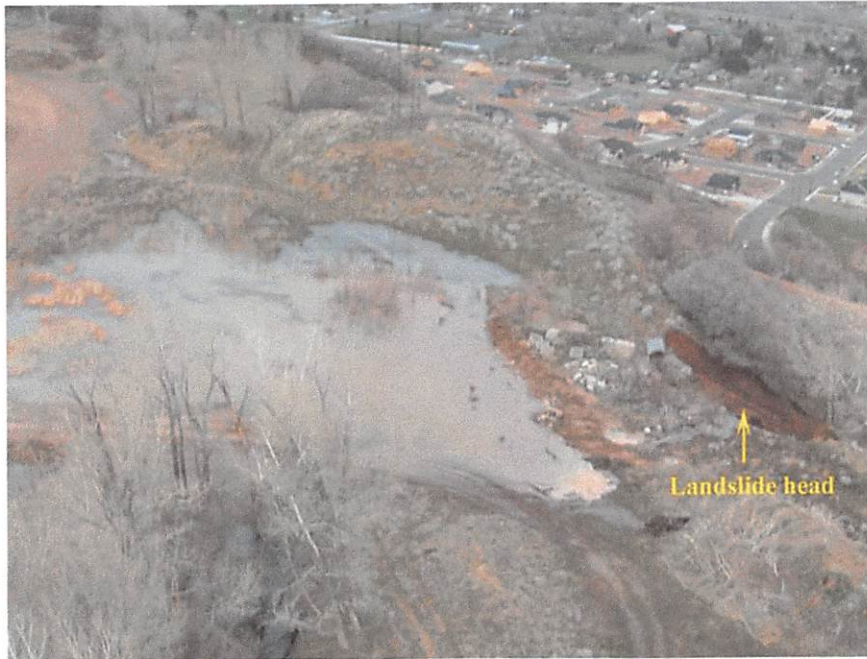
**Figure 5.** View looking northwest at the pond in the gravel pit and the landslide head (arrow). A berm was placed between the pond and the landslide to prevent water from flowing onto the landslide. Photo taken on the morning of April 10, 2005, by Davis County Sheriff's Office personnel.

The 1650 East landslide was a rapid earth flow that started as a slide at the slope crest adjacent to a pond in a gravel pit (figures 2 and 5). The landslide main scarp extends a short distance back from the slope crest onto flat ground toward the pond in the gravel pit. The landslide is mostly a failure of fill pushed out of the gravel pit onto the upper slope to form a berm along the slope crest (figure 6). The landslide also involved native materials underlying and downslope of the fill. The slide at the crest mobilized into a flow that accelerated rapidly downslope, removing trees and crossing dirt roads, the canal, and a rock wall at the back of the lot before impacting the house at 7687 South 1650 East (figures 2 and 7). The landslide impact

the pond (figure 5) also indicate the presence of perennial shallow ground water since surface-water runoff alone would not sustain this vegetation. Cottonwood trees growing along the slope crest also indicate shallow ground water (figure 6). Following the landslide, a soil berm was placed between the pond and the landslide to prevent pond water from flowing onto the landslide head (figure 5).

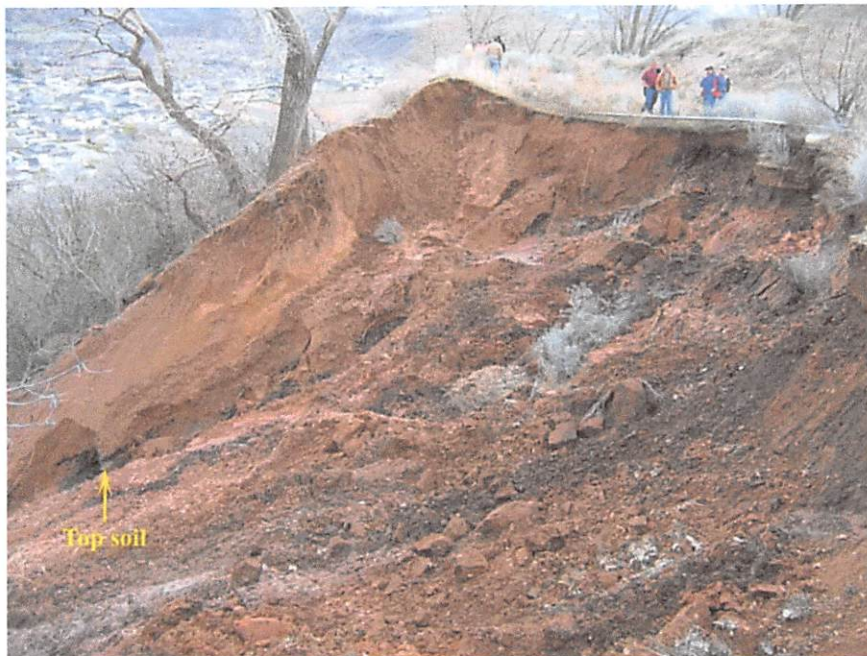
**Figure 6.** View to the southeast showing landslide main scarp and fill placed on the upper slope. Near the left edge of the photo, black top soil at the base of the scarp (arrow) underlying the brown fill is evident and indicates the original slope surface.

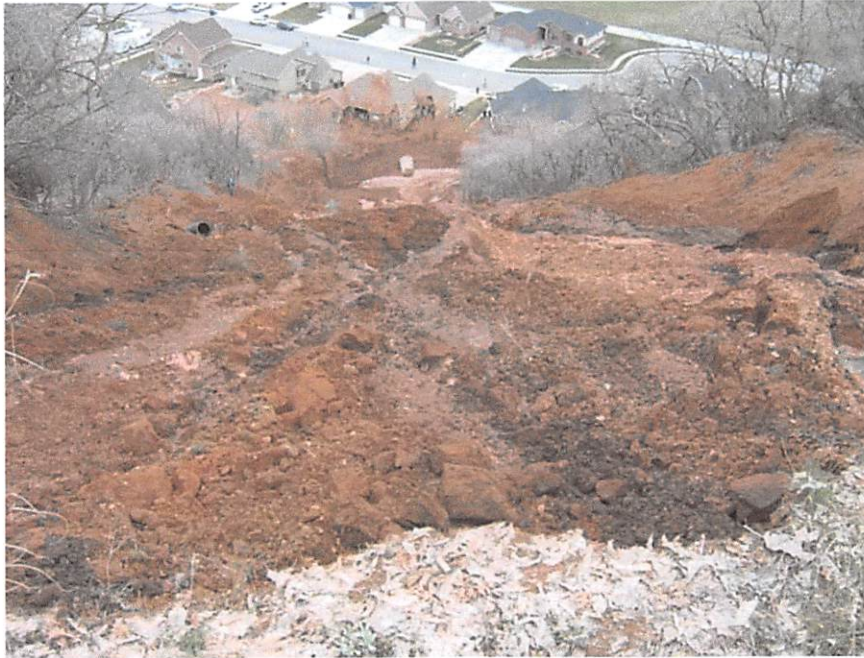
**Figure 7.** View looking down the landslide flow path at the damaged house at 1650 East 7687 South. The culvert in the lower slide path above the house was originally in the gravel pit. Subsequent water flow eroded the right side of the landslide.

The landslide likely moved initially as a shallow translational landslide but quickly transformed downslope into a rapidly moving earth flow. The landslide was about 80 feet wide and 600 feet long (figure 2). It initiated in the upper slope on gradients of as much as 60% (31°). The average gradient from the landslide main scarp to the impacted house is 45% (24°). The steep slopes accelerated the landslide downslope toward the subdivision. Some landslide material was deposited on the canal and canal access road (figure 9) and on dirt roads above the canal (figure 10), which reduced the landslide volume before impacting the house and likely reduced damage to the house. Following the landslide, water draining from the landslide crown and head eroded the right side of the landslide and flowed into the canal (figures 7 and 9).

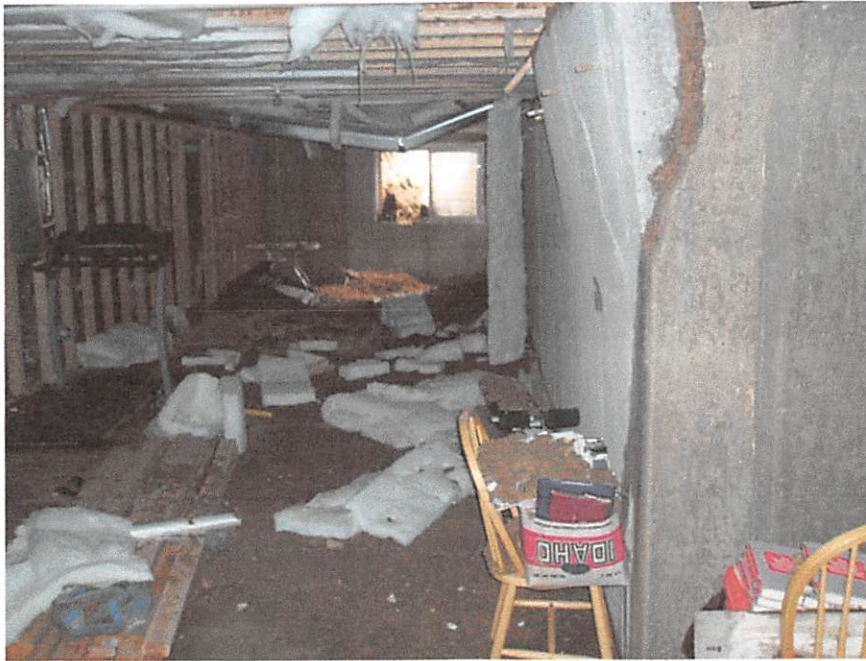
**Figure 8.** Basement at 1650 East 7687 South showing upper foundation wall (right side of photo) broken by landslide impact.

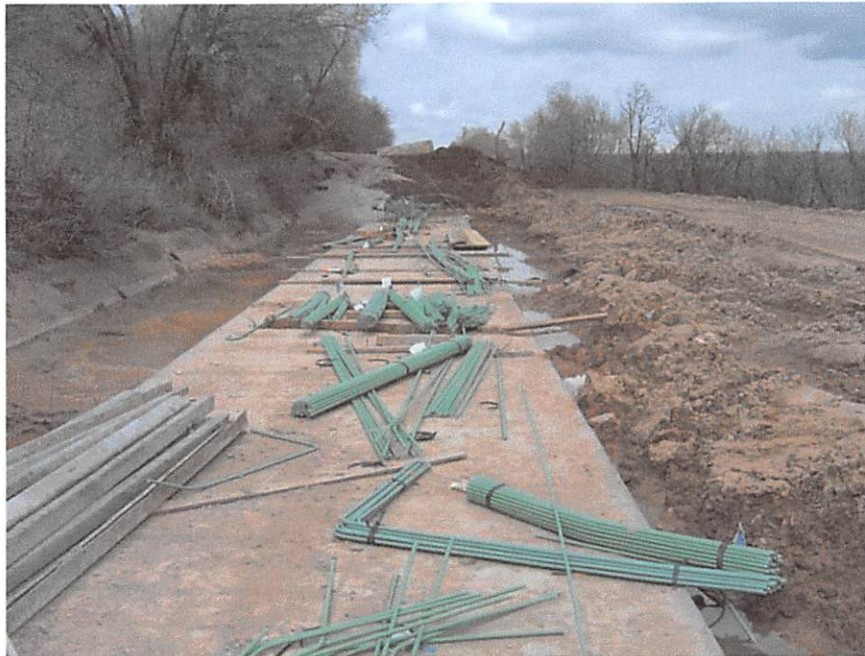
**Figure 9.** View looking northwest of Davis-Weber Canal showing landslide material deposited on the box culvert and canal access road. Following the landslide water and sediment flowed into the canal left of the box culvert.

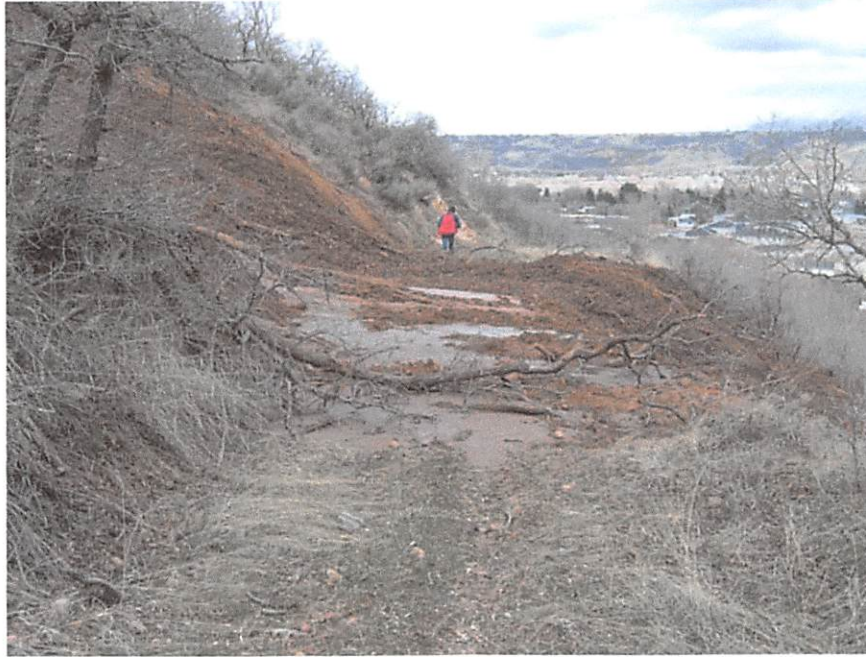
**Figure 10.** Landslide material deposited on a dirt road midslope above the Davis-Weber Canal.

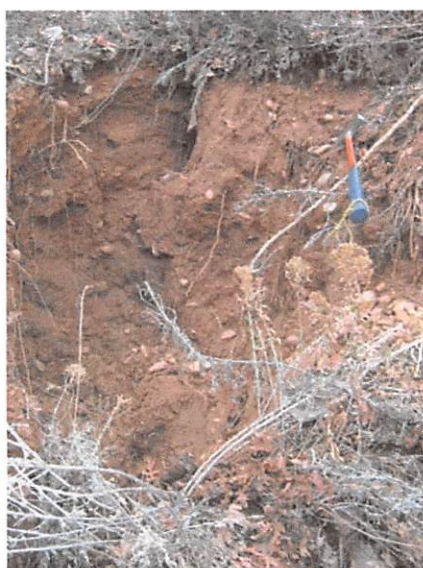
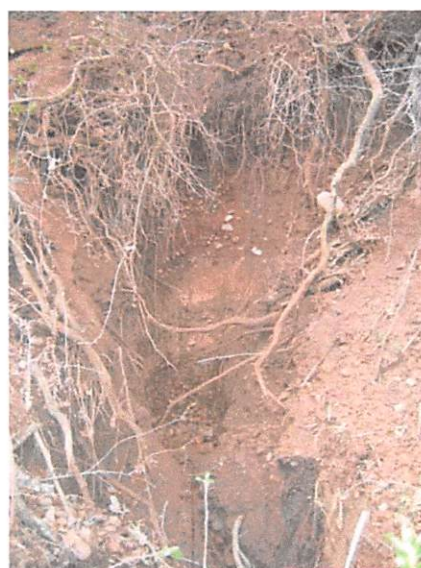
(a)

(b)

**Figure 11.** Piping holes in the upper slope near the landslide flanks. (a) Small piping hole near the landslide right flank. (b) Large piping hole adjacent to the landslide left flank.

- Piping holes near the head of the landslide below the slope crest indicate a pond and shallow ground water in the gravel pit atop the bluff saturated a zone in material along the slope crest and triggered the landslide. The steep slope, runoff of snowmelt into the pond, shallow ground water in the gravel pit, weight of embankment fill at the slope crest, and weak underlying geologic materials probably all contributed to the landslide.
