# Centennial Park Feasibility Study

Richfield Engineering Design Class

November 2019

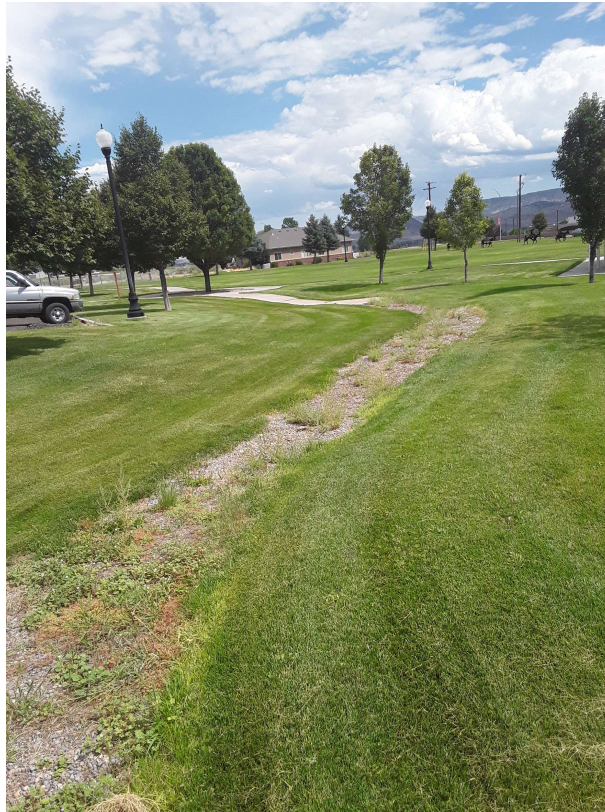
*Figure 3. Damage Sidewalk*

Due to settling, sidewalks are severely damaged and parts are missing. Sections of sidewalk are missing along 1000 N and by the north parking lot (Figures 3). In place of sidewalk there is loose gravel and weeds. The concrete pads by the pavilions, have large cracks up to an inch and a half wide (Figure 4). The handicap ramp at the south parking lot is missing and the handicap ramp at the north parking lot is damaged (Figures 5 and 6). It is critical to repair the handicap ramp.

| Sidewalks | Replace sidewalk with dirt path as needed. |

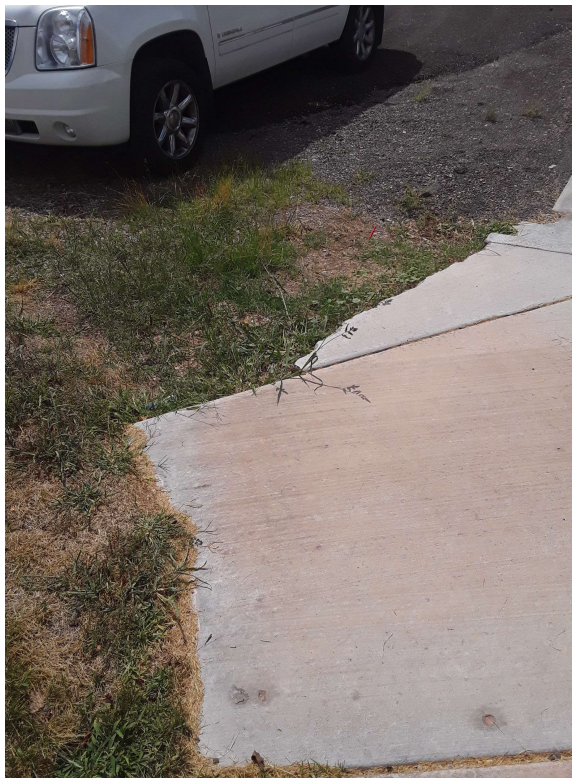
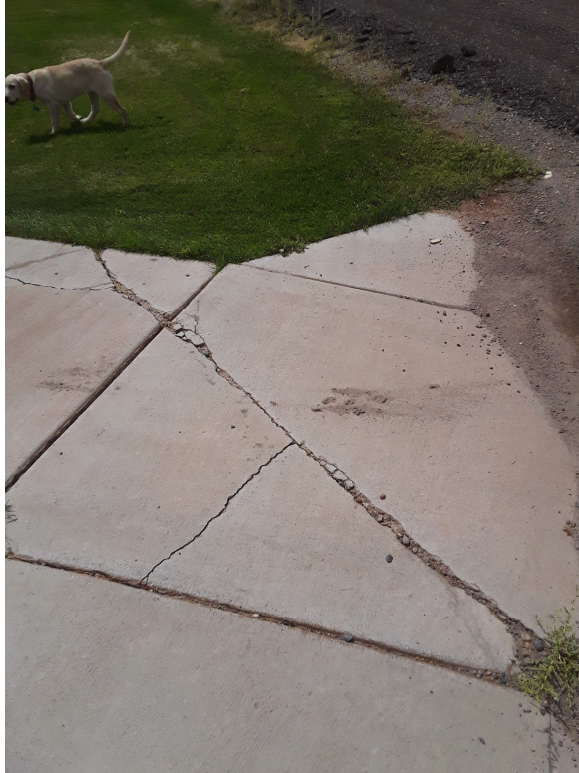
*Figure 5. Damage Handicap Ramp*

*Figure 6. Damage Handicap Ramp*

The American with Disabilities Act (ADA), requires wheelchair access to public places. Any ramp built must have a slope of 12 to 1; meaning for every 12 inches of length the ramp rises 1 inches.

| Handicap Ramps | Replace broken handicap ramps with dirt ramps with a slope of 12 to 1. (For every 12 inches of length, it will rise 1 inch.) |

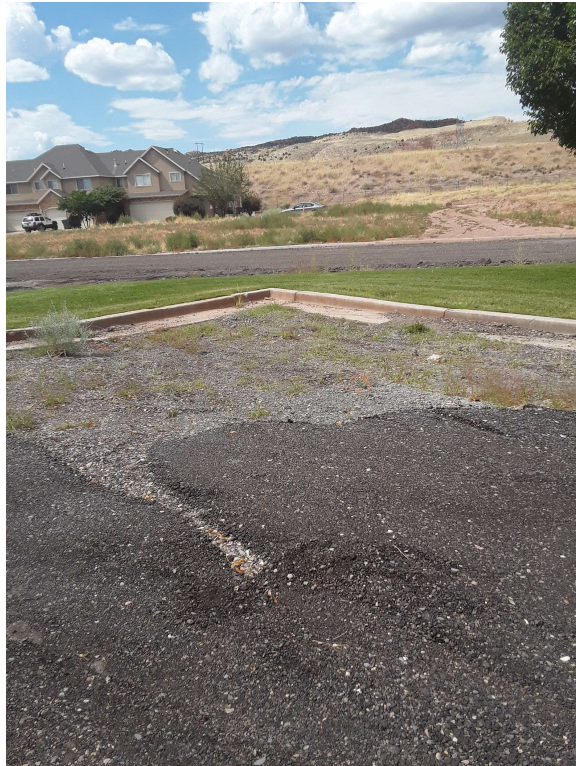
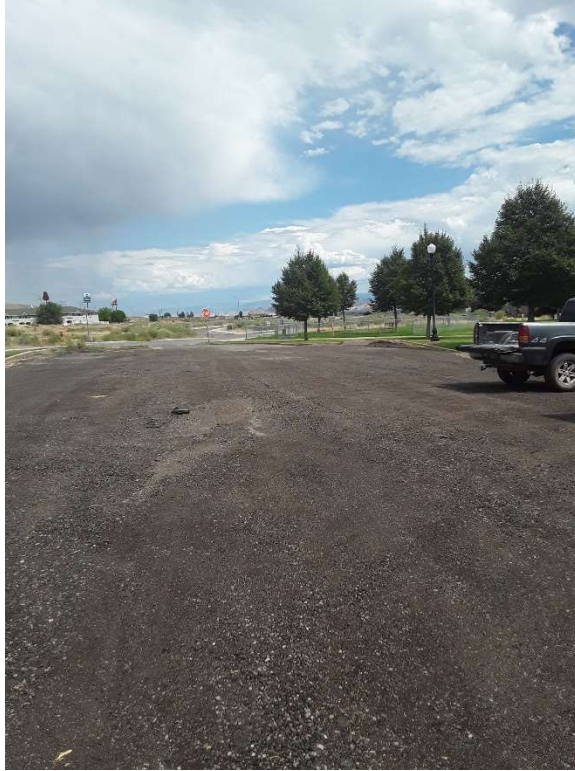
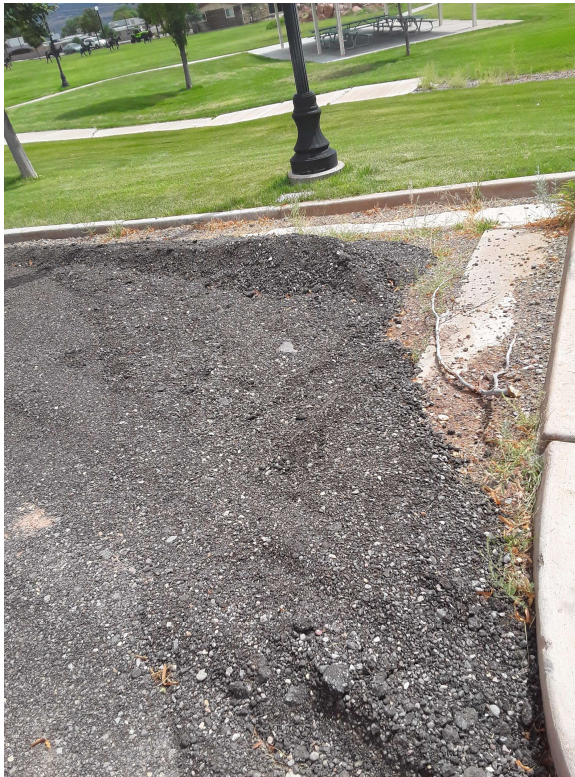
*Figure 7. North Parking Lot*

Both the north and south parking lots have been damaged by settling. The curb and gutter for both parking lots is deformed. This creates depressions where water gathers and weeds grow (Figures 7,8, and 9). To repair the damaged parking lot, the city has placed milled asphalt over the top of it. The milled asphalt is not evenly distributed and in some locations it has buried the curb.

| Parking Lots | Remove curb and gutter. Slope to drain |

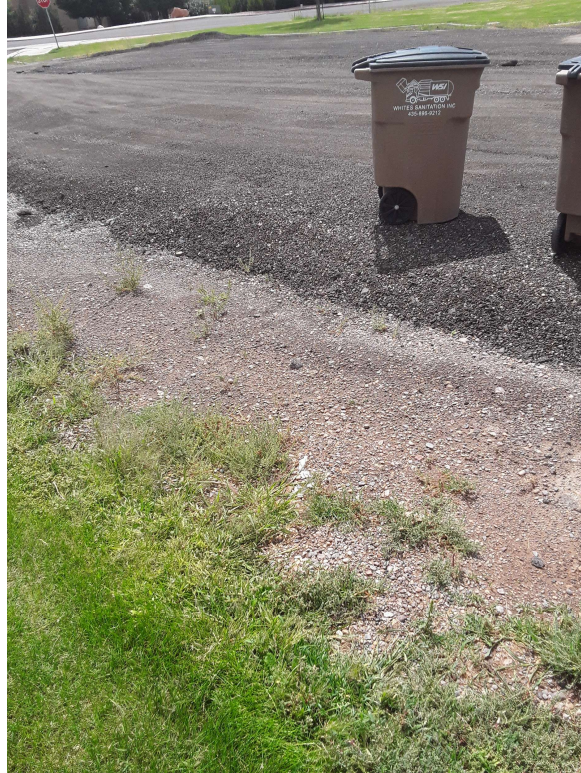
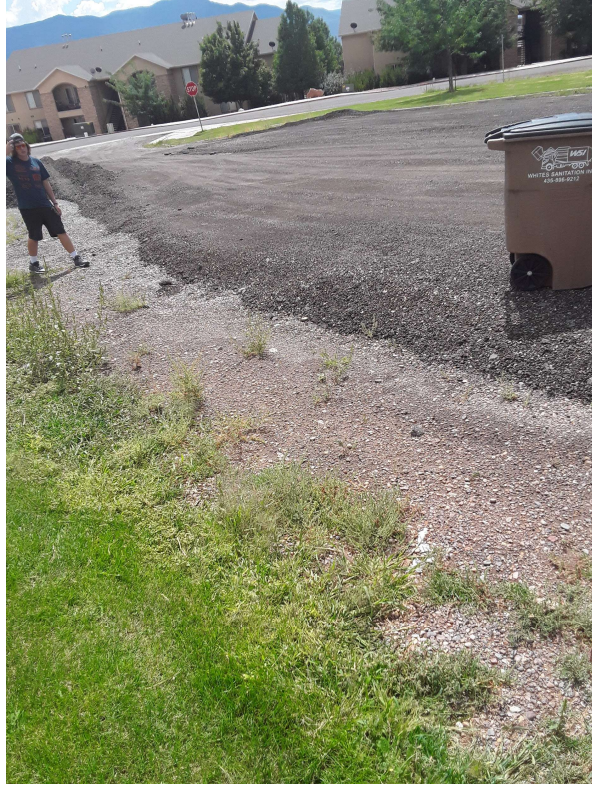
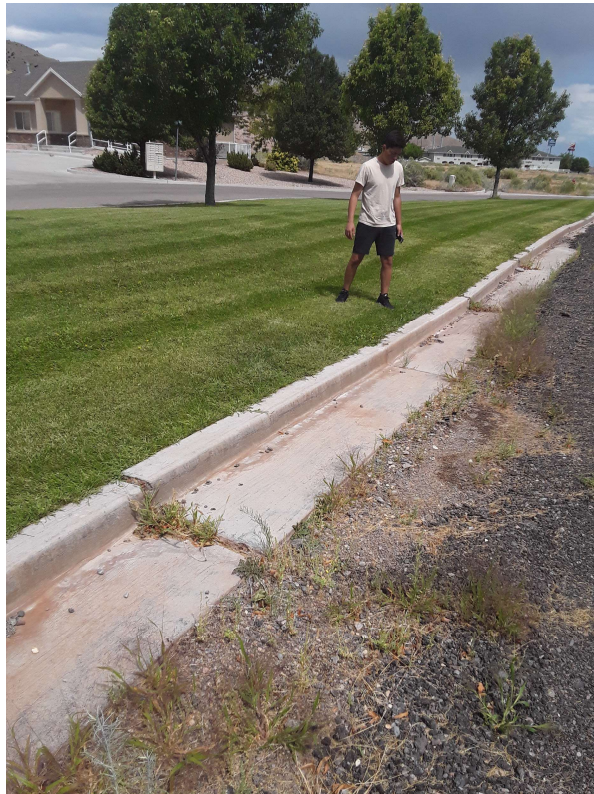
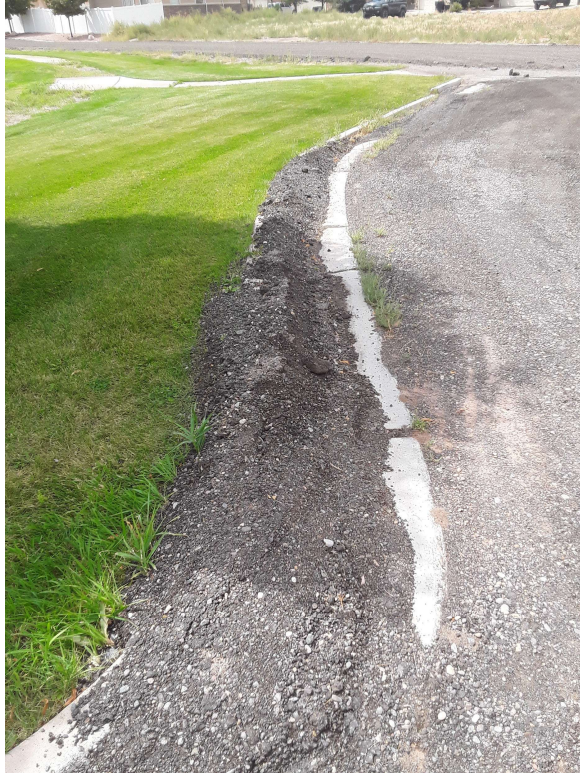
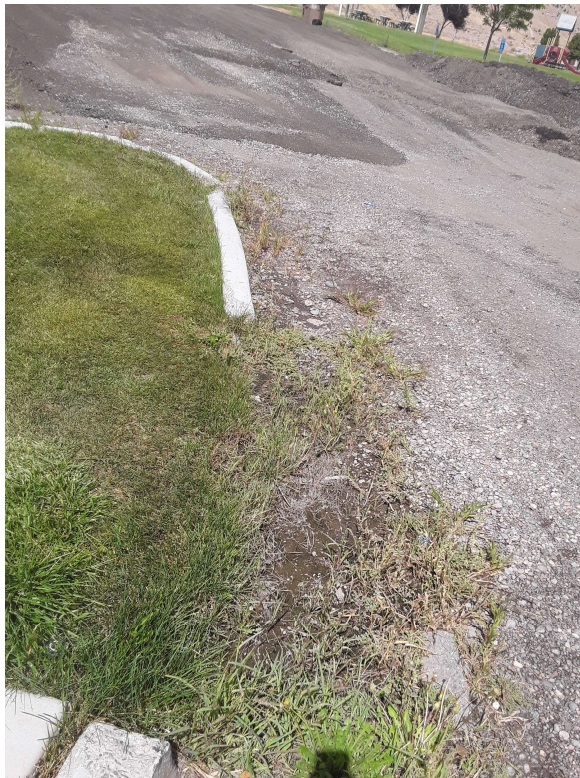
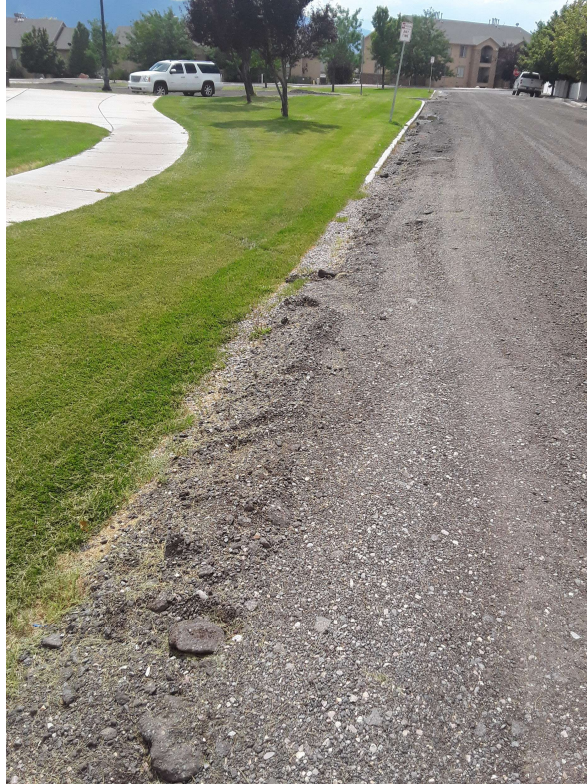
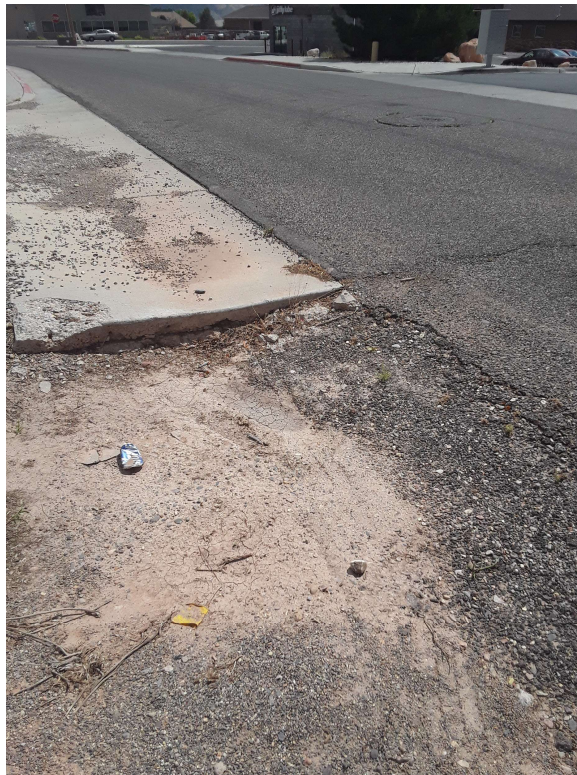
In many areas the curbs are buried, damaged, or missing all together (Figures 10, 11,12,13,14,15, and 16). The damage to the curbs and gutters does not allow for storm water to drain properly. This causes large pools of water to form and exacerbates the problems caused by settling.

*Figure 10. Centennial Park Drive*

*Figure 11. Centennial Park Drive*

*Figure 12. North Parking Lot Curb and Gutter*

*Figure 13. North Parking Lot Curb and Gutter*

*Figure 14. South Parking Lot Curb and Gutter*

*Figure 15. Centennial Park Drive Curb and Gutter*

*Figure 16. 1000 N Gutter*

| Curb and Gutter | Remove and grade to drain into grass |

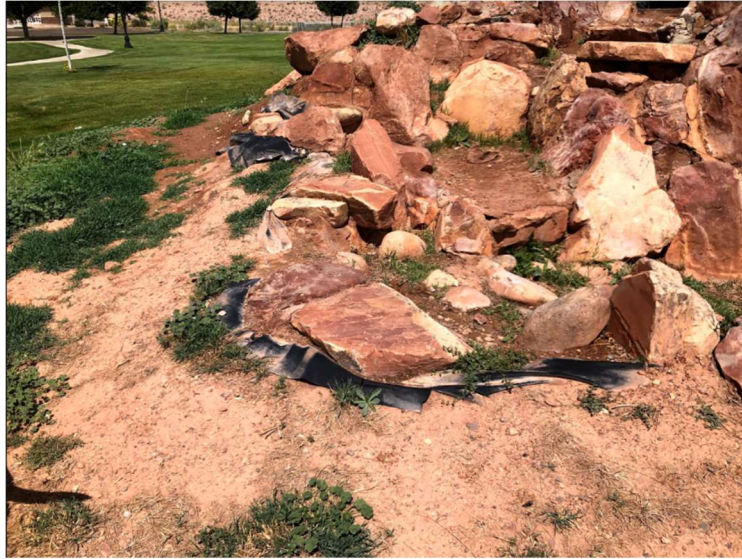
*Figure 17. Water Fountain*

Currently the Fountain does not work, the rocks are breaking off, and weeds are growing in the cracks (Figure 17).

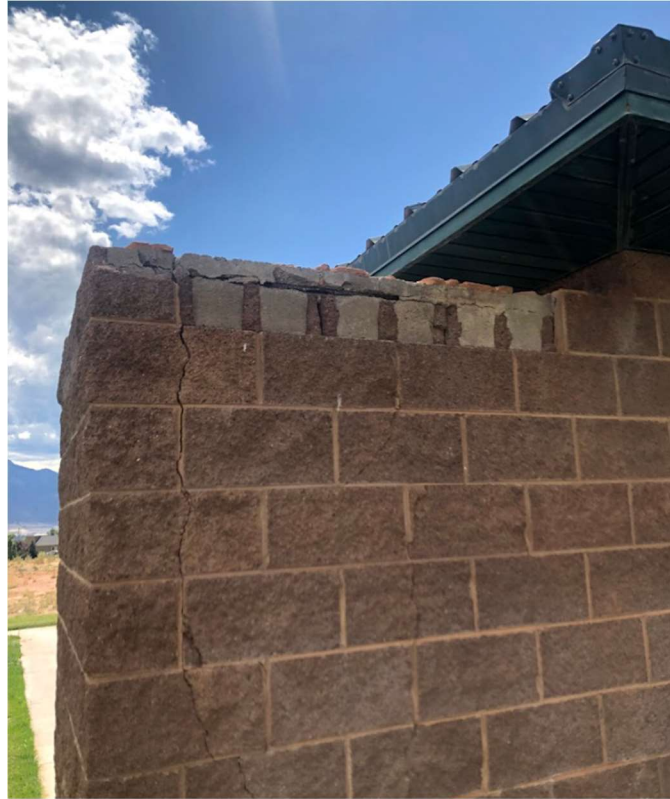
*Figure 18. Bathroom Wall*

The restroom wall is damaged with missing cinder blocks, and cracks from top to bottom (Figure 18). The building has been retrofitted with piles to protect against settling.

| Bathroom Wall | Repair or replace broken/missing cinder blocks |

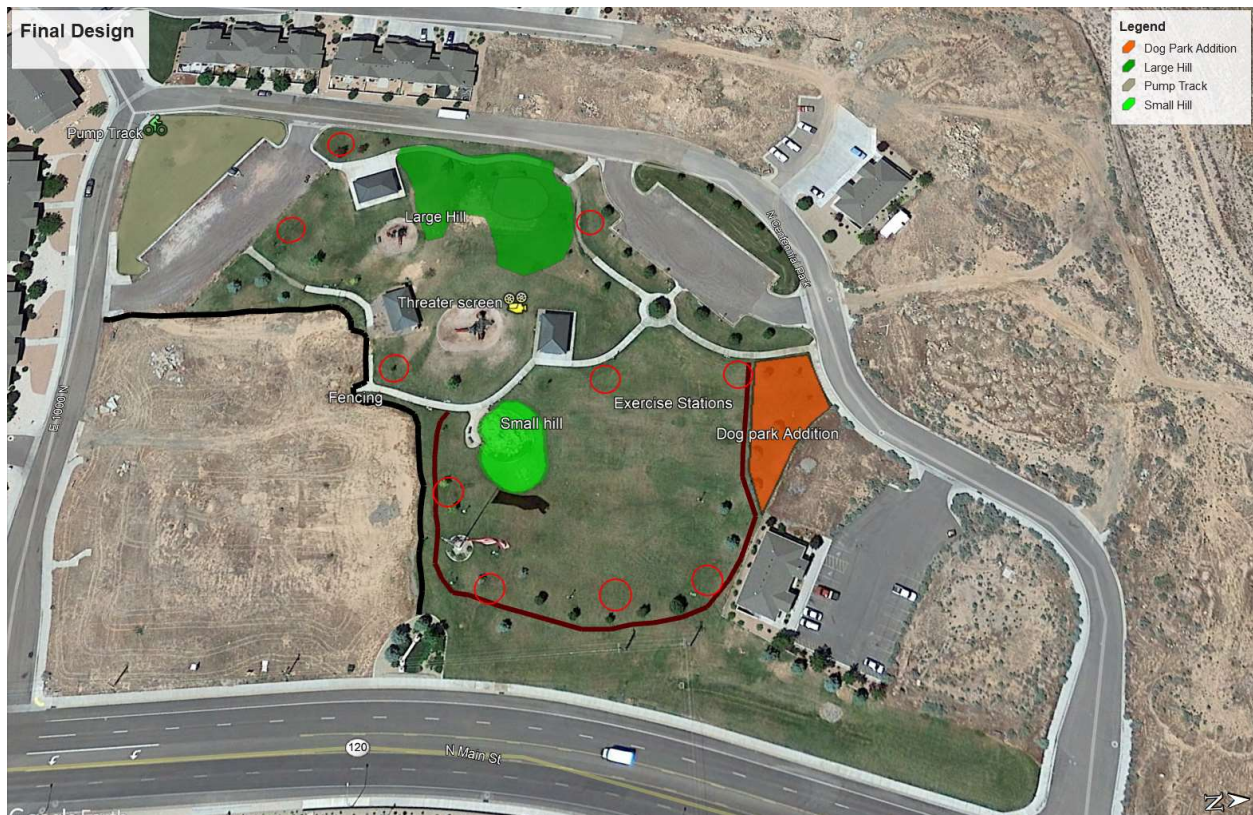
Figure 19. Final Design Layout

It is recommended that alternative 3 be used to repair the park and attract visitors to the park. Alternatives 1 and 2 do not meet the needs of the park and the city. Alternative 1 is not recommended due to the cost of a geotechnical study, engineer's plans, and construction. Alternative 2, is not recommended because it does not address the need to attract visitors to the parks.
