NOTICE OF MEETING
HISTORIC PRESERVATION COMMISSION
CITY OF ST. GEORGE
WASHINGTON COUNTY, UTAH

HISTORIC PRESERVATION COMMISSION AGENDA REPORT:
010/19/2022

Orson Pratt House – Rehabilitation Historic Landmark Rehabilitation (Case No. 2022-HPC-007)	
Request:	To consider a request to reroof the Orson Pratt House located in Green Gate Village.
Applicant:	Justin Brewer
Representative:	Justin Brewer
Location:	76 W. Tabernacle
General Plan:	COM (Commercial)
Zoning:	C-4 (Central Business District Commercial)
Land Area:	Approximately 1.42 acres

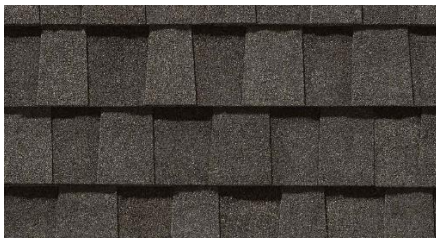
Landmark – Wewo

We would like to have the current wood shingle roof replaced with asphalt shingles. The two colors we are looking at are:

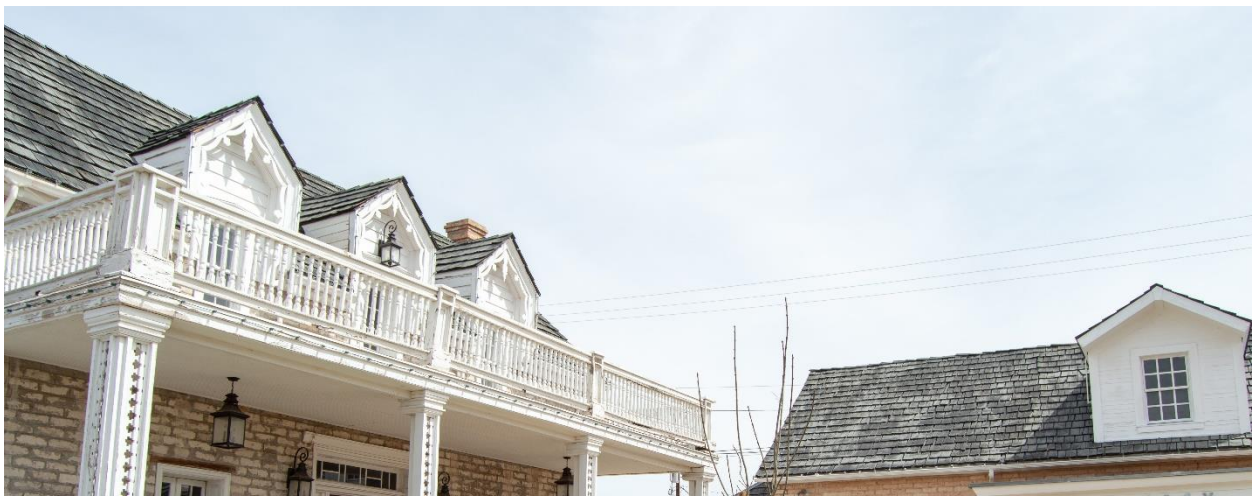
Current roof:

The applicant would like to replace the existing roof of the Orson Pratt House located in Green Gate Village at 76 W. Tabernacle. The current roof is made of wood shingles and is leaking. The applicant has received several estimates on the repairs with all of the estimates stating that the existing roof needs to be removed and replaced. The applicant has received quotes on replacing the roof with wood shingles and asphalt shingles. The applicant would like to go with asphalt shingles. (Please refer to Exhibit A, Applicant's Narrative.)

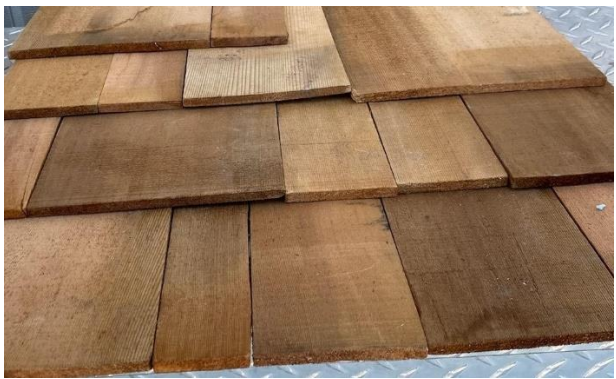
If we were to do wood shingles, it would look like this:

The Orson Pratt House is one of many historic buildings located in Green Gate Village. All of the buildings within Green Gate Village have the same roof material. They are all made of wood shingles. Due to the age of the roofs, all of the roofs are a dark grey color. Please refer to the photos in Exhibit B showing all sides of the Orson Pratt House as well as a photo of many of the other buildings in Green Gate Village. The final photo is of the leasing office for City View Apartments. This building is not a part of Green Gate Village, but the roof has recently been replaced with new wood shingles, making the color a light brown. If the roof of the Orson Pratt Home was replaced with wood shingles, this is what it would look like.

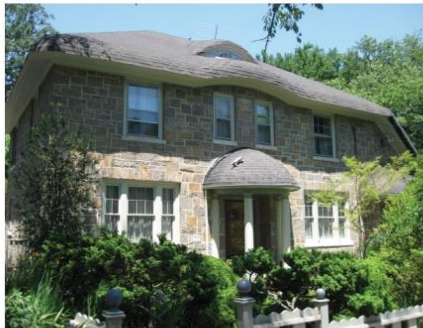
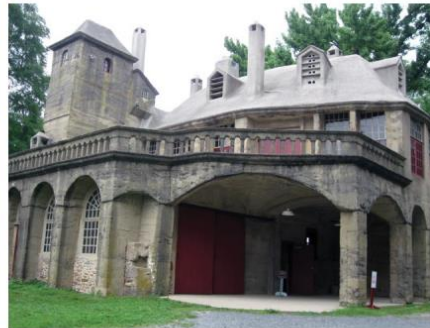
[9] Distinctively-shaped roofs are important in defining the historic character of these early 20th-century structures: (a) an asphalt shingle roof on a house; (b) and a concrete roof on Forthill, Doylestown, PA (1908-1912), designed and built by Henry Chapman Mercer.

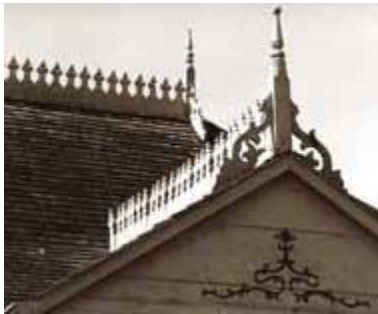
Decorative roofing feature. Photo: HABS Collection, NPS.

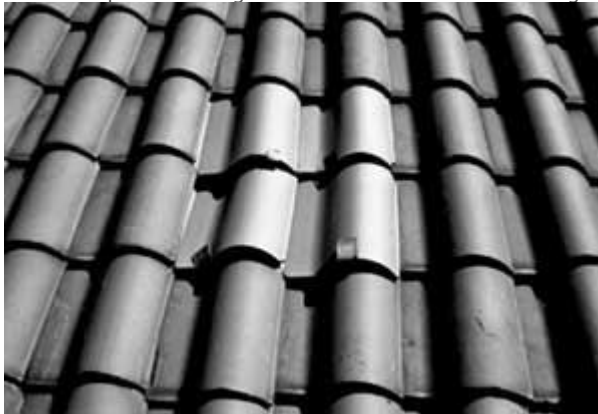
Repairs on this pantile roof were made with new tiles held in place with metal hangers. Photo: NPS files.

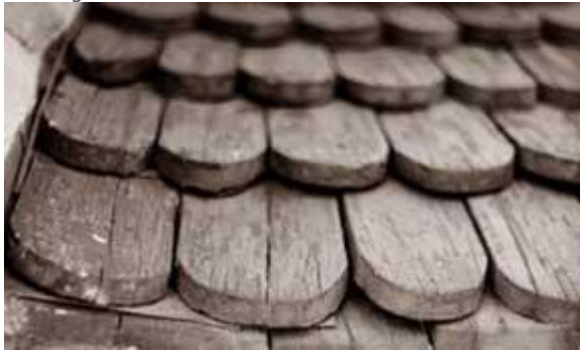
Replacement of particular historic details is important to the individual historic character of a roof, such as this rounded butt wood shingle roof. In the restoration, the drainage around a dormer was improved by the addition of carefully concealed modern metal flashing. Photo: NPS files.

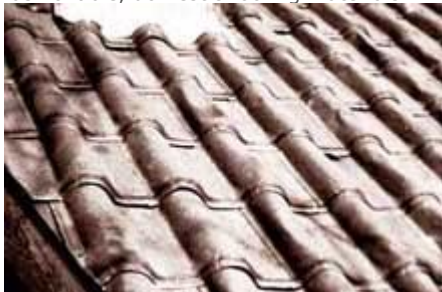
Galvanized sheet-metal shingles imitating the appearance of pantiles remained popular from the second half of the 19th century into the 20th century. Photo: NPS files.

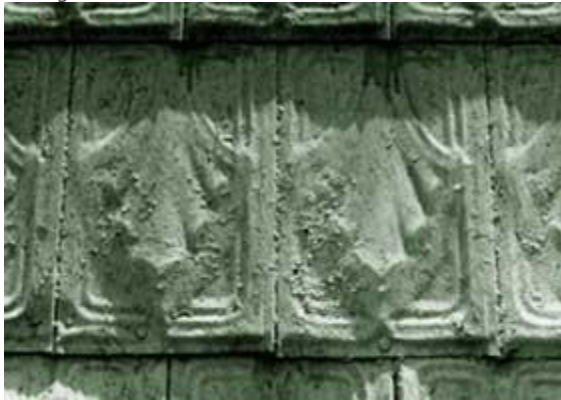
Tin shingles, commonly embossed to imitate wood or tile, or with a decorative design, were popular as an inexpensive, textured roofing material. Photo: NPS files.

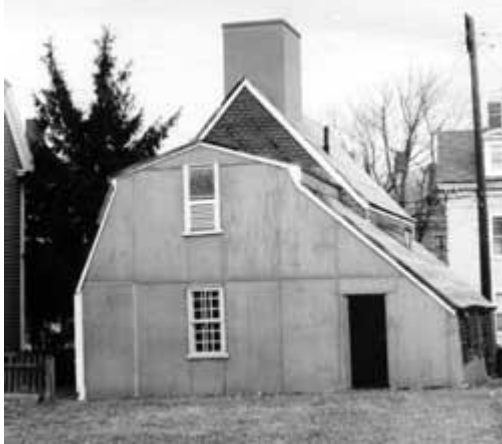
Temporary stabilization or "mothballing" with materials, such as plywood and building paper, can protect the roof of a project until it can be properly repaired or replaced. Photo: NPS files.

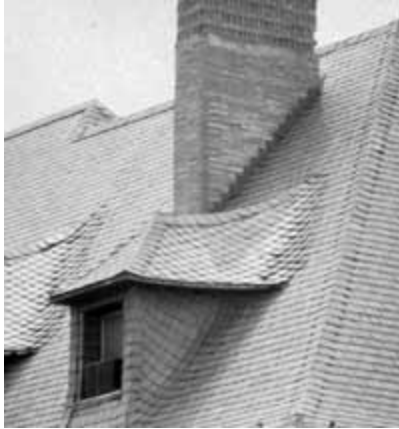
Because of the roof's visibility, the slate detailing around the dormers is important to the character of this structure. Photo: NPS files.

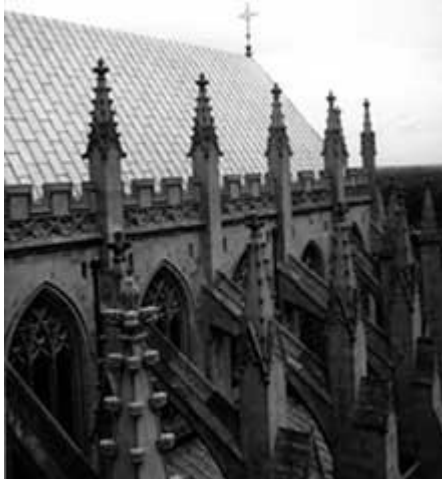
Good design and quality materials for the roof surface, fastenings, and flashing minimize failures. Photo: NPS files.

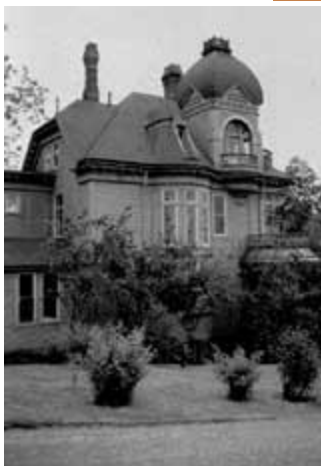
Special problems inherent in the design of an elaborate historic roof can be controlled through regular maintenance. The shape and detailing are essential elements of the building's historic character, and should not be modified, despite the use of alternative surface materials. Photo: NPS files.
