**MINUTES OF THE HELPER CITY COUNCIL MEETING**  
**Thursday, November 3, 2022**  
**at 6:00 p.m.**  
**in the Council Chambers**  
**19 South Main Steet**  
**Helper, Utah 84526**

# HELPER CITY UTAH

## ADA WALKABILITY STUDY

Jonathan Johansen, P.E.

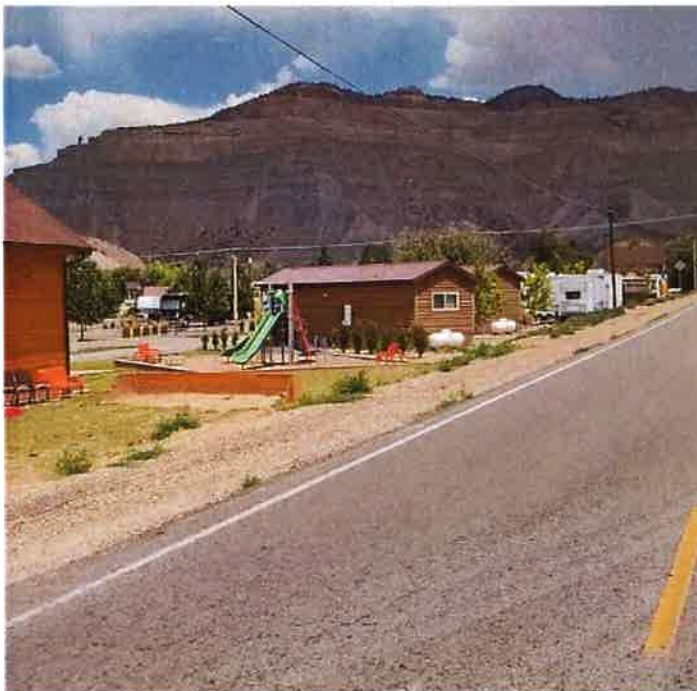
1. Castle Gate RV Park to Birch Street (west side of Main Street)

Existing Conditions - There is an outdated sidewalk with no pedestrian access to the south of the intersection of Birch Street and Main Street. The sidewalk ends abruptly and no walking access continues along Main Street to the Castle Gate RV Park.

Proposed Design Features – Remove the existing sidewalk and replace it with an ADA pedestrian access at the southwest corner of the intersection and continue a 5' wide sidewalk and 2.5' wide curb and gutter along the west side of Main Street to the north boundary of the Castle Gate RV Park property. Additional embankment, or installation of a retaining wall may be required to install the full cross section of sidewalk and curb and gutter in some areas. Replace the existing concrete driveway with a new ADA concrete driveway access. Continuing south to the RV Park Entrance, install a 4' wide swale with weed barrier and 4" cobble rock between the edge of Main Street and the proposed 5' sidewalk. The curb and gutter and swale will collect storm water off the west side of Main Street. Install an ADA pedestrian access at the end of the sidewalk.

See Drawing C-001 for plan layout.

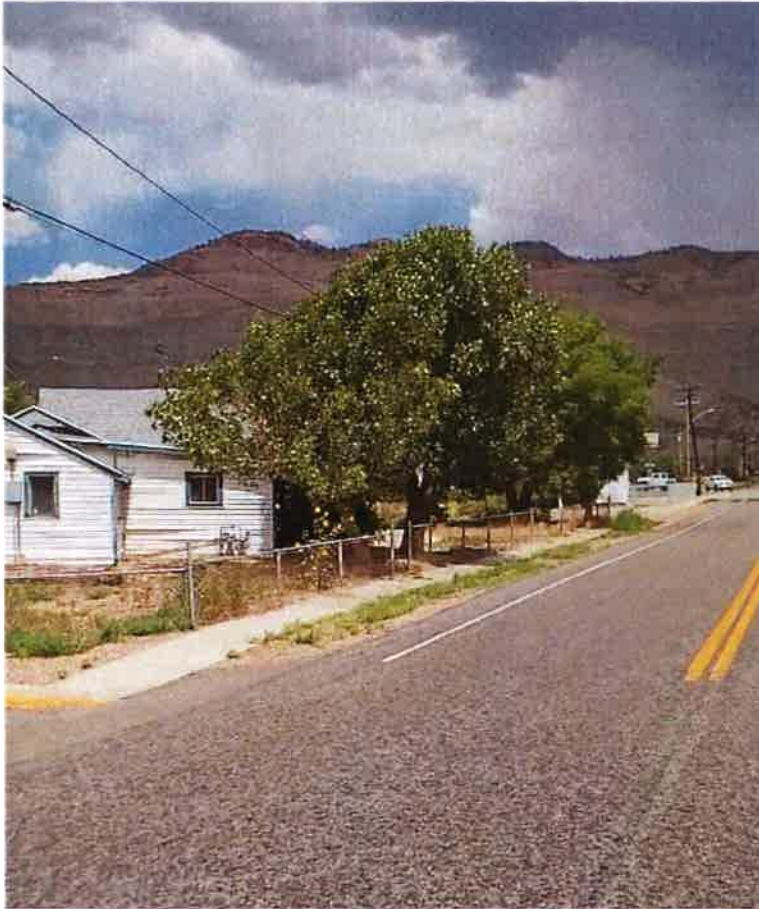
2. Birch Street to Maple Street (west side of Main Street)

Existing Conditions - There is a dilapidated sidewalk and pedestrian accesses on both corners of the block which do not meet ADA Standards.

Proposed Design Features – Remove the existing sidewalk and pedestrian accesses. Replace the sidewalk with a new 4' wide sidewalk, 2.5' curb and gutter and new ADA pedestrian accesses on each corner of the block. Install new ADA concrete driveway accesses at two locations.

See Drawing C-002 for plan layout.

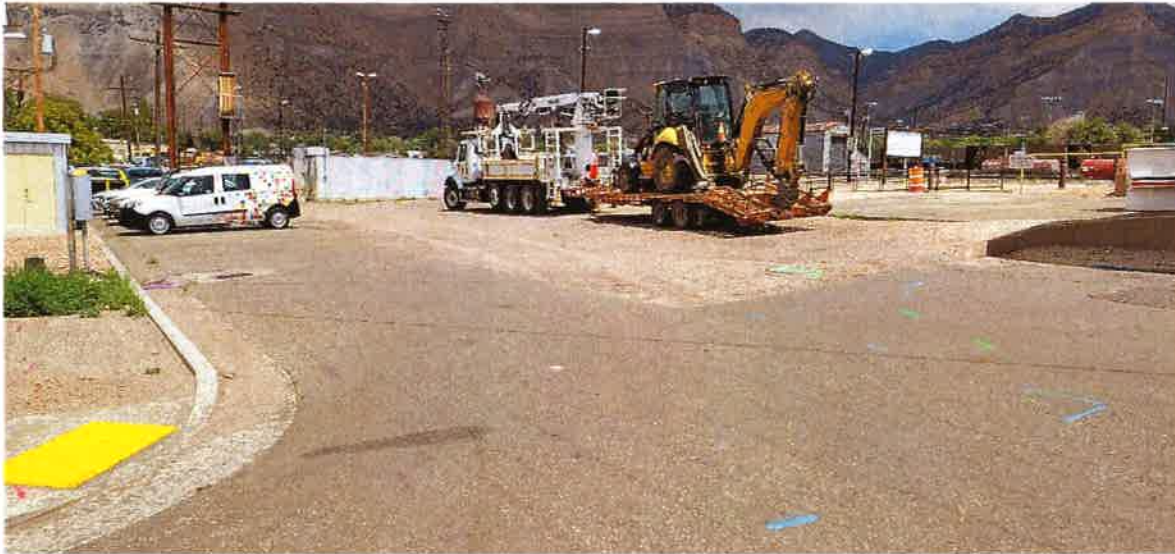
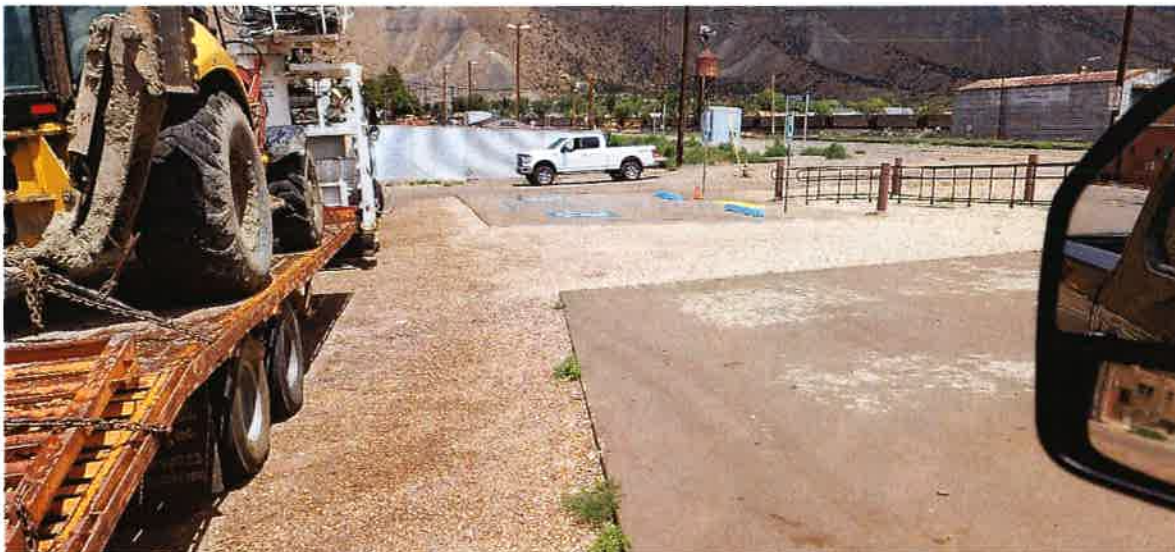
### 3. Helper Train Station (north and west of building)

Existing Conditions - There is no accessible pathway from Depot Street to the existing concrete pad on the north side of the train station.

Proposed Design Features – Create a pedestrian cross walk from the existing pedestrian access on the north side of Depot Street along the existing asphalt. Create a concrete ramp up to the existing grade of the existing concrete pad on the north side of the train station building. Within that ramp, a manhole will need to be raised and a tactile strip placed along the ramp.

See Drawing C-003 for plan layout.

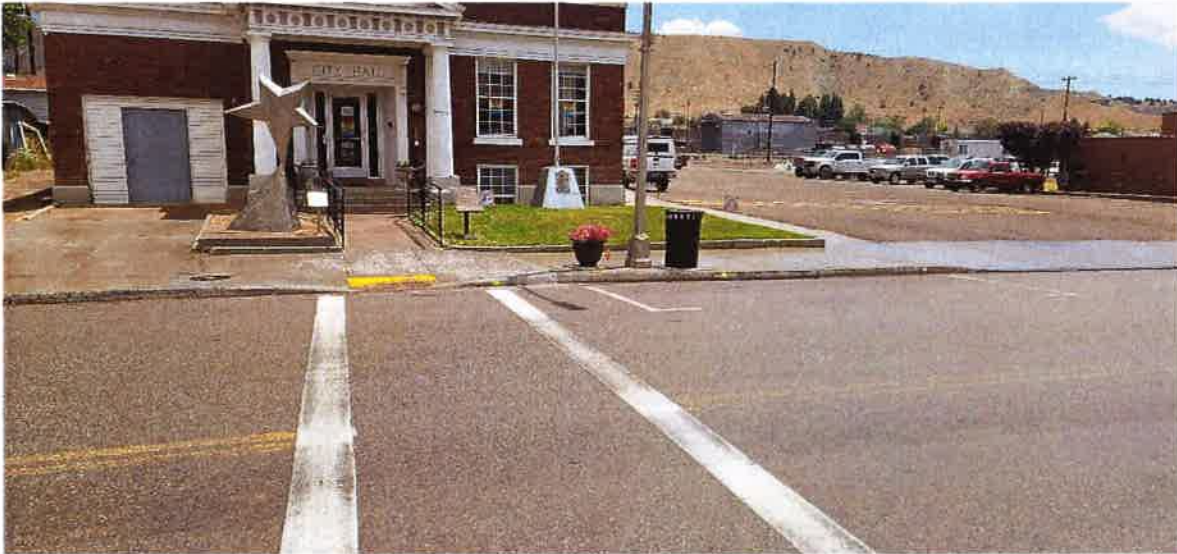
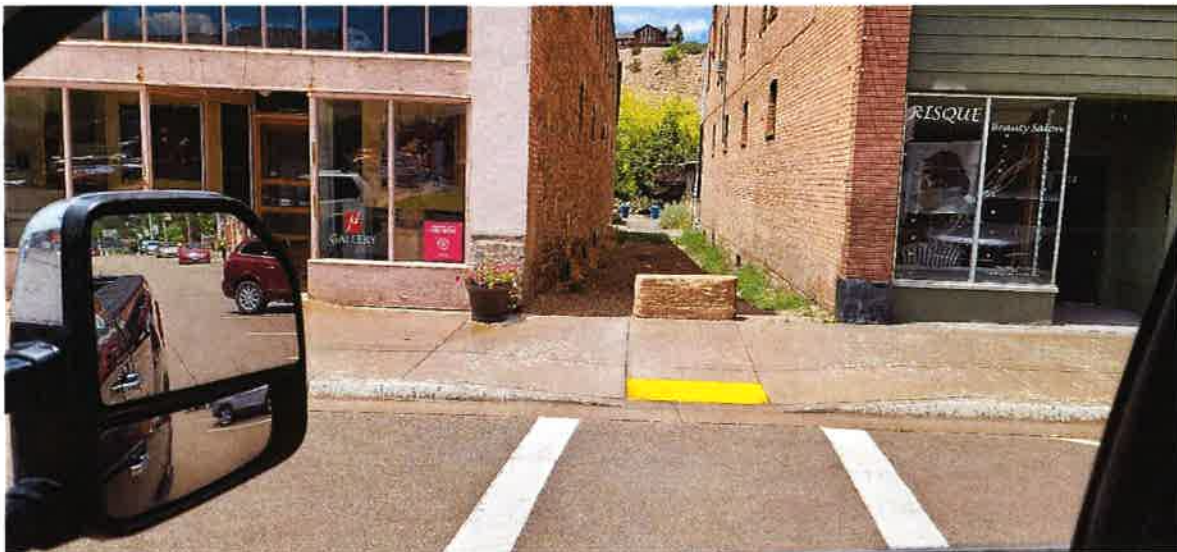
#### 4. Curb Islands (City Hall and Main Street)

Existing Conditions - There is an ADA pedestrian access across Main Street in the middle of the block but there are not curb islands adjacent to it to prevent parking too close to the crosswalk.

Proposed Design Features – Create curb islands at both pedestrian crossings. The curb islands will match improvements to Main Street that were recently completed. The new islands will further enhance the city's beautification plan. A wayfinding sign will also be installed directing pedestrians to the Helper Riverwalk Trail through the existing alleyway.

See Drawing C-004 for plan layout.

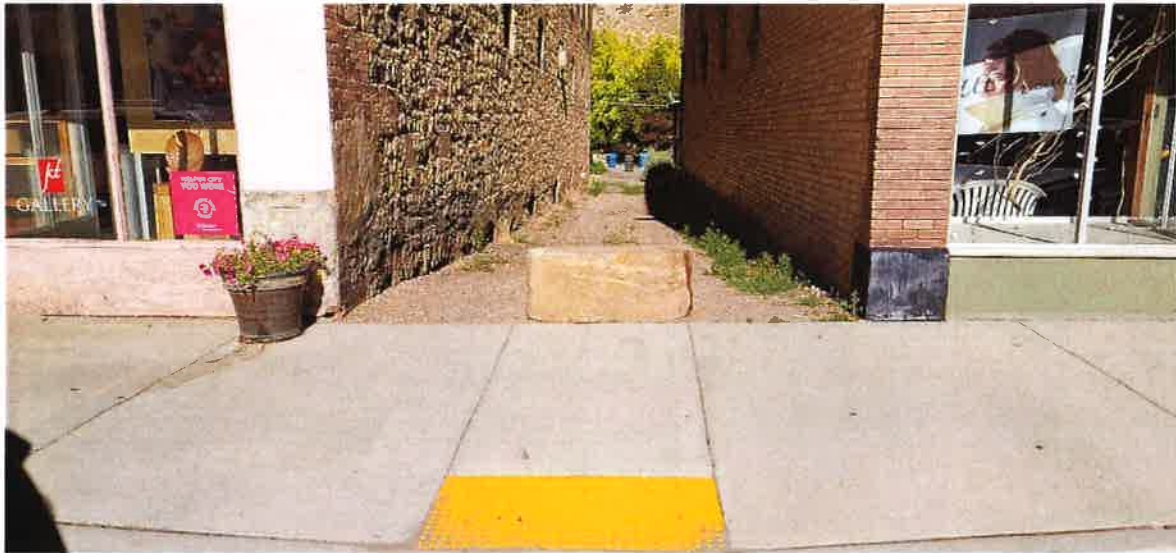
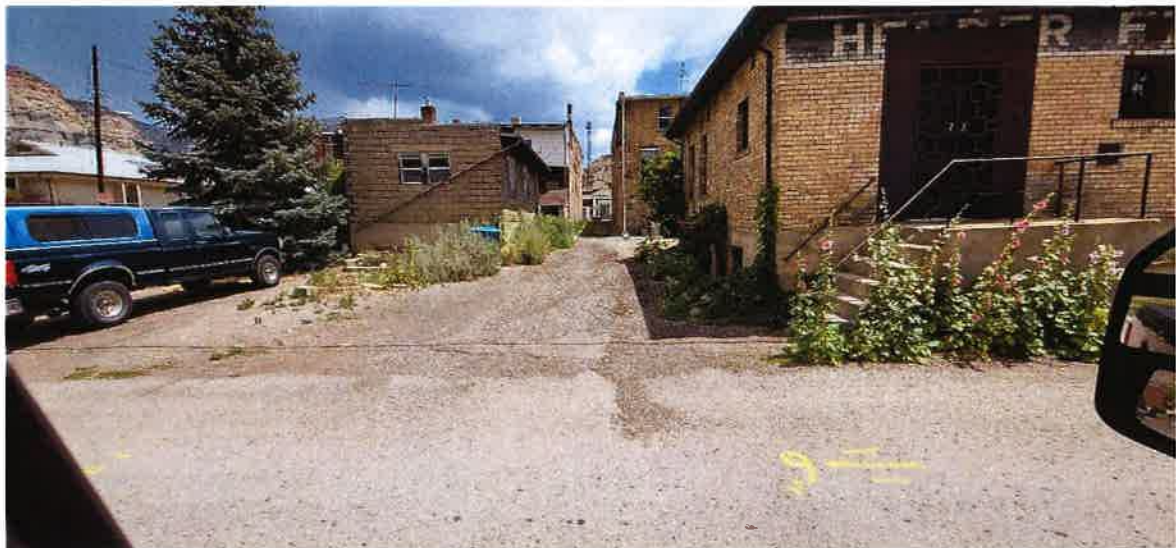
5. Alleyway Sidewalk (Main Street to 100 West)

Existing Conditions - There is a gravel walkway between buildings on Main Street and then turns to asphalt near 100 West. This alleyway is not ADA accessible.

Proposed Design Features – Remove the existing boulder on Main Street at the beginning of the alleyway and relocate. Install a 5' wide concrete sidewalk from Main Street to the east edge of 100 West. Install a tactile strip at the east edge of 100 West and paint a crosswalk across the road to allow for entrance to the Helper Riverwalk Trail. Install a weed barrier and 4" cobble rock between the two buildings in the alleyway on each edge of the new sidewalk to lower maintenance and upkeep. Three easements will be required from private property owners in order to install and maintain this proposed sidewalk through the alleyway.

See Drawing C-005 for plan layout.

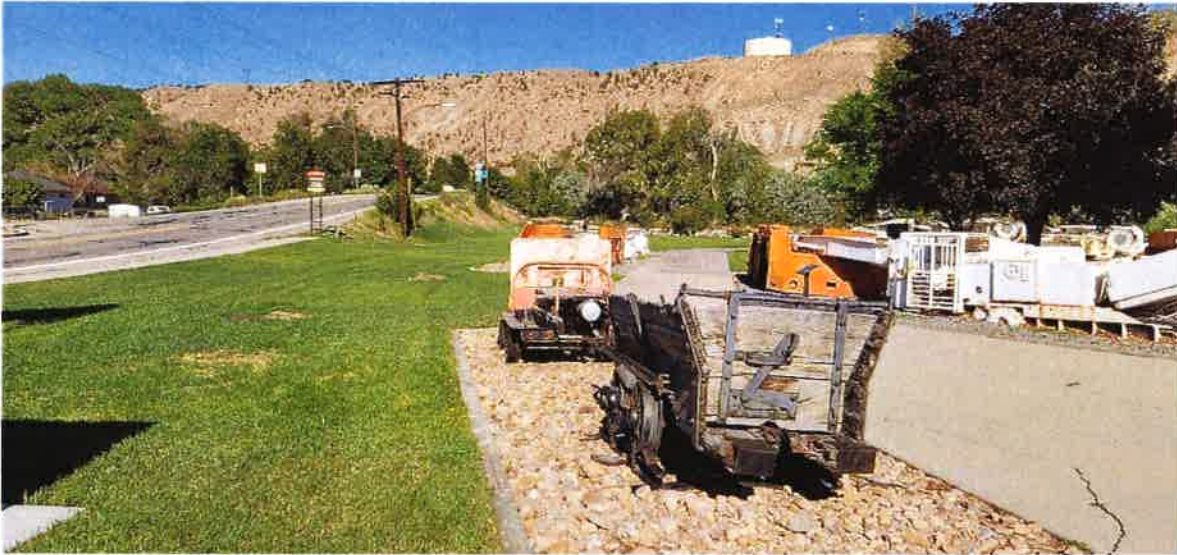
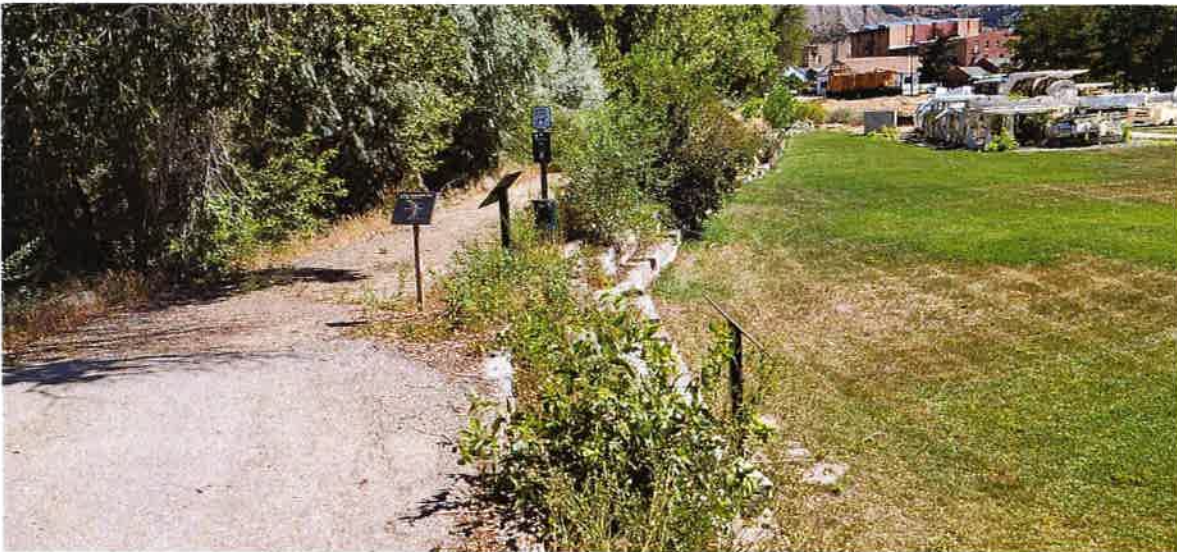
6. ADA access to Riverwalk Trail (Poplar Street and 100 West)

Existing Conditions - There is not an access to the Helper Riverwalk Trail from the museum courtyard. The Trail is approximately 4' higher than the existing ground level of the museum courtyard.

Proposed Design Features – Remove the existing sod along the new proposed 5' wide concrete sidewalk. Raise the ground elevation at the Trail access point and gradually ramp down at a slope of approximately 2.5% to the existing ground level and continue the new concrete sidewalk to tie into the existing concrete path that loops around the museum courtyard. Side slopes should be kept at a minimum of 3:1 slopes. Repair the sod/landscape along the edge of the new sidewalk.

See Drawing C-006 for plan layout.

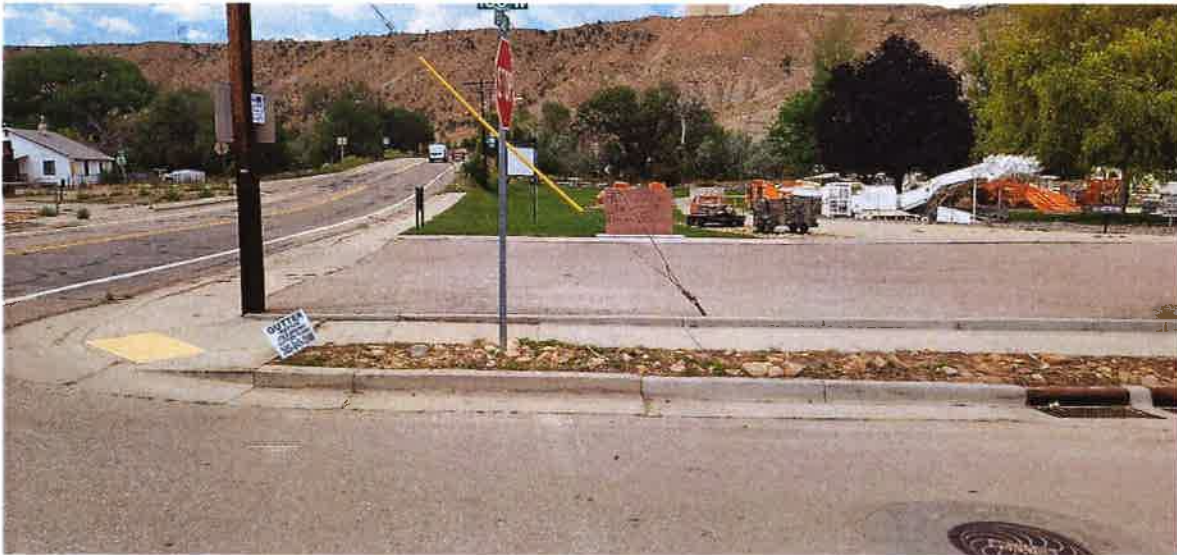
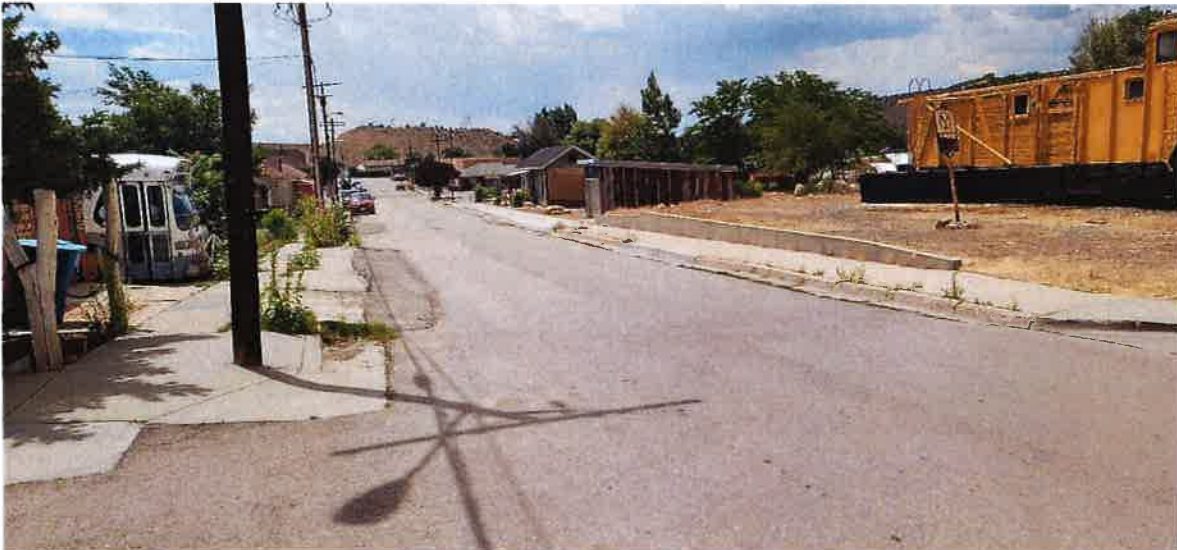
7. 100 West Sidewalk (Poplar Street to Ivy Street)

Existing Conditions – The sidewalk on the west side of the street is mostly updated but the two pedestrian accesses and newer driveway approach are not to ADA Standards. The driveway approach into the museum parking lot is dilapidated and not to the ADA Standards.

Proposed Design Features – Replace both pedestrian accesses and the two driveway approaches. Tie the north pedestrian access into the existing sidewalk which will require approximately 10' of new concrete sidewalk.

See Drawing C-007 for plan layout.

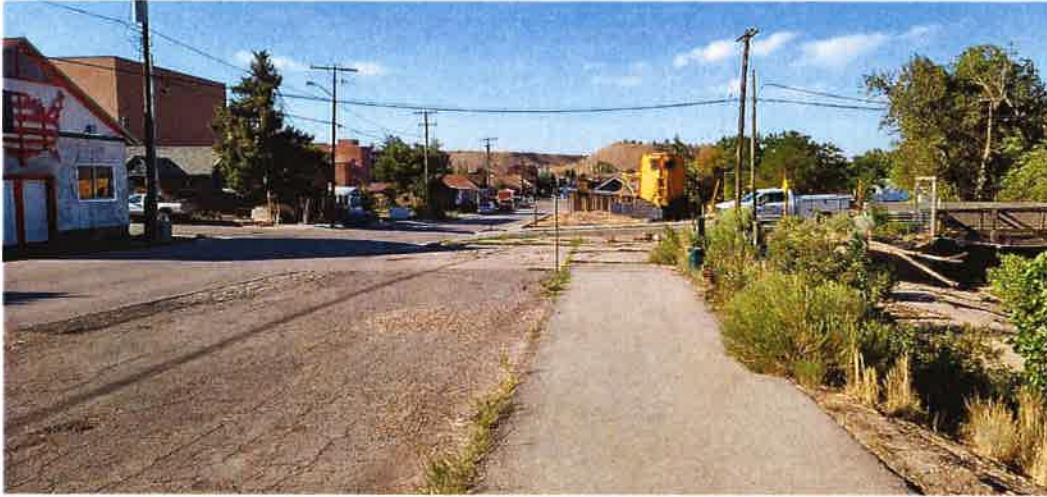
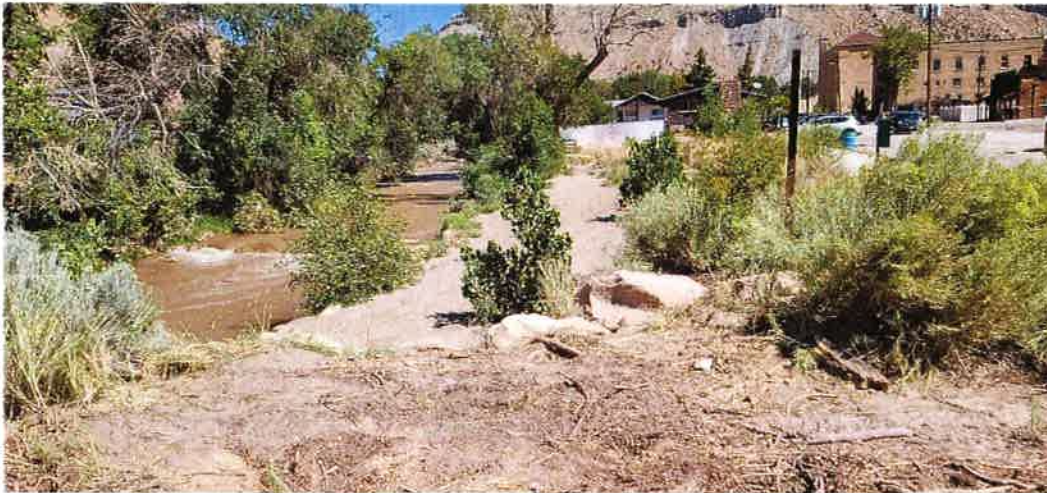
#### 8. 100 West Sidewalk (Ivy Street to Hill Street)

Existing Conditions – The west side of 100 West does not have a sidewalk or waterway for more than half of the block. On the northern end, some sidewalk improvements have been made but most will need to be removed and replaced. There are no pedestrian accesses on the west side. The existing parking lot is in very bad shape and needs repaired. The access to the river from the south corner of the block is not to ADA Standards.

Proposed Design Features – Install pedestrian accesses on both corners and continue the waterway south to the end of the block. The pedestrian access on the northeast corner will also need to be updated to ADA standards. Install a 5' wide reinforced concrete sidewalk along the waterway to the south corner of the block. This will require raising a water manhole. Replace the concrete sidewalk sections that are dilapidated and replace the driveway approach to comply with ADA Standards. Tie the end of the existing trail into the sidewalk with a new concrete path. Remove and replace the existing parking lot to include two ADA parking stalls and signs. Install a ramp and handrails to ADA standards from the Helper Riverwalk trail down to the Price River beach for access.

See Drawing C-008 for plan layout.

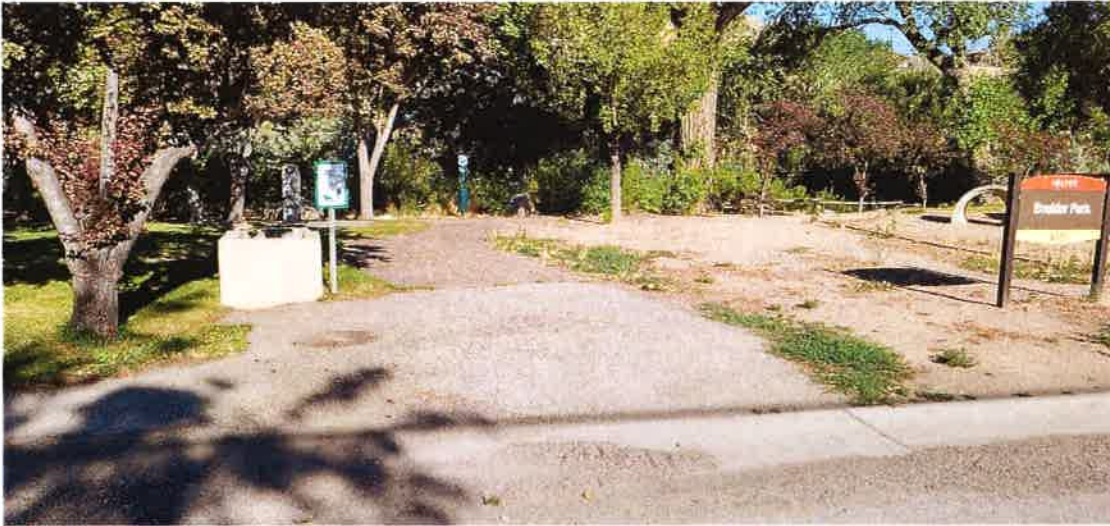
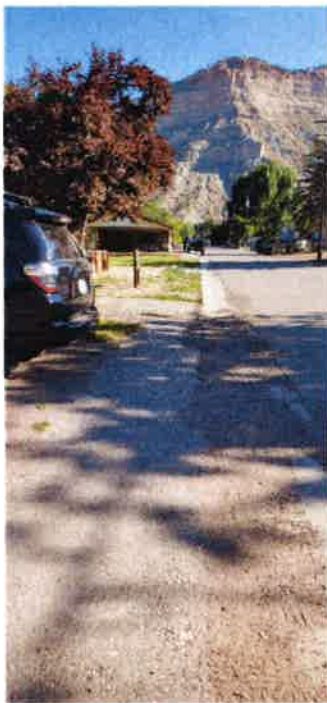
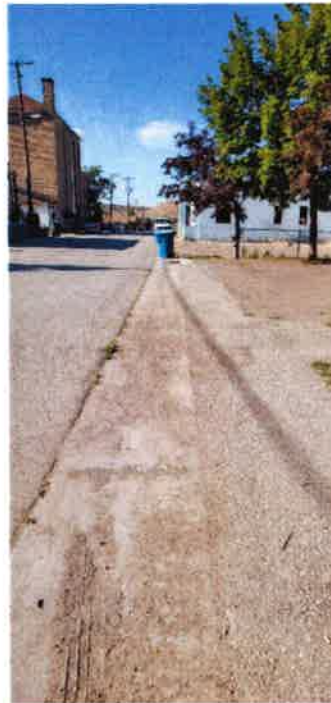
9. 100 West Sidewalk (Hill Street to Boulder Park)

Existing Conditions – The west side of the road has a waterway. There is some sidewalk on the southwest section of the block but it is very outdated. The pedestrian access on the southwest corner will also need to be updated to meet ADA Standards. The paved access to the Riverwalk Trail at the Boulder Park is dilapidated and crumbling. The access to the restrooms at the pavilion is too steep.

Proposed Design Features – Replace the existing concrete sidewalk at the southwest corner and then continue a 5' wide reinforced concrete sidewalk north to the Riverwalk Trail access. Some asphalt at the parking lot will need to be replaced to slope to existing grade from the new concrete. Install an 8' wide concrete path to the Riverwalk Trail that meets the ADA Standards. Along the waterway north of the Trail access, continue a 5' wide sidewalk to the entrance of the restrooms at the pavilion. The asphalt in front of the pavilion will need to be removed and replaced matching existing grade of the waterway to the new grade of the concrete sidewalk.

See Drawing C-009 for plan layout.

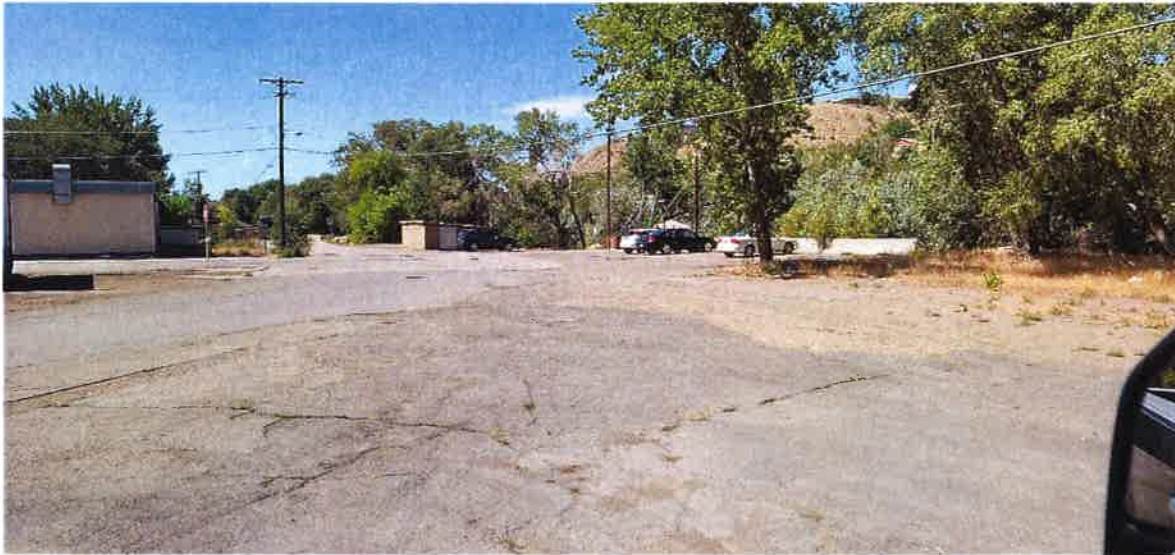
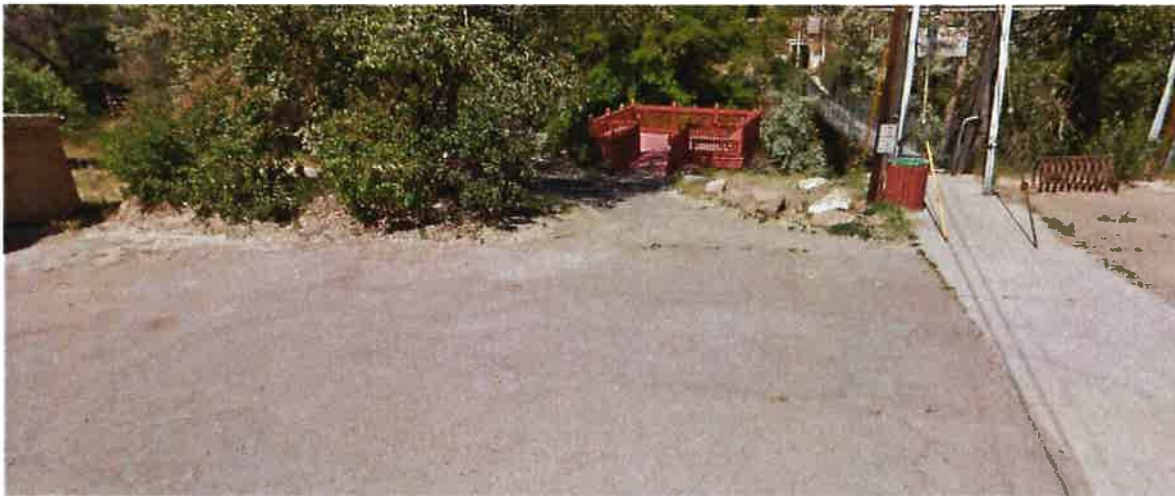
10. Janet Street entrance (ADA access to Riverwalk Trail)

Existing Conditions – The existing parking area is in good shape but there is not an ADA accessible parking stall or pathway to the access of the Riverwalk Trail.

Proposed Design Features – Install a 5' wide concrete sidewalk along the west end of the parking lot and concrete pathway to the Riverwalk Trail that meets the ADA Standards. Paint parking stalls and install an ADA parking sign.

See Drawing C-010 for plan layout.

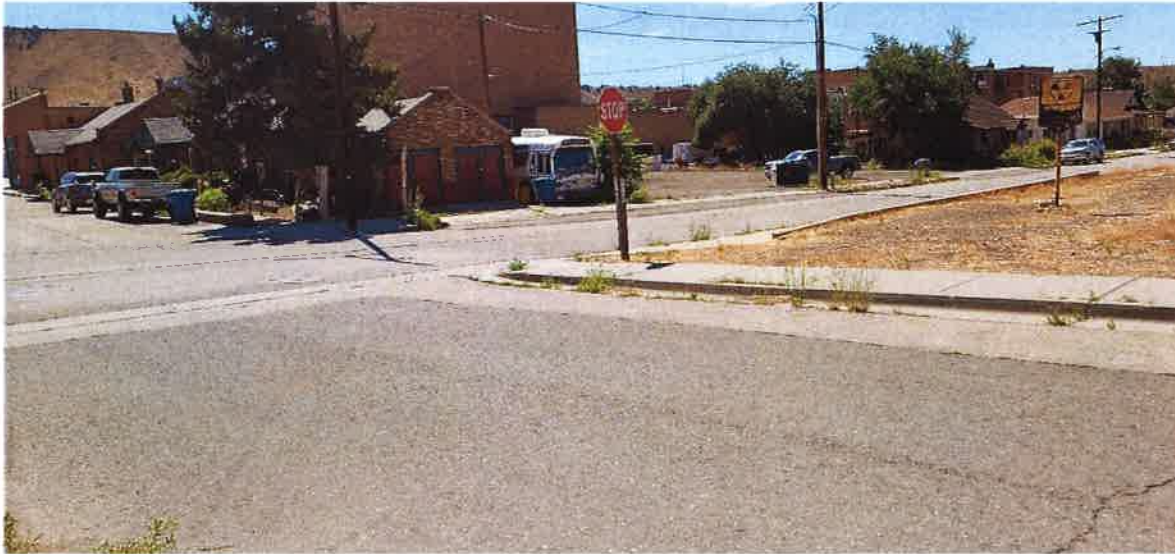
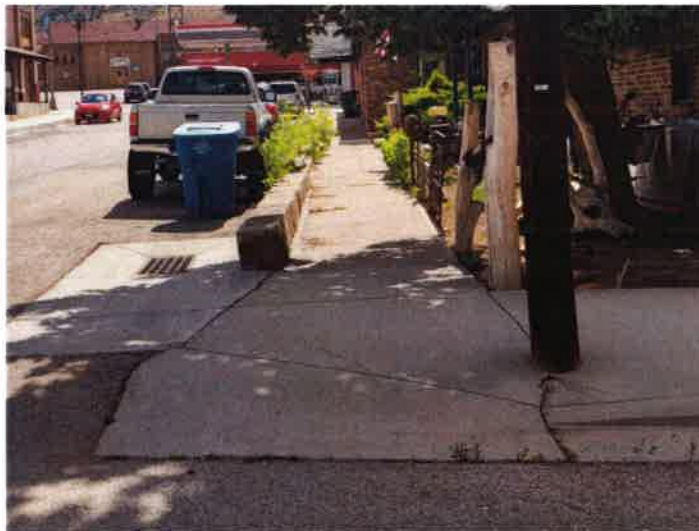
11. Ivy Street south side (100 West to Main Street)

Existing Conditions – The southeast corner pedestrian access is not to ADA Standards. The sidewalk to Main Street is dilapidated with a small retaining wall. The concrete running south on the east side of 100 West Street is older concrete.

Proposed Design Features – Replace the pedestrian access while leaving the existing power pole in place. Replace the existing concrete sidewalk and wall with a new concrete sidewalk and curb wall to the east. Replace the concrete sidewalk running south on 100 West Street with a reinforced concrete sidewalk along the overcast driveway. Replace the section of concrete sidewalk to the second overcast driveway as shown on the drawings. Install a wayfinding sign at the corner of Main Street to direct pedestrians to the Riverwalk Trail.

See Drawing C-0011 for plan layout.

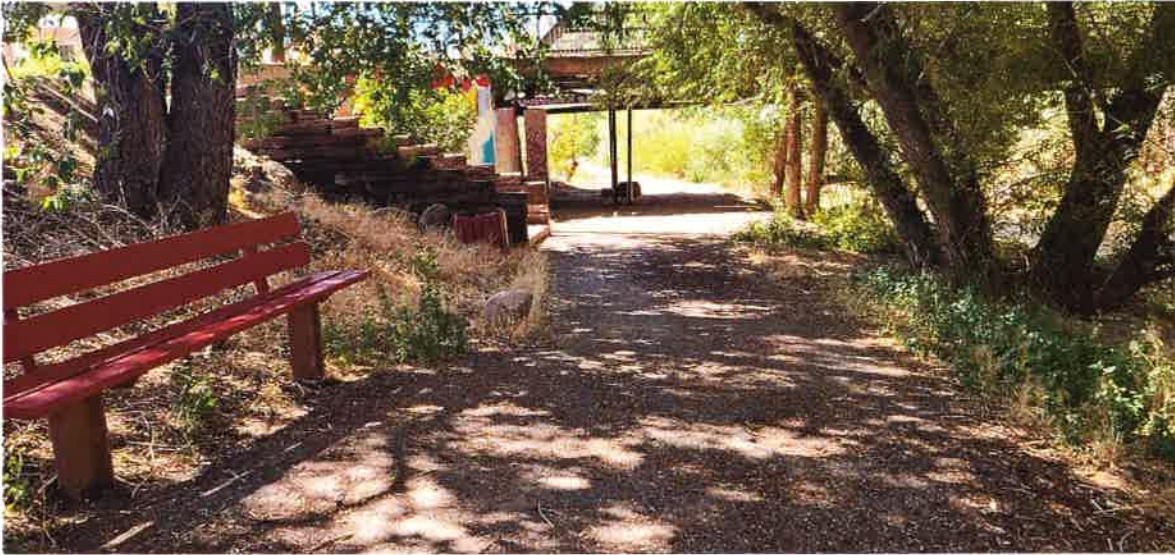
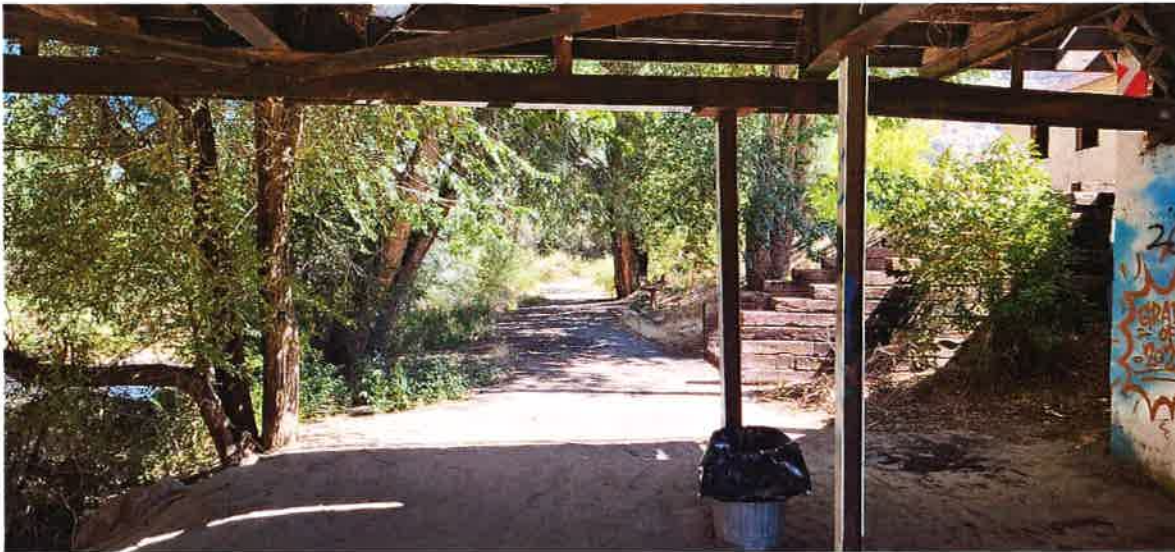
12. Riverwalk Trail (raise trail under bridge)

Existing Conditions – The Riverwalk Trail below the bridge at Hill Street is a low point and is being washed out by flood water.

Proposed Design Features – Raise the trail approximately 2' while still allowing for the adequate overhead space under the trail. Raise this section of the trail by importing granular borrow and then finish with a paved surface. In bringing this surface up, approximately 2 steps from the existing stair access to the street will be buried. Make a level landing at the bottom of the steps for access to the trail. The bench, garbage cans, etc. will need to be removed and then reinstalled once the trail is raised.

See Drawing C-0012 for plan layout.

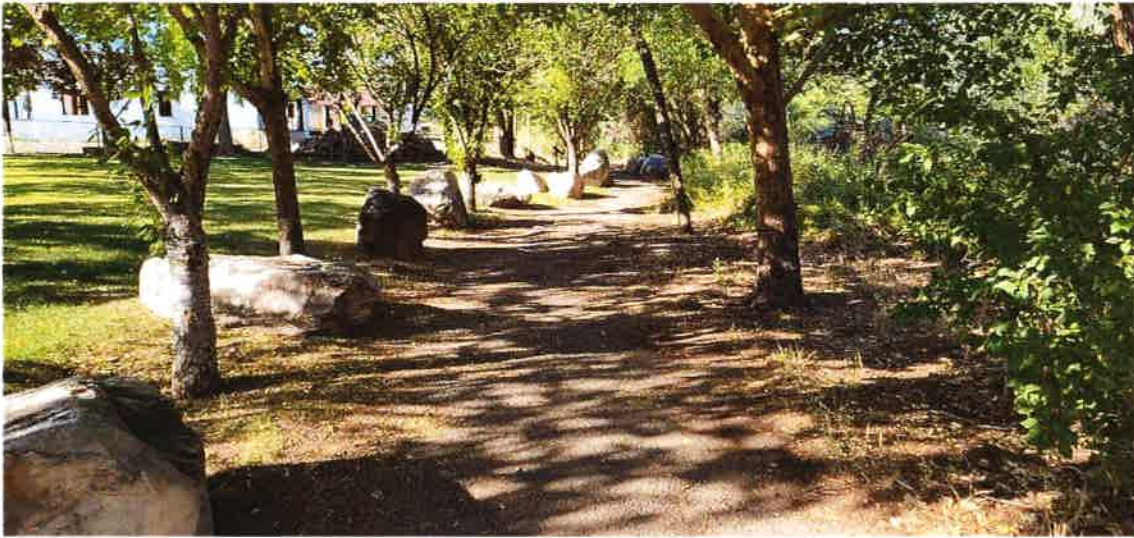
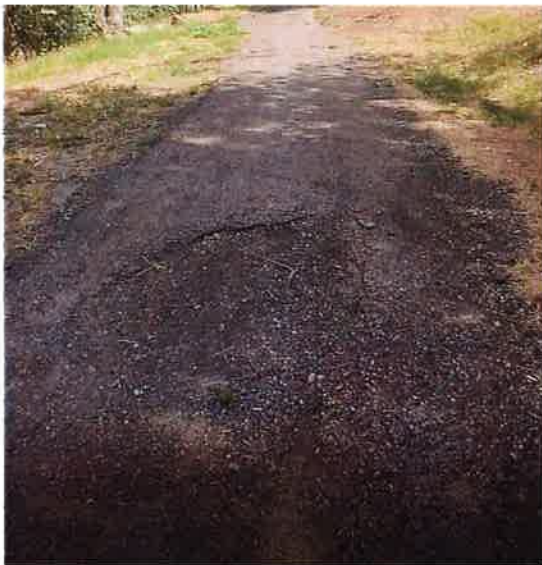
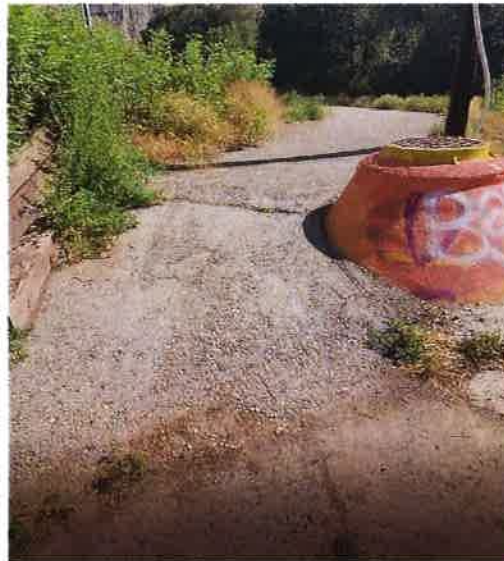
### 13. Riverwalk Trail Improvements

Existing Conditions – The Riverwalk Trail has multiple areas where the pavement is cracked, broken, and dilapidated. There are also a few locations where pavement will need to be extended to reach existing picnic tables and benches. At Janet Street, on the west side of the swinging bridge, a portion of the trail is too steep to meet ADA Standards.

Proposed Design Features – Remove and replace areas of the trail that are cracked and broken. Extend paved trail out to existing picnic tables and benches to meet ADA Standards. Raise the trail at a slope less than 5% from the swinging bridge to the north until the new slope intersects the existing trail grade.

See Drawings C-013A-C013C for plan layouts.

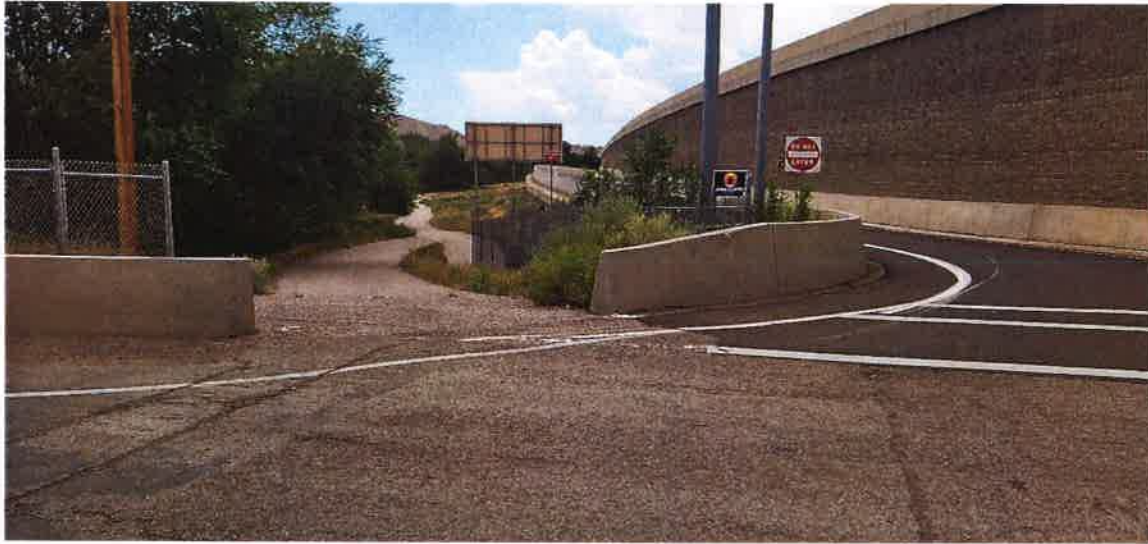
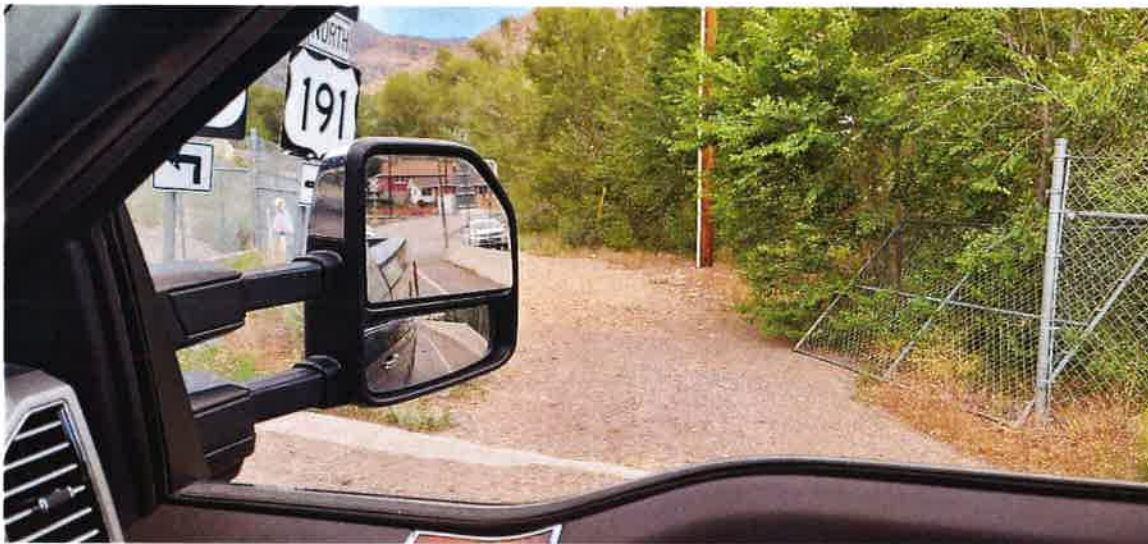
14. Main Street crossing (north and south crossing at Highway)

Existing Conditions – The existing Riverwalk Trail splits at Main Street where a concrete section goes under the road and a paved section crosses the road at existing grade. The trail does not have pedestrian accesses at the road. Once it crosses the road and heads north it is not paved until it ties back into the concrete section of the trail. The trail crossing is located at a sharp bend in the road to the east and an overpass to the west. It will be difficult for vehicles to see pedestrians crossing the road.

Proposed Design Features – Install pedestrian accesses on each side of the road crossing and pave the section of the trail to the north until it ties back into the existing trail. Install flashing pedestrian lights and flags on both sides of the trail at the Main Street crossing to alert vehicles they are approaching a pedestrian crossing.

See Drawing C-014 for plan layout.

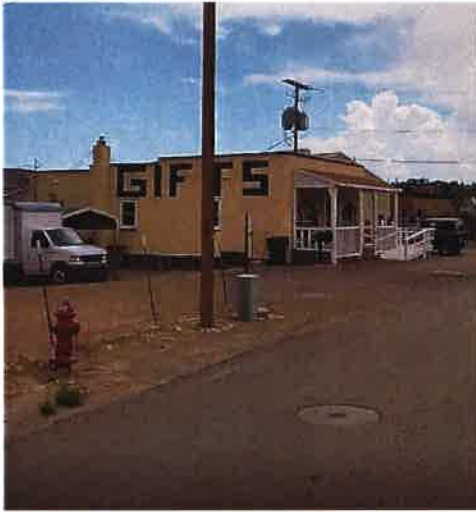
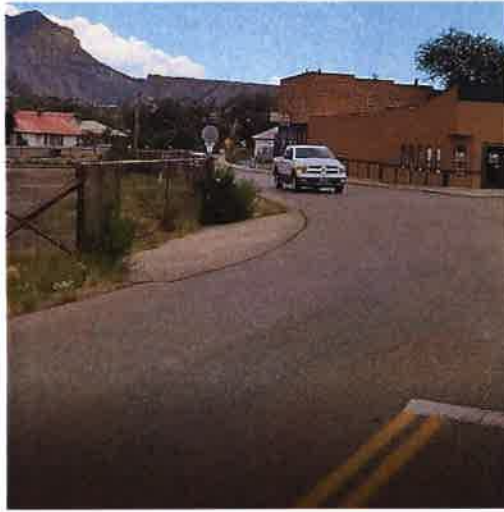
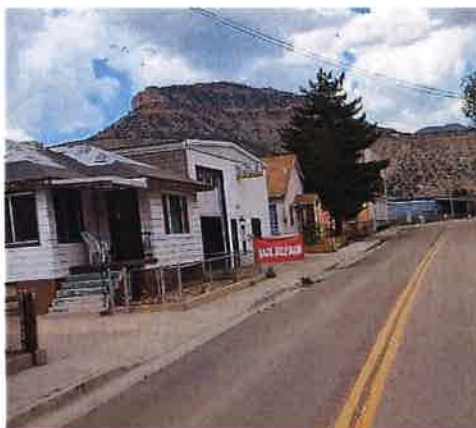
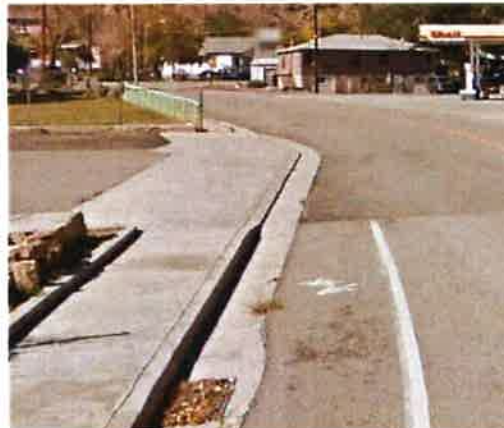
15. ADA Sidewalk (Swifts Stop & Shop to Pick N Rail)

Existing Conditions – There is an existing sidewalk on the south side of Main Street across from Swifts Stop & Shop heading west to Bryner Street. Along this stretch of sidewalk there are many sections that do not meet ADA Standards. Continuing on to the intersection of Bryner Street and Main Street (100 North) the concrete sidewalk stops. There is no sidewalk or access pathway north to the Pick N Rail grocery store.

Proposed Design Features – Remove and replace sections of the existing sidewalk and driveways on the south side of Main Street to meet ADA Standards. Install 5 pedestrian accesses along the route. Install a new 5' wide concrete sidewalk and curb and gutter on the west side of Main Street to the north. In doing these upgrades, an inlet box and water valve will need to be reconstructed. There will also be 2 fire hydrants that need to be removed and relocated.

See Drawings C-015A-C015D for plan layouts.

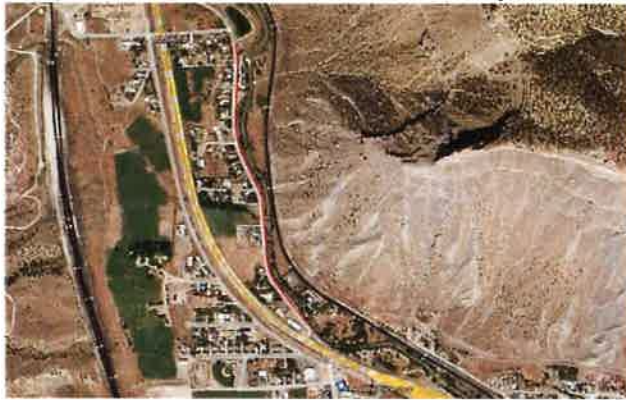
1. Gigliotti Pond – located on Martin Road, just north of Helper. The pond is ADA accessible by a paved trail which includes ADA fishing stalls. It is possible to tie the pond into the north end of the existing Riverwalk Trail and running north along the east side of Martin Road approximately 2,950 feet to the Gigliotti Pond parking area. See the route in the image below outlined in red. From there you are able to access the paved trail to the pond.

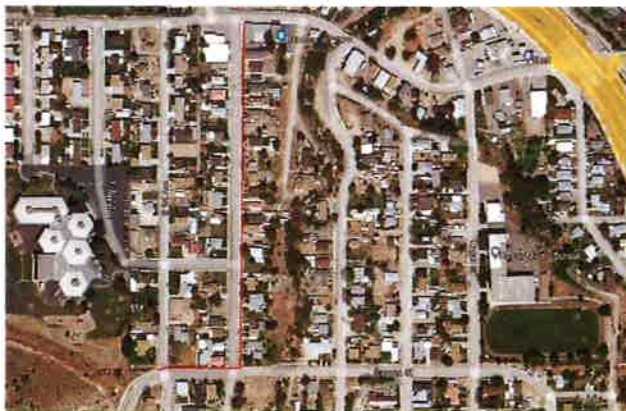
2. Spring Canyon Parkway Trail – located west of Helper along Spring Canyon Road. The trail parallels the north side of Spring Canyon Road for the most part. The Spring Canyon Trail follows the abandoned railroad line that served the coal camps of Peerless, Spring Canyon, Standardville, Latuda, Rains and Mutual. A possible ADA route would be to tie in to the proposed route at Main Street (15. ADA Sidewalk – Swifts Stop & Shop to Pick N Rail) and Bryner Street and continue south along the east side of Bryner Street to Canyon Street, then turn west and continue one block to the existing Trail for a total of approximately 1,600 feet. See the route in the image below outlined in red.
