Asbestos Abatement Services

Lamplighter Property

Hazardous Materials Inspection

Re: Hazardous Materials Inspection
Lamplighter Hotel
120 East Main Street, Vernal, Uintah County, Utah
Terracon Project No. 61237186 Task 4.26
EPA Cooperative Agreement #95815230
EPA ACRES Property ID #257935

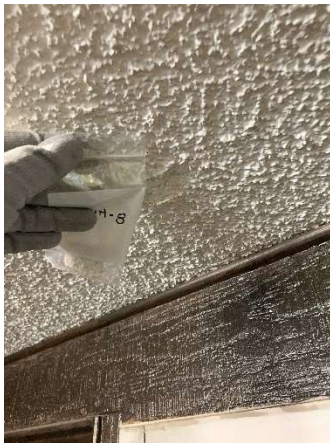
Photo #3 HA2: White popcorn ceiling texture, asbestos containing

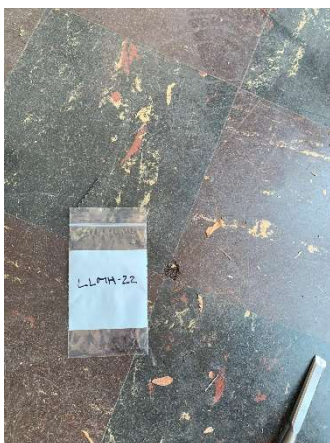
Photo #5 HA4: Dark red 9"x9" floor tile with white and red streaks and mastic, asbestos containing

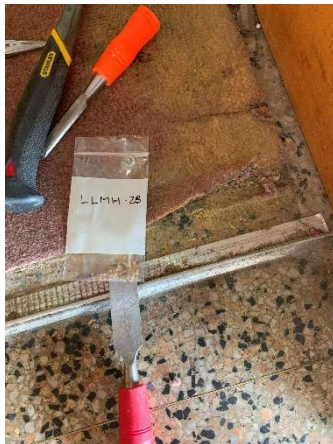
Photo #7 HA6: Carpet mastic, not asbestos containing

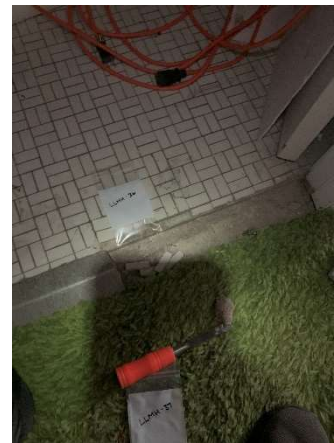
Photo #10 HA9: Thinset and grout, not asbestos containing

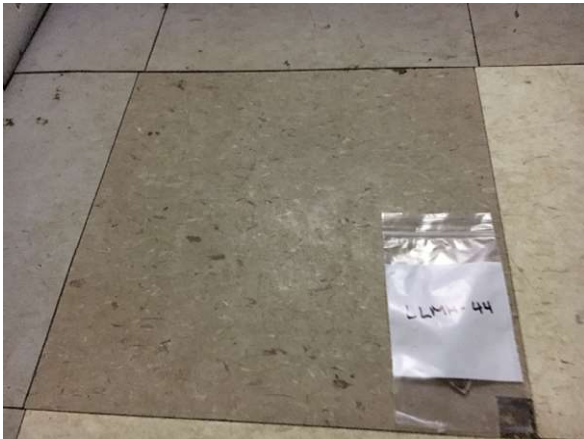
Photo #13 HA12: Brown 12"x12" floor tile and mastic and cementitious material, asbestos containing

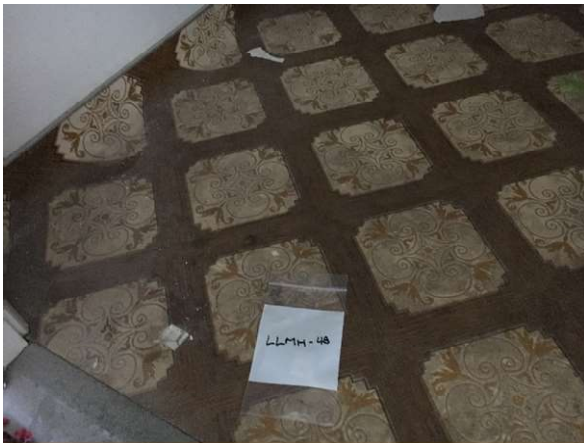
Photo #15 HA14: Brown 12"x12" vinyl tile with geometric pattern and mastic, asbestos containing

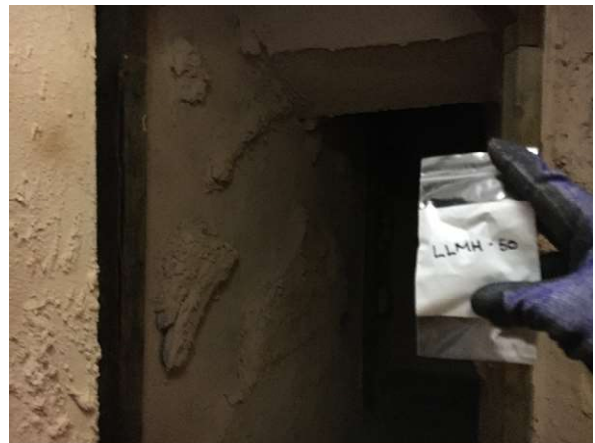
Photo #16 HA15: Cement coating on decorative cave, not asbestos containing

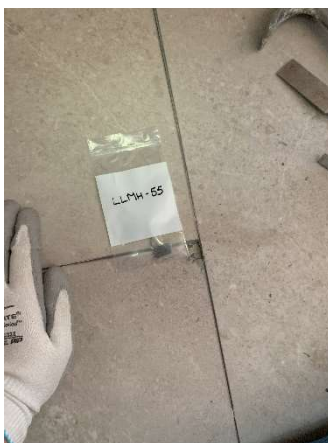
Photo #17 HA16: Gray 12"x24" floor tile and mastic, not asbestos containing

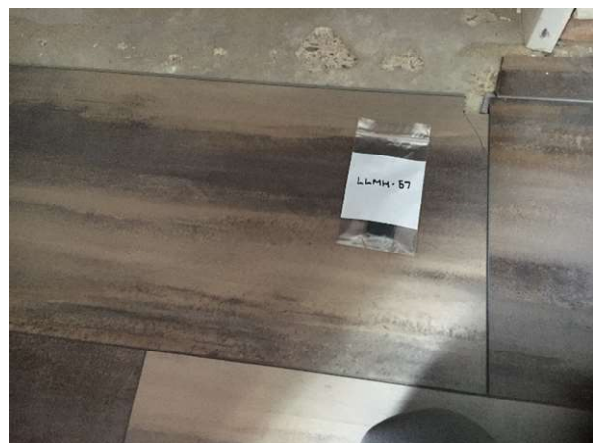
Photo #18 HA17: Wood pattern brown 12"x24" floor tile and mastic, not asbestos containing

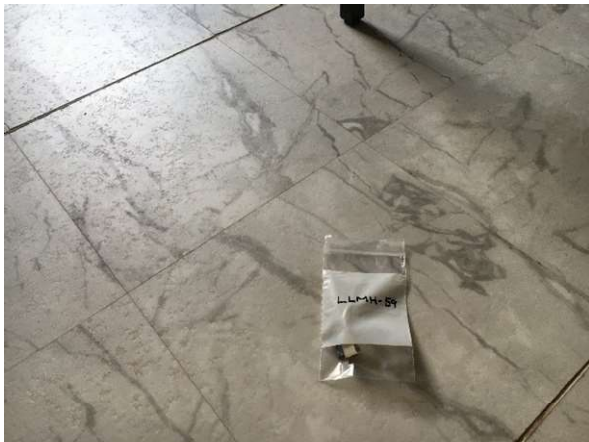
Photo #19 HA18: Light gray 12"x12" floor tile and mastic, not asbestos containing

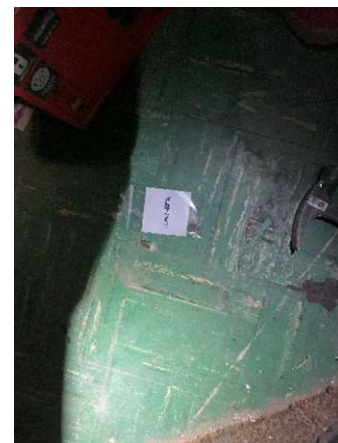
Photo #24 HA23: Green 9"x9" floor tile with white streaks and mastic, asbestos containing

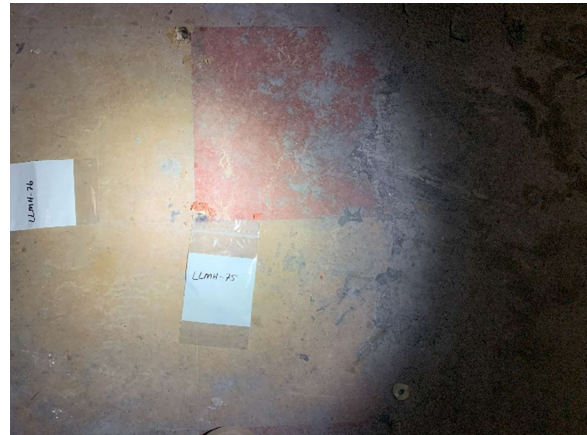
Photo #26 HA25: Red 9"x9" floor tile and mastic, asbestos containing

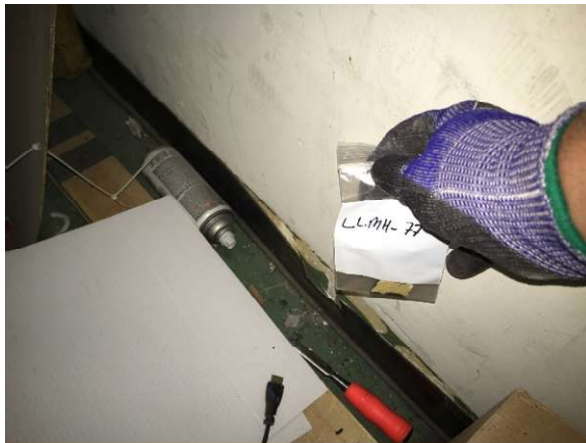
Photo #27 HA26: Tan cove base adhesive, not asbestos containing

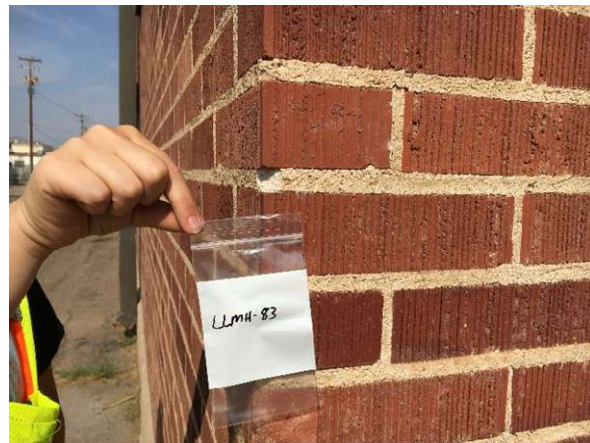
Photo #28 HA27: Mortar, not asbestos containing (incorrect sample number in photo)

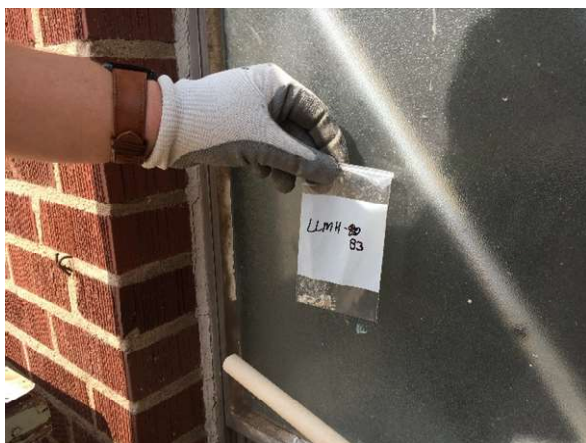
Photo #29 HA28: White window glazing, asbestos containing

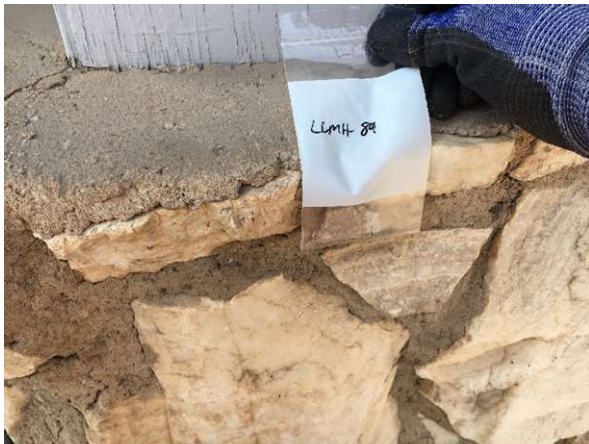
Photo #31 HA30: Decorative rock formation mortar, not asbestos containing

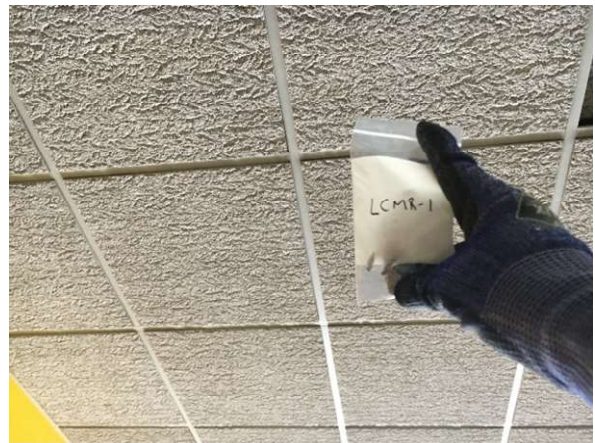
Photo #33 HA32: White 2'x4' ceiling tile with long gouges, not asbestos containing

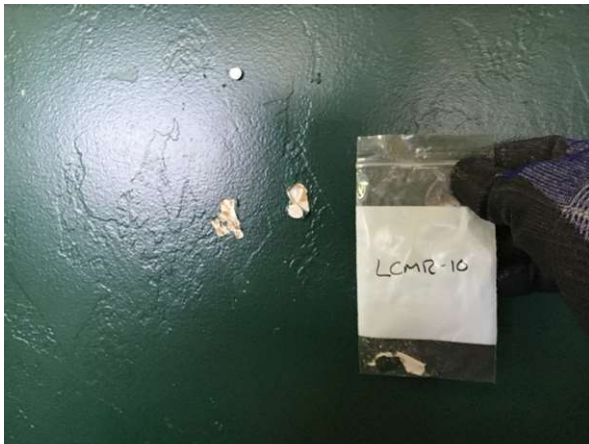
Photo #36 HA35: Gypsum board wall system, not asbestos containing

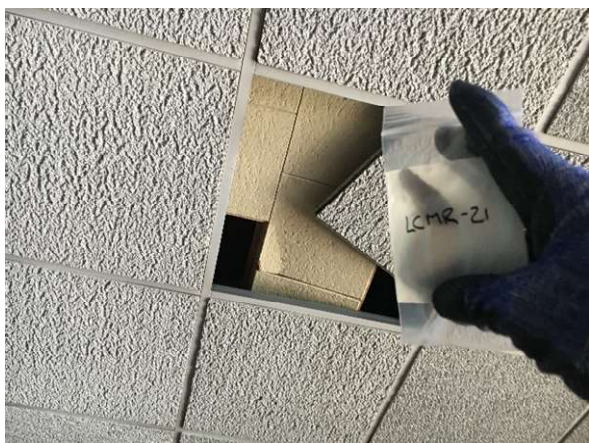
Photo #40 HA39: White 2'x4' ceiling tile with bumpy texture, not asbestos containing

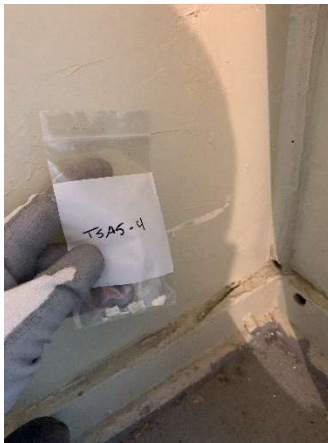
Photo #44 HA44: Gypsum board wall system, not asbestos containing

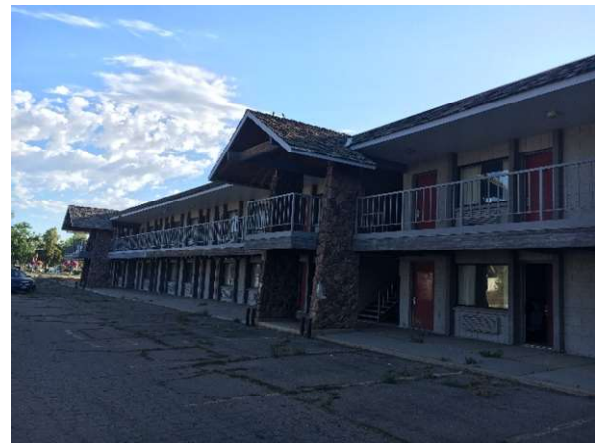
Photo #57 HA57: Tar paper roofing, not asbestos containing

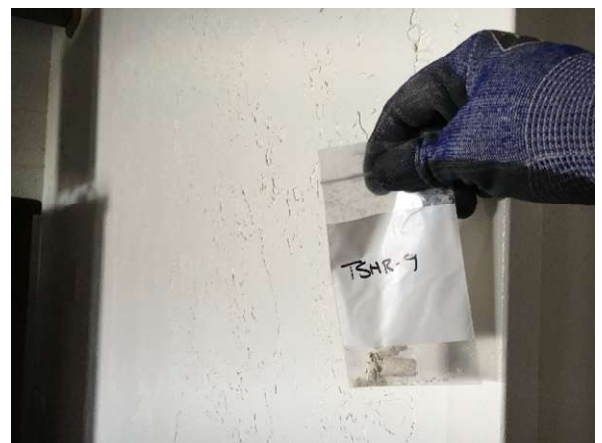
Photo #59 HA59: Gypsum board wall system, not asbestos containing

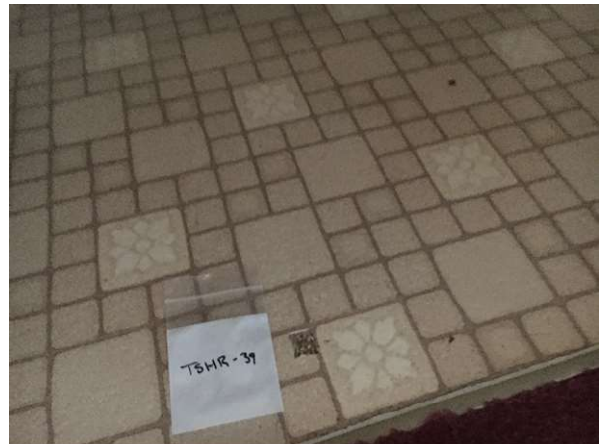
Photo #67 HA67: Carpet mastic, not asbestos containing

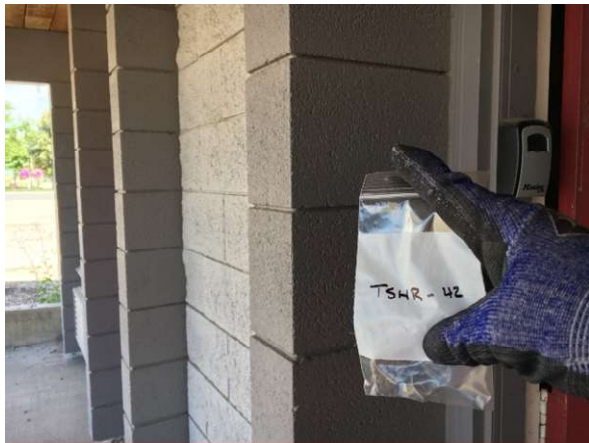
Photo #68 HA68: Thinset and grout, not asbestos containing

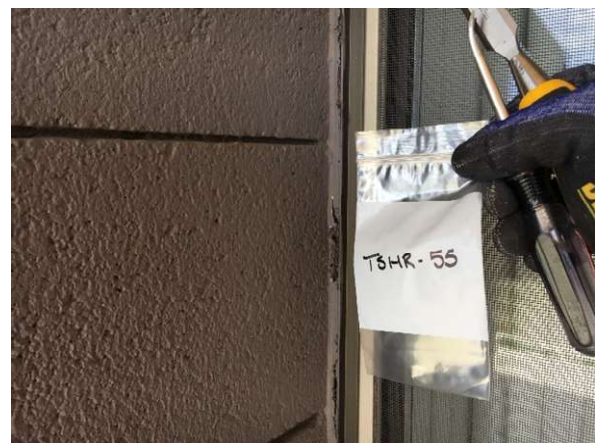
Photo #71 HA71: Decorative stone mortar, not asbestos containing
