# KAYSVILLE CITY BUILDING REPORT -

HISTORIC BUILDING CONDITION ASSESSMENT AND RECOMMENDATION REPORT

FFKR ARCHITECTS

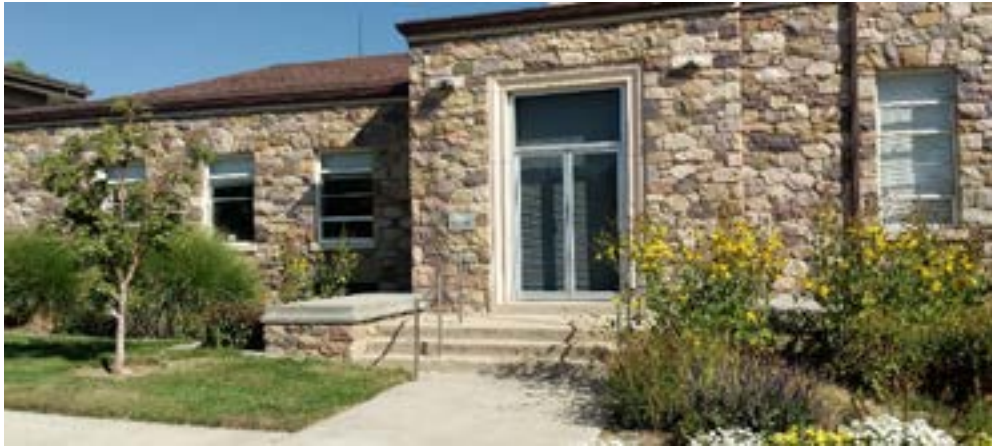
Photograph 1 – North-West Exterior of Building

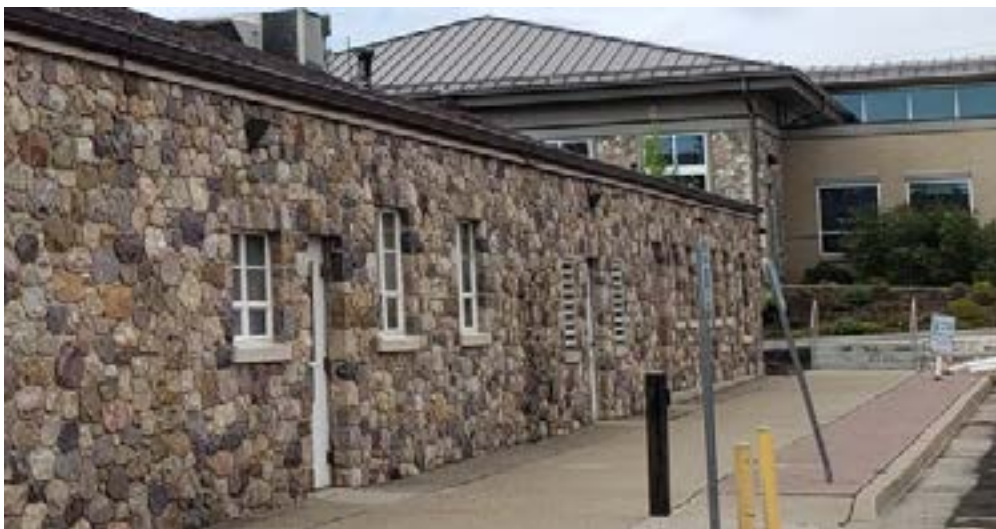
Photograph 3 –East Exterior of Building

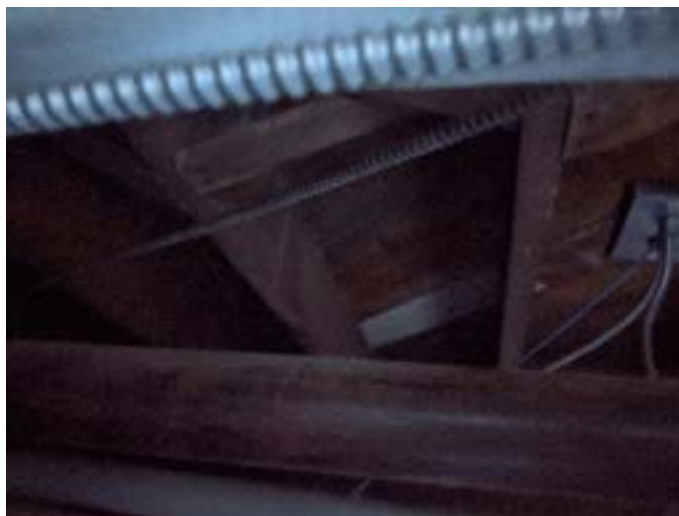
Photograph 17 – Diagonal 1x floor sheathing

| Status | Evaluation Statement | Comments |
|---|---|---|
| C <del>NC</del> N/A U | WOOD POSTS: There is a positive connection of wood posts to the foundation. | No connection observed. See <b>Photo 17</b> . |
| C NC <del>N/A</del> U | WOOD SILL BOLTS: Sill bolts are spaced at 6 ft or less with acceptable edge and end distance provided for wood and concrete. | Deficiency captured by wood sills. Bolting not observed See <b>Photo 17</b> . |
| C <del>NC</del> N/A U | STRAIGHT SHEATHING: All straight-sheathed diaphragms have aspect ratios less than 2-to-1 in the direction being considered. | Straight sheathing observed at roof diaphragm and spans greater than 24 ft. See <b>Photo 17</b> . |
| C <del>NC</del> N/A U | SPANS: All wood diaphragms with spans greater than 24 ft (7.3 m) consist of wood structural panels or diagonal sheathing. | Diagonal sheathing observed at floor diaphragm and spans greater than 40 ft. See <b>Photo 17</b> . |

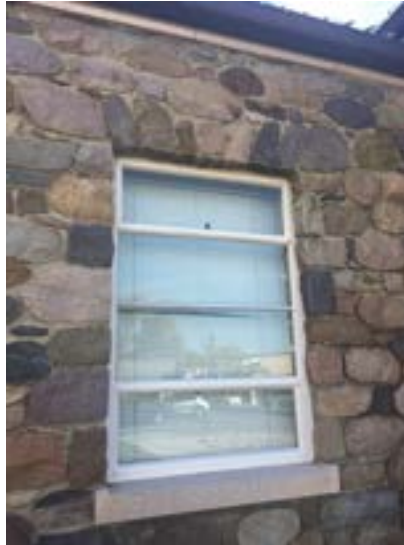
Original steel window and cast concrete sill.

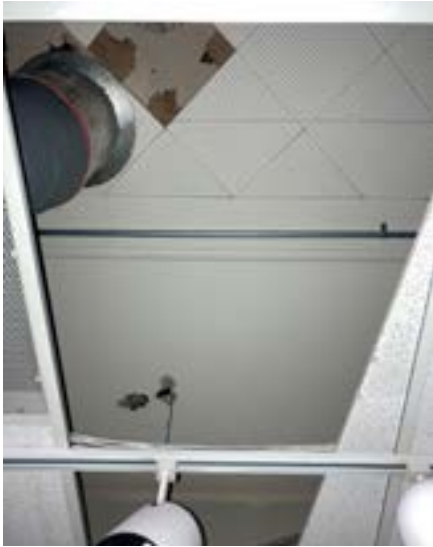
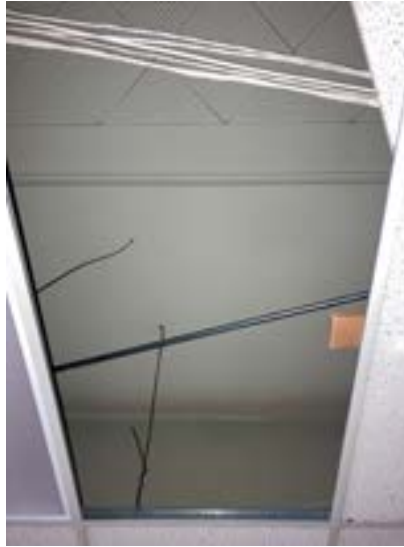
Original ceiling condition.

3. The original ceiling should be restored. Because there are acoustic tile adhered to the gypsum lath, they may be asbestos containing. The City should engage a qualified testing agency to test these for asbestos. If they are asbestos containing, they should be abated and replaced with a similar looking acoustic tile that can be glued to the gypsum substrates. If they do not contain asbestos, then they can remain. Because we have not directly observed these, there may be a fair amount that are damaged or missing and so it may make sense economically to replace them with new acoustic tiles.

The damage to the smooth decorative plaster borders can be replicated if necessary. It is unclear the extent to which this element is damaged or not. Because this is a character defining feature of the original space, this should be restored rather than replaced.
