NOTICE OF MEETING  
HILLSIDE REVIEW BOARD  
CITY OF ST. GEORGE  
WASHINGTON COUNTY, UTAH

**HILLSIDE REVIEW BOARD AGENDA REPORT: 02/28/2024**

| <b>Juniper Cove Phase 3</b><br>Hillside Development Permit (Case No. 2024-HS-003) | | |

Subject: Geologic-hazard Study  
Teakwood Subdivision  
Marblewood and Crimson Ridge Drives  
St George, Utah  
Project No. 2180172

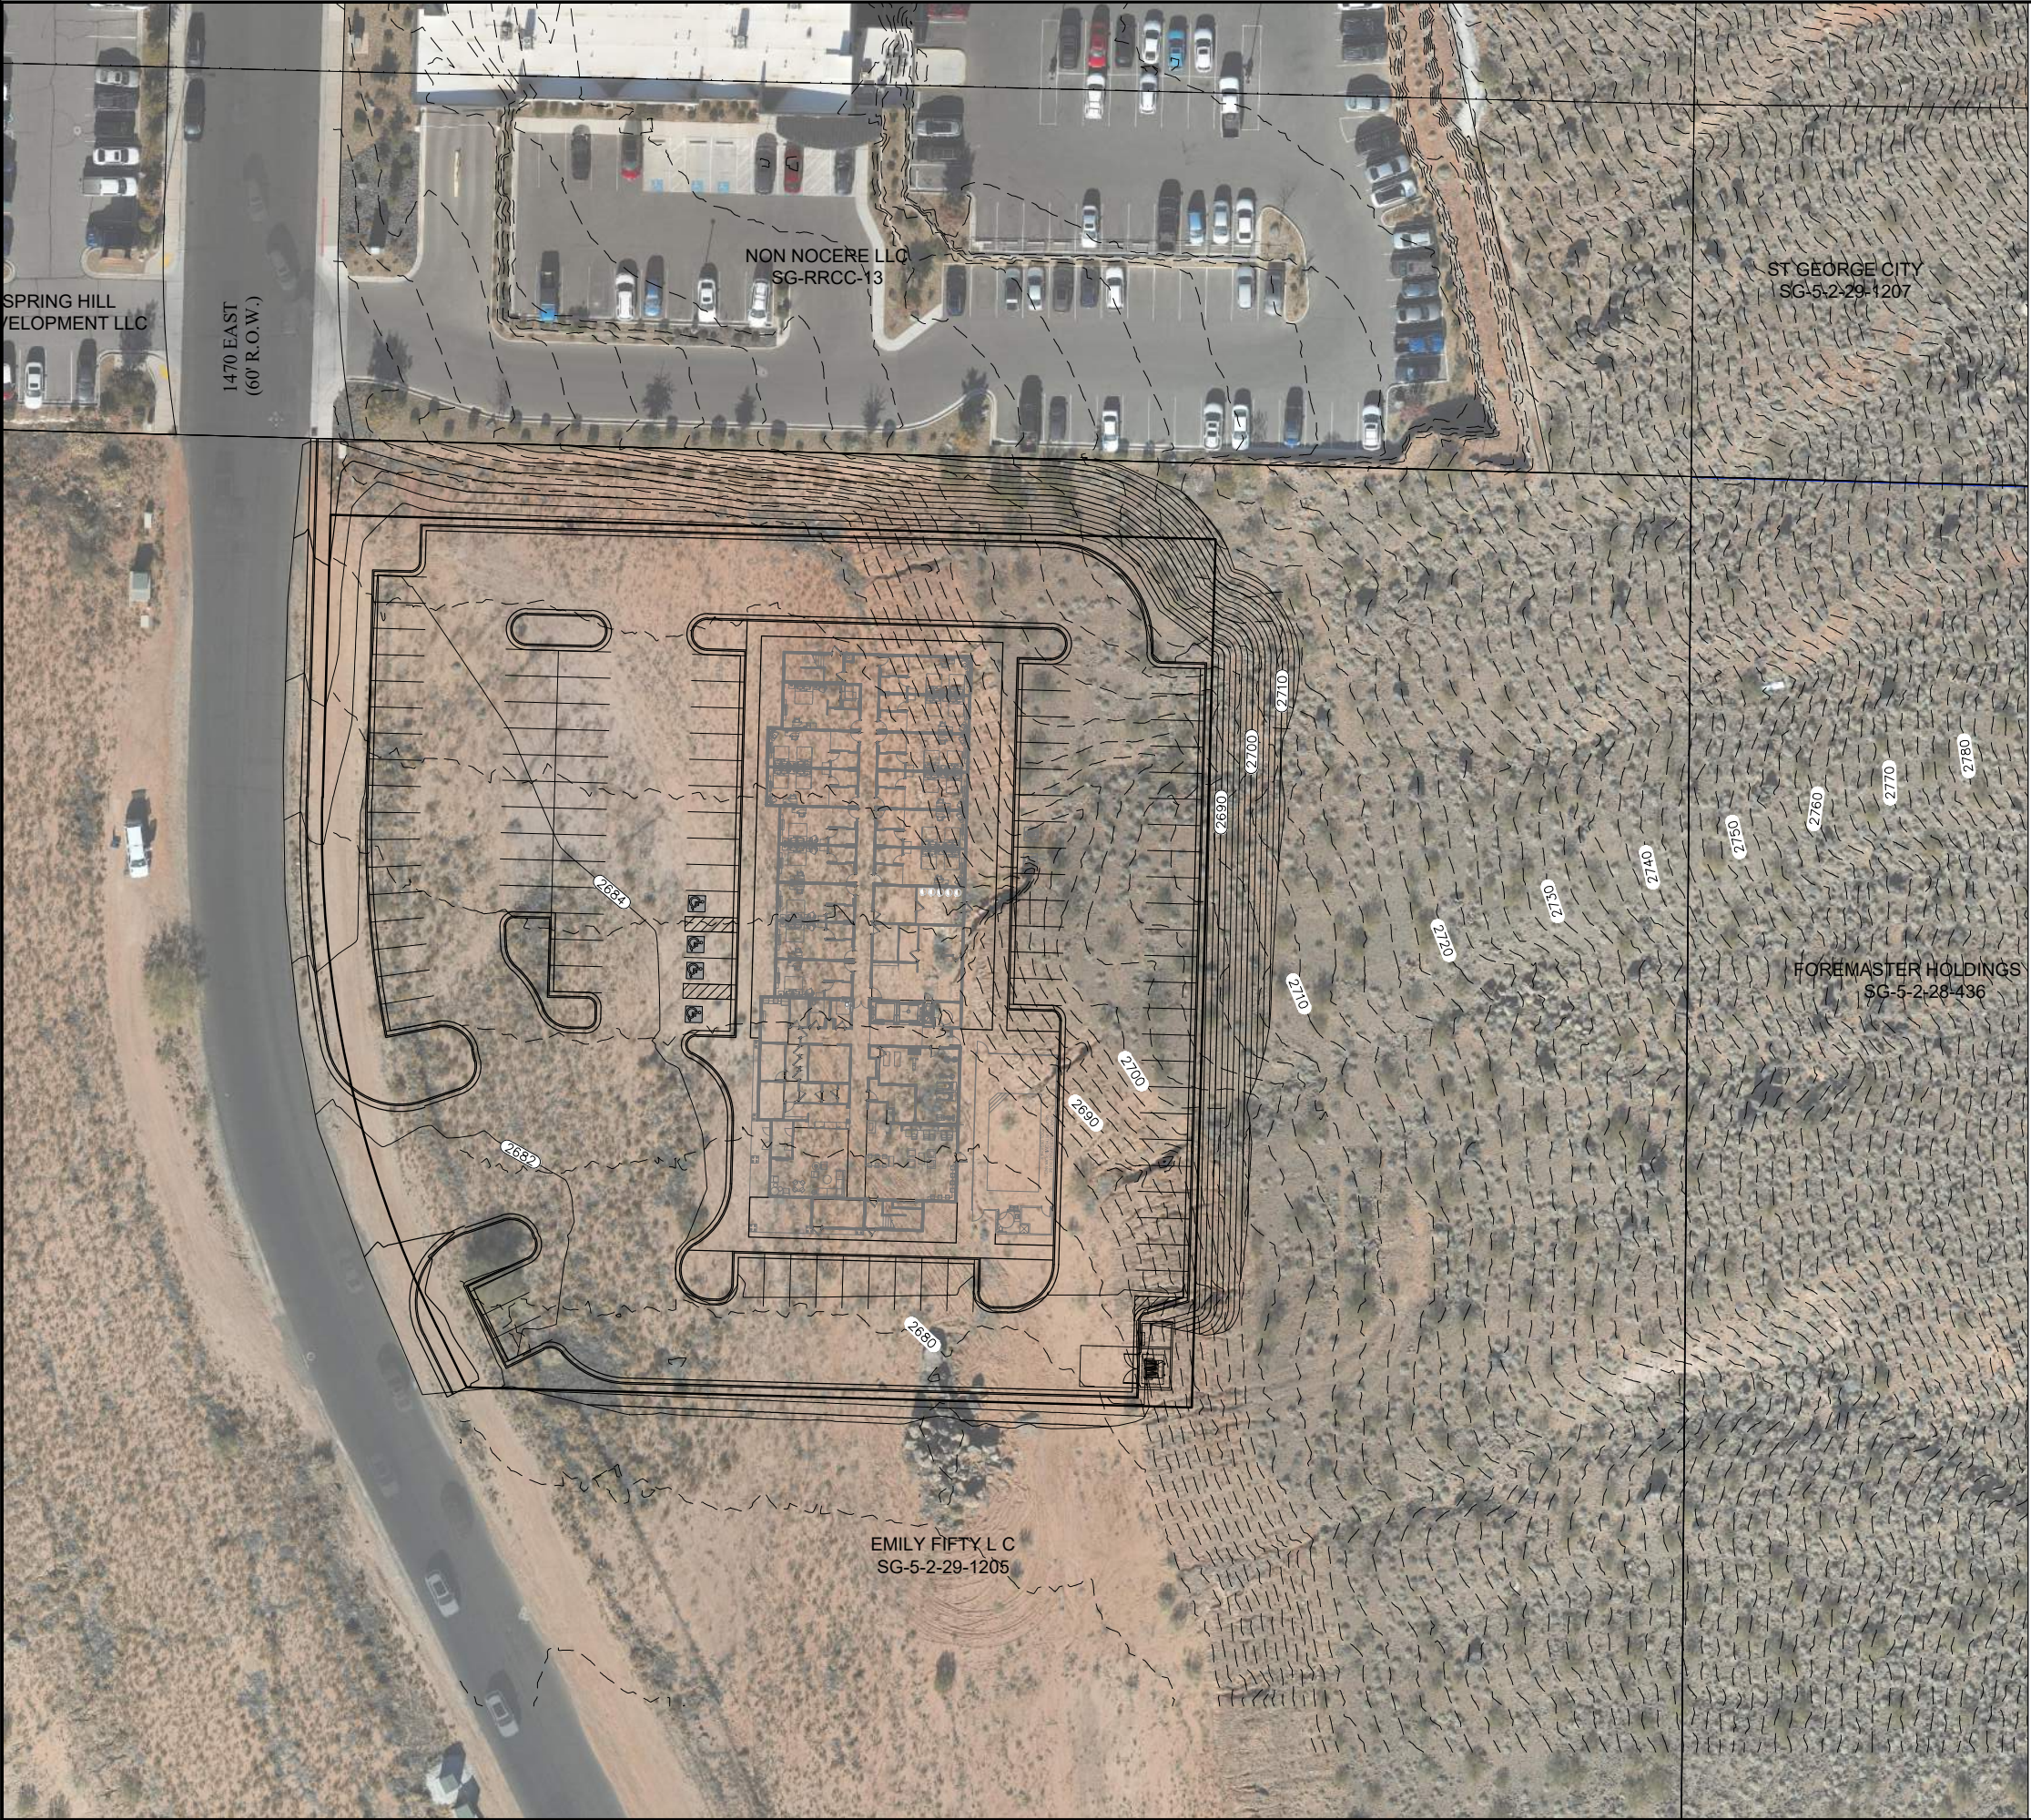
### **Earth Moving Plan**

EARTH MOVING NOTES

- SUITABLE EXISTING MATERIAL WILL BE USED FOR FILL ON-SITE.
- EXCESS AND UNSUITABLE MATERIAL WILL BE REMOVED FROM THE SITE.
- ANTICIPATED OPERATIONS MAY INCLUDE:
  - CAT D-6 DOZERS
  - CAT 980 SIZE LOADERS
  - CAT 345 SIZE EXCAVATORS

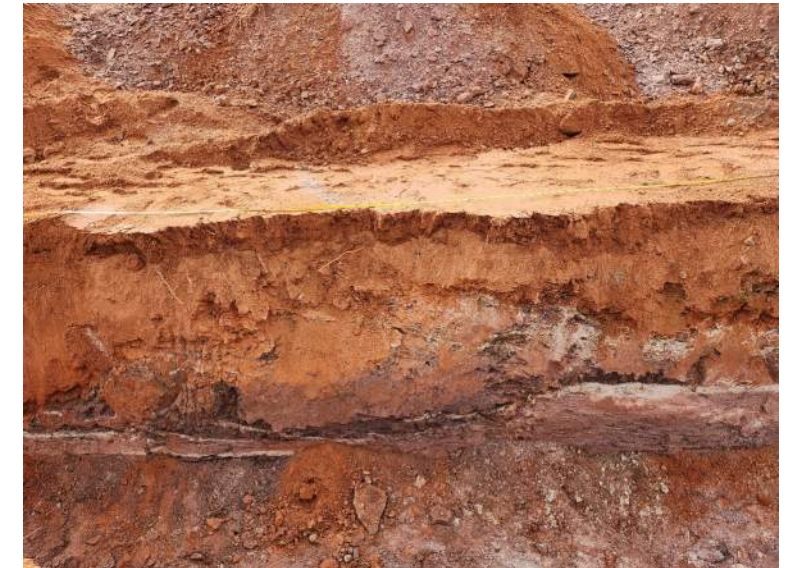
Image 1: Photograph of trench wall from approximately 0+15 to 0+25.

- Soil Types**
1. Fill: Silty Sand (SM), medium dense, slightly moist, fine to medium grained sand, brown to red brown
  2. Native: Silty Sand (SM), medium dense, slightly moist, fine to medium grained, brown to red brown
  3. Lean Clay (CL), medium stiff, slightly moist, fine to medium grained, purple and gray
  4. Sandstone, weathered to firm, dry to slightly moist, fine to medium grained, light pink and white

- Sample Locations**
- A. 0+21 at 3.5 ft
  - B. 0+64 at 3.0 ft

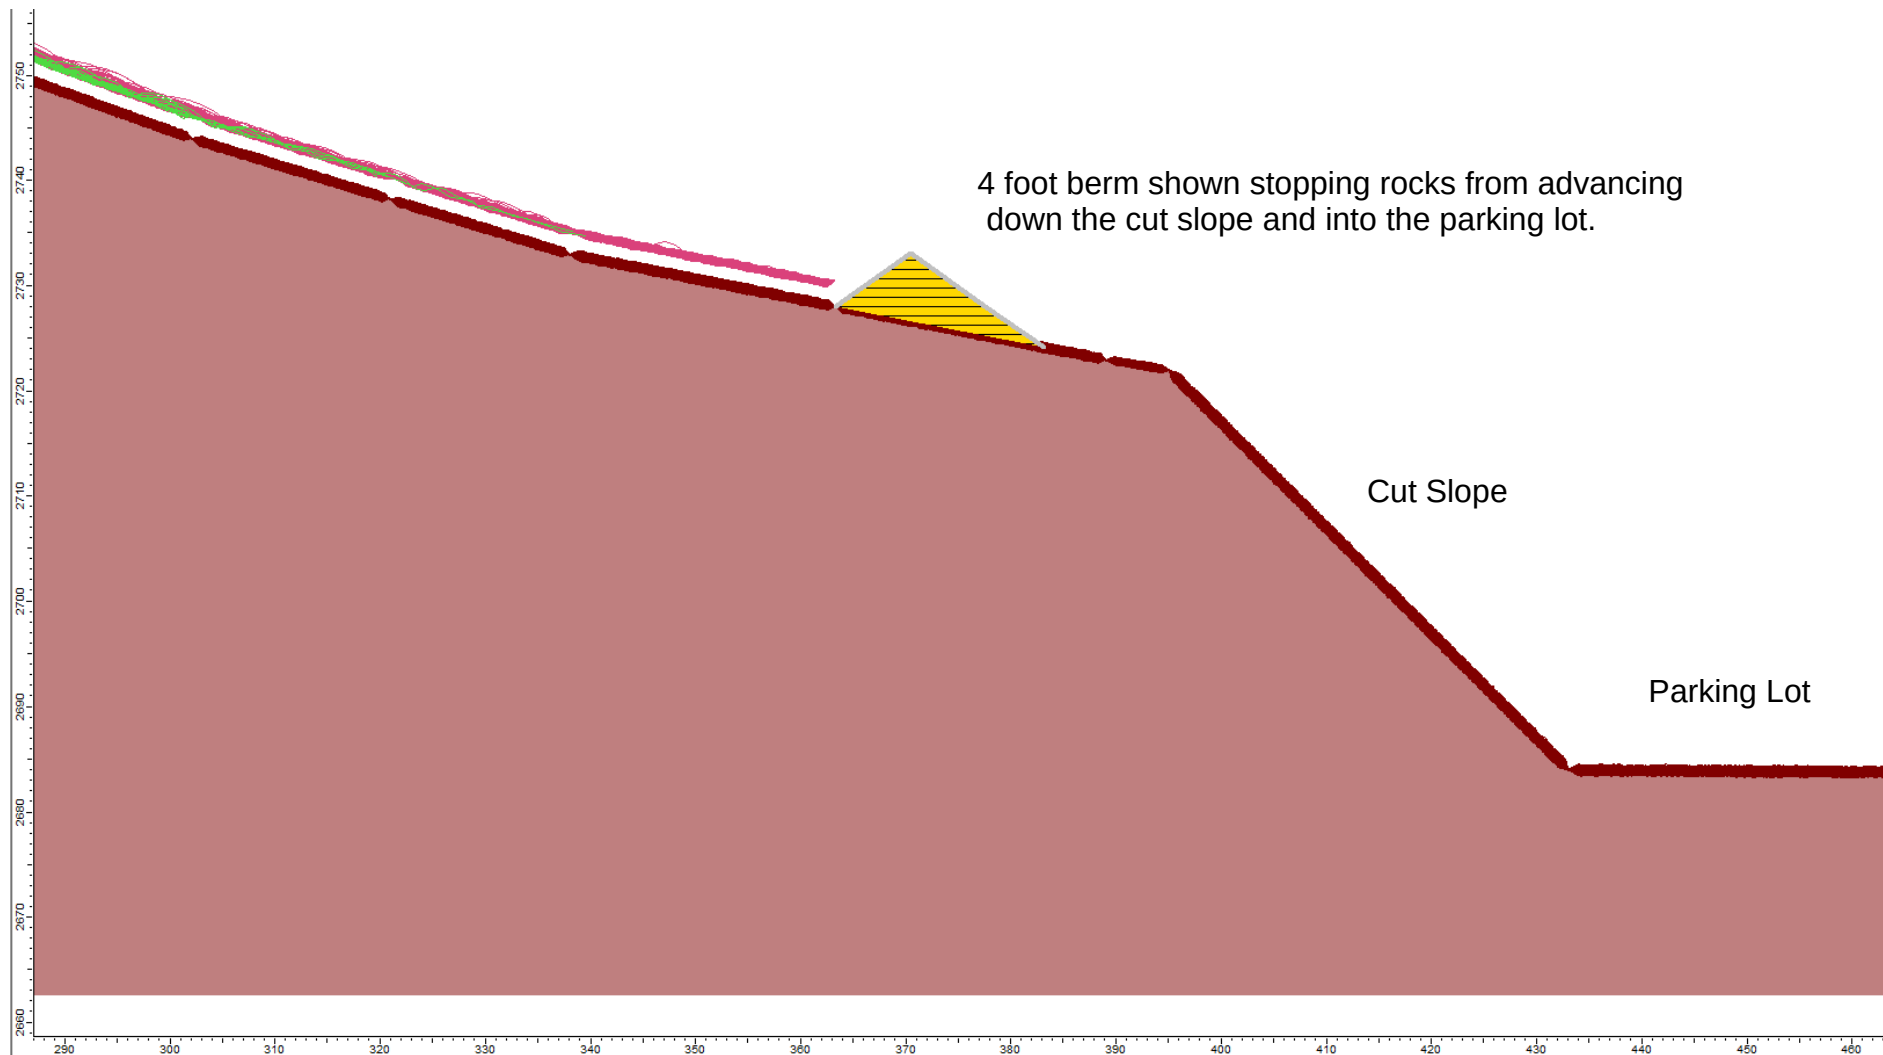
Figure E-3

**Rocfall2 Round Rock Paths with Berm**  
Landmark Project No 240016
