**PARK CITY HISTORIC PRESERVATION BOARD MEETING
SUMMIT COUNTY, UTAH
June 4, 2025**

Site Visit – The Historic Preservation Board Will Conduct a Site Visit at 176 Main Street

Project Summary: The Applicant proposes to deconstruct and reconstruct the Landmark Historic Structure at 176 Main Street to restore the 1907 footprint and form with a new foundation, basement, and material deconstruction to accommodate an addition on the north secondary and east tertiary facades.

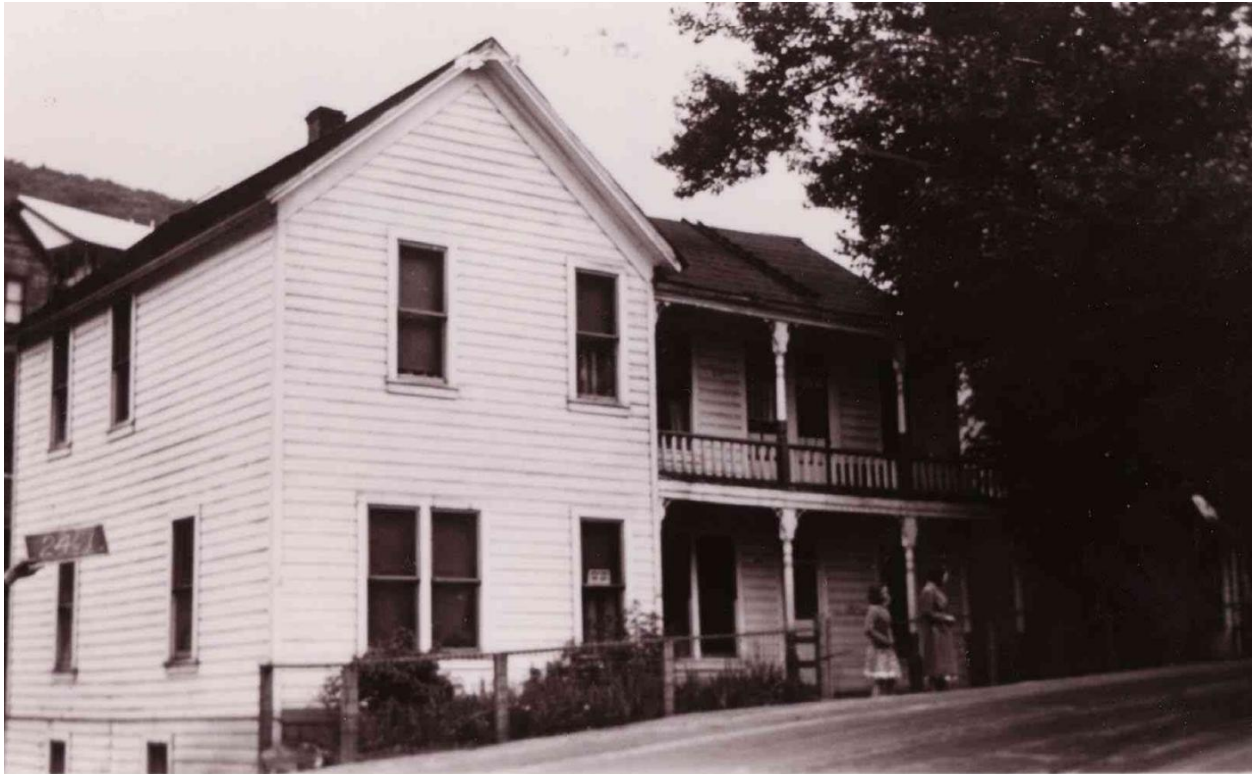
1940s Tax Photo of 176 Main

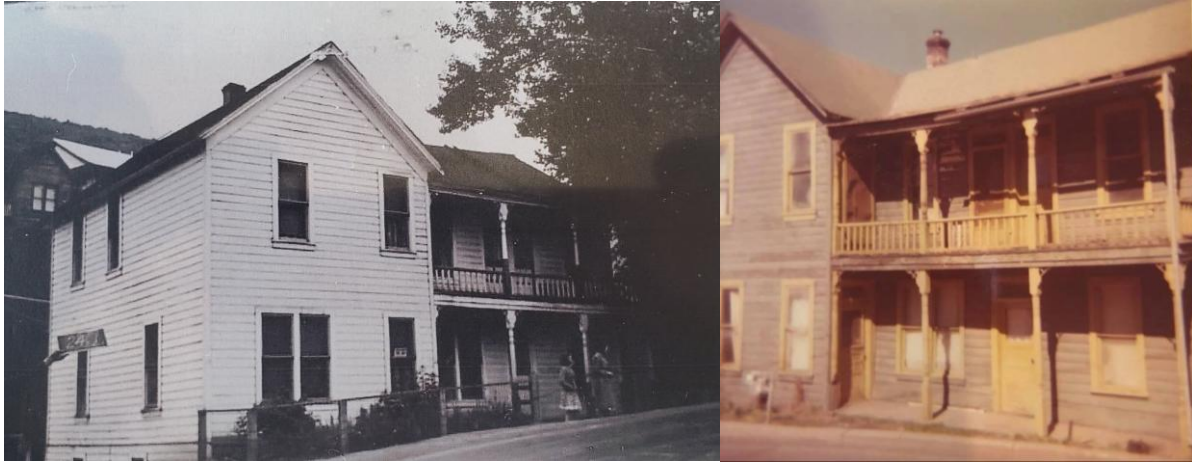
The existing Structure has undergone renovations, including an addition on the east (rear) façade sometime before 1970. Sometime between 1978 and 1983, architectural elements were installed, including two dormer windows on the north (side) façade, a cupola on the west (front) facade, and ornamentation on the west (front) facade.

176 Main prior to 1978, images provided by the Applicant

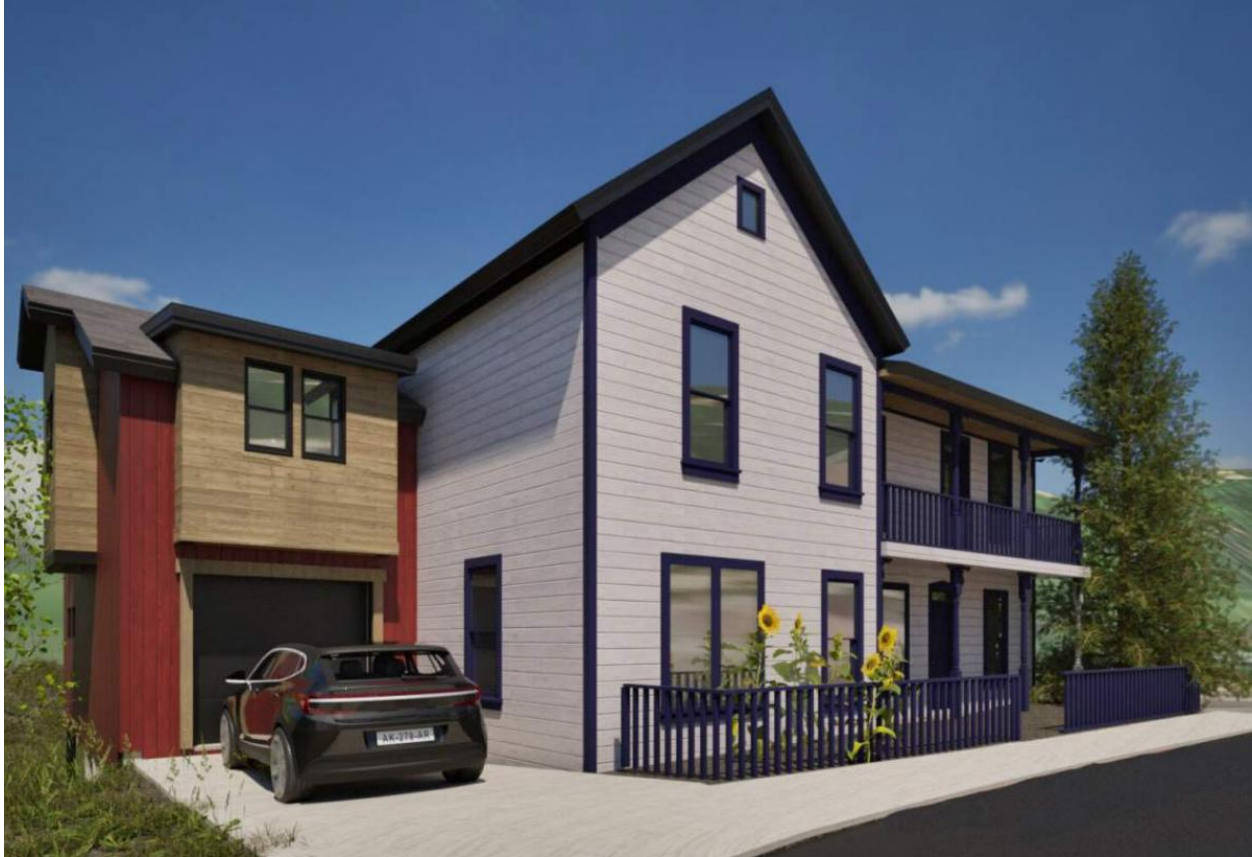
Proposed elevation of 176 Main when viewed from Main Street

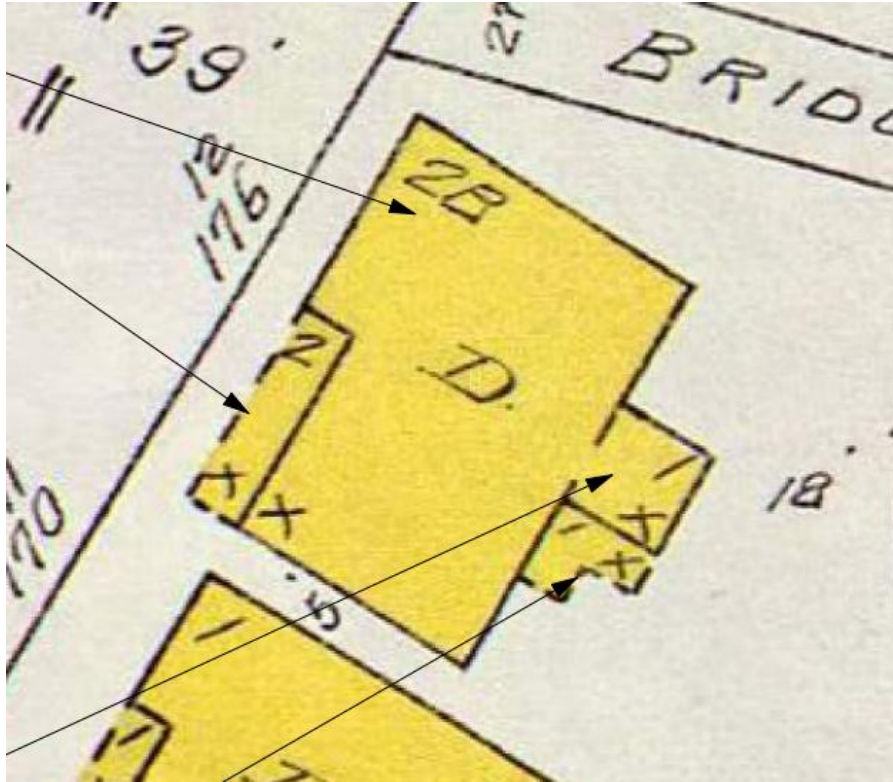
The Applicant proposes to restore the footprint of the Historic Structure to reflect its 1907 form. This includes the 1,185 square foot footprint of the Historic Structure shown in the proposed plans (Exhibit D – Proposed Plans). The Applicant has submitted a Sanborn Map from 1907 showing an addition that was constructed on the Structure and was removed sometime between 1907 and 1970 (Exhibit D – Proposed Plans). The Applicant proposes to restore the 108 square foot addition to restore the 1,293 square foot footprint of the Structure as it was built in 1907.

1907 Sanborn Map showing the 1907 footprint and the previous addition

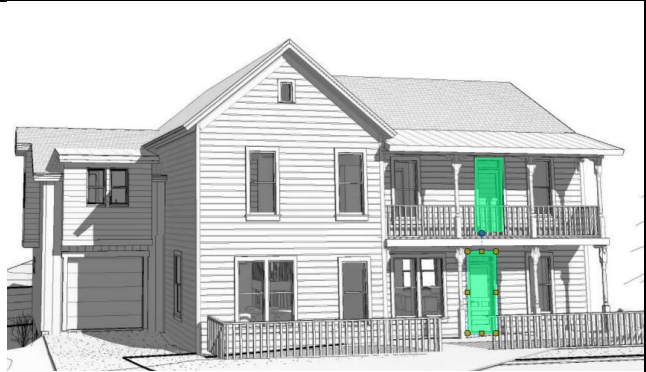
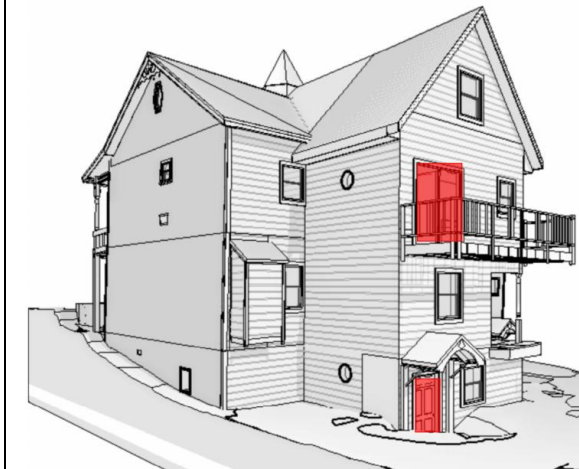
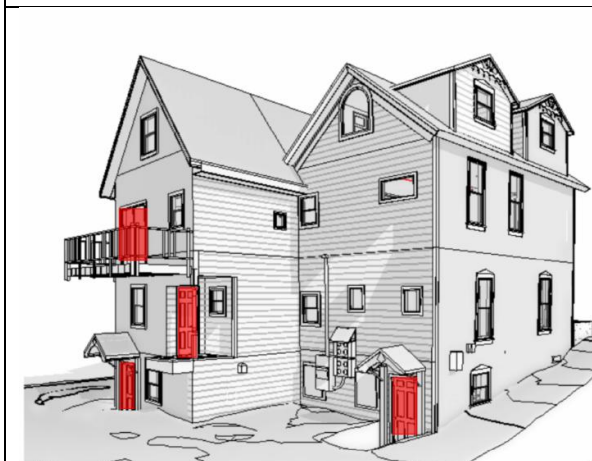
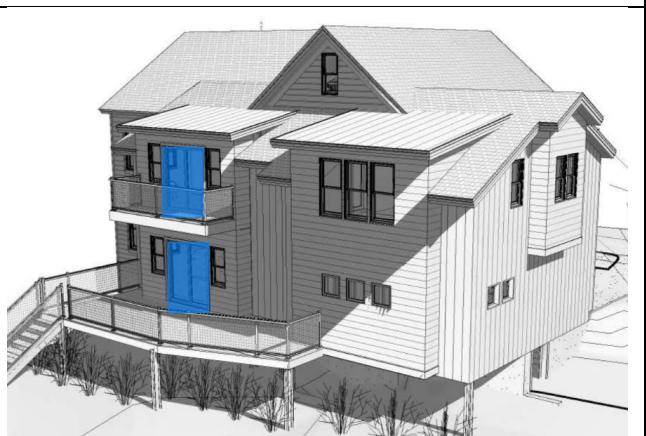
<p><i>Existing Elevations – Doors proposed to be removed are shown in red, doors to be retained are shown in green</i></p>	<p><i>Proposed Elevations – Doors proposed to be added are shown in blue, doors retained from existing conditions are shown in green</i></p>

Front (west) Facade

Side (south) and Rear (east) Facade

Rear (east) and Side (north) Facade

Rear (east) and Side (north) Façade

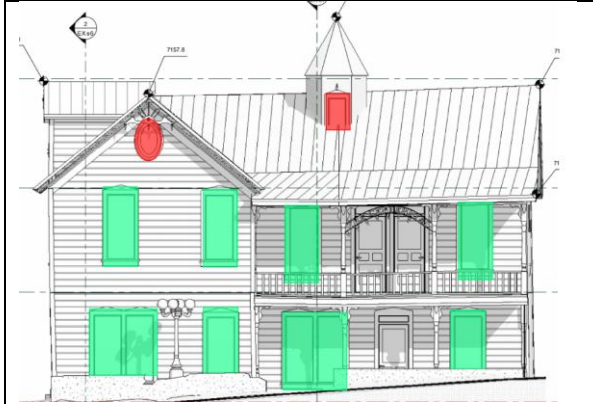
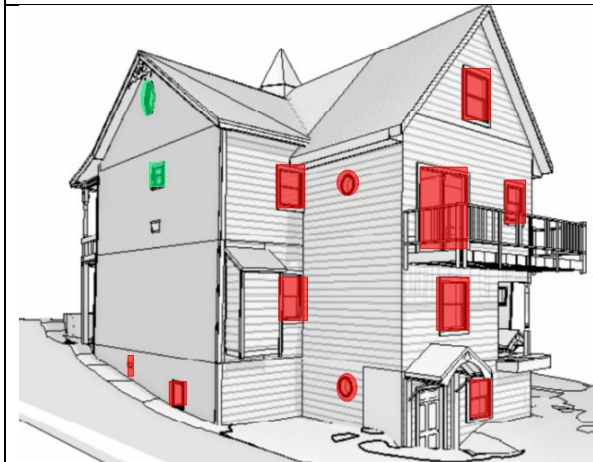
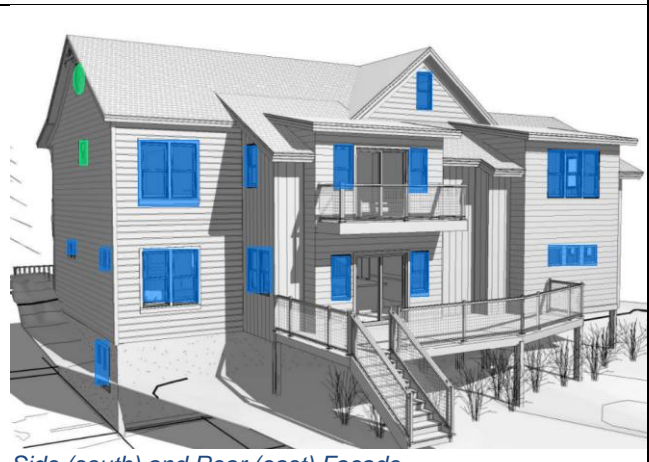
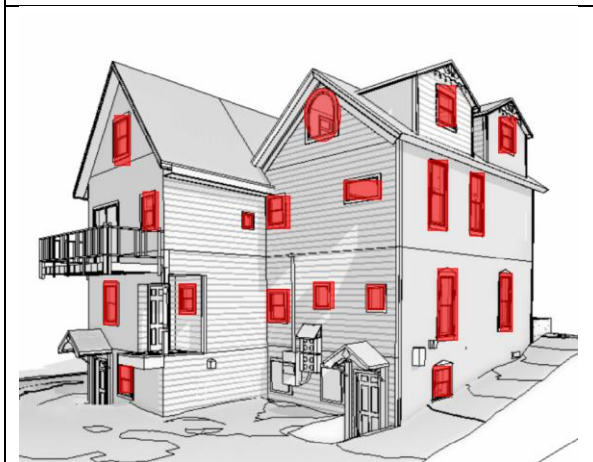
<p><i>Existing Elevations – Windows proposed to be removed are shown in red, windows to be retained are shown in green</i></p>	<p><i>Proposed Elevations – Windows proposed to be added are shown in blue, windows retained from existing conditions are shown in green</i></p>

Front (west) Facade

Side (south) and Rear (east) Facade

Side (north) and Rear (west) Facade

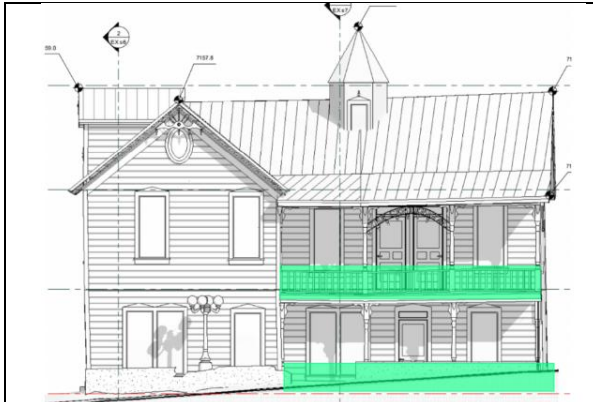
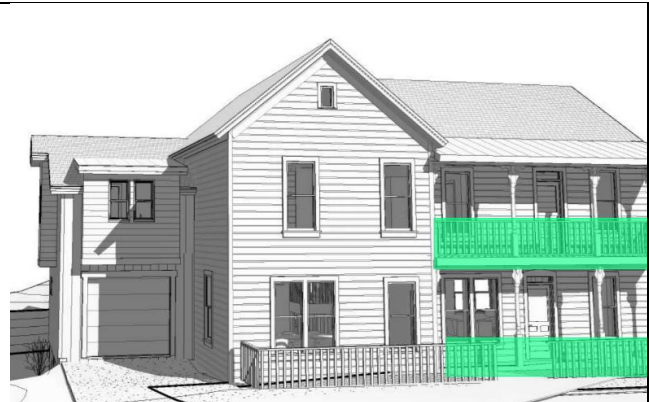
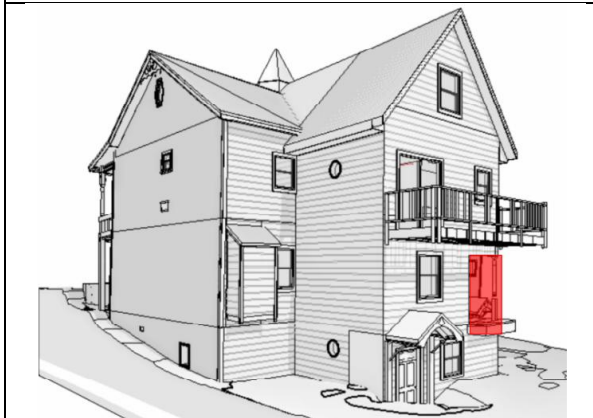
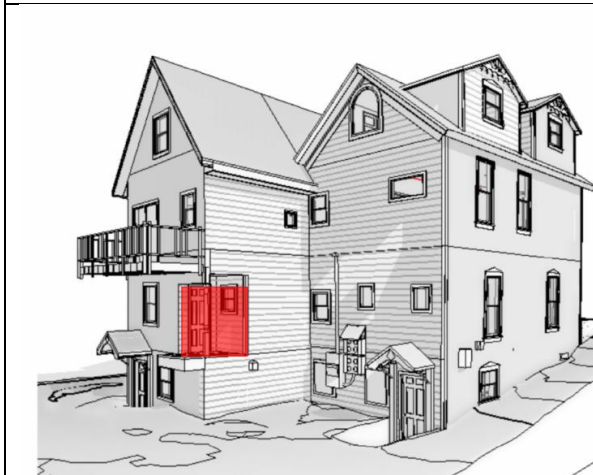
The Applicant proposes to repair the two historic porches on the front façade, and to remove two porches on the rear façade.

<p><i>Existing Elevations – Porches proposed to be removed are shown in red, porches to be retained are shown in green</i></p>	<p><i>Proposed Elevations – Porches proposed to be added are shown in blue, porches retained from existing conditions are shown in green</i></p>

Front (west) Facade

Side (south) and Rear (east) Facade

Rear (east) and Side (north) Facade

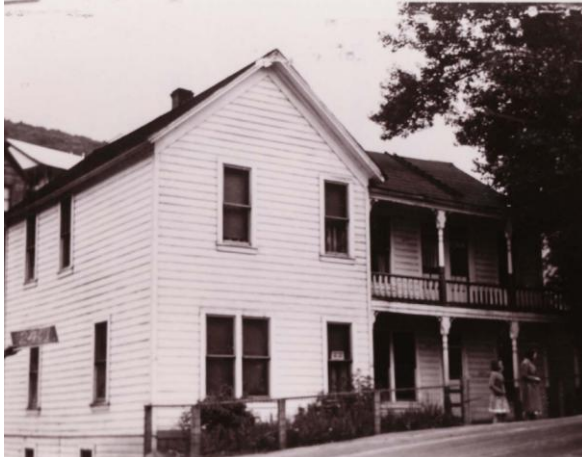
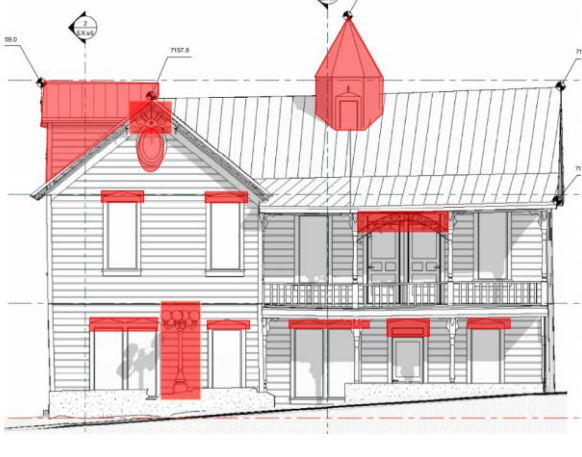
The Applicant proposes Reconstructing the Structure to the 1907 form. The Historic Site Form for the site suggests that the ornamental features such as the cupola, oval window, window pediments, dormers on the north roof, and architectural design

<p>Replacement features shall exactly match the historic features in design, size, dimension, form, profile, texture, material and finish.</p>	<p>elements on the front porch were added sometime between 1978 and 1983 (shown in red in the below illustration). The original Structure (seen in the right image below) was simple in form with unadorned elements.</p> <p>The Applicant proposes removing the architectural elements highlighted in red and restoring the Structure to its original form seen in the photo on the left.</p>
<p><i>Original 1901 Structure</i></p>	<p><i>Existing Conditions – Two dormers, pediments, and ornamentation added after 1978 and proposed to be retained are shown in orange, the light post shown in red is proposed to be removed</i></p>

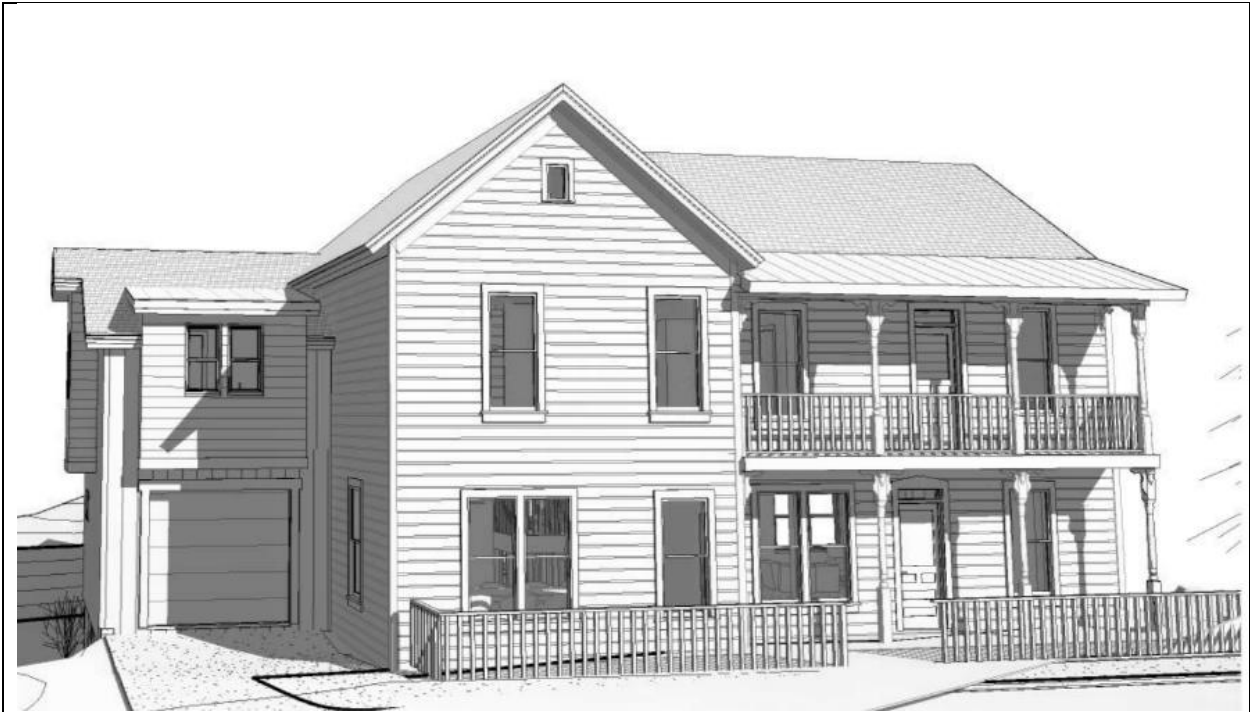
Proposed front elevation showing the restored 1907 form of the Structure and the proposed addition

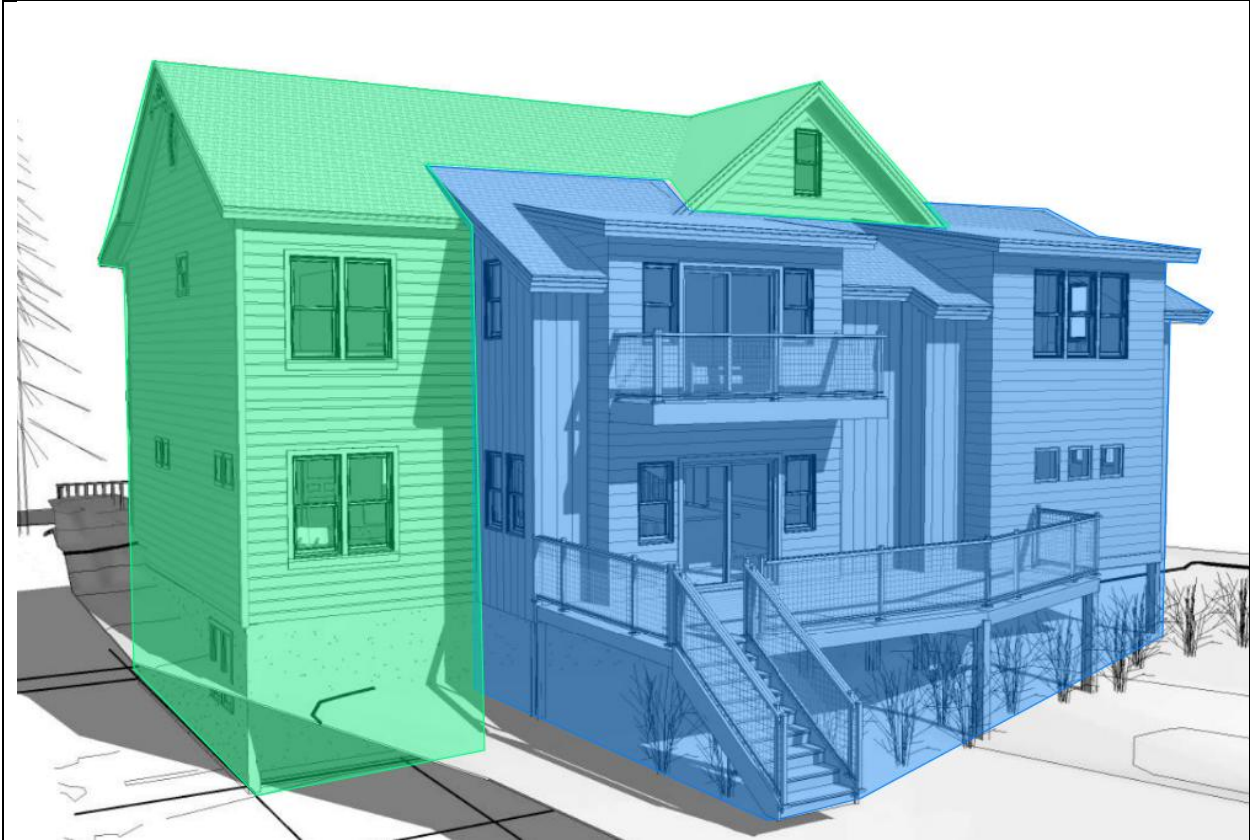
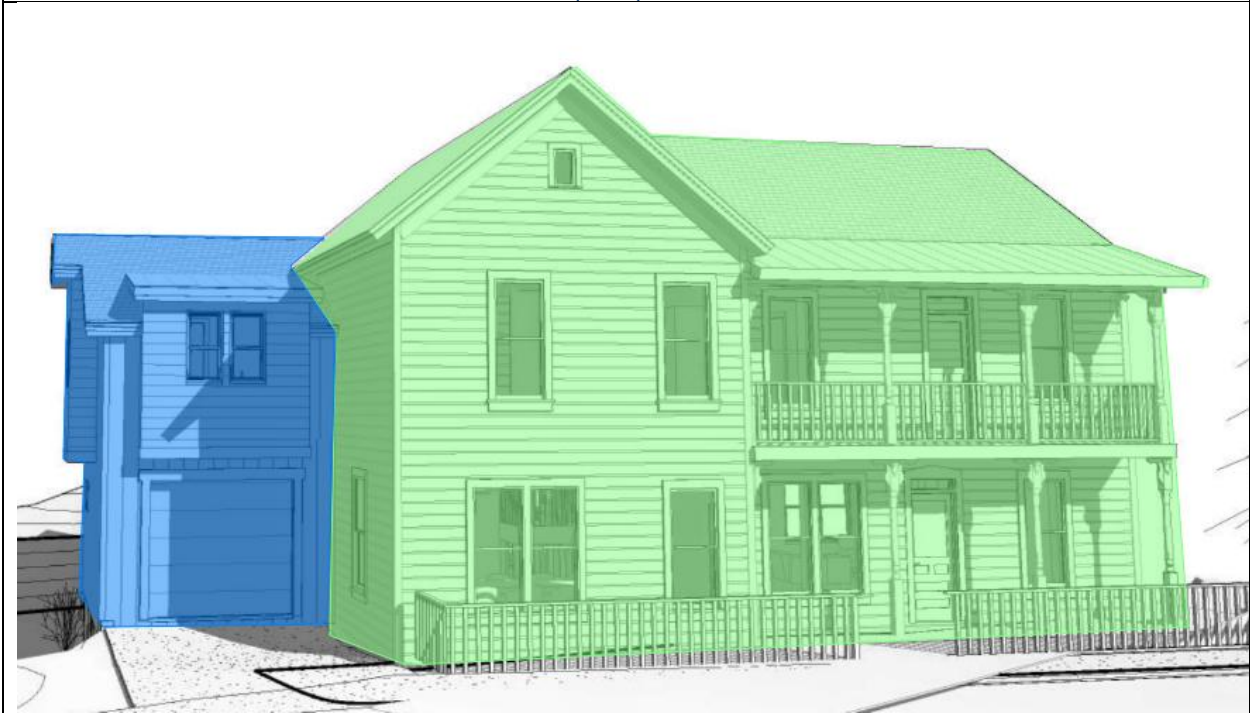
Proposed Elevations – Existing Historic Structure proposed to remain is shown in green, proposed addition is shown in blue.

Rear (east) Facade

North (west) Facade

Rear (east) and Side (north) facade

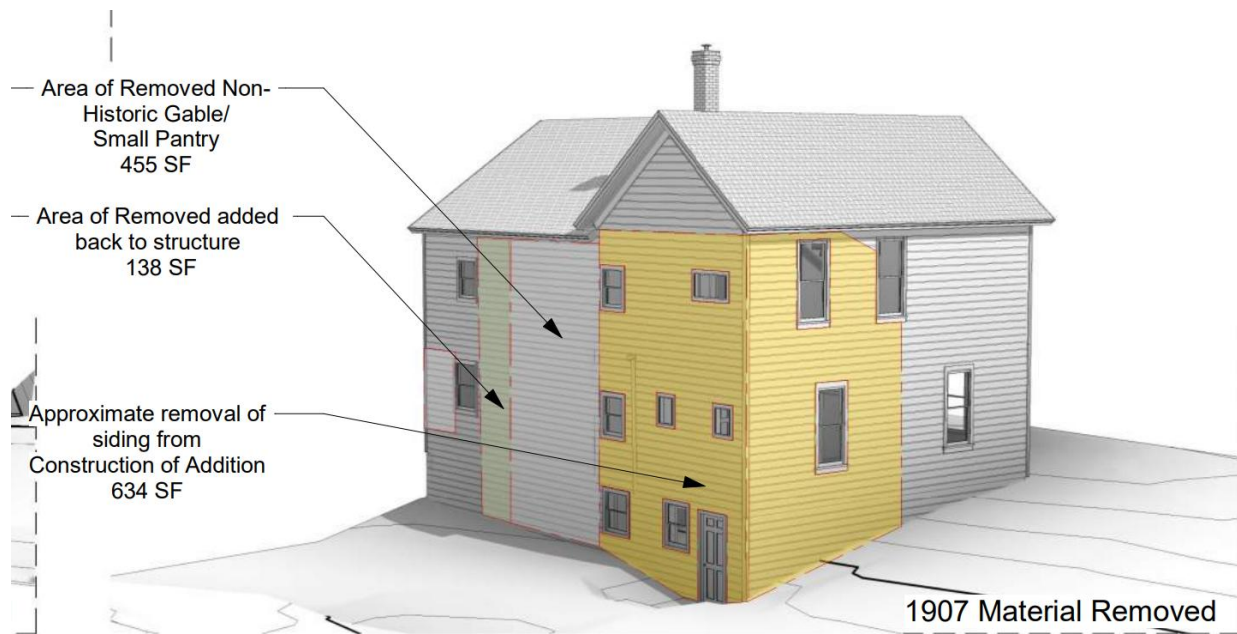
Pursuant to LMC § [15-11-12.5](#) the HPB reviews any requests any removal of Historic material to accommodate new additions. The Applicant proposes removing 634 square feet of Historic siding material to construct the rear addition. The Applicant proposes removing 496 square feet of non-Historic Siding to construct the addition and salvaging 138 square feet of Historic material to be reused on the Structure. The Applicant provided a plan outlining the material proposed to be salvaged and integrated into the Landmark Historic Structure (Exhibit D).

Figure provided by the Applicant showing the material proposed to be removed to construct the addition.

As provided in the above Analysis Section I Subsection 3 Staff recommends Conditions of Approval which require that the Applicant take careful steps to document, remove, preserve, and restore the Historic materials proposed to be removed from the Structure. Additional Staff recommends that Condition of Approval 15 be added to require that the Applicant submit an Industrial Hygienist Report that will be used to analyze the materials on the rear (north) façade can be panelized to preserve as many Historic materials as possible.

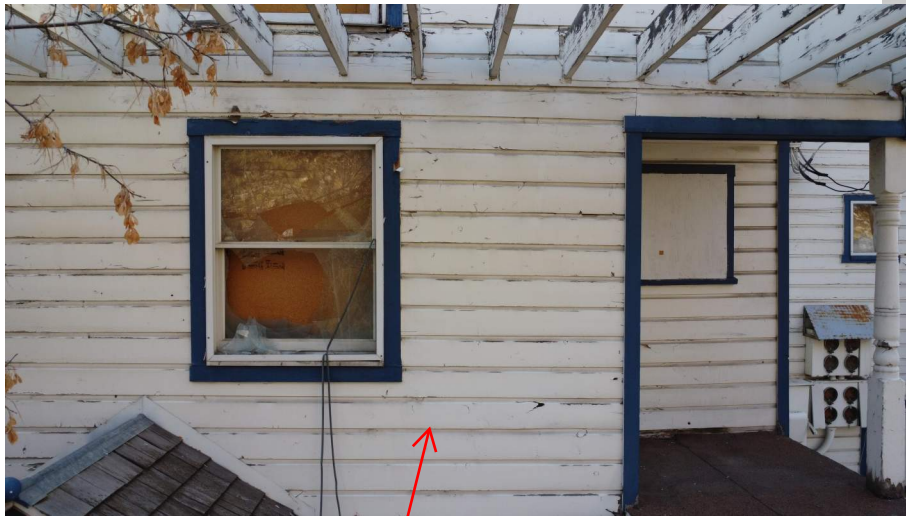
Newer Siding on more
recent addition to 1907
structure

All exterior wood walls appear to be original with little exterior protection for the structural elements, such as tar paper or additional layers of sheathing/ boards. As such, they have contributed to the poor condition of the house and structure as a whole. It appears that the East addition used similar siding to the rest of the structure when it was added and it may be desirable to use these wood siding boards on the front facades where wood boards are irreparable. Siding profile is a Novelty or Dutch Drop lap siding, 1x8
Wood not on Southern or Western aspects is in much better condition

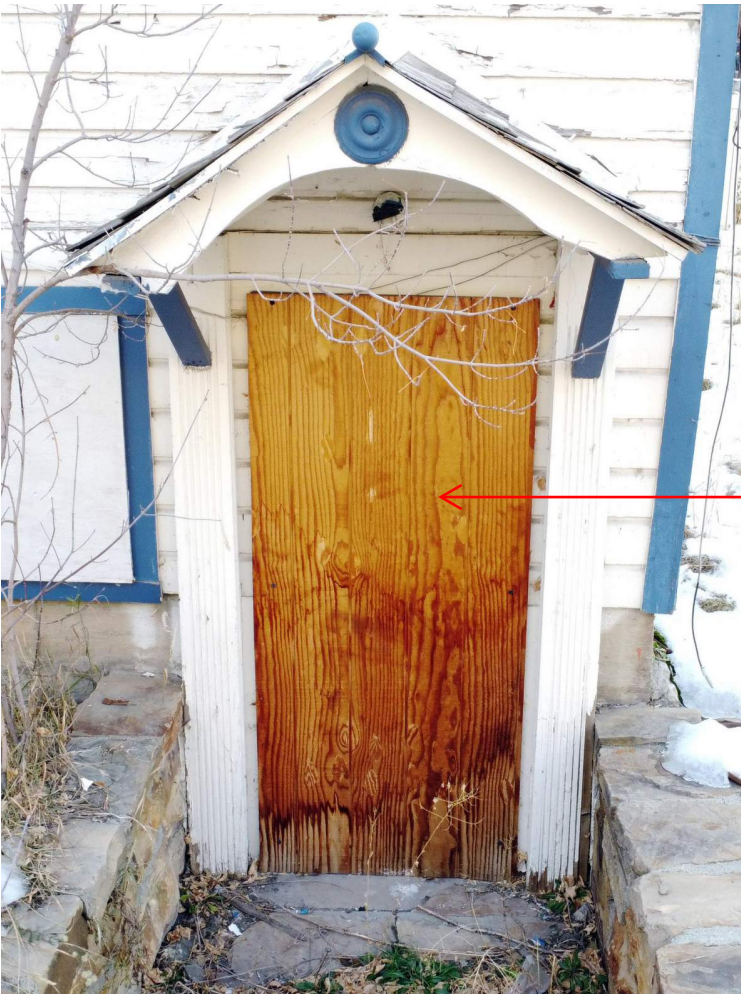
← Boarded up door - See door schedule

See Door Schedule
for More information

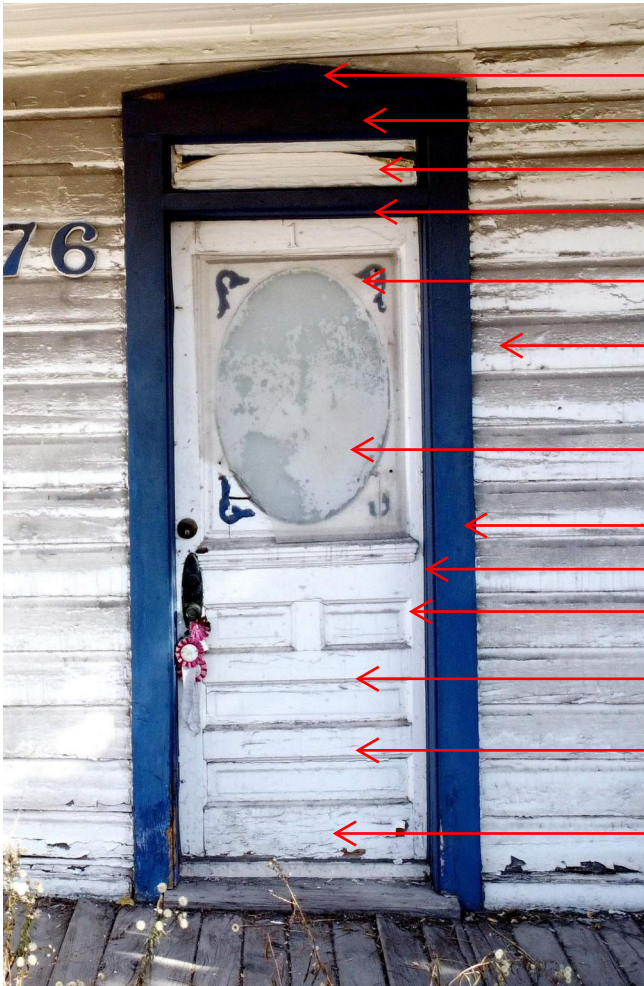
PHOTO #D8

Decorative Peaked Cap Pediment

Top Jamb

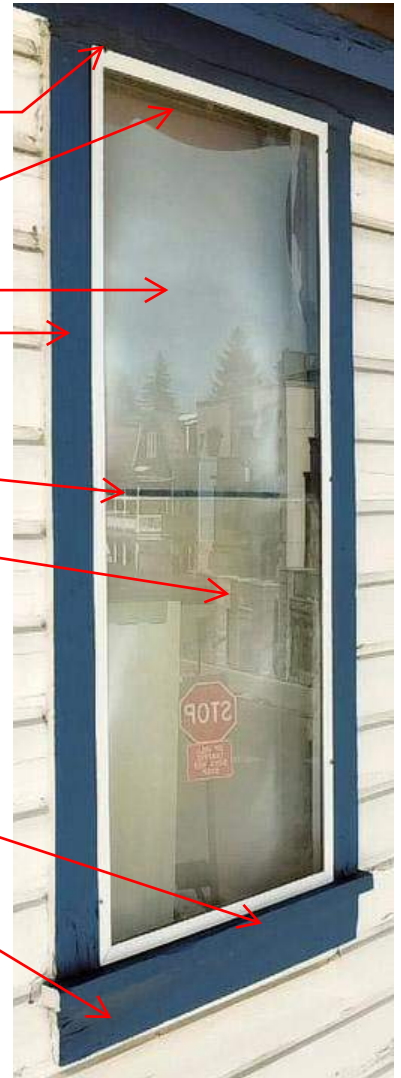
PHOTO #W4

- Head
- Upper Rail
- Sash
- Jamb
- Simulated Rail
- Storm Window Cover
- Stool
- Apron

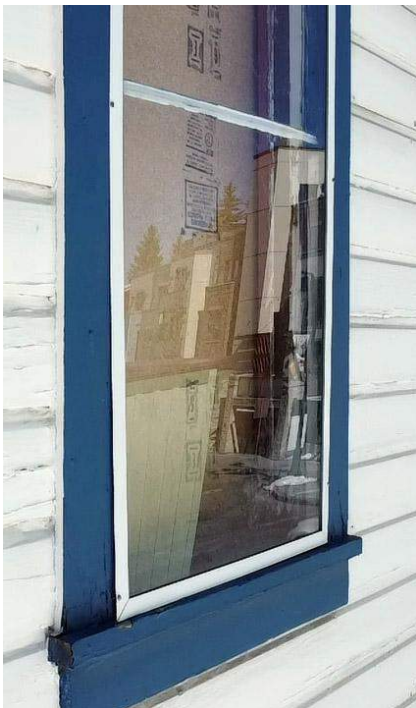
PHOTO #W3a

These 2 windows are not double hung but a single fixed pane of glass with a simulated rail to emulate the look of the neighboring double hung windows

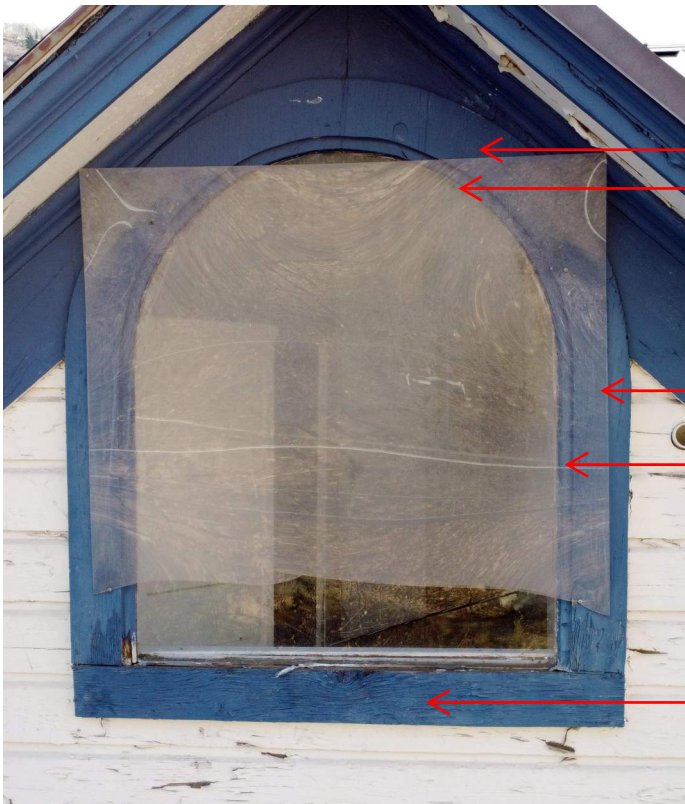
PHOTO #W10

- Curved Head
- Upper Rail

Jamb

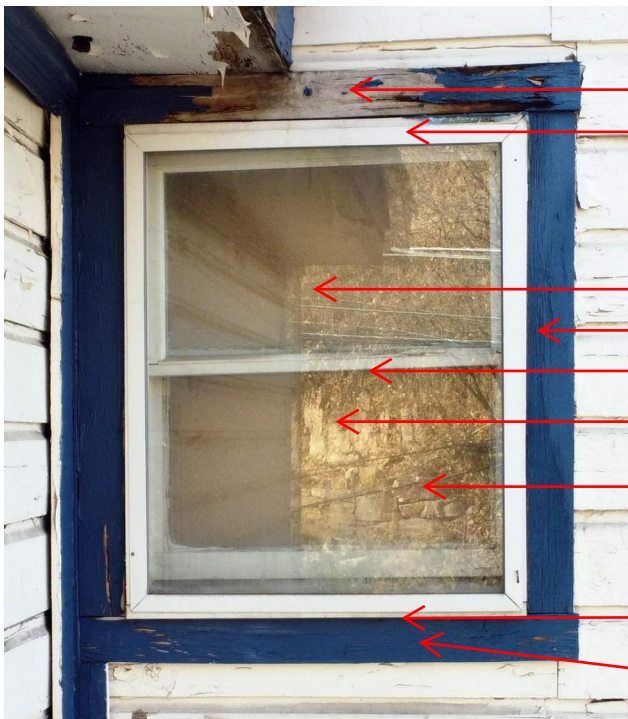
PHOTO #W12

- Head
- Upper Rail
- Upper Sash
- Jamb
- Lower Rail
- Lower Sash
- Storm Window Cover
- Sill
- Apron

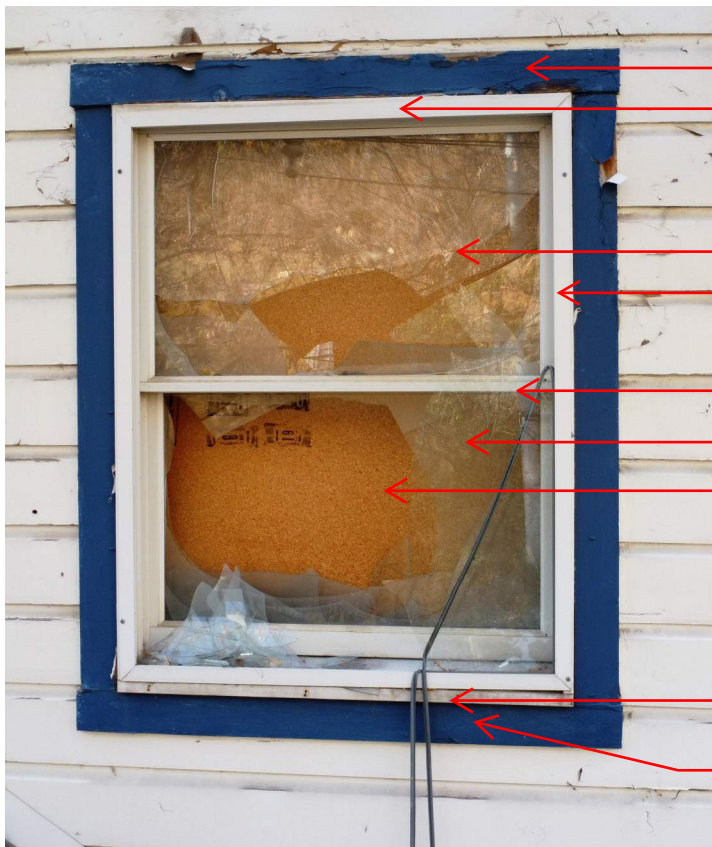
PHOTO #W14

- Head
- Upper Rail
- Upper Sash
- Jamb
- Lower Rail
- Storm Window Cover (Broken)
- Lower Sash
- Sill
- Apron

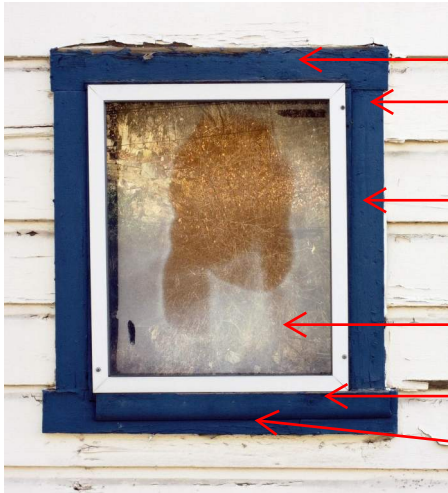
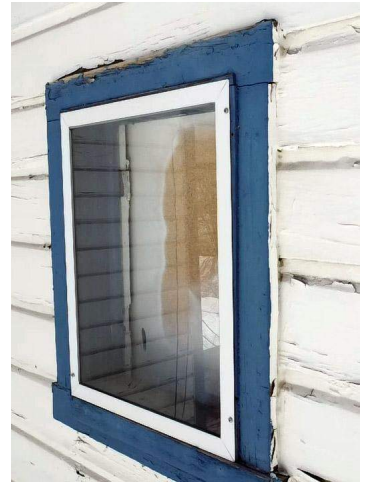
PHOTO #W17, W17a

- Head
- Upper Rail
- Jamb
- Storm Window Cover
- Sill
- Apron

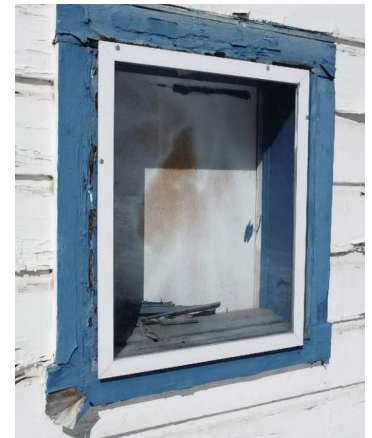
PHOTO #W18, 18a

- Head
- Upper Rail
- Jamb
- Storm Window Cover
- Sill
- Apron

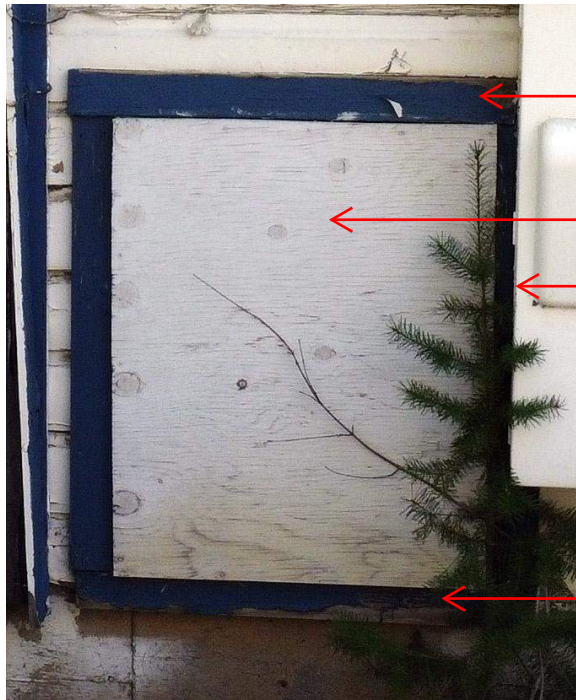
PHOTO #W20

Head

Plywood

Apron

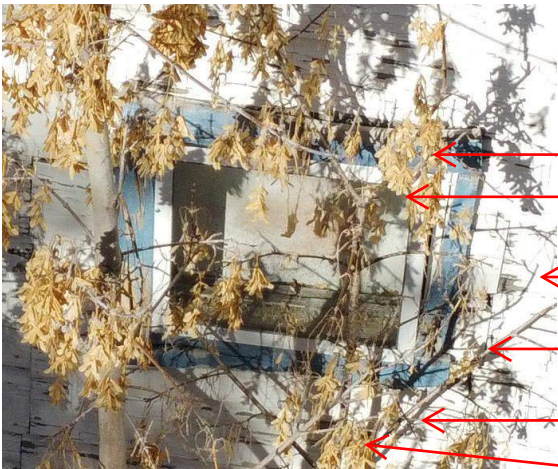
PHOTO #25, 25a

Head

Upper Rail

Sill

Apron

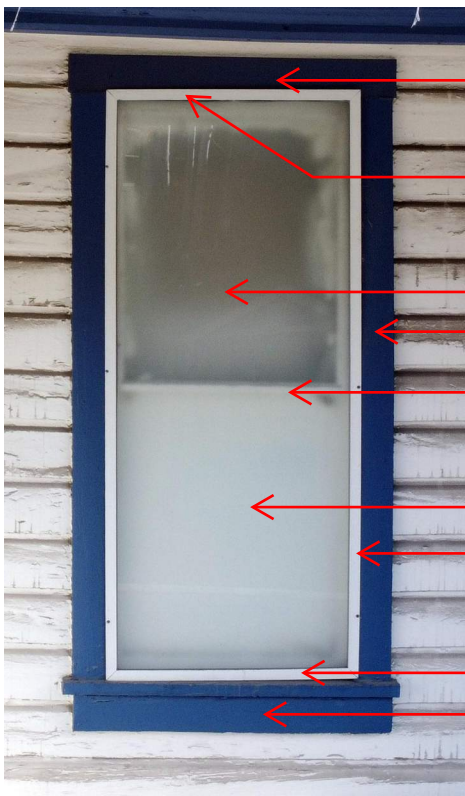
PHOTO #W32

Head

Upper Rail

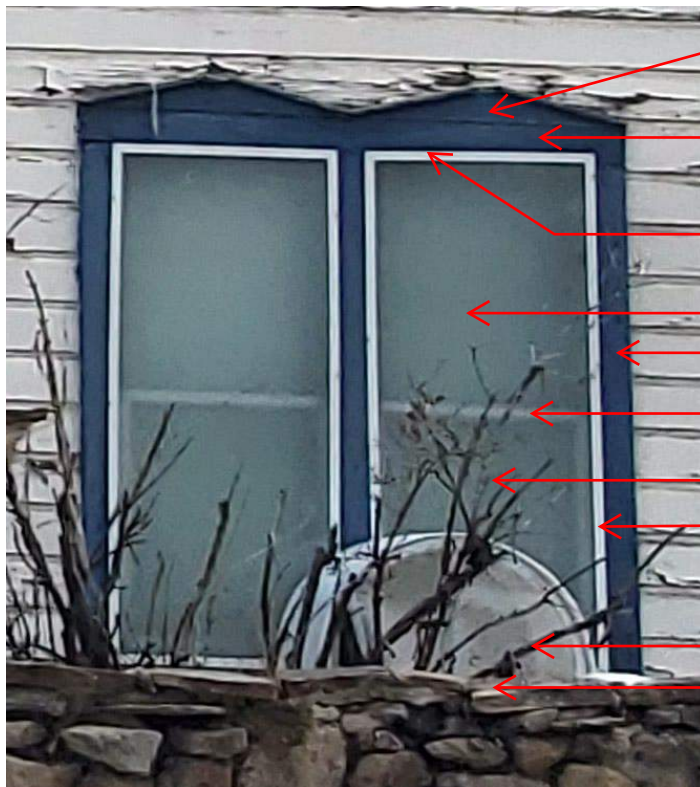
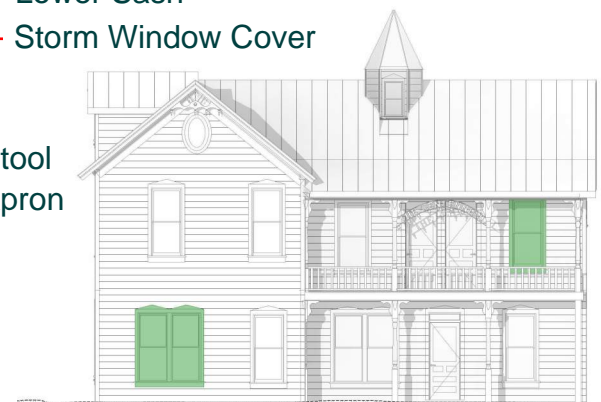
PHOTO #W34

Decorative Peaked Cap Pediment

Head

Stool

Apron

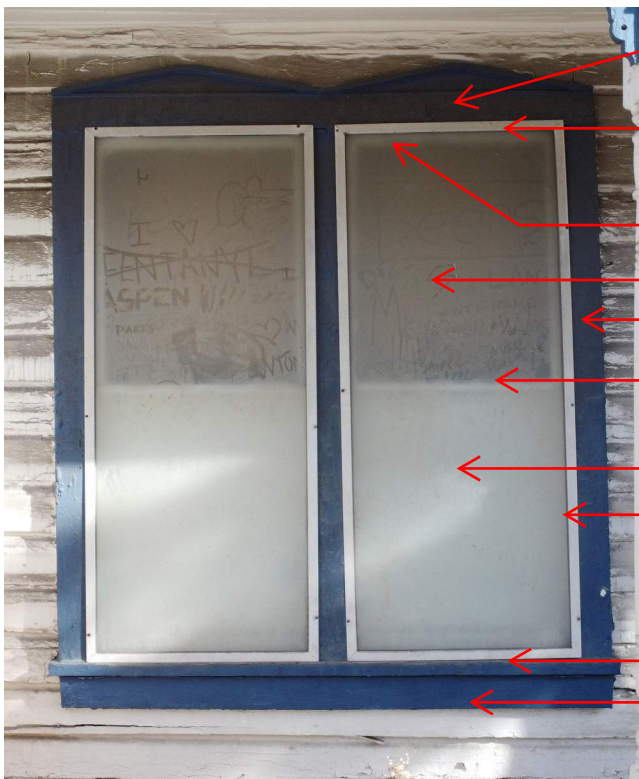
PHOTO #W36

Decorative Peaked Cap Pediment

Head

Storm Window Cover

Stool
Apron

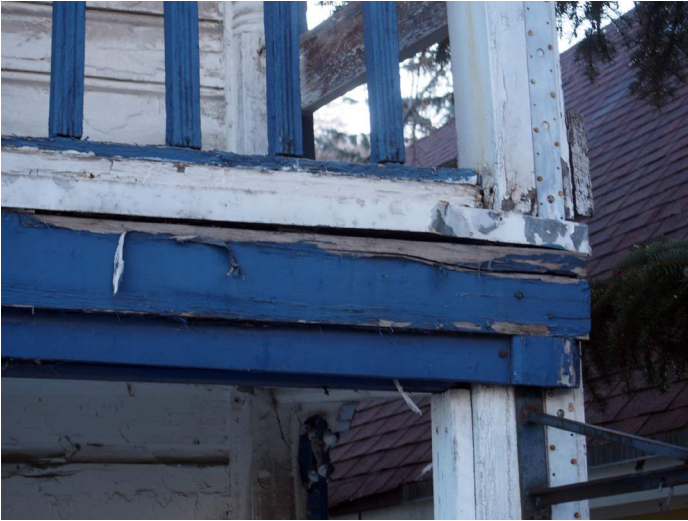
Trim at Front Porch SW corner

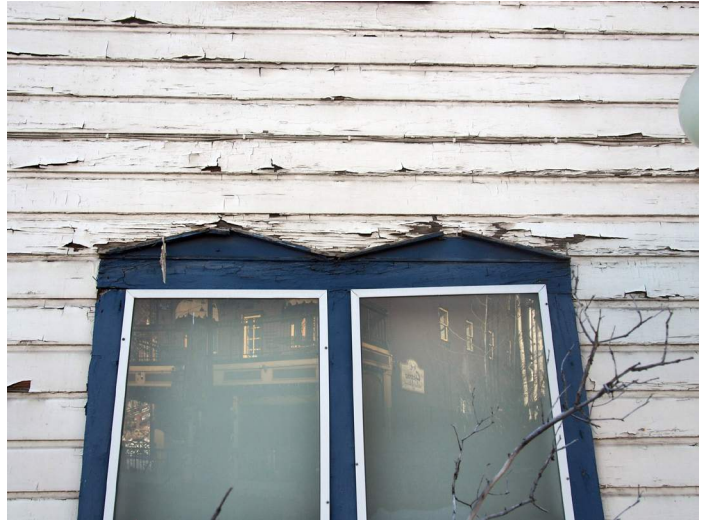
Missing finials on window trim and peeling paint

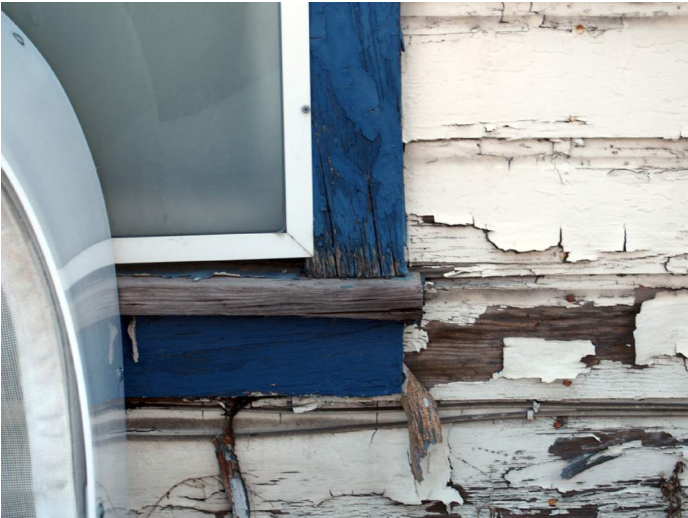
Window Trim at West Elevation

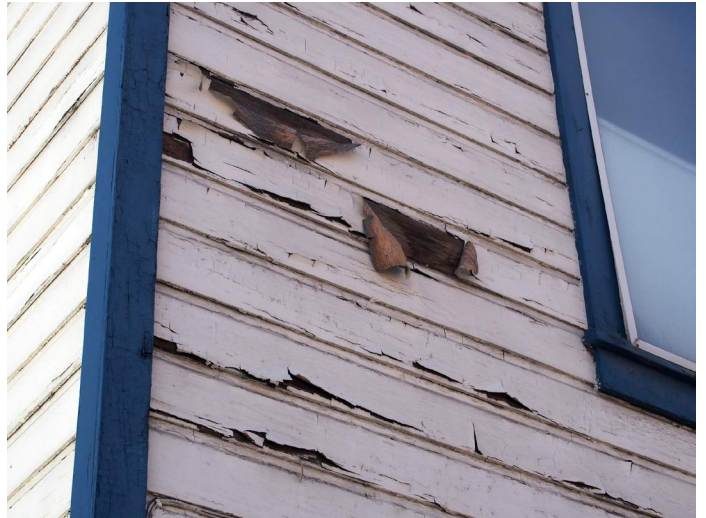
Example of Peeling paint on West Facade

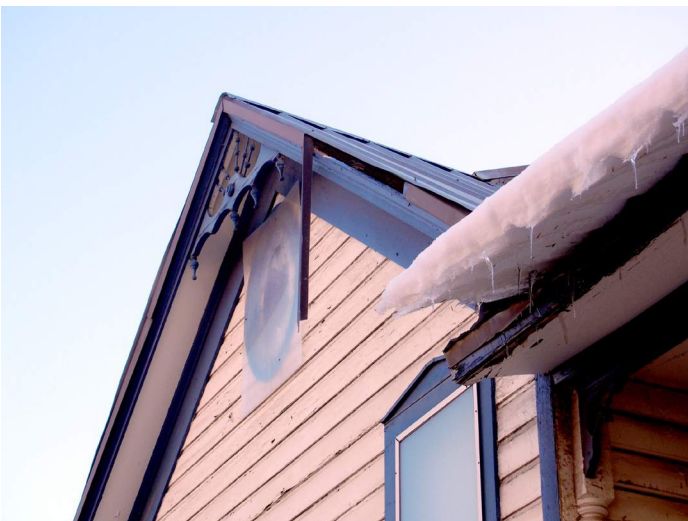
Drip edge failing and saturated soffit

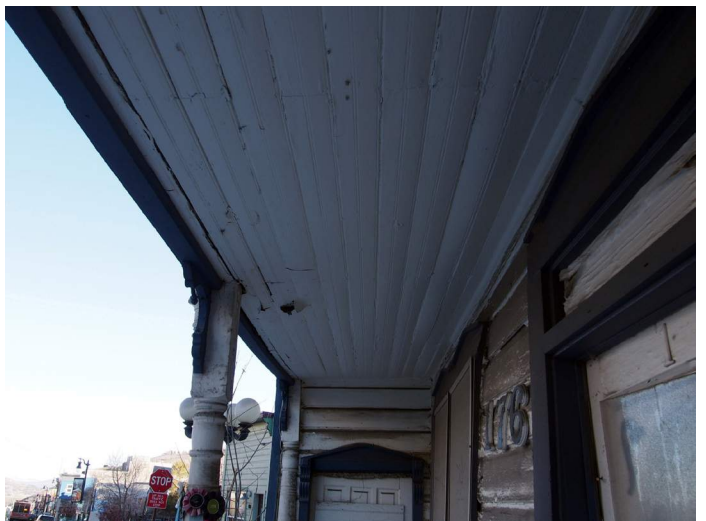
Front Deck soffit bowing

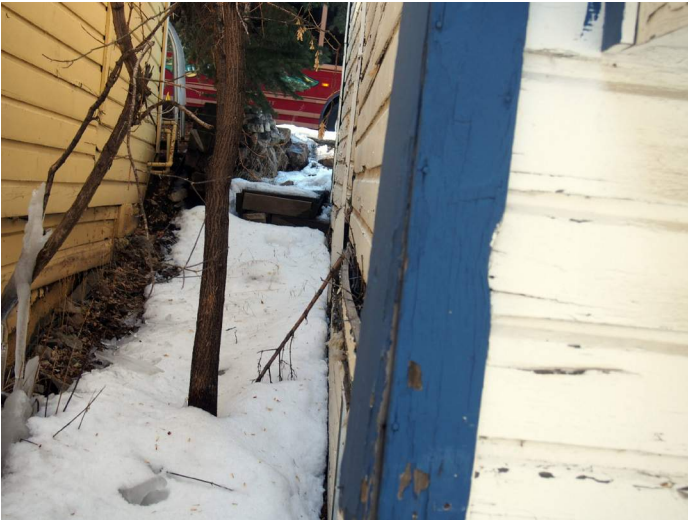
Bowing South wall

The current structure is severely compromised (see letter from structural engineer). Nearly 20 years ago the building was condemned and required to be stabilized. Temporary shoring was installed to keep the building from falling down. A more recent structural walk through by a professional structural engineer resulted in a recommendation for demolition or extreme caution with any work towards rehabilitation. The proposed work would demolish the existing structure and re-build using new materials that are not compromised. Using the plans in place with the HDDR, a replica of the building with historic nods to the past could be safely constructed in-situ.

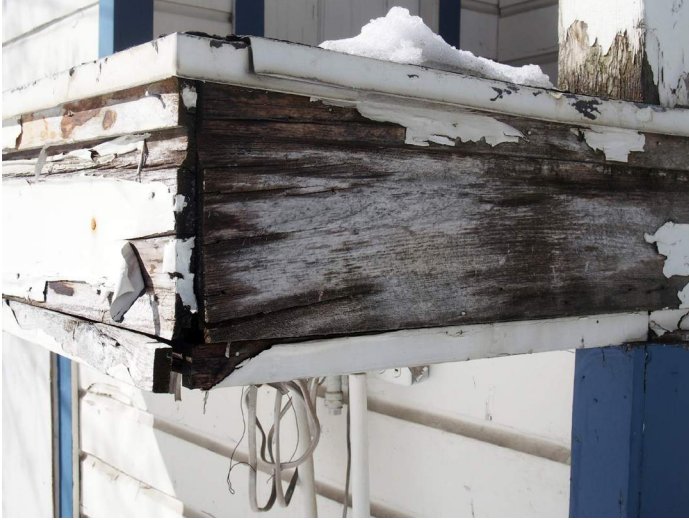
Trim compromised at rear Level 1 deck

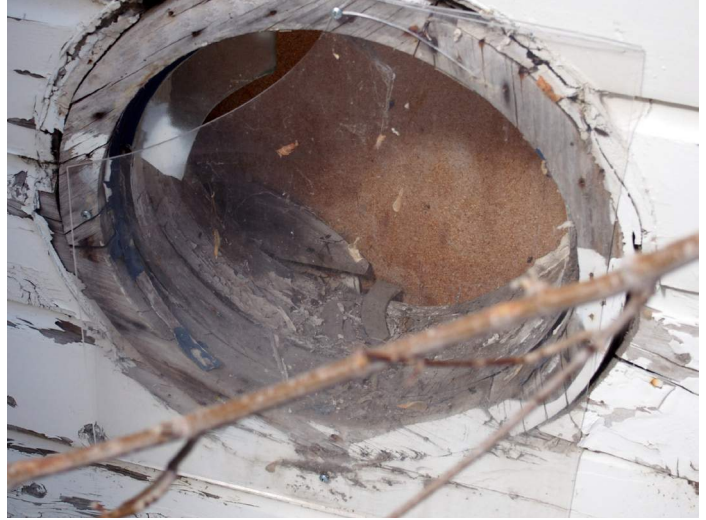
Lower portal window trim
