**PARK CITY HISTORIC PRESERVATION BOARD MEETING
SUMMIT COUNTY, UTAH
June 4, 2025**

Site Visit – The Historic Preservation Board Will Conduct a Site Visit at 176 Main Street

Project Summary: The Applicant proposes to deconstruct and reconstruct the Landmark Historic Structure at 176 Main Street to restore the 1907 footprint and form with a new foundation, basement, and material deconstruction to accommodate an addition on the north secondary and east tertiary facades.

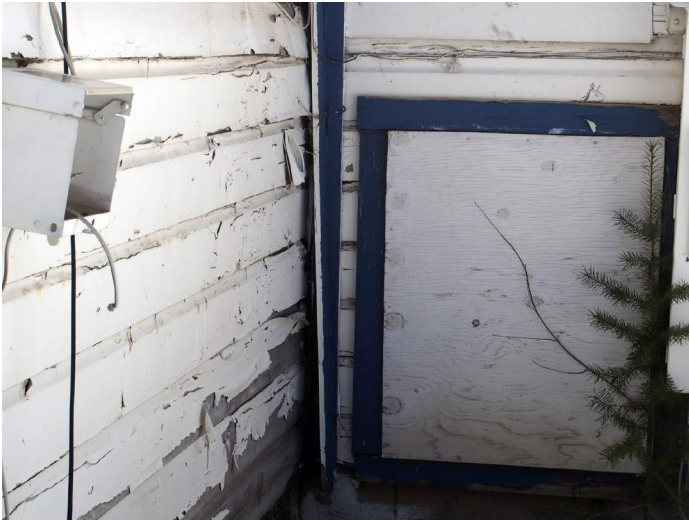
Peeling trim and paint at South and East inside corner

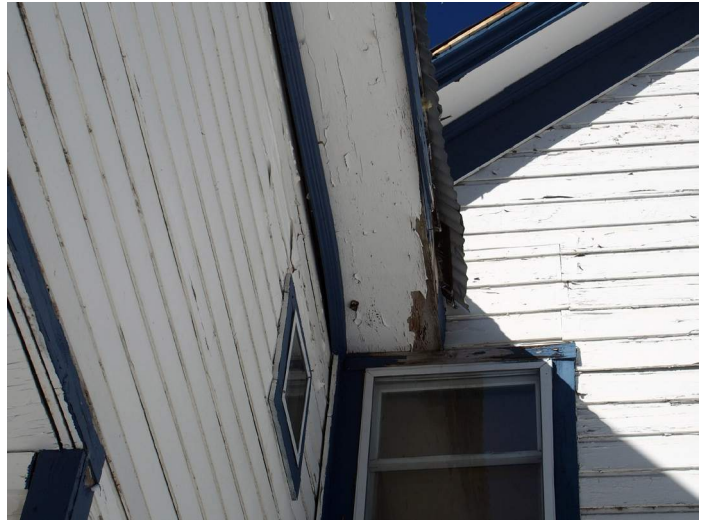
East gabled section soffit compromised

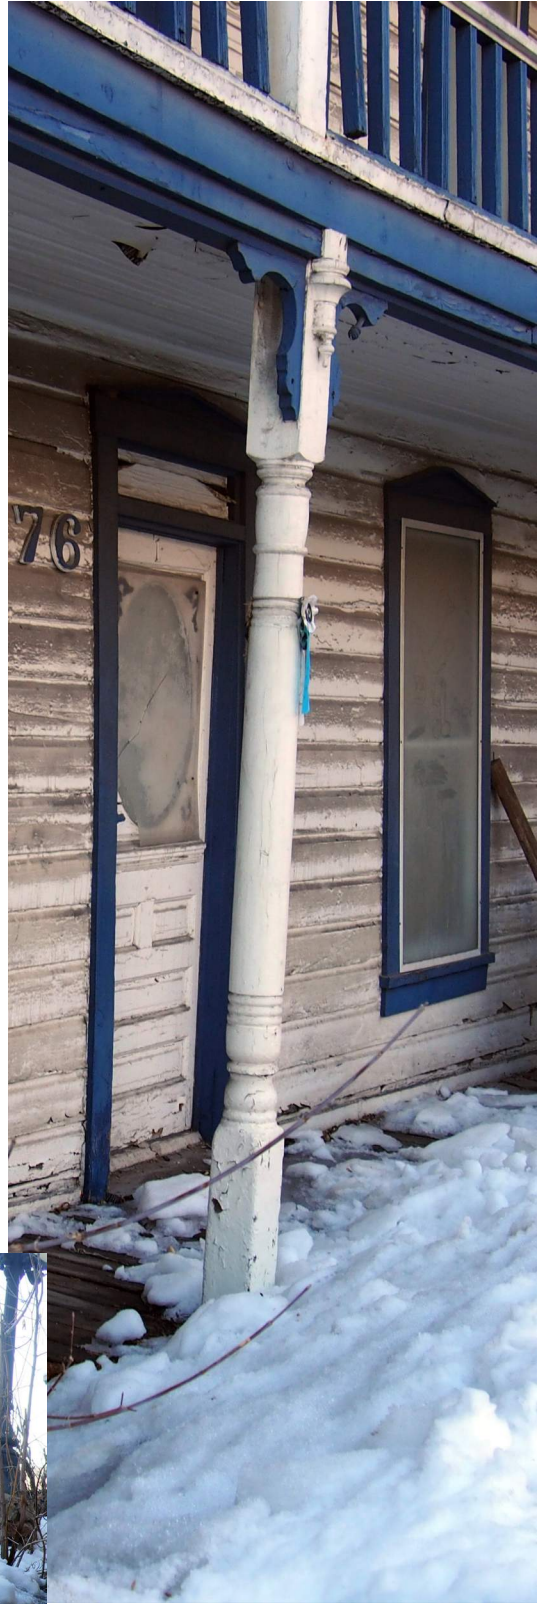
Front Porch Post

The lathe turned posts appear to be original or replaced as replicas with wood material since photographic evidence exists. While the other ornamentation on the building appears to build off the posts and their detailing on top, this other ornamentation does not appear to be particularly historic. As such, the columns should be either rehabilitated or retained as models for creating new posts in their likeness, in wood material. The post pattern could easily be templated and applied to new posts.
One of the posts has been removed and is residing in one of the apartments, assuming it's structural life had expired. The replacement is a 6x6 standard wood column that could be purchased at any hardware store

There are numerous posts to document but generally they are in poor condition and likely need replacement to perform structural duties. Photographs from historic documentation should be used to augment the remaining decorative elements in a rehabilitation of posts where possible and reconstruction where necessary.

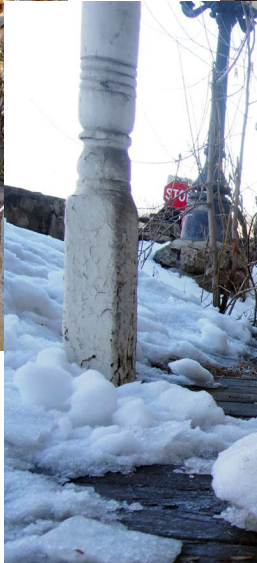
Base of Front Porch Post

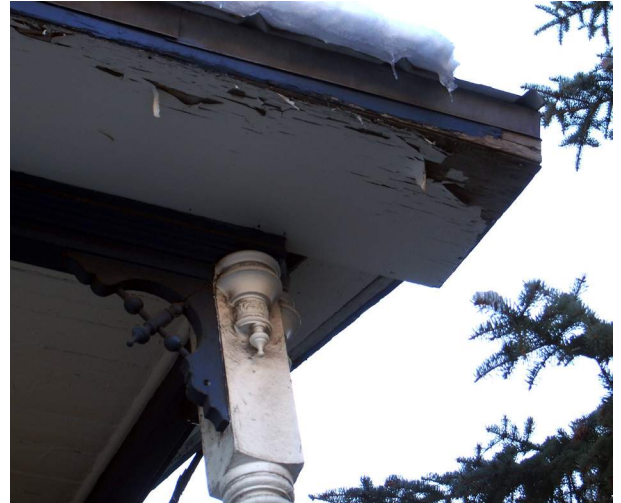
Upper Front Deck corner post

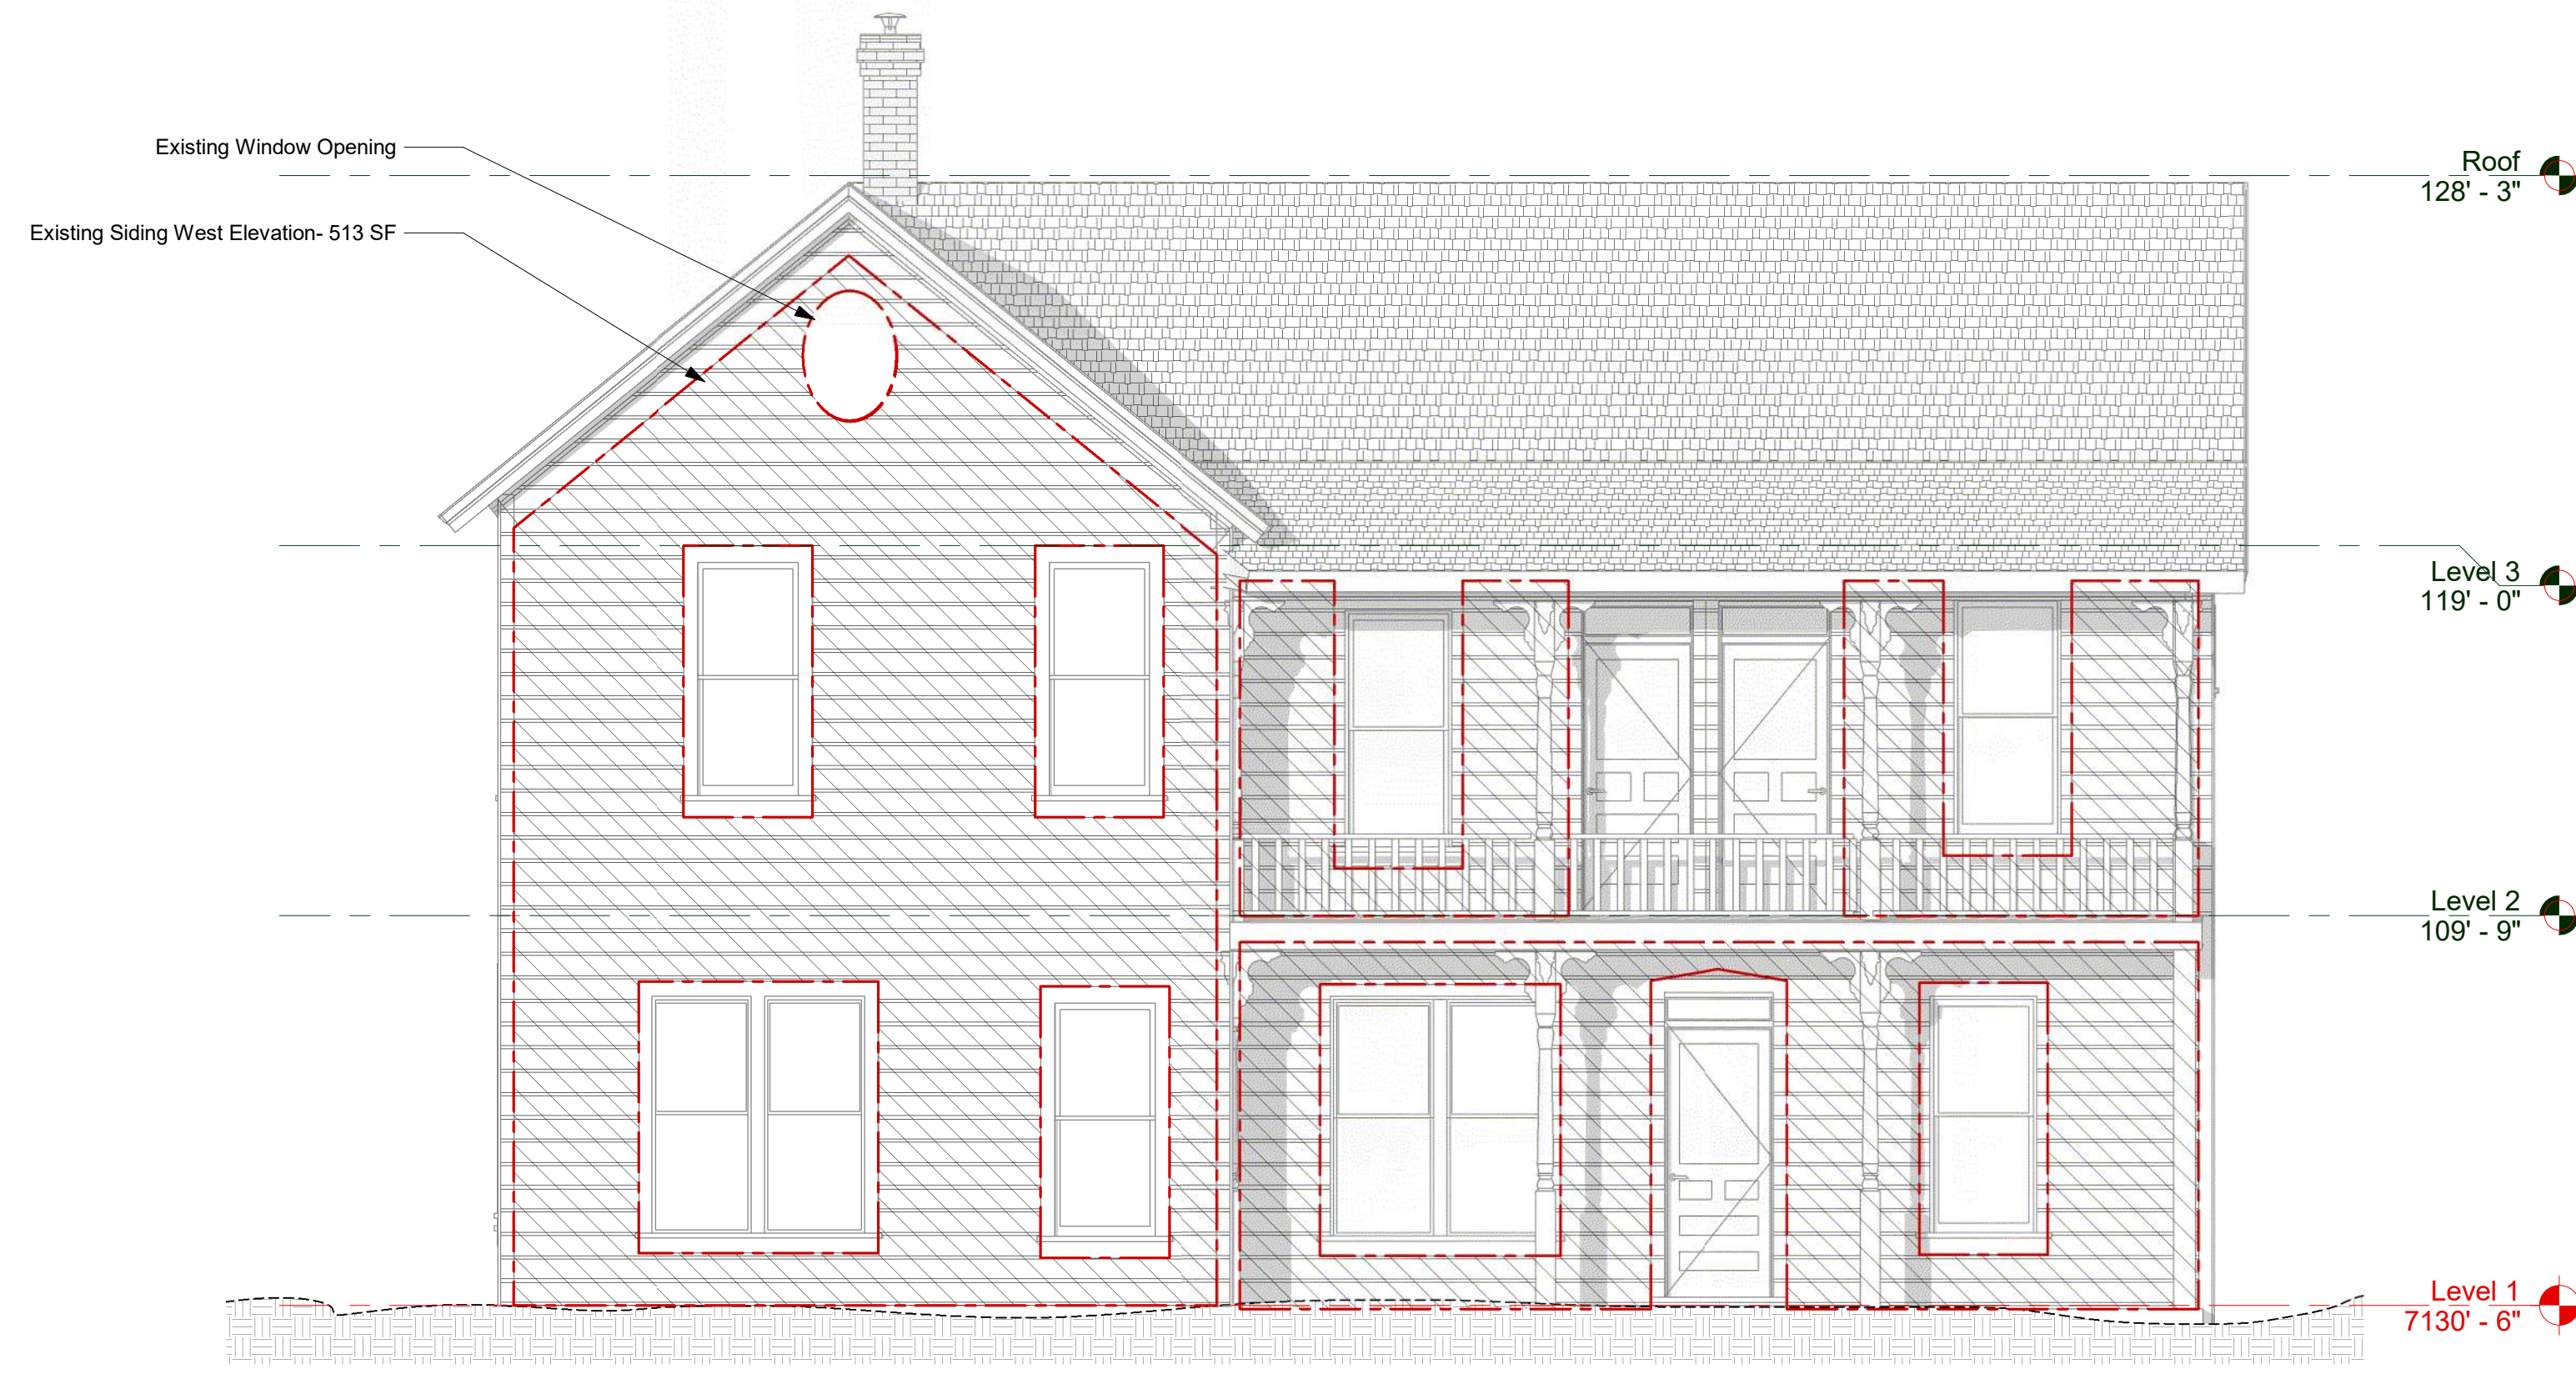
4 West Elevation - Siding
1/4" = 1'-0"

Late 1970's/ 80's Addition Removal	Salvaged Siding Diagram	Siding Calculation
■ Existing (1970s additions) to be Removed	■ Proposed wallprint of Addition to Historic Structure	Total Existing (Historic) Siding 2025 - 2,261 SF
■ Existing to Remain / Salvage	■ 1970s wallprint affecting 1907 Historic Structure	Total Siding Removed & Salvaged - 634 SF
■ Existing Questionable	■ Area of Infill available when removing 1970s addition	Total Siding Returned to Service - 138 SF
■ Fenestration added to Existing Structure		Total Salvaged Siding Removed - 496 SF
		% Siding Removed to when constructing Addition = 496sf / 2292sf = 21.9%

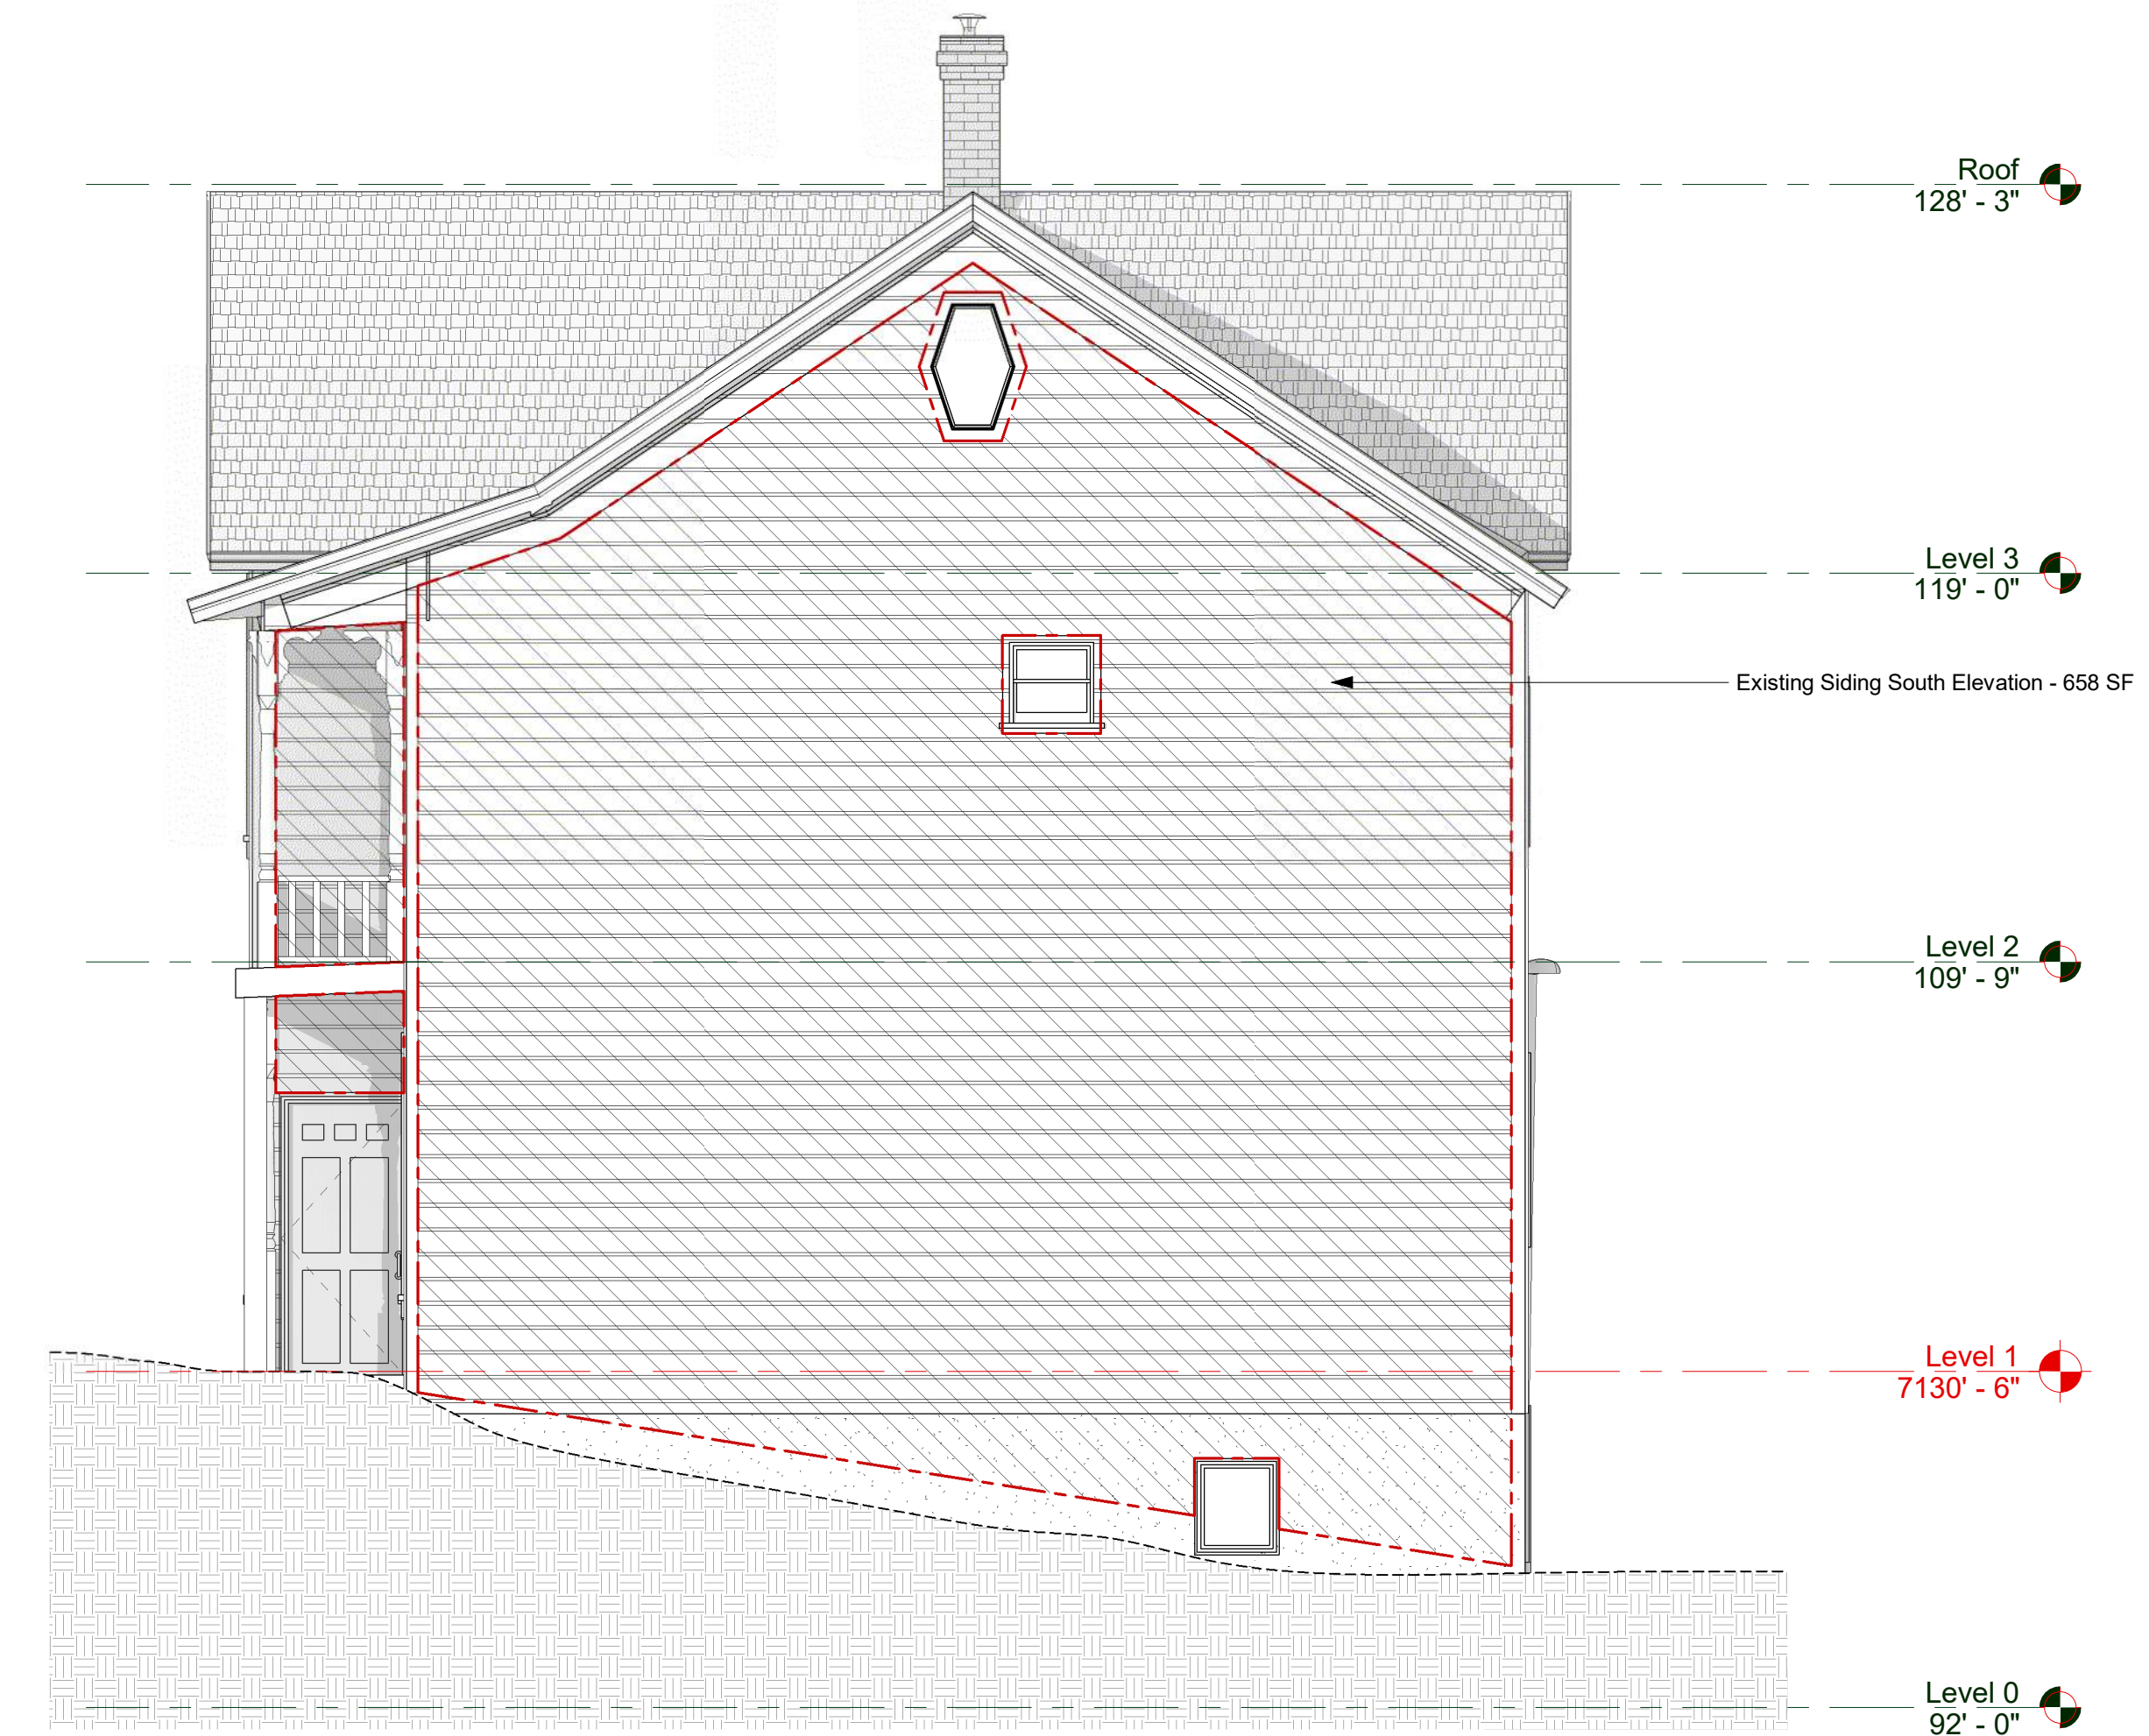
3 South Elevation - Siding
1/4" = 1'-0"

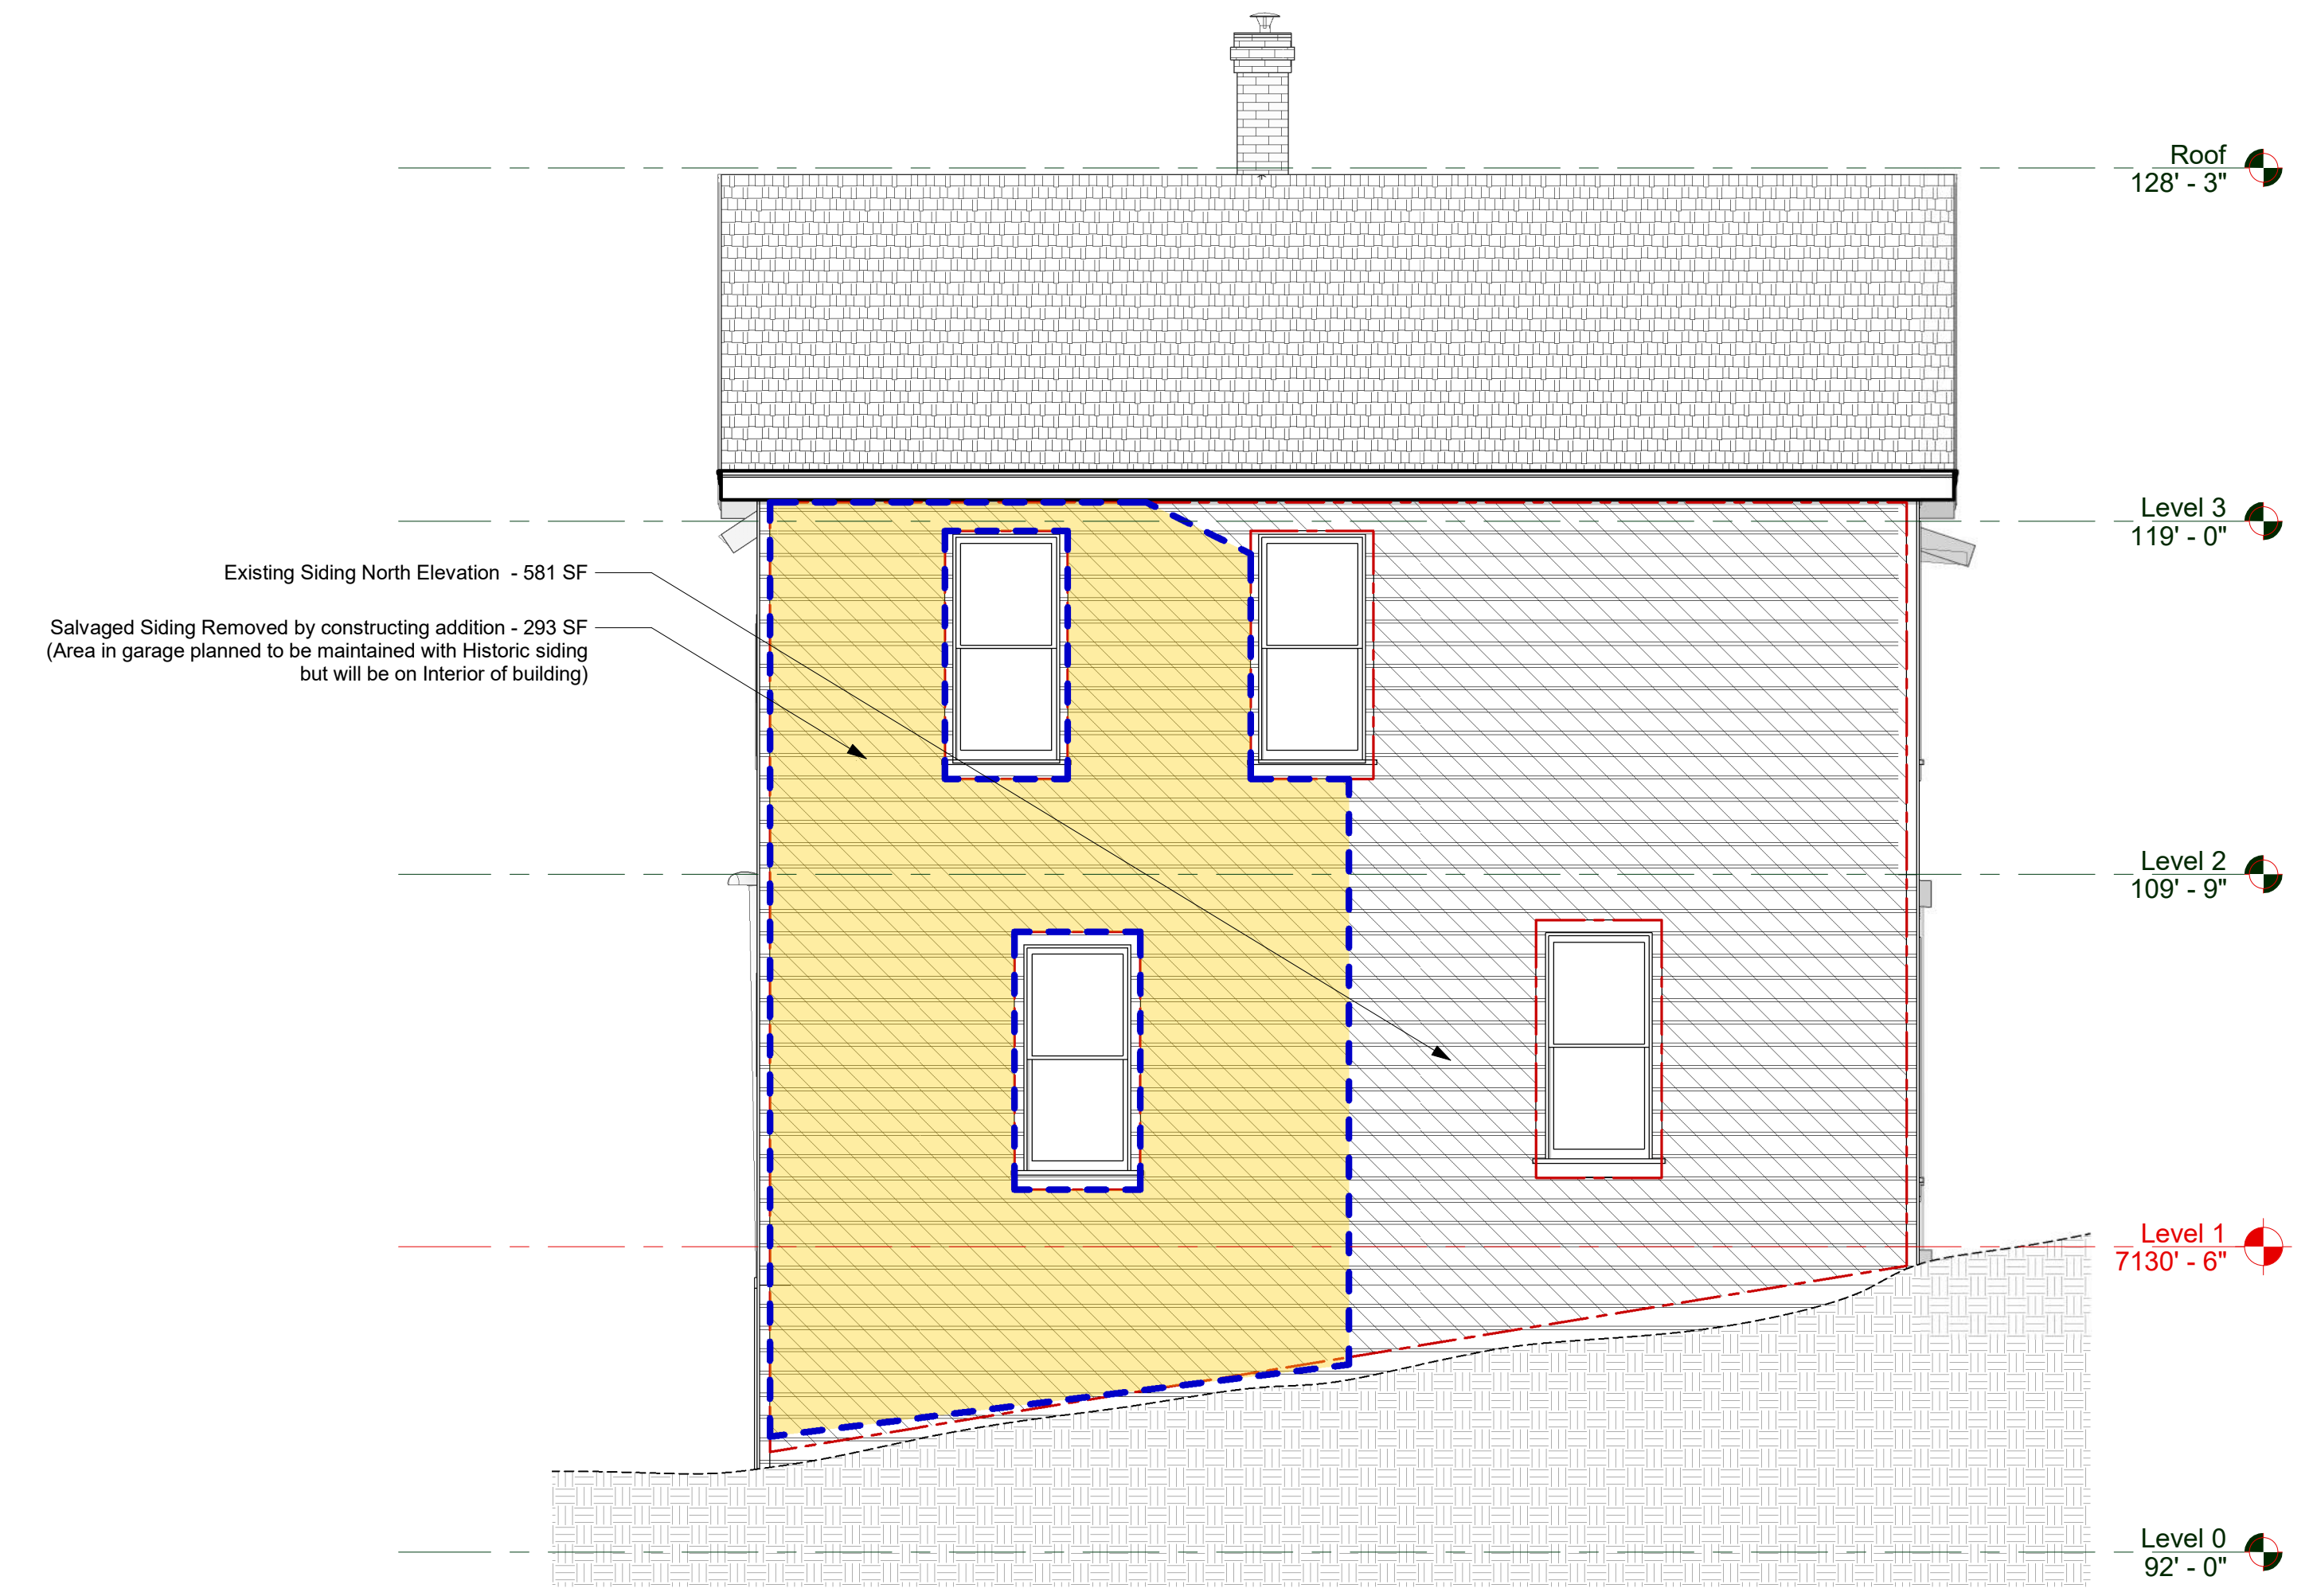
2 North Elevation - Siding
1/4" = 1'-0"

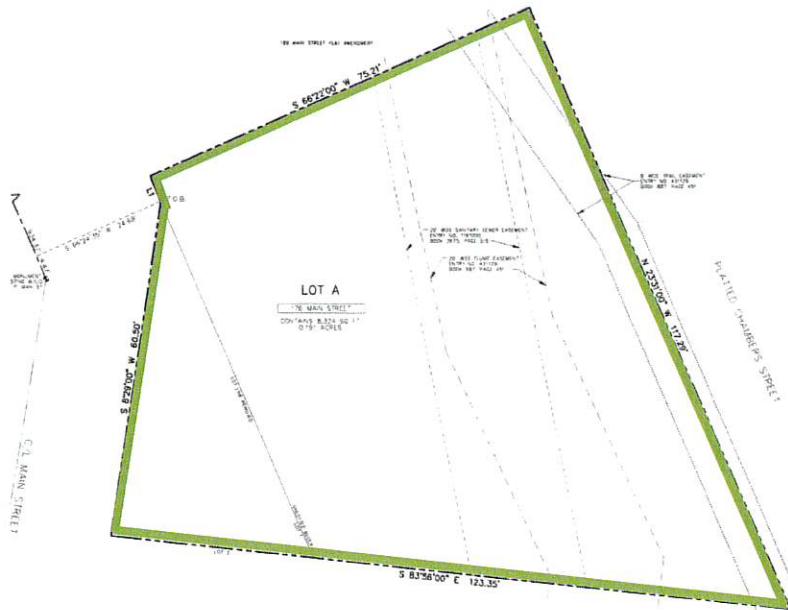
176 Main Street is a metes and bounds parcel located in Subzone B of the Historic Residential-2 Zoning District. The parcel is currently undergoing a Subdivision to create one Lot. 176 Main Street will have an unusual lot configuration due to its five (5) Lot Lines highlighted in green below on an excerpt from the Centennial Subdivision.

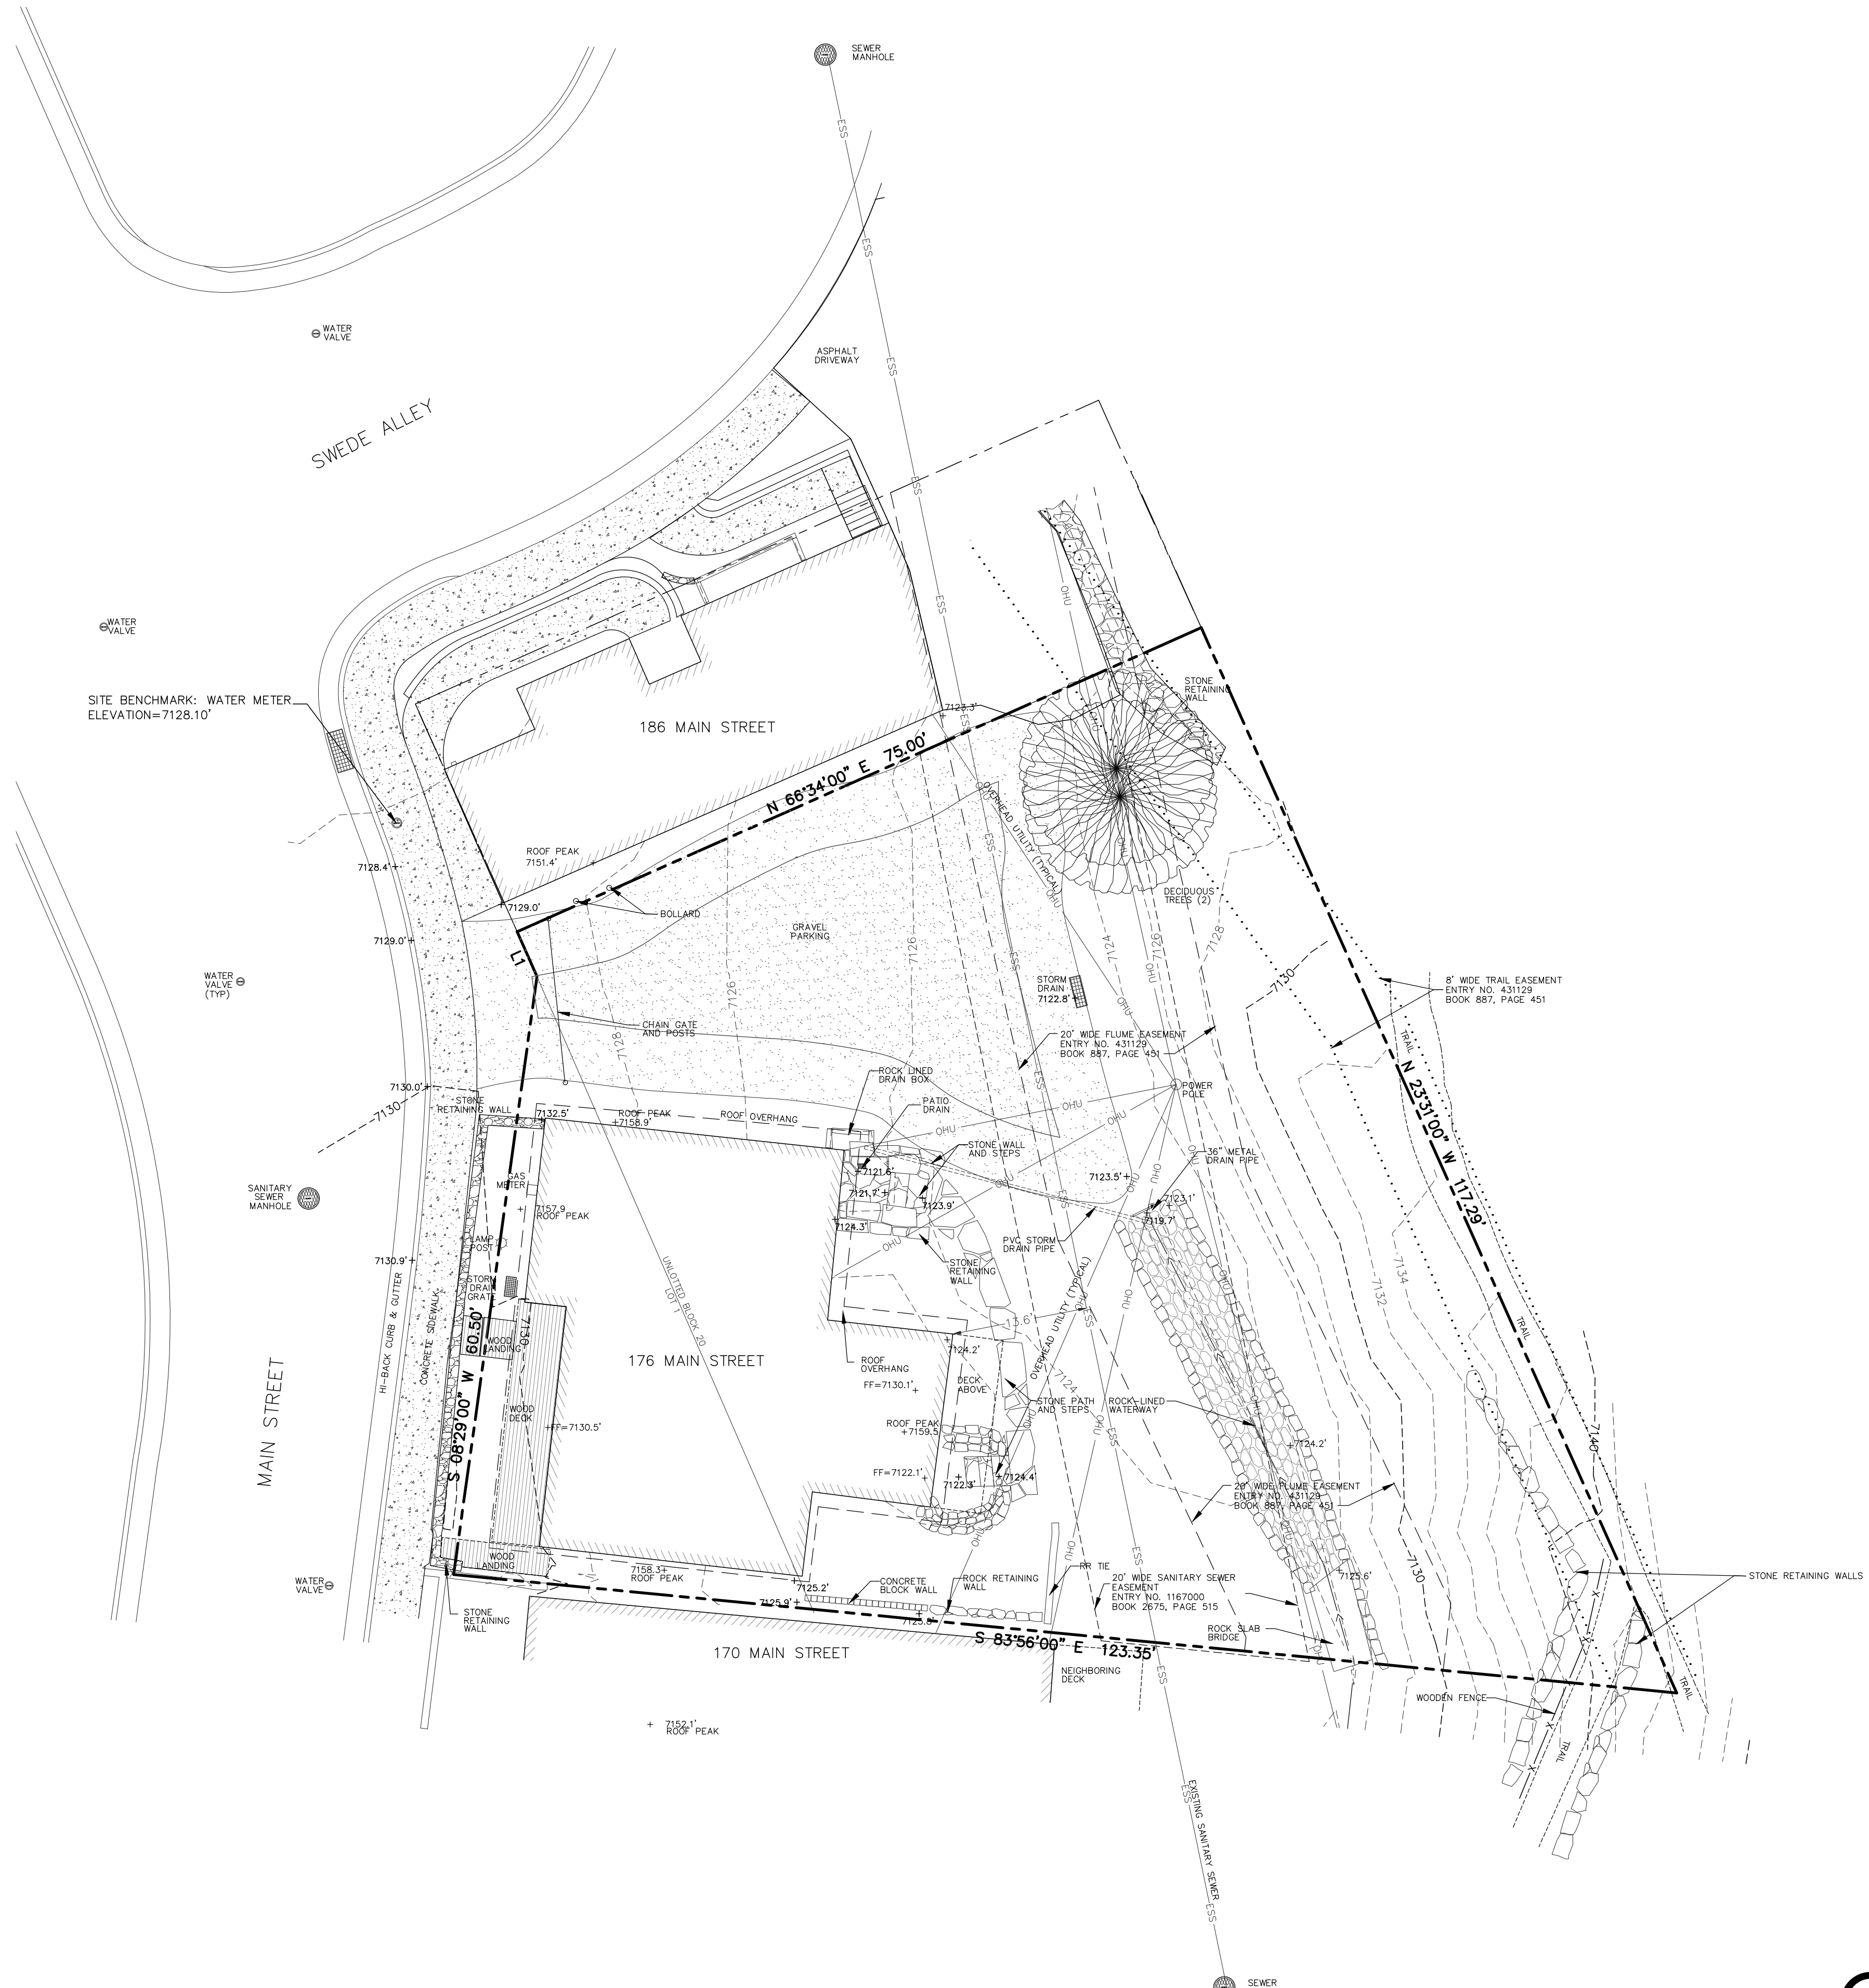
1. Site Benchmark: Water Meter, Elevation=7128.1'.
2. The architect is responsible for verifying building setbacks, zoning requirements and building heights.
3. 176 Main Street is parcel ID No. PC-262-A.

<p>435-649-9467</p> <p>ALLIANCE ENGINEERING</p> <p>CONSULTING ENGINEERS LAND PLANNERS SURVEYORS</p> <p>P.O. Box 2664 2700 West Homestead Road Suite 50, 60 Park City, Utah 84098</p>	<p>STAFF: MICHAEL DEMKOWICZ MARSHALL KING MEGAN BLOSSER</p>	<p>EXISTING CONDITIONS & TOPOGRAPHIC MAP 176 MAIN STREET</p>	<p>SHEET 1 OF 1</p>
	<p>DATE: 4/1/24</p>	<p>FOR: MOUNTAIN SEAS DEVELOPMENT, LTD.</p> <p>JOB NO.: 9-3-24</p> <p>FILE: X:\ParkCitySurvey\dwg\srvtopo2023\030820\030820.dwg</p>
