STREETS AND TRAFFIC SAFETY COMMITTEE MEETING

Traffic Safety Committee Staff Report

Subject: 2014 Traffic Volume and Accident Report
Author: City Engineer, Paul Rowland
Date: May 12, 2015

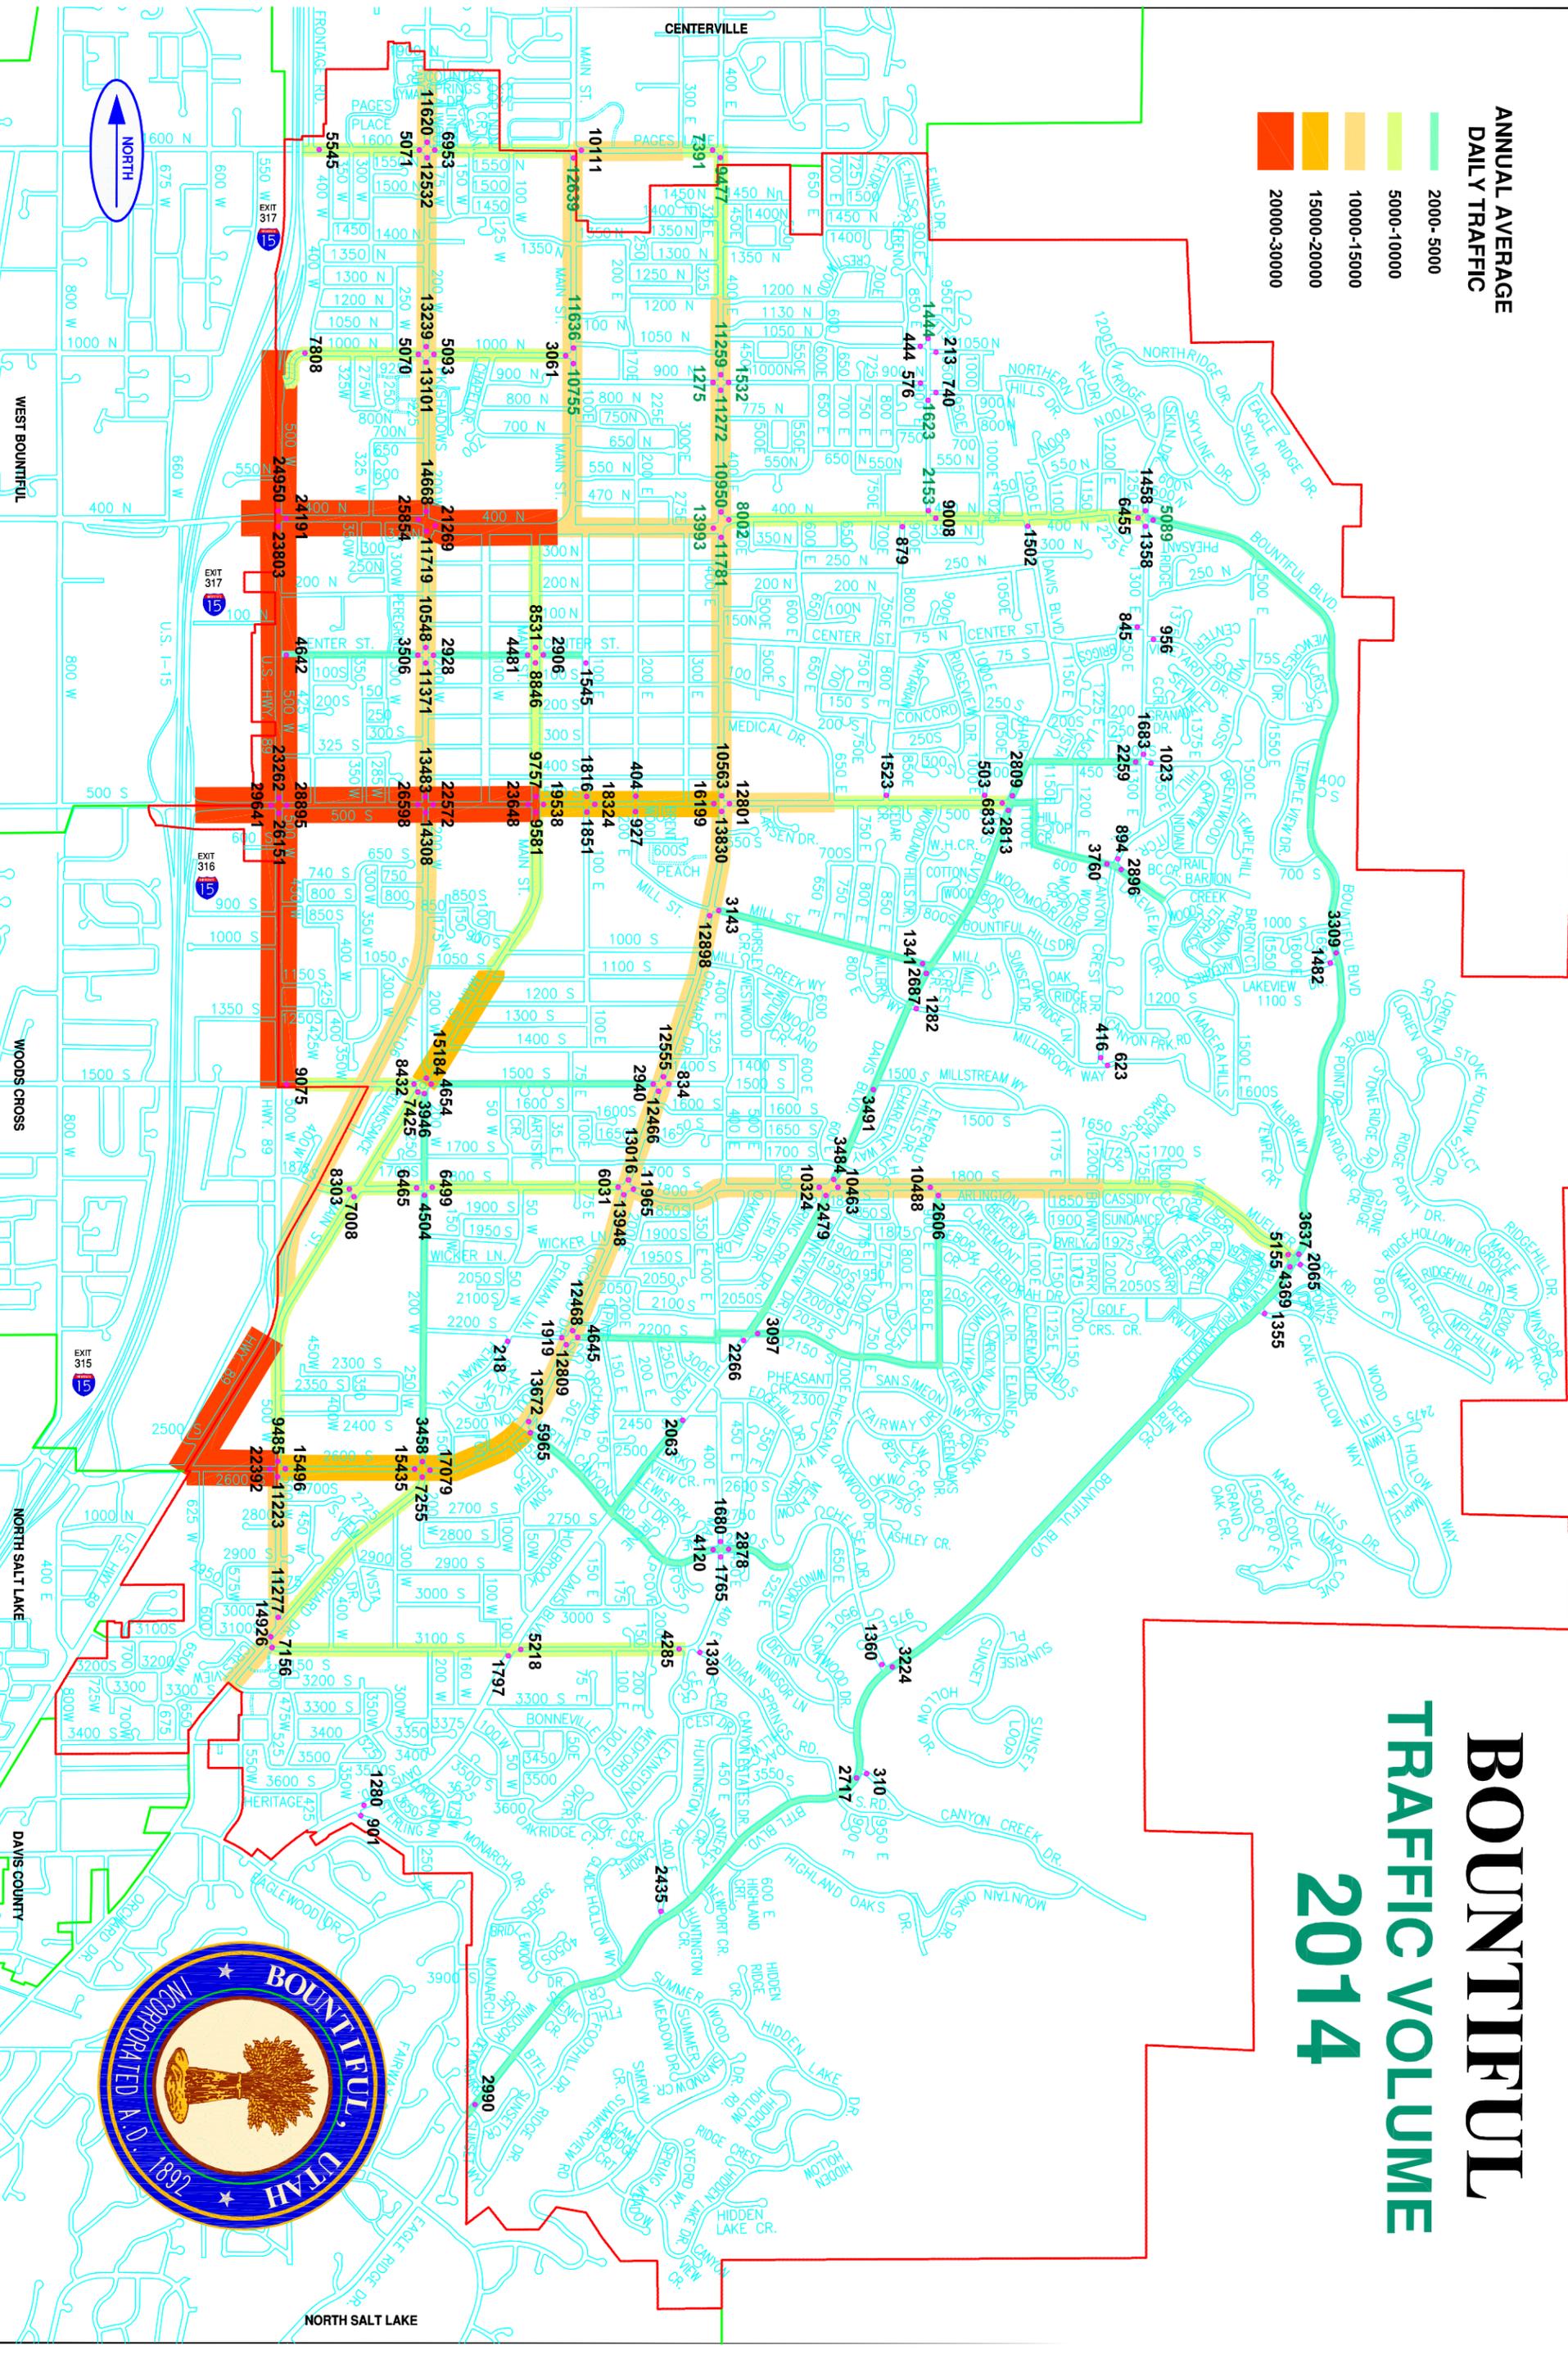
TRAFFIC VOLUME

2014

We have completed the review of the traffic volumes and traffic accidents for the 2014 calendar year. Enclosed is a copy of the Traffic Volume Map and the Traffic Accident Table for 2014.

On most streets the average traffic volumes in 2014 showed slight increases from the volumes experienced in 2013. The major east-west collectors that access I-15 all have had an increase with 500 South showing about a 10% increase. The other freeway access roads had smaller increases, but larger than most of the last decade. This is also the first year in many years that volumes have change on roads east of Orchard Drive/400 East. Bountiful Blvd. shows increases along the entire length except in the area right around the LDS Temple. Enclosed is a Traffic Volume Map for 2014. This map includes some of the updated traffic volumes on state highways, except that the counts we receive from the state DOT are always one year behind.

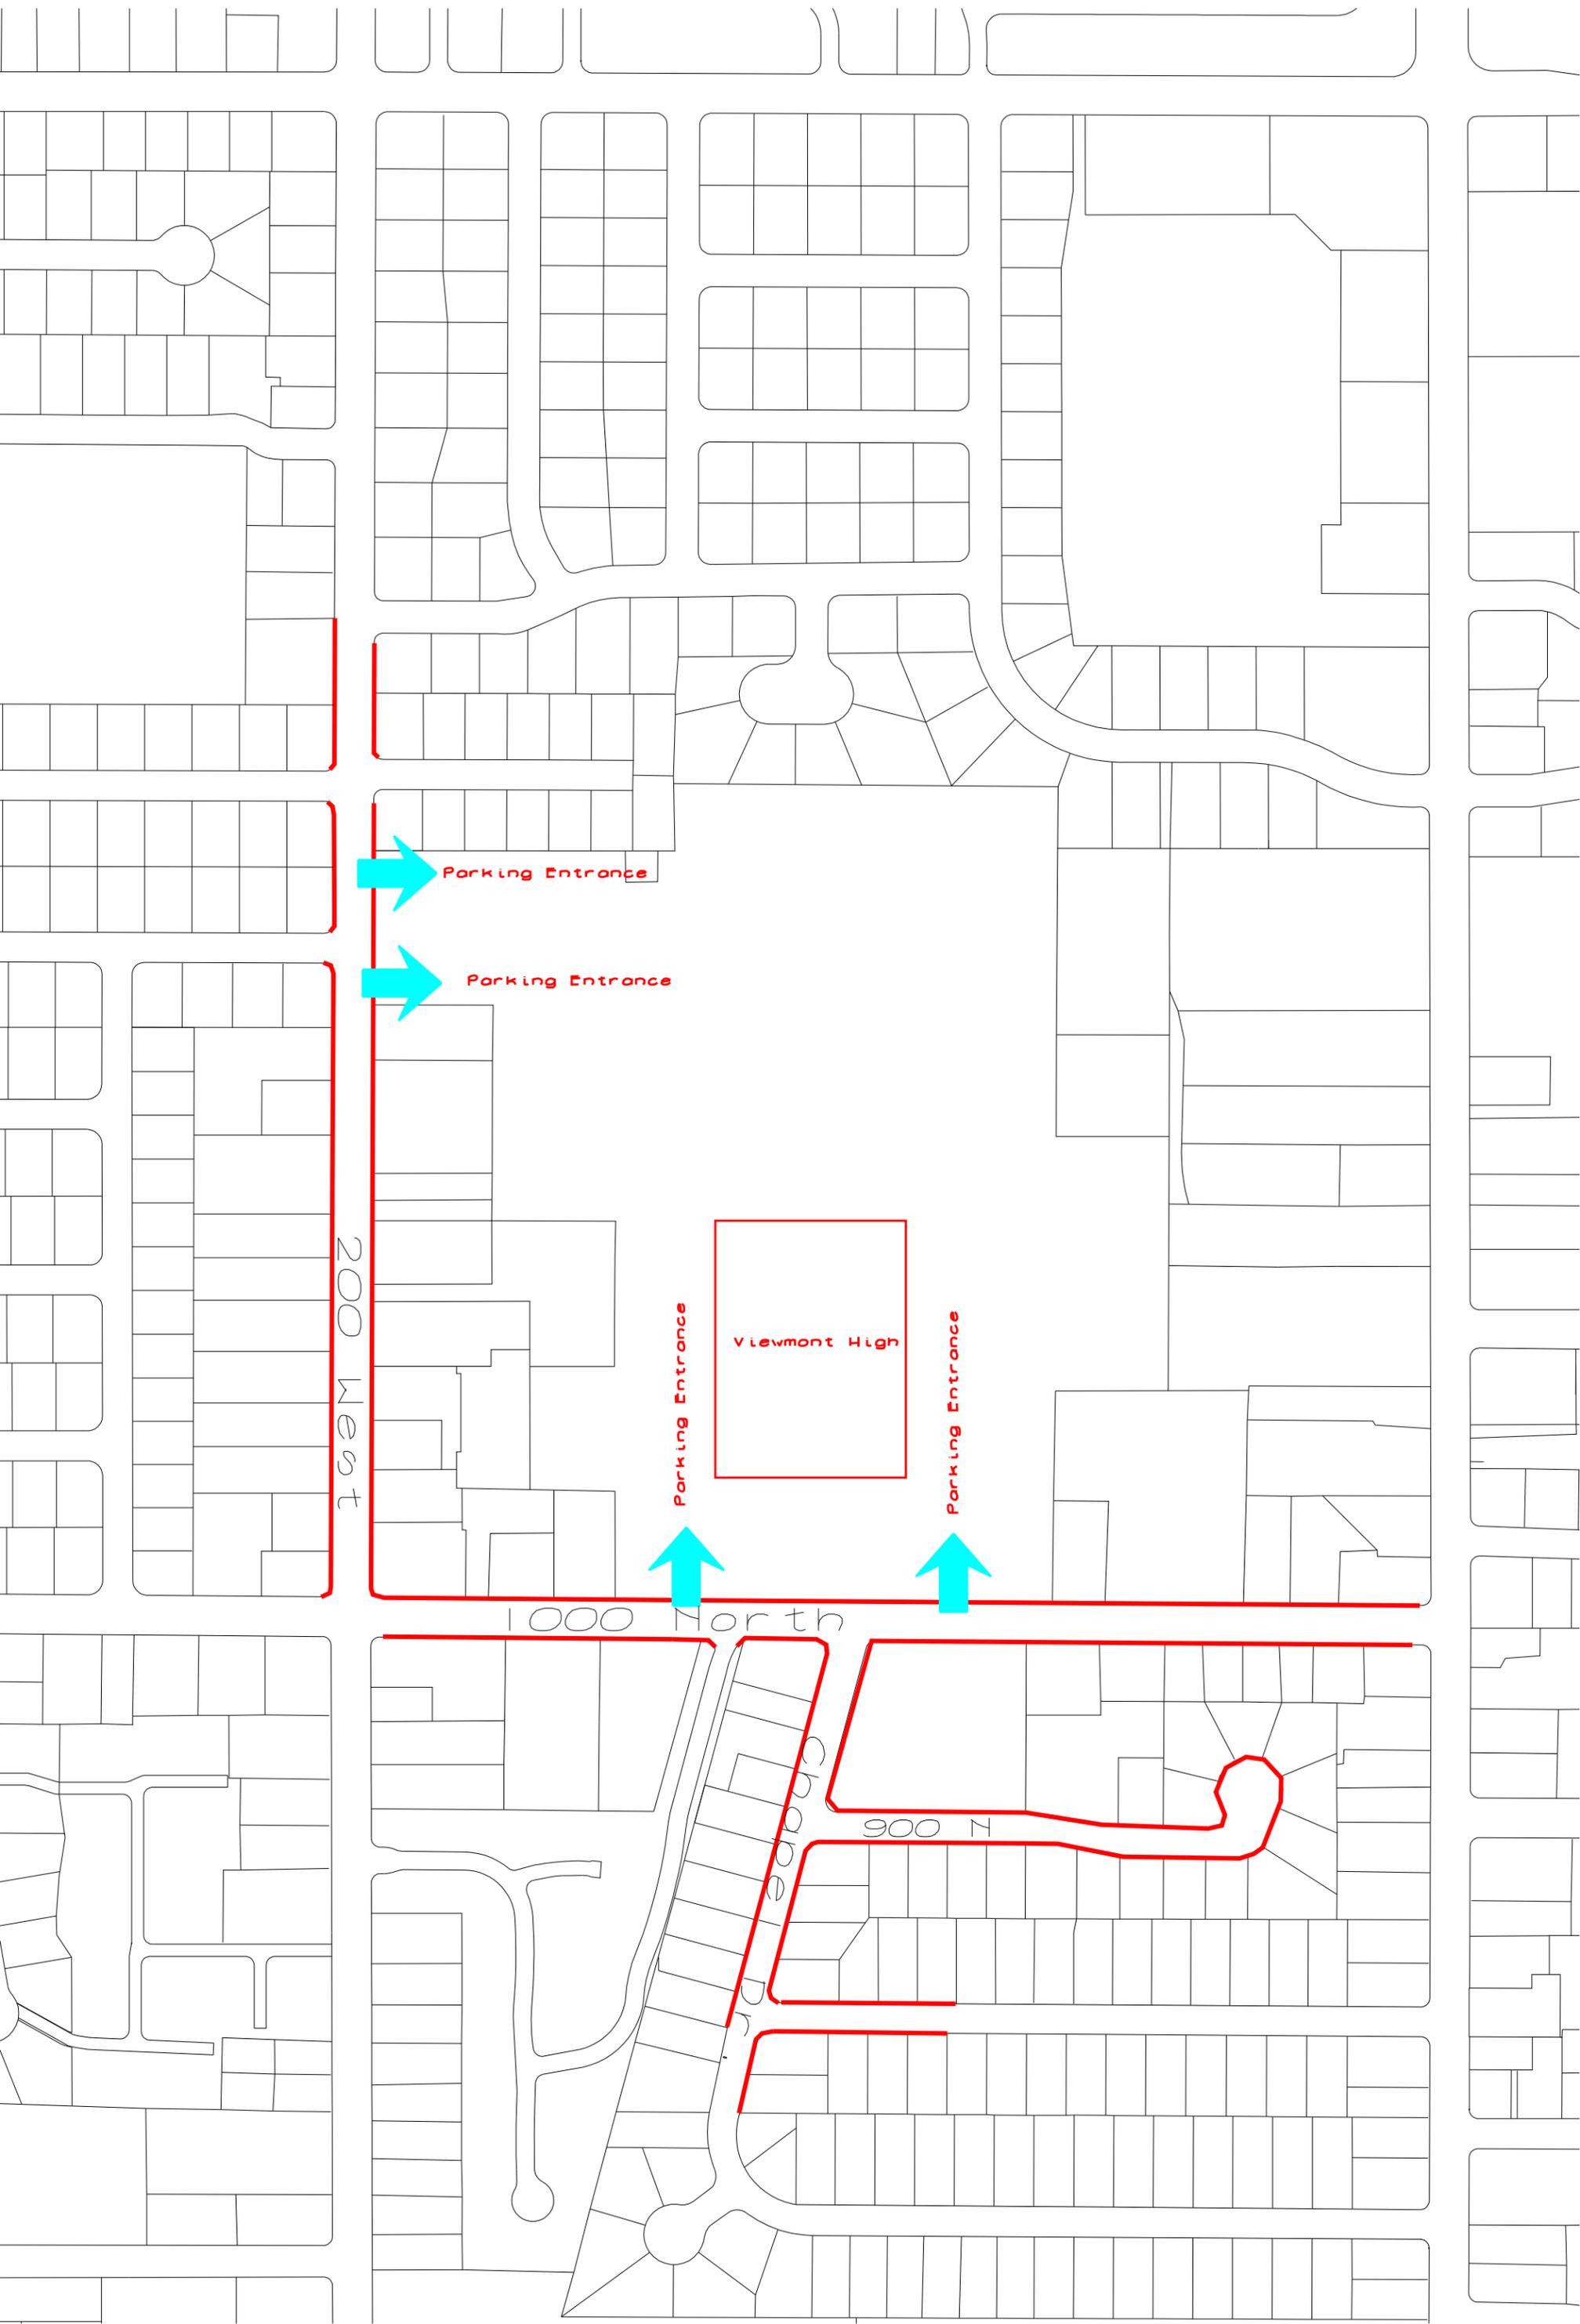
1. Map showing current school hour restricted parking areas.

200 West

Viewmont High
