ARROYO CROSSING - PHASE II INFRASTRUCTURE PROJECT
ADDENDUM #1 TO RFB

**FEASIBILITY LEVEL GEOTECHNICAL ENGINEERING
STUDY/DESIGN LEVEL PAVEMENT
RECOMMENDATIONS**

ARROYO CROSSING PROJECT

Prepared For:
Ms. Audrey Graham
Moab Area Community Land Trust
Project Number: 55599GE

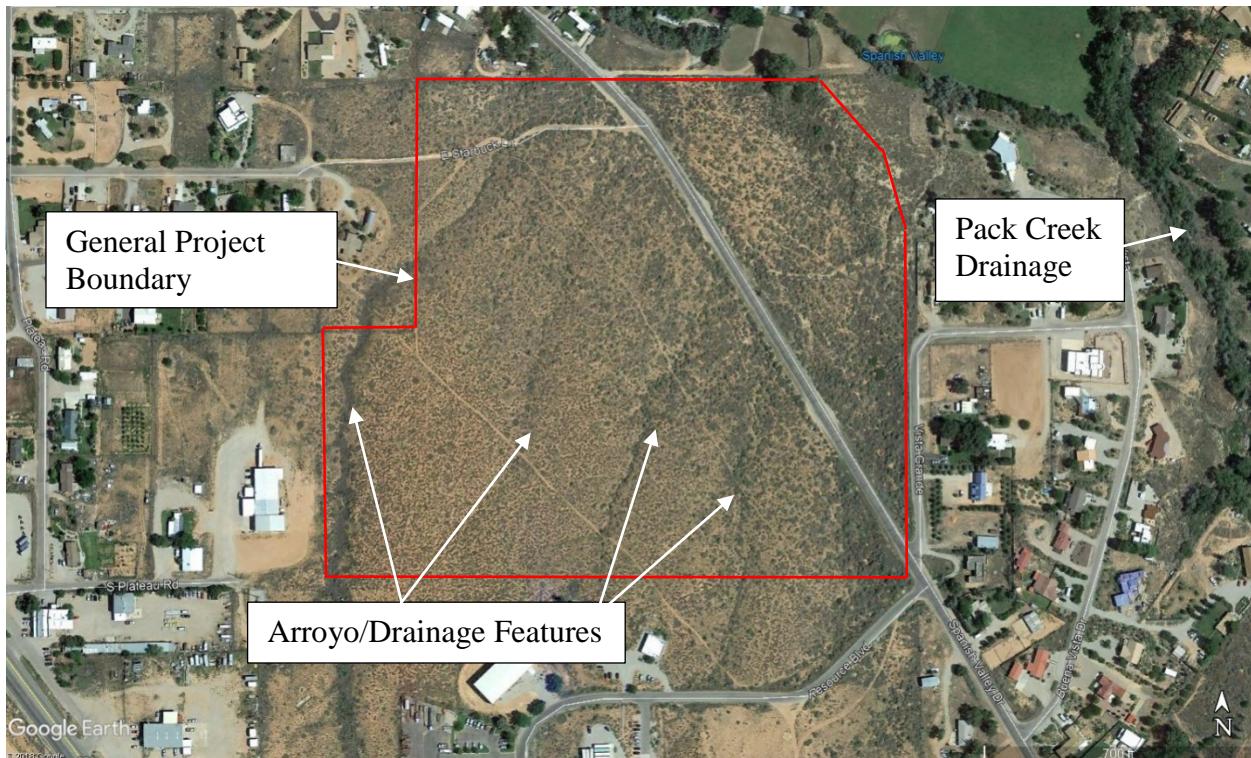
Figure 3.2: Site Characteristics

As discussed above, the project site is generally 60-acres in area. The approximate geometry of the project boundaries is shown on Figure 3.2 below. The project area currently consists of undeveloped land. The ground surface on the project site generally slopes down to the northeast with slope inclinations in the range of about 10:1; horizontal to vertical (h:v) to 15:1; h:v with interspersed areas with little to no slope inclination. Numerous shallow to moderate sized arroyo's/drainages run through the project site with a gradient down to the northeast. The depth of the drainage features range from about 5 to 15 feet with side slope inclinations in the range of about 5:1; h:v. Pack Creek is located below and to the east-northeast of the subject property.

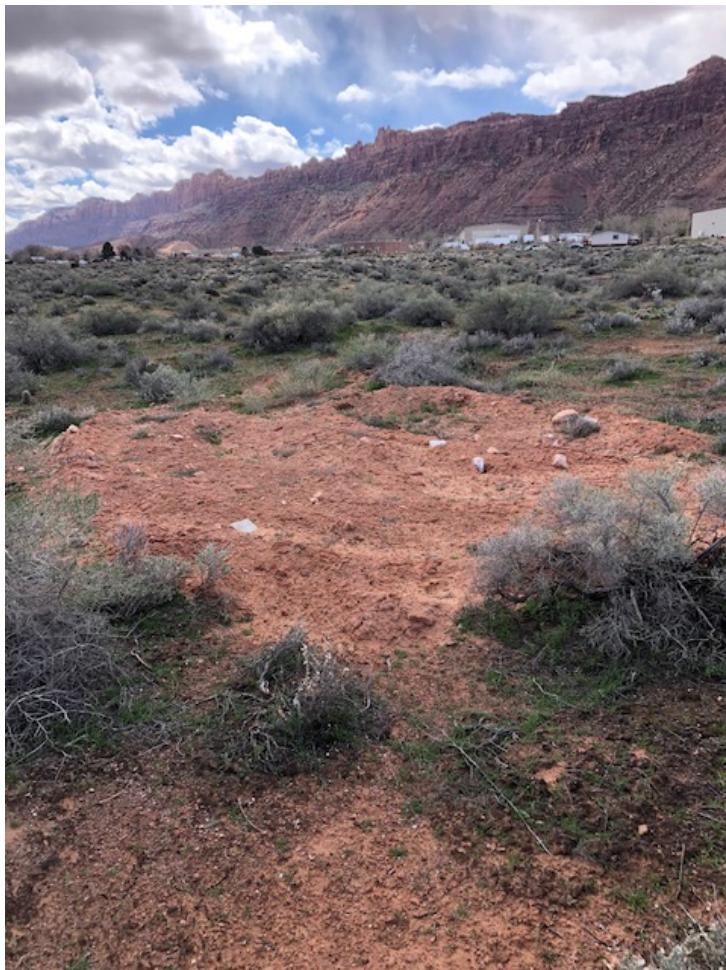
Photograph of Previously Excavated Test Hole

We observed numerous test holes throughout the project site, likely excavated for a previous geotechnical engineering study. We do not know the particulars of the test holes regarding the disturbed area and depth of the test holes. We recommend that information regarding the test holes be obtained such as the logs of the test holes and any photographs that may be available to help further assess the limits and depths of the previous disturbance. The locations of the previously excavated test holes should be mapped/surveyed in the near future for future identification as the development progresses. We anticipate that the soil backfill within the test holes was not monitored for compaction and may exhibit a high consolidation potential. The test holes will need to be re-excavated to the previous bottom of the test holes and carefully backfilled (placement of compacted fill materials is generally discussed later in this report). We recommend that the backfill placement and compaction be carefully monitored. A photograph of one of the test hole locations that we observed is provided below.

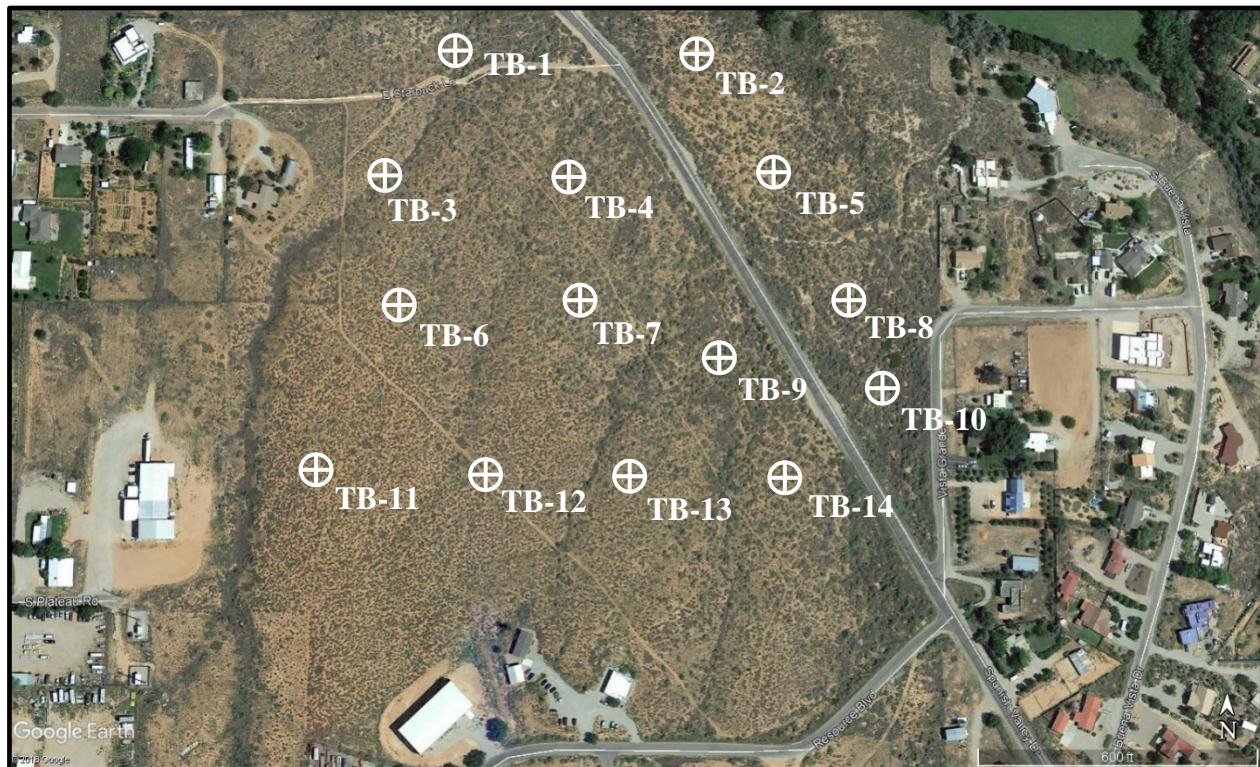
Figure 3.3: Approximate Test Boring Locations Relative to Google Earth Imagery

The approximate test boring locations shown on the figures above were prepared using notes taken during the field work and are intended to show the approximate test boring locations for reference purposes only. We marked each of the test boring locations in the field if it is desired to obtain surveyed locations of the borings.

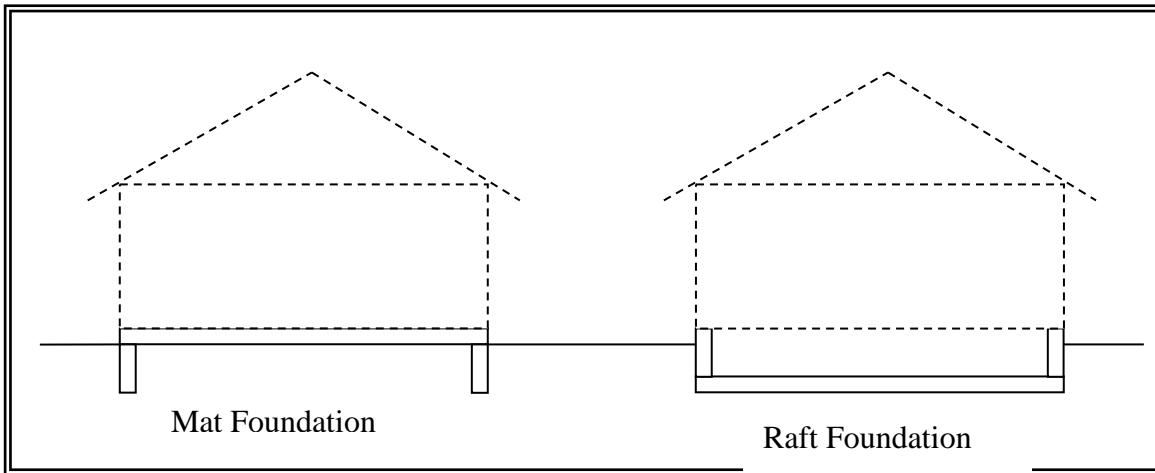
Mat or raft foundations are commonly used to support structures on sites with soft and/or wet soil conditions. The design concepts of either system are similar, but their configurations are slightly different. This is shown in the sketch below.

Depending on the subsurface conditions, the depth of the support elevation of a raft foundation may be varied as needed to alter the design capacity of the system.

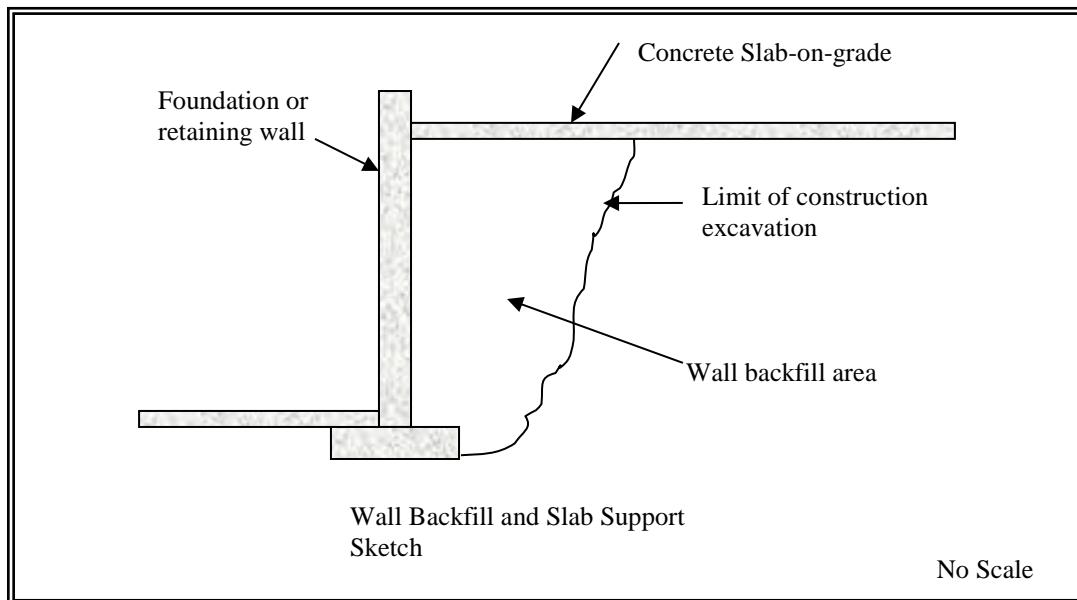
It is relatively common that both interior and exterior concrete flatwork is supported by areas of fill adjacent to either shallow foundation walls or basement retaining walls. A typical sketch of this condition is shown below.

Settlement of the backfill shown above will create a void and lack of soil support for the portions of the slab over the backfill. Settlement of the fill supporting the concrete flatwork is likely to cause damage to the slab-on-grade. Settlement and associated damage to the concrete flatwork may occur when the backfill is relatively deep, even if the backfill is compacted.

If this condition is likely to exist on this site it may be prudent to design the slab to be structurally supported on the retaining or foundation wall and designed to span to areas away from the backfill area as designed by the project structural engineer.

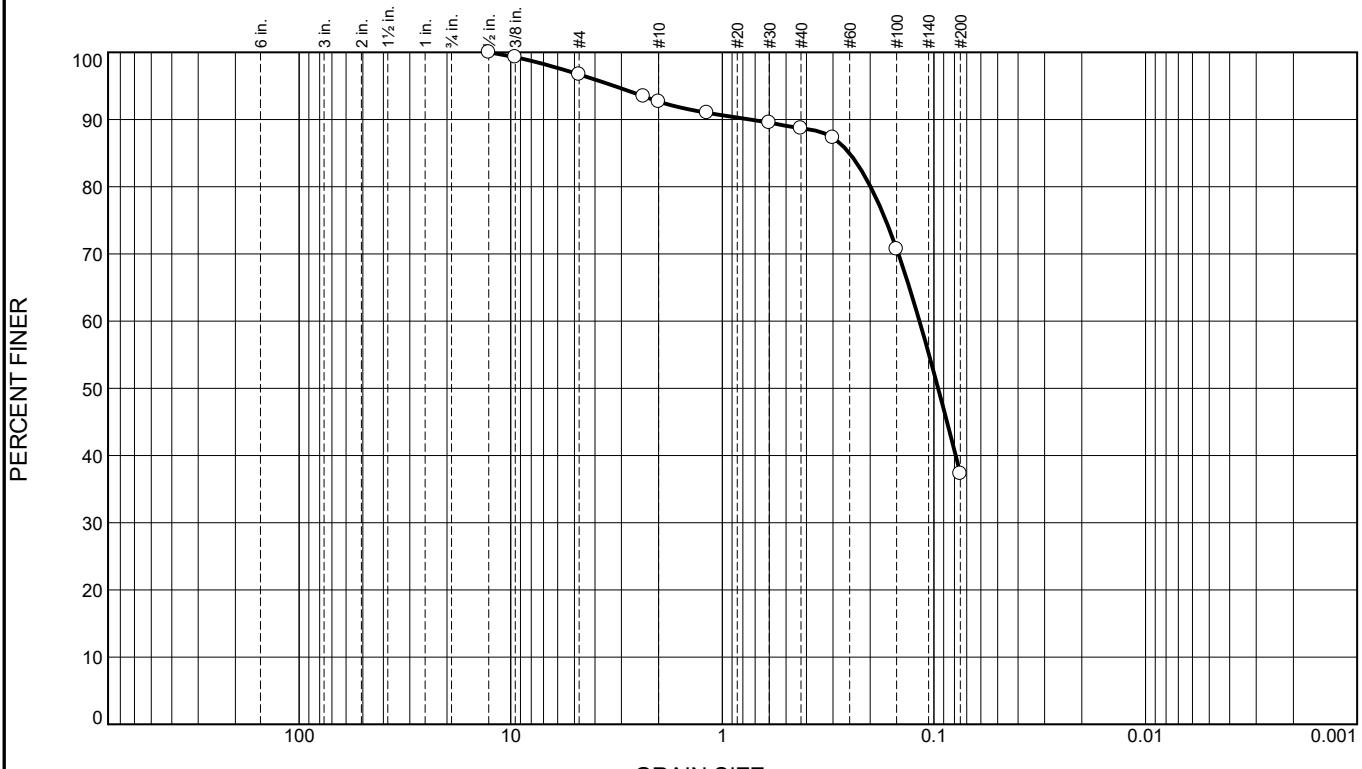
Particle Size Distribution Report

SIEVE SIZE	PERCENT FINER	SPEC.* PERCENT	PASS? (X=NO)
.50	100.0		
.375	99.3		
#4	96.7		
#8	93.5		
#10	92.7		
#16	91.0		
#30	89.5		
#40	88.7		
#50	87.3		
#100	70.7		
#200	37.3

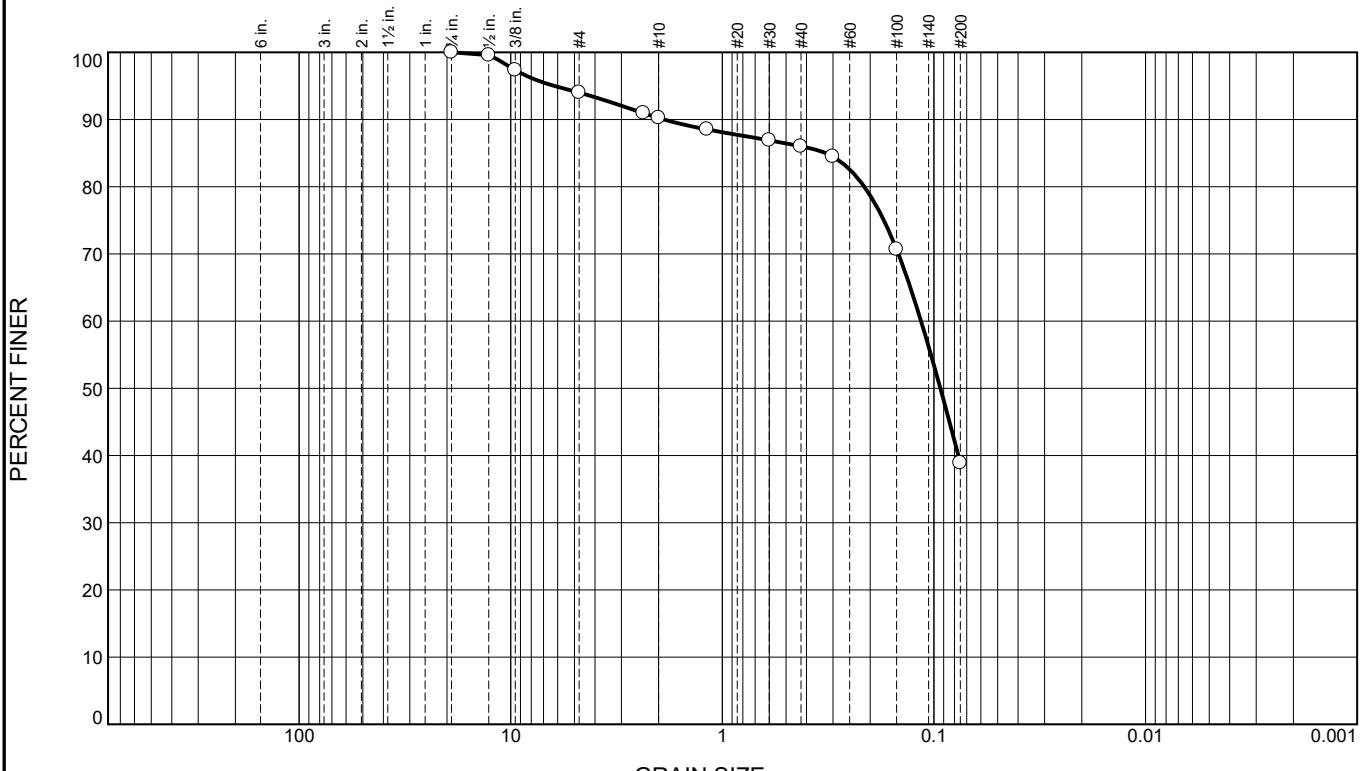
Particle Size Distribution Report

SIEVE SIZE	PERCENT FINER	SPEC.* PERCENT	PASS? (X=NO)
.75	100.0		
.50	99.6		
.375	97.3		
#4	94.0		
#8	91.0		
#10	90.2		
#16	88.5		
#30	86.9		
#40	86.0		
#50	84.5		
#100	70.7		
#200	38.9

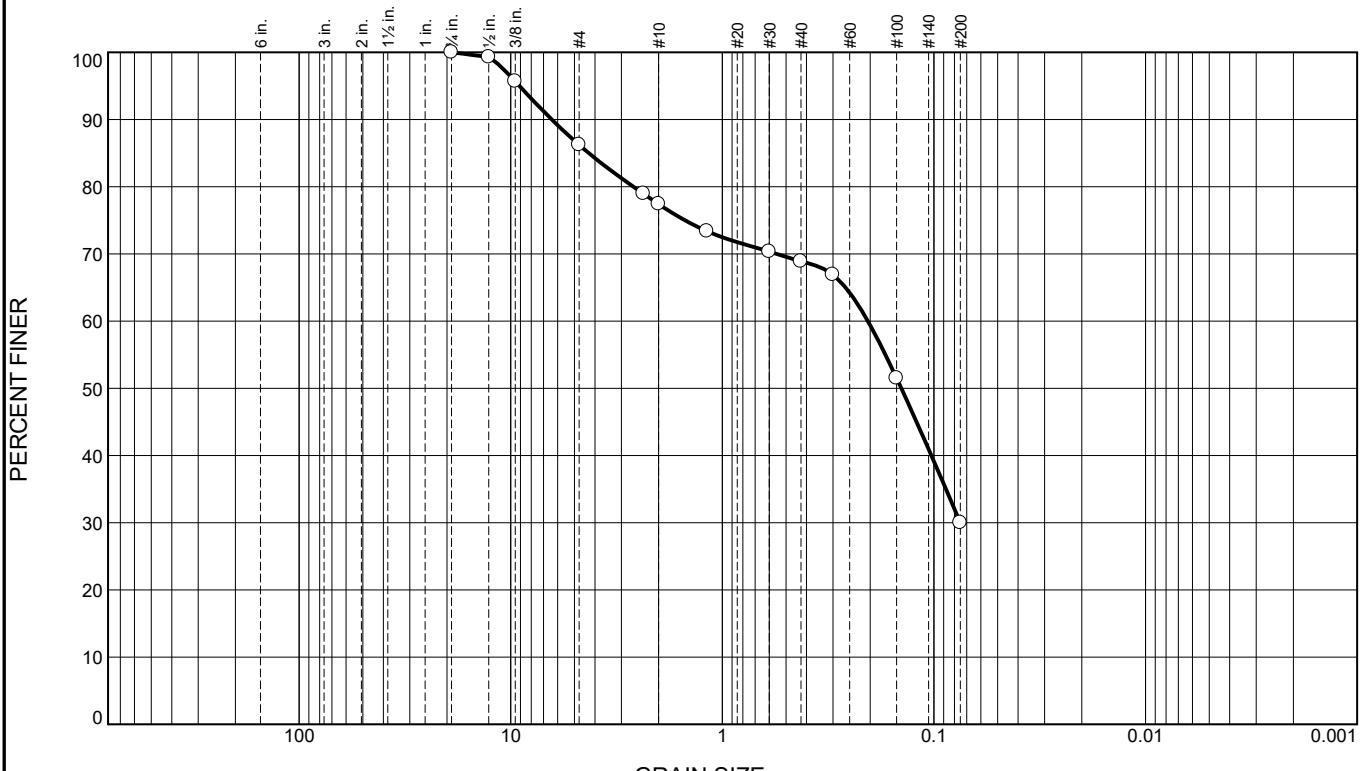
Particle Size Distribution Report

SIEVE SIZE	PERCENT FINER	SPEC.* PERCENT	PASS? (X=NO)
.75	100.0		
.50	99.3		
.375	95.7		
#4	86.2		
#8	79.0		
#10	77.4		
#16	73.4		
#30	70.3		
#40	68.9		
#50	66.9		
#100	51.5		
#200	30.0

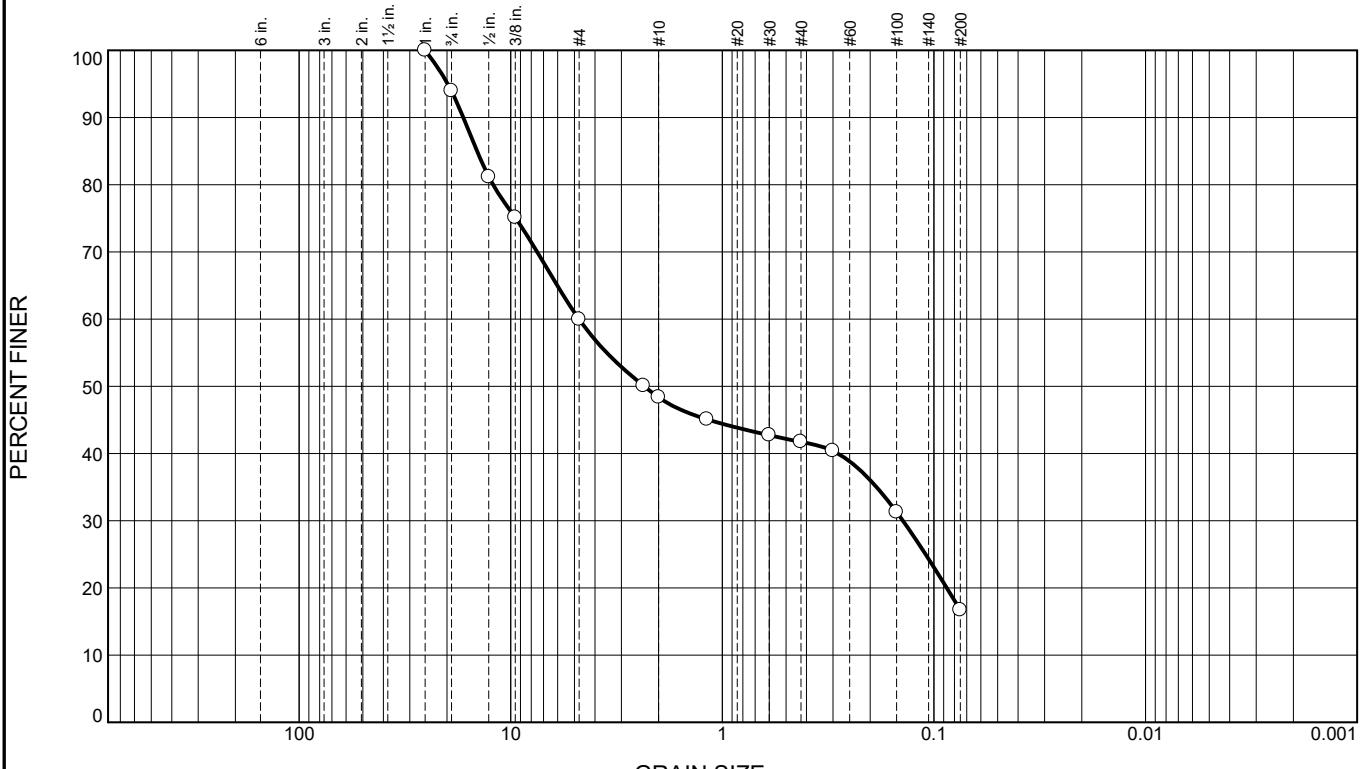
Particle Size Distribution Report

SIEVE SIZE	PERCENT FINER	SPEC.* PERCENT	PASS? (X=NO)
1.0	100.0		
.75	94.0		
.50	81.1		
.375	75.1		
#4	60.0		
#8	50.1		
#10	48.4		
#16	45.1		
#30	42.7		
#40	41.7		
#50	40.4		
#100	31.3		
#200	16.7

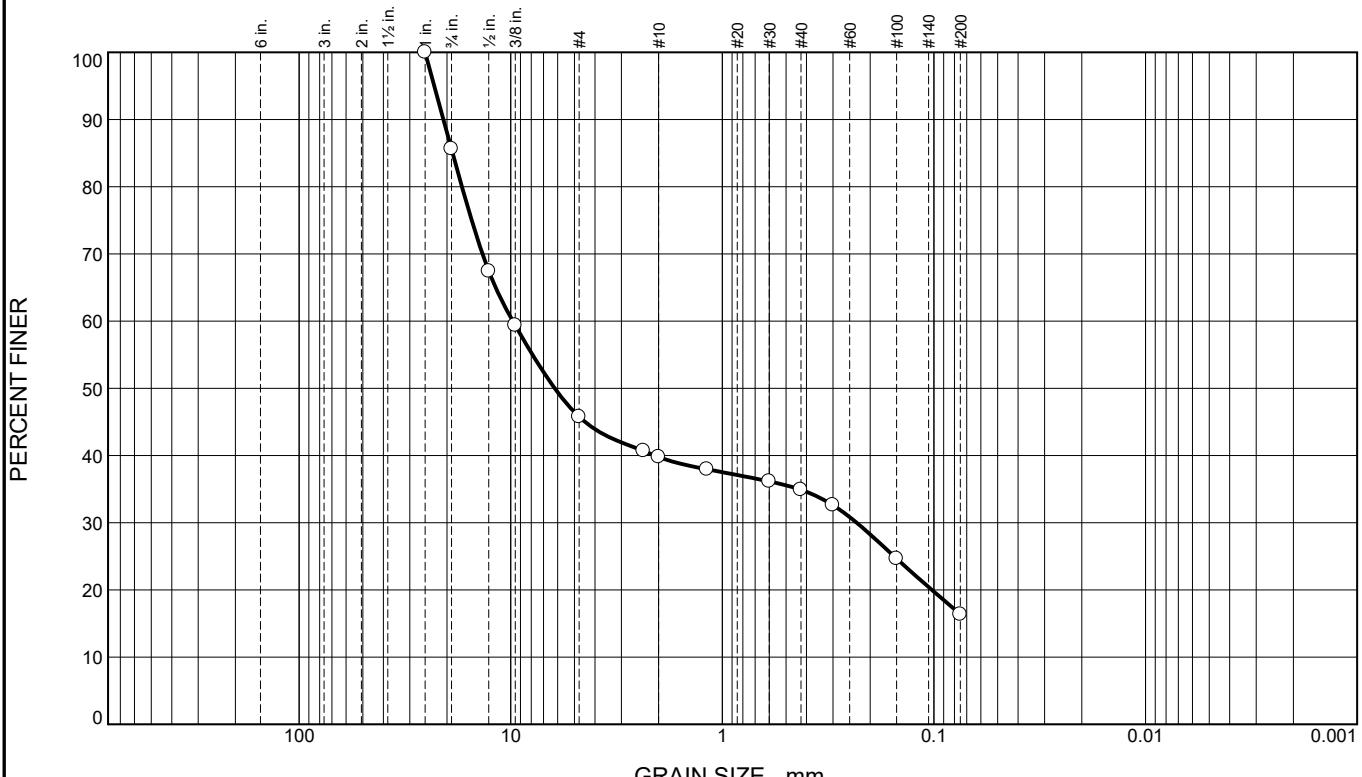
Particle Size Distribution Report

SIEVE SIZE	PERCENT FINER	SPEC.* PERCENT	PASS? (X=NO)
1.0	100.0		
.75	85.6		
.50	67.4		
.375	59.4		
#4	45.8		
#8	40.7		
#10	39.8		
#16	37.9		
#30	36.1		
#40	34.9		
#50	32.6		
#100	24.7		
#200	16.4

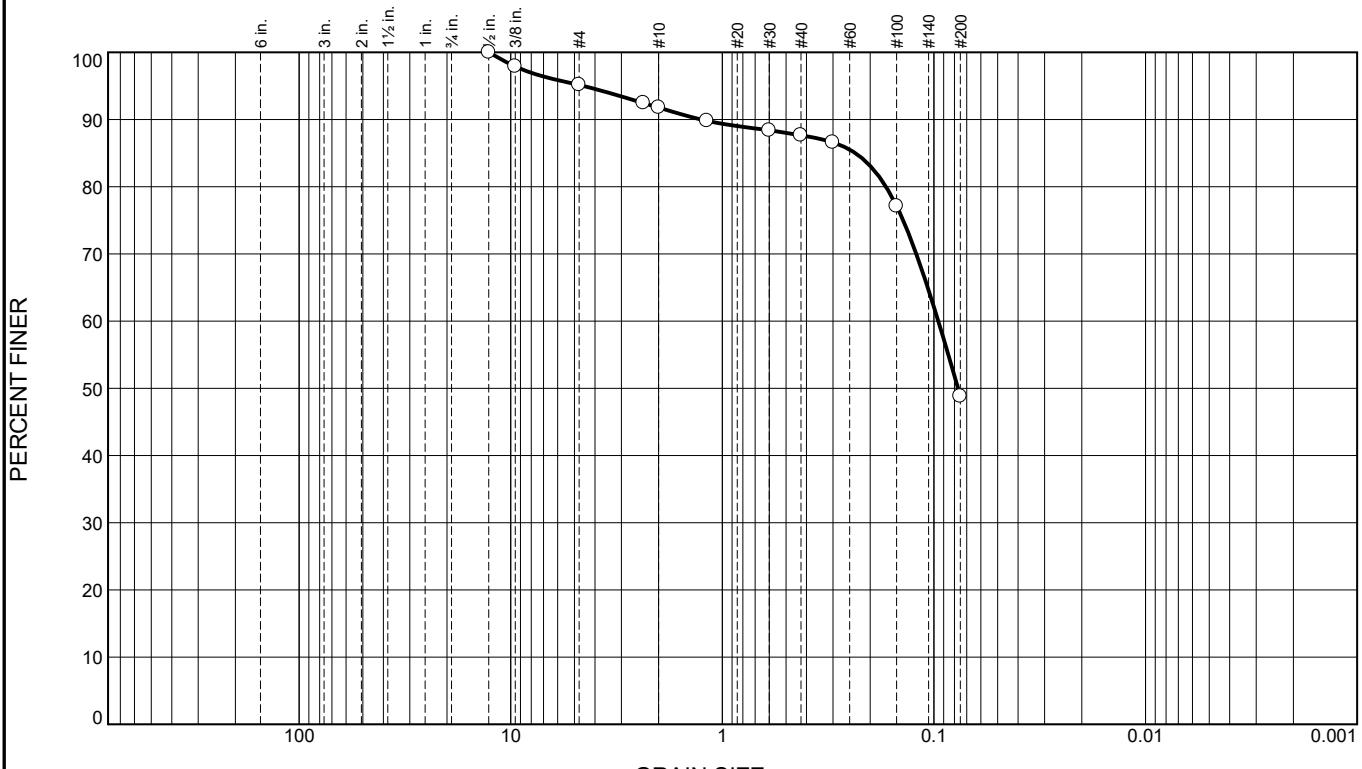
Particle Size Distribution Report

% +3"	% Gravel		% Sand			% Fines	
	Coarse	Fine	Coarse	Medium	Fine	Silt	Clay
	0.0	0.0	3.3	4.2	38.8	48.8

SIEVE SIZE	PERCENT FINER	SPEC.* PERCENT	PASS? (X=NO)
.50	100.0		
.375	97.9		
#4	95.1		
#8	92.4		
#10	91.8		
#16	89.8		
#30	88.4		
#40	87.6		
#50	86.6		
#100	77.1		
#200	48.8

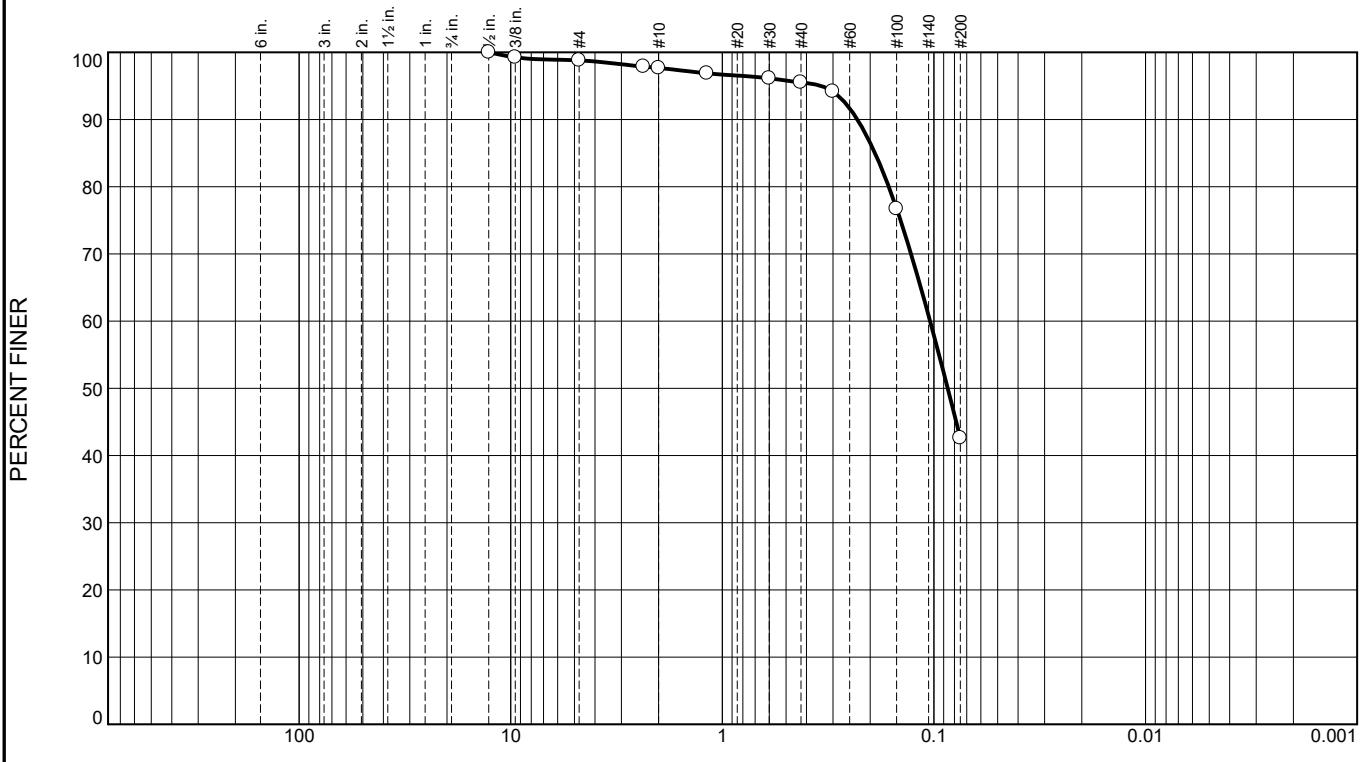
Particle Size Distribution Report

% +3"	% Gravel		% Sand			% Fines	
	Coarse	Fine	Coarse	Medium	Fine	Silt	Clay
	0.0	0.0	1.1	2.2	52.9	42.6

SIEVE SIZE	PERCENT FINER	SPEC.* PERCENT	PASS? (X=NO)
.50	100.0		
.375	99.3		
#4	98.8		
#8	97.9		
#10	97.7		
#16	96.9		
#30	96.1		
#40	95.5		
#50	94.2		
#100	76.7		
#200	42.6

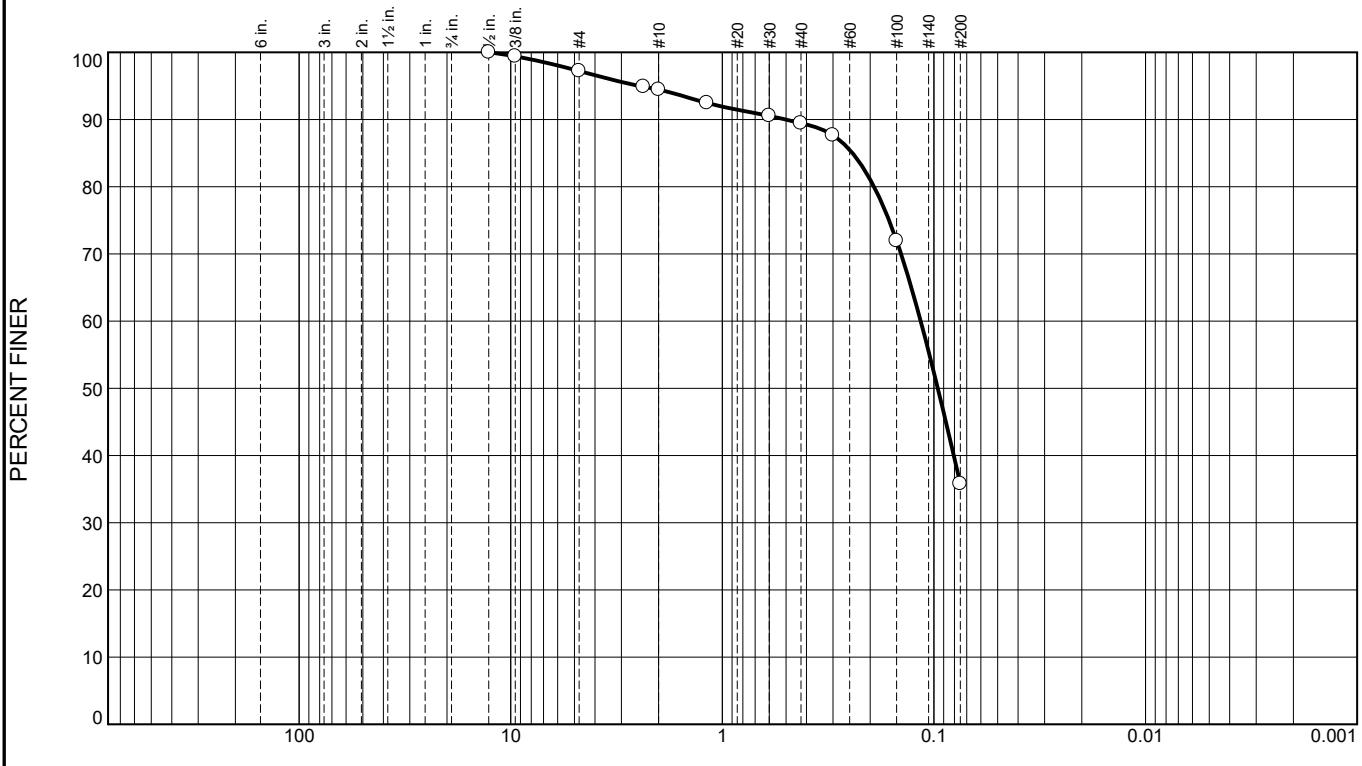
Particle Size Distribution Report

% +3"	% Gravel		% Sand			% Fines	
	Coarse	Fine	Coarse	Medium	Fine	Silt	Clay
	0.0	0.0	2.8	2.8	4.9	53.7	35.8

SIEVE SIZE	PERCENT FINER	SPEC.* PERCENT	PASS? (X=NO)
.50	100.0		
.375	99.4		
#4	97.2		
#8	94.9		
#10	94.4		
#16	92.5		
#30	90.5		
#40	89.5		
#50	87.7		
#100	71.9		
#200	35.8

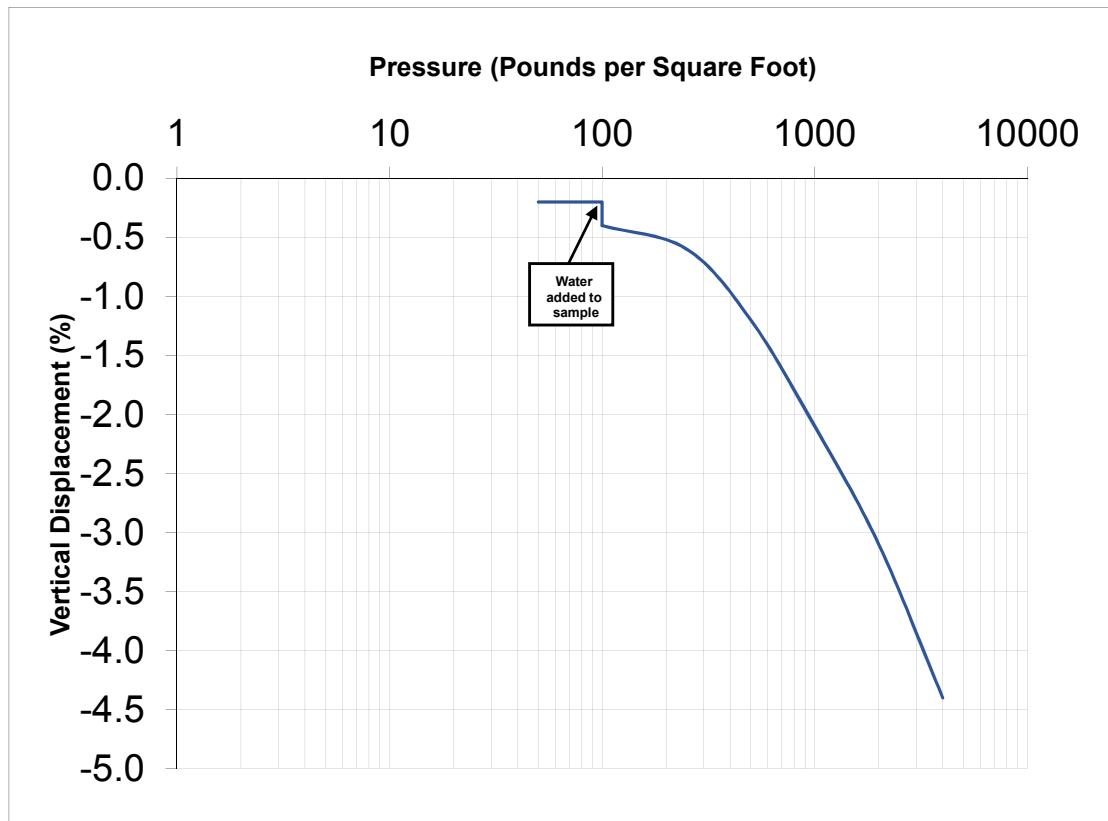
Project Number:	55599GE
Sample ID:	C10219-d
Figure:	4.9

SWELL - CONSOLIDATION TEST

SUMMARY OF TEST RESULTS		
Sample Source:	TB-1@3'	
Visual Soil Description:	SM Silty Sand	
Swell Potential (%):	Consolidated	
Constant Volume Swell Pressure (lb/ft ²):	N/A	
	Initial	Final
Moisture Content (%):	4.0	19.1
Dry Density (lb/ft ³):	106.2	110.3
Height (in.):	1.000	0.956
Diameter (in.):	1.94	1.94

Moisture content and dry density; the moisture content and in-situ dry density of some of the Modified California Barrel liner samples was assessed. The results of these tests may be found on the consolidation test results presented on Figures 4.9 through 4.24 of Appendix B. These test results are also tabulated below.

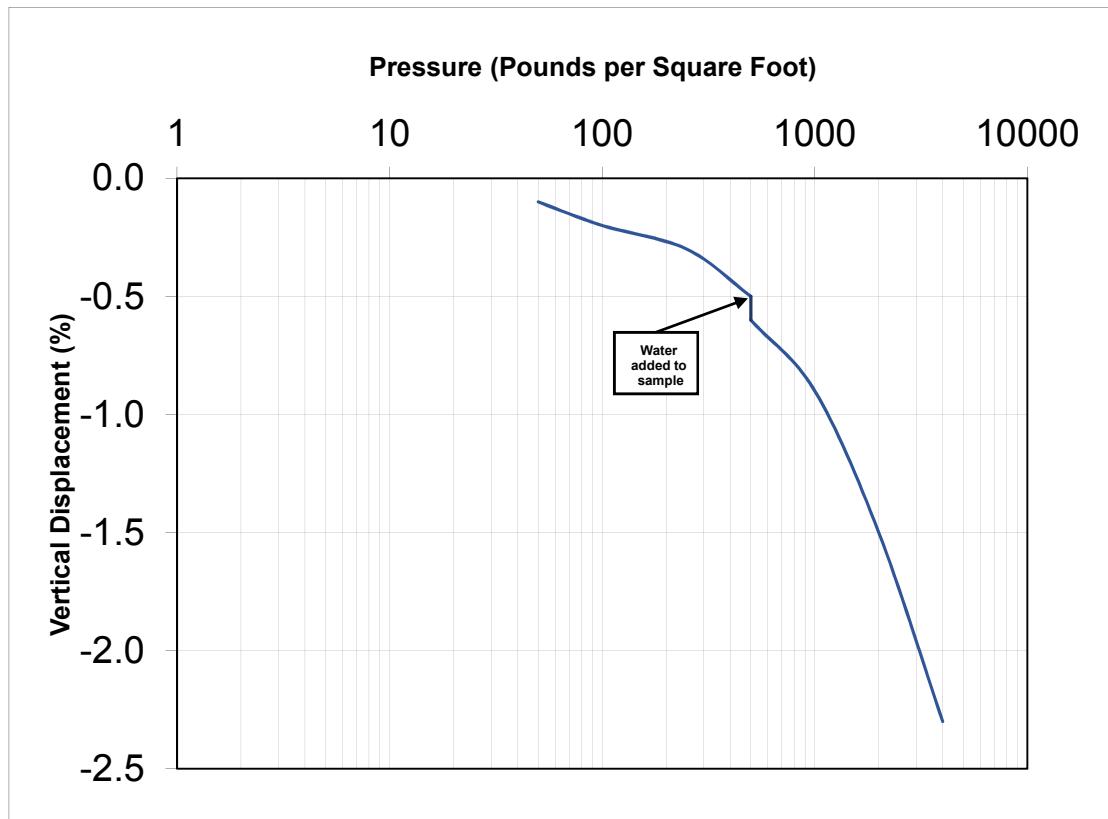
Project Number:	55599GE
Sample ID:	10219-M
Figure:	4.10

SWELL - CONSOLIDATION TEST

SUMMARY OF TEST RESULTS		
Sample Source:	TB-3@3'	
Visual Soil Description:	SM Silty Sand	
Swell Potential (%):	Consolidated	
Constant Volume Swell Pressure (lb/ft ²):	N/A	
	Initial	Final
Moisture Content (%):	8.2	14.3
Dry Density (lb/ft ³):	116.7	119.1
Height (in.):	1.000	0.977
Diameter (in.):	1.94	1.94

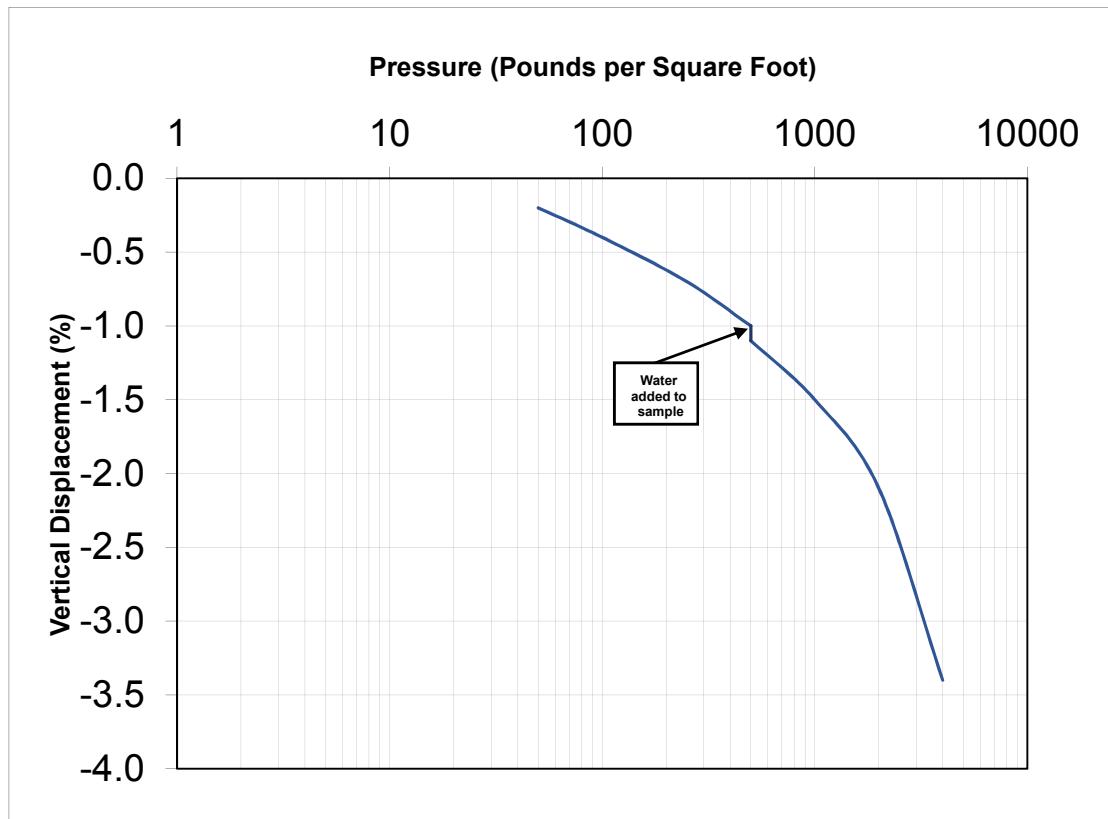
Project Number:	55599GE
Sample ID:	10219-R
Figure:	4.11

SWELL - CONSOLIDATION TEST

SUMMARY OF TEST RESULTS		
Sample Source:	TB-4@3'	
Visual Soil Description:	SM Silty Sand	
Swell Potential (%):	Consolidated	
Constant Volume Swell Pressure (lb/ft ²):	N/A	
	Initial	Final
Moisture Content (%):	8.4	17.7
Dry Density (lb/ft ³):	111.2	114.1
Height (in.):	1.000	0.966
Diameter (in.):	1.94	1.94

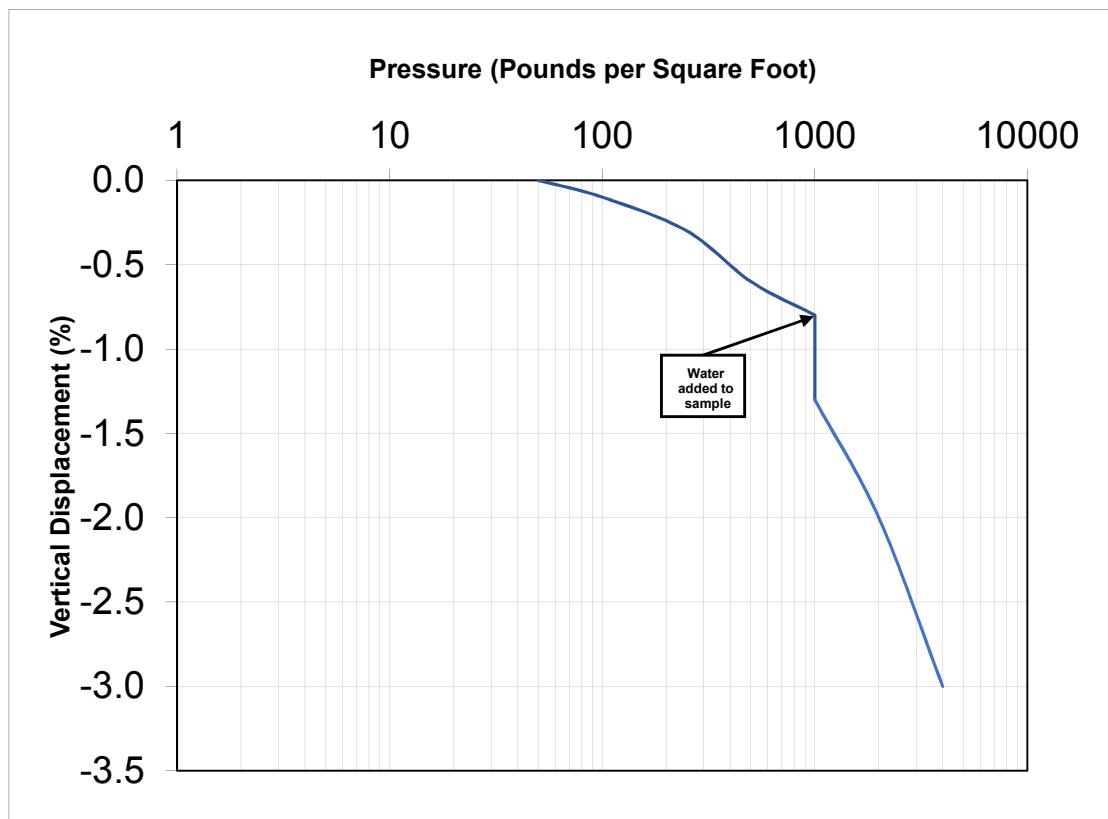
Project Number:	55599GE
Sample ID:	C10219-T
Figure:	4.12

SWELL - CONSOLIDATION TEST

SUMMARY OF TEST RESULTS		
Sample Source:	TB-4@8'	
Visual Soil Description:	SM Silty Sand	
Swell Potential (%):	Consolidated	
Constant Volume Swell Pressure (lb/ft ²):	N/A	
	Initial	Final
Moisture Content (%):	3.0	14.0
Dry Density (lb/ft ³):	118.4	120.6
Height (in.):	1.000	0.970
Diameter (in.):	1.94	1.94

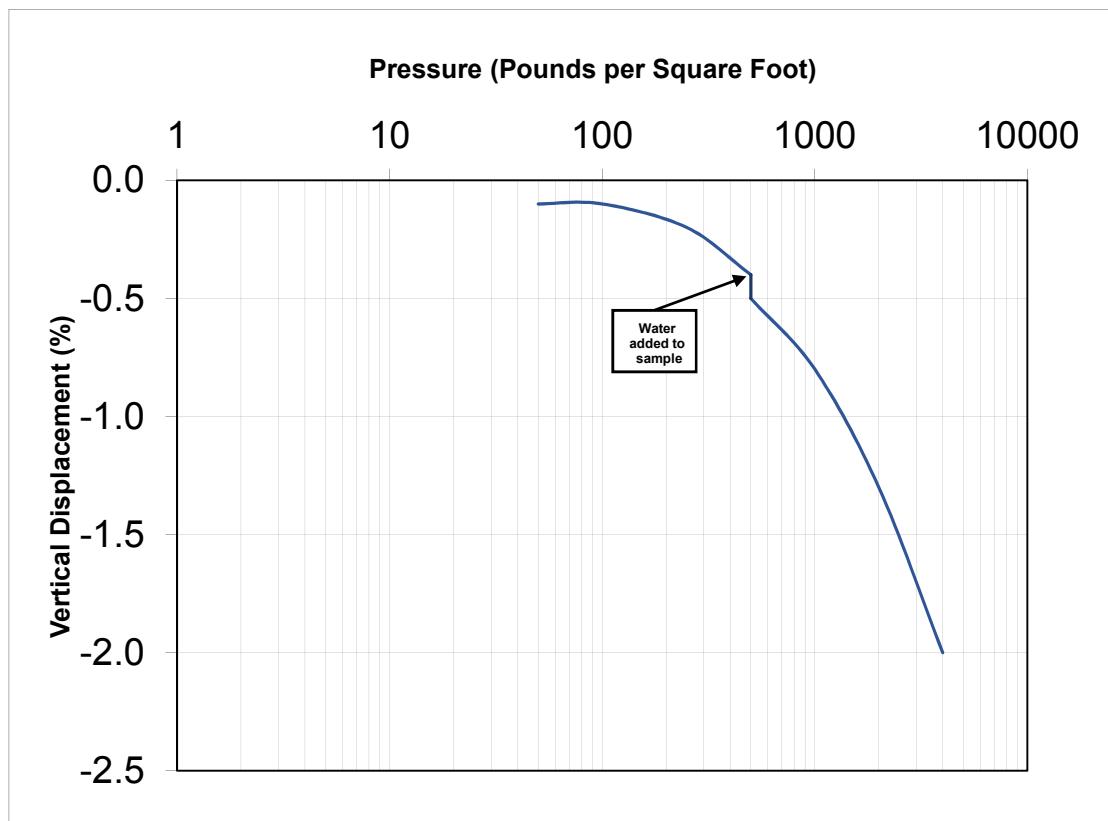
Project Number:	55599GE
Sample ID:	10219-BB
Figure:	4.13

SWELL - CONSOLIDATION TEST

SUMMARY OF TEST RESULTS		
Sample Source:	TB-6@4'	
Visual Soil Description:	SM Silty Sand	
Swell Potential (%):	Consolidated	
Constant Volume Swell Pressure (lb/ft ²):	N/A	
	Initial	Final
Moisture Content (%):	7.0	12.3
Dry Density (lb/ft ³):	122.8	124.5
Height (in.):	1.000	0.980
Diameter (in.):	1.94	1.94

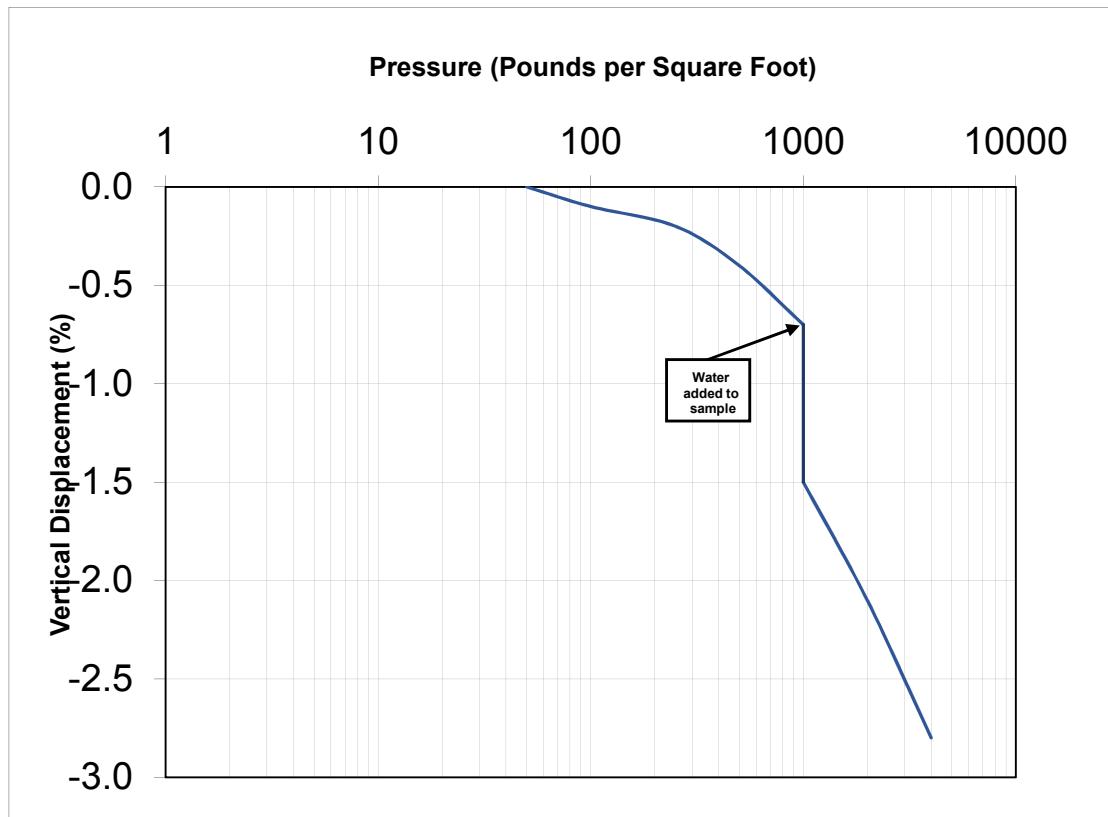
Project Number:	55599GE
Sample ID:	10219-dd
Figure:	4.14

SWELL - CONSOLIDATION TEST

SUMMARY OF TEST RESULTS		
Sample Source:	TB-6@9'	
Visual Soil Description:	SM Silty Sand	
Swell Potential (%):	Consolidated	
Constant Volume Swell Pressure (lb/ft ²):	N/A	
	Initial	Final
Moisture Content (%):	2.6	17.2
Dry Density (lb/ft ³):	110.1	111.6
Height (in.):	1.000	0.972
Diameter (in.):	1.94	1.94

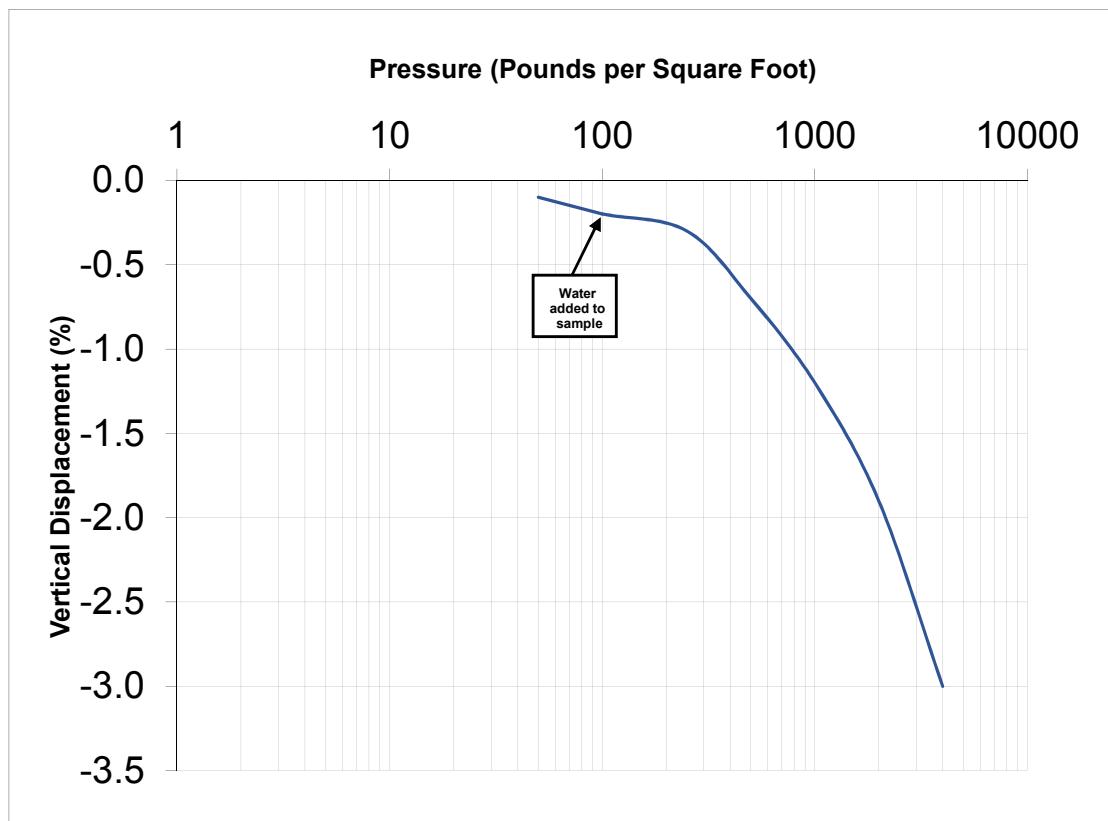
Project Number:	55599GE
Sample ID:	C10219-KK
Figure:	4.15

SWELL - CONSOLIDATION TEST

SUMMARY OF TEST RESULTS		
Sample Source:	TB-7@3'	
Visual Soil Description:	SM Silty Sand	
Swell Potential (%):	Consolidated	
Constant Volume Swell Pressure (lb/ft ²):	N/A	
	Initial	Final
Moisture Content (%):	7.6	17.0
Dry Density (lb/ft ³):	110.3	112.7
Height (in.):	1.000	0.970
Diameter (in.):	1.94	1.94

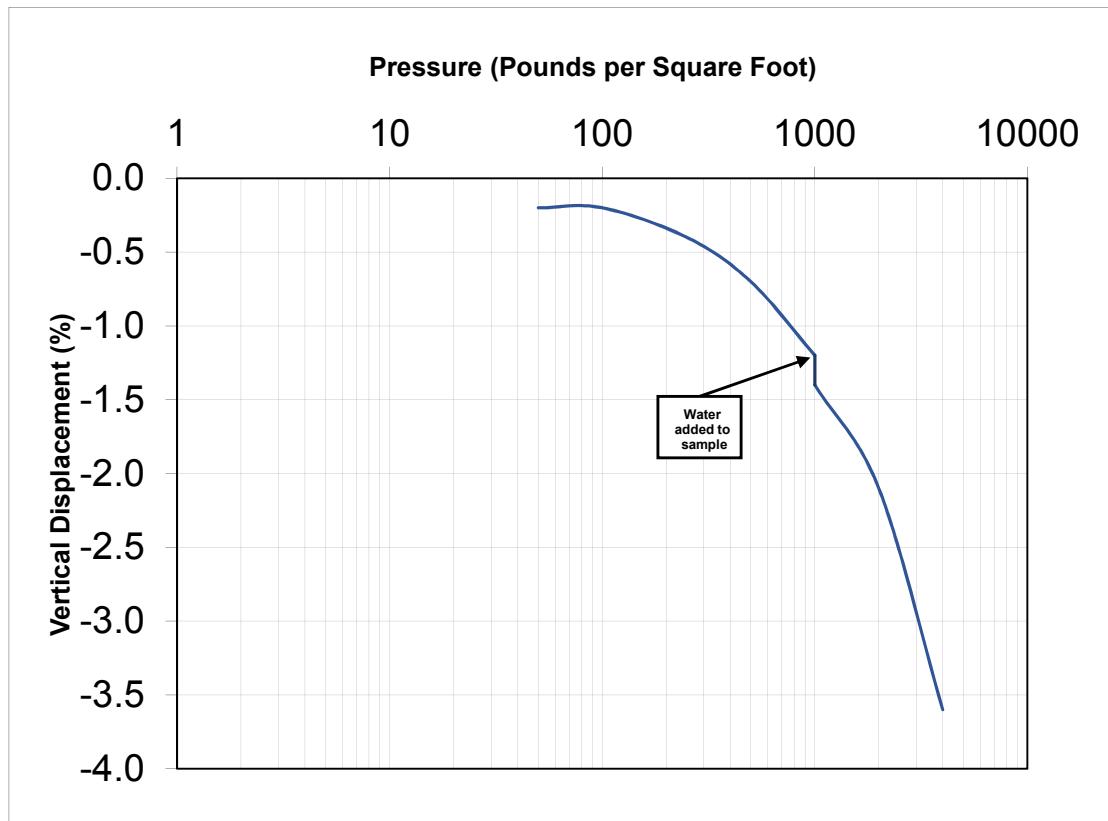
Project Number:	55599GE
Sample ID:	C10219-MM
Figure:	4.16

SWELL - CONSOLIDATION TEST

SUMMARY OF TEST RESULTS		
Sample Source:	TB-7@8'	
Visual Soil Description:	SM Silty Sand	
Swell Potential (%):	Consolidated	
Constant Volume Swell Pressure (lb/ft ²):	N/A	
	Initial	Final
Moisture Content (%):	5.0	13.2
Dry Density (lb/ft ³):	122.0	125.2
Height (in.):	1.000	0.964
Diameter (in.):	1.94	1.94

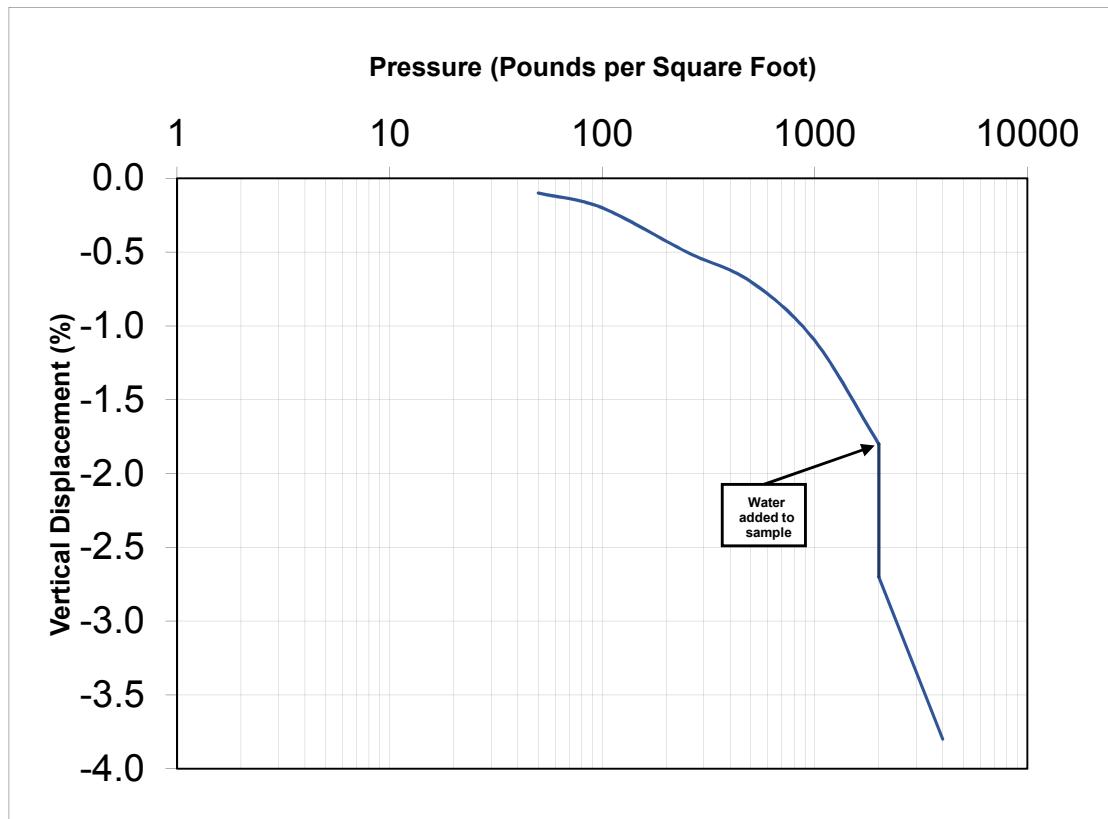
Project Number:	55599GE
Sample ID:	C10219-OO
Figure:	4.17

SWELL - CONSOLIDATION TEST

SUMMARY OF TEST RESULTS		
Sample Source:	TB-7@13'	
Visual Soil Description:	SM Silty Sand	
Swell Potential (%):	Consolidated	
Constant Volume Swell Pressure (lb/ft ²):	N/A	
	Initial	Final
Moisture Content (%):	3.9	14.5
Dry Density (lb/ft ³):	120.8	124.0
Height (in.):	1.000	0.962
Diameter (in.):	1.94	1.94
