ARROYO CROSSING - PHASE II INFRASTRUCTURE PROJECT
ADDENDUM #1 TO RFB

**FEASIBILITY LEVEL GEOTECHNICAL ENGINEERING
STUDY/DESIGN LEVEL PAVEMENT
RECOMMENDATIONS**

ARROYO CROSSING PROJECT

Prepared For:
Ms. Audrey Graham
Moab Area Community Land Trust
Project Number: 55599GE

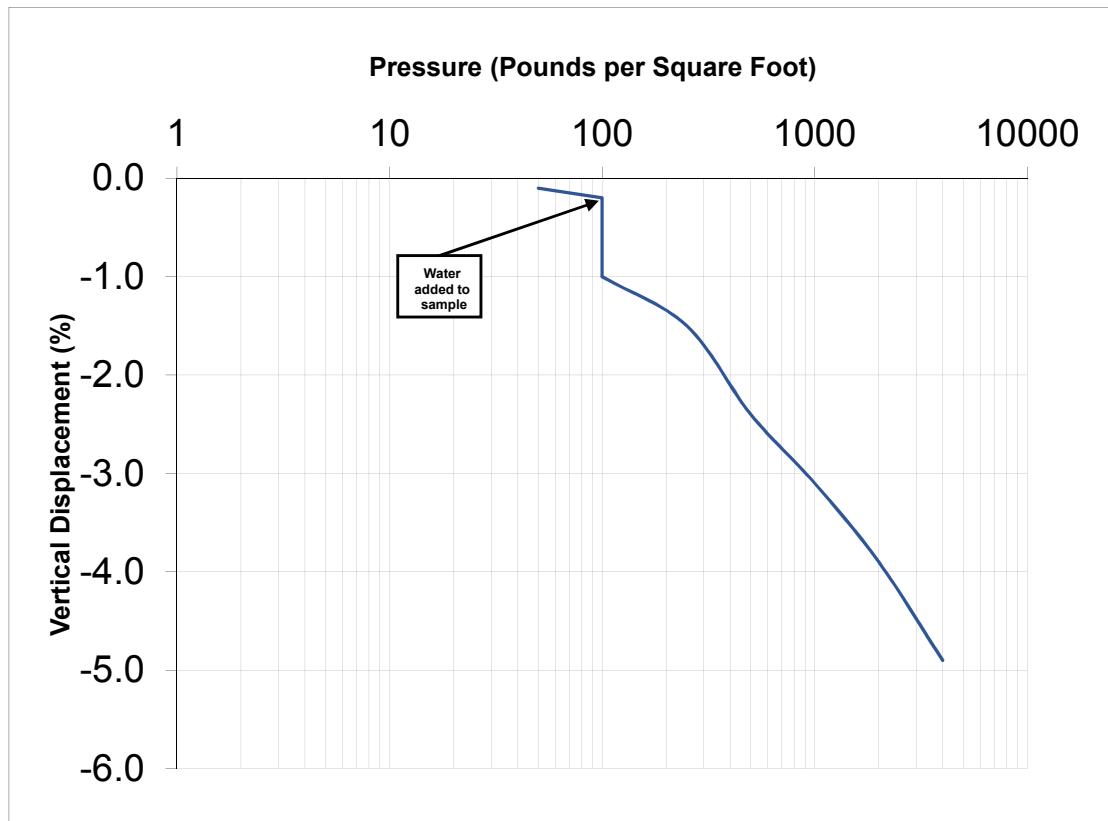
Project Number:	55599GE
Sample ID:	C10219-QQ
Figure:	4.18

SWELL - CONSOLIDATION TEST

SUMMARY OF TEST RESULTS		
Sample Source:	TB-8@3'	
Visual Soil Description:	SM Silty Sand	
Swell Potential (%):	Consolidated	
Constant Volume Swell Pressure (lb/ft ²):	N/A	
	Initial	Final
Moisture Content (%):	5.8	24.6
Dry Density (lb/ft ³):	91.8	97.3
Height (in.):	1.000	0.951
Diameter (in.):	1.94	1.94

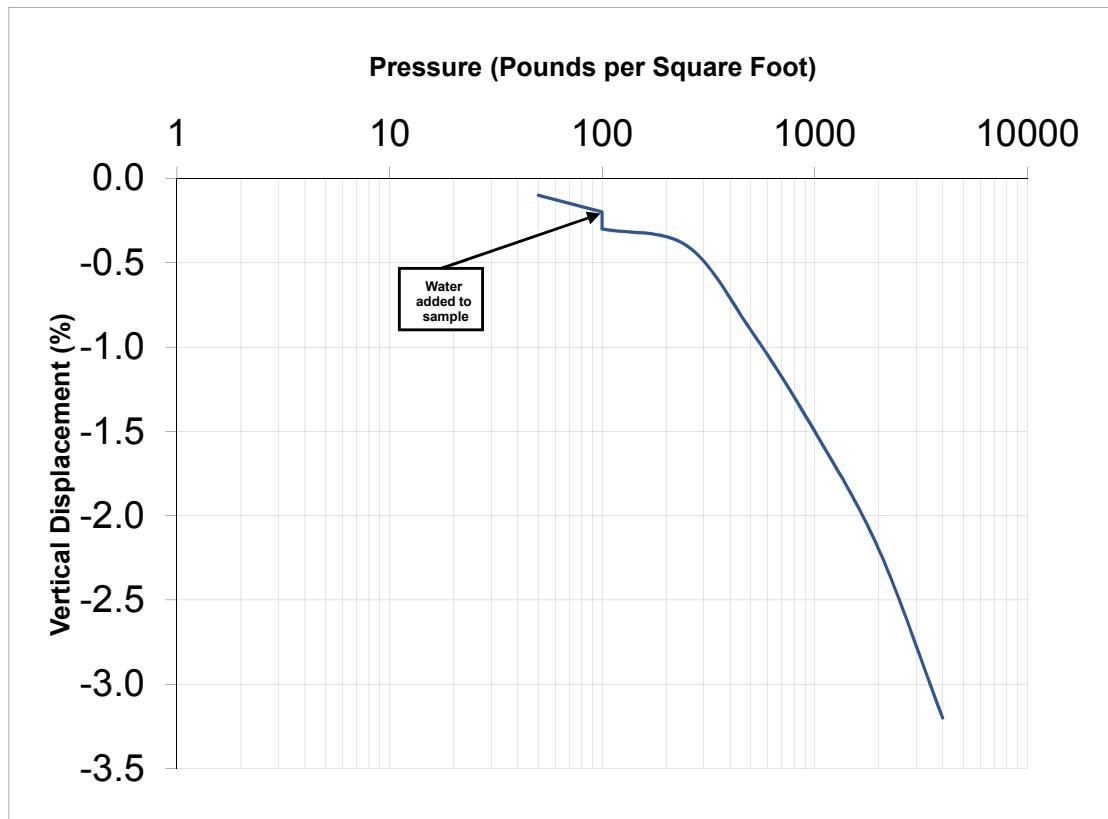
Project Number:	55599GE
Sample ID:	C10219-XX
Figure:	4.19

SWELL - CONSOLIDATION TEST

SUMMARY OF TEST RESULTS		
Sample Source:	TB-11@3'	
Visual Soil Description:	SM Silty Sand	
Swell Potential (%):	Consolidated	
Constant Volume Swell Pressure (lb/ft ²):	N/A	
	Initial	Final
Moisture Content (%):	8.7	12.8
Dry Density (lb/ft ³):	122.2	125.7
Height (in.):	1.000	0.968
Diameter (in.):	1.94	1.94

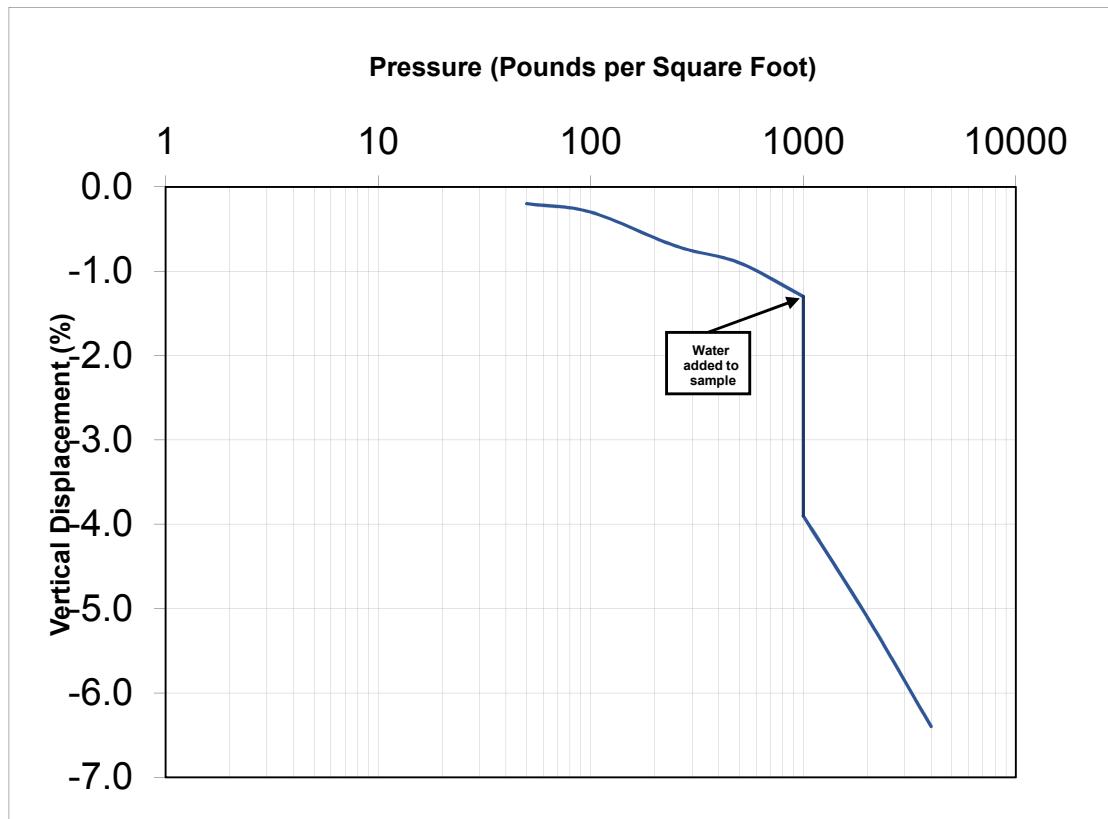
Project Number:	55599GE
Sample ID:	10219-ZZ
Figure:	4.20

SWELL - CONSOLIDATION TEST

SUMMARY OF TEST RESULTS		
Sample Source:	TB-11@8'	
Visual Soil Description:	SM Silty Sand	
Swell Potential (%):	Consolidated	
Constant Volume Swell Pressure (lb/ft ²):	N/A	
	Initial	Final
Moisture Content (%):	1.6	19.8
Dry Density (lb/ft ³):	106.3	110.7
Height (in.):	1.000	0.936
Diameter (in.):	1.94	1.94

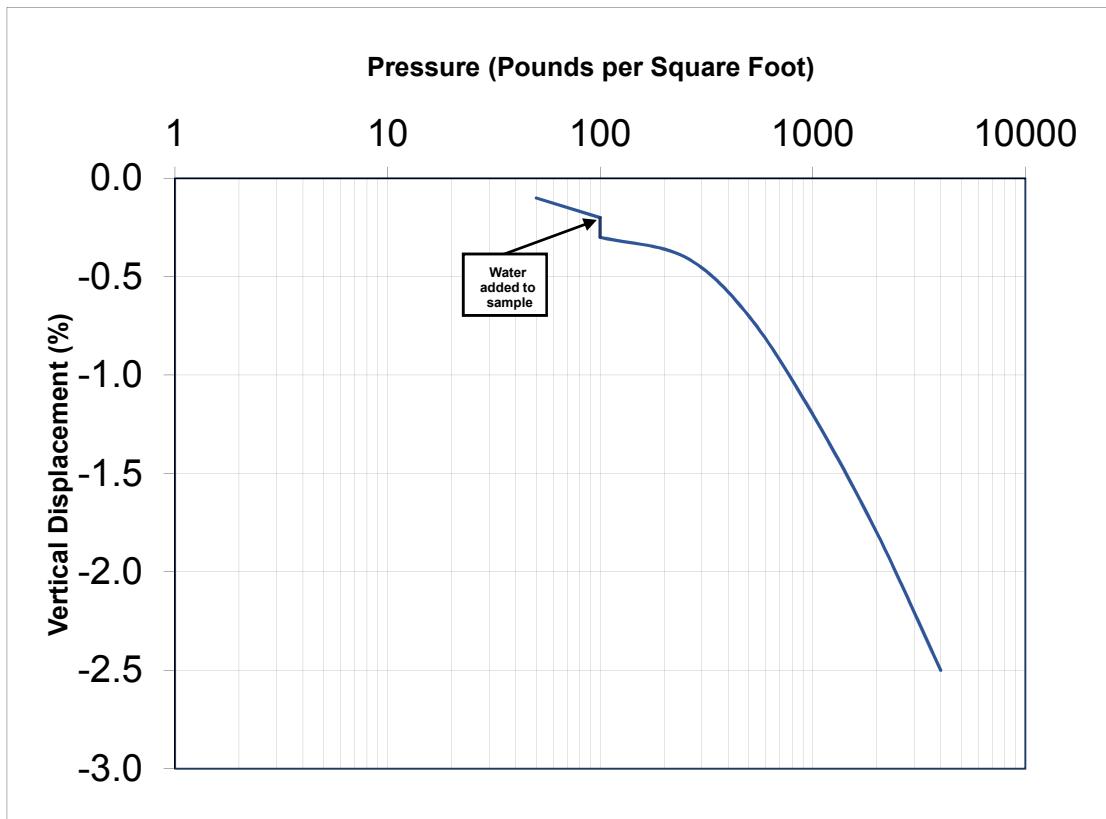
Project Number:	55599GE
Sample ID:	10219-B3
Figure:	4.21

SWELL - CONSOLIDATION TEST

SUMMARY OF TEST RESULTS		
Sample Source:	TB-12@3'	
Visual Soil Description:	SM Silty Sand	
Swell Potential (%):	Consolidated	
Constant Volume Swell Pressure (lb/ft ²):	N/A	
	Initial	Final
Moisture Content (%):	7.4	13.9
Dry Density (lb/ft ³):	120.9	123.3
Height (in.):	1.000	0.975
Diameter (in.):	1.94	1.94

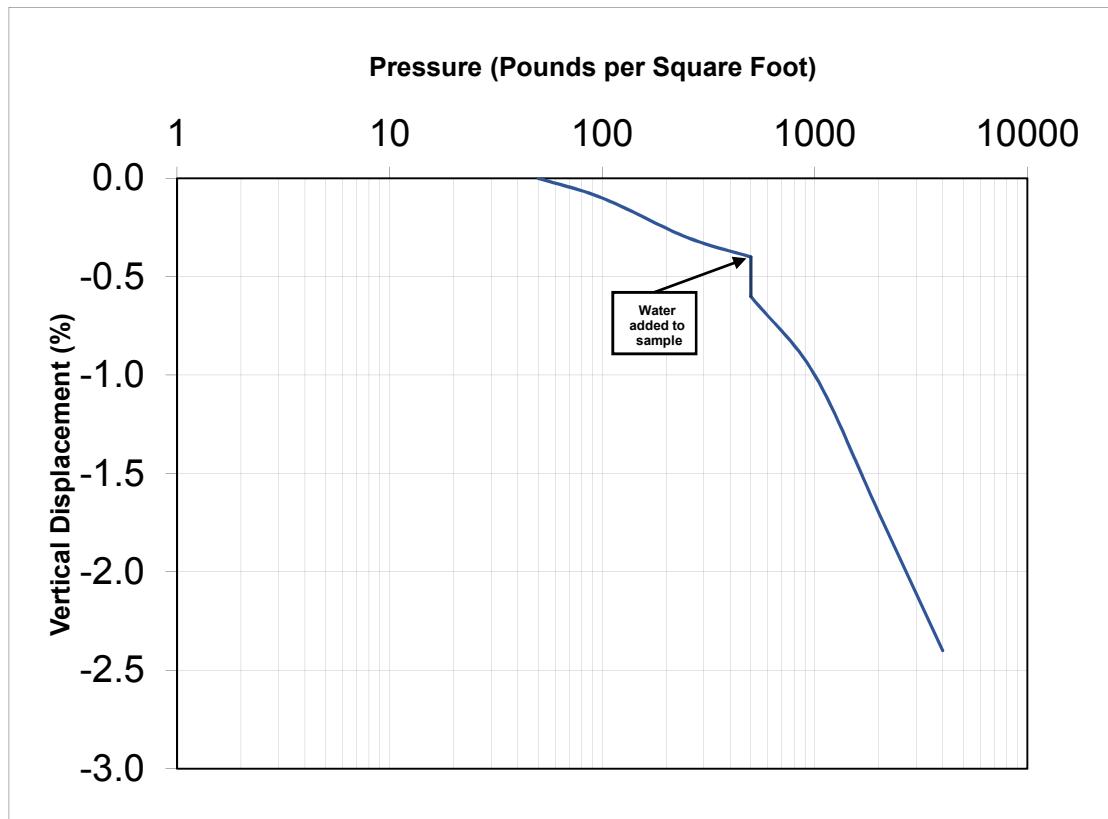
Project Number:	55599GE
Sample ID:	10219-F3
Figure:	4.22

SWELL - CONSOLIDATION TEST

SUMMARY OF TEST RESULTS		
Sample Source:	TB-13@4'	
Visual Soil Description:	SM Silty Sand	
Swell Potential (%):	Consolidated	
Constant Volume Swell Pressure (lb/ft ²):	N/A	
	Initial	Final
Moisture Content (%):	8.0	18.9
Dry Density (lb/ft ³):	112.7	113.0
Height (in.):	1.000	0.976
Diameter (in.):	1.94	1.94

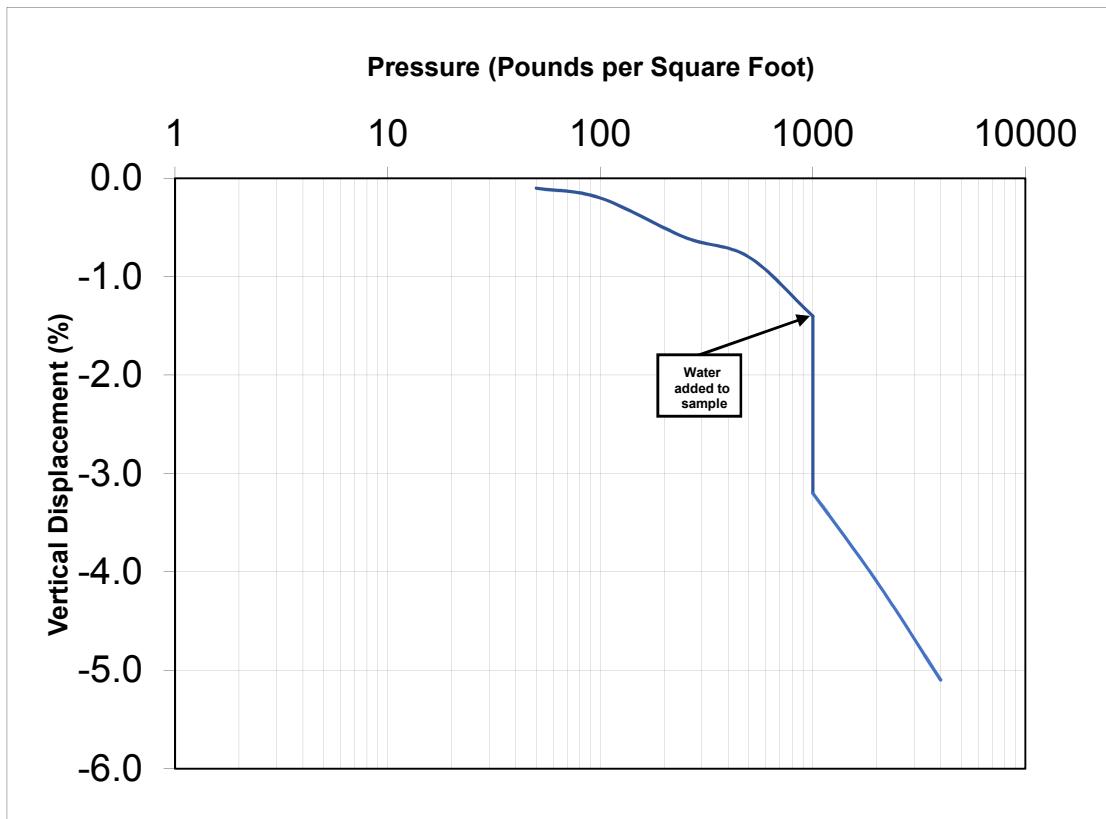
Project Number:	55599GE
Sample ID:	C10219-H3
Figure:	4.23

SWELL - CONSOLIDATION TEST

SUMMARY OF TEST RESULTS		
Sample Source:	TB-13@9'	
Visual Soil Description:	SM Silty Sand	
Swell Potential (%):	Consolidated	
Constant Volume Swell Pressure (lb/ft ²):	N/A	
	Initial	Final
Moisture Content (%):	3.4	16.6
Dry Density (lb/ft ³):	111.2	115.5
Height (in.):	1.000	0.949
Diameter (in.):	1.94	1.94

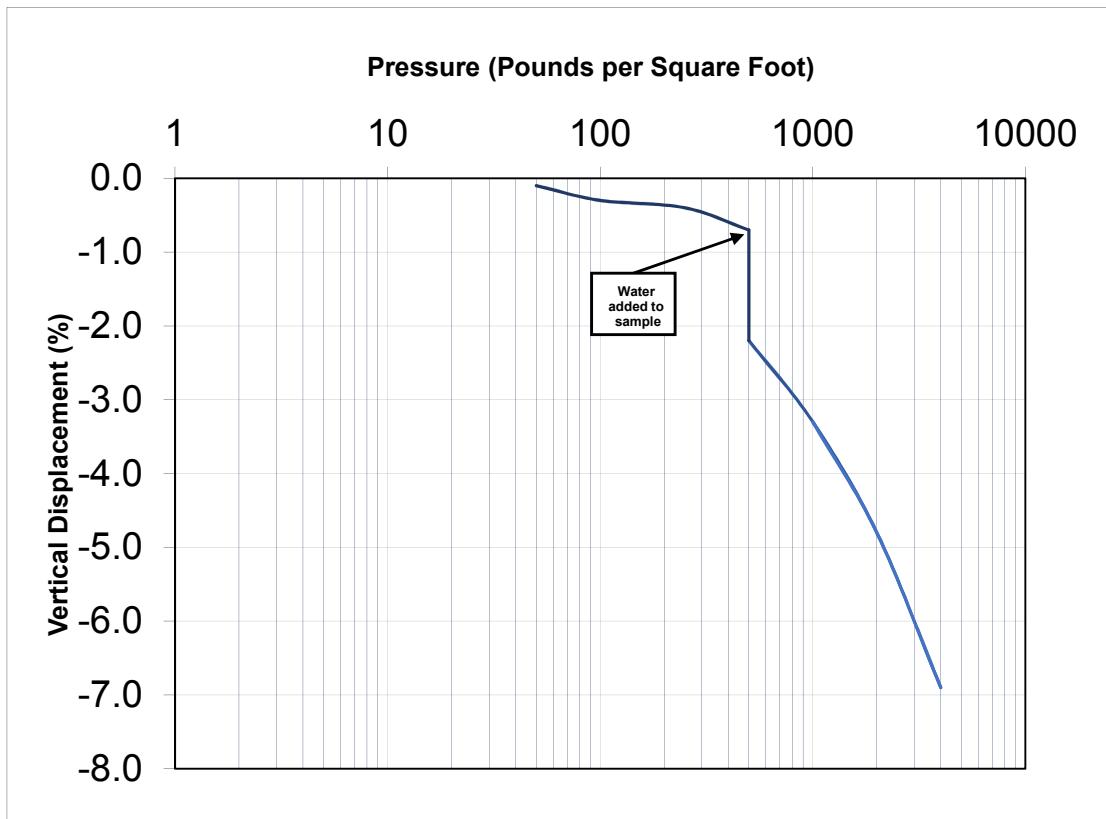
Project Number:	55599GE
Sample ID:	C10219-L3
Figure:	4.24

SWELL - CONSOLIDATION TEST

SUMMARY OF TEST RESULTS		
Sample Source:	TB-14@4'	
Visual Soil Description:	SM Silty Sand	
Swell Potential (%):	Consolidated	
Constant Volume Swell Pressure (lb/ft ²):	N/A	
	Initial	Final
Moisture Content (%):	1.6	15.5
Dry Density (lb/ft ³):	109.4	115.3
Height (in.):	1.000	0.931
Diameter (in.):	1.94	1.94

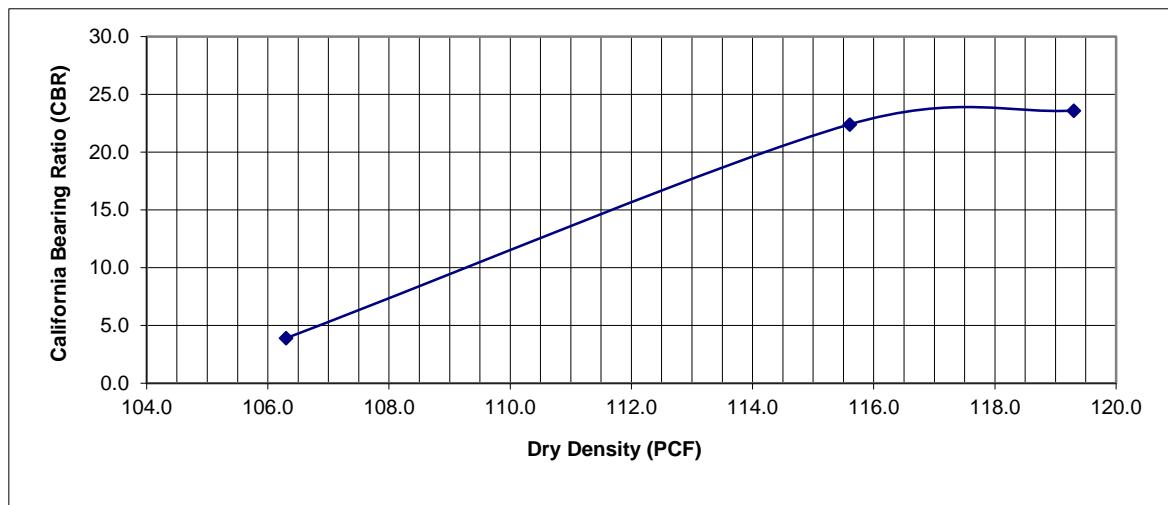
**California Bearing Ratio Test Results
 ASTM D1883**

<u>Pre-Soak</u>			<u>After 72 hour Soak</u>			
Dry Density (PCF)	Moisture Content (%)	Relative Compaction (%)	Dry Density (PCF)	Moisture Content of Top One (1) Inch (%)	Swell (%)	CBR (0.100" penetration)
106.3	10.3	84	109.1	14.5	0.0	3.9
115.6	10.0	91	117.5	11.5	0.0	22.4
119.3	10.1	94	120.9	10.9	0.0	23.6
