PARK CITY HISTORIC PRESERVATION BOARD MEETING SUMMIT COUNTY, UTAH November 17, 2025

On September 8, 2025, the City issued Building Permit #25-0638 for 218 Sandridge.

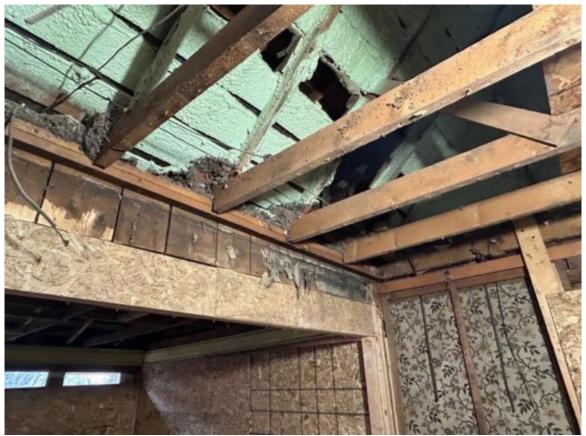
Figure 2: Applicant's photo showing deteriorated roof structure on the Significant Historic Structure at 218 Sandridge Road in October 2025.

- Remove the Historic 1907 roof form and reconstruct it with proper structuring and new standing seam-metal roofing, salvaging all possible salvageable Historic Materials, and
- Remove the Historic 1889 roof form and reconstruct it with proper structuring and new standing seam-metal roofing, salvaging all possible salvageable Historic Materials.

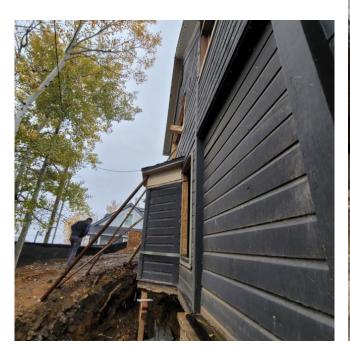
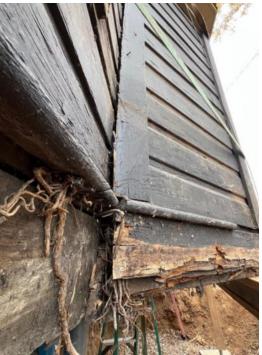
Figure 3: Applicant's photos showing structurally compromised west wall of the Historic 1907 addition at 218 Sandridge in October 2025.

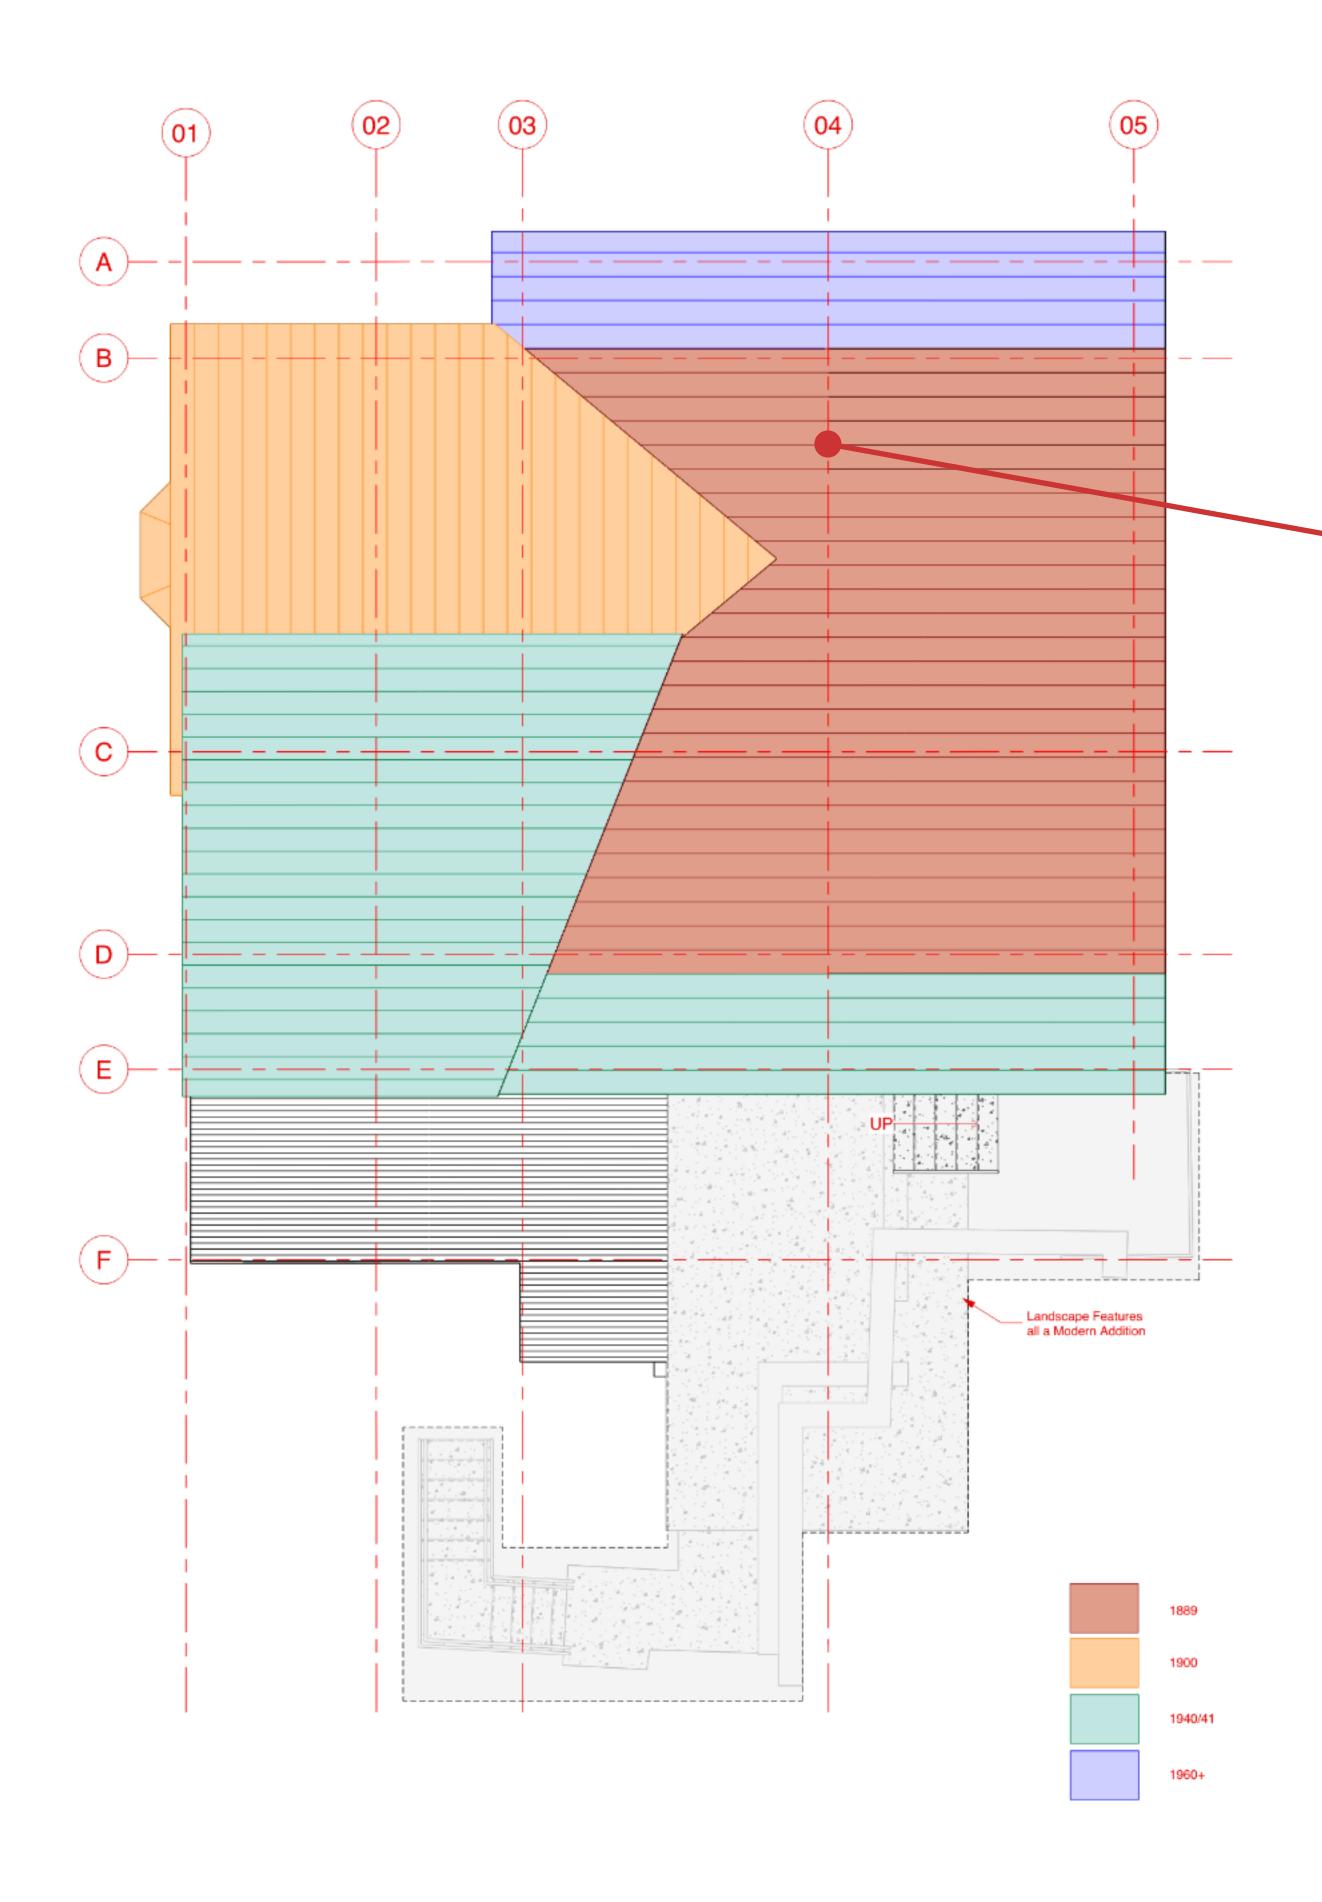
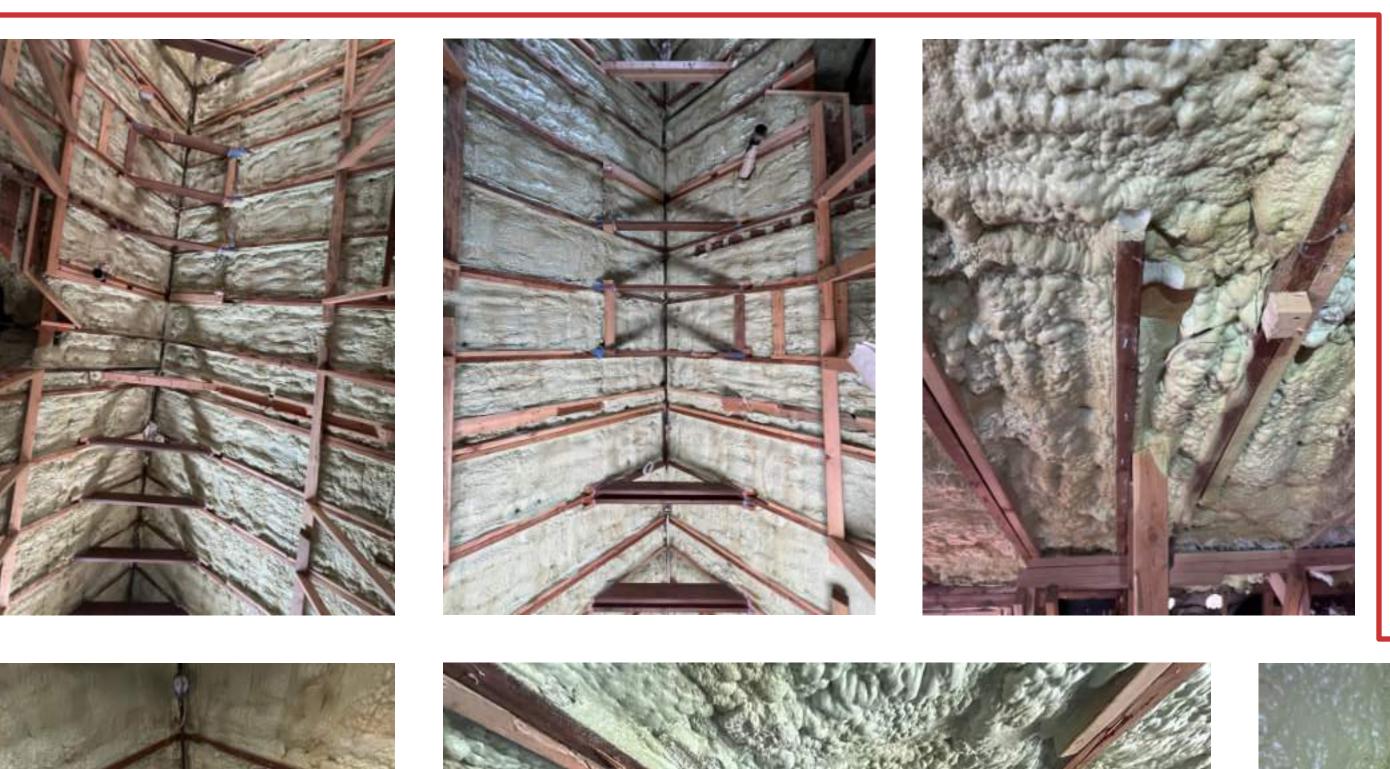
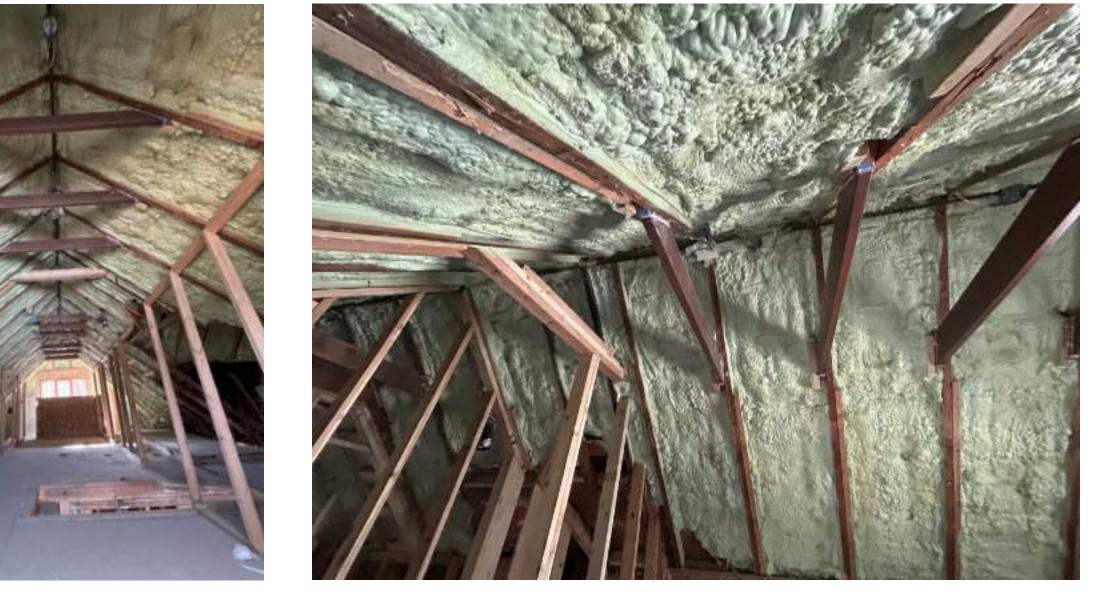
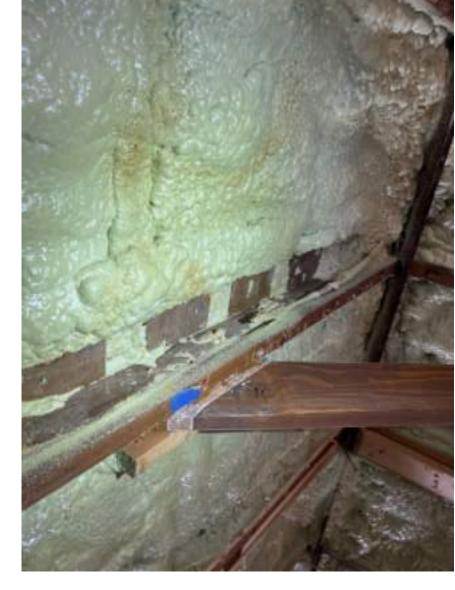
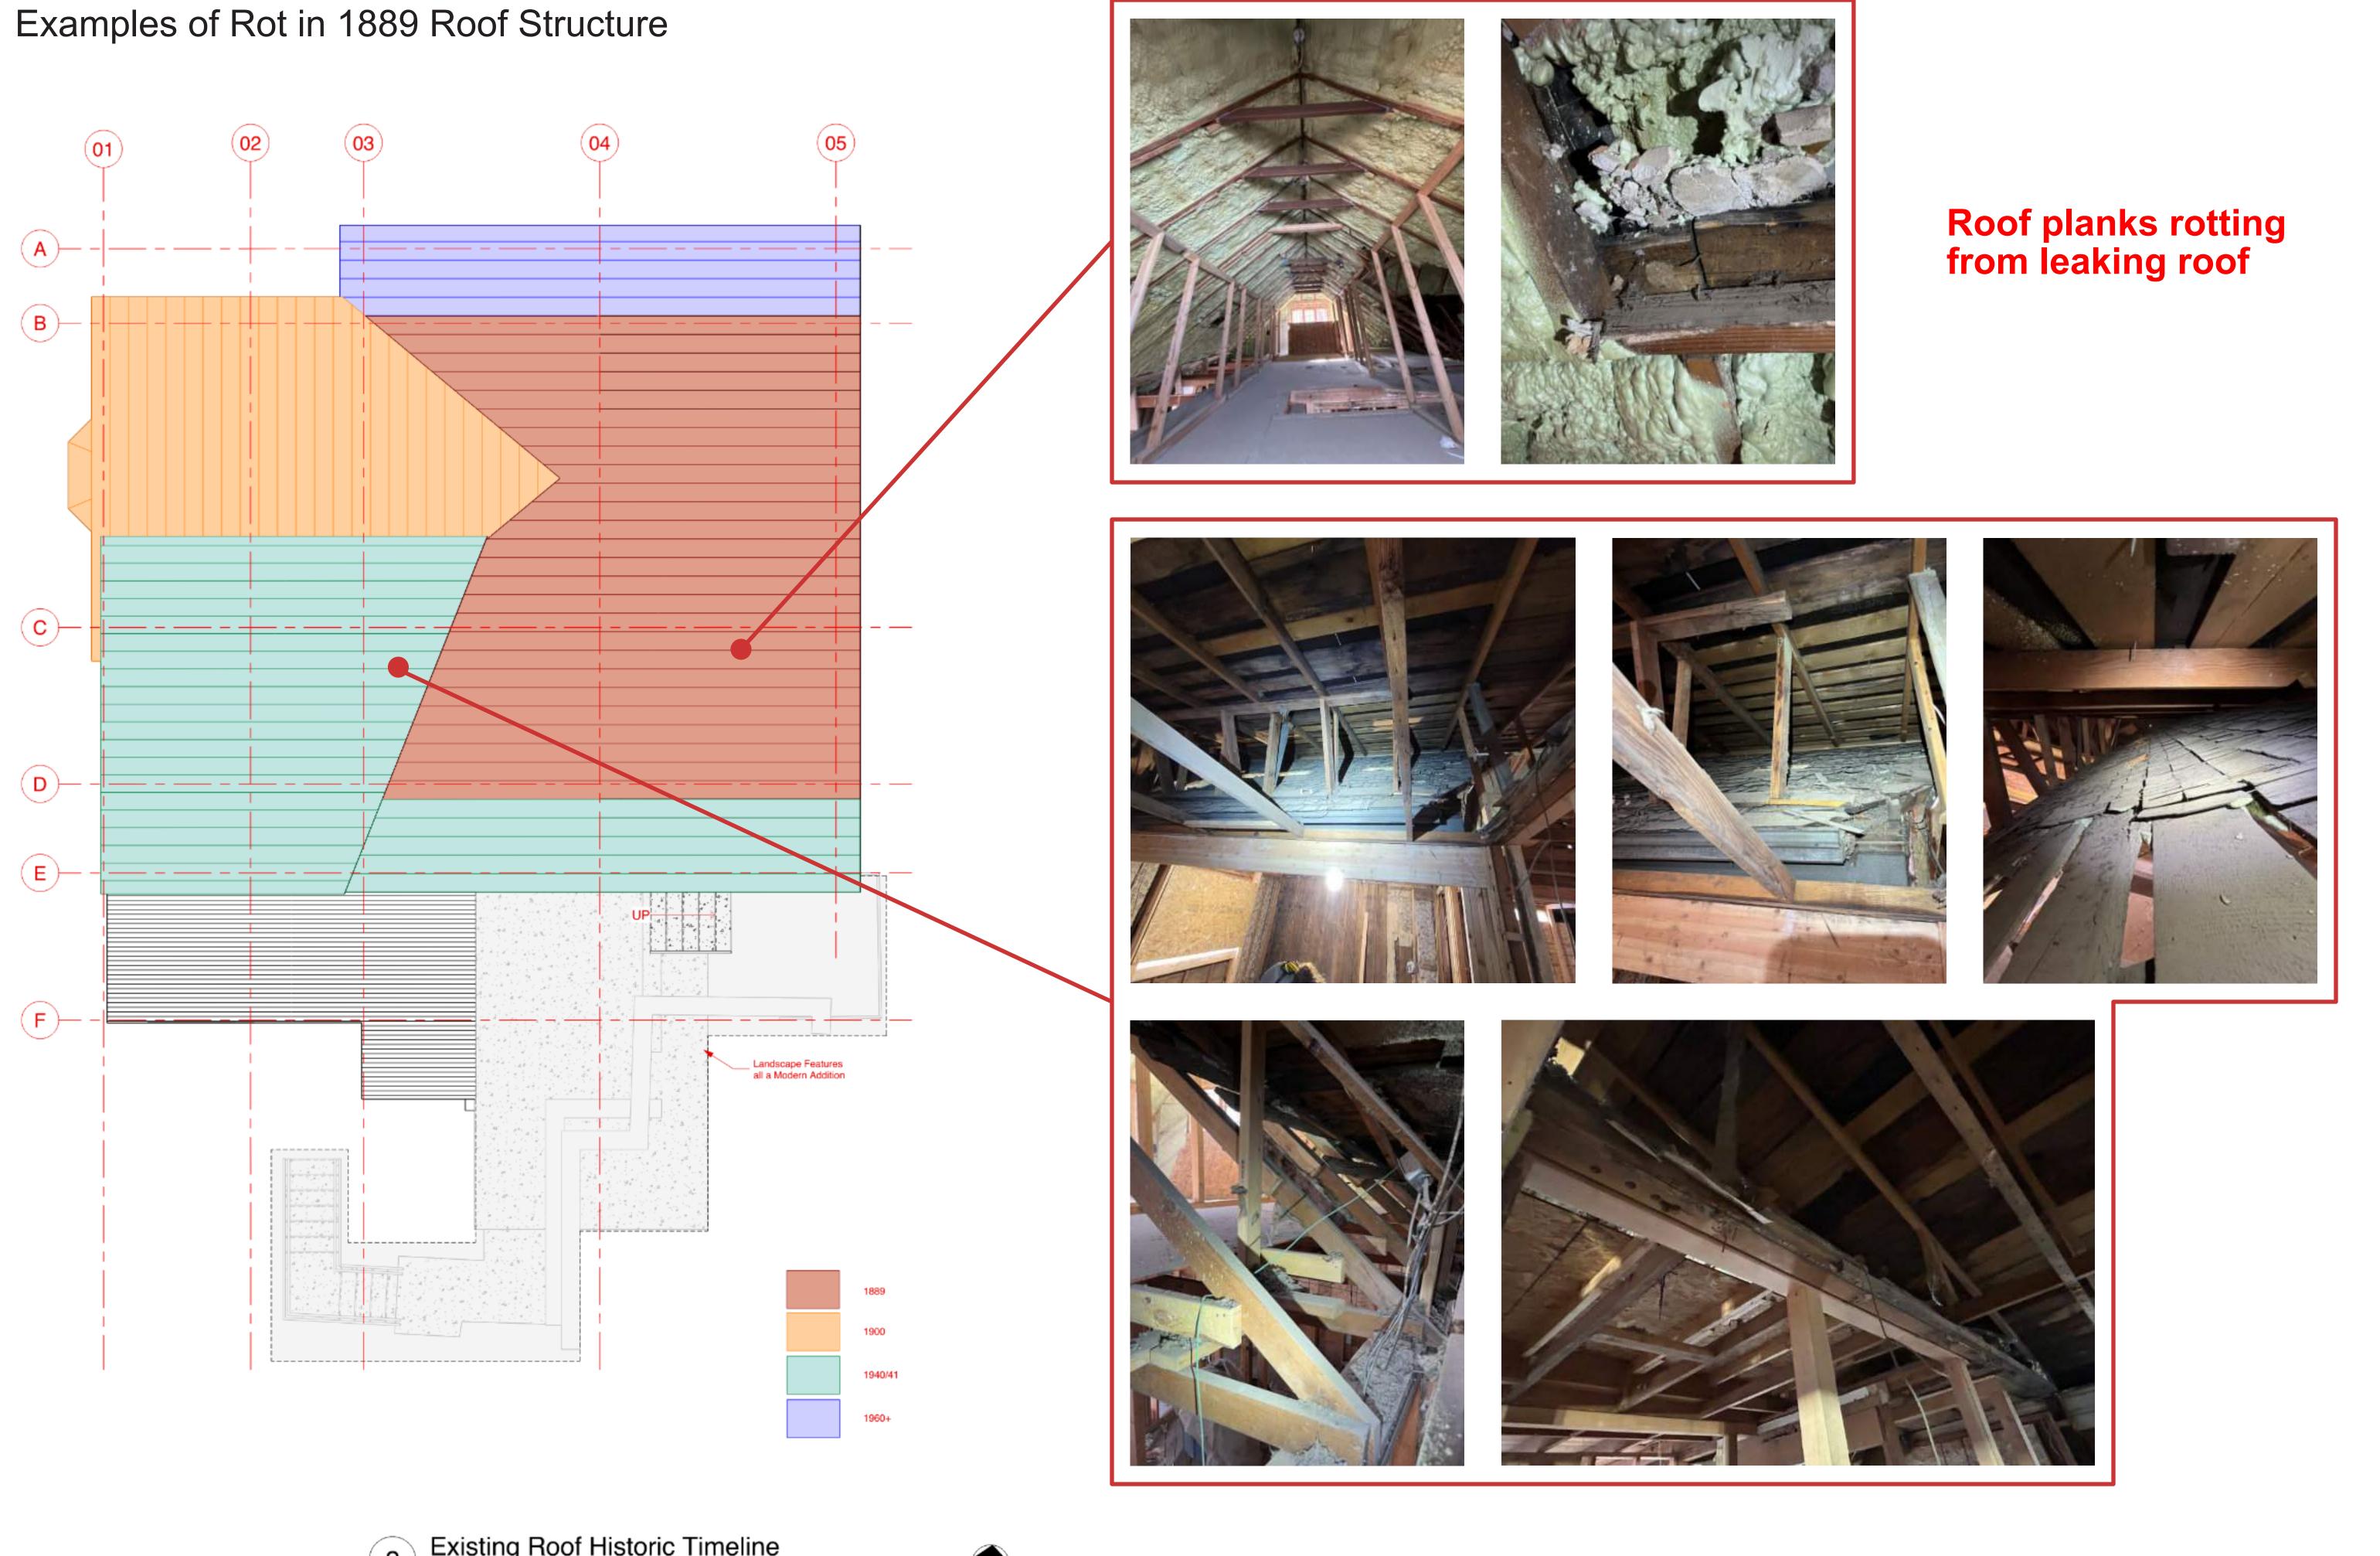
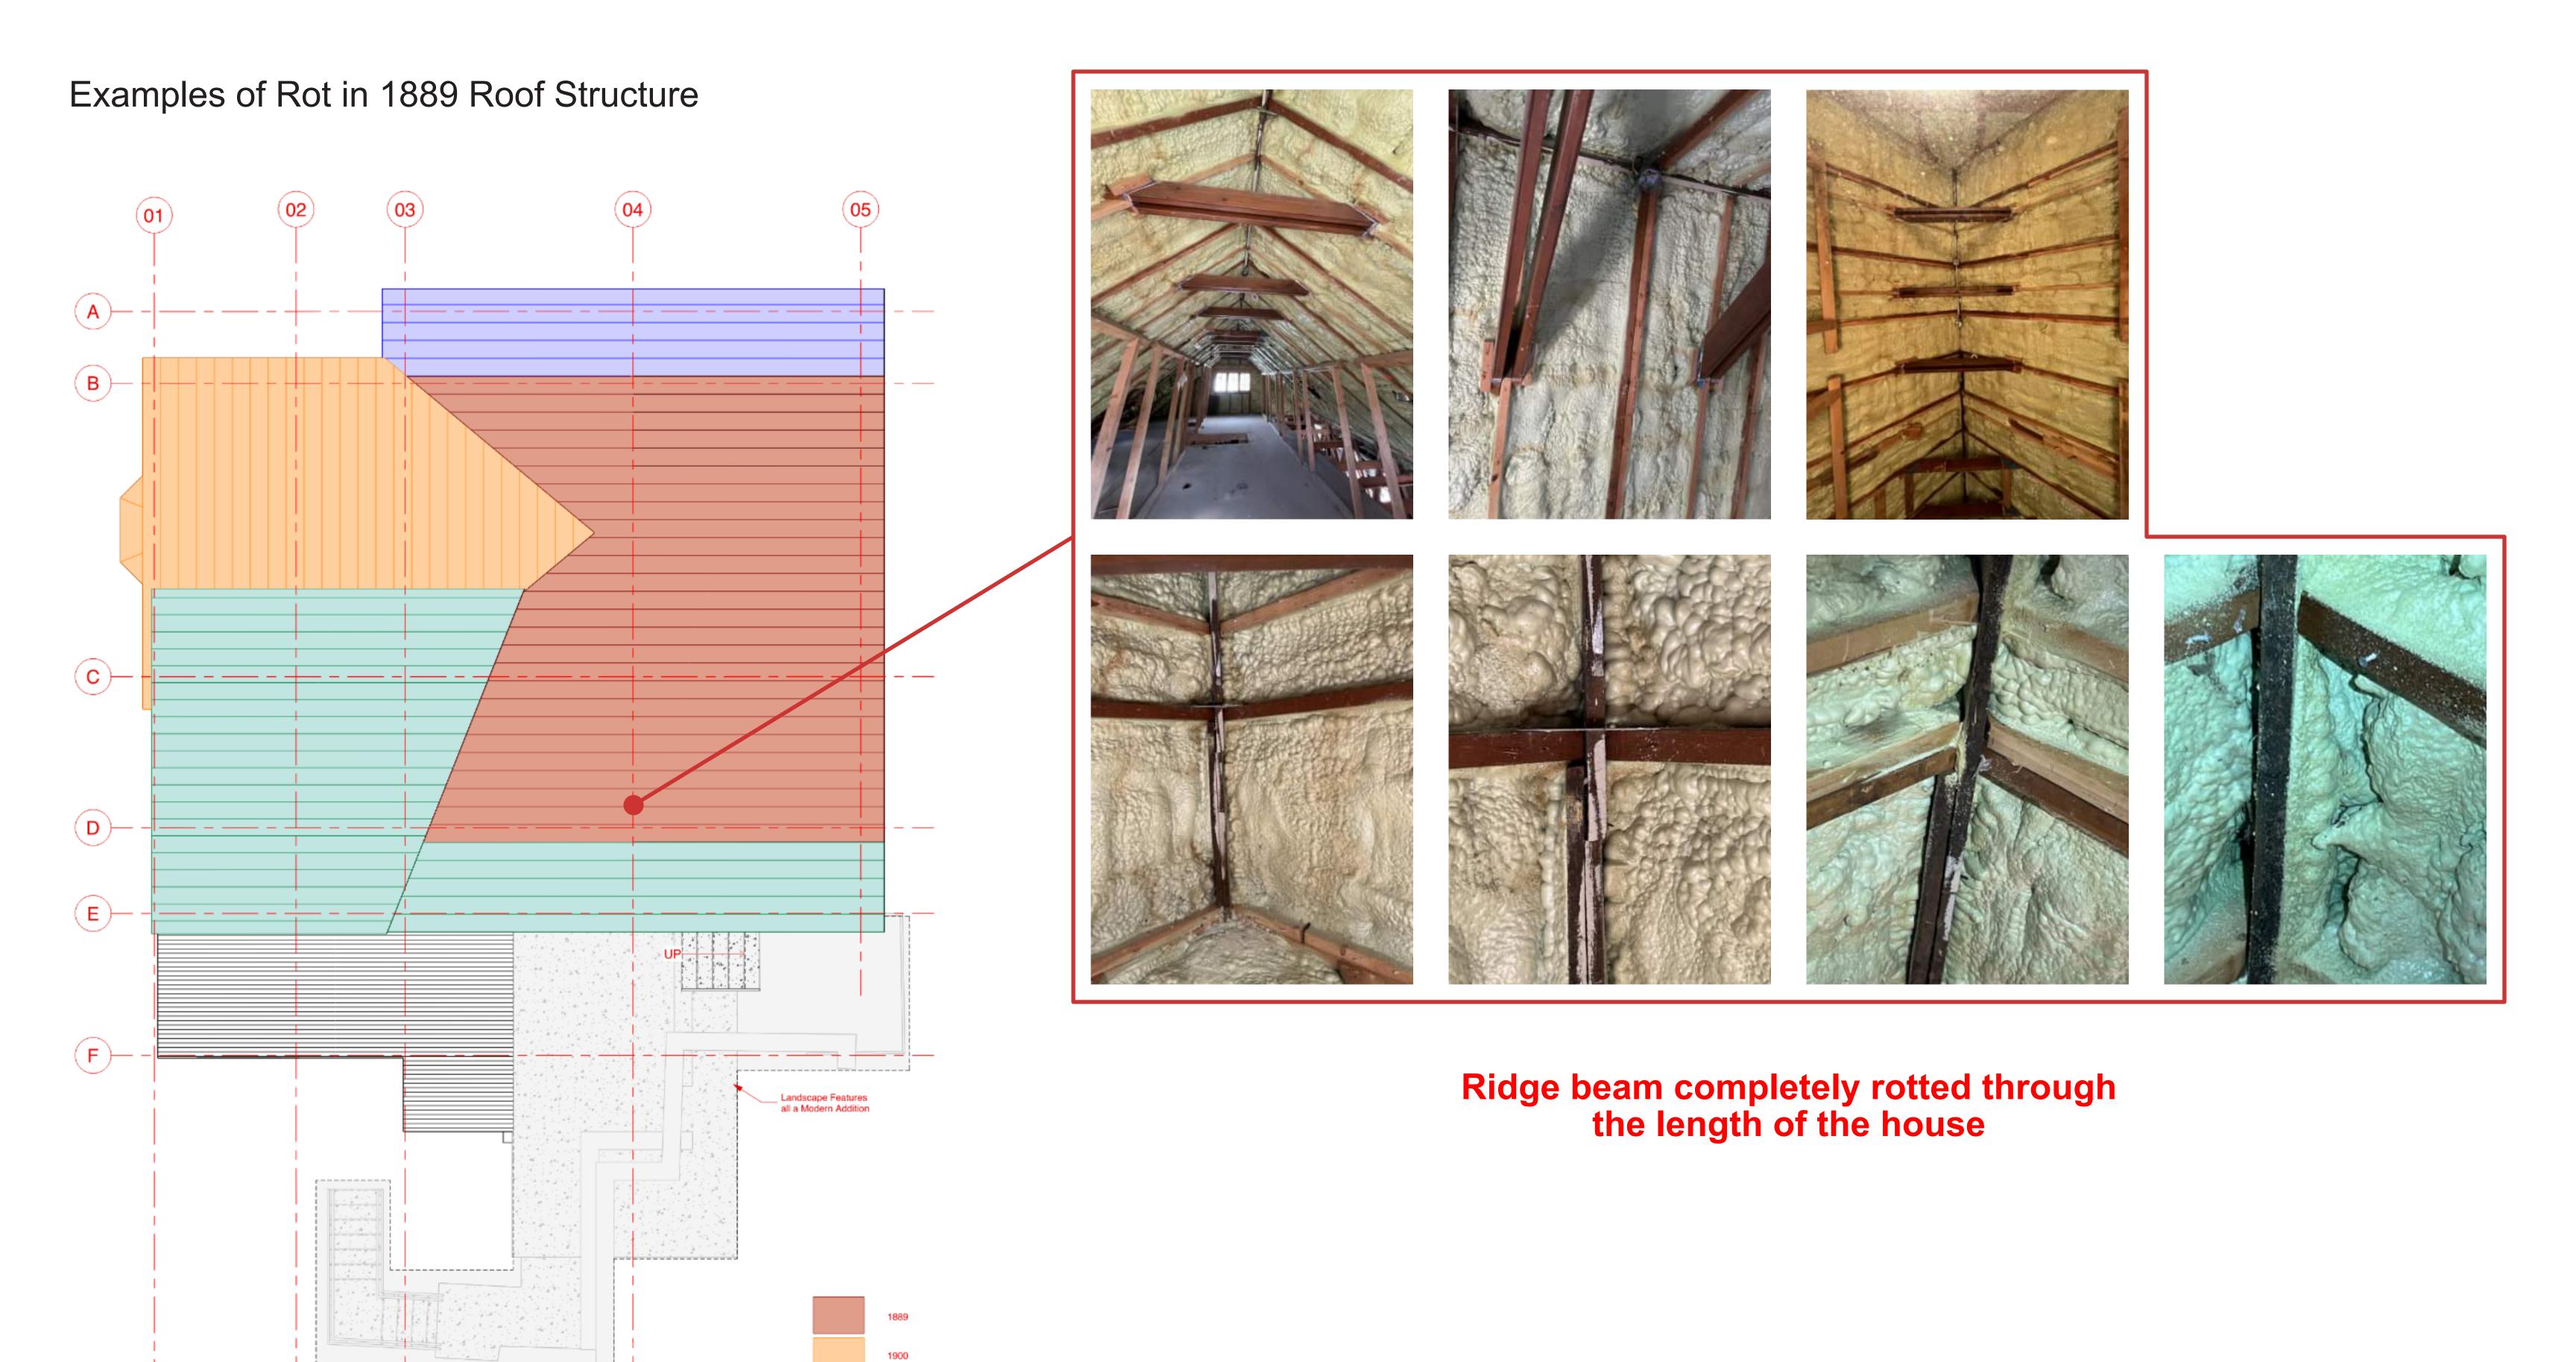
Examples of Rot in 1889 Roof Structure

Roof joists do not run continuous

Ridge beam completely rotted through the length of the house

Spray foam has trapped moisture between roof and the roof planks, causing rot

Incomplete and improper framing

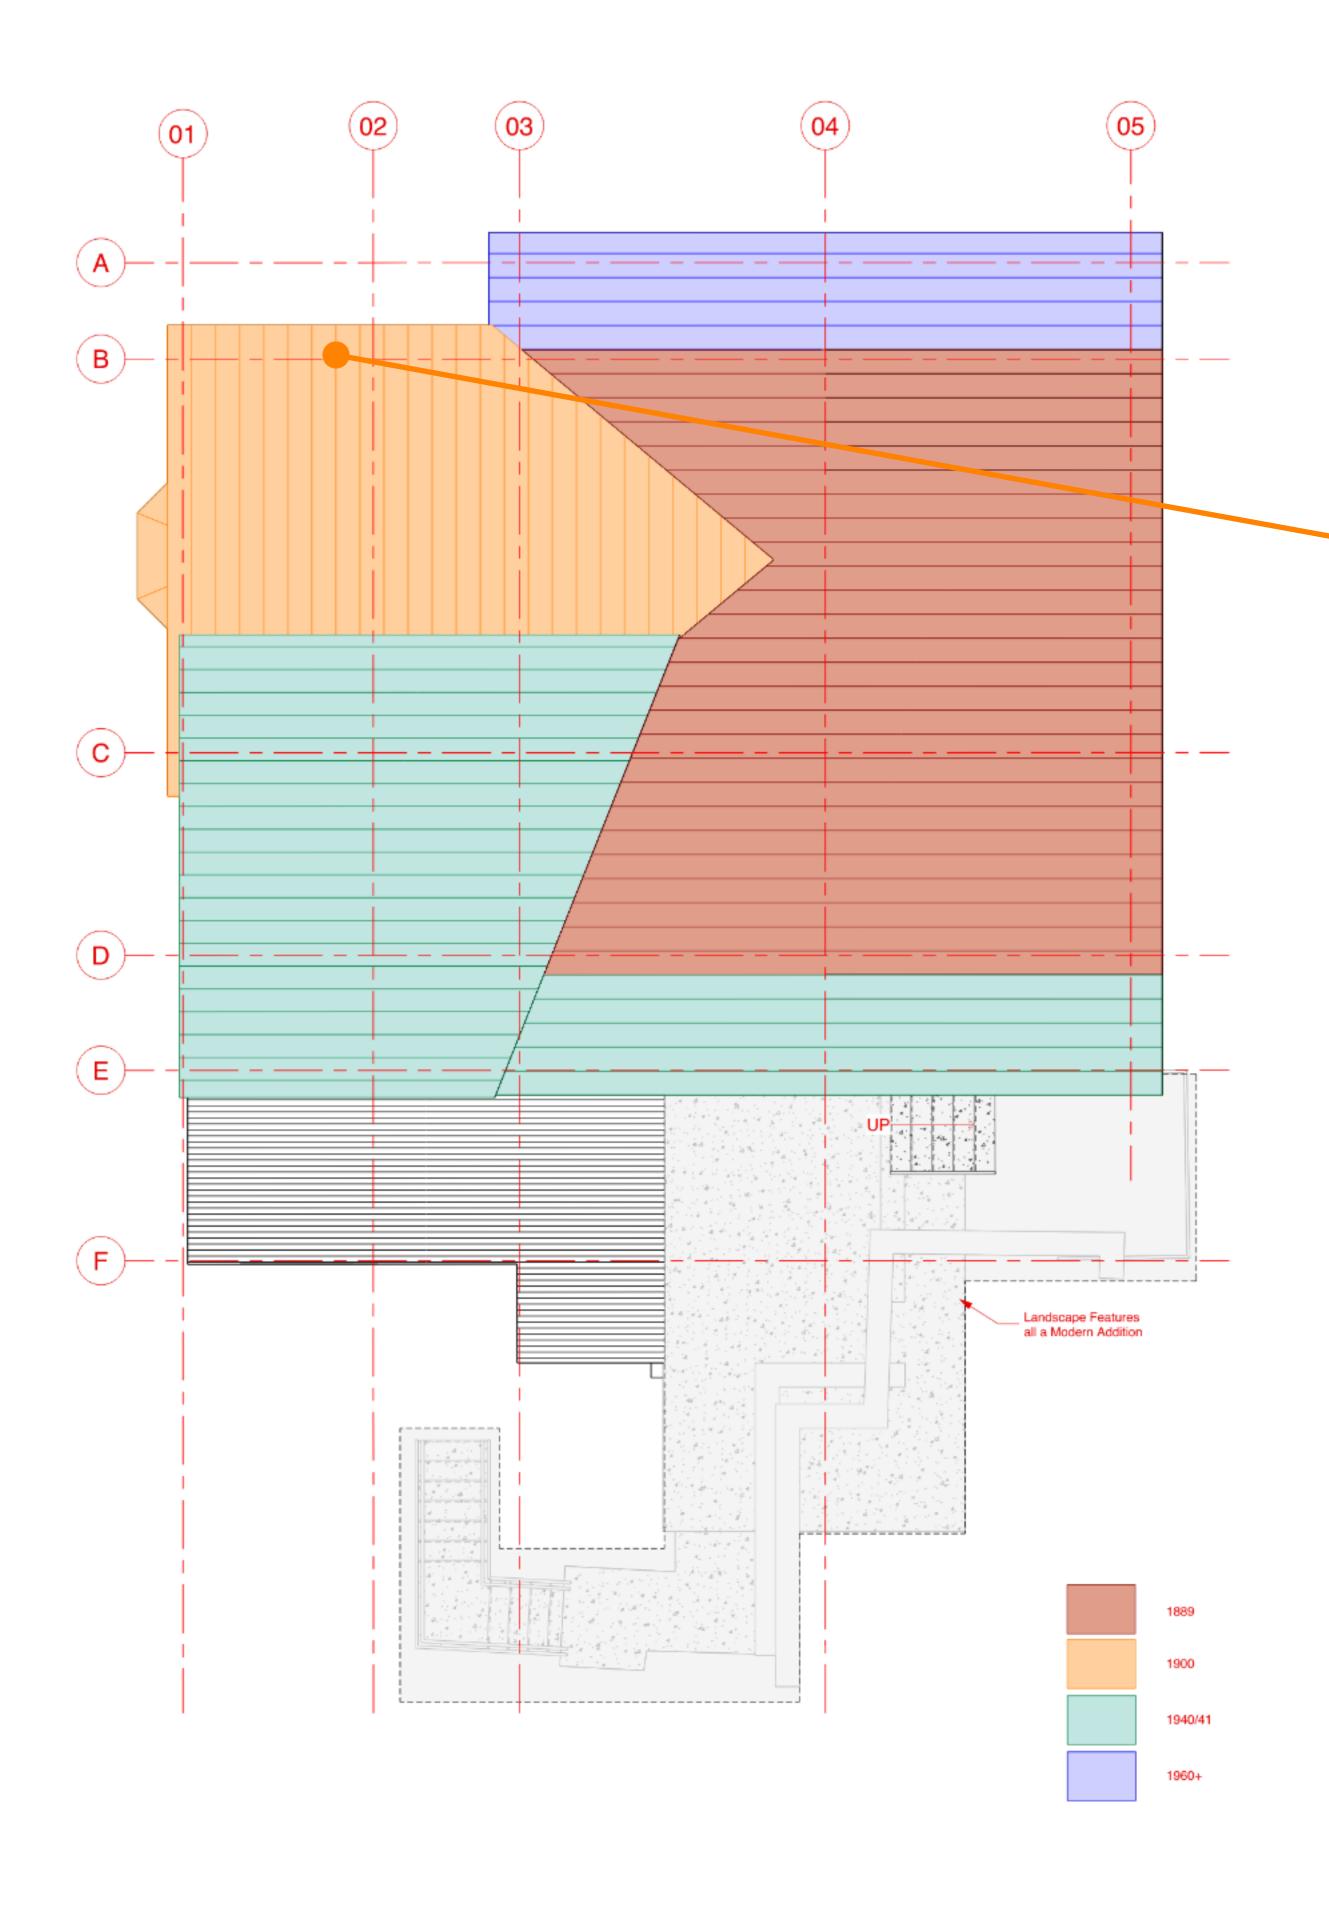
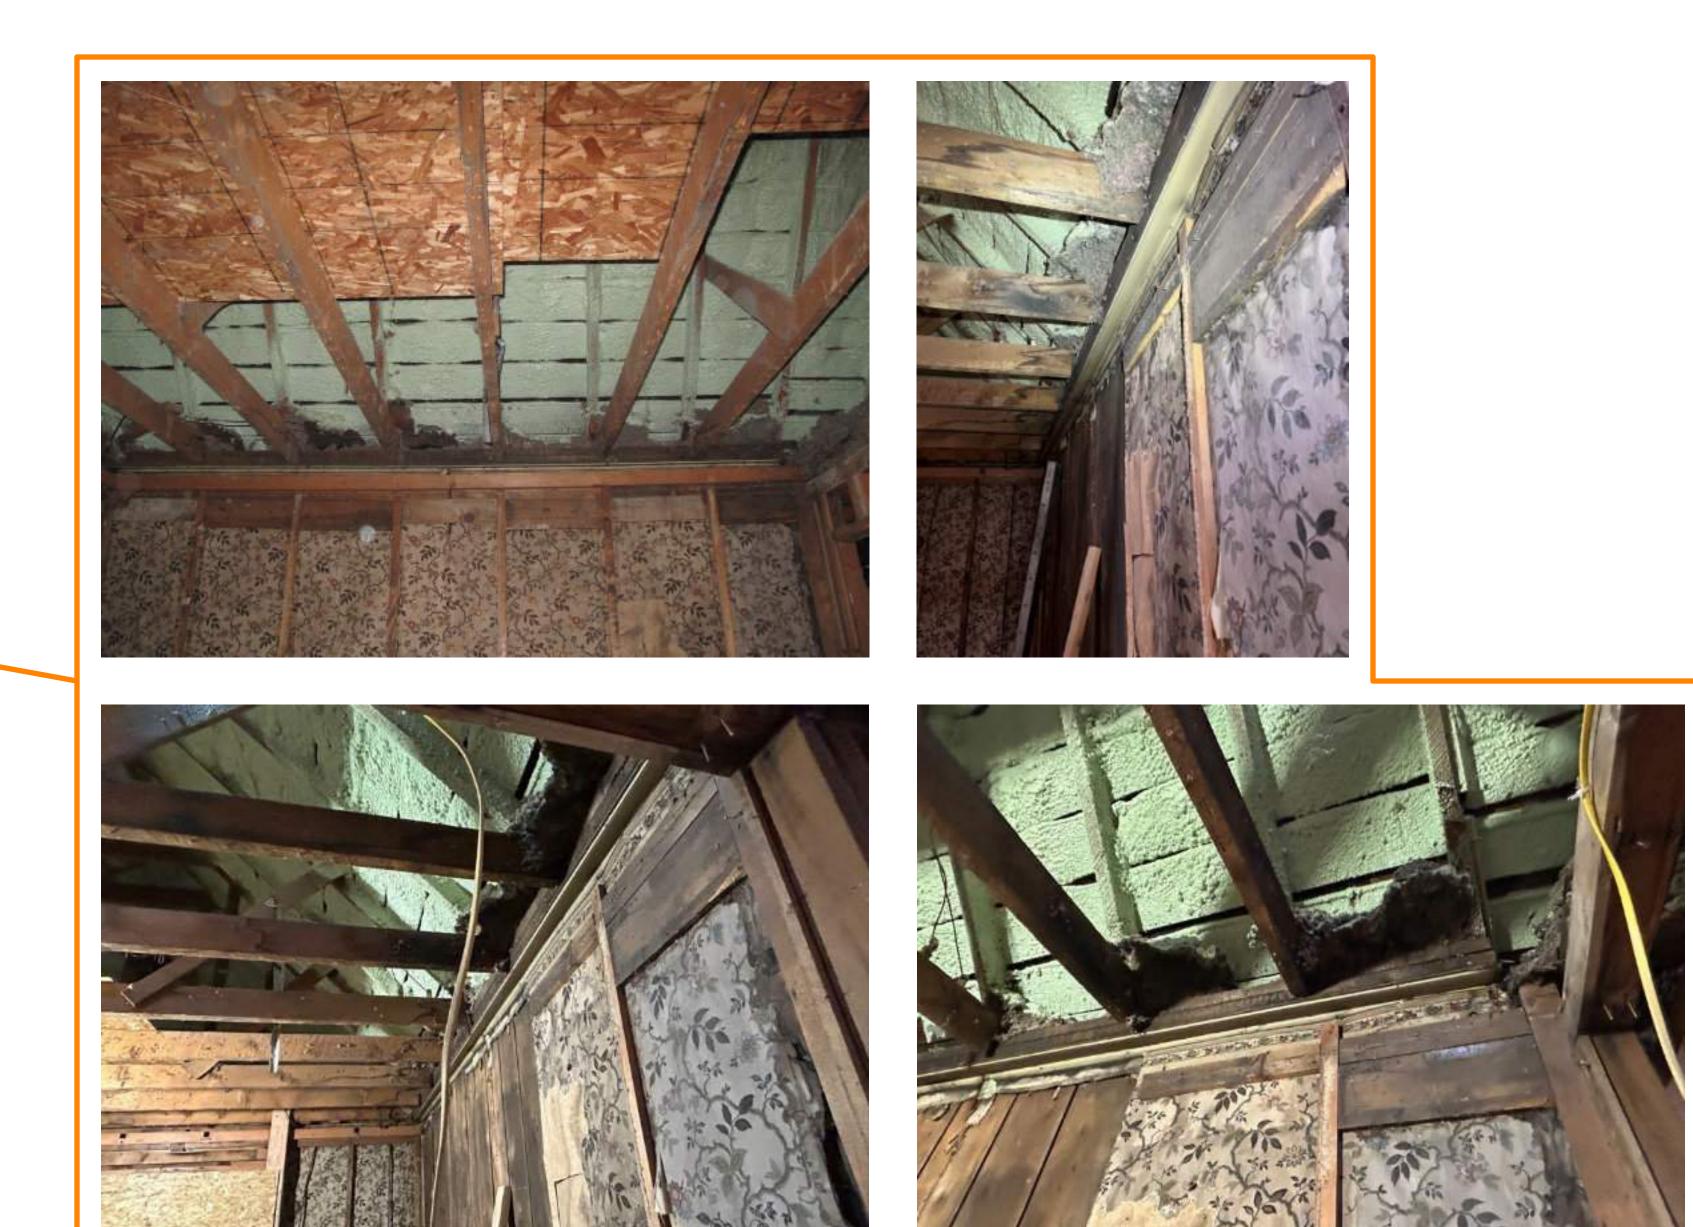
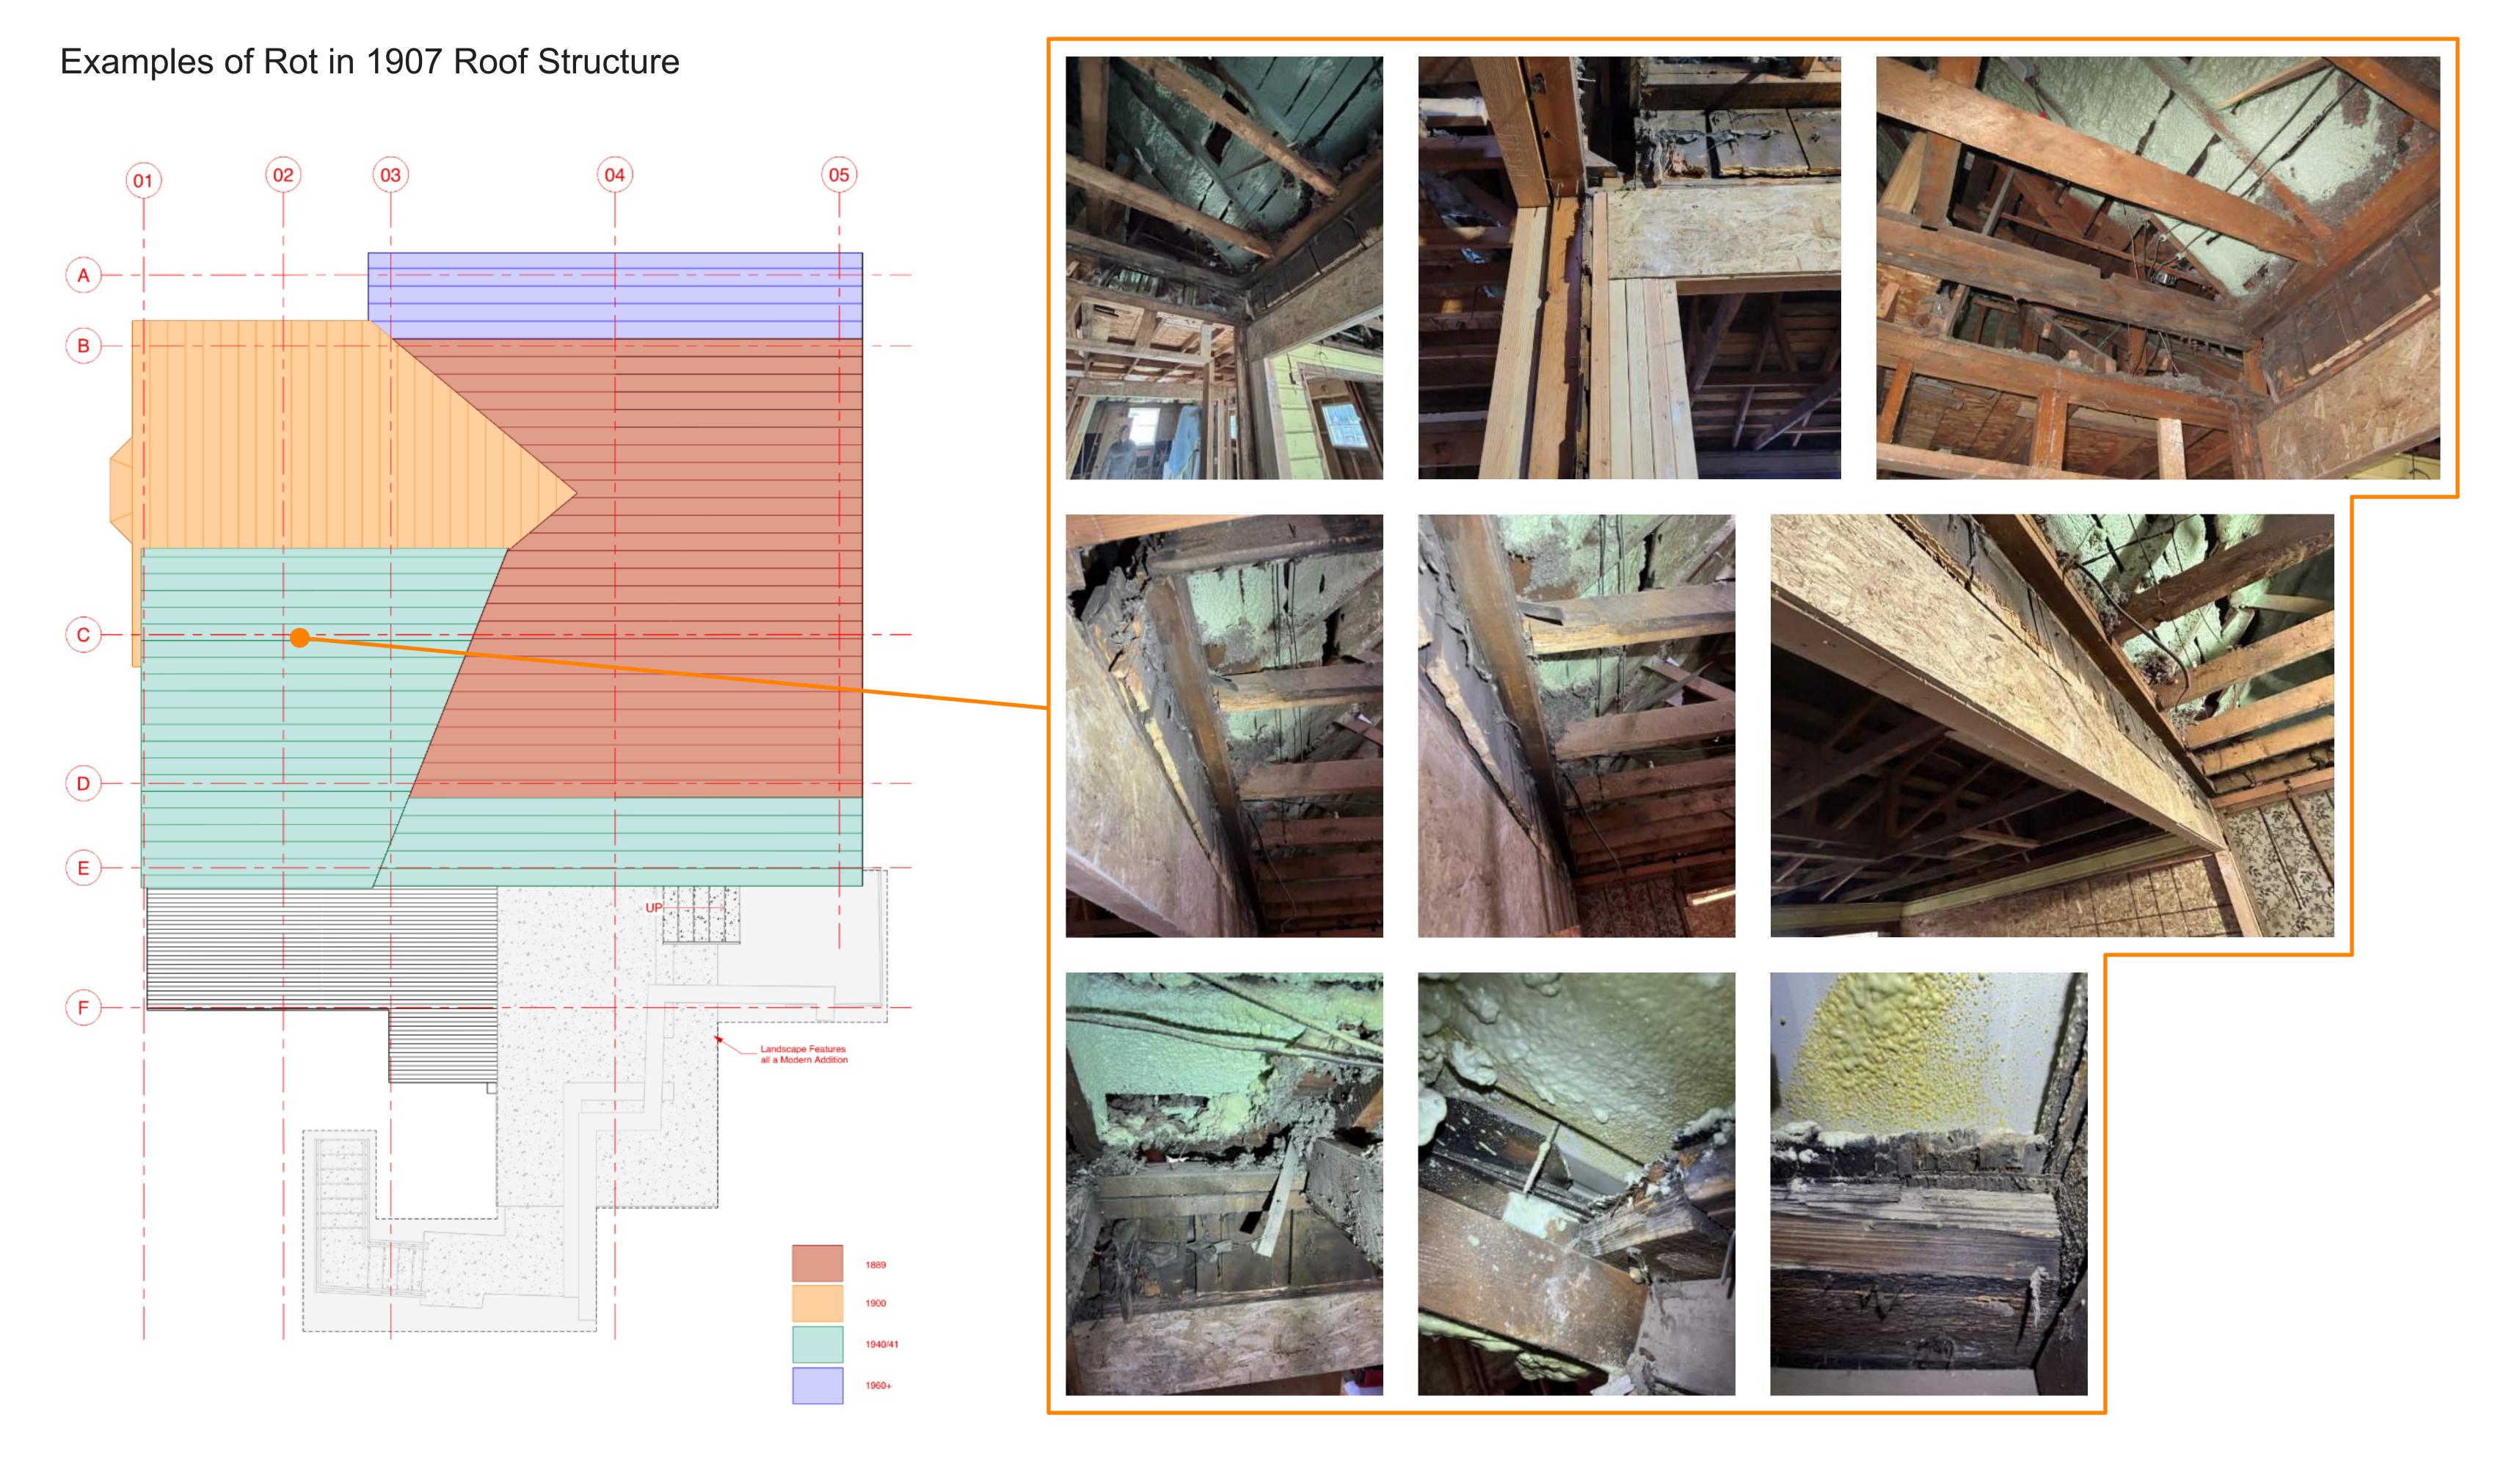
Roof is resting on less than an inch of wall

Examples of Rot in 1907 Roof Structure B **c** Advanced rotting in roof planks joists D

Advanced rotting paired with improper framing
