PARK CITY HISTORIC PRESERVATION BOARD MEETING SUMMIT COUNTY, UTAH November 17, 2025

On September 8, 2025, the City issued Building Permit #25-0638 for 218 Sandridge.

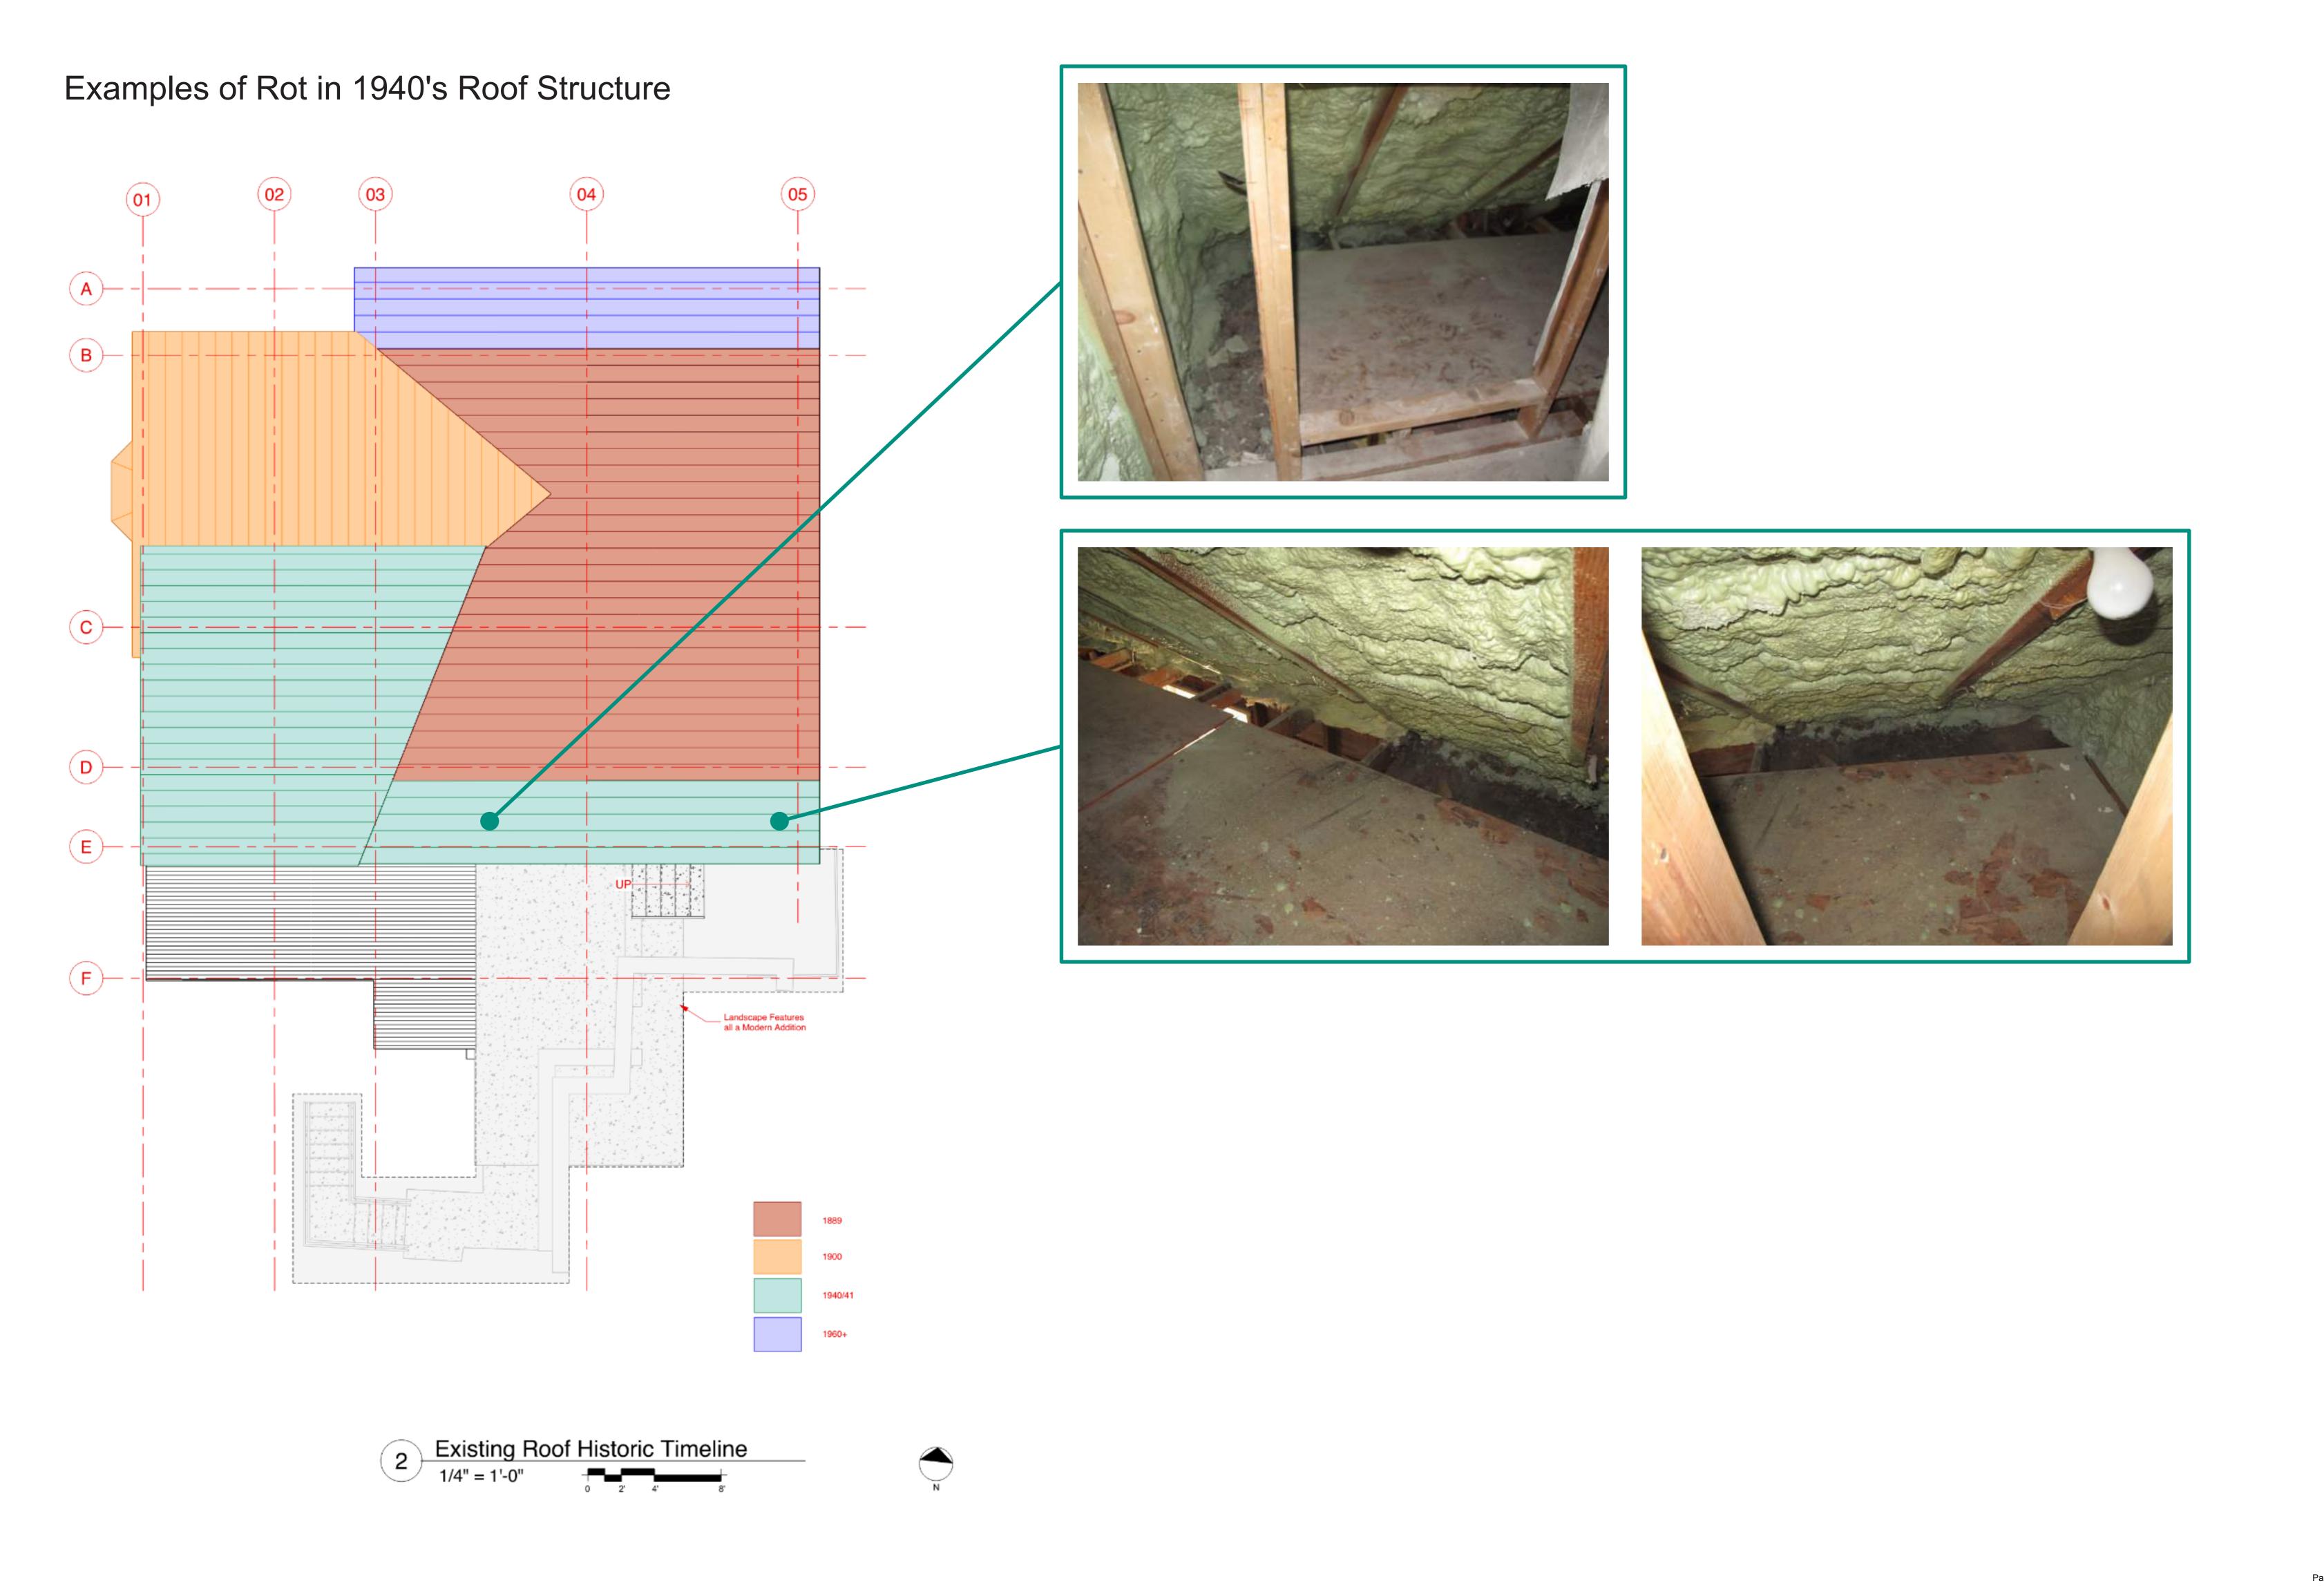
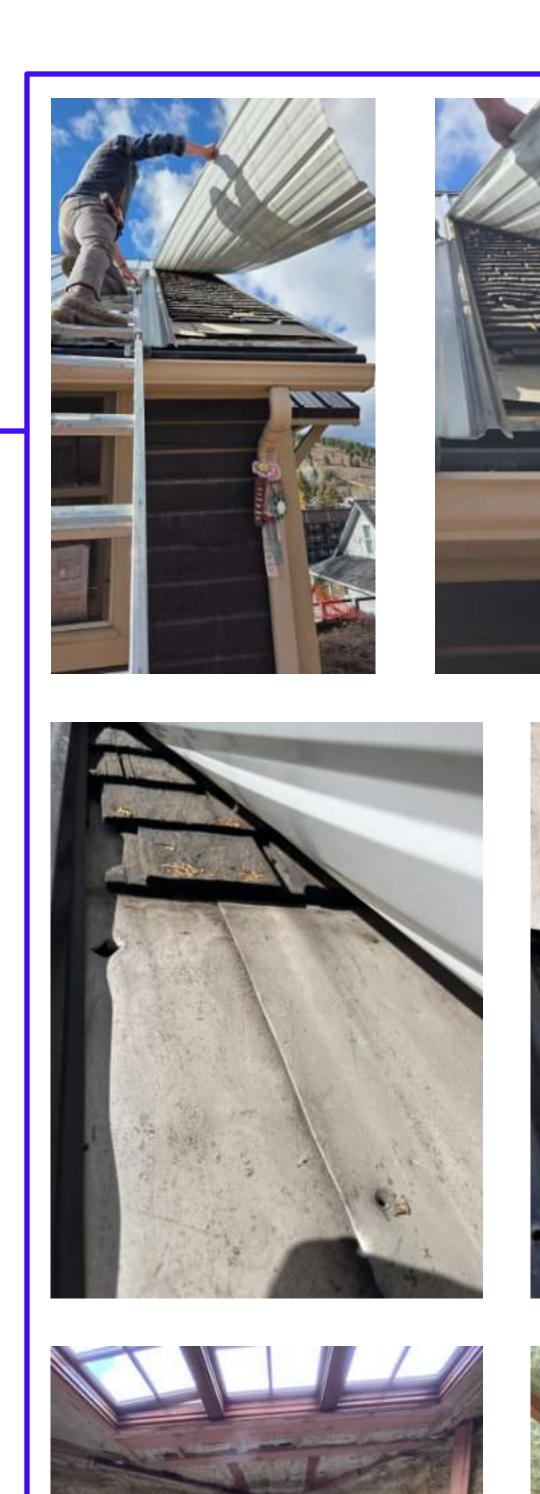
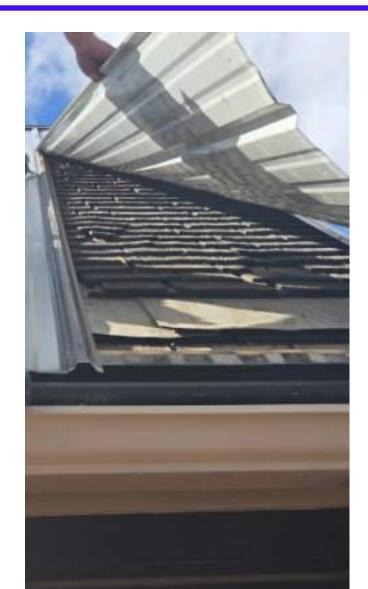
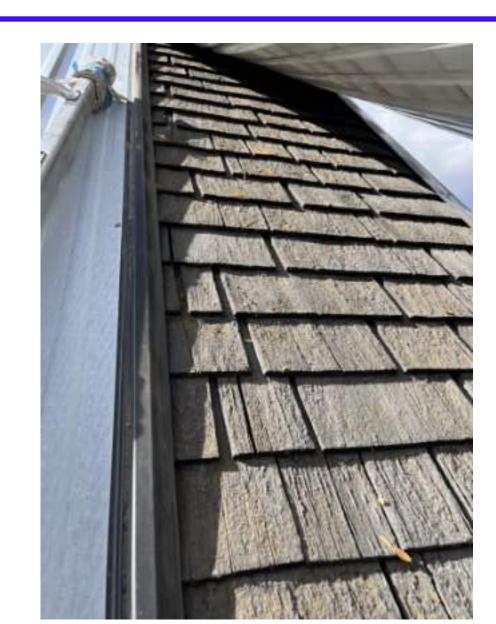
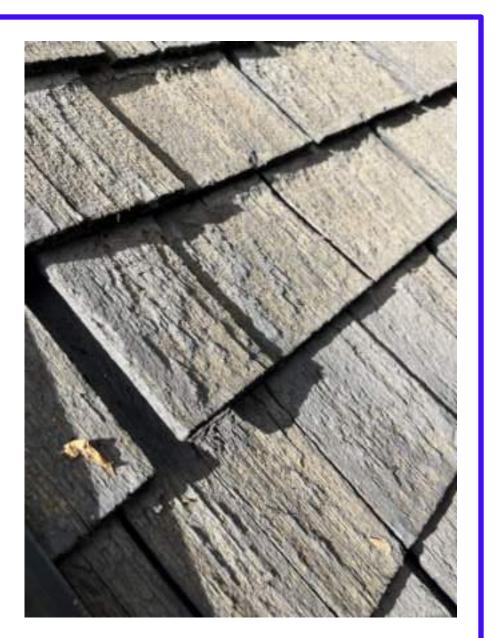
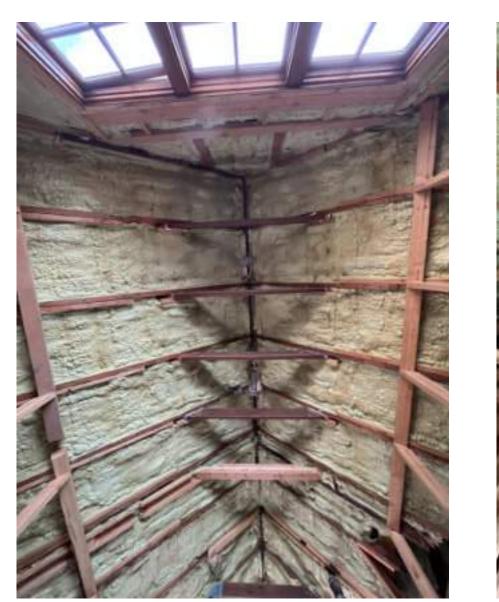
Examples of Rot in 1960's Roof Structure В \bigcirc D E F

Corrugated metal roof is leaking, trapping moisture between original shingles and spray foam. Wood shingles and planks are rotten and very brittle.

Shingles are very intermittent and not continuous across the entirety of the roof.
