Rural School Sports Facilities Grant Program

Application for Funding – FY2026

Name of Eligible School: North Sanpete High School

North Sanpete High School
Stadium Pictures and Descriptions

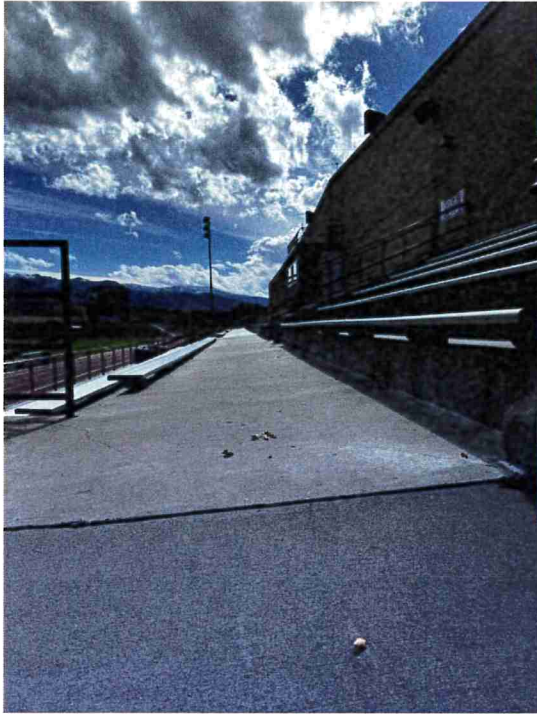
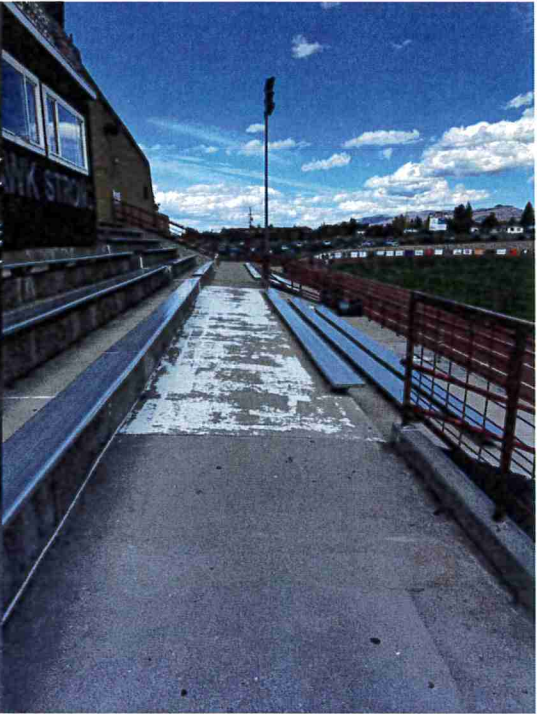
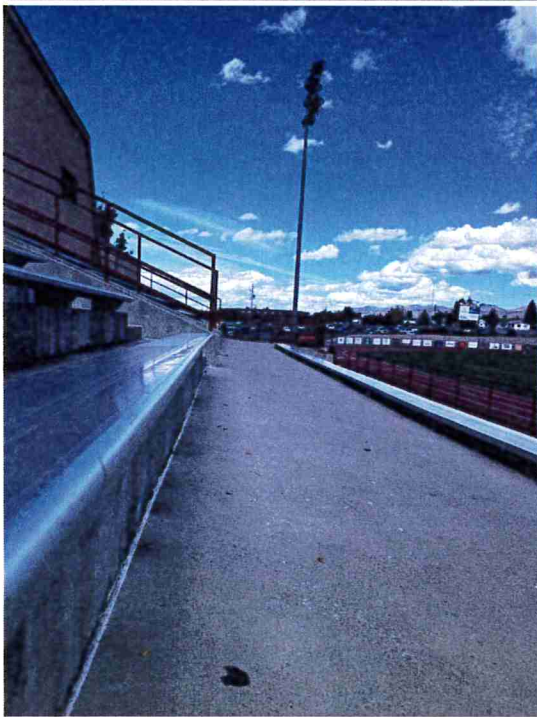
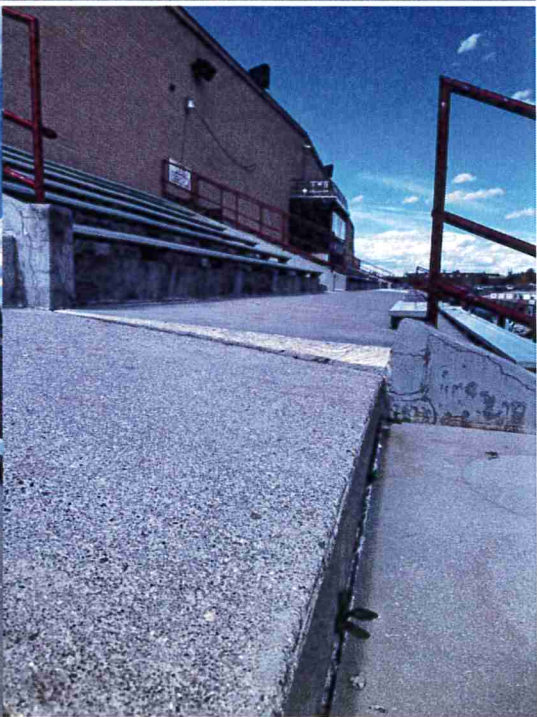
Railings

In multiple places in the stadium, the cement holding the railings is crumbling away.

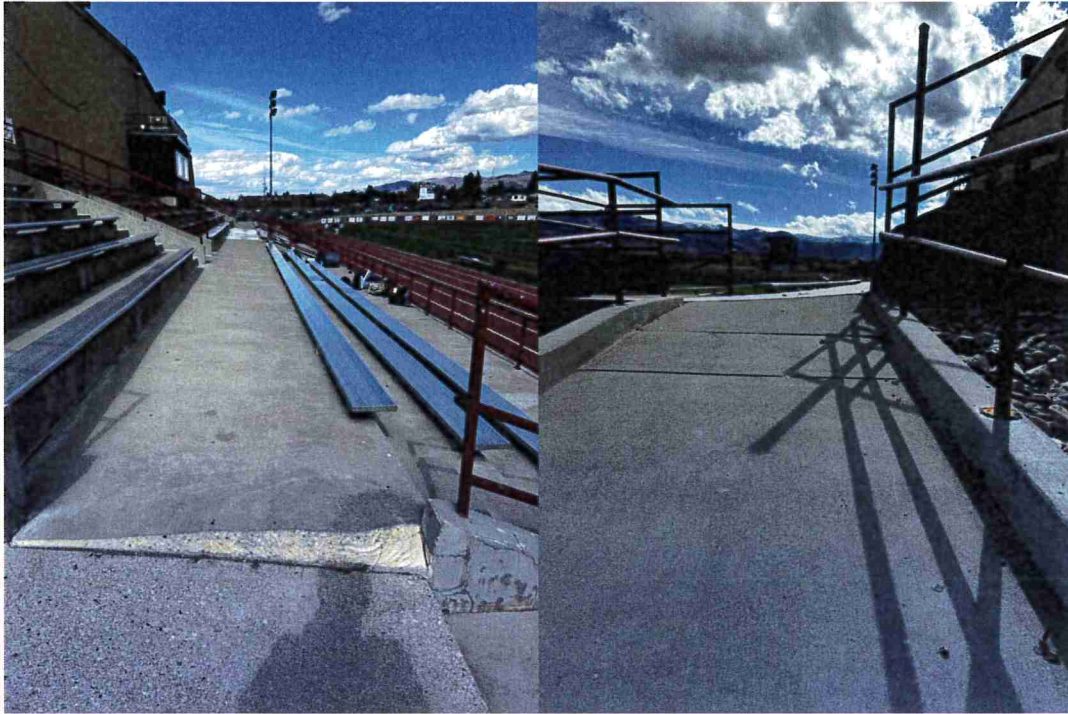
Main Walkway

The main walkway through the stadium is slanted towards the track. The transitions between the main entrance ramp and the main walkway on the north end of the stadium and the main walkway and the cement seating area on the south end of the stadium have become tripping hazards due to settling.

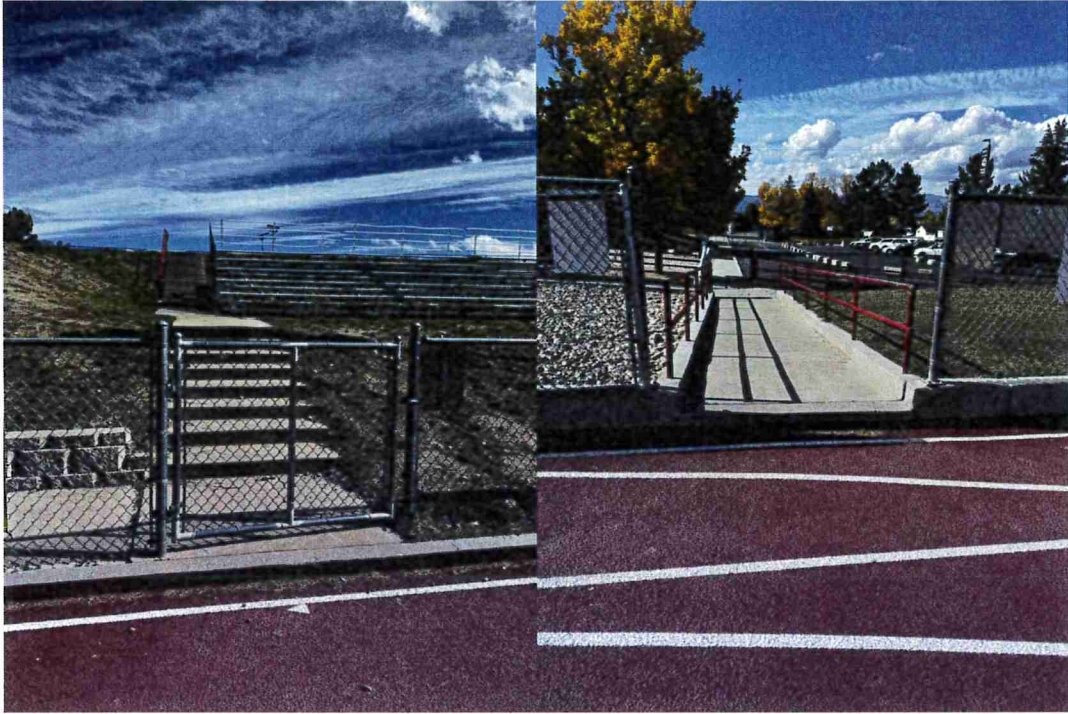
Track Access

There is no wheelchair access to the track from the stadium main entrance or the visitor side seating. Both track access points have a 4" drop to the track.

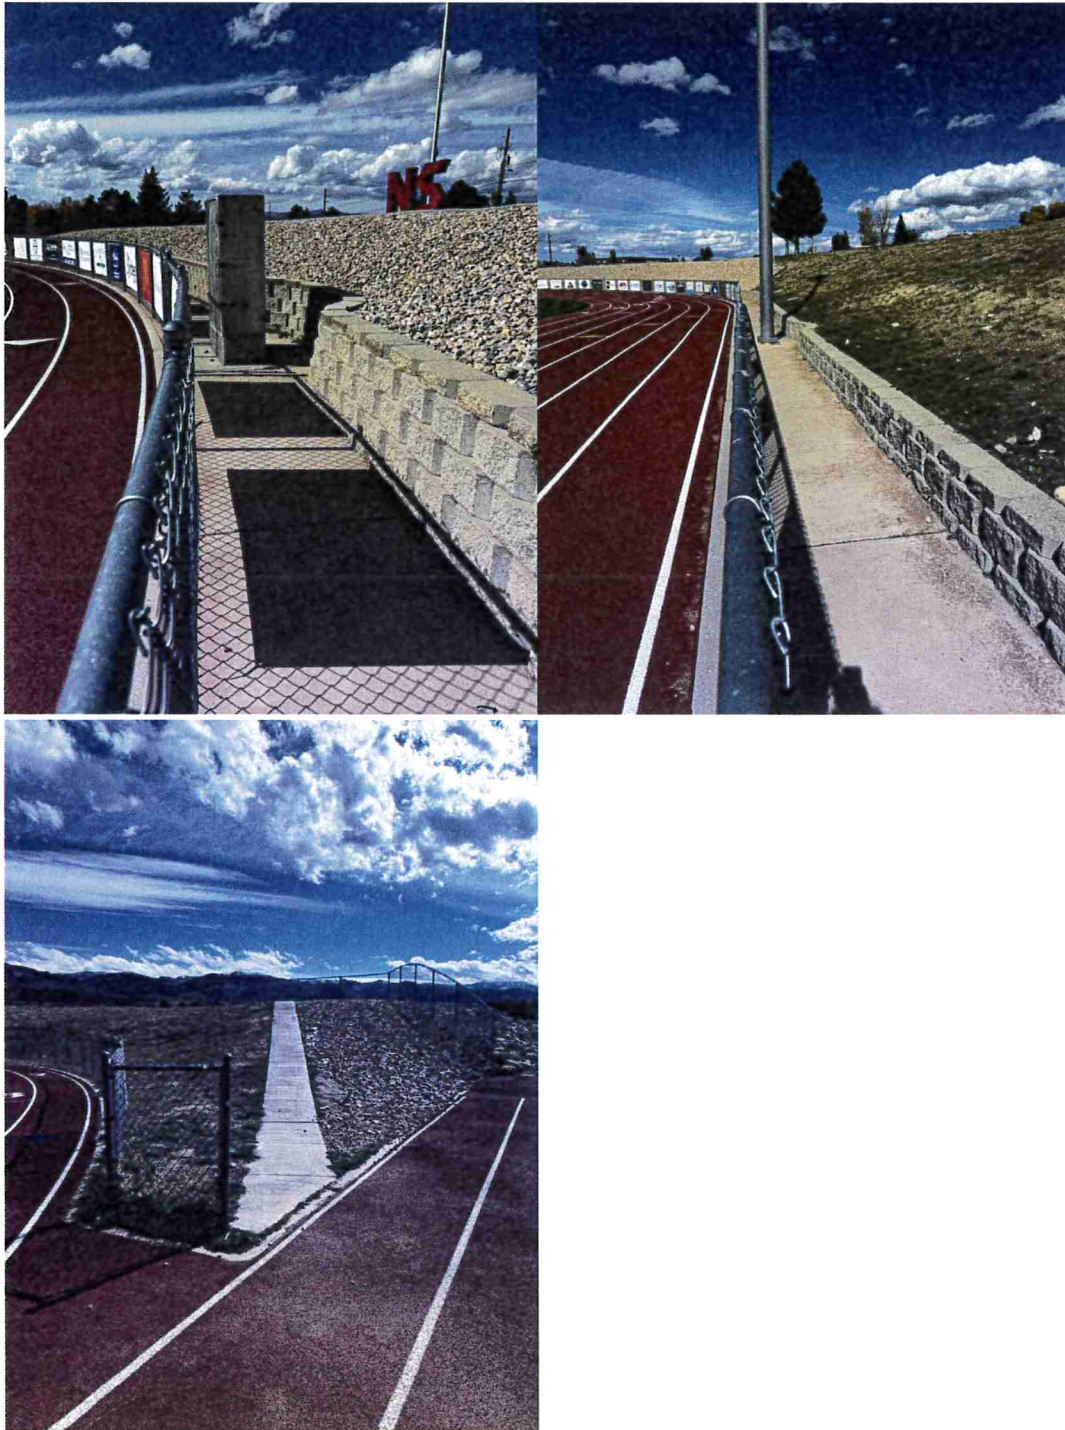
Sidewalk

The sidewalk on the south end of the stadium is very narrow and has a steep grade coming off the berm to the track/concession area. The sidewalk on the north end of the stadium has a light pole and a power box that makes those areas of the sidewalk impassable for wheelchairs and some strollers.

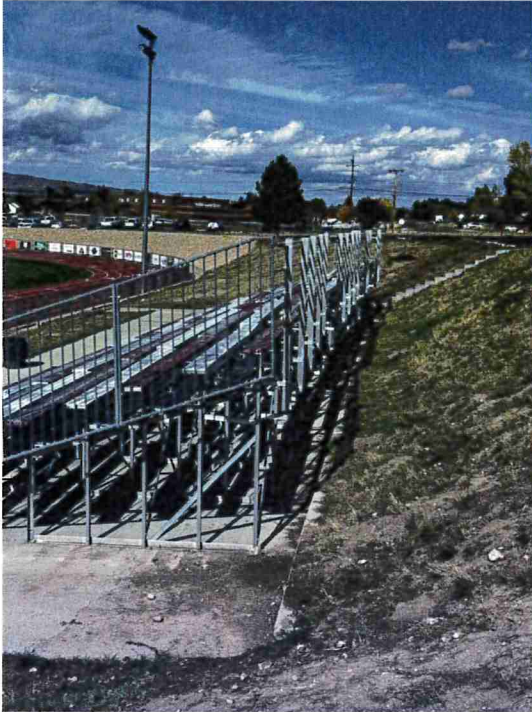
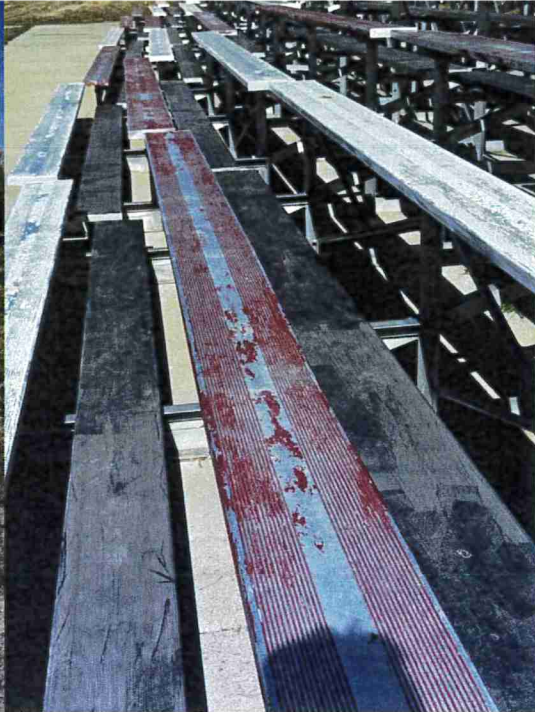
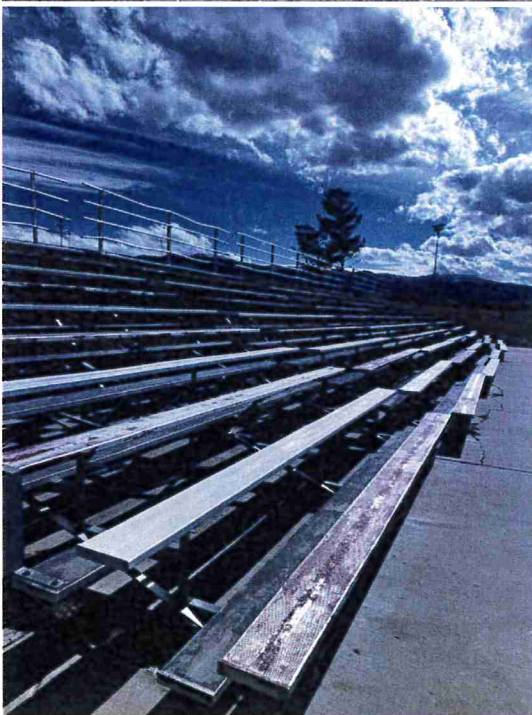
Visitor Bleachers:

There are large gaps and no hand railings or walkways to reach seats on upper rows.

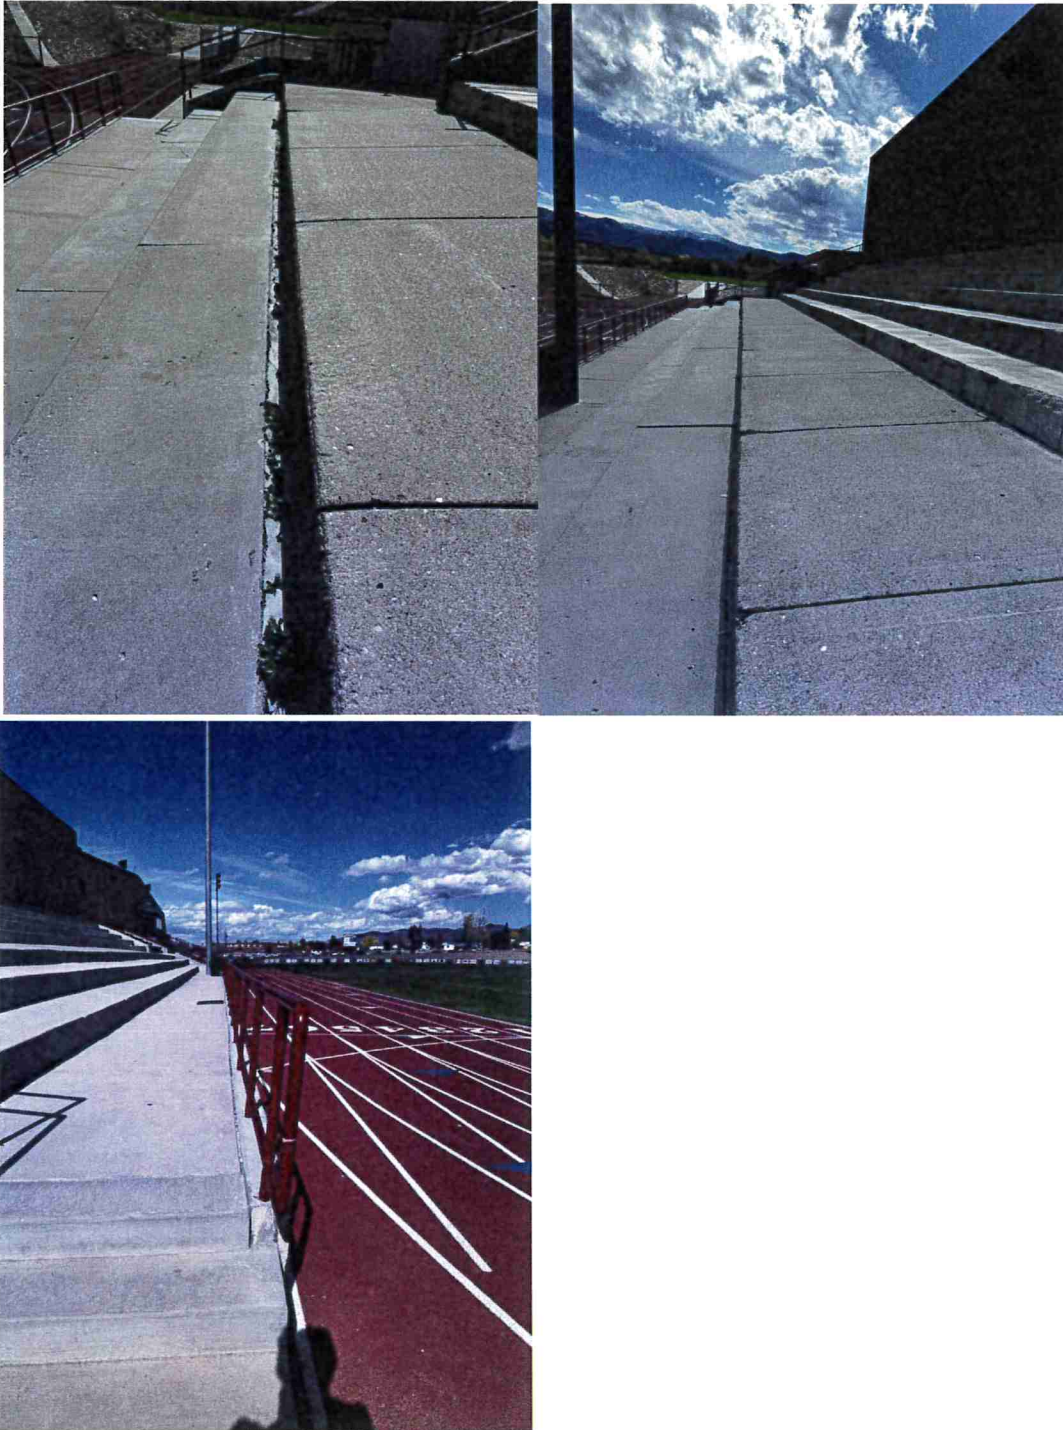
Cement Seating Area:

Cement is separated, leaving large gaps. The cement section that holds the front railing is separating and falling away from the main cement section.

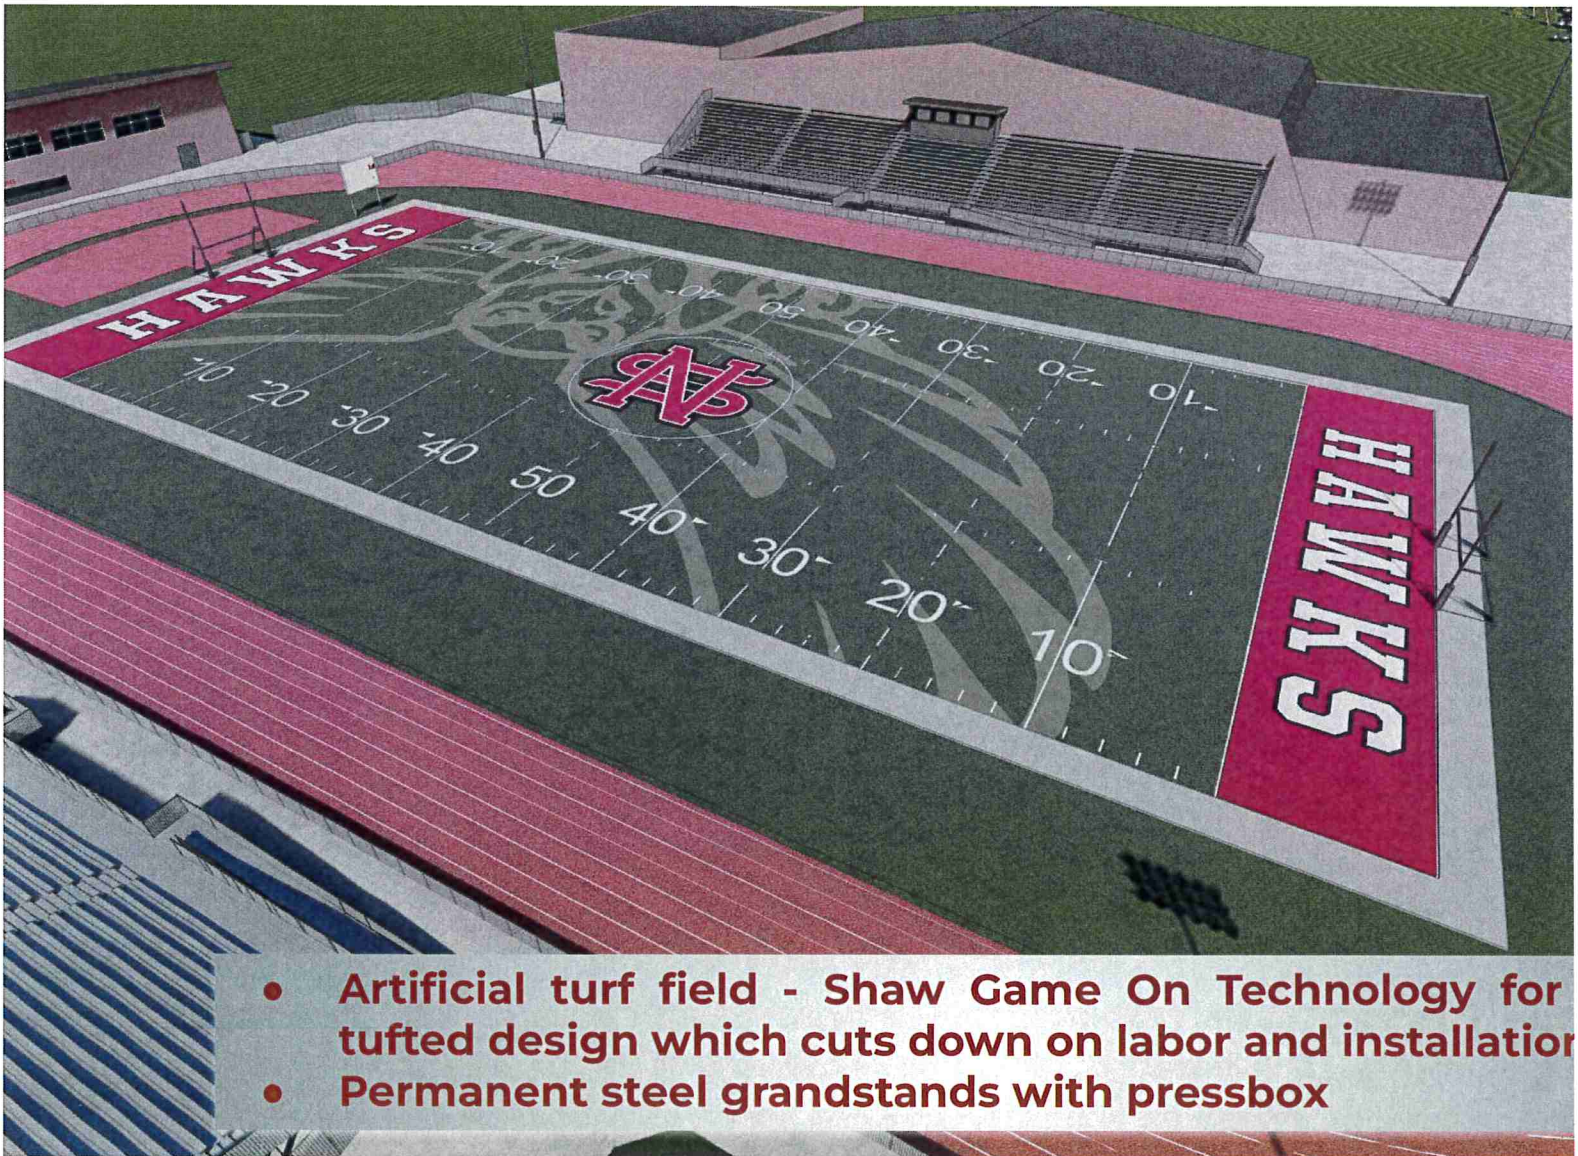
- Artificial turf field - Shaw Game On Technology for tufted design which cuts down on labor and installation
- Permanent steel grandstands with pressbox
