UTAH LAKE RECREATION ACCESS PLAN

NOVEMBER 2025

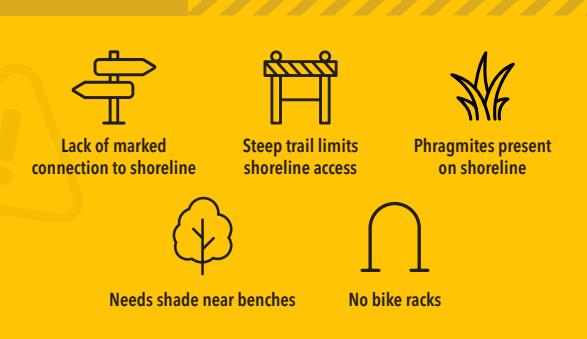
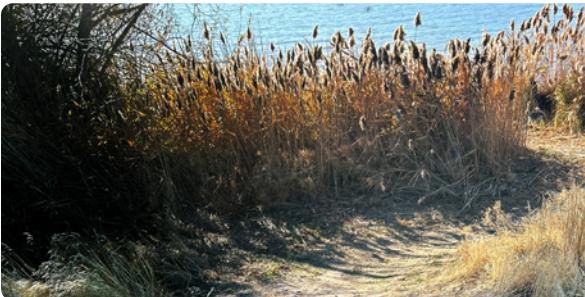
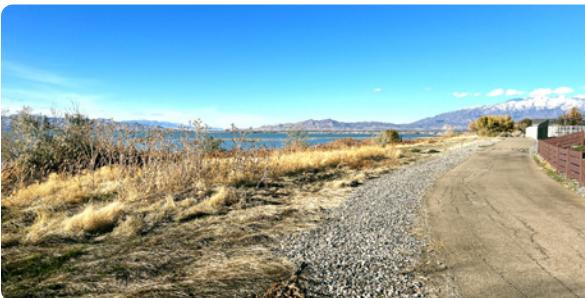
Pain Points:

This access point is located along the Utah Lake Shoreline Trail on the south side of Vineyard City and has a small paved parking lot. The sandy shoreline makes it ideal for beach activities and launching small, hand-carried watercraft. A dog waste station is available at the entrance.

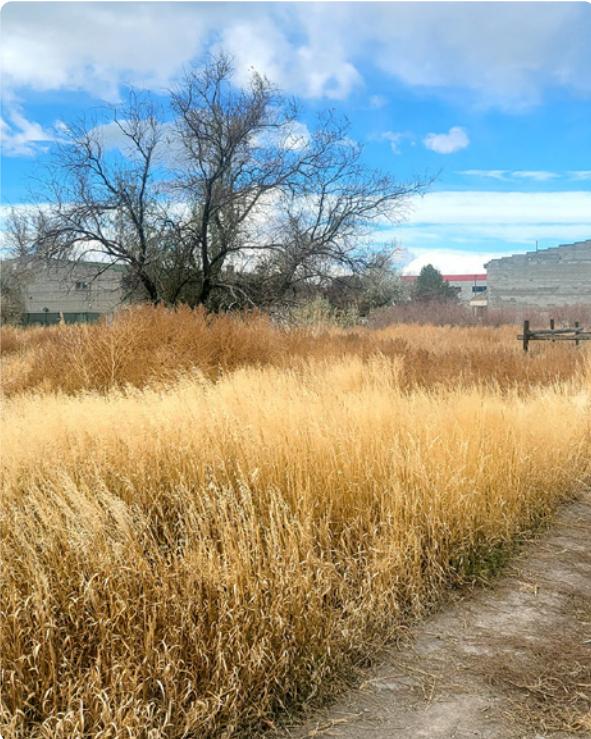
Overgrown vegetation blocks the trail

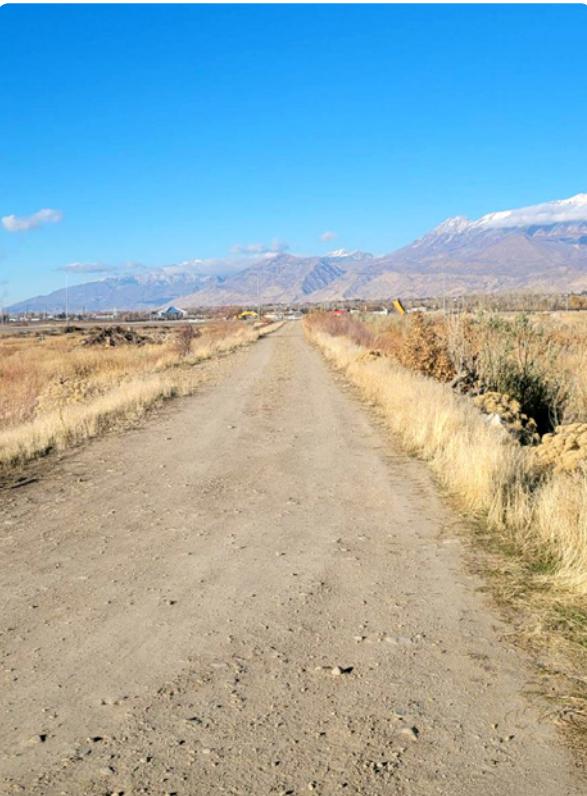
Roads are in poor
condition

Airport Dike - This site has moderately poor road conditions with uneven surfaces and loose gravel. The initial turnoff is asphalt but is in extremely poor condition. Consider regular grading and maintenance.

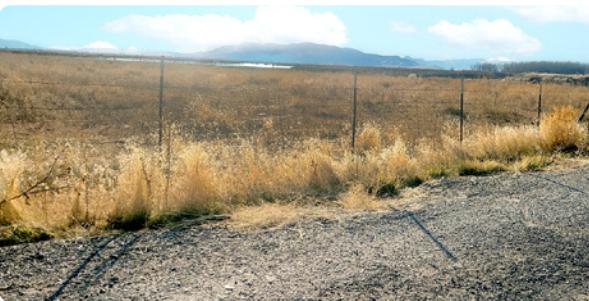
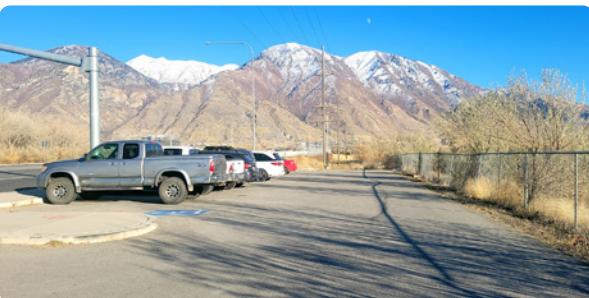
Needs better signage to the shoreline; incorrectly labeled on Google Maps.

- Create a map of access
- Improve signage

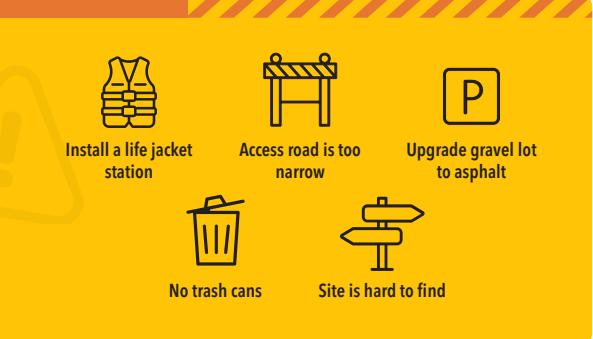
Swede Lane is a boat launch access point featuring a primitive gravel/dirt ramp for launching motorized boats. The site has no additional amenities and is difficult to locate due to limited wayfinding signage. Access roads are narrow and may pose challenges for some boats. The existing ramp was very muddy and in poor condition.

- Replace primitive boat ramp with a concrete ramp
- Install fishing dock

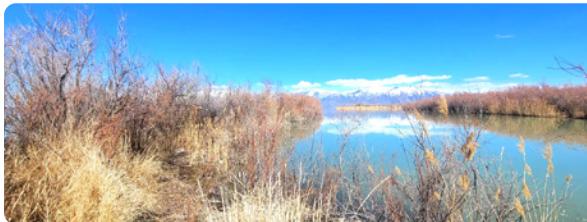
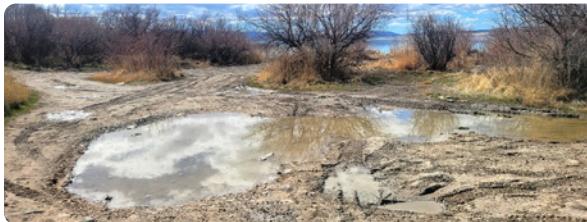
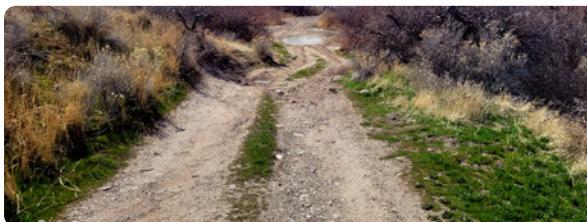
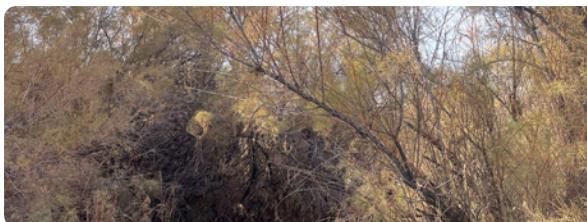
Access roads in poor condition

Lots of trash on the ground

Given this site's proximity, many of the Lincoln Beach improvements will also benefit this site. Additionally, The Utah Lake Commission identified several improvements for this site and submitted them for funding via the DNR [Watershed Restoration Initiative](#). Funding was not awarded.

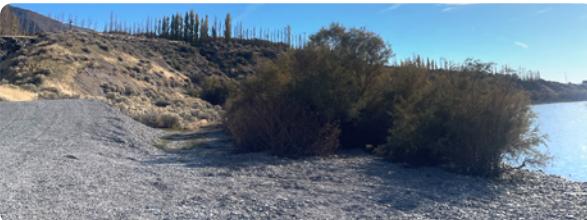
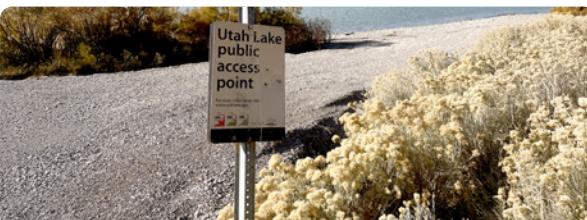
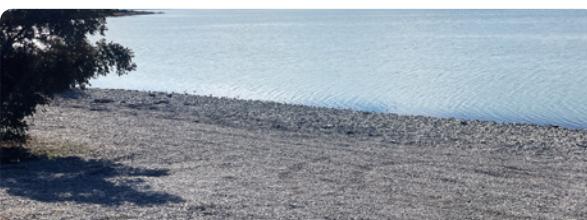
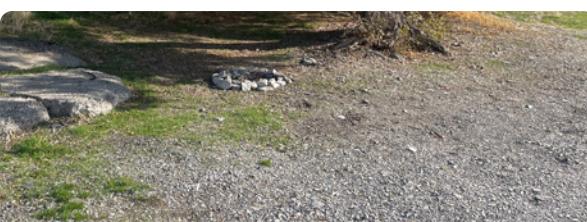
No trash cans

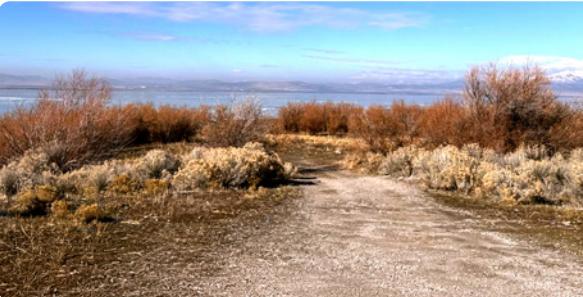
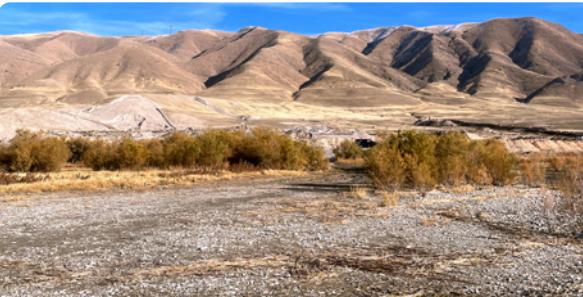
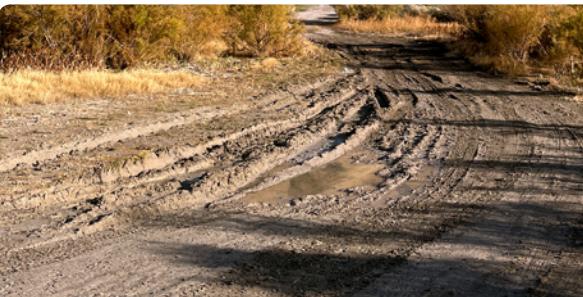
Access is provided by dirt and gravel roads in moderately poor condition. Noise from the nearby gravel pit creates a significant disturbance for visitors seeking a quieter recreational experience.

Access roads in poor condition

Trash on the ground

Goosepoint North Access - Mud holes and uneven terrain are found on some road segments at this site. Spot repairs and surface stabilization would reduce maintenance issues and improve access.

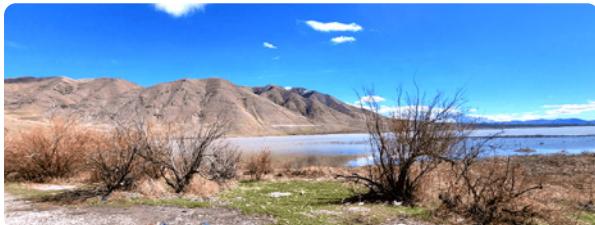
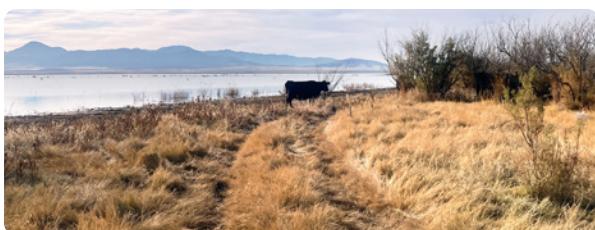
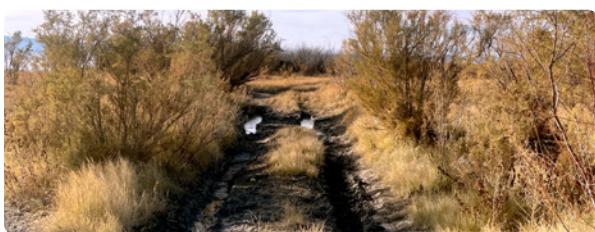
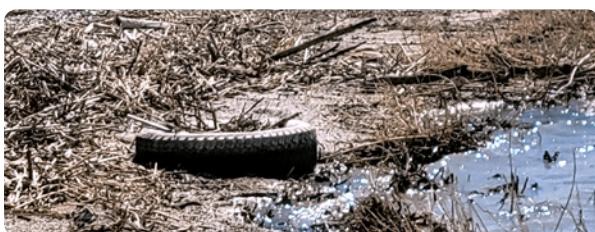
This is an undeveloped access point located at Goosepoint on the southeastern side of the lake. This site has no amenities, limited street parking, and is accessed by rough dirt roads that become muddy and nearly impassable for most vehicles, especially during wet conditions. This is a popular shore fishing area with some waterfowl hunting and birding opportunities.

Access roads in poor condition

- Manage vegetation for access.
- Install Fishing dock

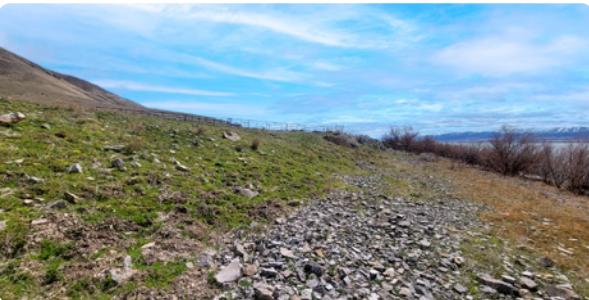
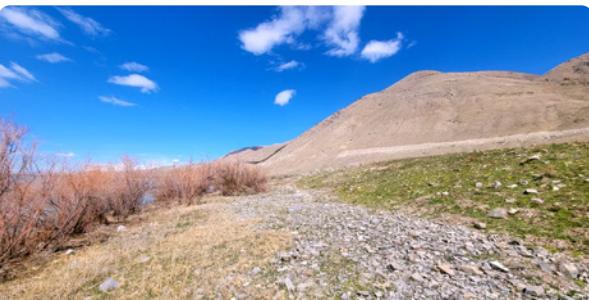
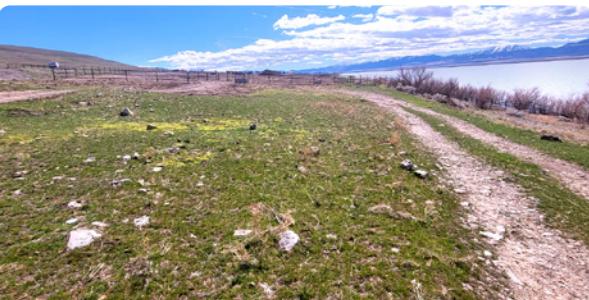
This undeveloped access point has no amenities and is a popular fishing location. The steep bank makes it difficult to carry small watercraft to the shoreline. Lack of wayfinding on dirt roads makes it difficult to access.

Steep slope to shoreline

- Install gravel boat ramp for small motorized boats.

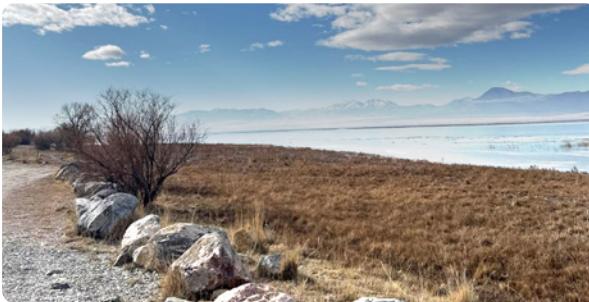
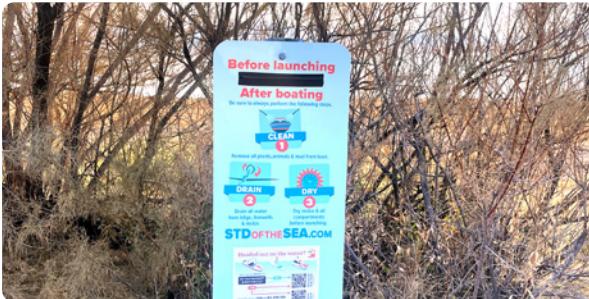
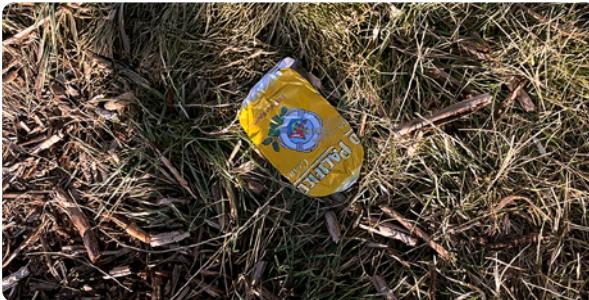
LeBaron Point is an undeveloped access point located off a gravel road on the southern side of Utah Lake near Genola. With no recreation amenities, this site is best suited for fishing or launching small, hand-carried watercraft. Some trash was found along the shoreline.

Trash on the ground

- Protect against motorized vehicle access.

- Install concrete boat ramp
- Install fishing dock

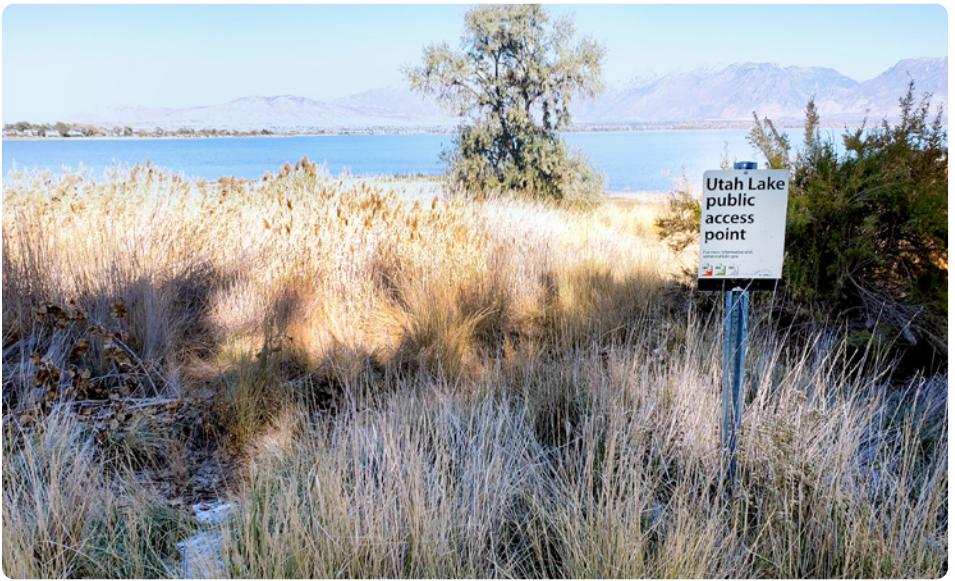
Eagle Park destination sign is small and blends in with the vegetation

- Install destination signs at all access points, clearly marking entrances, turn-offs, and parking areas. Signs should be highly visible, weather-resistant, and conveniently placed for users.
- At large sites, install internal wayfinding to key amenities such as trails, shoreline, restrooms, or other amenities.
- All signs should follow a unified design standard to create a recognizable and consistent visual identity across the lake.
- Coordinate with Google Maps and other platforms to ensure all access points are correctly labeled and pinned. Periodically audit online listings and submit corrections as needed.
- Create and implement a comprehensive wayfinding plan for Utah Lake and its access points.

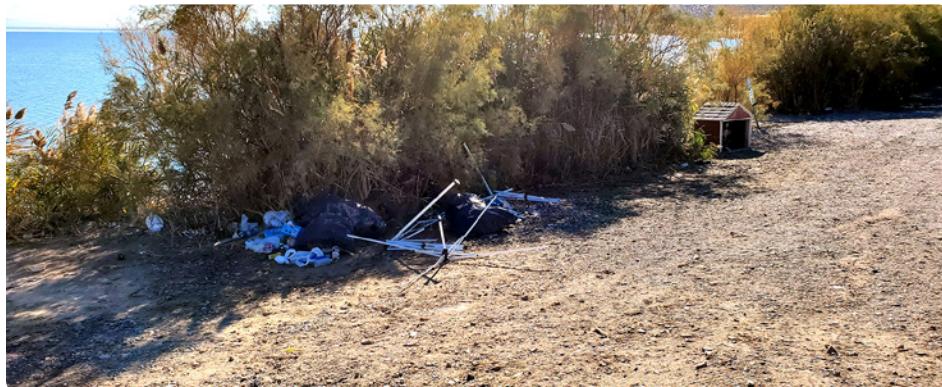
The Knolls

This access point is connected to a campground on the western side of the lake. It features a life jacket loaner station and a gentle slope into the water, making it well-suited for launching boating. The gravel shoreline was littered with a significant amount of trash during this assessment.

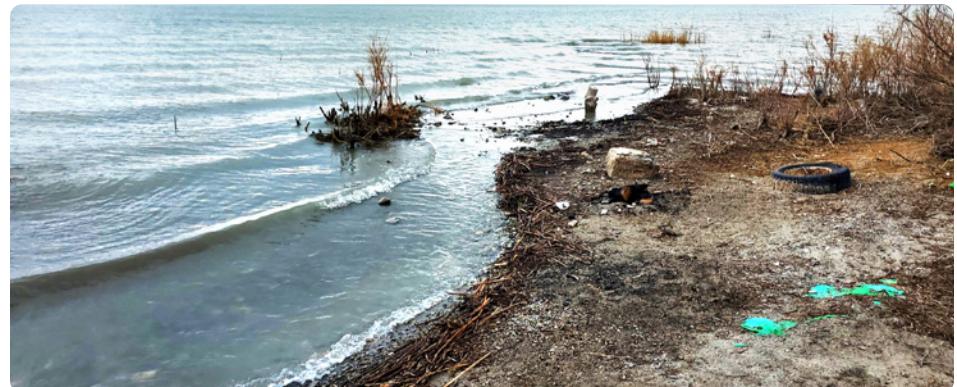
Big Cove Sportsman Access is an undeveloped access point located on BLM land on the western side of Utah Lake. With no recreational amenities, this site is best suited for fishing or launching small boats.

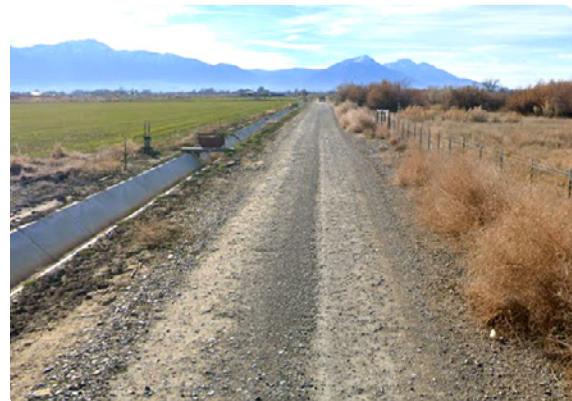
Swede Lane - The current dirt road is too narrow for many boats and trailers. As part of any future boat ramp improvements, the road should be widened and upgraded to better accommodate boat access.

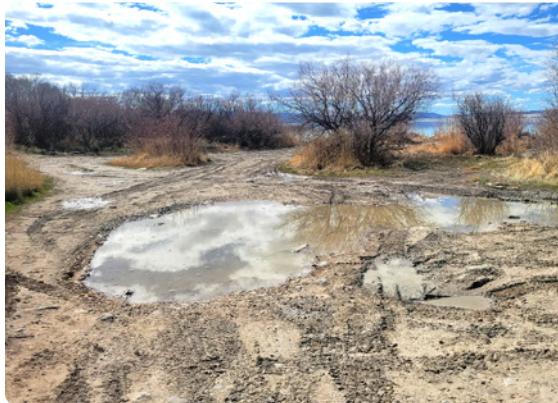
Lincoln Point - Access roads have large muddy sections and irregular, rolling terrain that makes travel slow and difficult. Grading and drainage improvements would improve access and reliability.

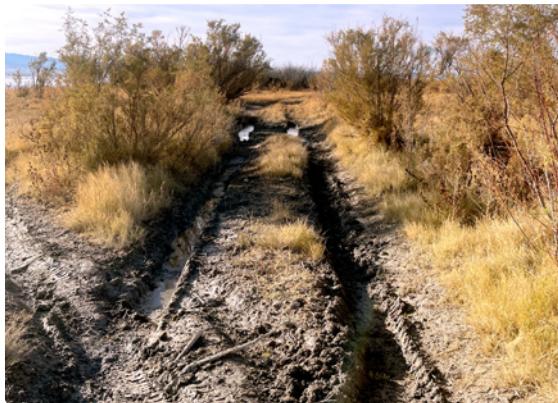
Goosepoint South Access - Access roads have deeply rutted mud holes making the site inaccessible for most vehicles. Upgrading to gravel would improve reliability and open the site to a wider range of users.

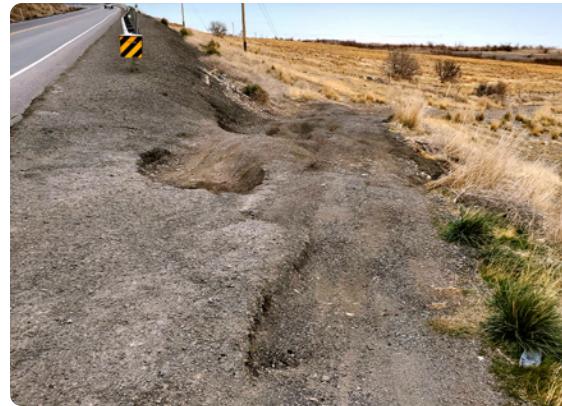
Big Cove Sportsman Access - The turn-off from SR-68 is very steep with deep potholes, making the site inaccessible for most vehicles. Consider grading the road and filling potholes to reduce the slope and improve access.

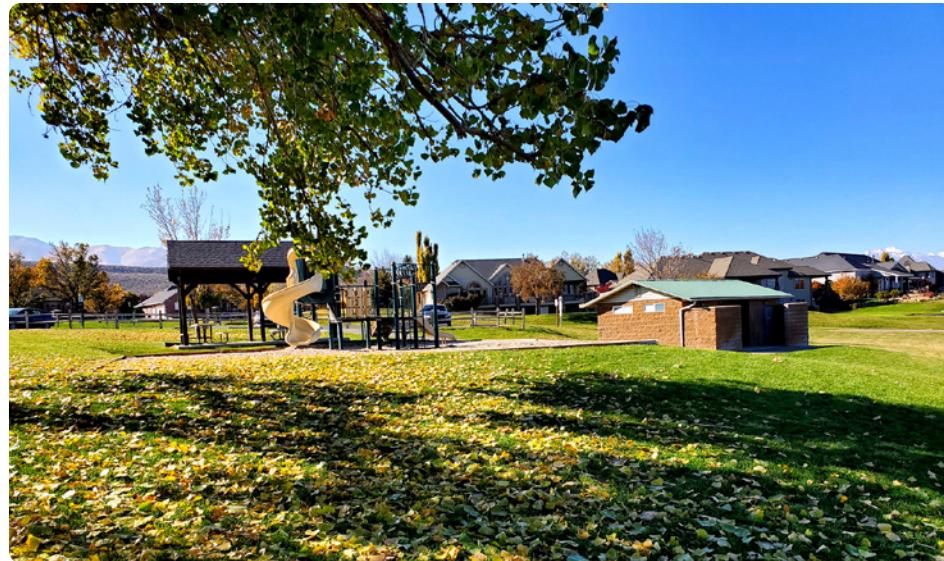
Eagle Park - This semi-private site is managed by the Saratoga Springs HOA. Park facilities, including the parking lot, playground, are restrooms, are technically private and intended only for local residents. Given this site's proximity to the lake and the shoreline trail, we recommend coordinating with the HOA to provide public access and shared use of park facilities.

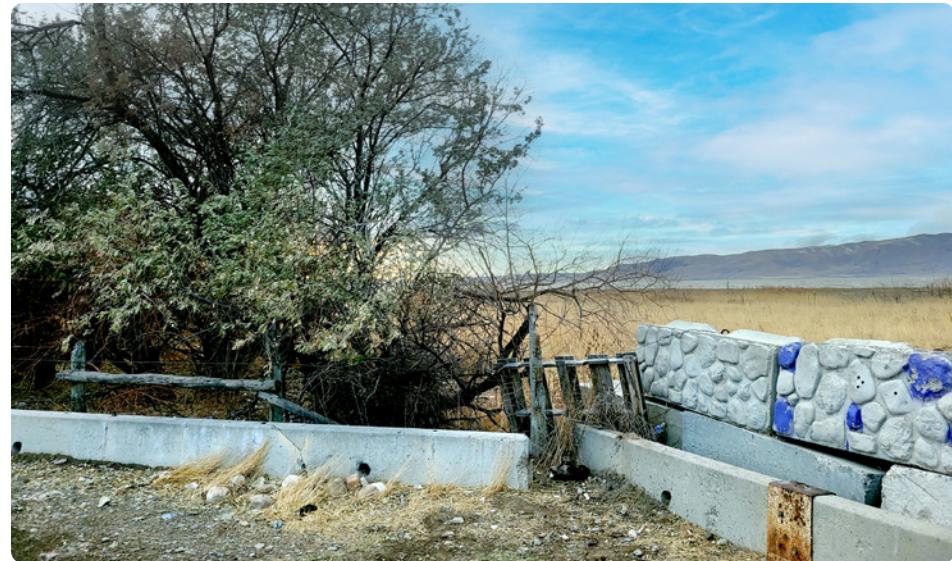
4000 W in Lakeshore - This site is public, but physical barriers installed by adjacent private property owners make the area appear private and inaccessible. If removing these barriers is not possible, consider providing clear signs and a marked path form the parking area to the shoreline to better communicate public access.

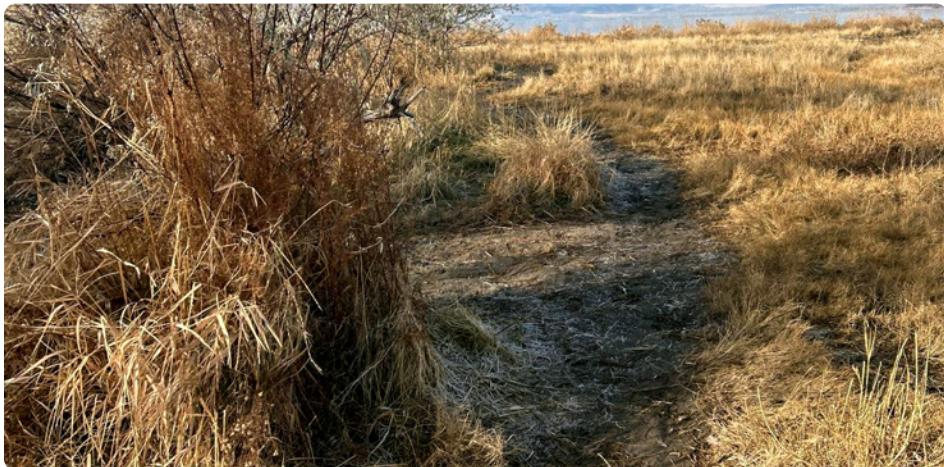
Battle Creek WIA - The trail to the shoreline includes some small sections with steep inclines that may be challenging for some users. Consider grading this trail to improve access.

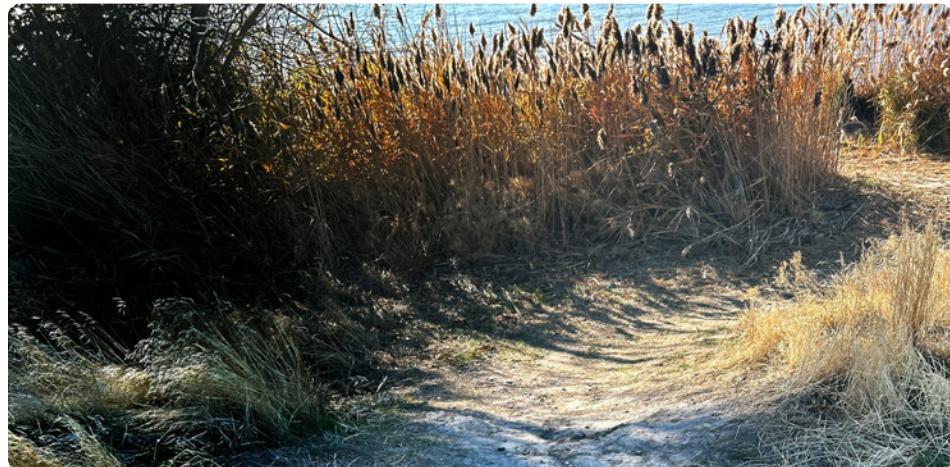
Vineyard 170 South Access - This site features a narrow, steep dirt path from the trail to the shoreline that may restrict access for some users and will likely degrade overtime. Consider improvements to reduce this slope.

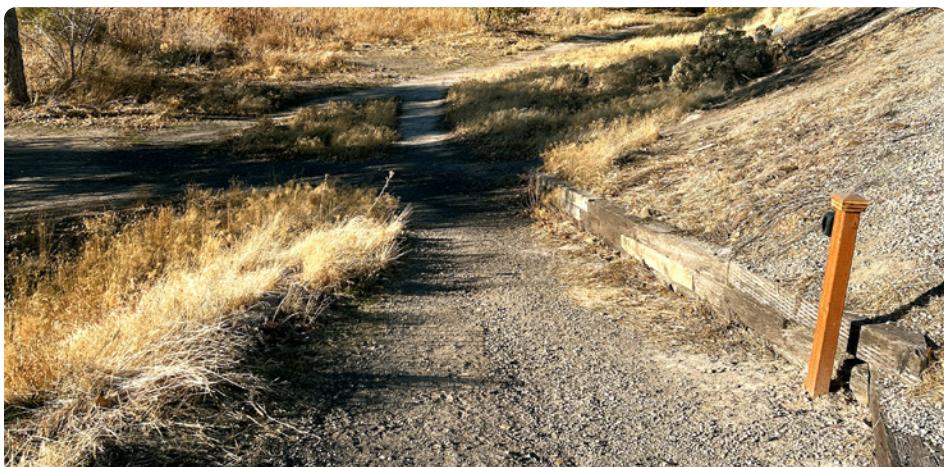
Vineyard Center Street - This site features a fairly steep, narrow dirt path that leads from the parking area to the shoreline. This slope may be challenging for some users and will likely degrade overtime. Consider providing a more durable surface (concrete) and a handrail to support safe access.

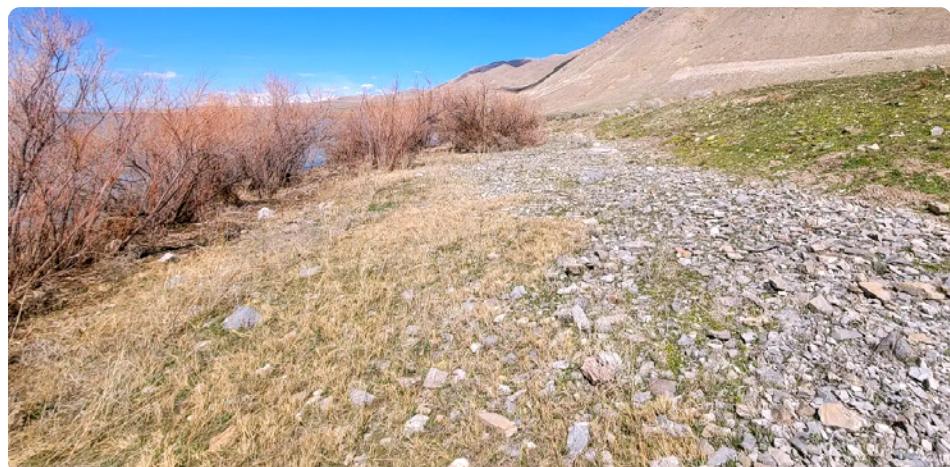
Tower View Point - This site features a steep, rocky slope down to the shoreline. Consider grading the trail to reduce the slope and provide a more stable surface (dirt or gravel).

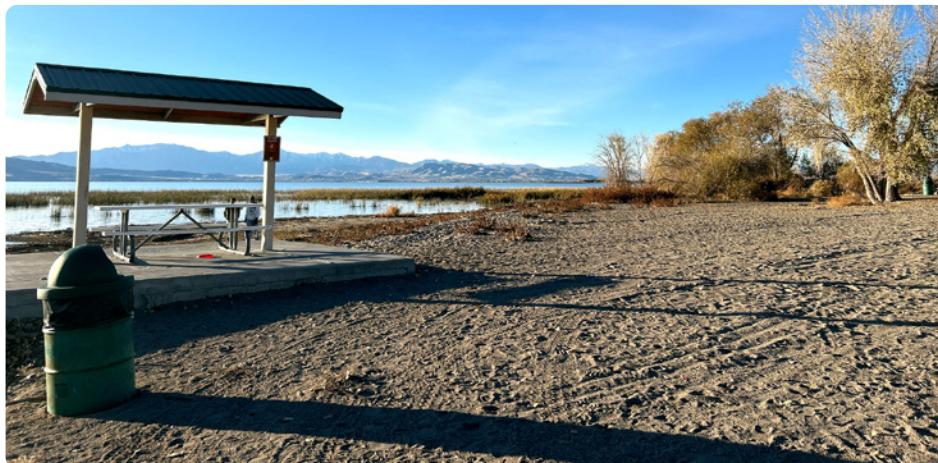
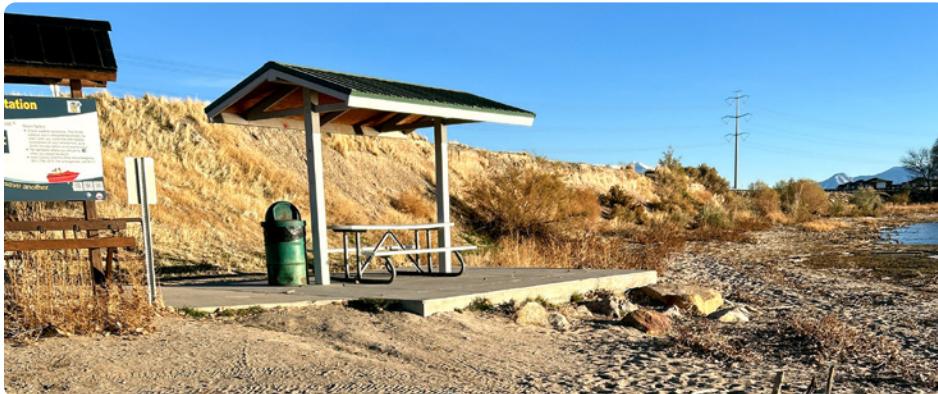
Vineyard Beach - This site includes many park amenities on a sandy beach. Unfortunately, lack of sand has created steep steps next to many of these amenities. Consider adding more sand to provide smoother access.

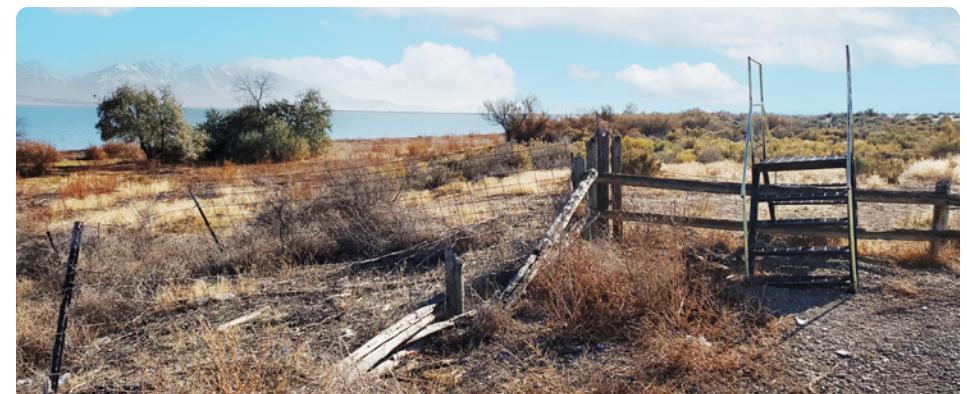
Mosida Acres - This access point features a small staircase over a fence which creates a barrier for many users. This staircase should be replaced with a gate to allow ground-level access for all users.

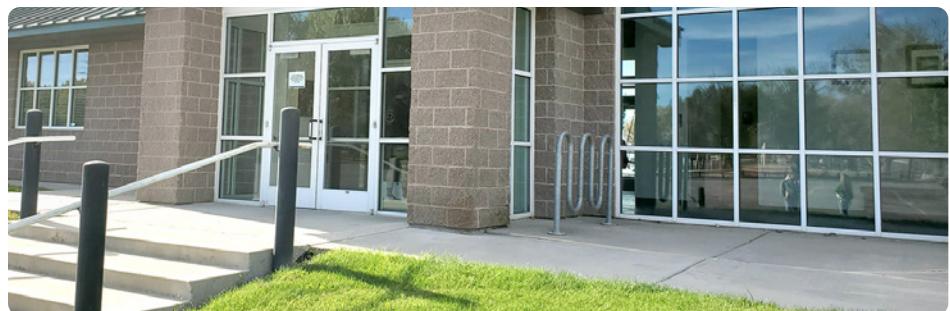
Utah Lake State Park - bike rack is placed too close to the building

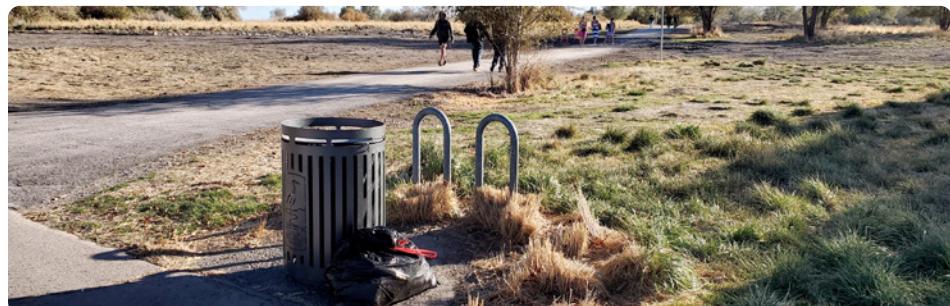
Inlet Park - bike rack is surrounded by overgrown grass and placed too close to the trash can

Bike Rack Recommendations

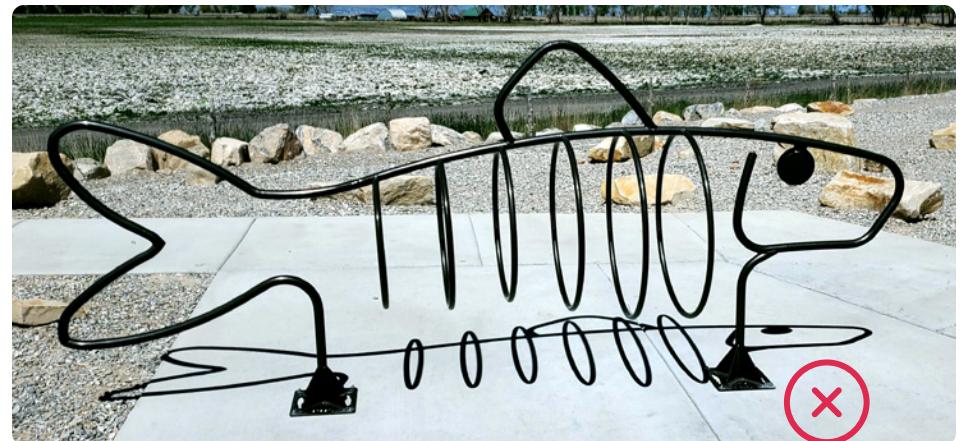
Skipper Bay Trailhead - the June Sucker "ribs" are placed too close together, making it difficult to lock bikes between them. Consider spacing them at least 2 feet apart.

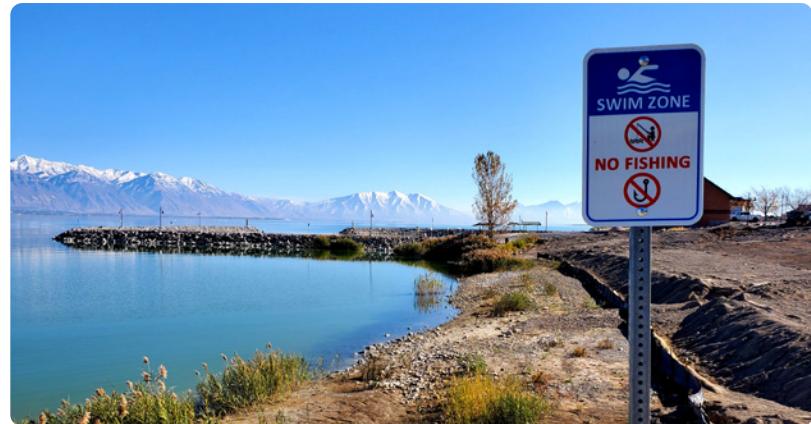
Saratoga Springs South Marina - jetty provides fishing access

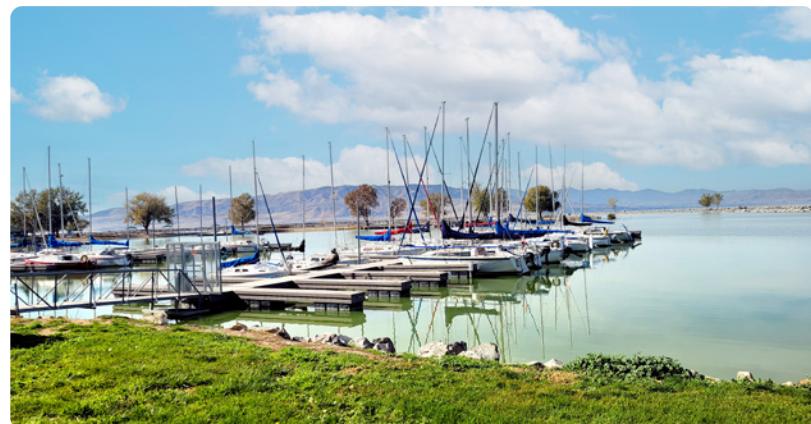
Utah Lake State Park - boat docks, fishing allowed only during off-season

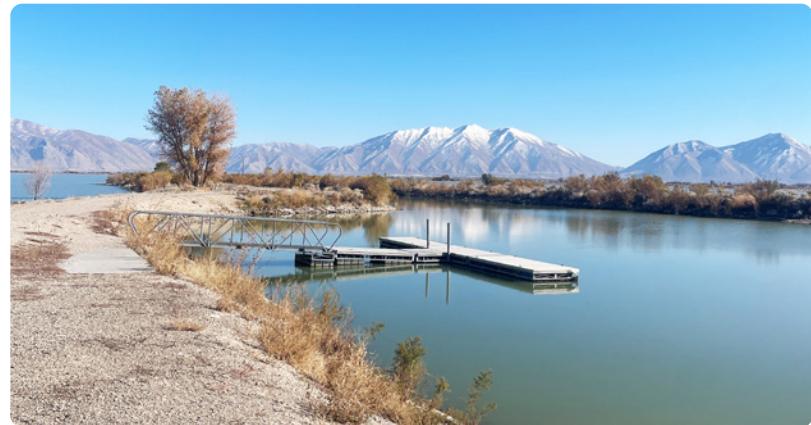
Lincoln Beach - jetty and boat dock

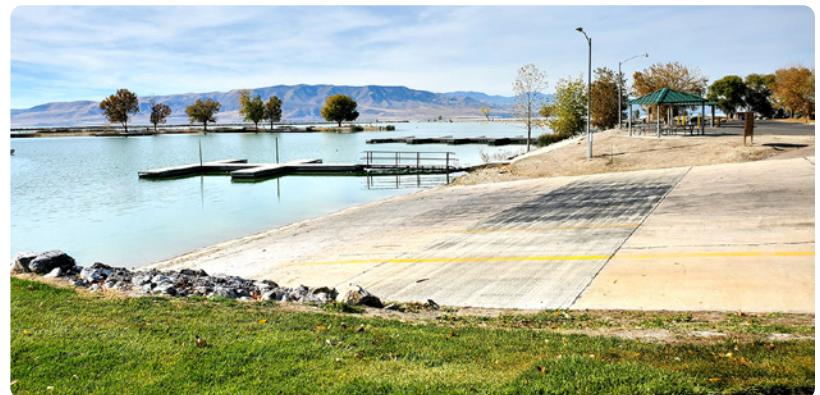
Utah Lake State Park - boat dock and boat launch

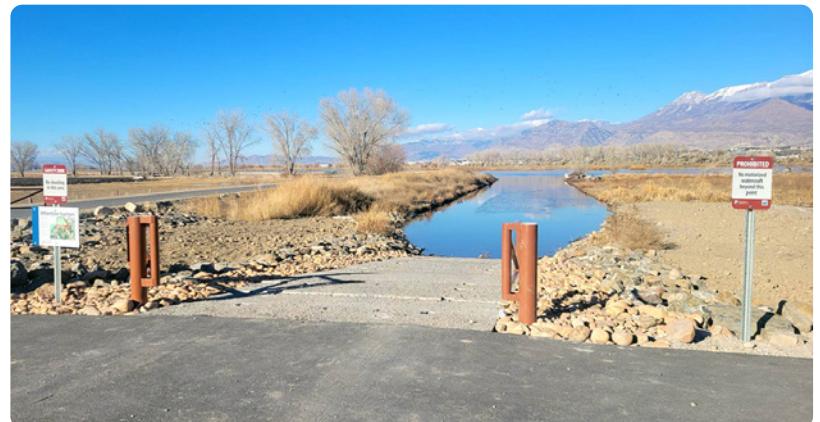
Skipper Bay Trailhead - hand carry boat launch

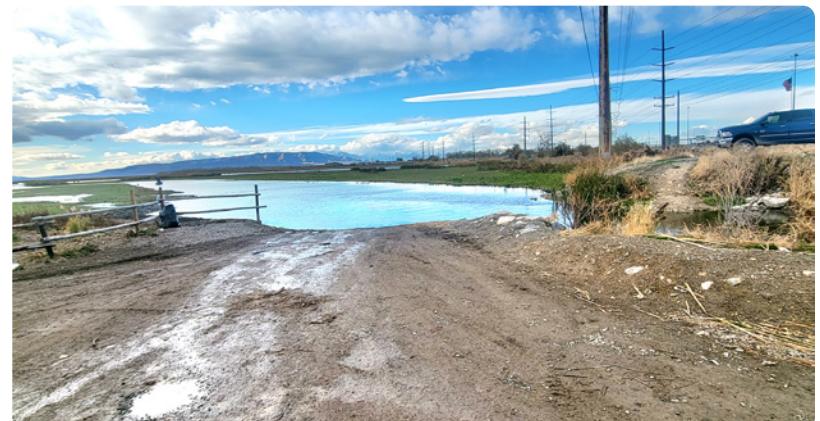
Mill Race - primitive boat launch

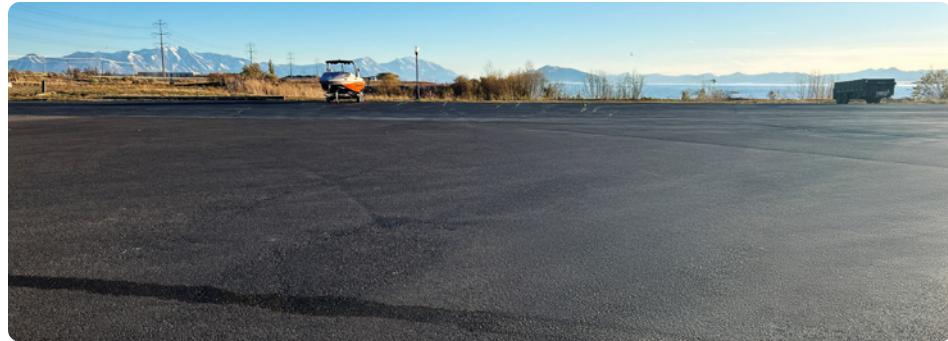
Lindon Marina - too much pavement

Shade Trees or Structures Recommendations

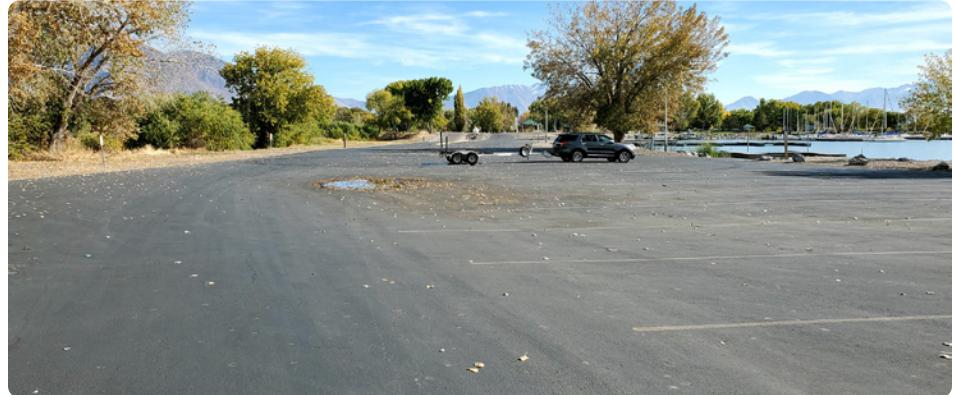
Utah Lake State Park - too much pavement

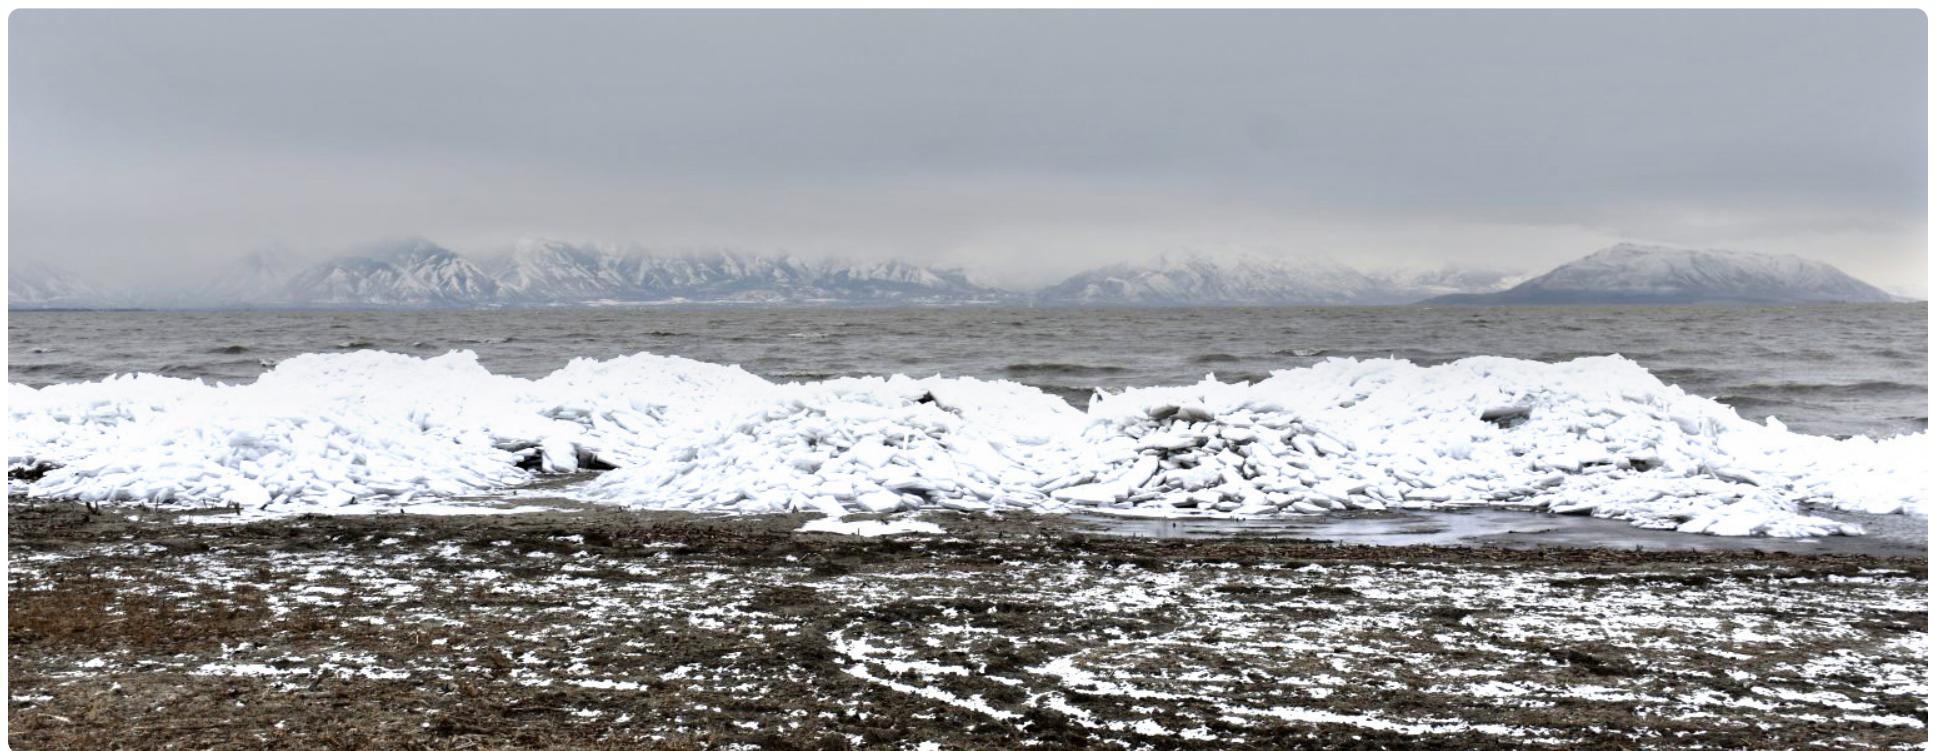
Ice stacks near Northlake Park (source: Utah Adventure Family)

Waves and seasonal ice movement can damage shoreline infrastructure such as docks, piers, and ramps.

- 14 access points are rated as having high damage potential. These sites should incorporate reinforced docks, flexible anchoring systems, or floating elements to mitigate damage.
- 12 access points have moderate damage potential.
- 9 access points have low damage potential. These areas are located away from the shoreline and face minimal risk.

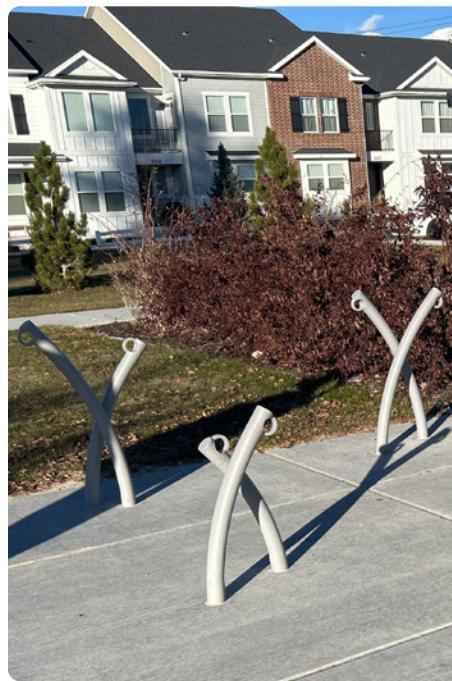
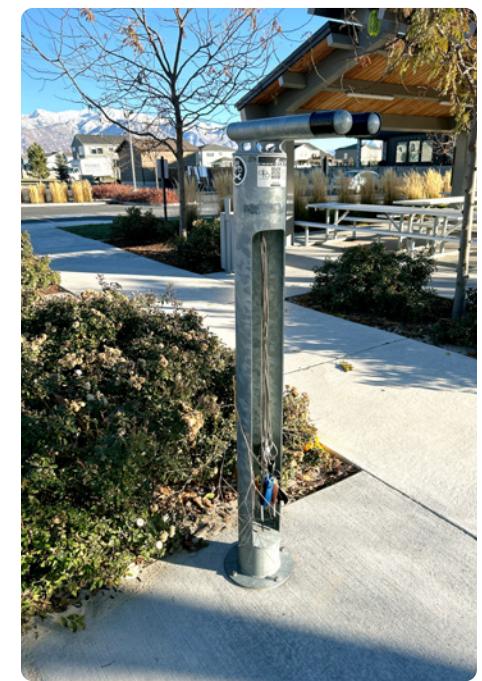
Bike racks and bike repair station at Sunset Beach Park.

Bike repair stations are an additional bike amenity to consider. The only existing repair station is located at Sunset Beach. Vineyard is considering additional stations at Vineyard Beach, Vineyard Center Street, and Vineyard 170 South Access.

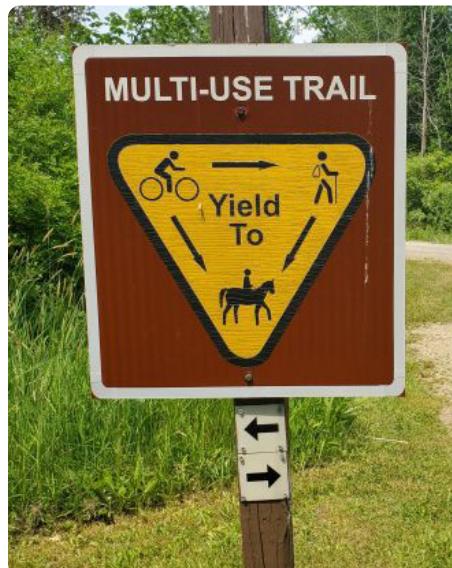
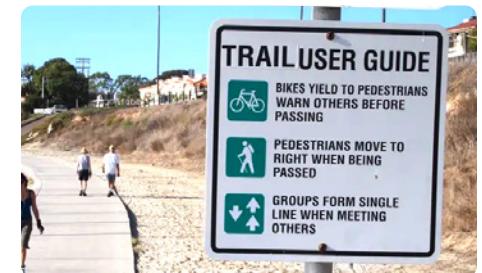
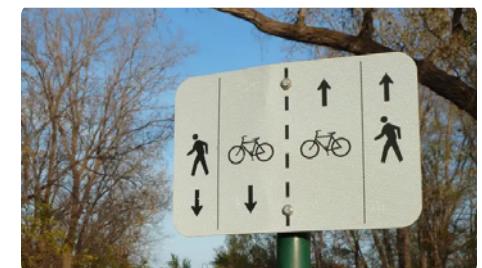
Multi-use trail etiquette signs.

Signage and pavement markings should establish expectations for shared use. Trail etiquette signs can encourage behaviors such as keeping right, passing with verbal warning, and yielding to slower users. In higher-volume segments, consider designating specific zones for different user types.
