**Hillside Permit****HILLSIDE REVIEW BOARD AGENDA REPORT: 06/23/2021****HILLSIDE DEVELOPMENT PERMIT****Netta's Knoll**

Case No. 2021-HS-004

**Request:** This is a request for a Hillside Development Permit to allow disturbance of areas in the 20-30%, 30-40% and 40% and above slope areas. This application is in anticipation of a single-family subdivision on the top of Netta's Knoll.

**GEOLOGIC HAZARD ASSESSMENT  
AND PRELIMINARY GEOTECHNICAL  
RECOMMENDATIONS**

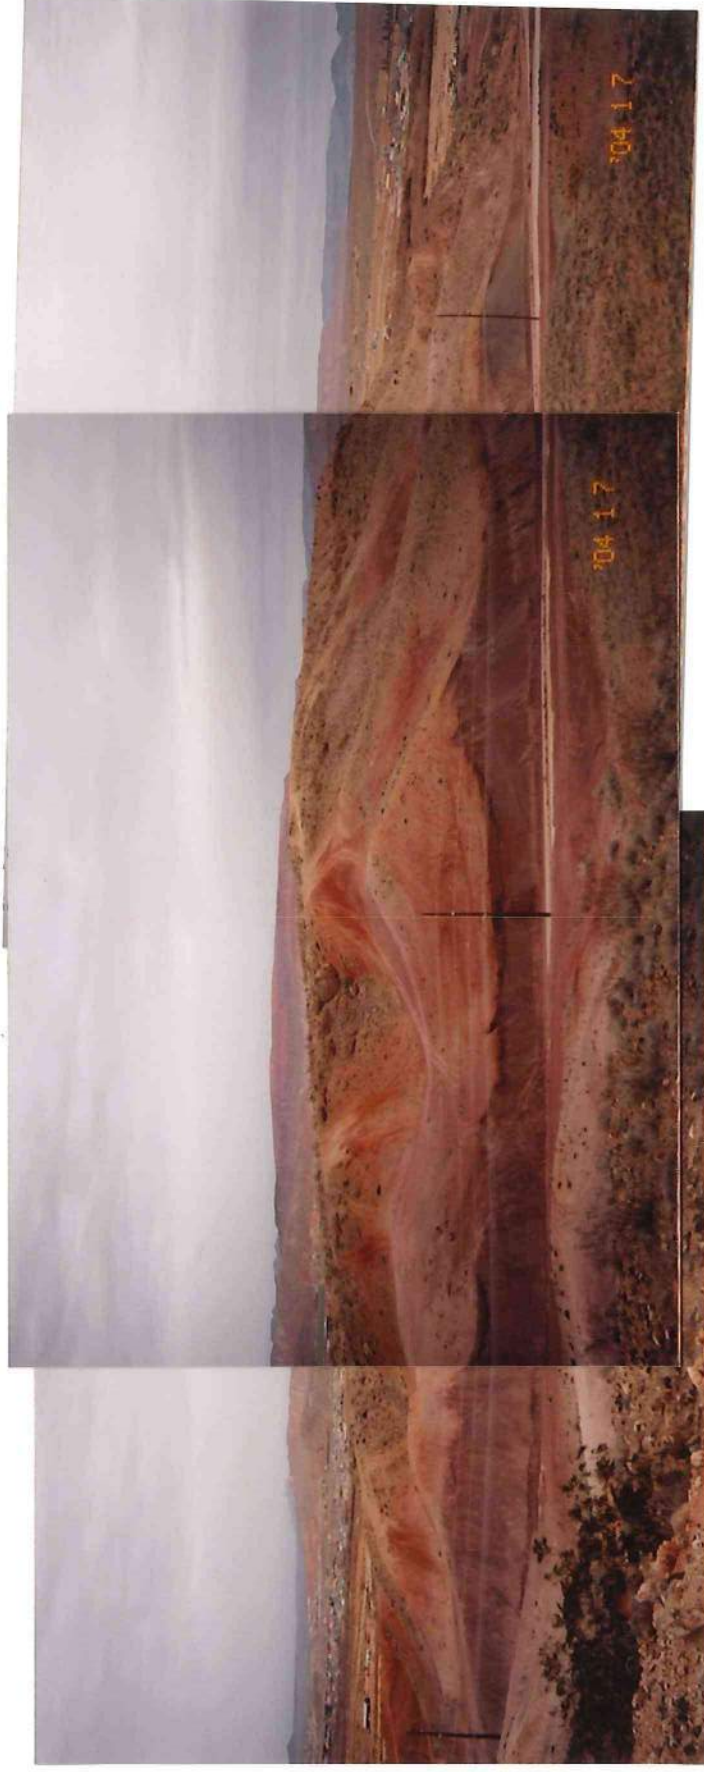
Photo Exhibit 1: View of subject site looking east from Foremaster Drive.

The proposed site is located along the top of an existing knoll. The conglomerate cap of the ridge is a retreating cliff face due to the undercutting of the underlying less competent Moenave and Chinle Formations. When the less competent underlying layers are eroded, tension cracks develop in the cliff-forming conglomerate and rock falls or slopes result (see Photo Exhibits 1 and 2). This erosional process is very slow.

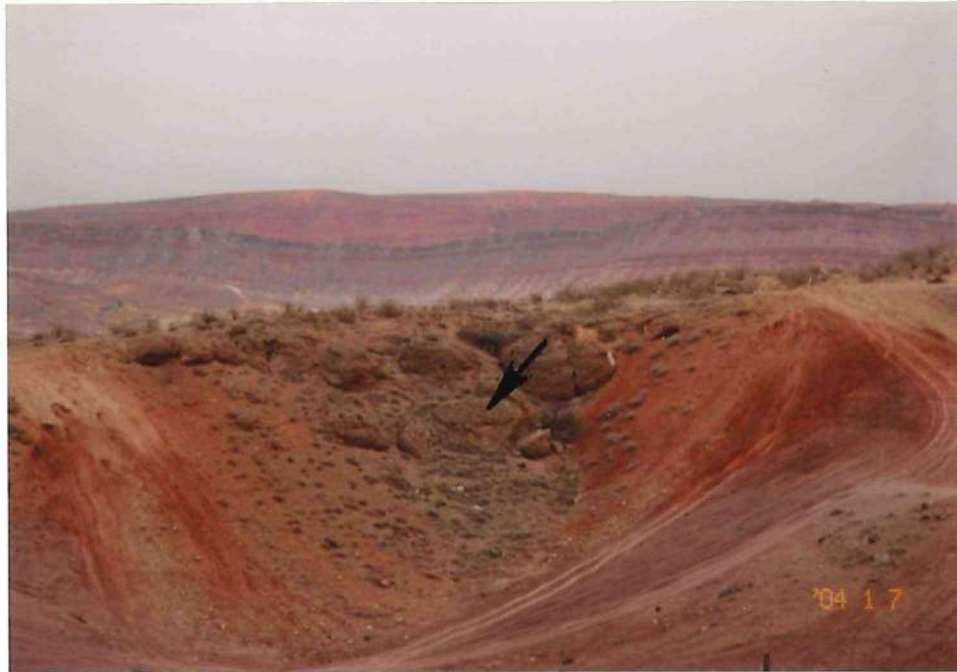
**Photo Exhibit 2** - View of conglomerate rockfall on western hillside looking east.

Based on field observation, rockfall onto the proposed building site is not a concern. However, rockfall as a result of weathering of the less resistant shale and mudstone bedrock below the conglomerate layer, has occurred along the western and southern portions of the site. The conglomerate cobbles and boulders appear to slide rather than roll and were not observed to have traveled to the base of the slope. Therefore, rockfall hazard along the subject site is very low.

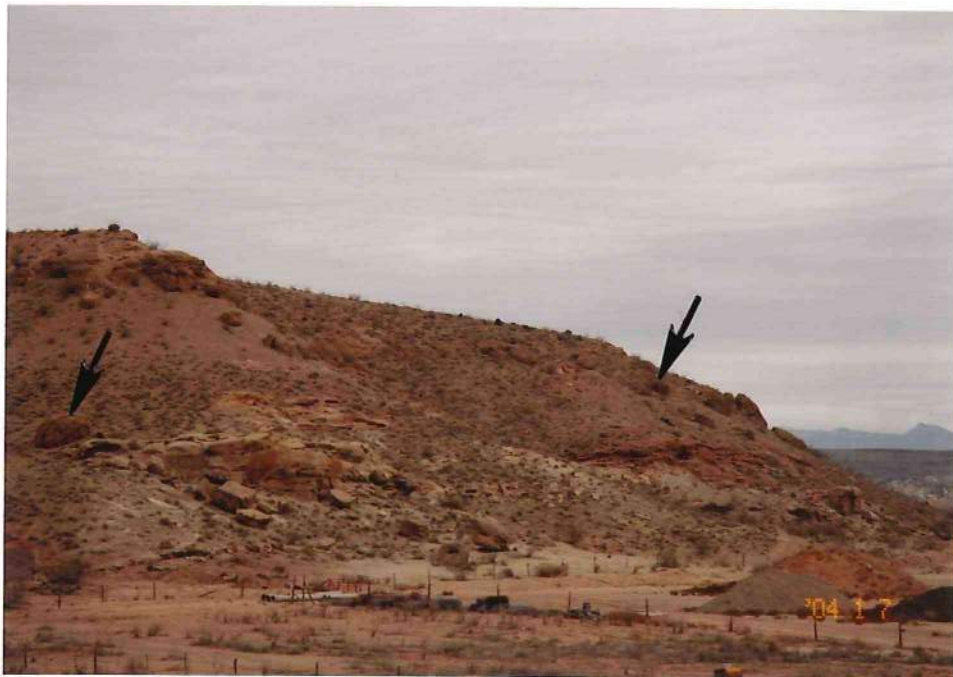
**Photo Exhibit 3** - View of southern portion of the site looking northeast. Some conglomerate boulders have broken off and rolled or slid down the slope (see arrows).

5. Based on field observation, rock fall hazard on the proposed site is very low. Some conglomerate boulders were observed along the slope of the western and southern portion of the site and are a result of the less resistant shale and mudstone weathering and the conglomerate breaking off and rolling or sliding down the hill. No conglomerate boulders were observed to have traveled to the base of the hill.

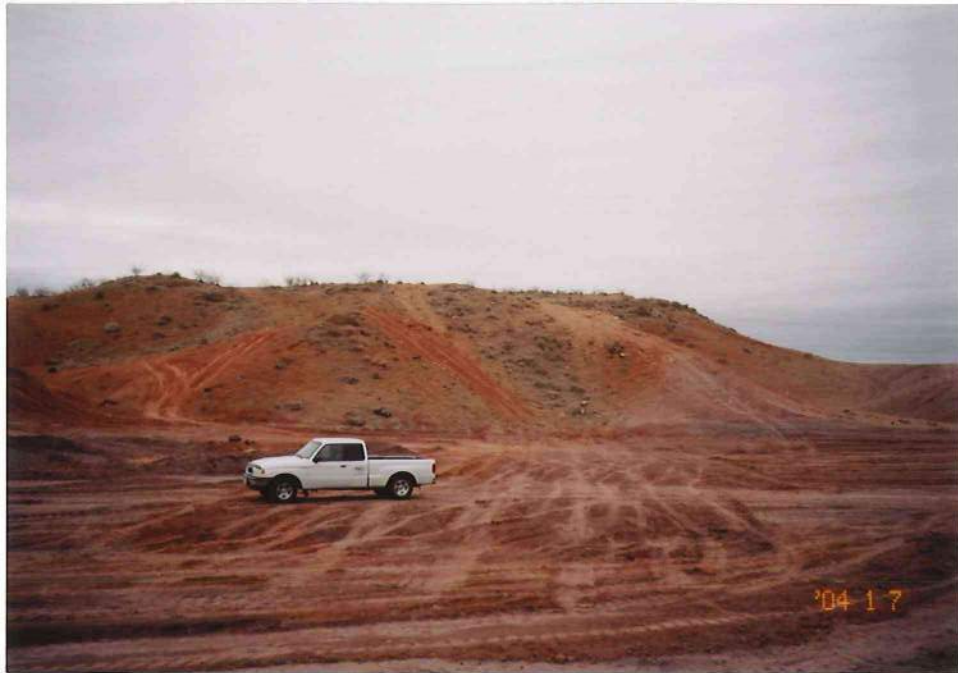
**Photo Exhibit 4** - View of northern portion of the site looking south.

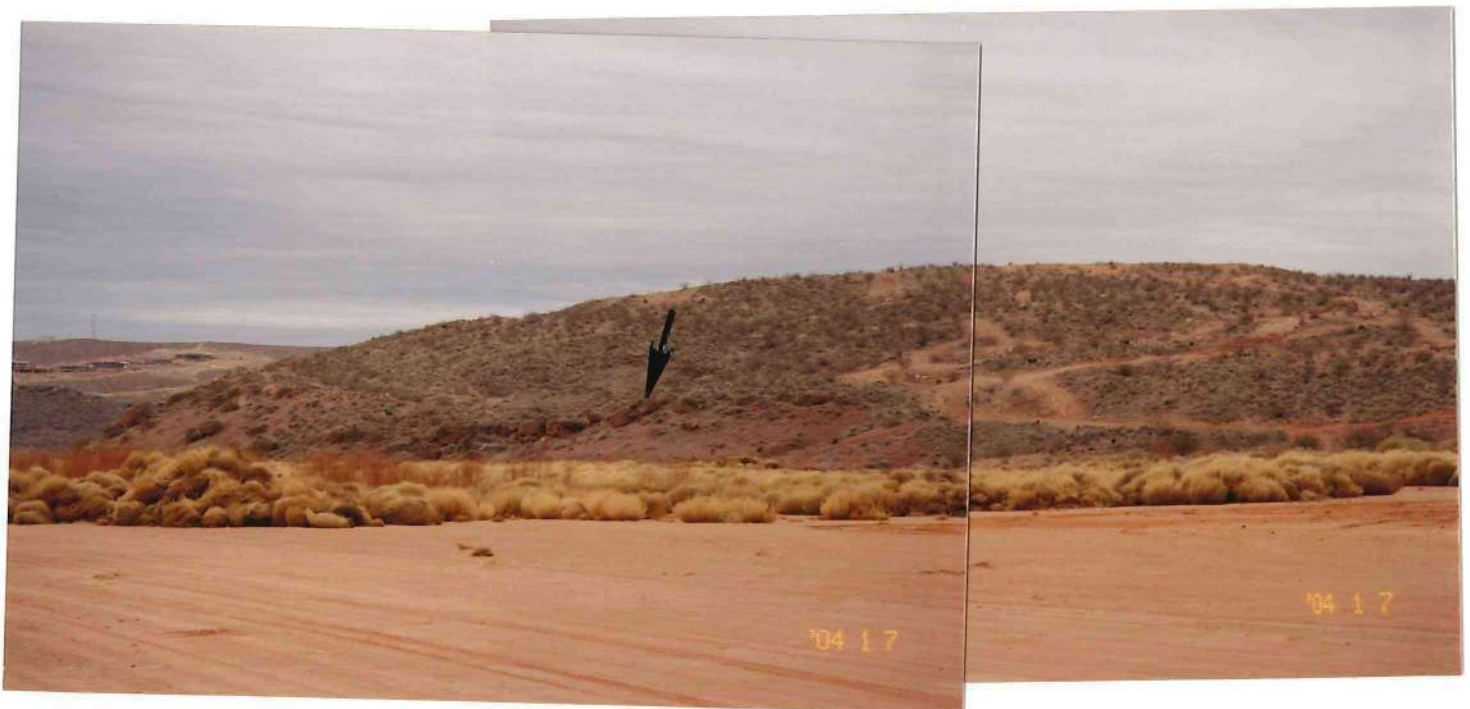
**Photo Exhibit 5** - View of the eastern portion of the site looking southwest from the old 3H Turf Farm area. Arrows indicate location of conglomerate outcroppings.
