Asbestos Abatement Services

Lamplighter Property

Hazardous Materials Inspection

Re: Hazardous Materials Inspection
Lamplighter Hotel
120 East Main Street, Vernal, Uintah County, Utah
Terracon Project No. 61237186 Task 4.26
EPA Cooperative Agreement #95815230
EPA ACRES Property ID #257935

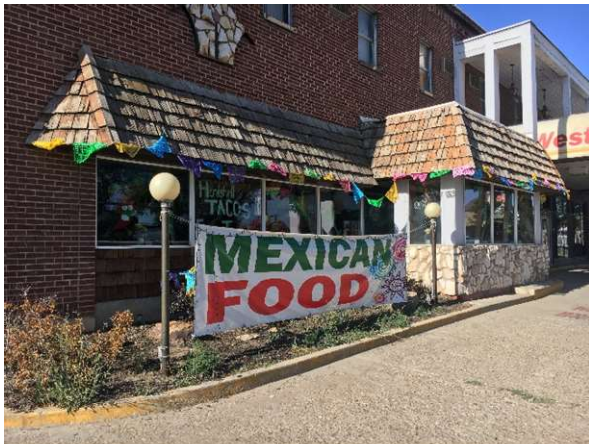
Photo #1 Exterior view of the Lamplighter Hotel

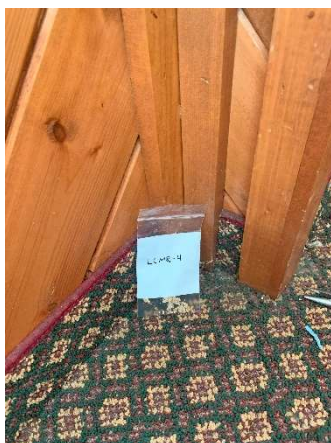
Photo #34 HA33: White 2'x2' rough texture ceiling tile, not asbestos containing

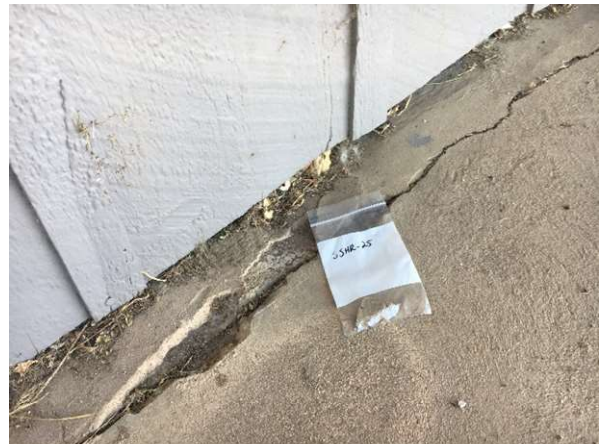
Photo #55 HA55: Mortar, not asbestos containing

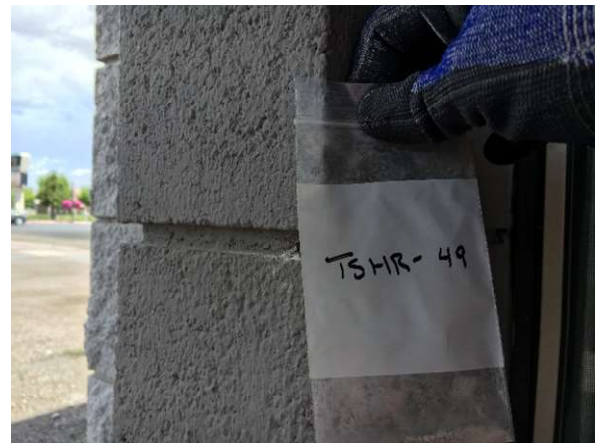
Photo #69 HA69: Exterior paint on block, not asbestos containing
