# KAYSVILLE CITY BUILDING REPORT -

HISTORIC BUILDING CONDITION ASSESSMENT AND RECOMMENDATION REPORT

FFKR ARCHITECTS

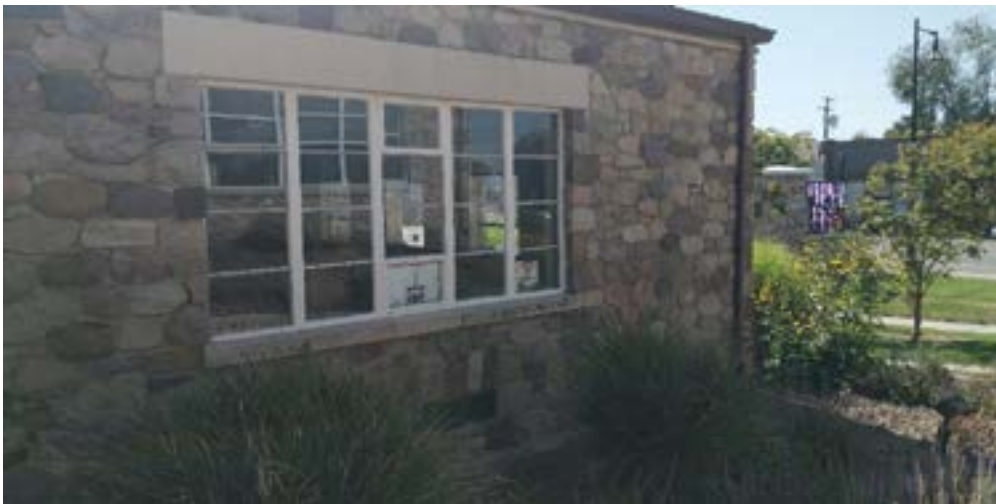
Photograph 2 – North Exterior of Building

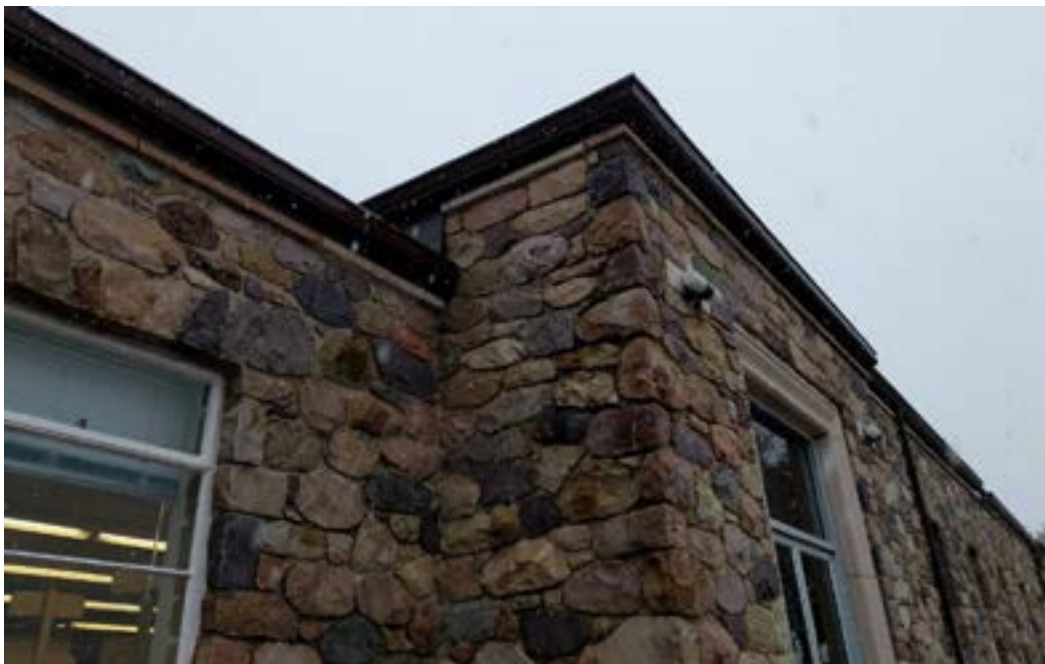
Photograph 4 – Reentrant Corner on North-West side (South-West side similar)

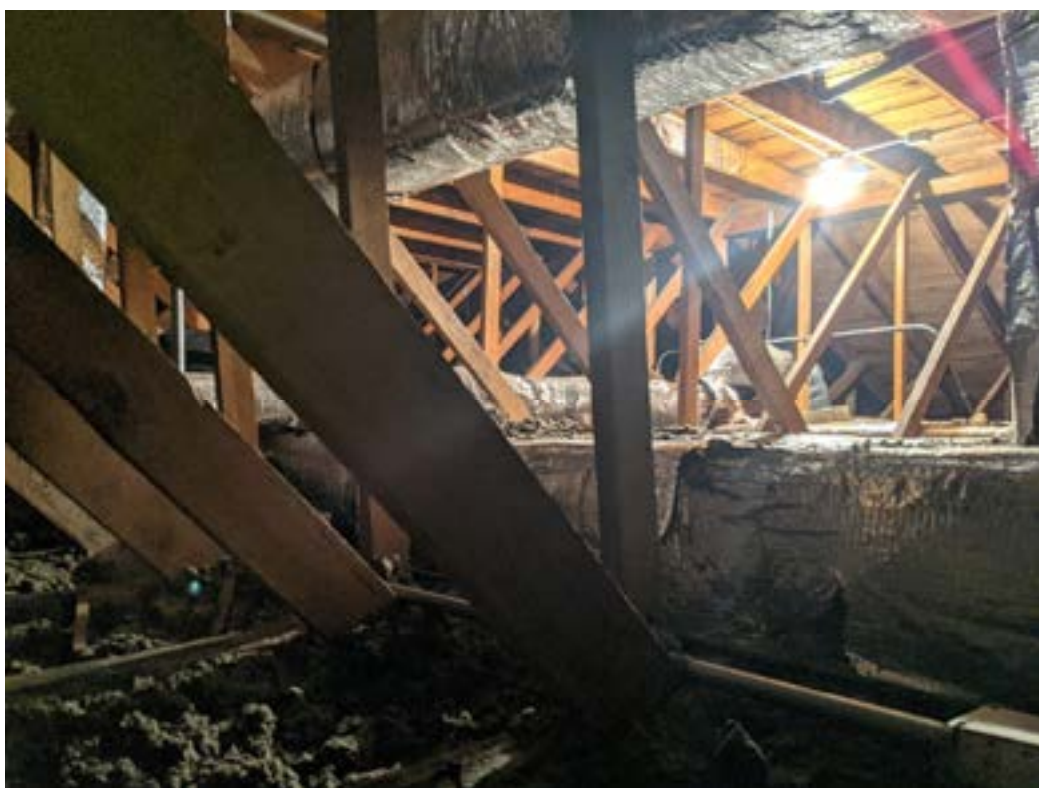
Photograph 5 – Roof truss framing viewed from attic access

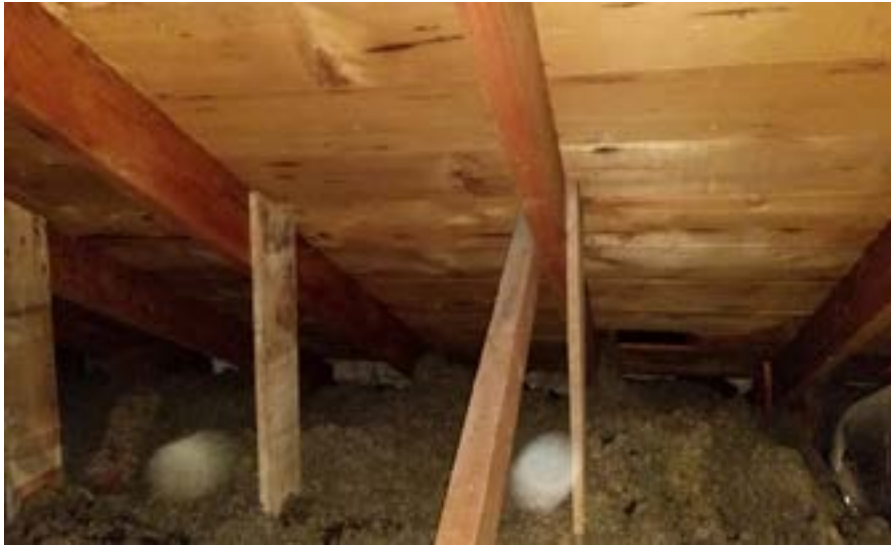
Photograph 6 – Straight 1x Roof Sheathing

| Status | Evaluation Statement | Comments |
|---|---|---|
| C <del>NC</del> N/A U | DIAPHRAGM CONTINUITY: The diaphragms are not composed of split-level floors and do not have expansion joints. | No chord element observed. See <b>Photo 6</b> . |
| C <del>NC</del> N/A U | ROOF CHORD CONTINUITY: All chord elements are continuous, regardless of changes in roof elevation. | The roof diaphragm is straight sheathed and exceeds 2:1 aspect ratio. See <b>Photo 6</b> . |

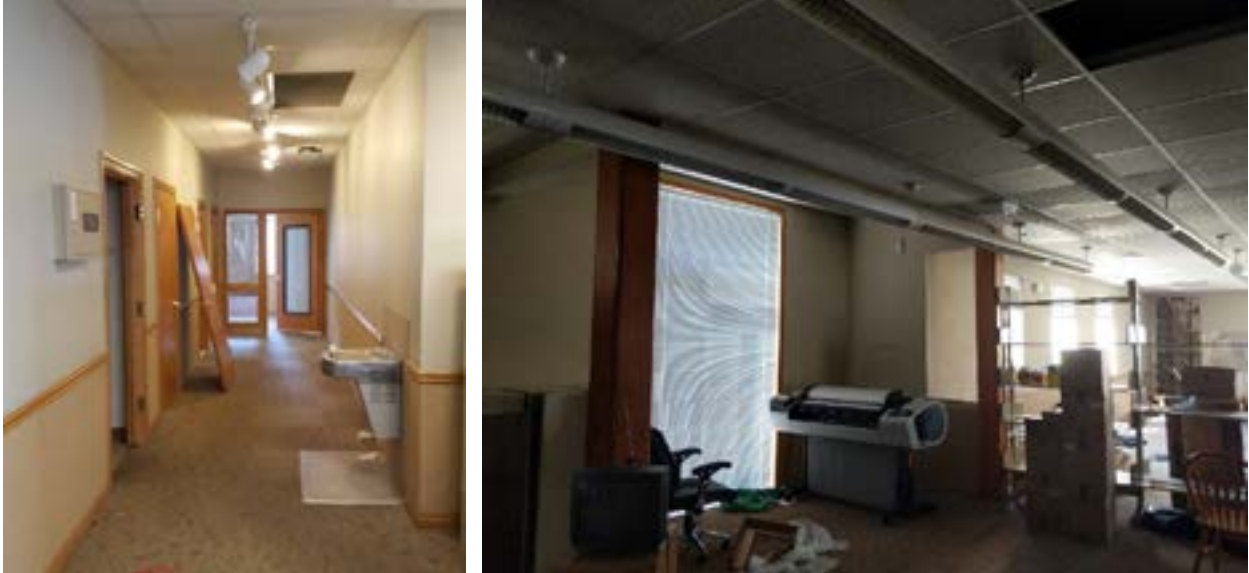
Photograph 9 – Interior Bearing Systems. Left: Wood stud wall running North-South on East side of building, Right: Beam – header configuration on North-West side of building

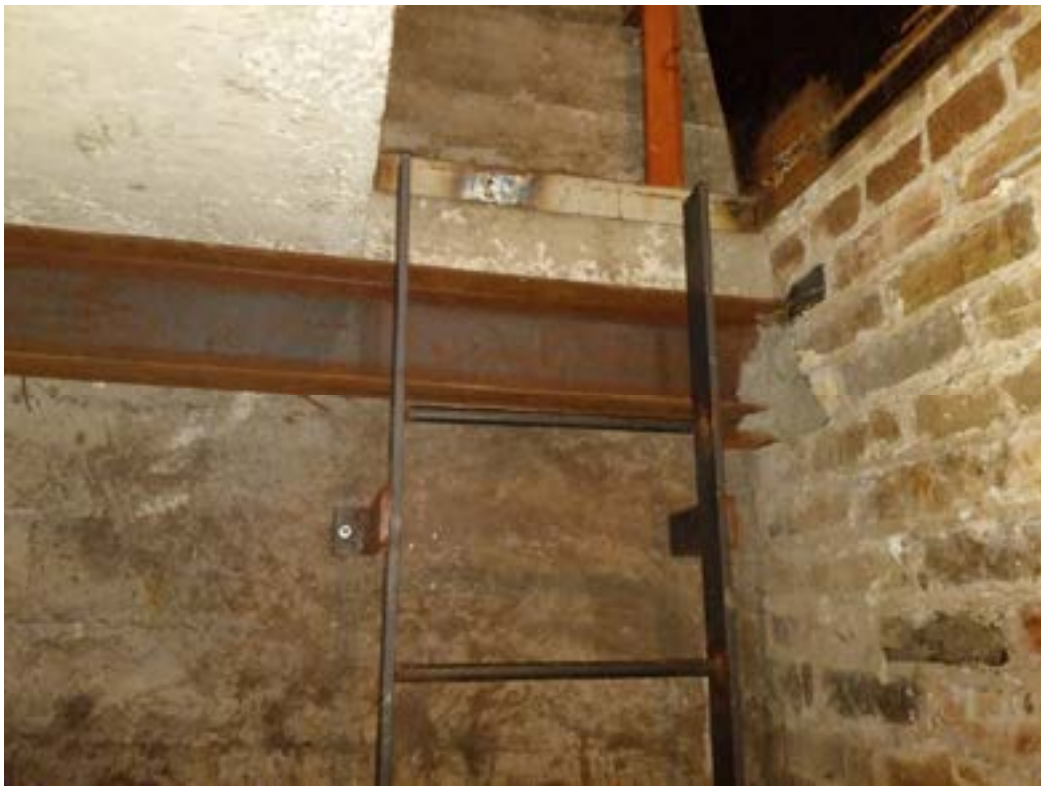
Photograph 14 – Underside of coal storage, six inch concrete slab with steel wide flange support beams

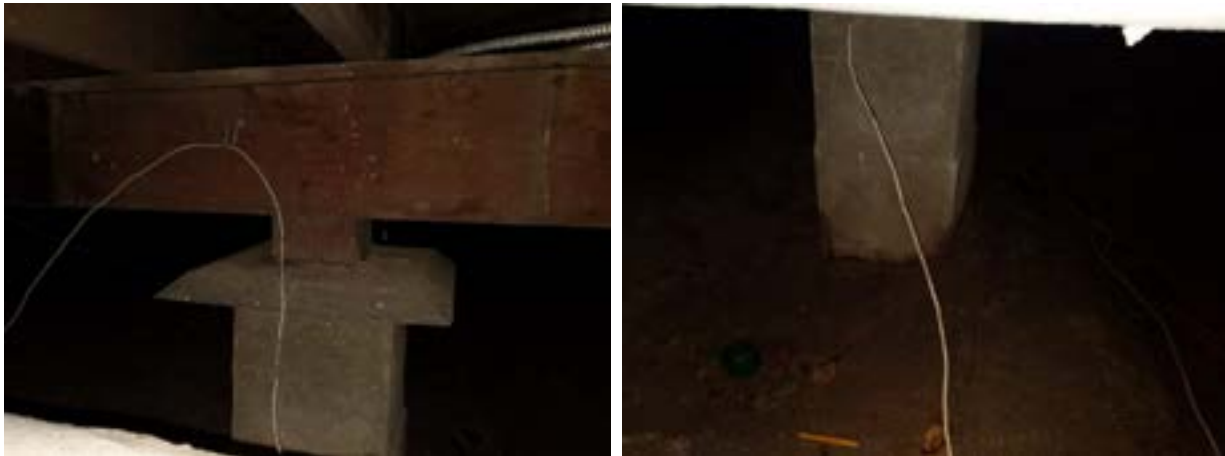
Photograph 15 – Multi-ply 2x support beam in crawl space supporting joist and supported by post. Left: top of post, Right: shovel formed concrete footing

| Status | Evaluation Statement | Comments |
|---|---|---|
| <b>Connections</b> | | No connection observed. See <b>Photo 15</b> . |
| C <del>NC</del> N/A U | WOOD SILLS: All wood sills are bolted to the foundation. | No connection observed. See <b>Photo 15</b> . |
| C <del>NC</del> N/A U | GIRDER-COLUMN CONNECTION: There is a positive connection using plates, connection hardware, or straps between the girder and the column support. | No connection observed. See <b>Photo 15</b> . |

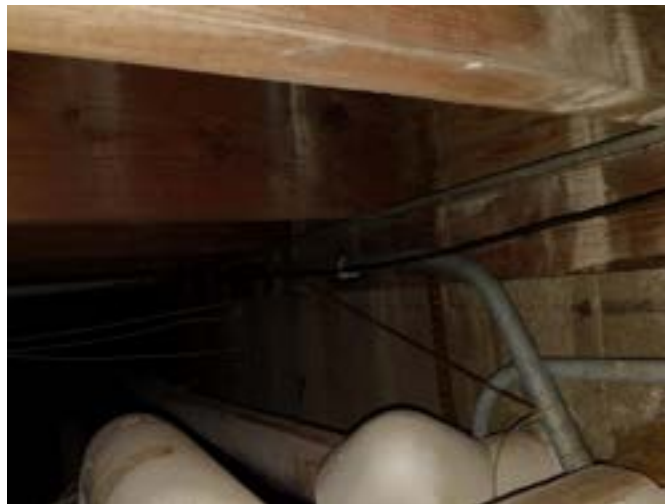
Photograph 16 – 2x4 ledger supporting floor joists.

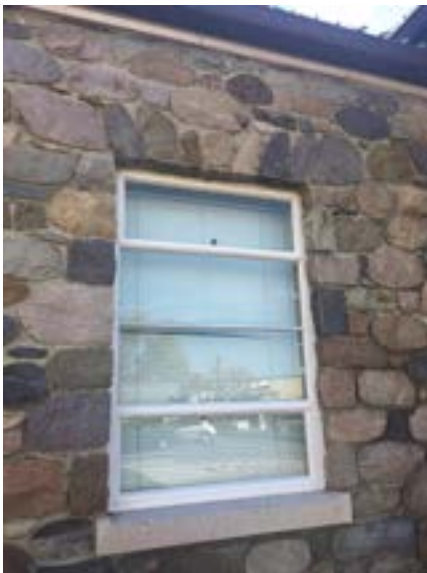
Keystone lintel on west elevation.

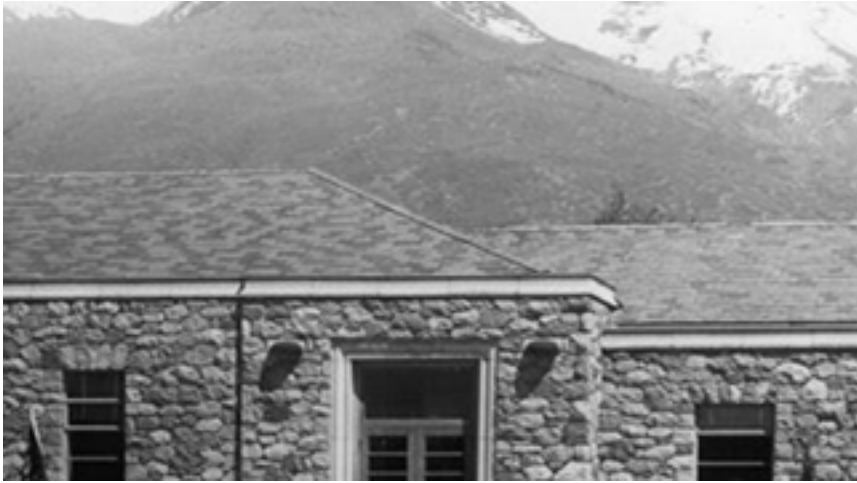
Original roof shown framed behind cast concrete coping.

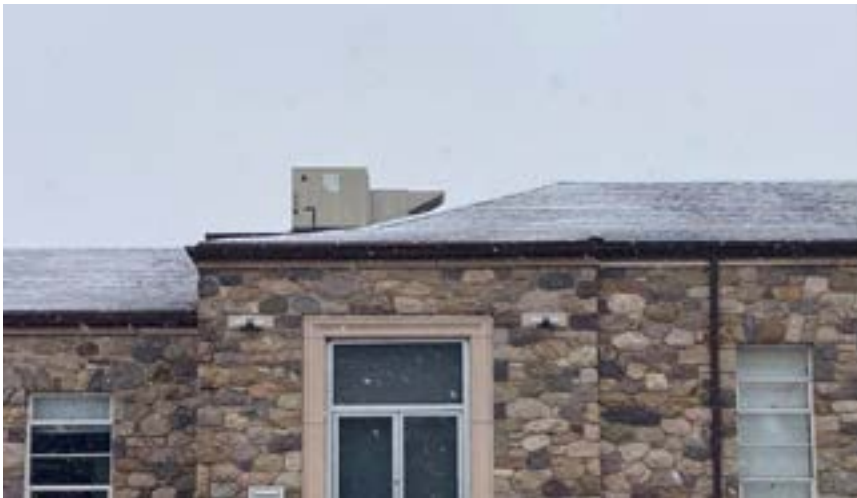
Overbuilt roof showing flare to front of cast concrete coping.

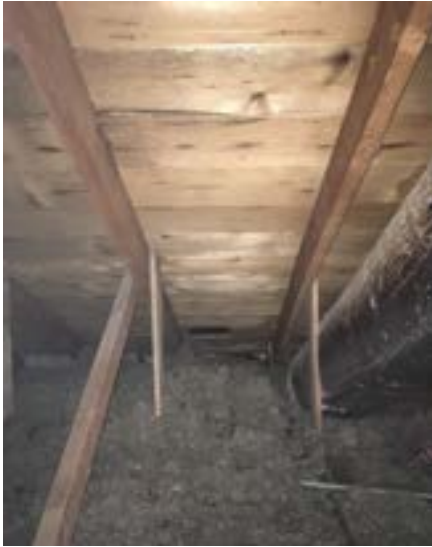
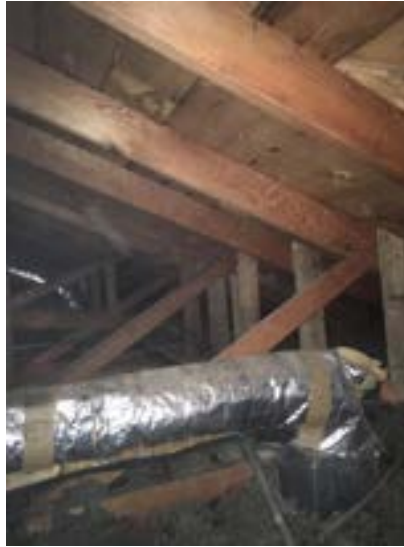
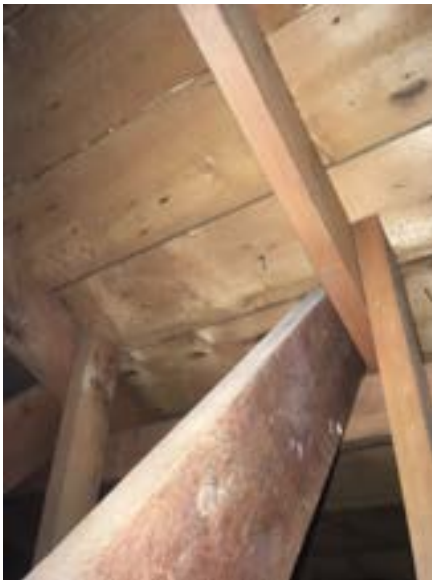
Existing trusses in attic.

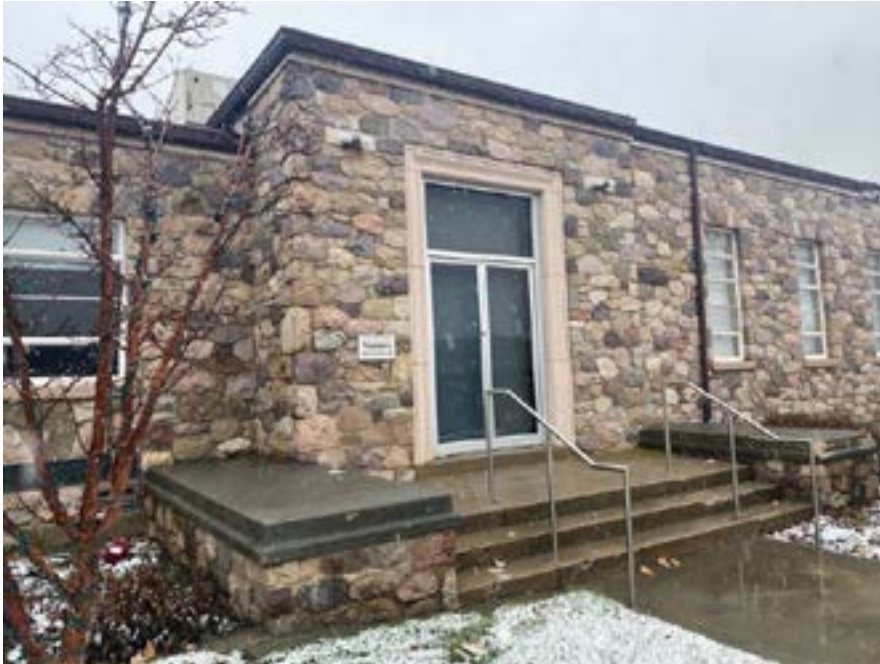
Existing door at northwest entry.

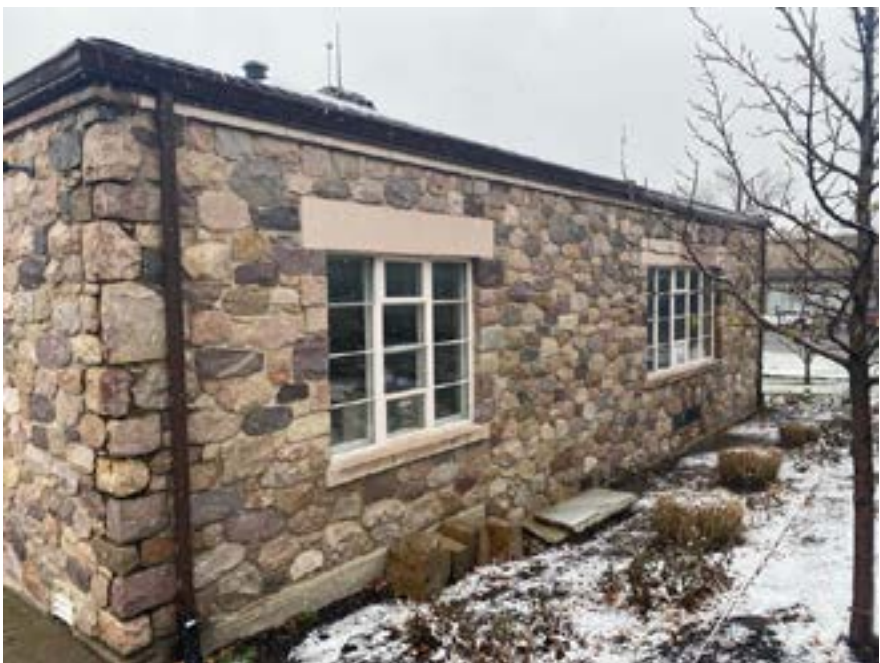
Existing windows at north elevation.

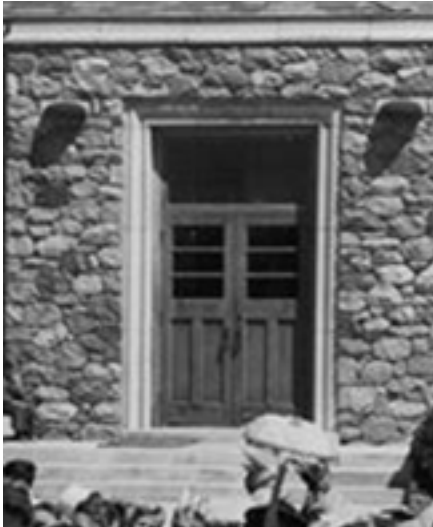
Original entry door and transom at west elevations.

Replacing the west entry doors and transom with new doors and transom provides an opportunity to install a door with increased thermal efficiency as well as providing modern, code compliant

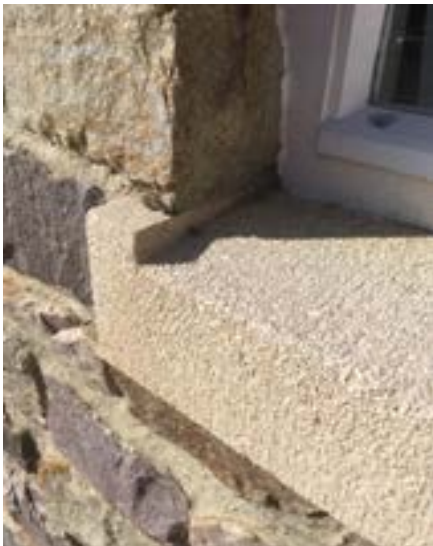
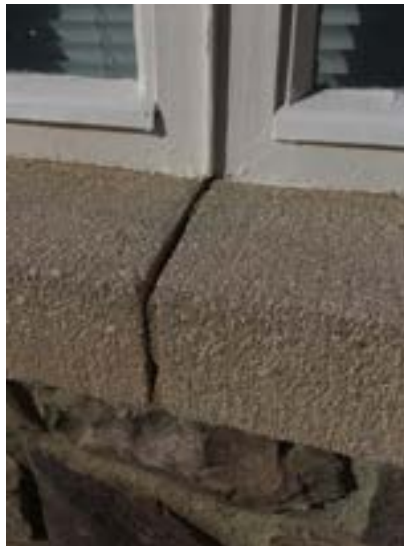
Original steel window and cast concrete sill.

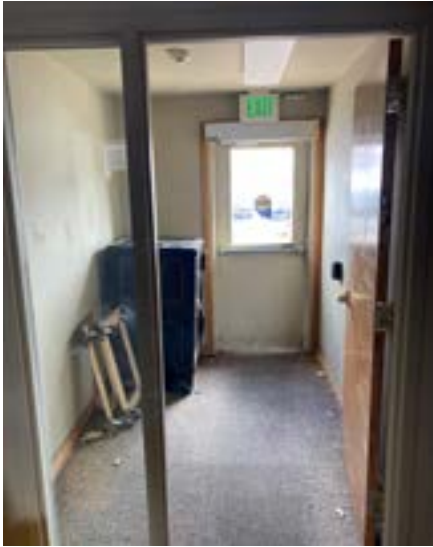
East entry door. Note lack of clearances on the strike side of the door.

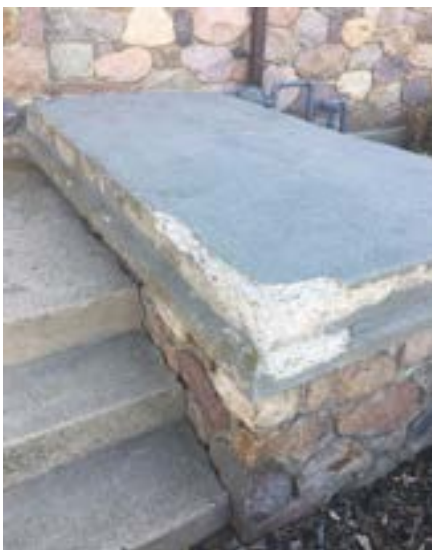
West entry stoop and stair.

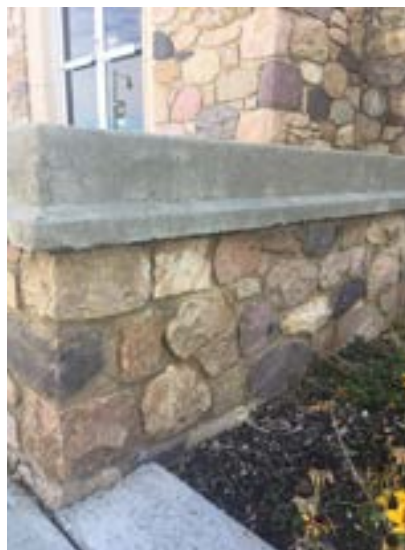
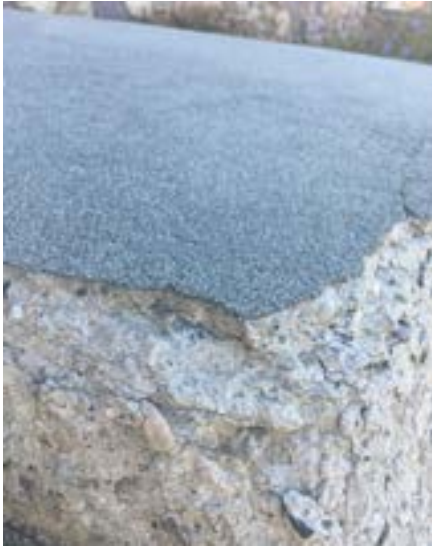
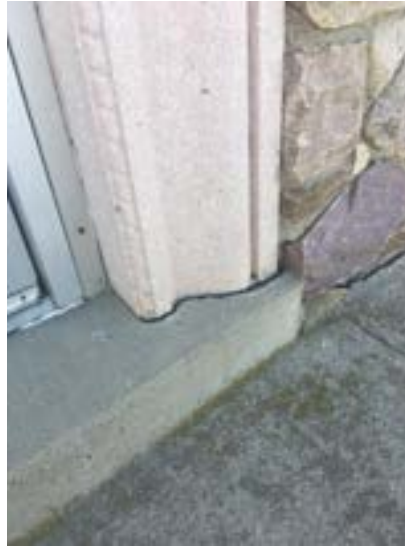
West entry stoop and stair.

2. New handrails should be installed for the revised rise and run of the new stair. The handrails should be a modern handrail, unembellished, with a galvanized or stainless steel finish.

3. At a minimum, the soils around the haunches should be replaced with a drainable gravel medium, about 24 inches wide and as deep as the base or the footing. The landscaping and irrigation should not abut the haunch. This will allow any water that does drain against the building to be collected and dispersed into the surrounding soils and will allow it to evaporate back out. If water does enter the wall of the haunch, it has a means to escape as vapor into the drainable fill.

4. There are two options on the concrete copings. The first recommendation would be to repair them in place. The second preference would be to replace them, if repairs are infeasible. It will be necessary to engage a specialty contractor to perform this work, whether repairing or replacing.

If repairing, removing the damaged and loose material and creating a bondable surface (ragged surface) and reforming the new concrete around stainless steel pins epoxied to the original material. The new concrete will necessarily match the profiles of the existing. The parge coat should be removed and replaced with a new parge coat matching the original, thus achieving a uniform texture.

If replacing, care should be taken to match the existing profiles exactly. A new parge coat should match the original. The top surfaces should be sloped to the outside, away from the stair and the coping should be anchored to the stone wall.

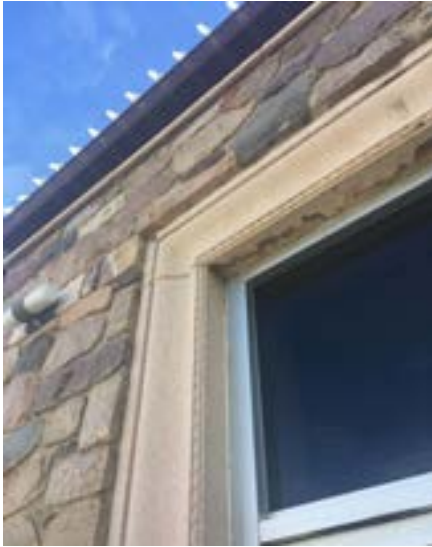
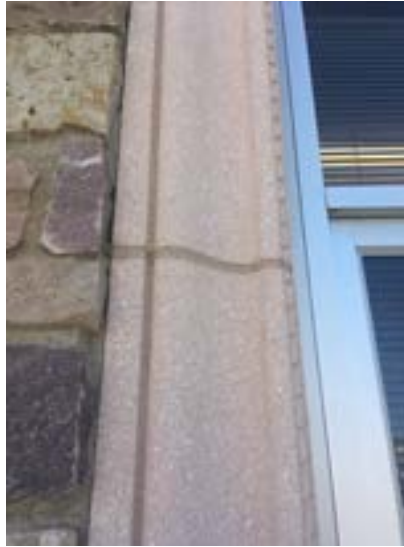
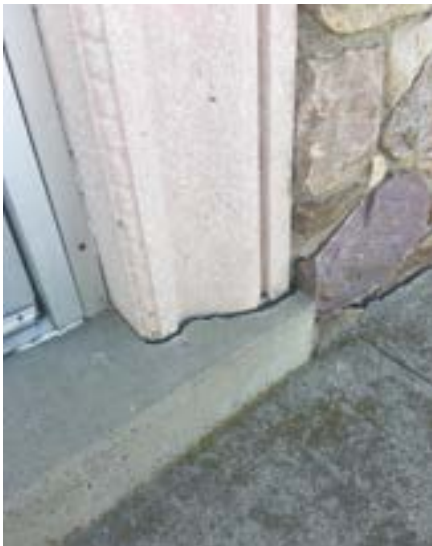
West entry cast stone door casing.

These elements are in very good condition overall. The issues revolve around open joints between the units or between the units and the adjacent wall, or between the units and the door. Where the cast stone meets the step at the entry there is a significant joint between the two materials where the concrete is scribed around the cast stone.

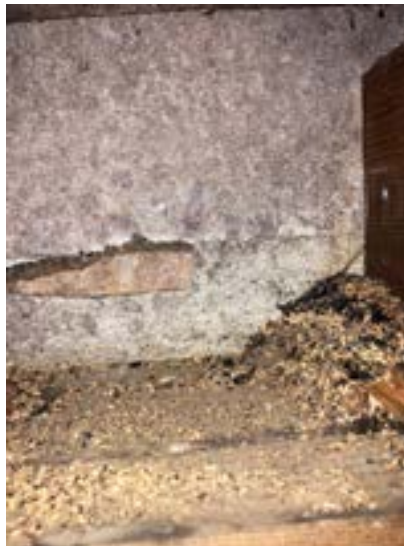
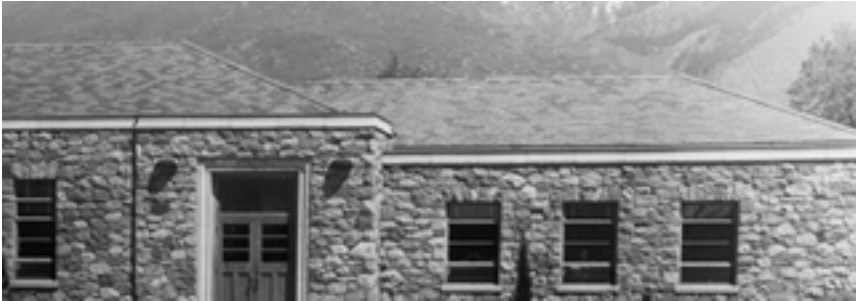
Back side of cast stone coping.

These elements are in very good condition overall though only the front of the cast stone was observed and a very limited amount on the back where the wall had been opened on the interior. The issues revolve around open joints between the units or between the units and the adjacent wall as well as ensuring that these elements are securely attached to the wall.

Early image depicting west elevation cast stone coping.

1. The cast stone elements should be preserved in place. The joints between the cast stone units should be repointed with an appropriate lime-based mortar (see above). The joints between the cast stone and the wall should be caulked and sealed with an elastomeric caulk.
2. The cast stone copings should be anchored to the framing at areas above entries to the building to minimize risk of failure at egress point. The structural sheet S102 indicates where these areas are located.

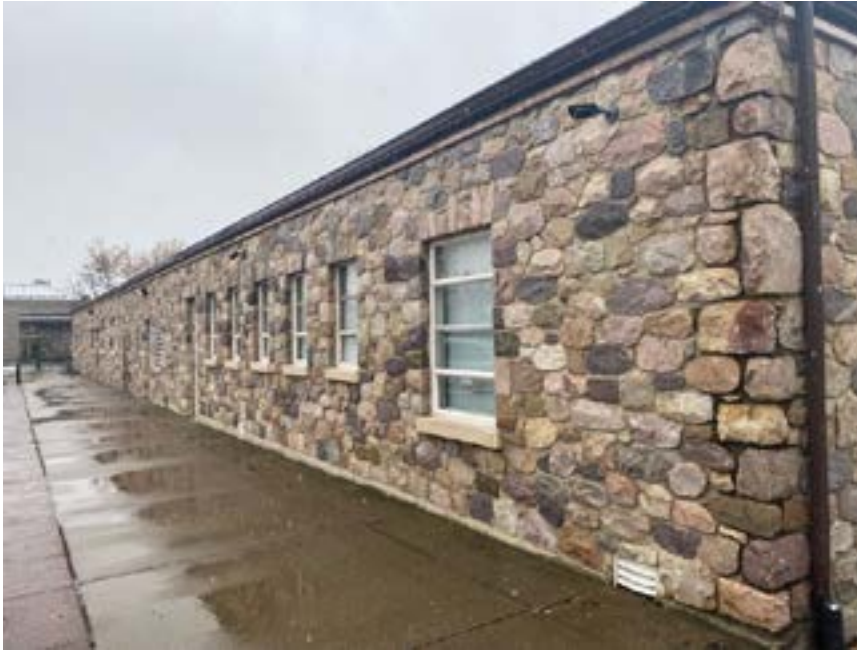
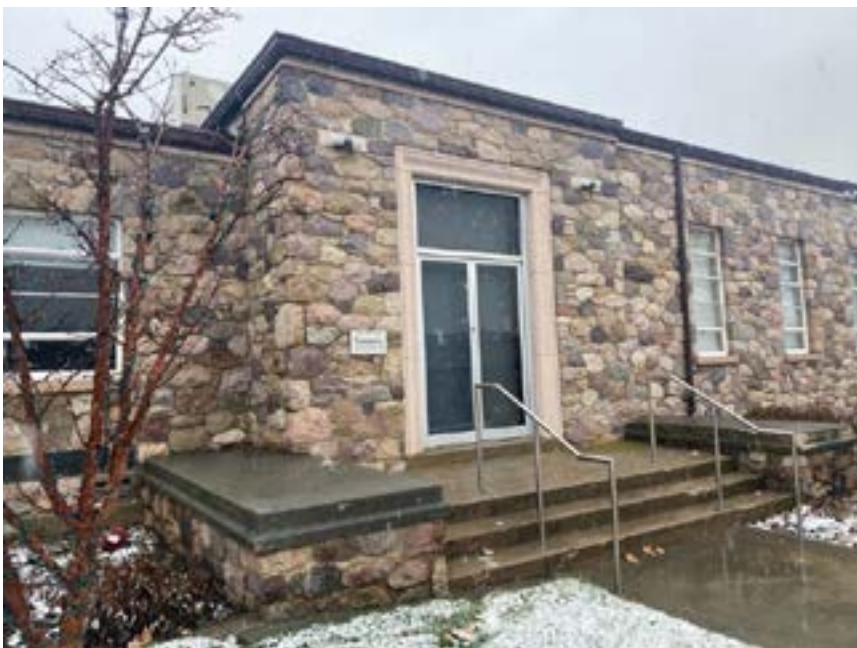
East entry condition.

West entry condition.

1. Because there is an accessible entry on grade on the east side of the building there is no need to install an accessible ramp. The accessible parking stalls should provide a clear and unobstructed path to the accessible entry. There are currently ramps providing access through the north and south sides of the building from the street side back to the rear where the main entry is located.
2. All entry doors need to be equipped with compliant accessible hardware which allows individuals with disabilities to grasp

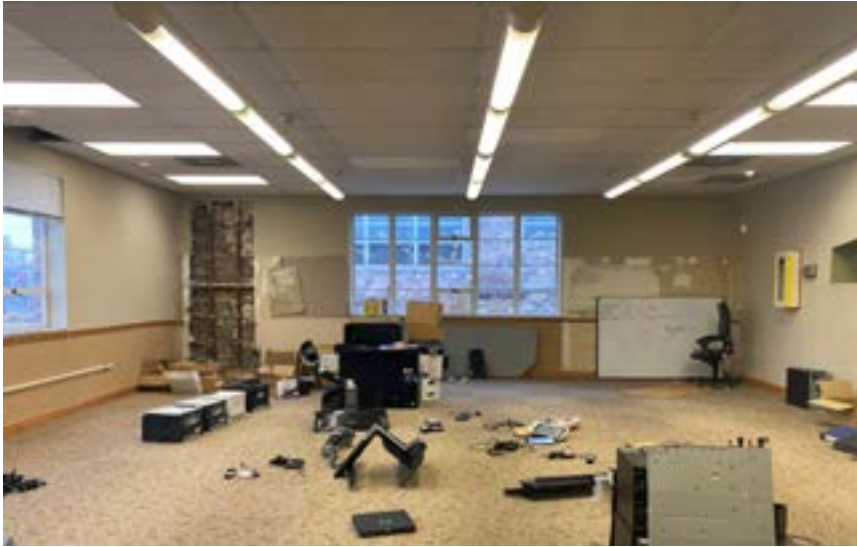
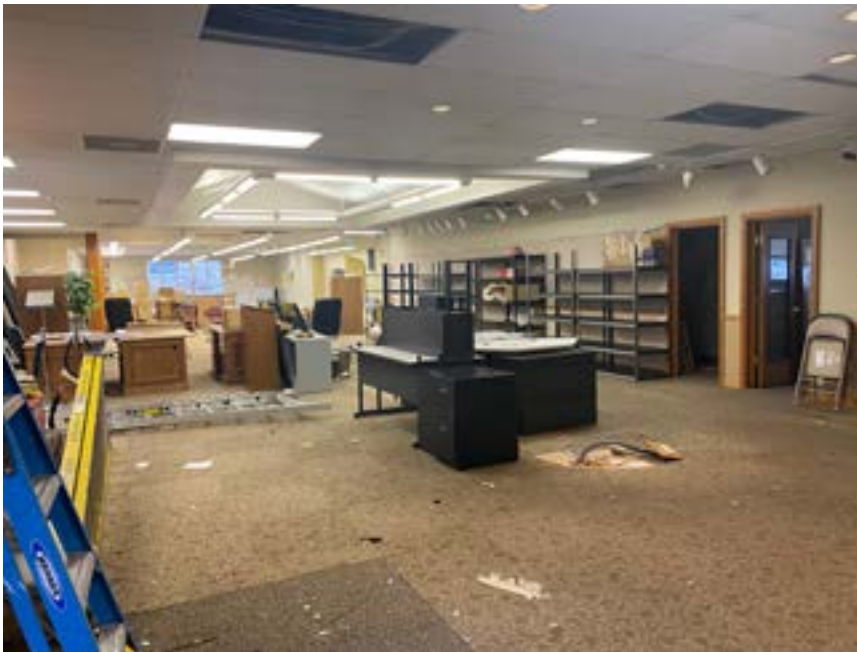
Interior ceiling condition, looking north.

Because the ceiling of the central block was higher currently there is a gabled design with hard gypsum board finishes in the central block. Above this is ostensibly the original ceiling, though it was not directly observed.

The newer ceiling is in good condition, however its design is inconsistent with the time period of the original space.

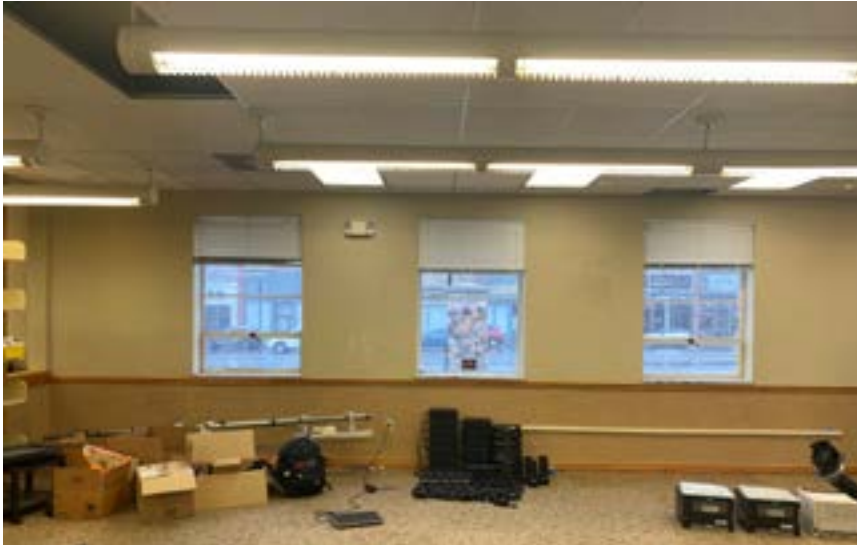
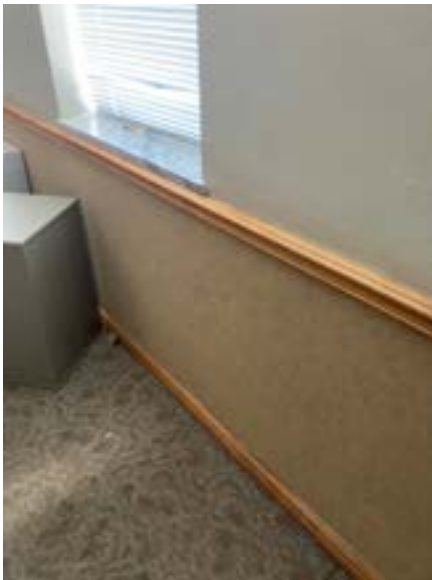
Wall condition, looking west.

Wall condition, showing existing finishes.

As stated the interior walls are mostly original, and all are in very good condition. If original, they are likely to be framed to the underside of the structure.

The finishes are mostly in good condition outside of normal wear and tear.

1. Some of the new work is required by structural such as the collector walls that divide up the existing space where the central block meets the north and south wings of the building.
2. The north vestibule on the west side should be reconstructed to match the vestibule on the south.
3. New vestibules should be constructed at the north and south entries on the east elevation. The new entry doors should be reconfigured to meet the required code clearances.
4. Because the structural upgrade is calling

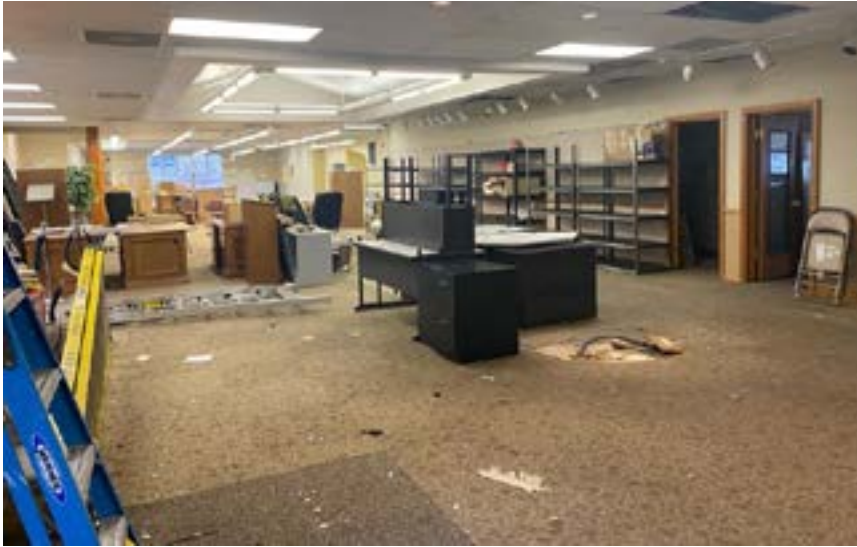
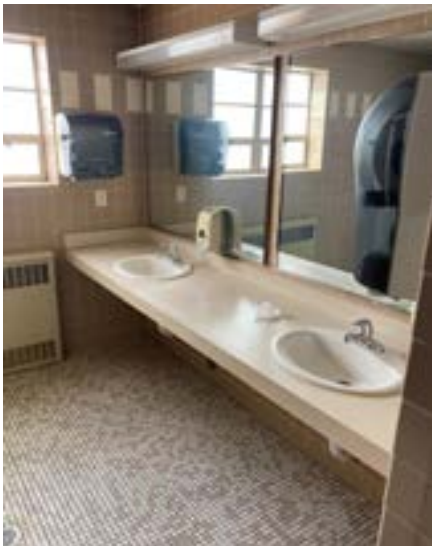
Flooring condition, showing existing finishes.

The flooring, the carpeting and the tile in the restrooms is in fair condition. The carpeting has water damage in areas where water has leaked into the building.

1. Because the structural upgrades require that the existing flooring and subflooring be removed, even though it is in fair condition, it will be removed.
2. New sheathing per structural will replace the original diagonal sheathing.
3. New carpeting (Carpet tiles) should be installed throughout except for the restrooms, mop rooms, etc. where new tile will be installed.

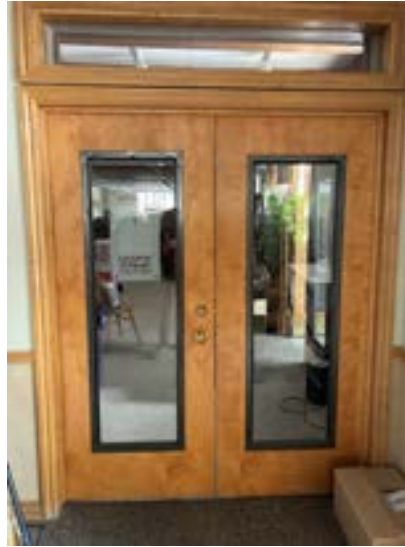
New door condition, at LeConte Stewart entry.

are extant in the building. Newer doors have been installed which mimic the finishes on the original doors such as the doors on the Le Conte Stewart Room. The original doors have a boondend pattern on the veneer, the newer doors do not.

The original doors are in good condition overall, though they lack accessible hardware throughout.

1. The existing original doors should be restored. The hardware should be replaced to meet accessibility standards.
2. New doors should replicate the original, especially the new vestibule doors at the entry points.

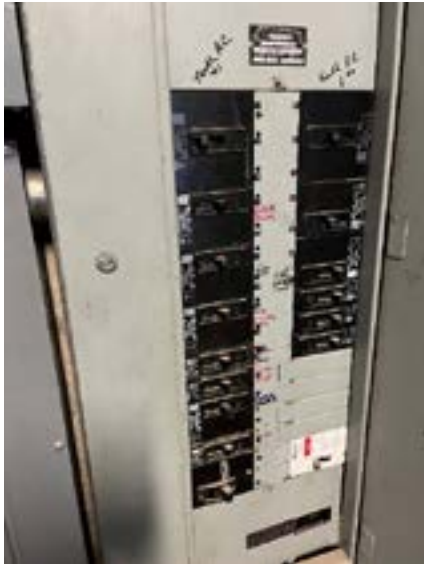
Existing 3 phase, 120/240V high leg panel

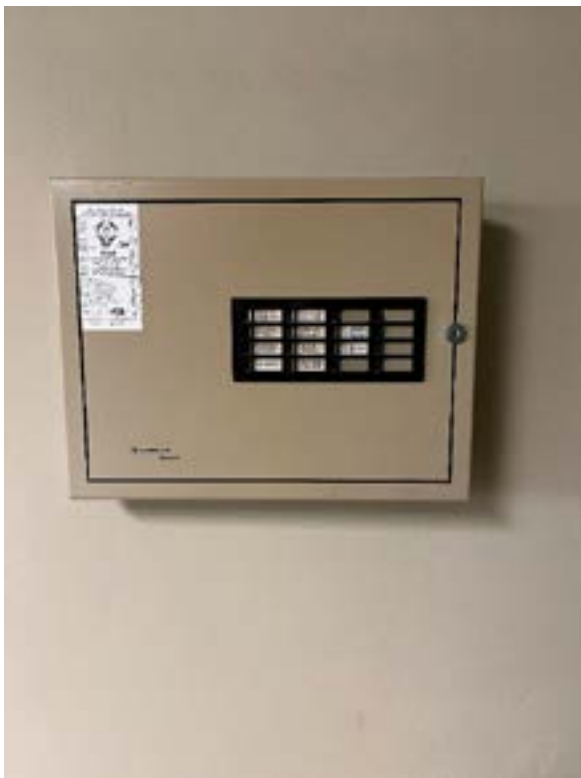
Old panel (unless desired by Owner or if monitoring other items, could be deleted)

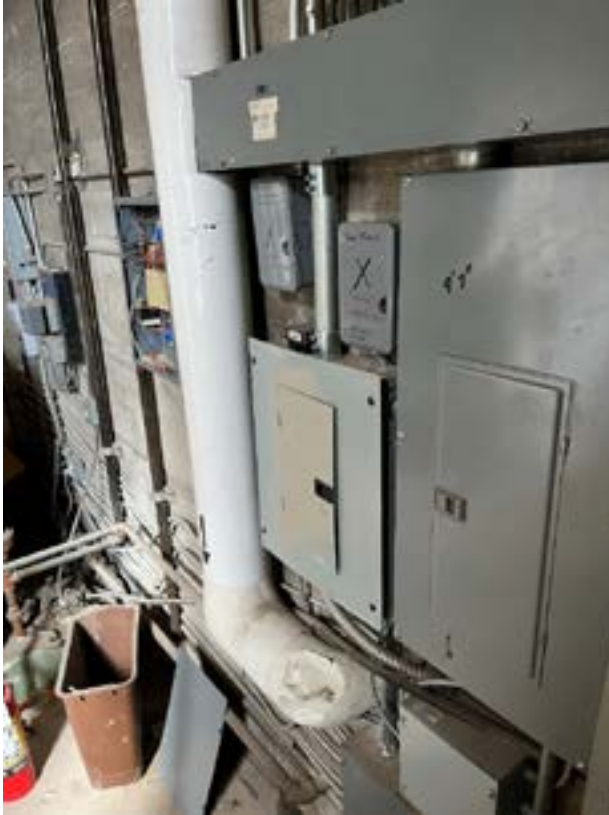
Panel with plumbing piping running underneath.

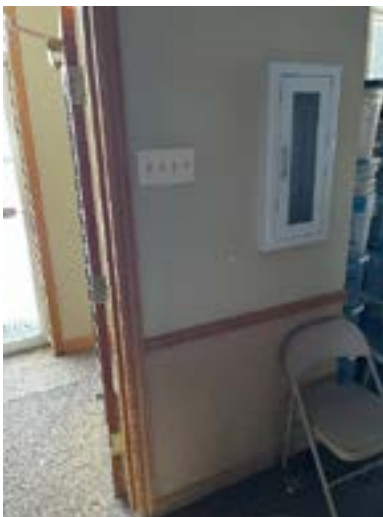
Light switches above ADA height.
